C.O. BRAWNER ENGINEERING LTD.
Consulting Geotechnical Engineers

October 23, 1995

Re: Mt. Polly Tailings Dam

The Mt. Polly Tailings Dam site was inspected with George Headley on Thursday, October 19, 1995. Photographs of the site are appended.

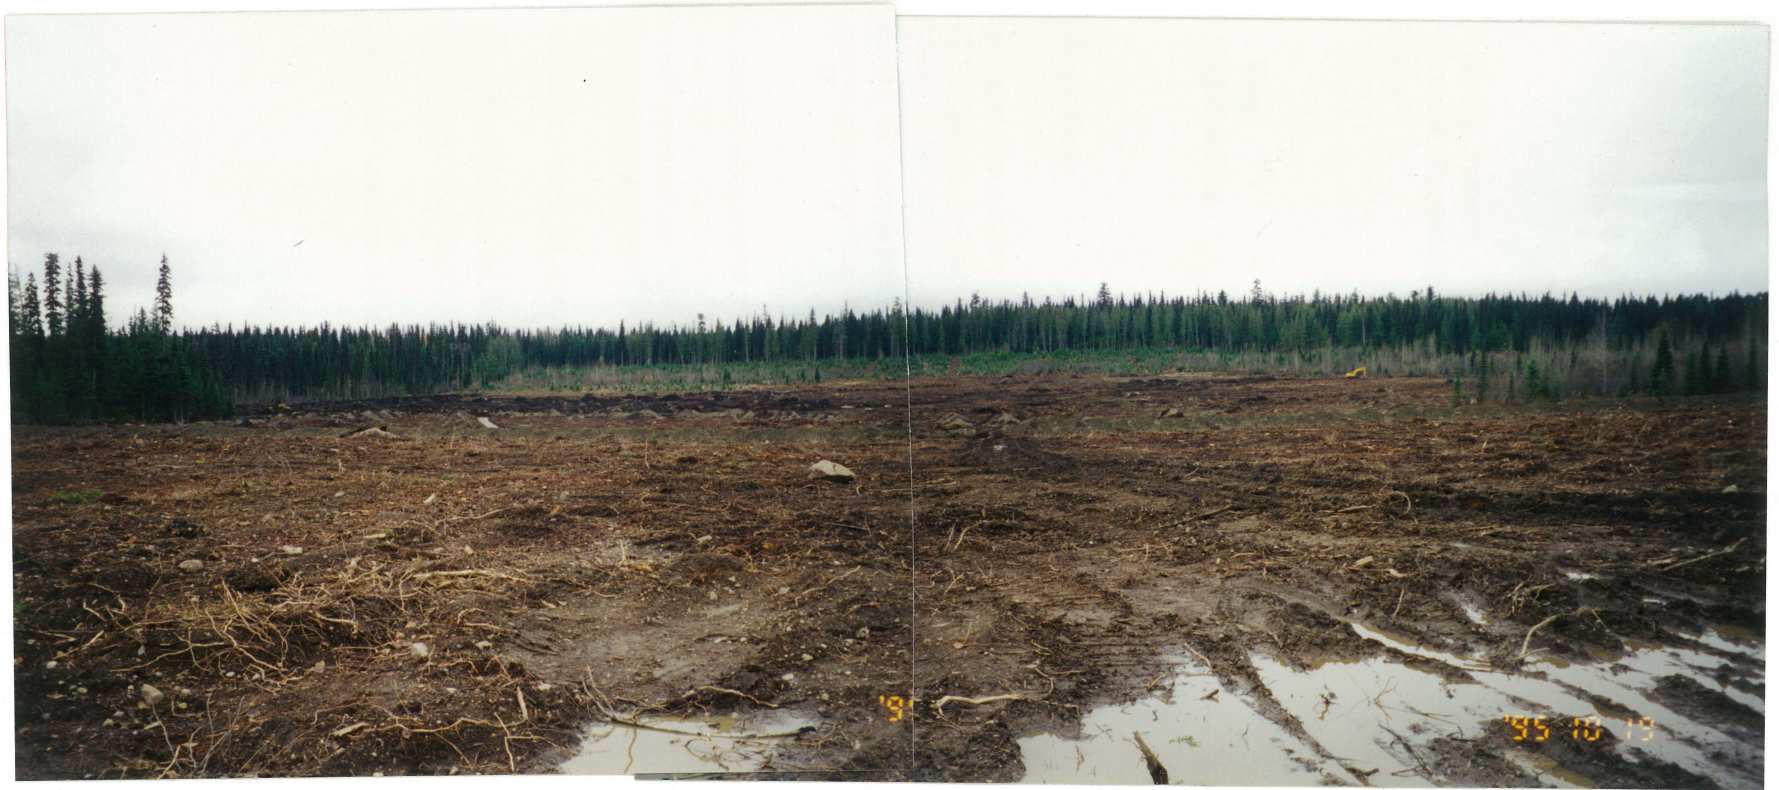
The site has been cleared of vegetation and numerous surface drainage trenches have been developed. The organic overburden has not been removed. All test pits have been filled back in.

Photo 1 - Looking west across the site of the main dam. The site has been cleared and drainage ditches have been installed. The surface organics have not been removed. Test pits have been backfilled.

All of the organic overburden must be removed.

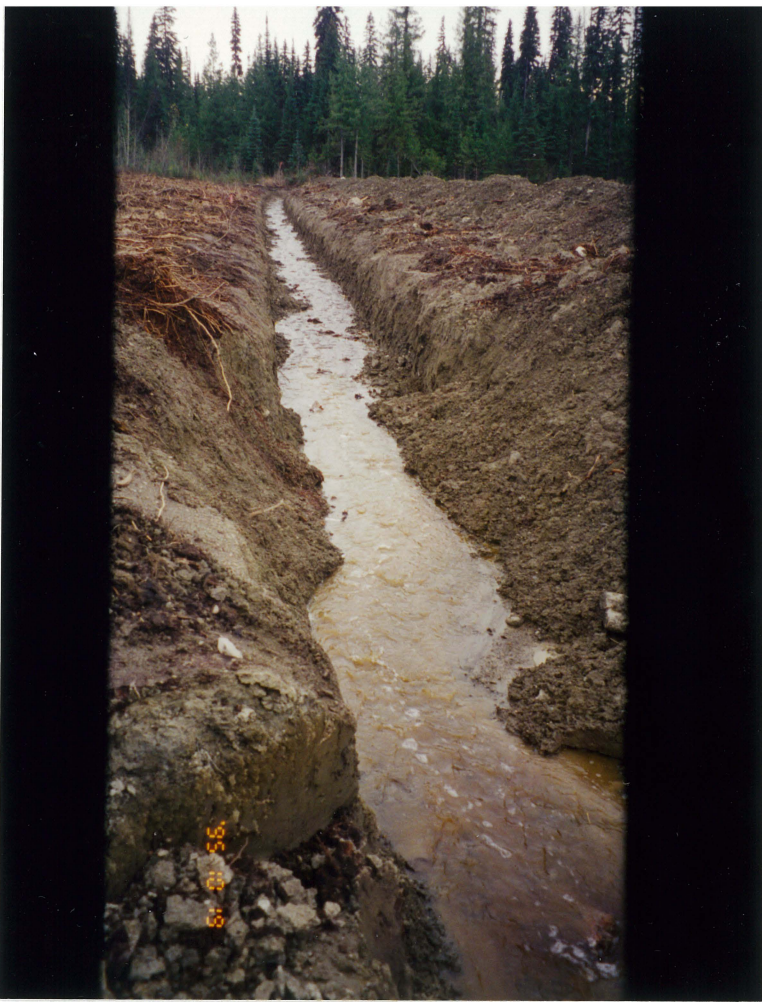
Photo 2 - Ditch excavated to contain a small creek across the site. The southern portion of the ditch is in medium dense to dense glacial till and the southern portion is in glacial lacustrine soils. Note the transition from stable side slopes to ravelling slopes. Easterly end of the dam.

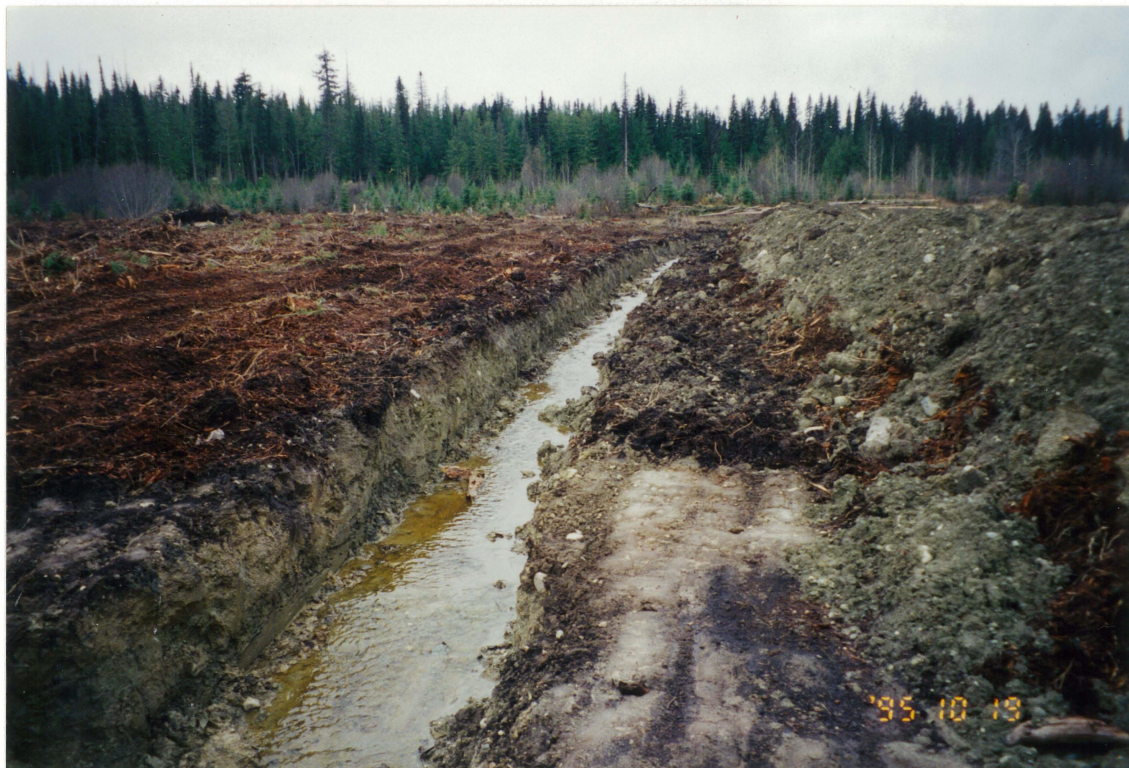
Photo 3 - Looking North along the westerly portion of the dam site. Drainage ditch in glacial till.

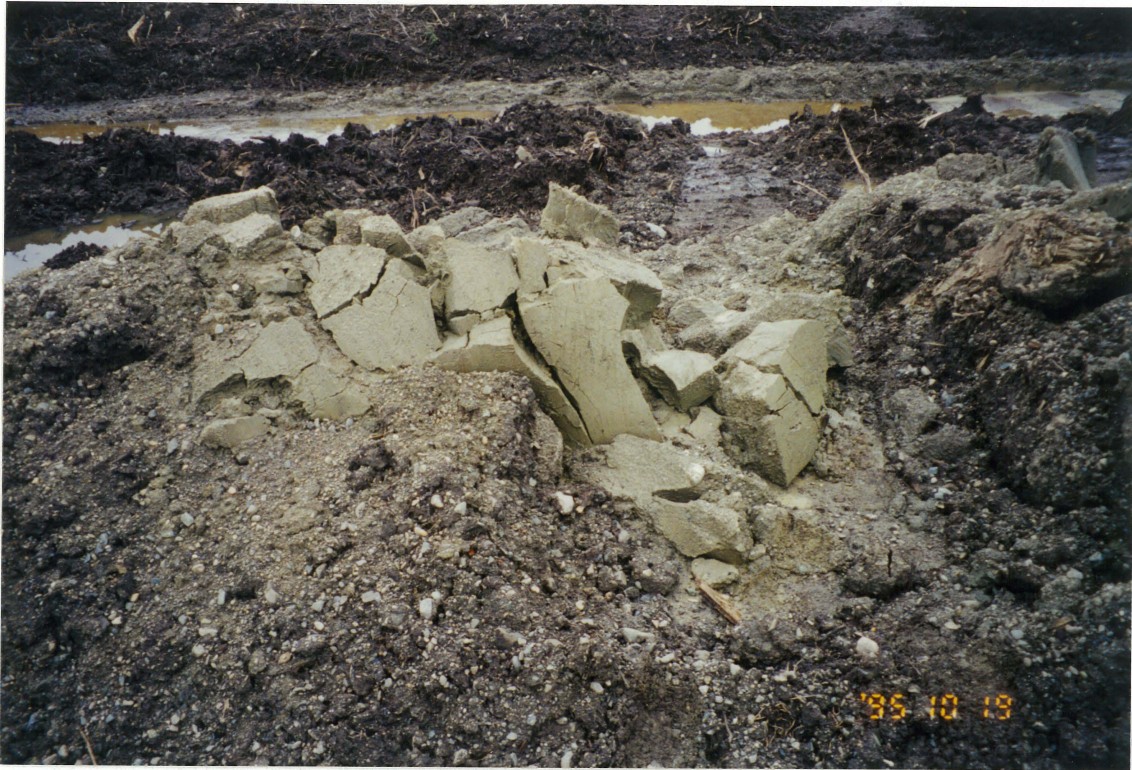
Photo 4 - Excavated medium dense glacial lacustrine clayey sandy silt. This material has medium strength, low permeability and medium-low compressibility.

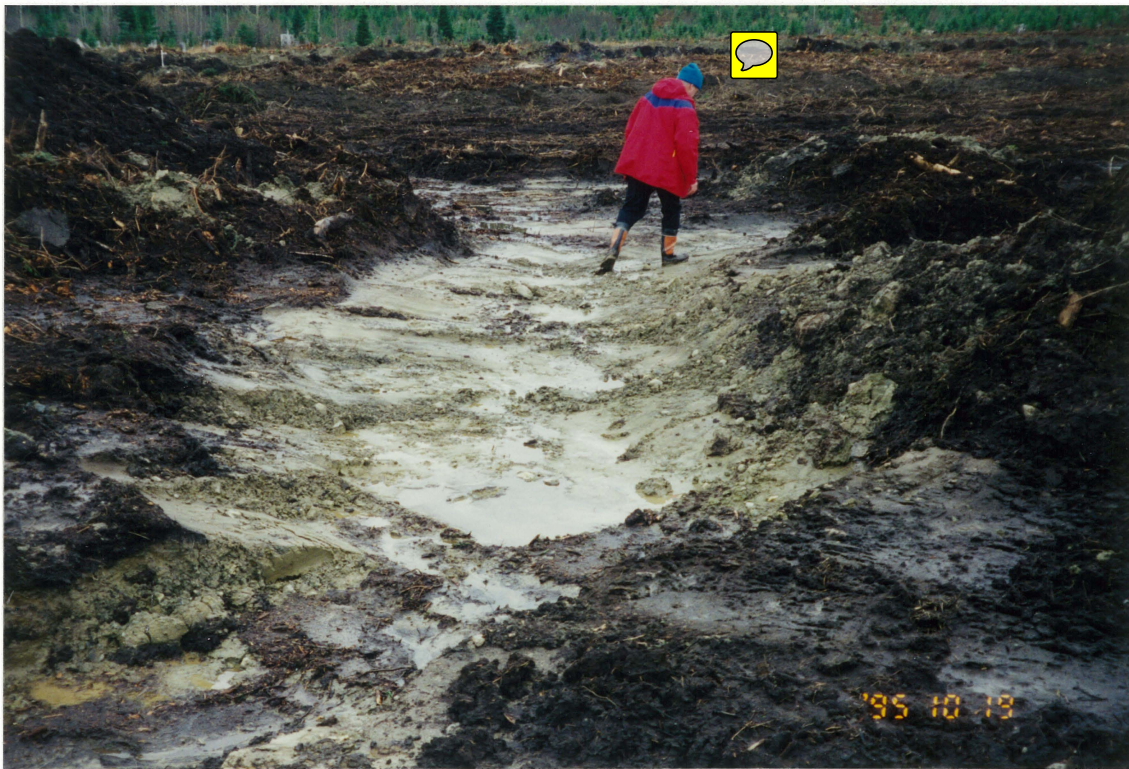
Photo 5 - Glacial till surface exposed by removing organic overburden. The exposed surface is slippery. Prior to placing and fill the surface must be scarified.

The excavation of the surface glacial till leaves a smooth surface. To tie the first layer of fill and disrupt the smooth surface, that surface must be scarified.

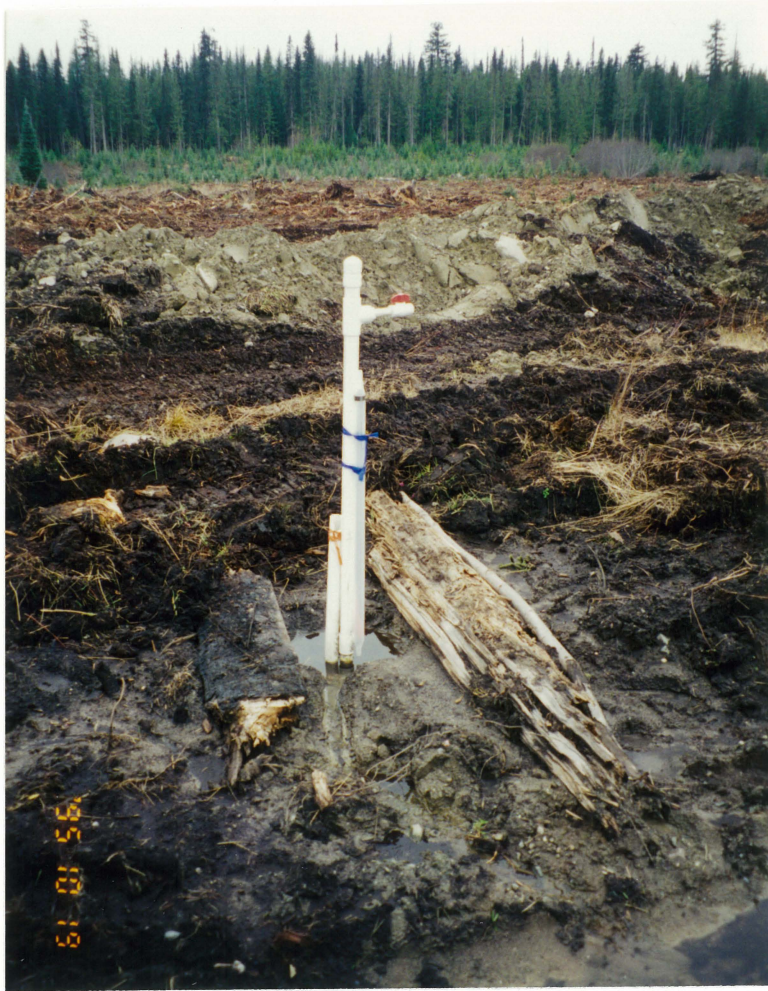
Photo 6 - Piezometer installed with water sampling capability. Toe area of the main dam.
