MOUNT POLLEY MINING CORPORATION

Re: Geotechnical Inspection Report, September 24, 2012

REPORT OF GEOTECHNICAL INSPECTOR

Date of Inspection: September 24, 2012

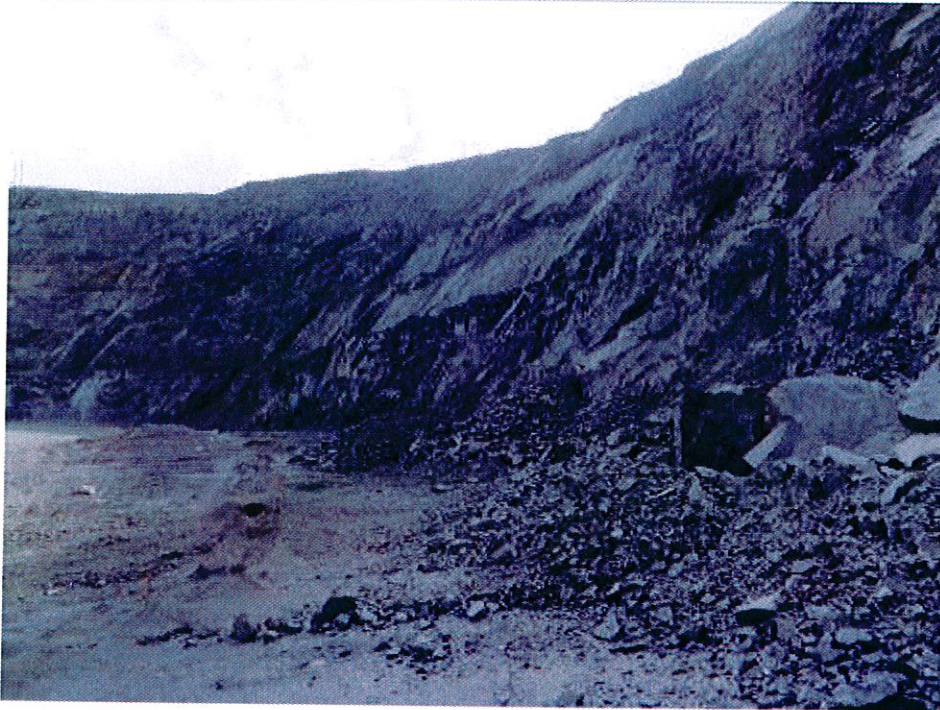
The Springer Pit utilizes either 12m or 24m high bench faces using a multi bench mining system. It is understood (although not confirmed) that the benches are designed to be either 8 or 12m wide. The Mine uses pre-shear holes on all its final walls; we noted that only about 10% of the ½ barrels from these blasts are still present on the final walls. Significant geologic structure is present that control bench stability; in some instances the benches are lost entirely due to structure, see Photo 1. In many cases there is crest breakback of between 2m and 5m due to structure, see Photo 2 and 3.

Photo 1: Springer Pit. Benches lost entirely above 1036 bench due to adverse geologic structure. Note that drilling was recently completed 12 m from the toe and that minor rockfall has run out as far as these holes.

Within 15 Days the Mine shall submit an analysis of the rockfall hazard from highwall above the southeast side of the 1036 bench where benches have been lost and highwall is effectively greater than 36m.

- This area of the Springer pit will be reviewed on the October 24 site visit by Al Chance of Golder Associates, with any resulting alterations to their current design parameter recommendations incorporated into pit designs. A table summarizing pit design parameters currently recommended by Golder is included below. These parameters reflect observations and updates by Golder as recent as September 2011.*

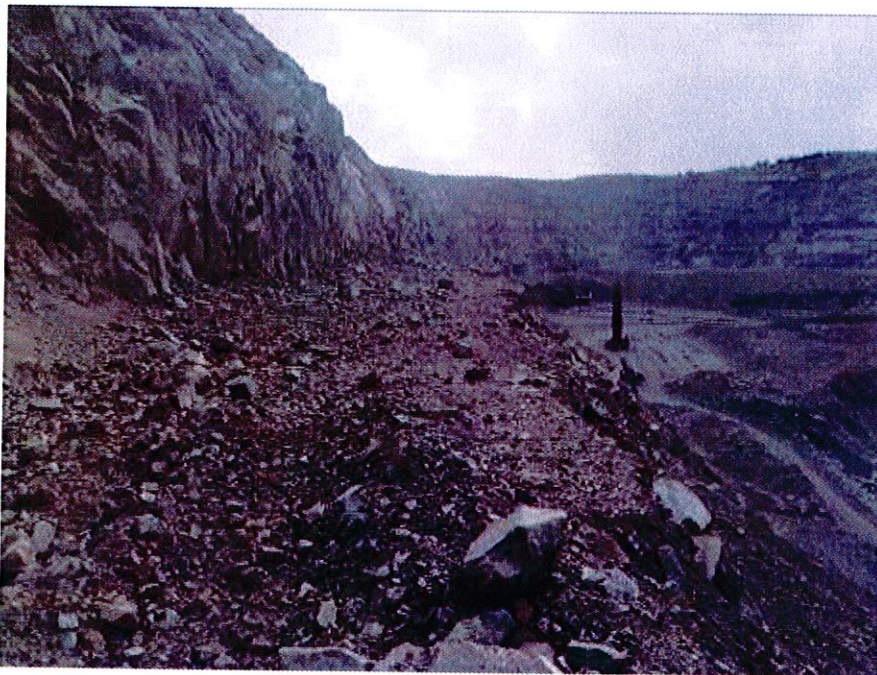
The geologic structure is resulting in rockfall; in some segments of the pit there is only isolated block fall, see Photo 3. In other areas of the pit there is more regular fall of rocks, see Photo 2. On occasion there are areas of rockfall that completely fill the bench, see Photo 4.

- The western segment has 24m high bench faces. Bench width ranges from 14m to 7m (this indicates that there is up to 5m of crest breakback). The benches are generally clean with only isolated rockfall, see Photo 3. Rockfall was noted to have run out up to 12m from the toe; this indicates potential for rockfall to cascade over benches where the crest is lost.
- The northeastern segment has 12m high bench faces. Bench width ranges from 6.5 to 8.5m (this indicates that there is up to 1.5m of crest breakback assuming benches were planned to be 8m). Much small rockfall is present, see Photo 2, however the benches are not full and are still capable of catching rockfall. Rockfall was noted to have run out up to 8m from the toe; this indicates potential for rockfall to cascade over benches where crest breakback occurs.

Photo 2: Northeast side of 1072 Bench. Crest break back has resulted in almost 50% of bench having a width less than 8m. Note that much rockfall is present but benches are not full.

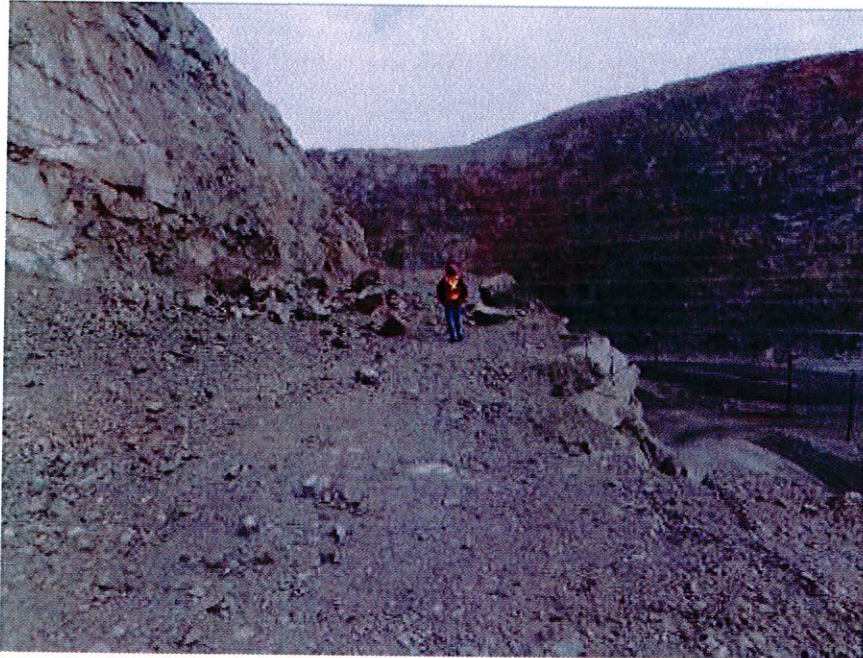
Photo 3: South side of 1072 Bench. Crest break back on geologic structure locally reduces bench width from the planned 12m down to 7m. Note only isolated rockfall blocks.

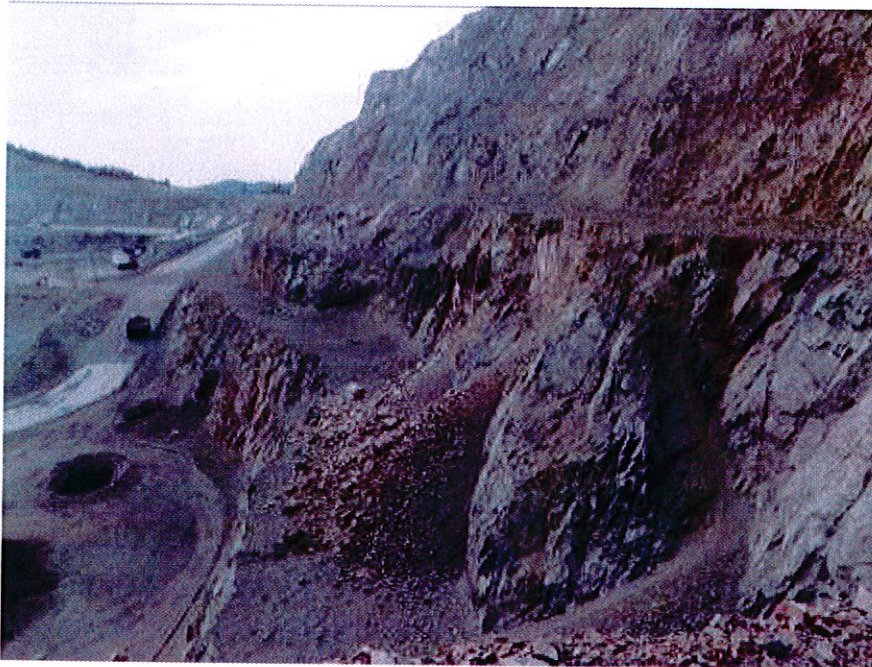
Photo 4: Accumulation of rockfall on 1048 bench poses a rockfall hazard to persons below. Note that drillers were recently working within about 12m of the toe and a pipe line is located along the toe on 1024 bench.

Clean off rockfall accumulation in northern corner of 1048 bench, or otherwise address the rockfall hazard as per Section 6.23.2 of the Code.

- This area was cleared off and loaded out using an excavator on October 8, 2012.

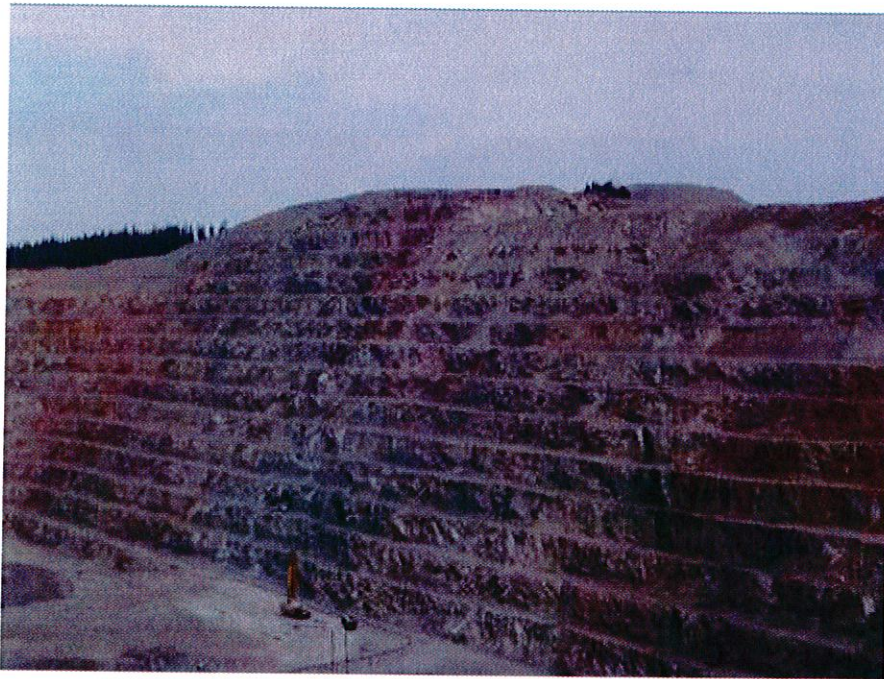
The Phase 4 pushback for the Springer Pit has commenced. It is understood that ultimately the Springer Pit will incorporate the Caribou Pit. Material from the pushback is filling the upper benches of the existing pit. This will eventually create a situation where rockfall material may cascade down slope and potentially cause a hazard to those working below.

Photo 5: Material from push back is progressively filling upper benches resulting in loss of rock fall catchment and rock cascading down pit.

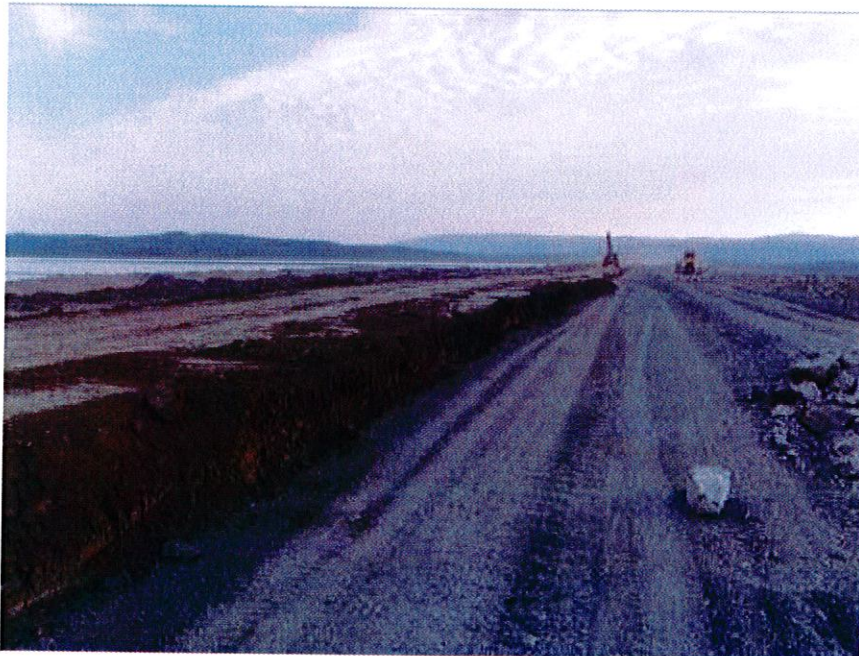
The Stage 8 dam raise to elevation 963.5m was underway at the time of this inspection. EMNG has previously reviewed and accepted the designs for this lift. We reviewed placement procedures for the till core and filters, see Photo 6. We also observed sand cell construction on the upstream side of the west dam and discussed the problems and potential impacts of limited sand placement on the central dam due to gravity placement limitation, it is understood that the Mine's consultants (AMEC) will be reviewing. We also inspected the keyway tie in on the South Dam. All construction appears to be well done. A quality control and quality assurance program is in place and it is understood that there have been no significant issues. The Mine reports that instrumentation has responded as expected during construction. It was noted that some of the instrumentation is not well protected from potential construction equipment damage and recommend that this be remedied.

Photo 6: TSF. Stage 8 till and filter construction. To facilitate compaction till is placed at 2:1 slope beyond line then trimmed back.
