**MOUNT POLLEY MINING CORPORATION
MOUNT POLLEY MINE**

**TAILINGS STORAGE FACILITY
REPORT ON 2010 ANNUAL INSPECTION**

**TAILINGS STORAGE FACILITY
REPORT ON 2010 ANNUAL INSPECTION
(REF. NO. VA101-1/29-2)**

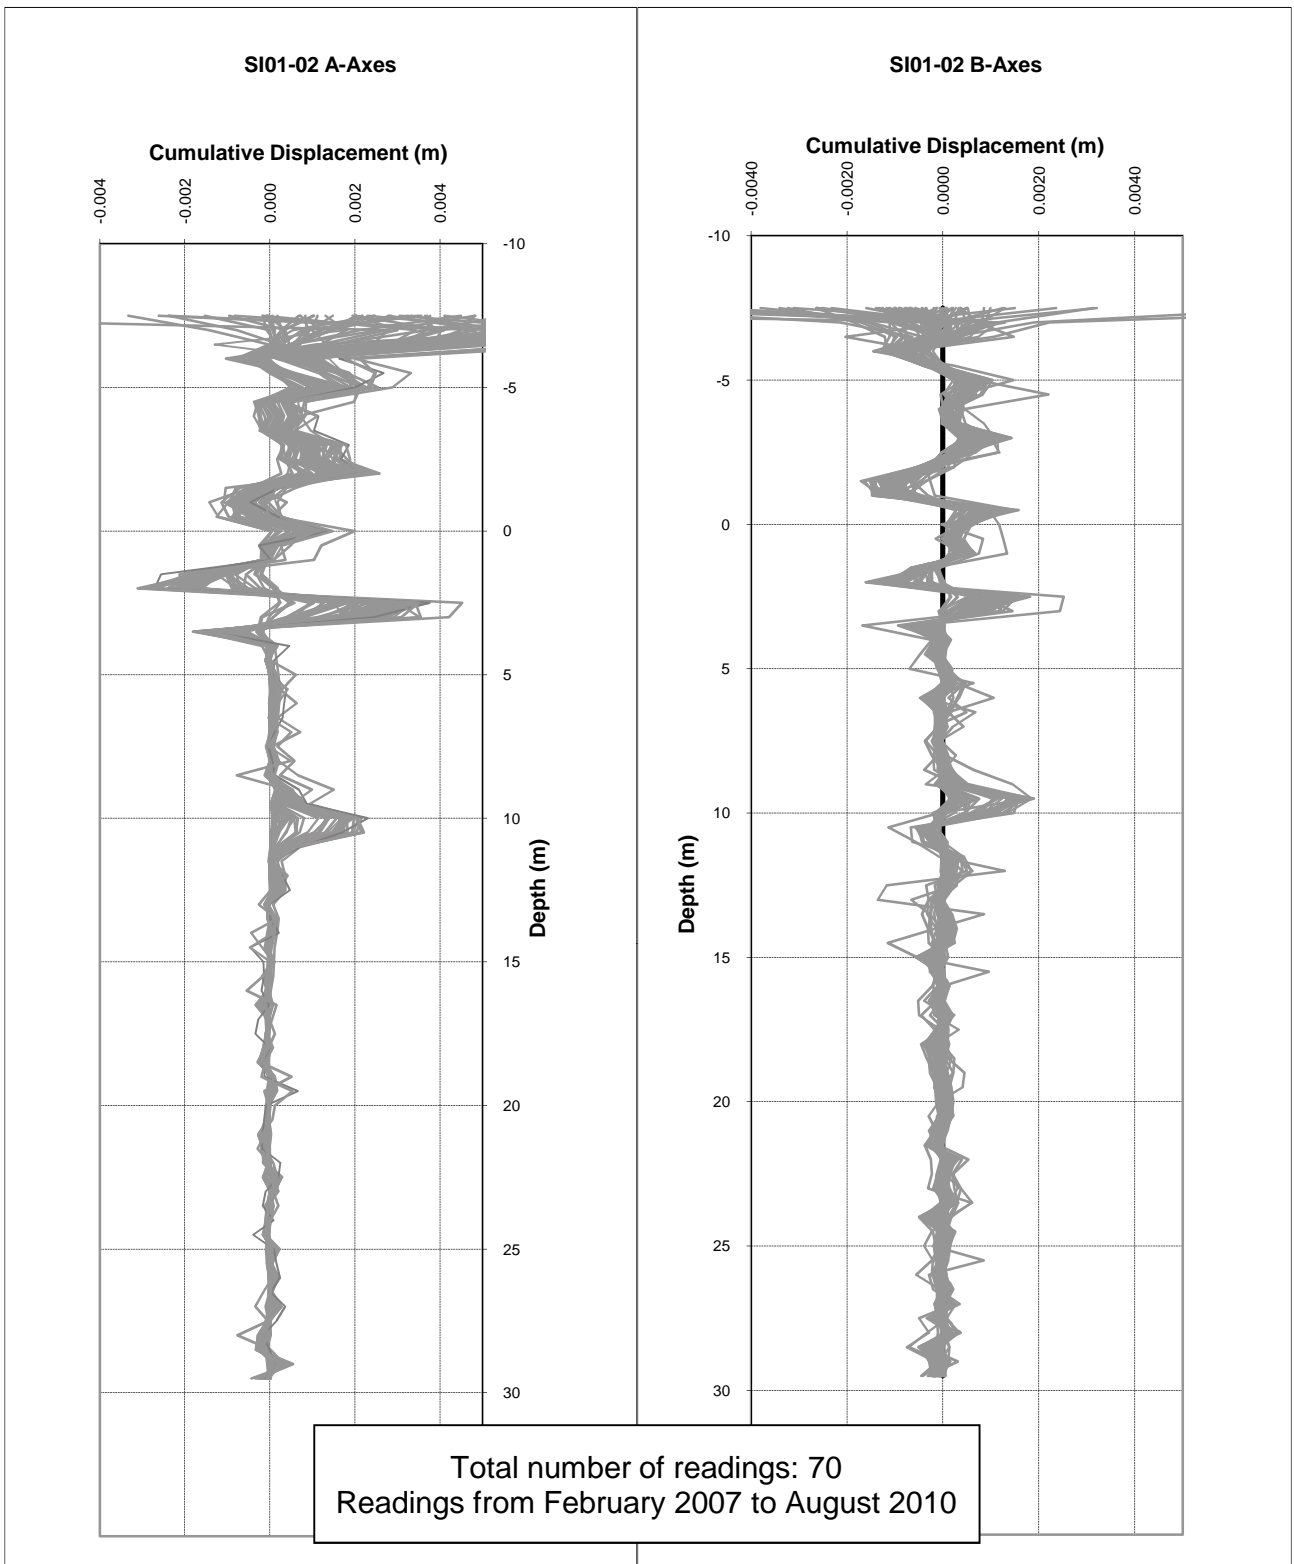
- Slight deviations measured in the lacustrine unit in Inclinator SI01-02 resulted in the recommendation for constructing a downstream buttress². The results of the stability assessment recommended a buttress be constructed downstream of the Main Embankment to an elevation of 920 m for a crest elevation of 958 m, the crest elevation for the Stage 6b embankment. The Stage 6b buttress footprint, which extends to both sides of the Main Embankment Seepage Collection and Recycle Pond, is shown on Drawing VA101-1/29-210. The letter also recommended that the buttress be constructed prior to the commencement of the Stage 6b construction program, which did not happen.

MOUNT POLLEY MINING CORPORATION	
MOUNT POLLEY MINE	
TAILINGS STORAGE FACILITY STAGE 6B DOWN HOLE INCLINOMETER CUMULATIVE DISPLACEMENT SI01-02	
	P/A NO. VA101-1/29 REF NO. 2 FIGURE B4 REV 0

It is recommended that the Main Embankment buttress requirements and timing be re-evaluated as part of the Stage 7 design of the TSF.

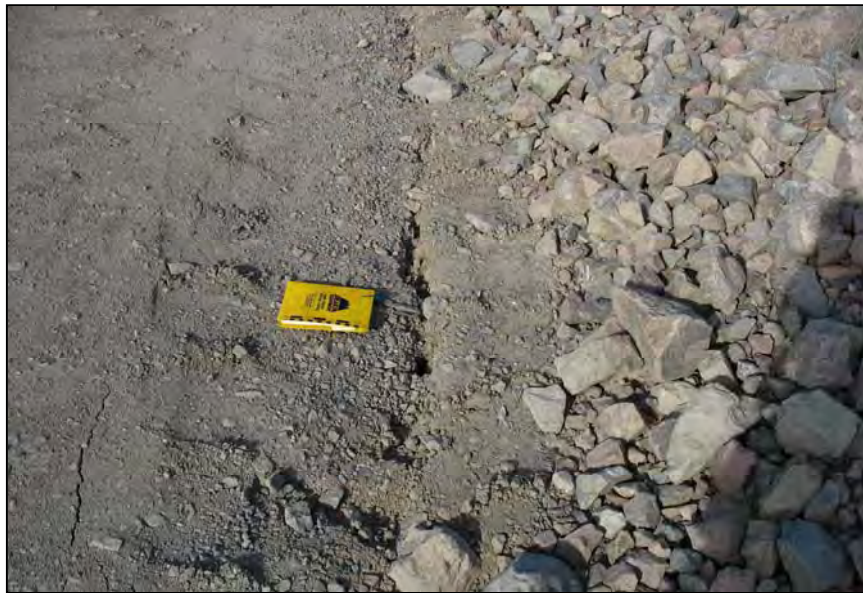
- A tension crack was observed at the Perimeter Embankment at an approximate chainage of 3+400. The tension crack is in the Zone C material at the downstream edge of the embankment crest. The tension crack was apparently identified two months earlier by the grader operator and was approximately 10 to 15 m long. The area has since been graded over but portions of the tension crack are still visible. The location of the tension crack in relation to the downstream slope is not an uncommon occurrence in rock slopes as the outer edge of the material typically receives less compaction effort. A tension crack does not necessarily indicate a plane of weakness in fill materials but it can't be ignored either. The tension crack is located on a section of the Perimeter Embankment located upstream of the Zone S borrow area.

PHOTO 6 – Tension Crack at the Perimeter Embankment.

It is recommended that a stability assessment be completed for this area to assess whether the borrow area configuration has any impact on the integrity of the current, and ultimate embankment section. It should also be noted that the identification of a tension crack, or any other abnormal observation at the tailings dam, should be reported to the design engineer immediately and prior to any remedial action being taken.
