MEMO

Project No.: KX05414

Subject: Mt. Polley Tailing Facility Field Review

This memo presents the day by day account of activities, observations, and recommendations made by AMEC for the Mount Polley Mine tailings storage facility (TSF) during the period of May 25 to May 29, 2014. Please find attached figure for location references and selected photos.

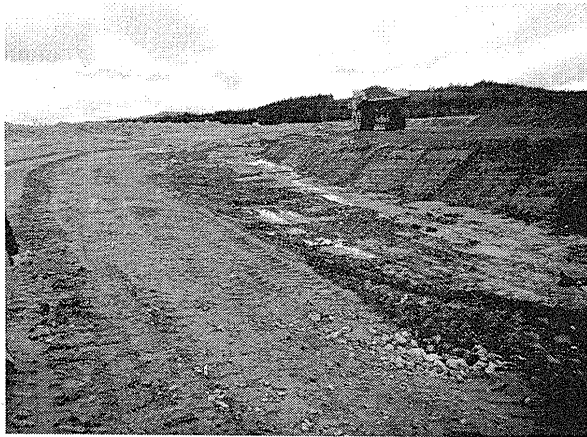
- Dmitri Ostritchenko of AMEC arrived on site at 11:00 am.
- AMEC reviewed the conditions at corner 3, no direct seepage over the core, or significant erosion was noted in or around the identified low area.

- Corner 3 (approximately stn.1+500 to 1+600) – 966.3 m (the low area was localized to a smaller section between stn. 1+565 to 1+579).
 - Corner 2 (approximately stn. 2+270 to 2+800) – 966.4 m, no seepage noted.

Photo 1: Corner 3, May 26

- Reconfirmed the recommendation to divert water away from the TSF, and remove water from the the TSF to establish the required minimum freeboard as previously noted.
- Increase instrumentation monitoring frequency from bi-weekly to a weekly readings, and conduct a new set of readings as soon as possible.
- Maintain ongoing surveillance of the localized low spots along the TSF core and establish upstream berms to provide temporary required freeboard for the TSF.
- Address all the low spots to establish a minimum core elevation of 967.0 m along the entire crest of the TSF.

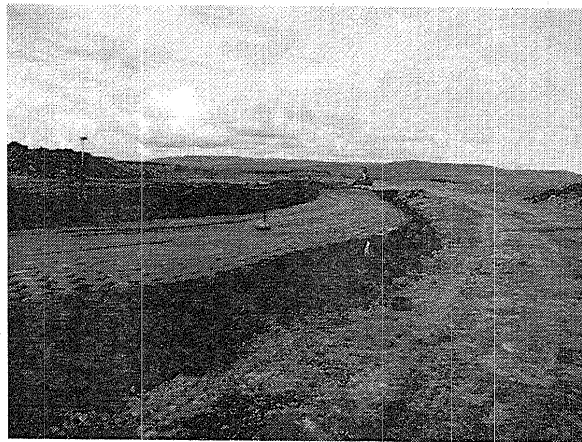
- AMEC attended a meeting with the Mine Superintendent and MPMC Engineering department to discuss and assign strategies/priorities for diverting water away from the TSF facility.
- AMEC observed core construction at Corner 3 to raise the effective elevation of the core to 966.7 m. Additional seepage noted during construction. At the lowest section, the construction work was deemed to be temporary; as a minimum core width of only 4 m was established (minimum 5 m core width is required as per design).
- No seepage was noted at corner 2 or corner 5.
- A low spot in the core was observed at the perimeter pipe crossing (approximately stn. 3+950 to 4+000). Standing water noted to be present on the core, no major erosion or water movement was noted. The surveyed low point of the core at this location was 966.2 m.
- The pond elevation was reported to be at 966.4 m.

Photo 2: Corner 3, end of day May 27

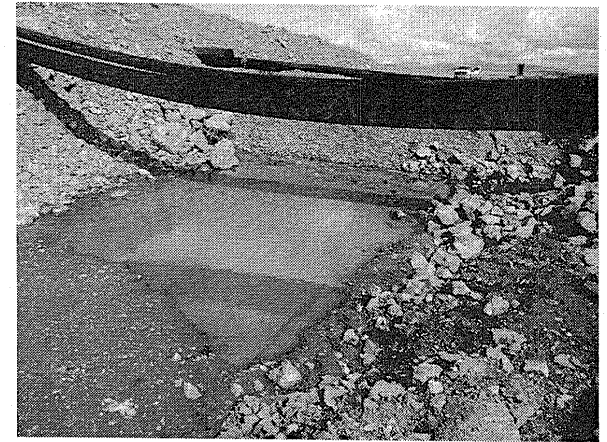
Photo 3: Standing water over the core at perimeter pipe crossing on May 27th

- Verify the source of the standing water found at perimeter pipe crossing.
- Establish an upstream berm to provide a temporary freeboard at the perimeter pipe crossing.
- Continue to monitor all the low core locations for changing conditions on a regular basis.
- Lower the pond level to establish the required freeboard.

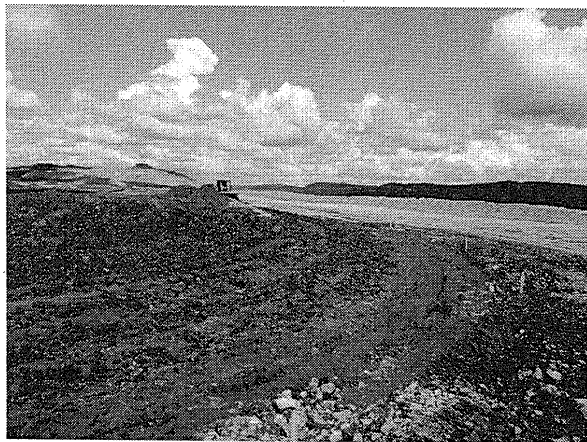
Photo 4: Corner 2, May 28 prior to core construction

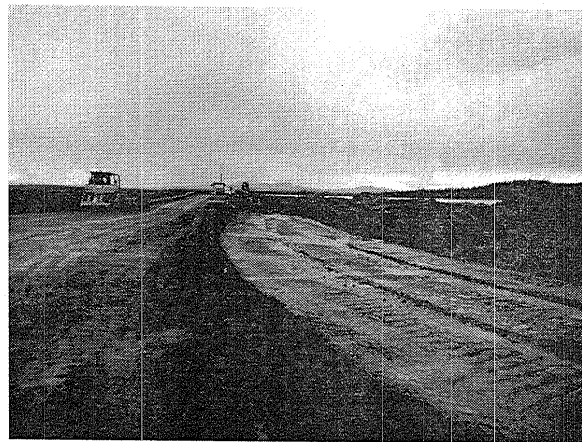
- AMEC observed till placement for establishing a minimum core elevation of 967.0 m at corner 3. A 4 m wide core section between elevation 966.2 to 966.5 remains and will have to be addressed as this lift was deemed to be temporary.
- AMEC observed core construction at Corner 2 to establish an effective elevation of the core to 966.7 m. The material was placed/sealed but was not compacted due to a change in weather.
- AMEC observed core construction at perimeter pipe crossing to an effective core elevation of 966.3 m. Due to bad weather additional core construction was not possible. Thus an upstream berm around the perimeter pipe crossing was established at the end of the day to provide temporary freeboard.
- No seepage was noted at corner 5.
- The pond elevation was reported to be at 966.37 m.

Photo 5: Corner 2, May 28 end of day

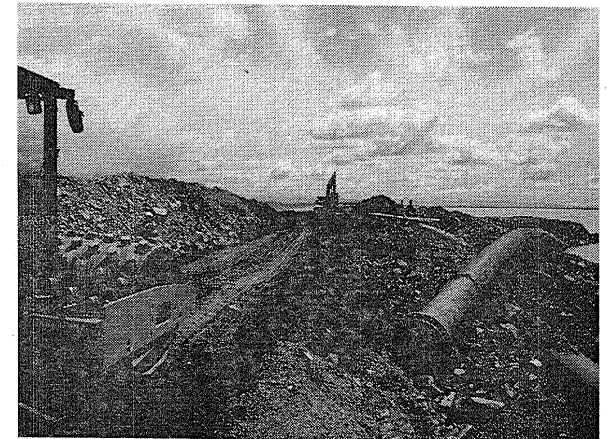
Photo 6: Till compaction at perimeter pipe crossing on May 28th

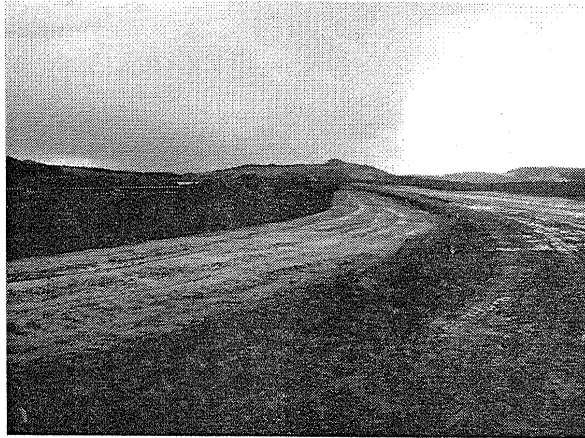
Photo 7: Corner 3, May 28

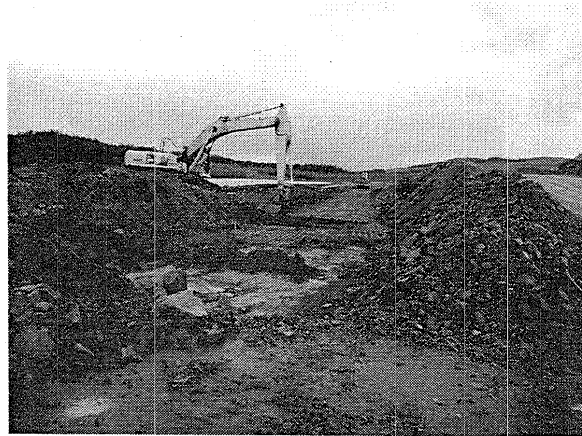
Photo 8: Establishing a temporary berm at perimeter pipe crossing due to weather on May 28

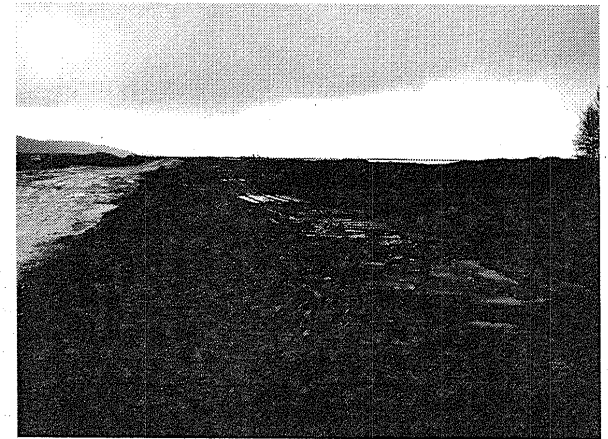
Photo 9: Corner 5, May 28

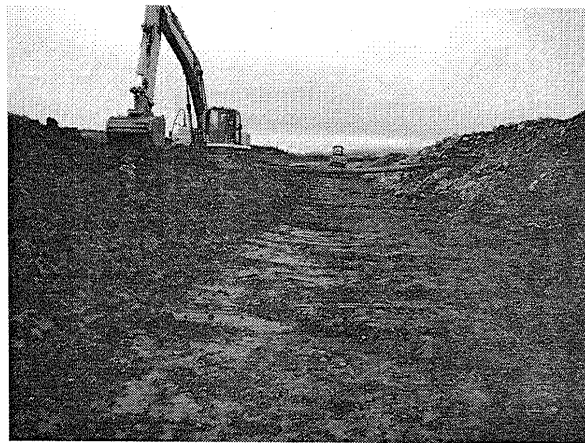
Photo 10: Perimeter pipe crossing, prior to construction on May 29

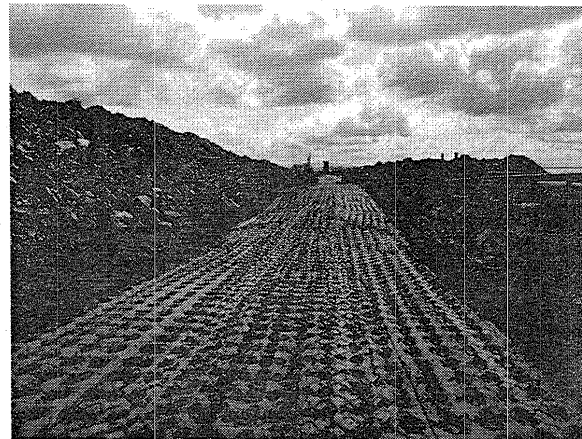
- AMEC observed core construction at the perimeter pipe crossing and an effective core elevation of 967.0 m was established with the last lift of (between 966.7 to 967 m) material being placed/sealed but not compacted due to change in the weather.
- No seepage was noted at corner 5.
- The pond elevation was reported to be at 966.45 m.
- Luke Marquis of AMEC arrived on site and will remain to monitor progress for planned works.

Photo 11: Perimeter pipe crossing construction on May 29

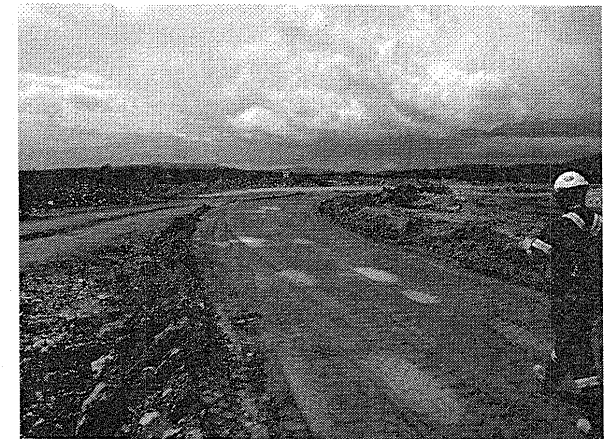
Photo 12: Corner 3, May 29
