MOUNT POLLEY MINE TAILINGS STORAGE FACILITY BREACH

August 4, 2014

Investigation Report
of the Chief Inspector of Mines

MOUNT POLLEY MINE
MOUNT POLLEY MINING CORPORATION
SUBSIDIARY OF
IMPERIAL METALS CORPORATION

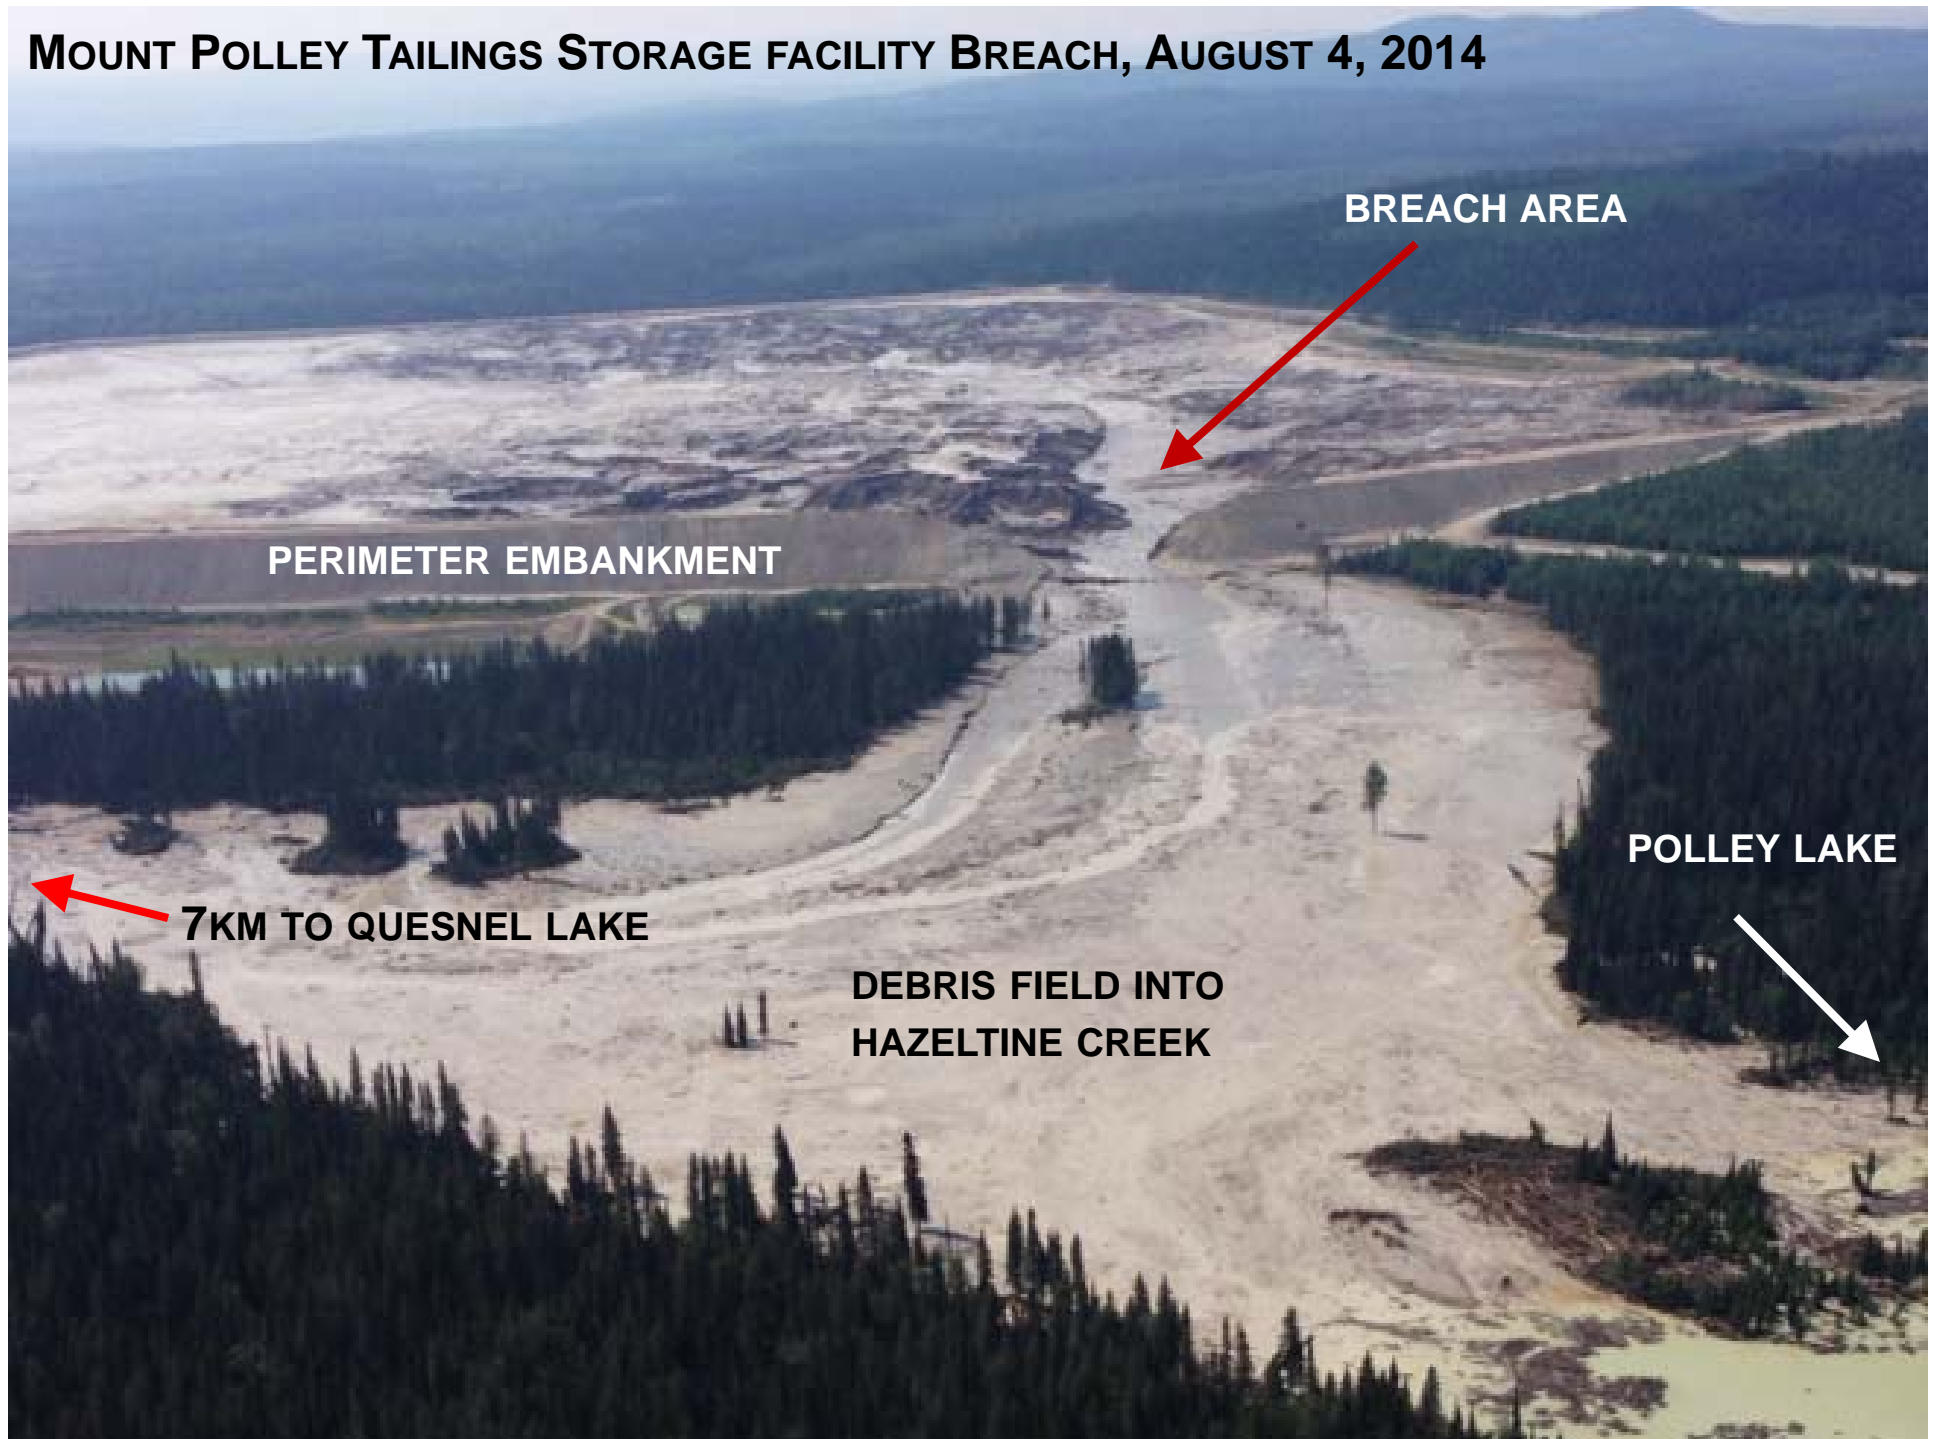
MOUNT POLLEY TAILINGS STORAGE FACILITY BREACH, AUGUST 4, 2014

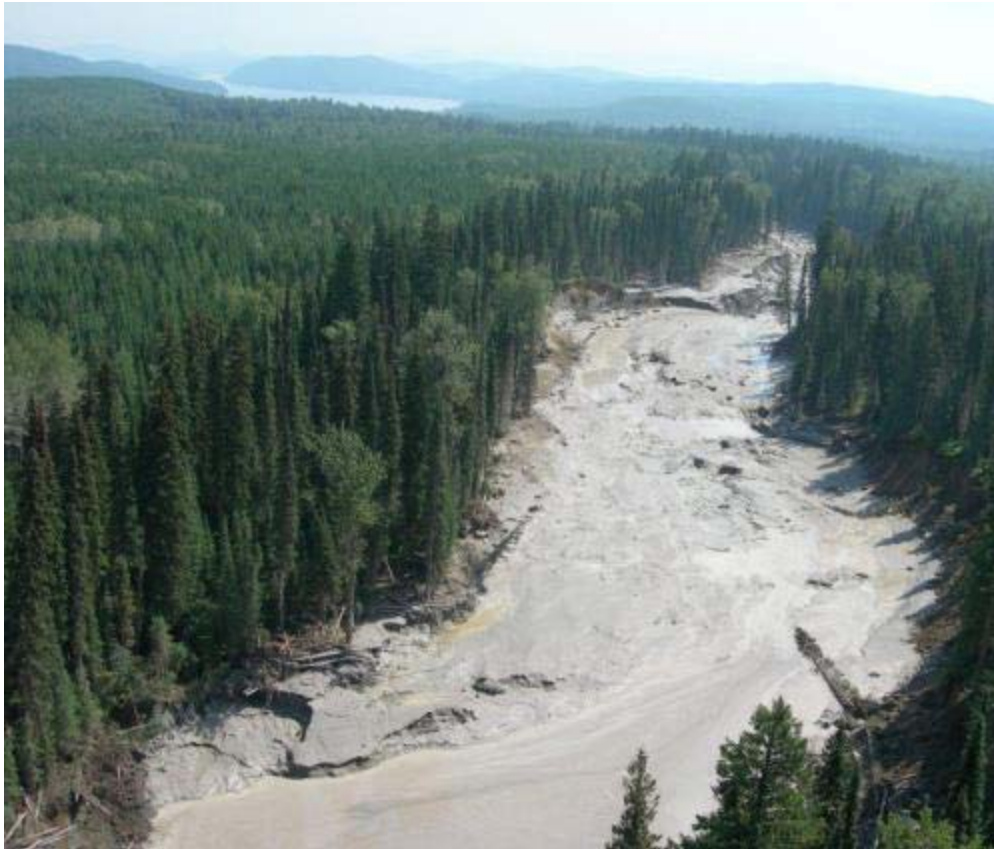
**DEBRIS FIELD THROUGH
HAZELTINE CREEK**

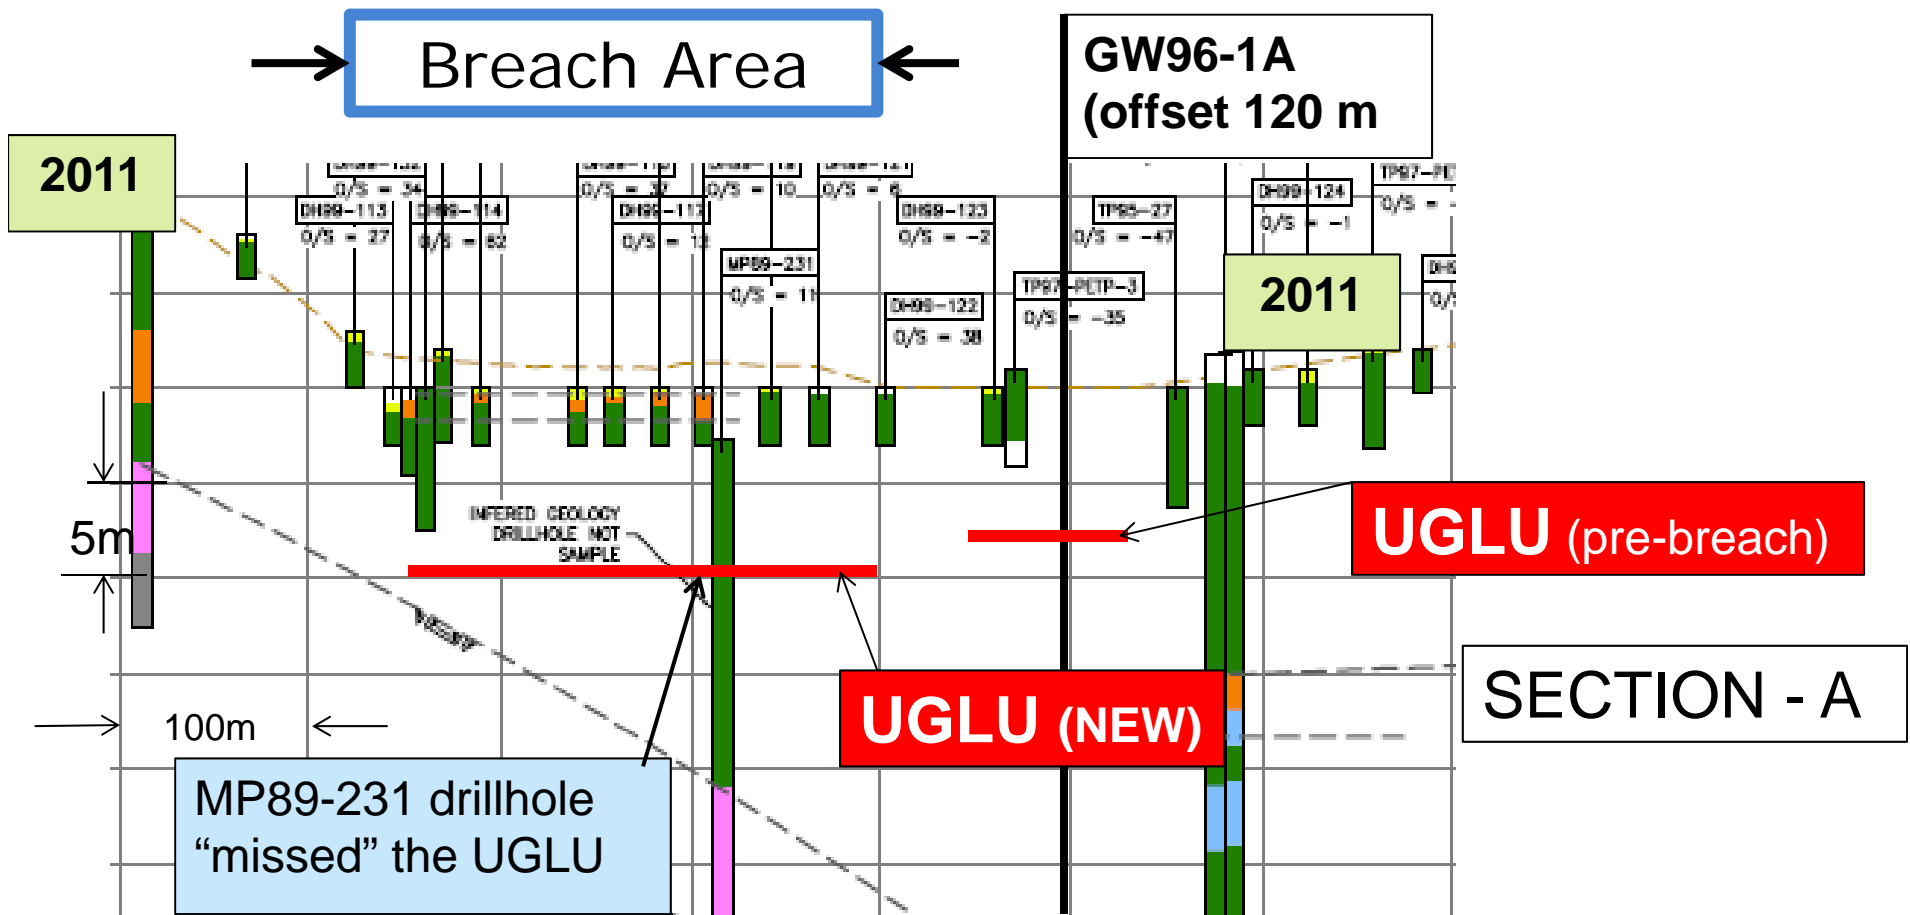
Limited deep soil investigations did not identify the weak clay layer (UGLU) - complex geologic history

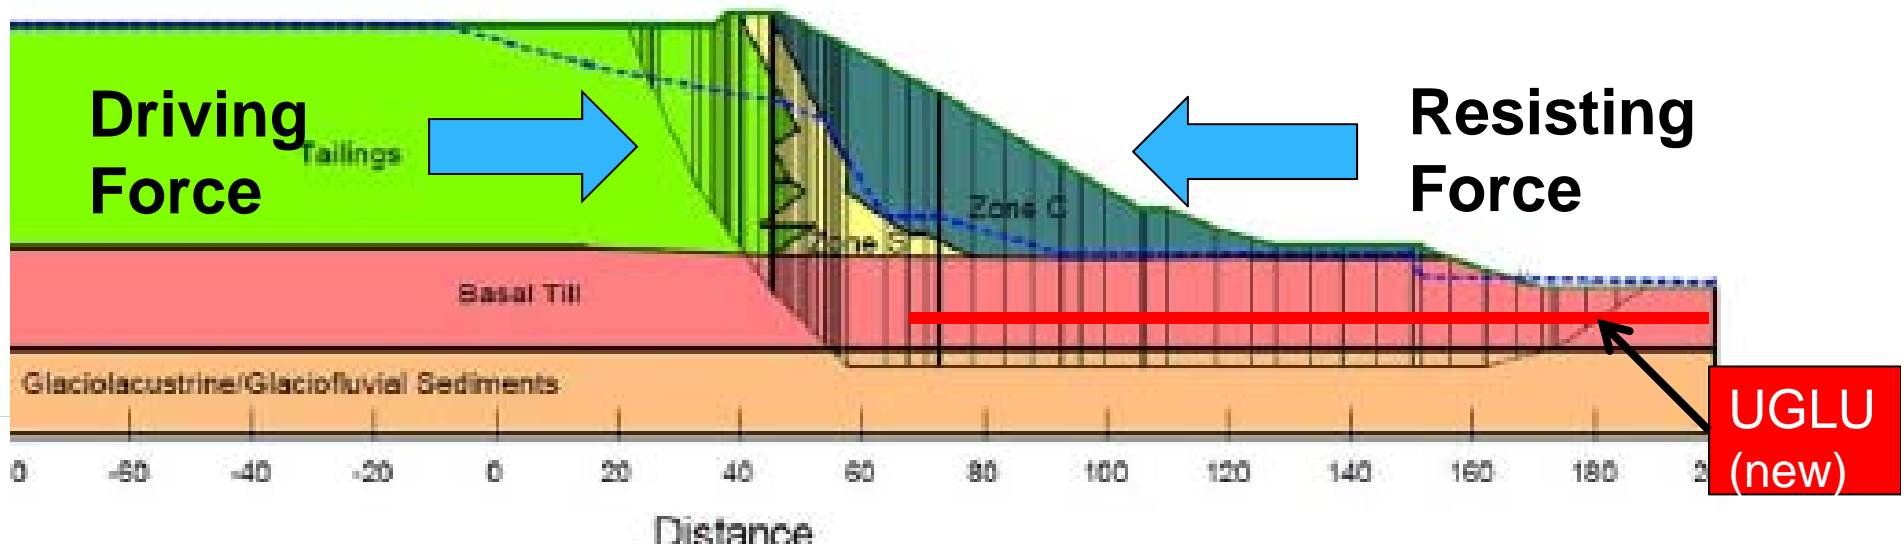
The soil foundation conditions did not include the UGLU.

- Purpose of stability analyses
- The expected Factor of Safety calculated for the stage 9 permit was 1.63

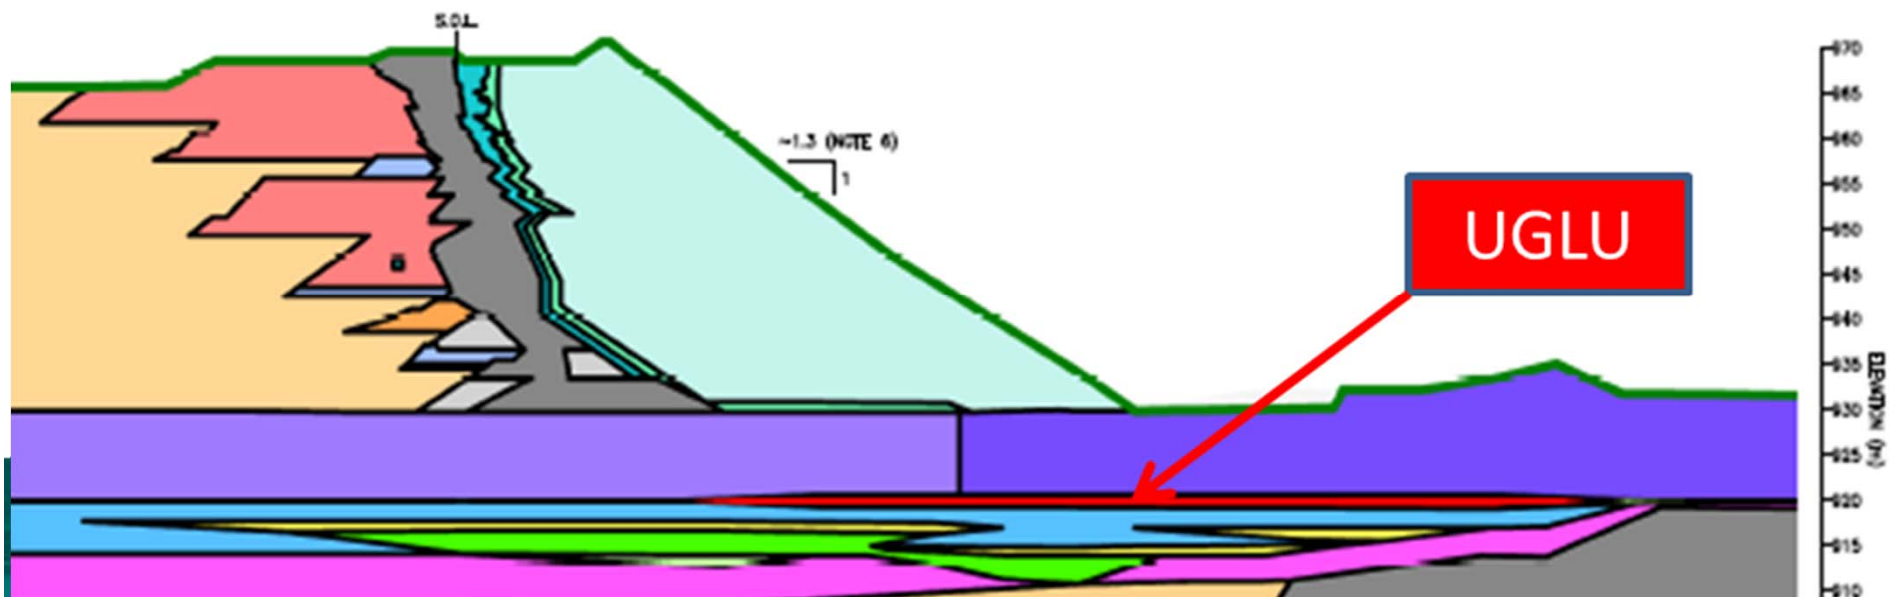
Dam failed by sliding on foundation clay layer, glaciolacustrine in origin at 10 m depth (UGLU)

- Location was confirmed in area of breach
- 40 m high steep embankment subjected UGLU to stresses initiating progressive failure of dam
- Comprehensive analysis builds upon Expert Panel

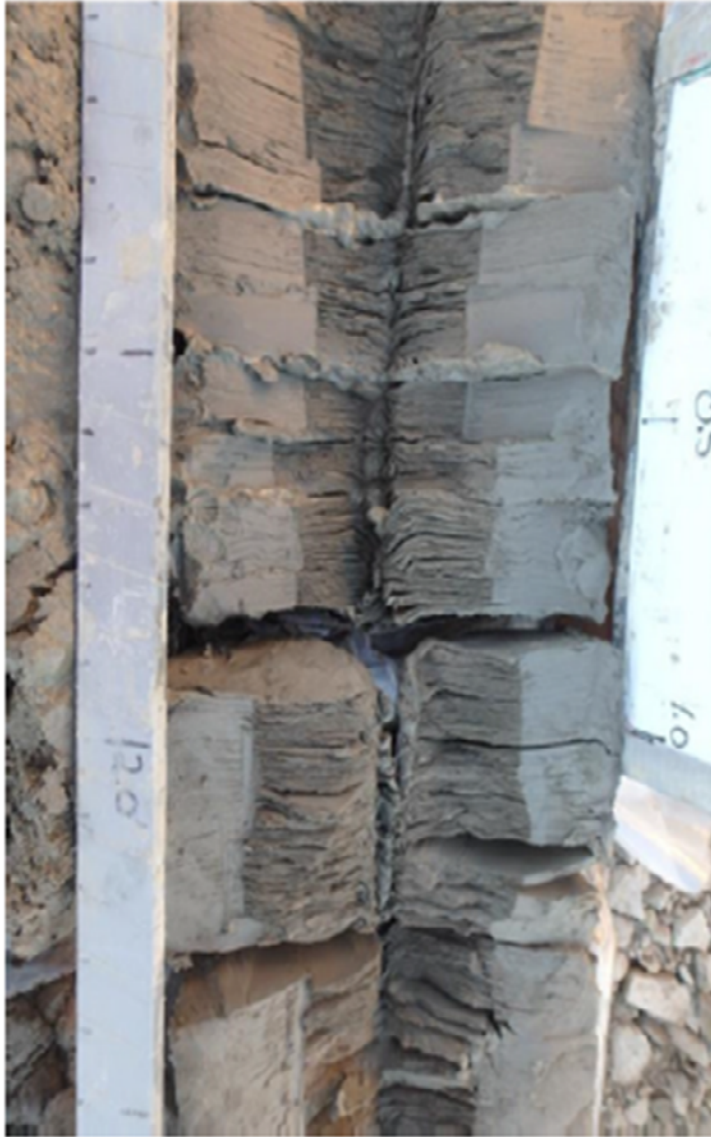
Undisturbed clay outside failed embankment area

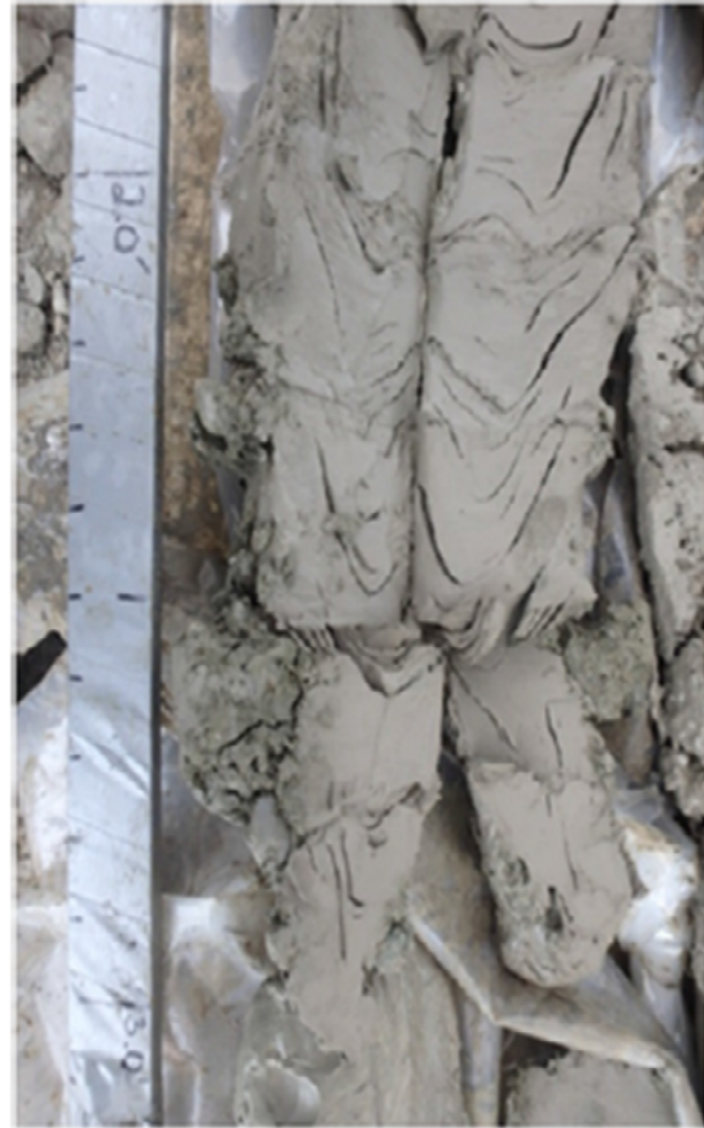
Disturbed clay below failed embankment area

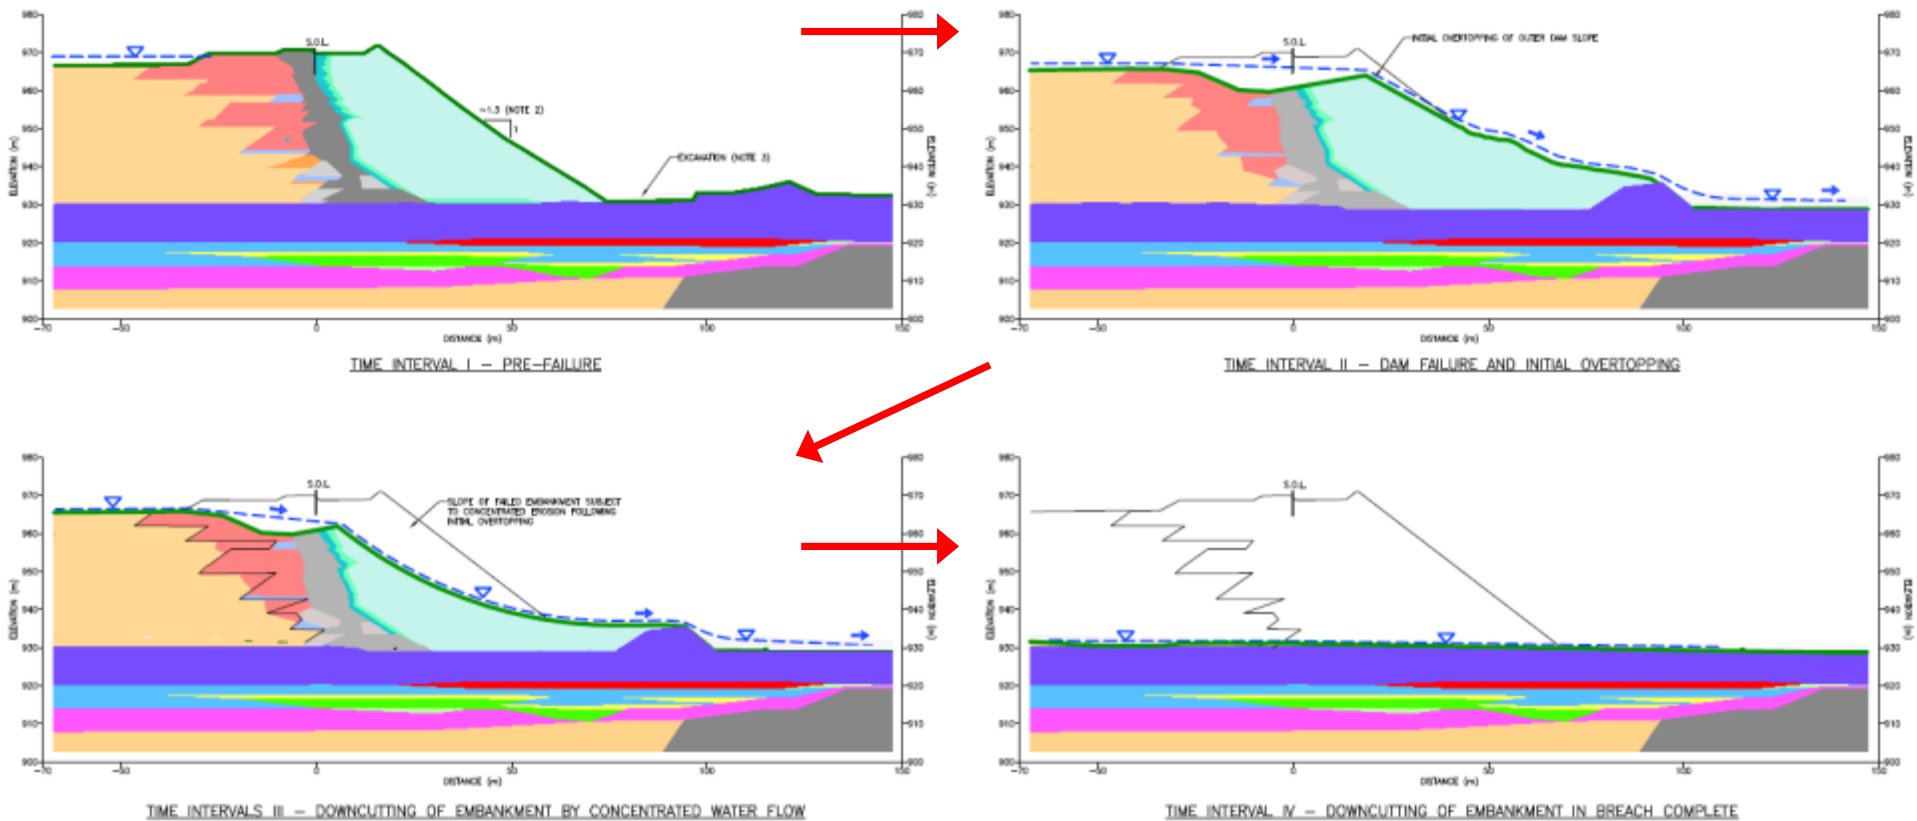
Conceptual Sequence of Dam Failure through Reconstructed Breach Section

Erosion followed the failure as the water overtopped the slumped crest of the embankment.
