## GEOTECHNICAL ENGINEERING SERVICES FOR AFTON TAILINGS STORAGE FACILITY

# Phase 1: Review Possibility of Mount Polley Mine Conditions at Afton TSF site

**Report Number:** 1526512

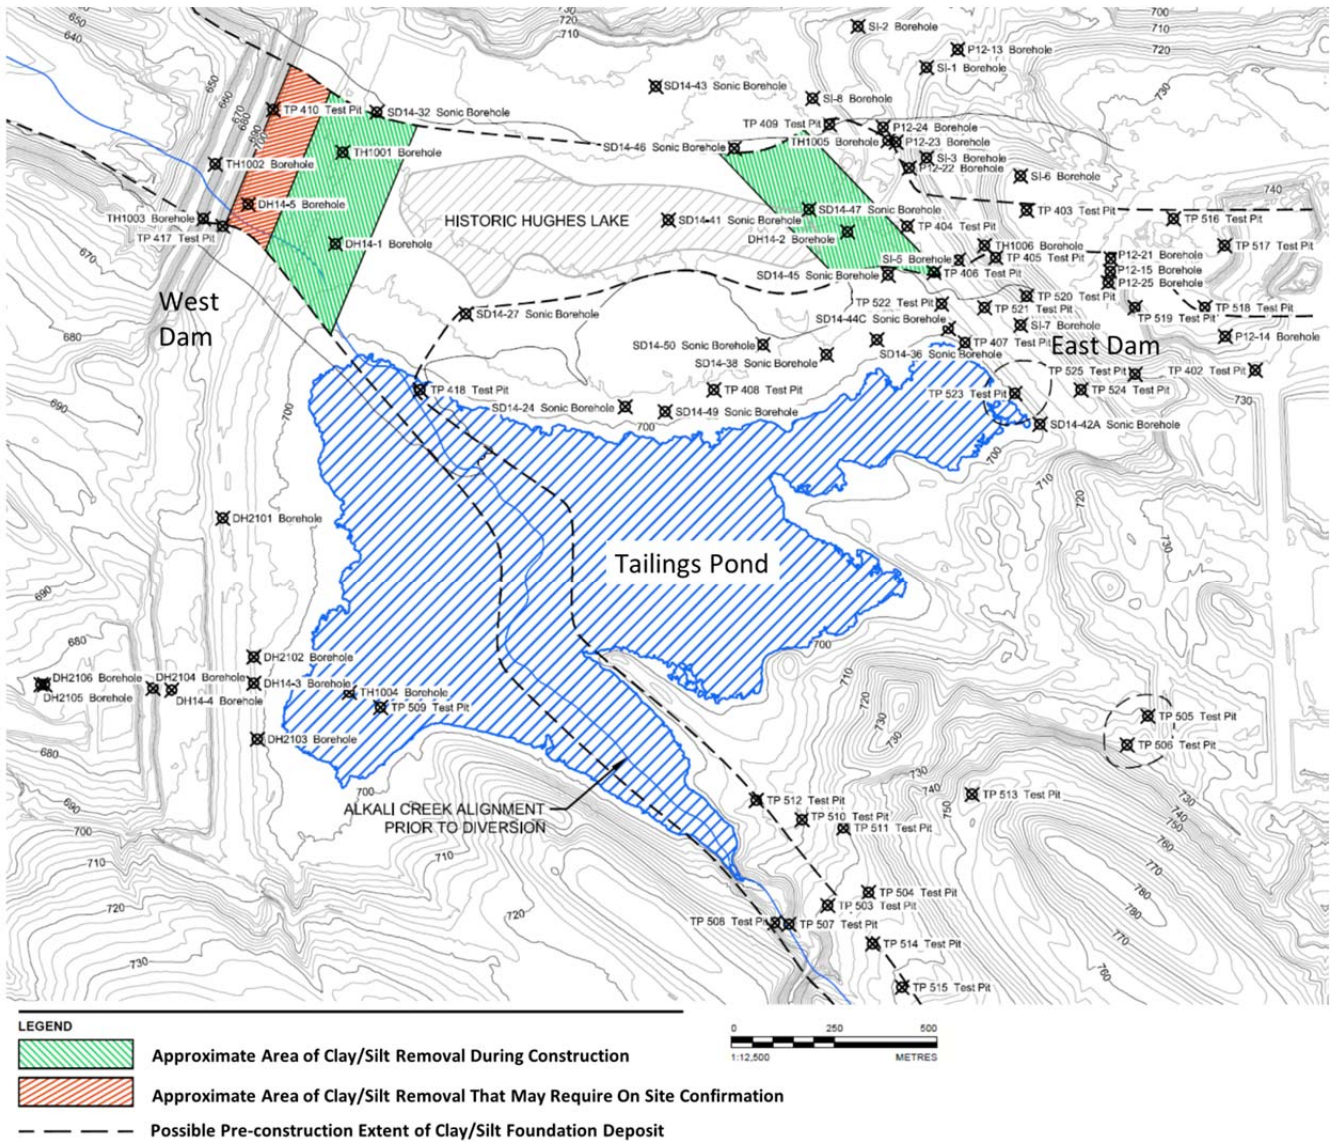
Figure 5: TSF Plan Showing the Boreholes in the Foundation and Estimated Extent of Clay/Silt Deposits

- Area from the downstream extent of fine filter on the foundation to the toe of the dams. Based on boreholes/test pits TH1002, TH1003 and TP410 in this area under the West Dam and borehole/test pits TH1006 and TP404 under the East Dam, the clay/silt deposit in this area was lower than the average depth of 0.6 m under both dams. The average thickness of the clay/silt deposits is 0.9 m and 2.5 m under the West and East Dams, respectively, before construction. The construction specifications for foundation preparation required clearing and grubbing beneath the rockfill portions, and ground stripping as required by the Engineer (KL1976). Golder considers that it is likely that the clearing and grubbing operation was not deep enough to remove the clay/silt layer in this area.

The original design of the West Dam was to extend the fine filter on the foundation to about 80 m downstream from the West Starter Dam toe. The as-built section shows the extent of the fine filter on the foundation only to about 30 m downstream of the West Starter Dam. From the construction records it is not clear what foundation preparation was followed within this 50 m zone difference between the design and as-built extent of the fine filter. A borehole drilled in 2014 (DH14-5) drilled after the West Dam construction did not identify a clay/silt deposit under this area at the West Dam downstream foundation. The ground surface of this borehole is at Elevation 648 m, which is slightly higher than the Hughes Lake level before construction. The DH14-5 drill method was most likely designed considering the rockfill on top of the foundation and not necessarily would capture the detail of a soft soil layer beneath the rockfill. Also the borehole is close to the edge of the estimated extents of the clay/silt deposits (Figure 5). The thicker clay/silt deposits at this area in the middle of valley at the lower ground surface elevation area may still be in place. This area is shown on Figure 5 as an area where clay/silt removal is uncertain (i.e., the red-hatched area).

Should the owner contemplate raising the dam, an investigation program should be designed and executed to understand the potential extents of clay/silt material within the foundation footprint of the West Dam.

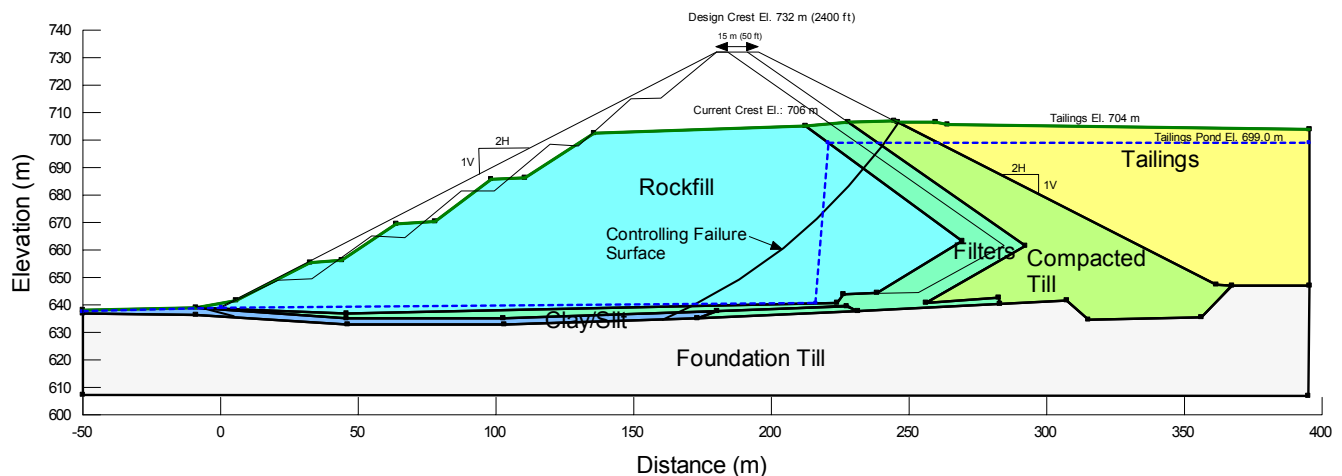
*Figure 6: West Dam Stability Analysis Section, Controlling Failure Surfaces*

Stability analysis was considered for failure surfaces that may result in release of the tailings material and water from the West Dam. Golder estimates that such failure surfaces may start from the upstream crest of the dam to the downstream toe (Figure 6).

The results of stability analysis show that the Dam Safety Guidelines (CDA 2007 and 2013), in terms of calculated minimum factors of safety, are satisfied when undrained shear failure of the clay/silt is considered in the analysis for the static condition and post-earthquake condition. However, depending on the assumed extent of the clay/silt despots under the downstream portion of the dam, the calculated minimum factor of safety from pseudo-static analysis can be slightly less than the CDA specified value.
