June 30, 2015

Reference No. 1214280022-018-L-Rev0-11000

**RESPONSE TO MINISTRY OF ENERGY AND MINES MEMORANDUM DATED FEBRUARY 3, 2015
REGARDING THE BEAVERDELL TAILINGS FACILITIES**

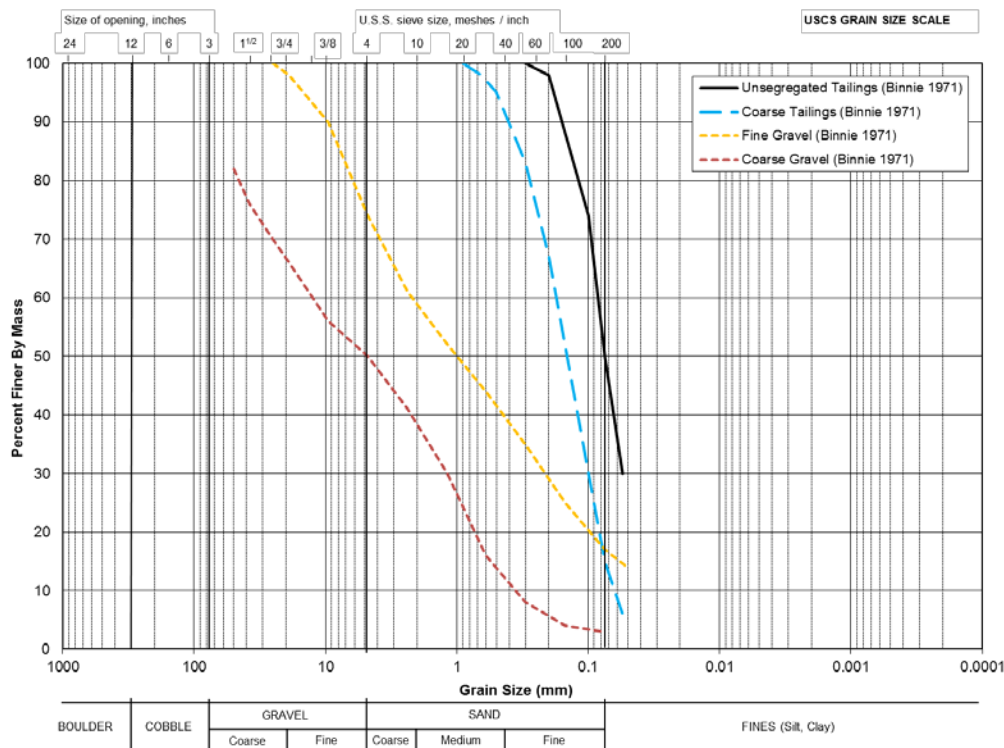
Chart 1: Pond 4 Gradations for Filter Compatibility Comparison

Gradations of the coarse tailings (beach) are filter compatible with the gradations of the slimes for samples taken in Ponds 4, 5, 6, and 7.

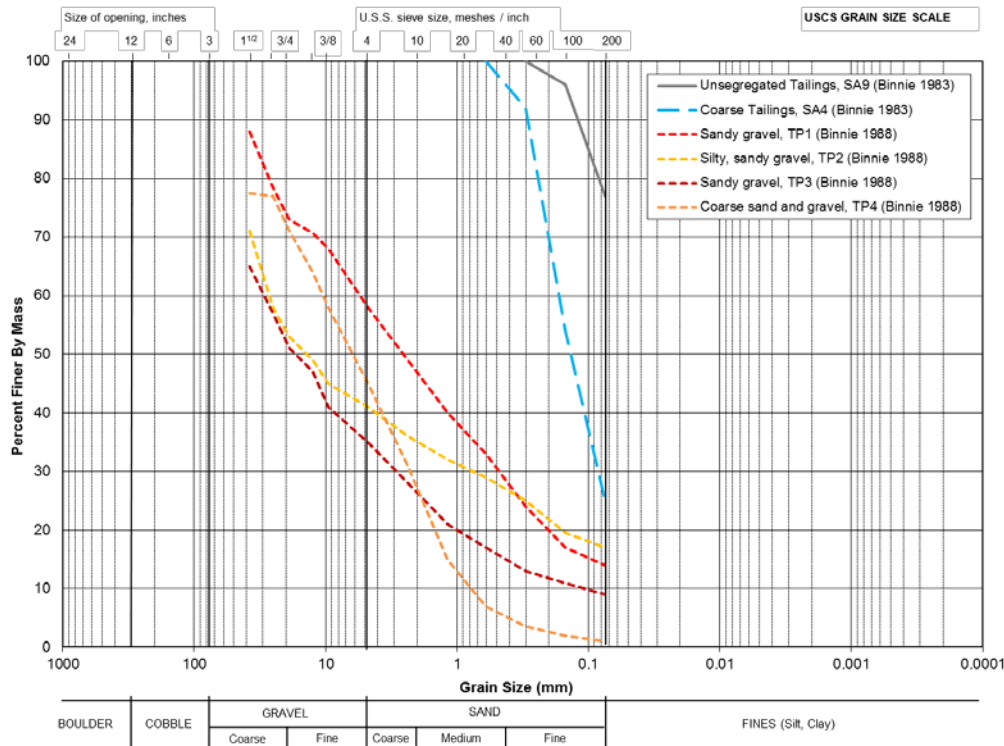
Chart 4: Pond 7 Foundation/Dam Section Gradations and Pond 6 Tailings Gradations for Filter Compatibility Comparison

Gradations of the coarse tailings (beach) are filter compatible with the gradations of the sand and gravel dam for all samples taken except for the coarse sand and gravel from test pit (TP) 4 in Pond 7. However, Pond 7 was never filled with tailings, so this gap represents a low risk for piping failure.
