**Reference: Bell Mine Site
2014 Dam Safety Inspection**

BELL MINE SITE
2014 DAM SAFETY INSPECTION
FINAL REPORT

November 2014

AMEC File: TE143007

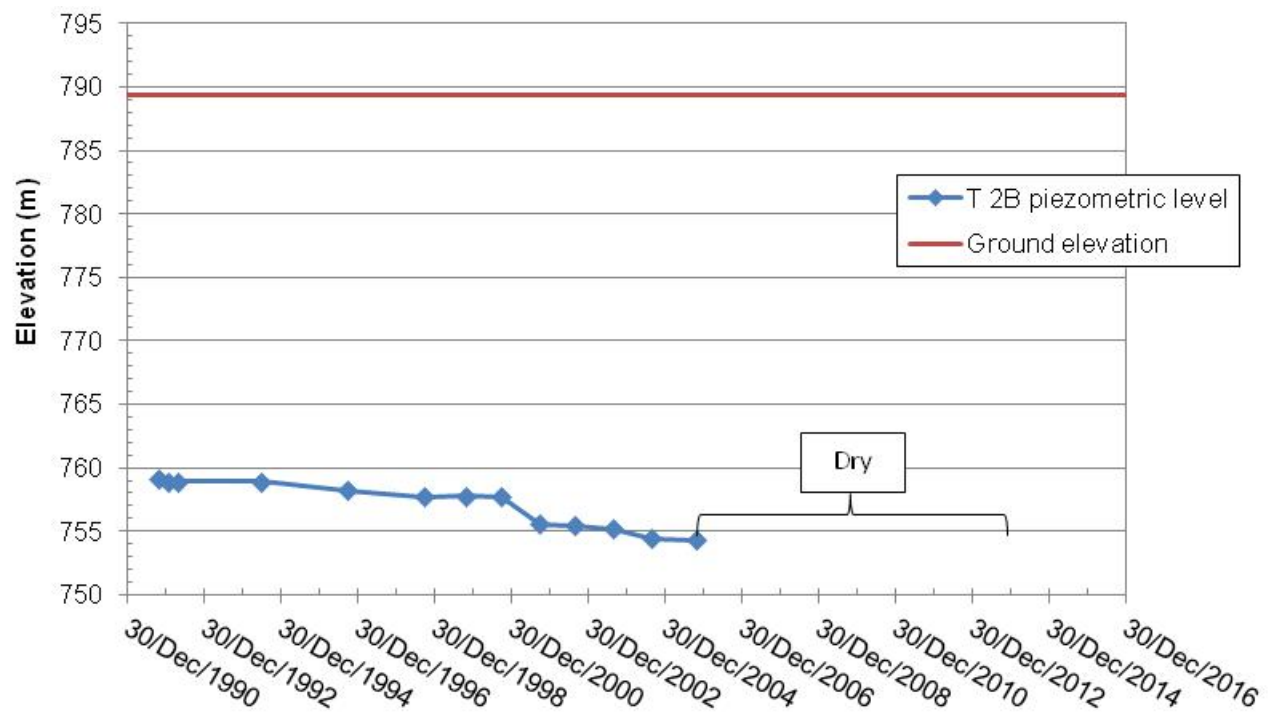
Figure 6.2 Piezometer T 2B - Historic Water Levels (location: tailings)

The piezometric levels are generally steady. Immediately upstream of the tailings dams, the tailings are essentially fully drained ('semi-dry'). Piezometer T 2B is now reading dry. For the other standpipes, it is not clear that the readings that are being measured are reflective of the pore pressure conditions at those locations. The piezometric elevations that are measured are 1 to 5 m above the base of the standpipe. When undertaking future readings, Glencore should also locate the bottom of the pipe below the measured water level to determine if the water level that is being measured in the standpipe is actually reflective of the surrounding groundwater conditions and not as a result of the standpipe being infilled with soil which could give a false reading.

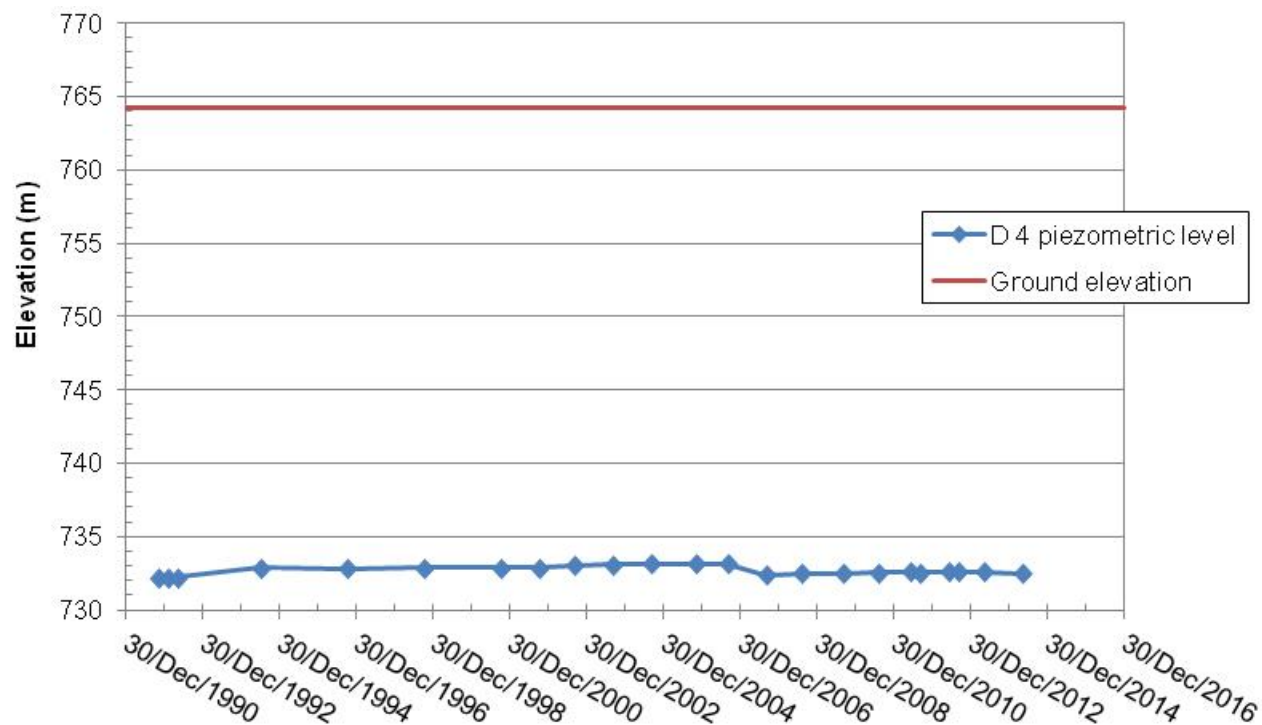
Figure 6.5 Piezometer D4 - Historic Water Levels (location: tailings)

As noted in MBS 2013, Piezometers D3 and D4 are located in Dam 1, next to the stabilizing berm, in an area where strong ARD is generated in the dam rockfill shell. This might affect the performance of the piezometers. However, D3 is reading dry now.

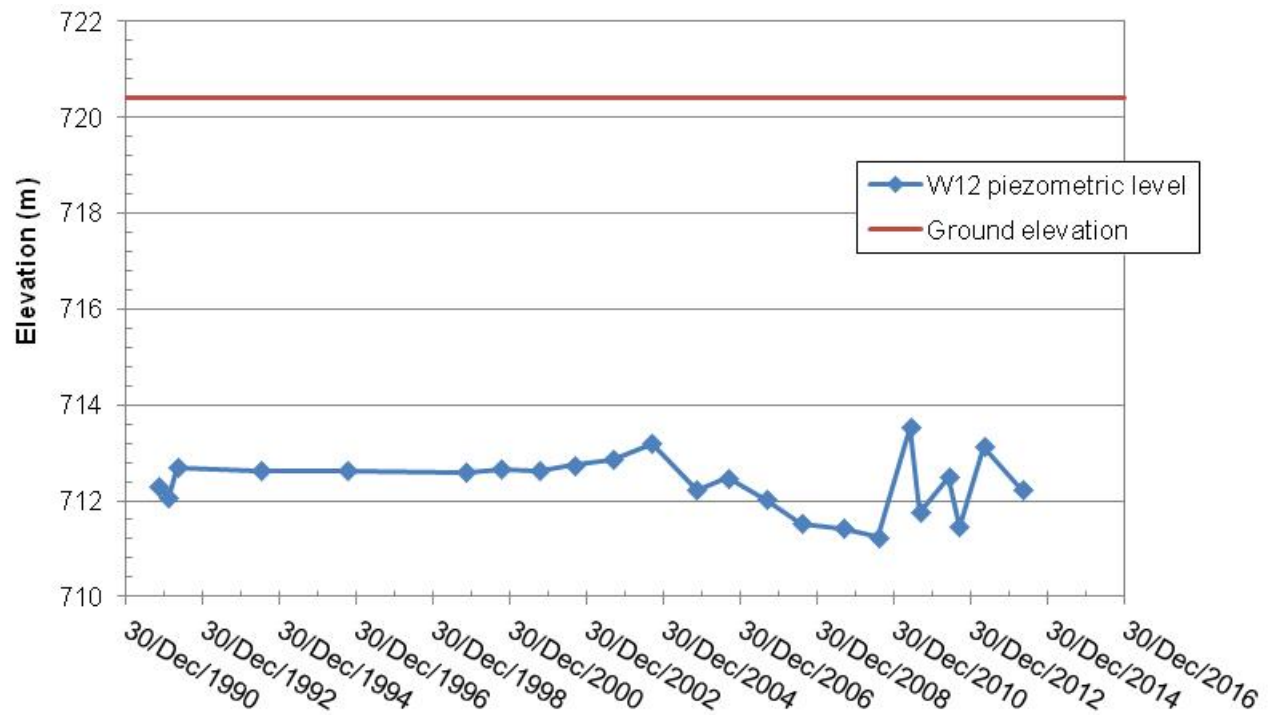
Figure 6.7 Piezometer W12 - Historic Water Levels (location: downstream of TEX)

The fluctuations noted in Piezometer W12 may be related to fluctuations in the seepage collection pond downstream of this piezometer (CP7-1).

Note: Monitoring well W12 was damaged after September 2007 but it was repaired and continues to be monitored.

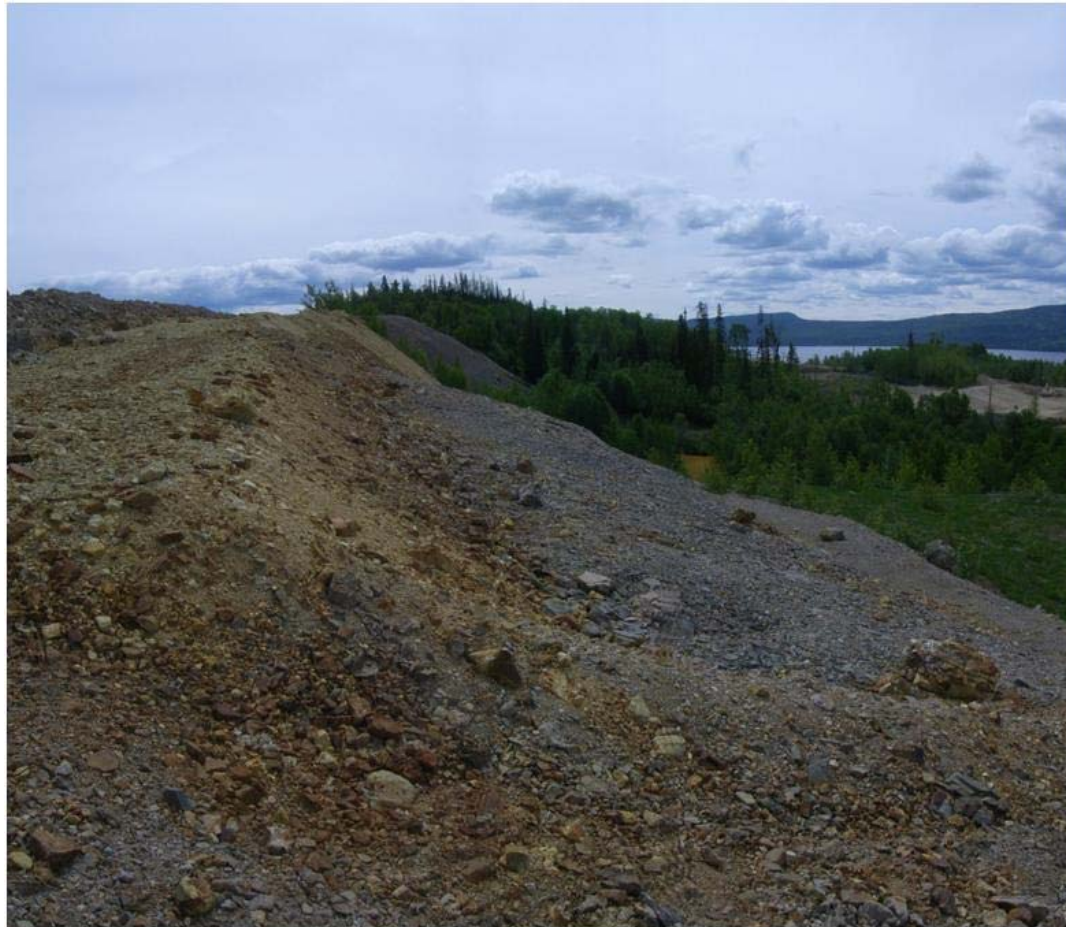
Photo C1-4: View of downstream slope of Dam 1, looking south from north end of the dam. Note the slope showing rockfill comprising dam shell. (11 June 2014)

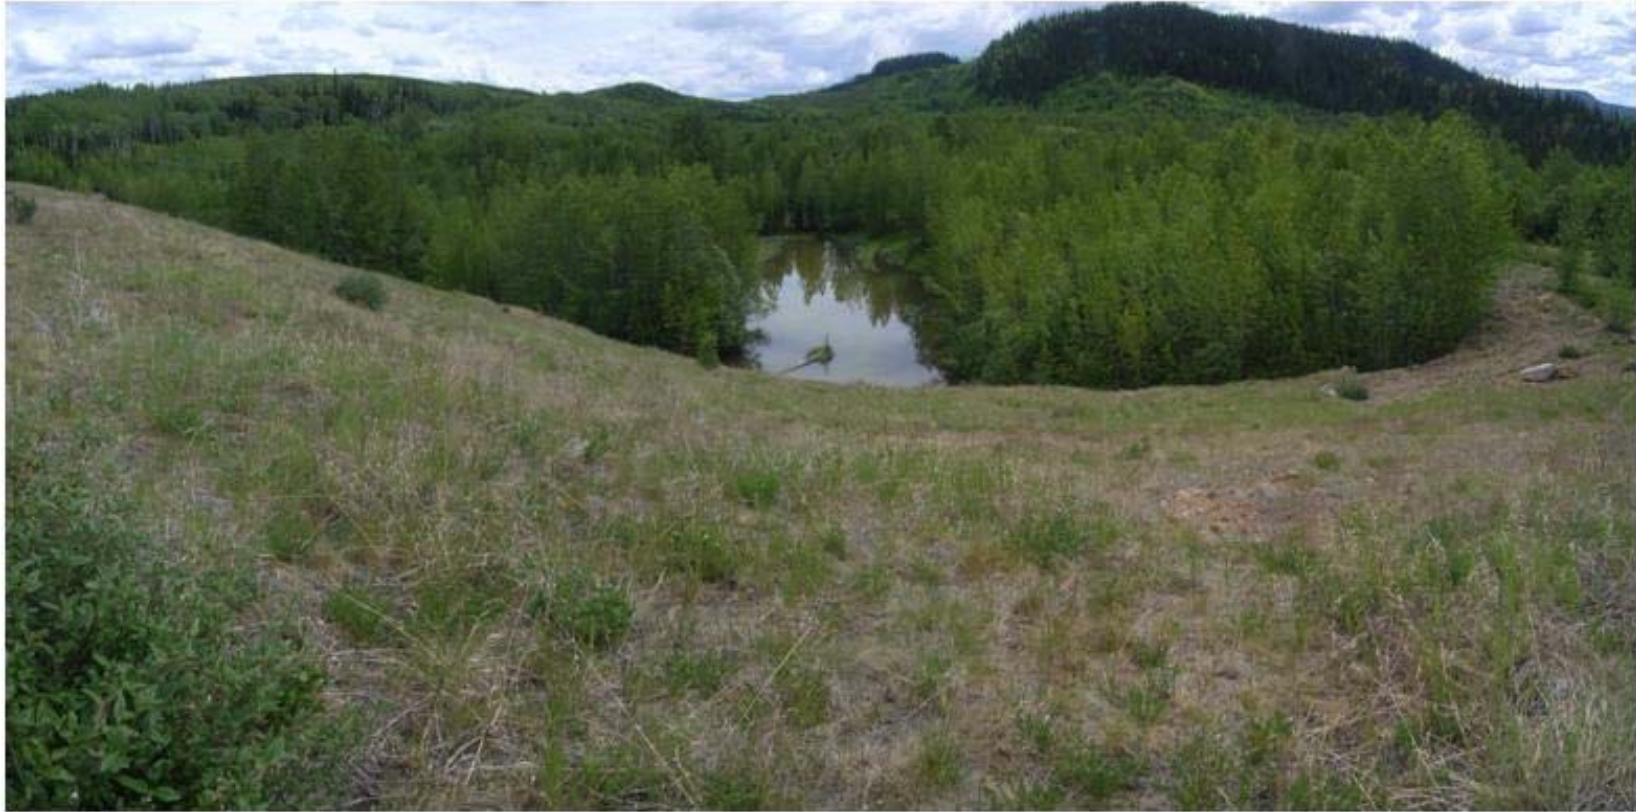
Photo C2-2: View of downstream slope and toe of Dam 2, looking south from about mid-way along its length. Water ponded at toe is not part of the seepage collection system. (11 June 2014)

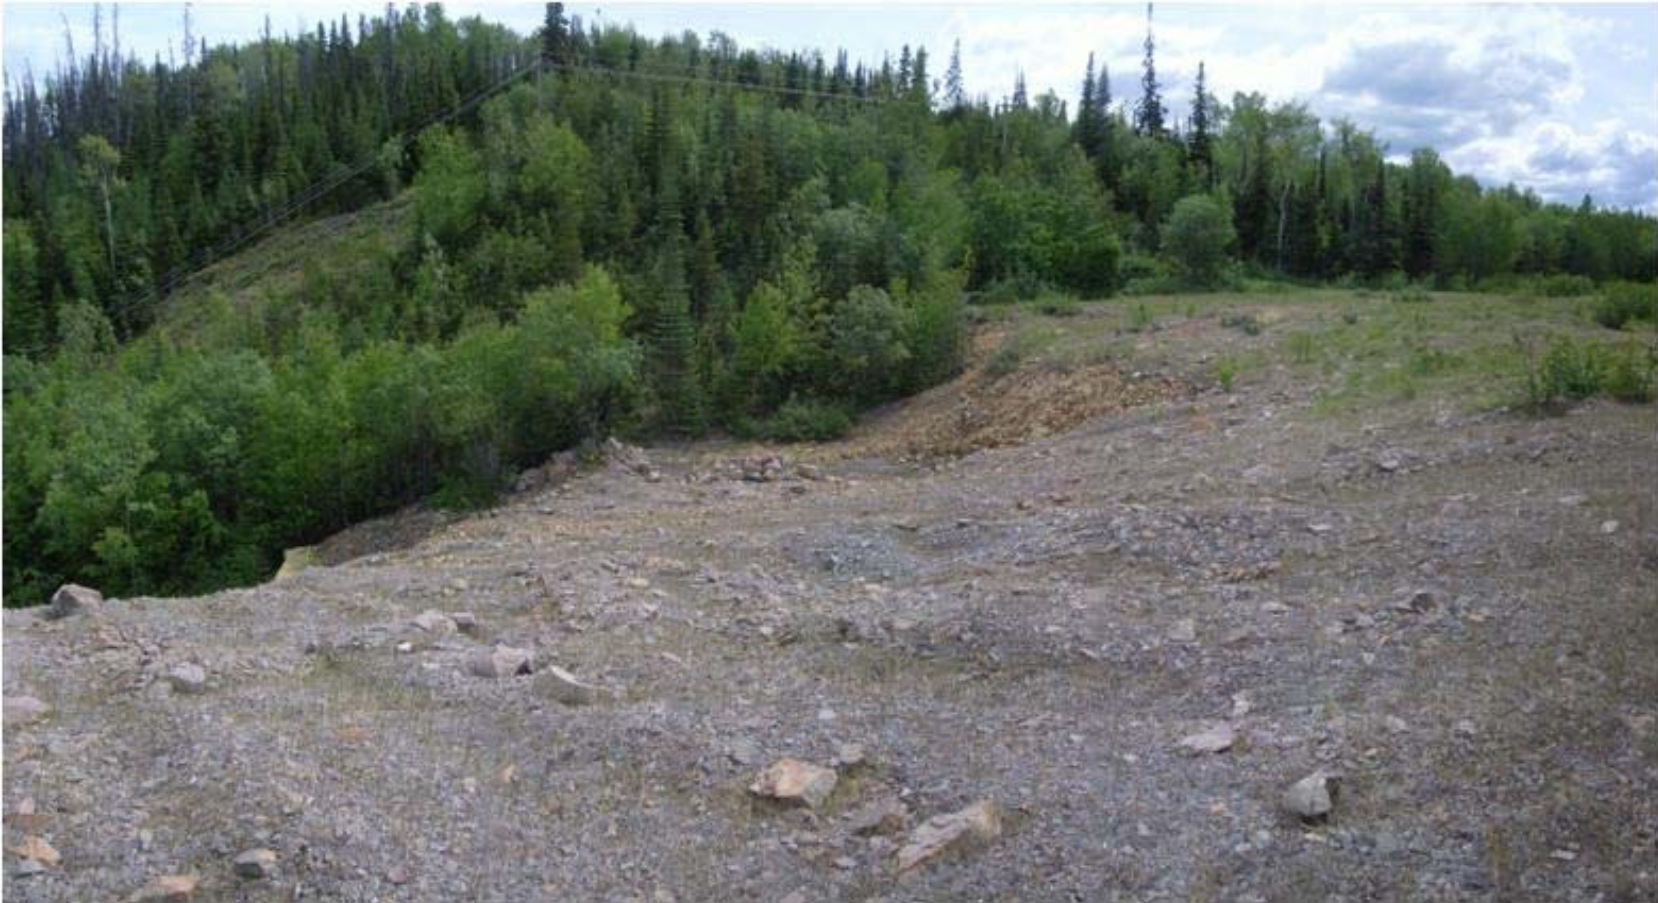
Photo C3-2: View of south abutment with natural ground.
Note there is no evidence of adverse effects due to flow down the abutment. (11 June 2014)

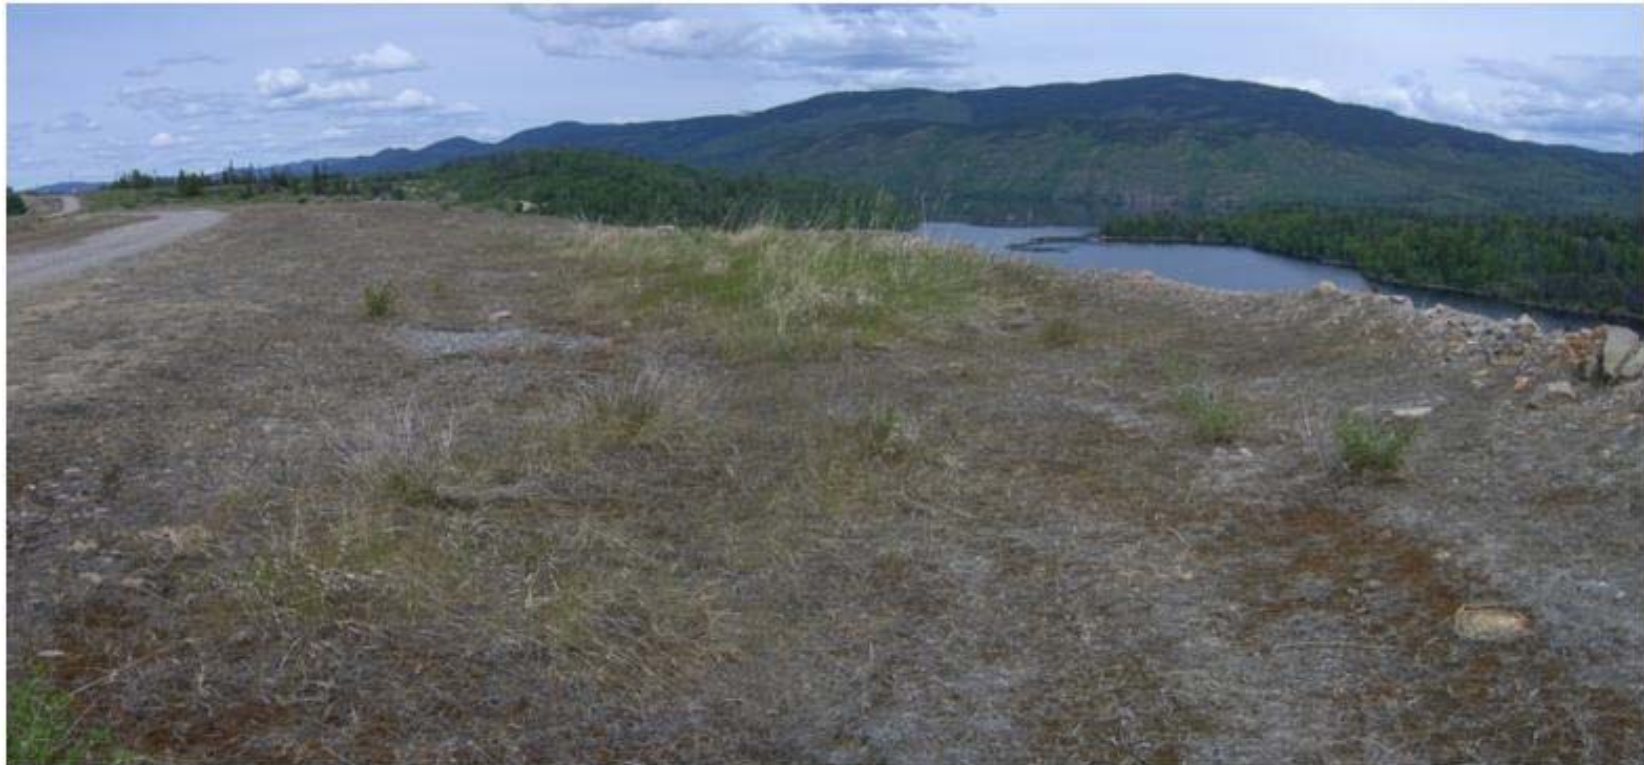
Photo C3-4: View of the crest of Dam 3.

Note that a sinkhole was observed this area. About one third of the way along the dam from the south end. (11 June 2014)

No.	2014 DSI Recommendations
1	Dig a 1 m ² hole with an excavator over the sinkholes at Dam 3. Grade the surface around the sinkholes toward the excavation to allow water to shed to the hole. Monitor for further sinkhole development.
2	When reading the piezometers, check the bottom depth below the measured water level to determine if the water level being measured is reflecting the actual conditions. If necessary, pump water into the standpipes and flush out sediment that may have accumulated in the standpipe.
3	Continue to monitor the downstream slope of Dam 7 for erosion.
4	Conduct an assessment of the damage that could occur to Dam 3 if one of the pipes running up the face of the dam from CP3-1 were to rupture. The rockfill shell will likely limit damage, but this should be checked.
5	Assess the spillway capacities (accounting for vegetation growth) and the ability of the spillway to withstand erosion.

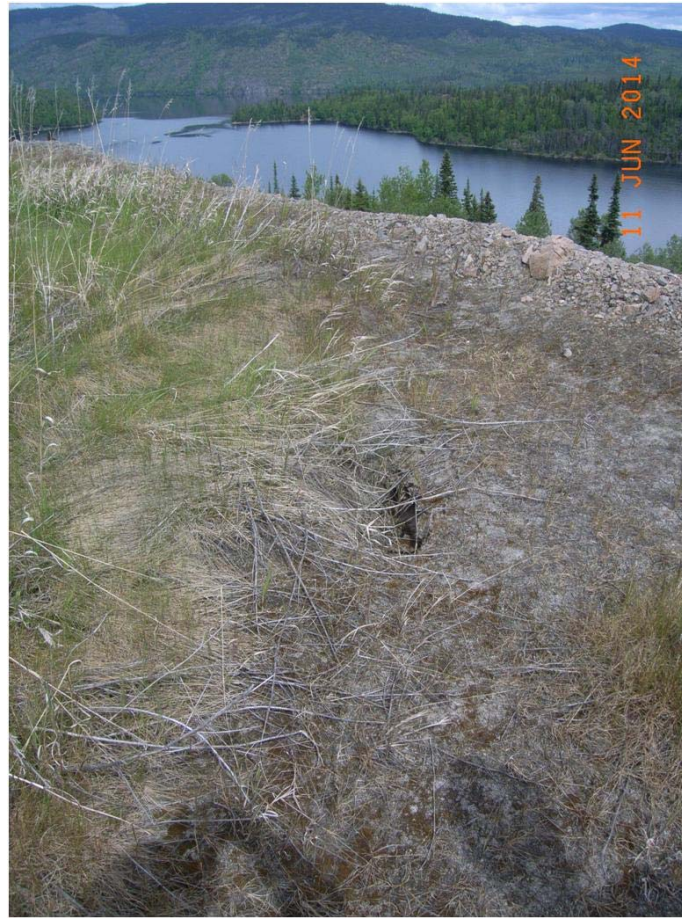
Photo C3-5: Close up view of sinkhole on the downstream side of the crest. Note that this area is a topographic low where water can accumulate and flow downward into the rockfill shell of the dam. The sinkhole has formed in the soil cover material over the rockfill. (11 June 2014)

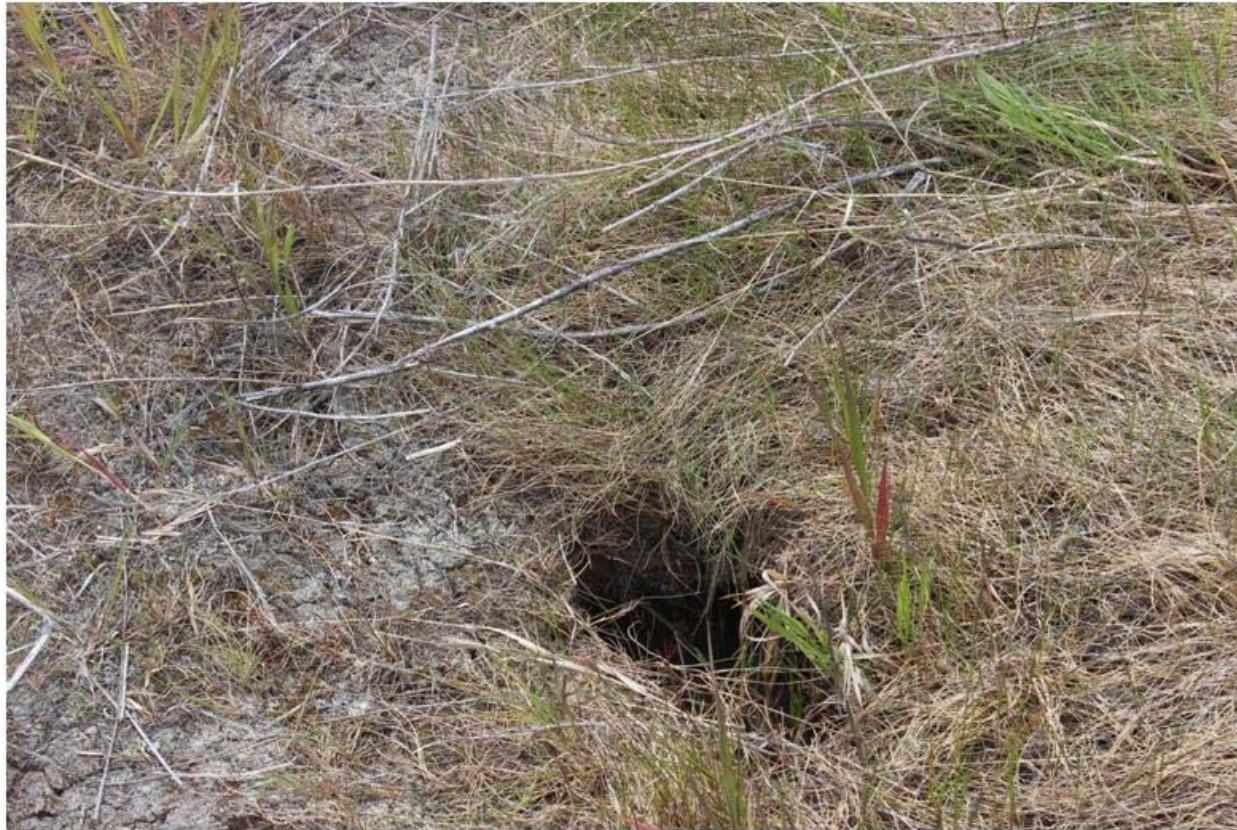
Photo C3-6: Close up view of another sinkhole in the vicinity of the one above. This one was created by pushing down with a foot, noting the soft ground, and then causing the surficial soil to fall into the hole. (11 June 2014)

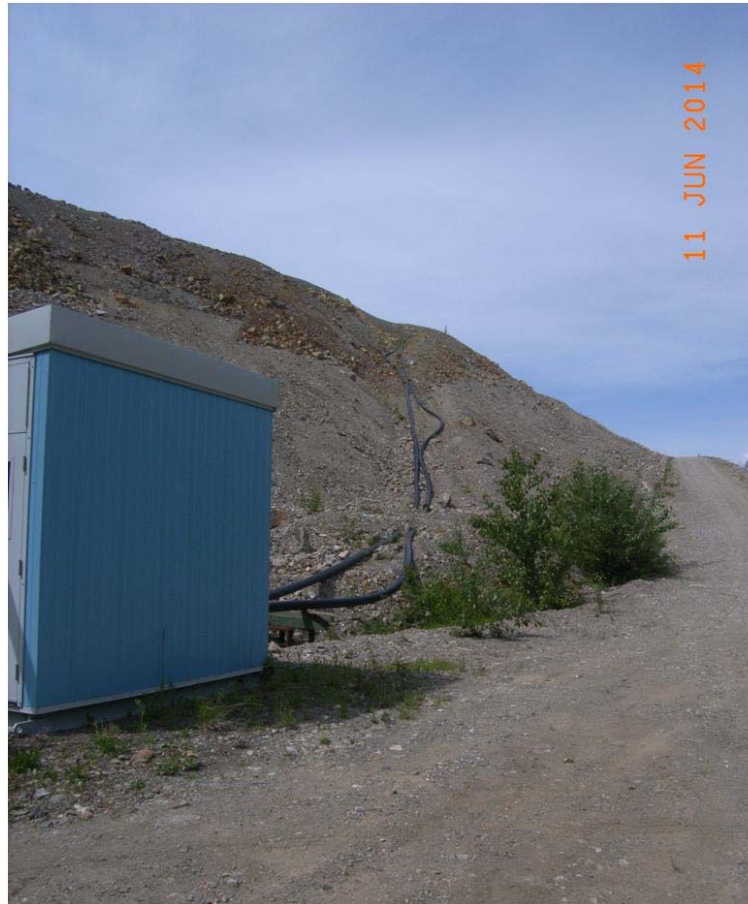
Photo C3-8: View of downstream slope of Dam 3, from CP3-1. Note pipes from CP3-1 passing up the slope of Dam 3 that can cause erosion if the pipes rupture. According to Glencore personnel, the volume of water that can be released during a rupture is limited and the downstream shell is built of rockfill, hence the potential for significant damage to the downstream slope is low.
(11 June 2014)

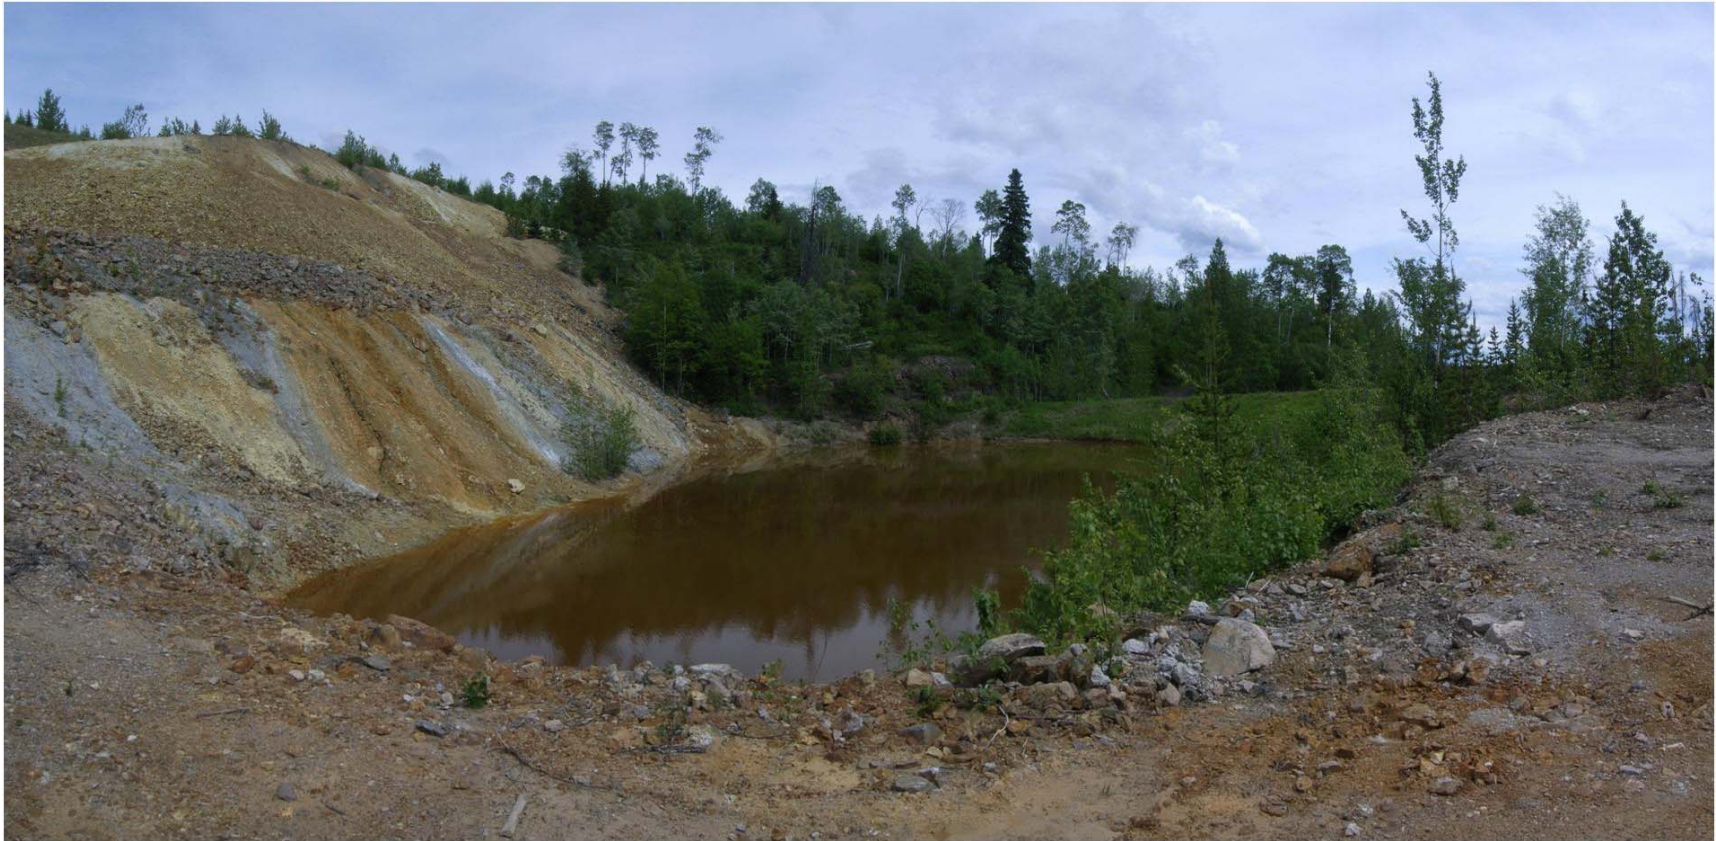
Photo C7-2: View of downstream slope of Dam 7, on the left side of Collection Pond CP7-1, looking east from the west end of the CP7-1 pond. This was an area where there was a concern with respect to erosion on the downstream slope noted in the 2013 DSI. There was no significant change from 2013. (11 June 2014)

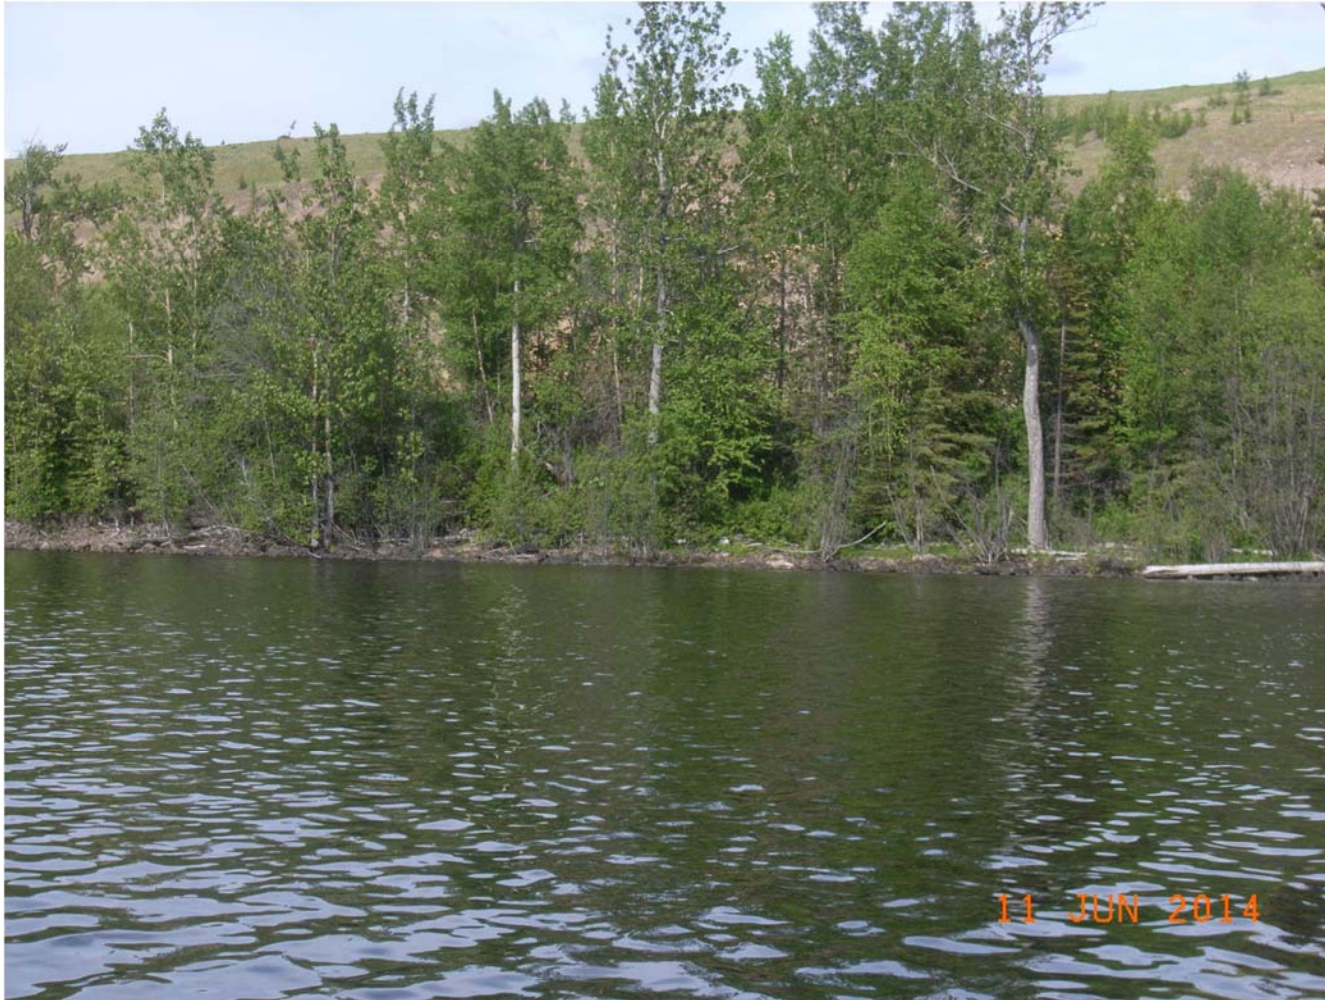
Photo D1-5: View of downstream toe of CP1-3, east from Babine Lake to the toe. Note there is no evidence of concentrated seepage entering the lake. (11 June 2014)

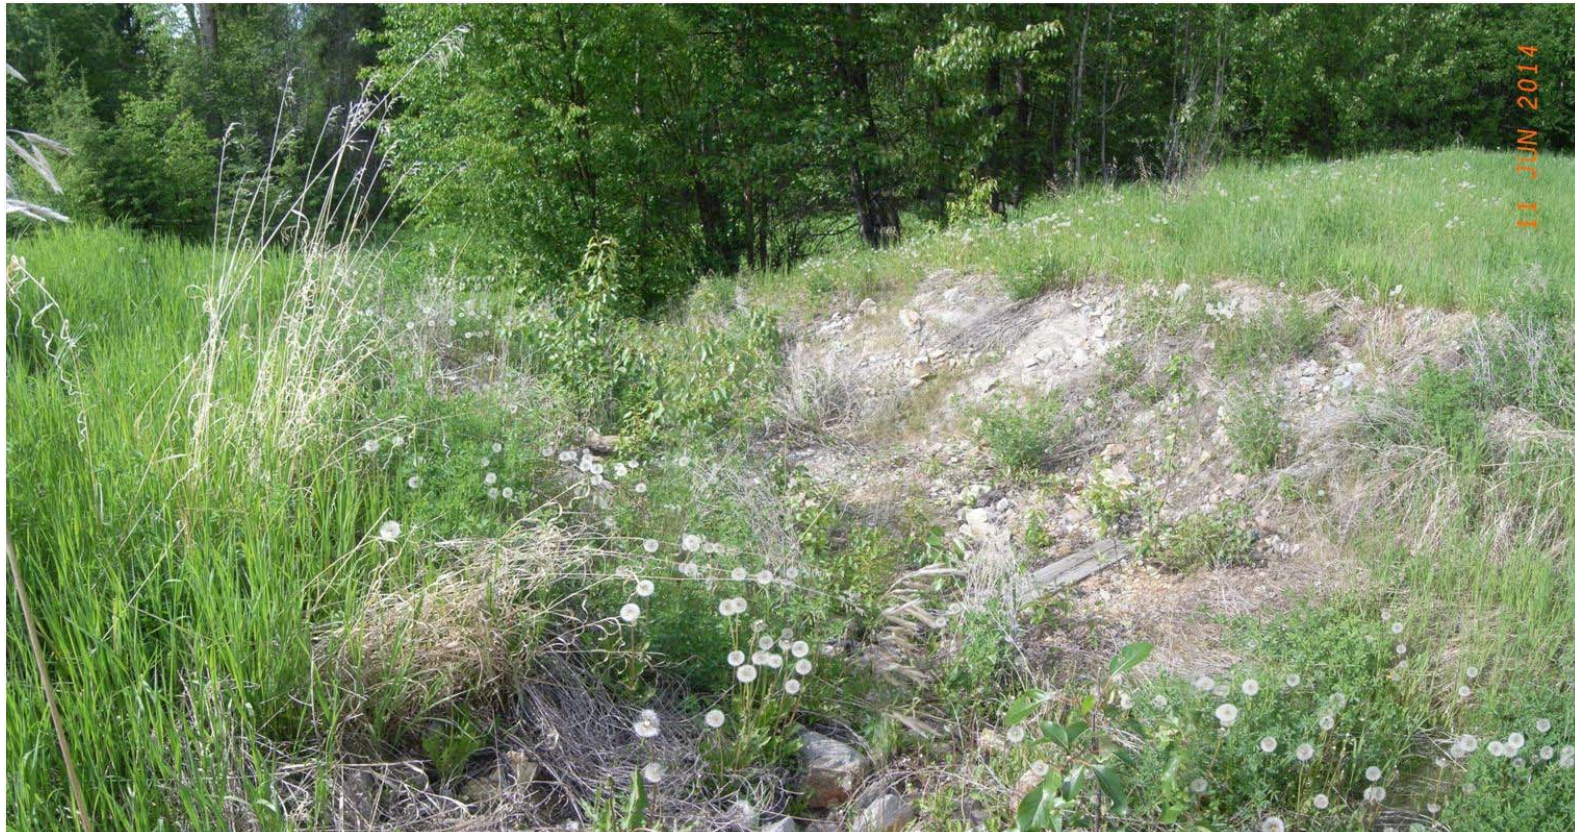
Photo D2-2: View of CP1-5 spillway, looking north from crest of the dam. Note small and irregular size of the erosion protection.
(11 June 2014)

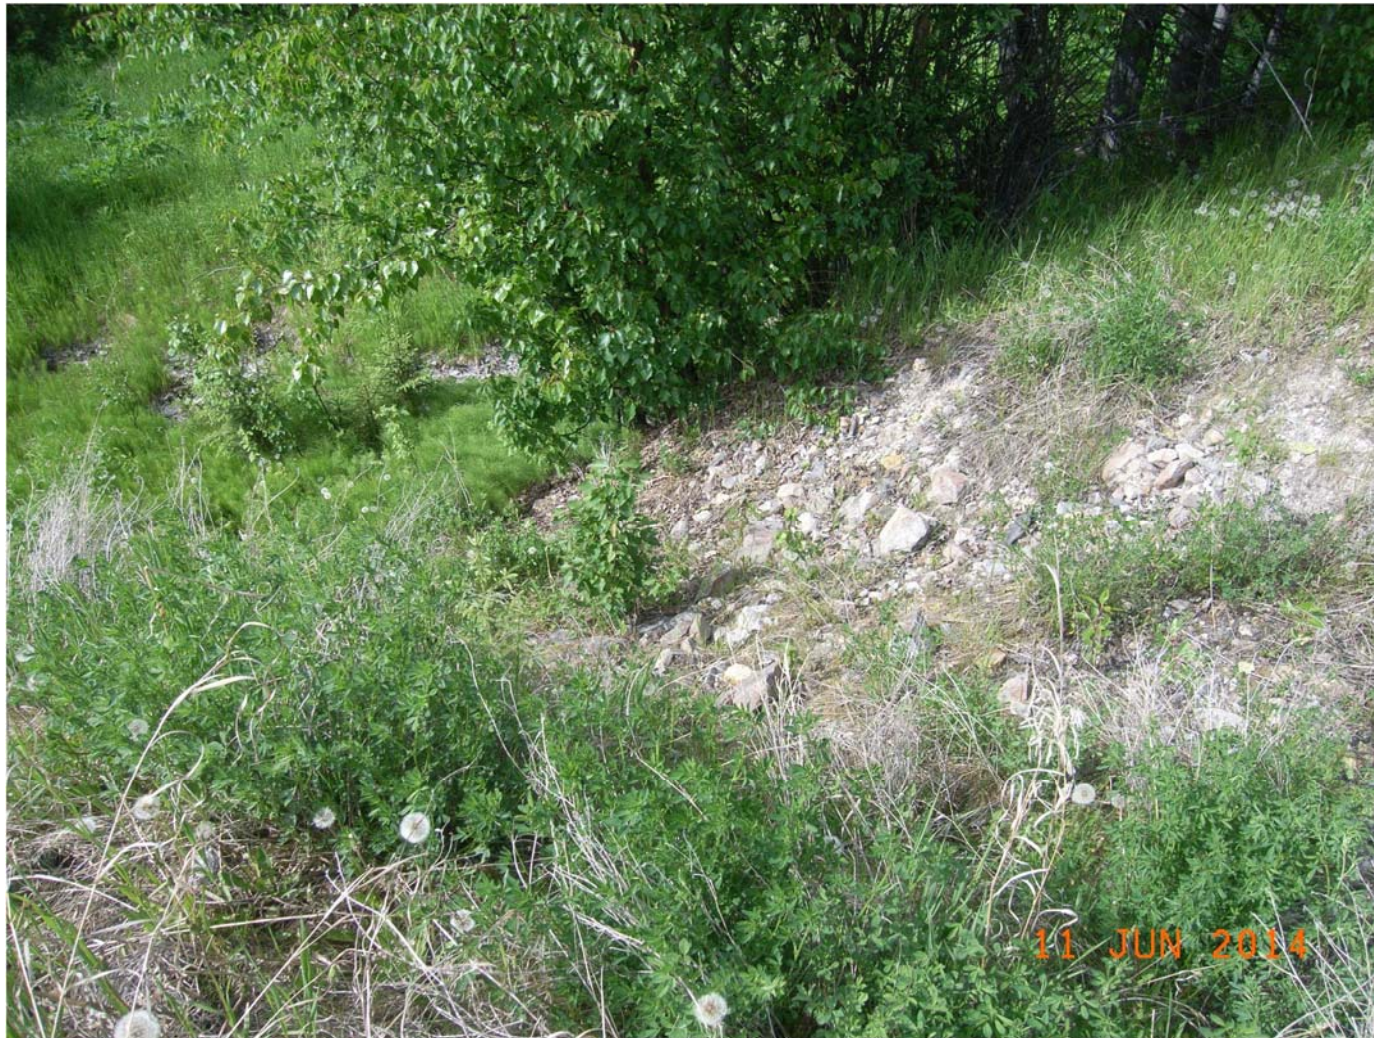
Photo D2-3: View of downstream end of spillway at CP1-5, looking north west from within the spillway. Note small size of the erosion protection (11 June 2014)

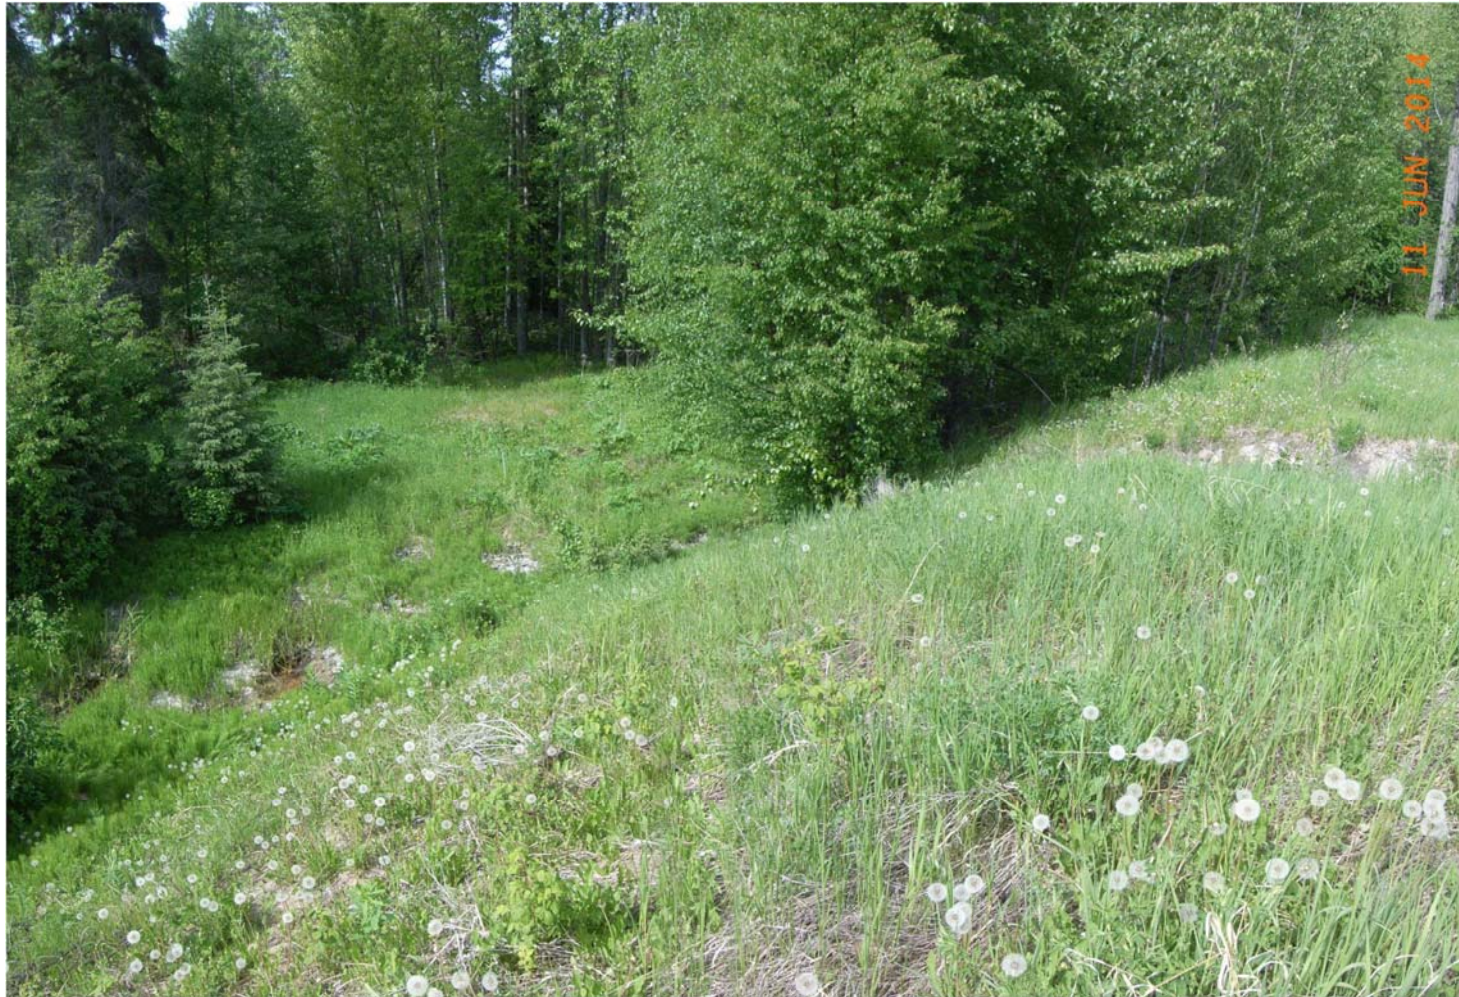
Photo D2-4: View of downstream slope and toe of CP1-5, looking north from crest of west segment. Note there are no signs of adverse seepage. (11 June 2014)

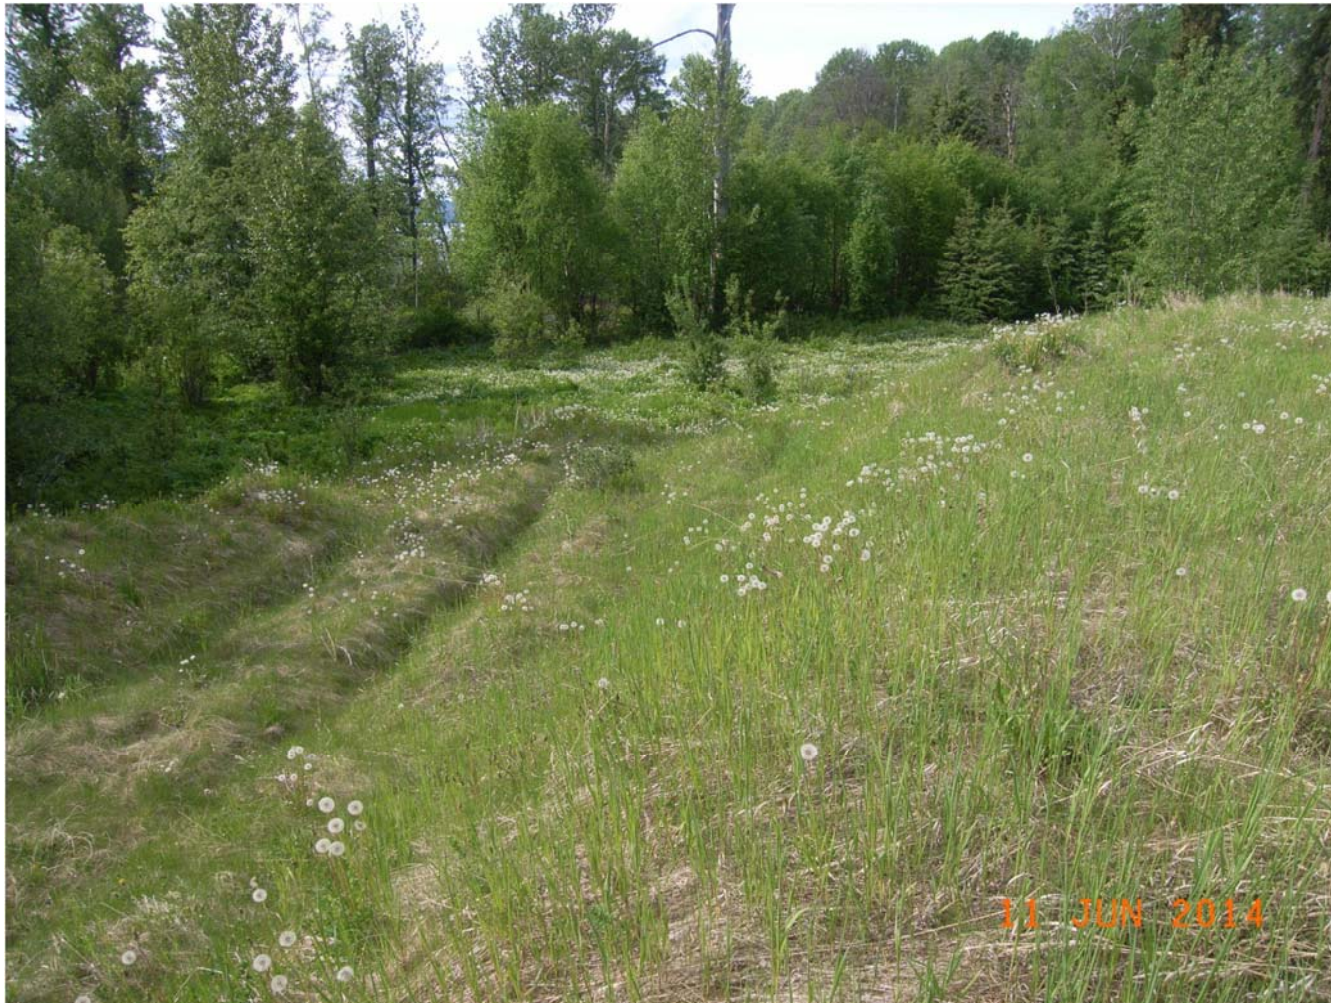
Photo D2-5: View of downstream slope and toe of CP1-5, west from the crest. Note there are no signs of adverse seepage. (11 June 2014)

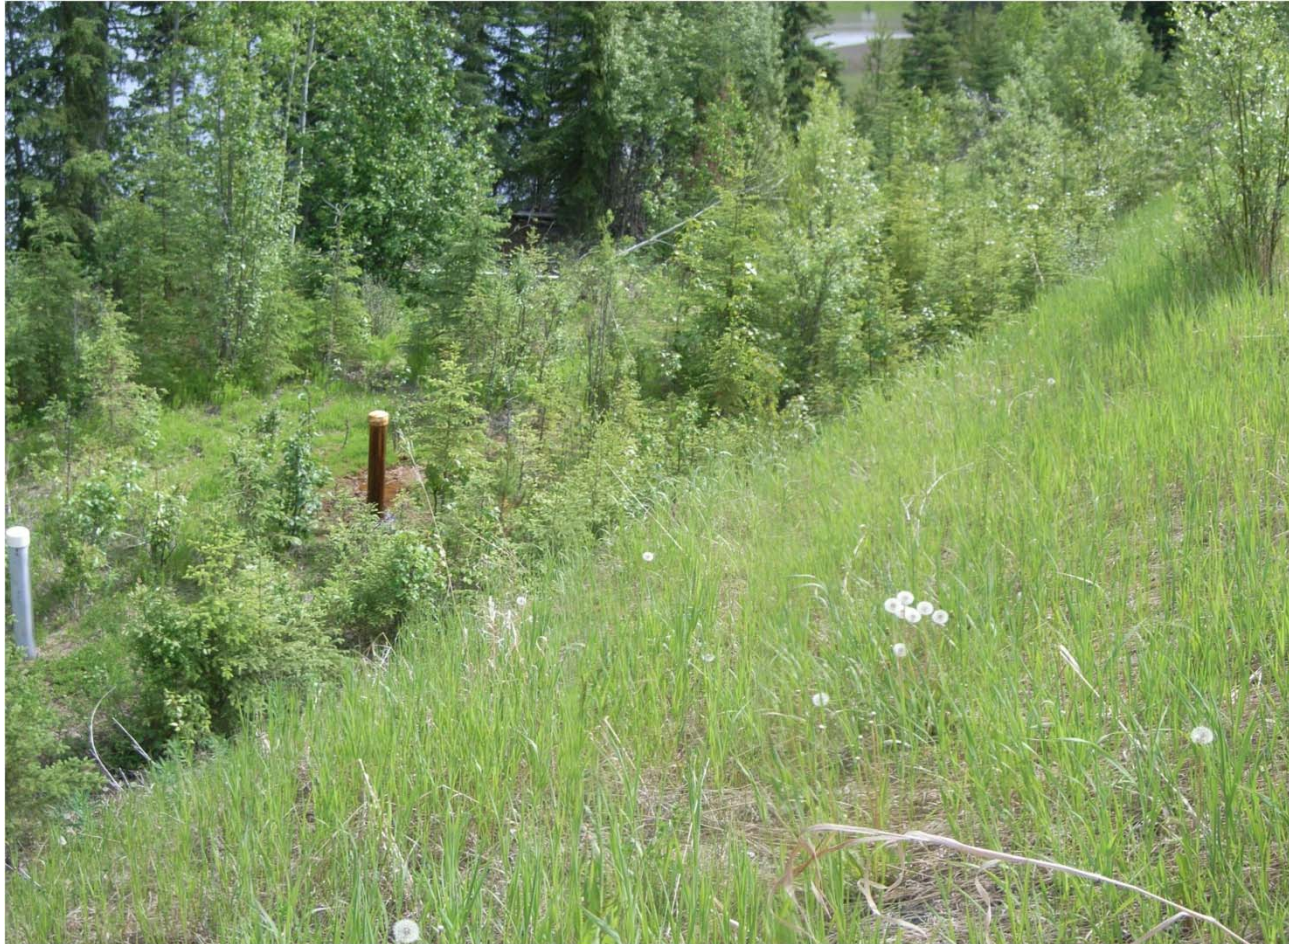
Photo D5-3: View of downstream toe of CP5 Dam, showing monitoring wells. Along east toe of the dam, looking southeast
Note that one of the wells has water flowing over the top of the well casing. (11 June 2014)

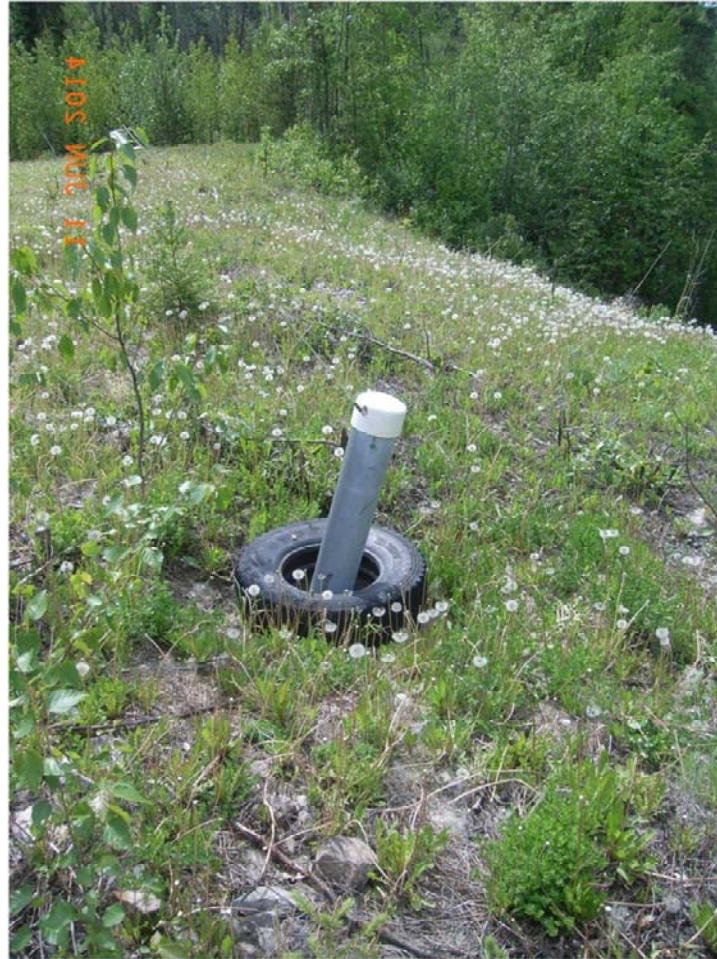
Photo D6-4: Close up view of the crest of dam showing protective casing around standpipe monitoring well. The monitoring well is located on the downstream slope, mid-way along the dam. Looking east. Note that the protective casing and the standpipe were broken. (11 June 2014)

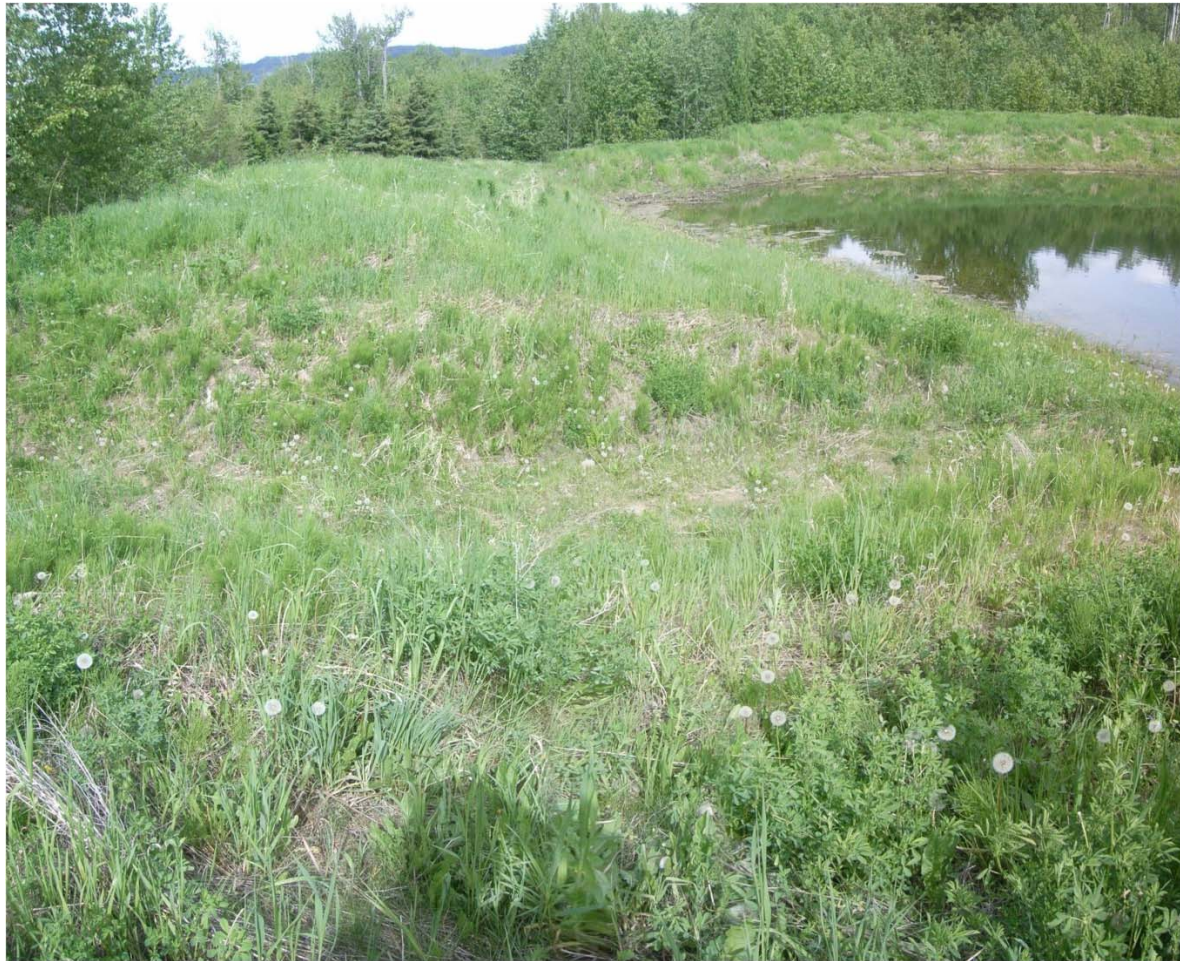
Photo D7-3: View of crest of CP8 Dam, looking east from west end of the north dam. Note spillway in the foreground and low area of the crest in the background. (11 June 2014)
