**Reference: Bell Mine Site
2014 Dam Safety Inspection**

BELL MINE SITE
2014 DAM SAFETY INSPECTION
FINAL REPORT

November 2014

AMEC File: TE143007

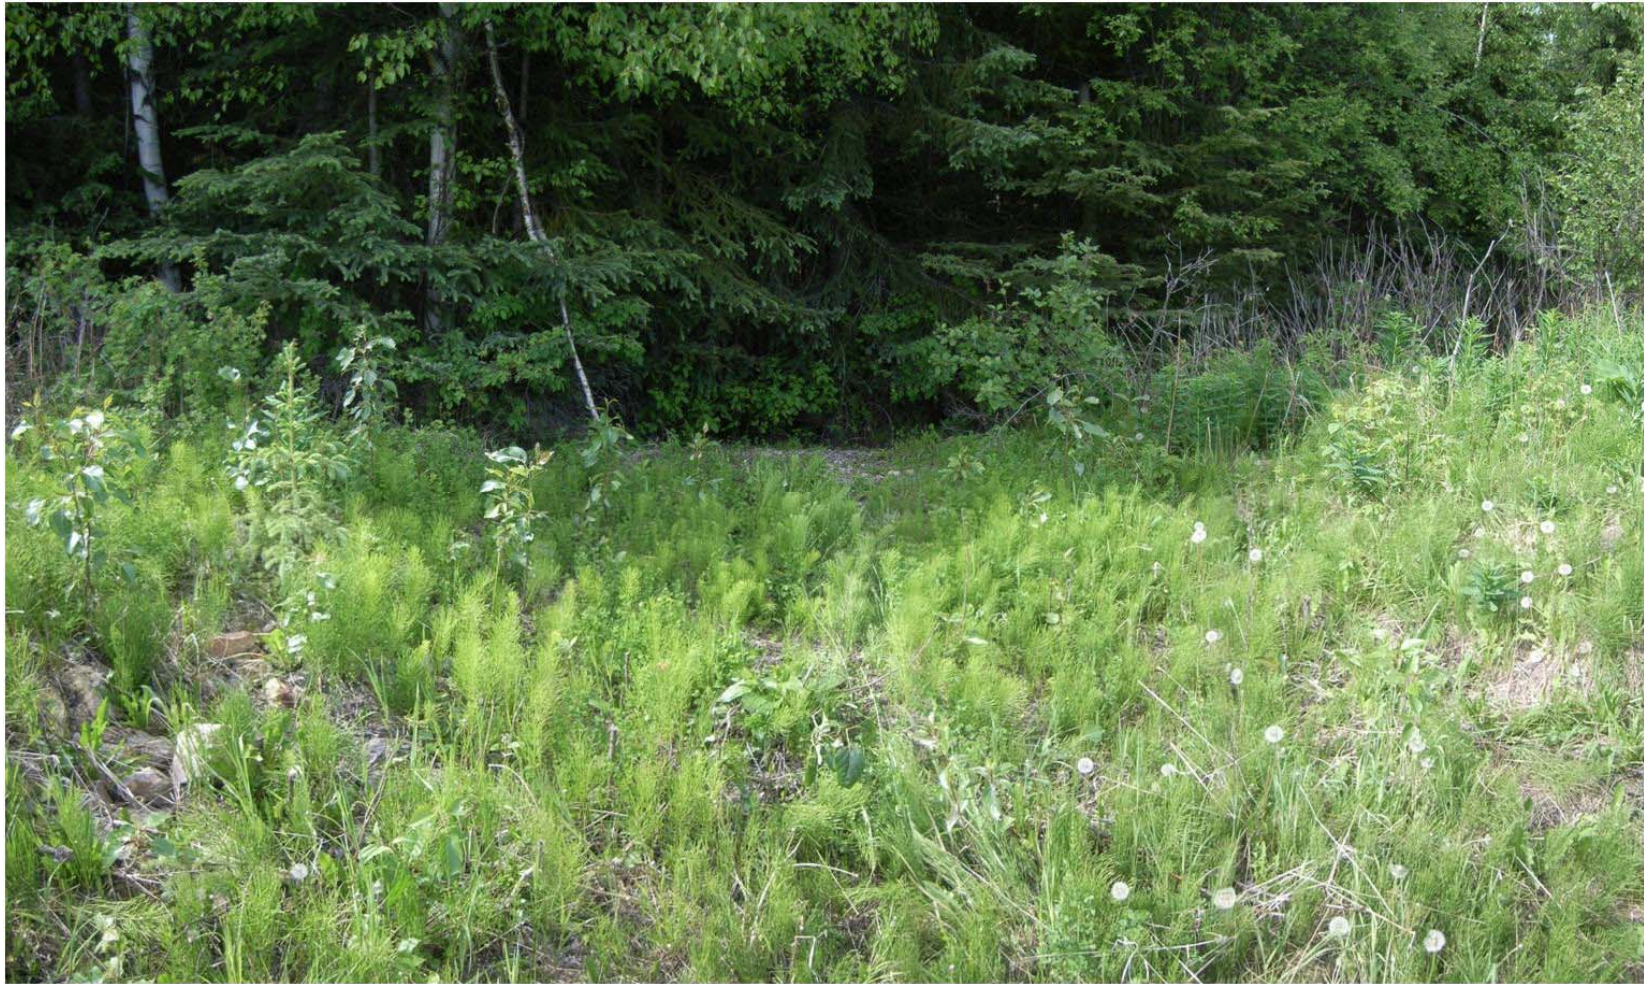
Photo D7-4: View of CP8 spillway, looking north from the crest along the spillway located mid-way along the north dam. Note lack of erosion protection in the spillway. (11 June 2014)
