# SONA RESOURCES CORPORATION BLACKDOME MINE TAILINGS STORAGE FACILITY

## REPORT ON 2014 ANNUAL INSPECTION

VA101-70/15-1  
Rev 0  
November 19, 2014

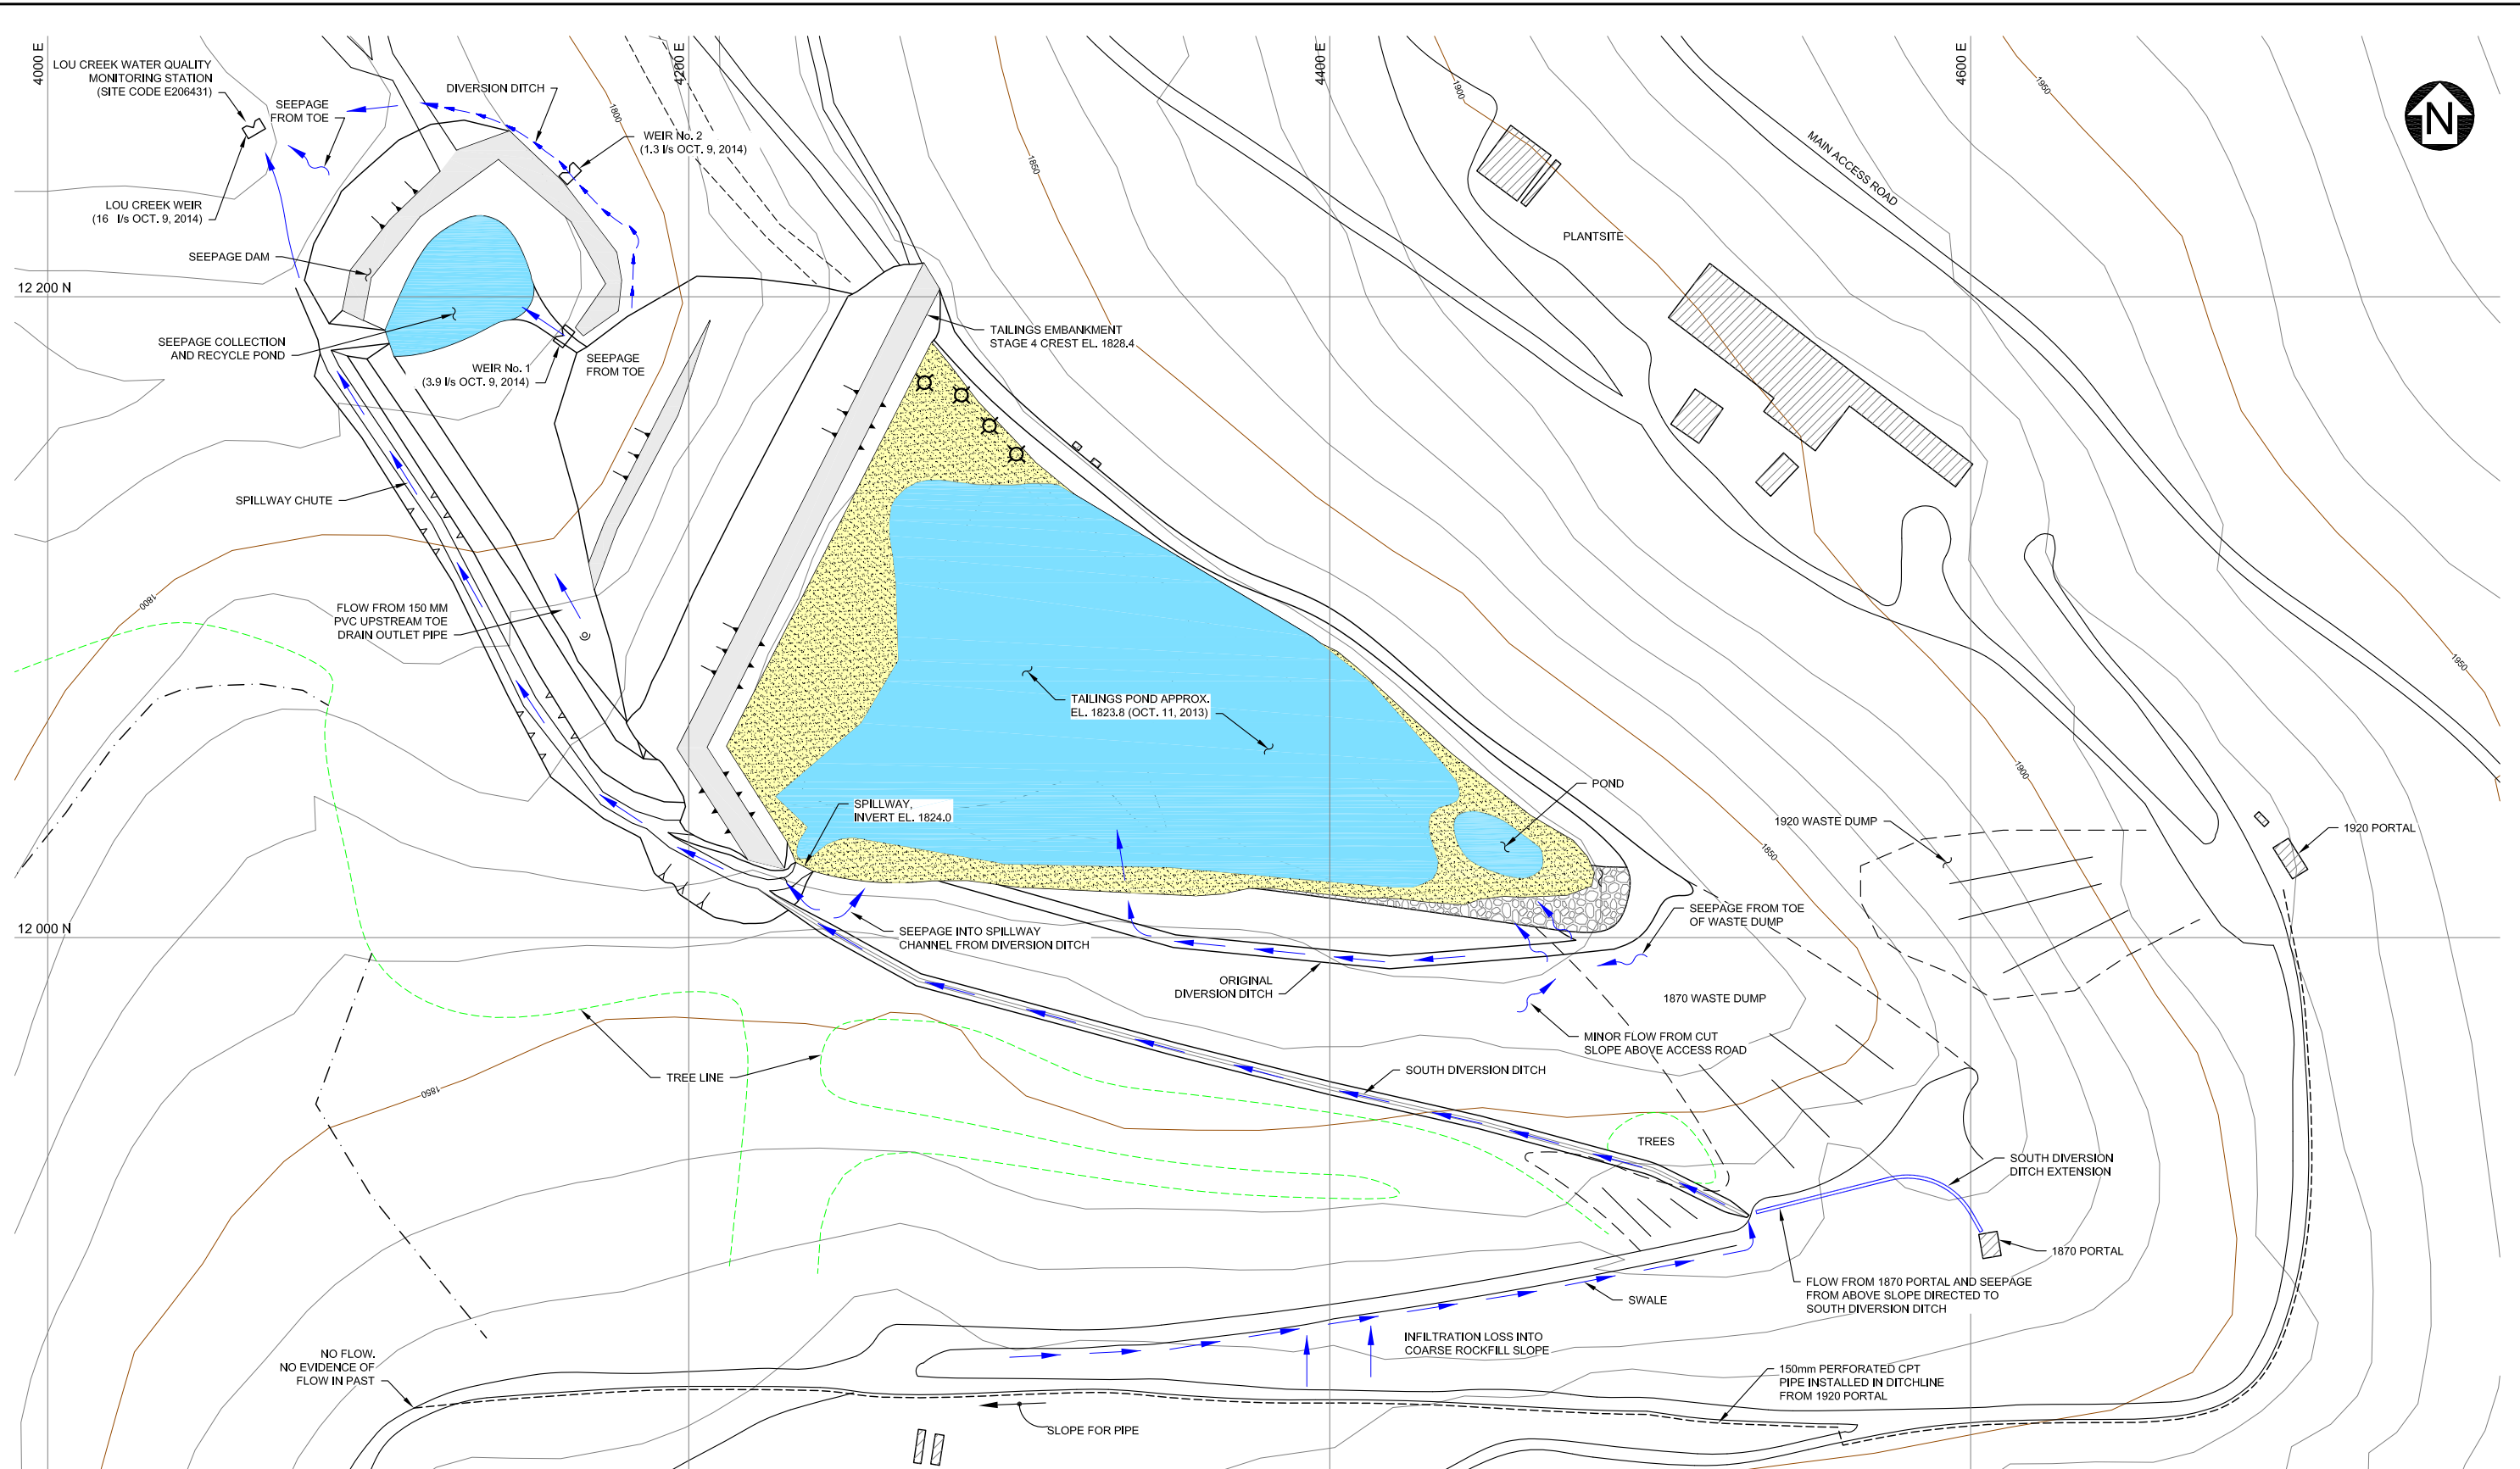
The four sinkholes observed along the north flank of the facility during the 1998 inspection were observed again in 2014. The sinkholes are above the water level of the tailings pond and no water was flowing into them. The sinkholes resulted when tailings material migrated through permeable talus and rockfill in the embankment foundation. Previous evaluations recognized the sinkholes and associated seepage through the embankment foundations were unlikely to pose a risk to dam stability, as the foundation materials were considered to be non-erosive.

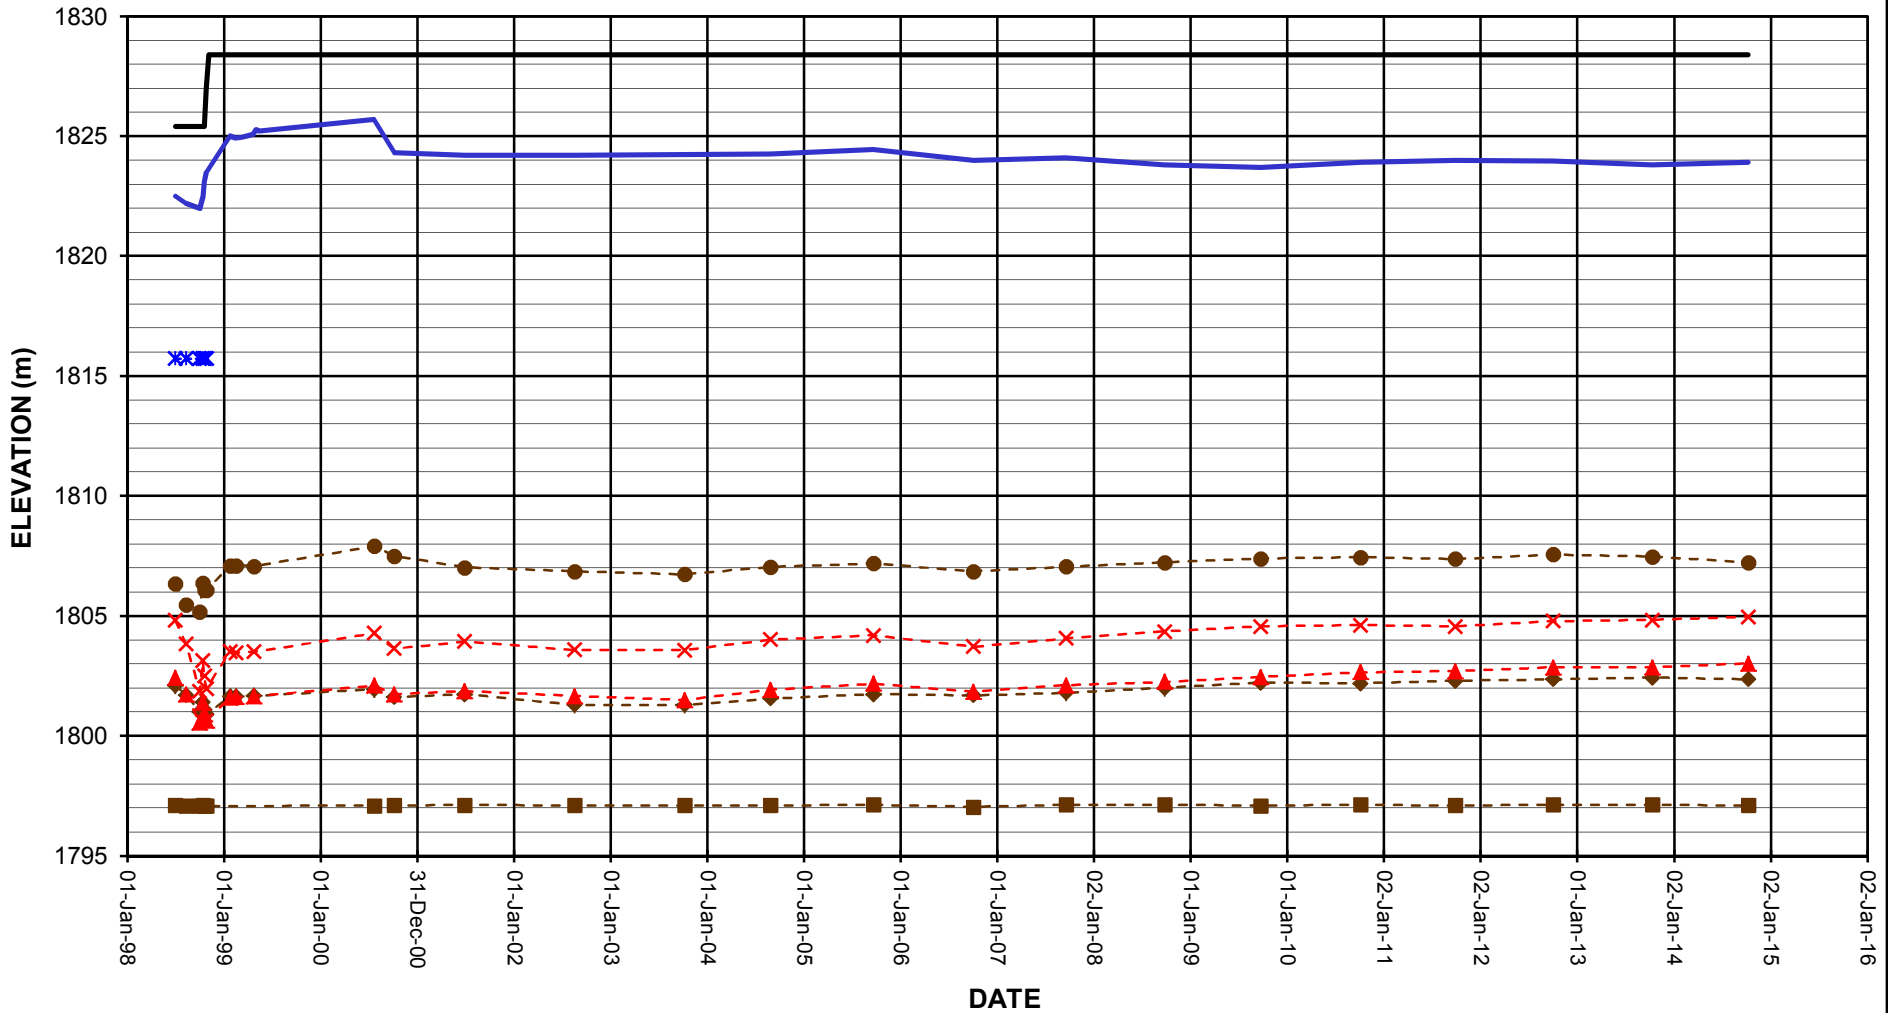
SONA RESOURCES CORPORATION	
BLACKDOME MINE	
TAILINGS STORAGE FACILITY 2014 ANNUAL INSPECTION STANDPIPE PIEZOMETER MONITORING - PLANE 1	
	P/A NO. VA101-70/15
	REF NO. 1
<b>FIGURE 2.4</b>	
REV 0

**NOTES:**  
 1. DASHED LINES INDICATE ASSUMED WATER LEVELS.  
 2. PIEZOMETER 1-6 NOT FUNCTIONING.

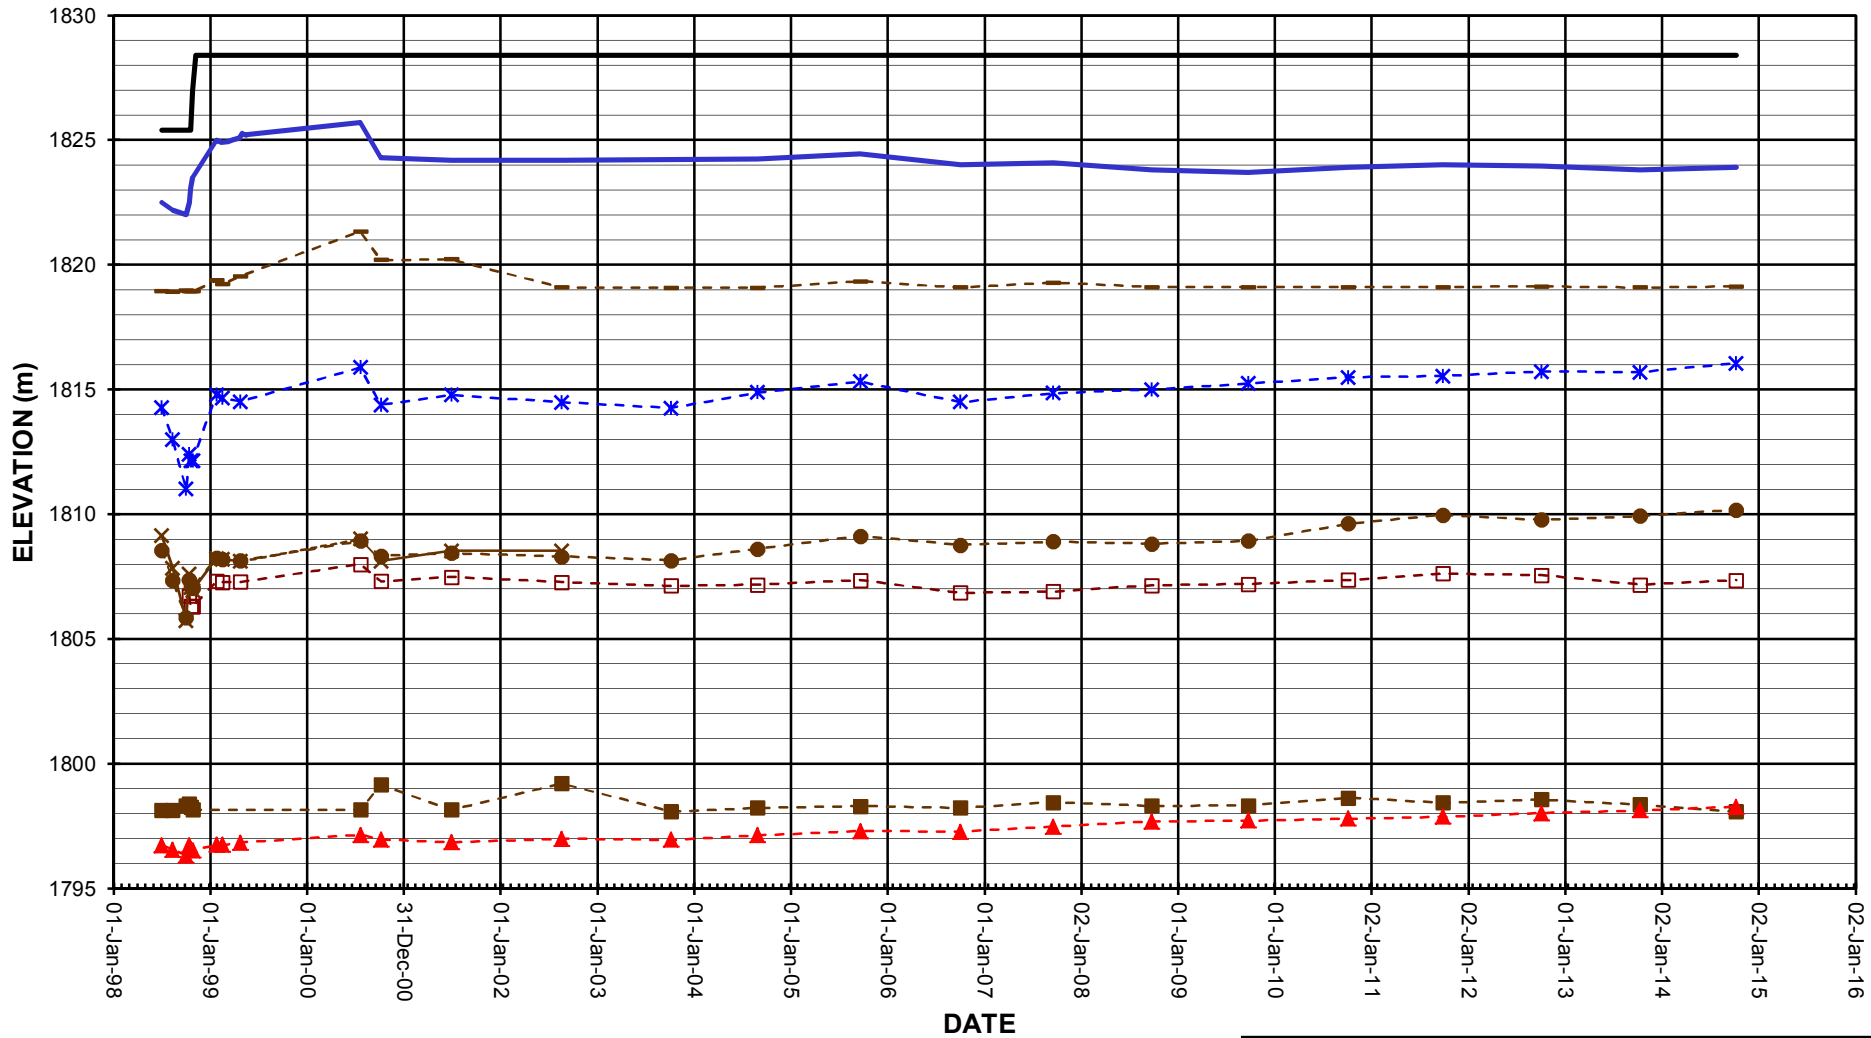
SONA RESOURCES CORPORATION	
BLACKDOME MINE	
<b>TAILINGS STORAGE FACILITY 2014 ANNUAL INSPECTION STANDPIPE PIEZOMETER MONITORING - PLANE 2</b>	
	P/A NO. VA101-70/15
	REF NO. 1
<b>FIGURE 2.5</b>	
REV 0

**NOTES:**  
 1. DASHED LINES INDICATE ASSUMED WATER LEVELS.  
 2. PIEZOMETER 2-5 NOT FUNCTIONING.

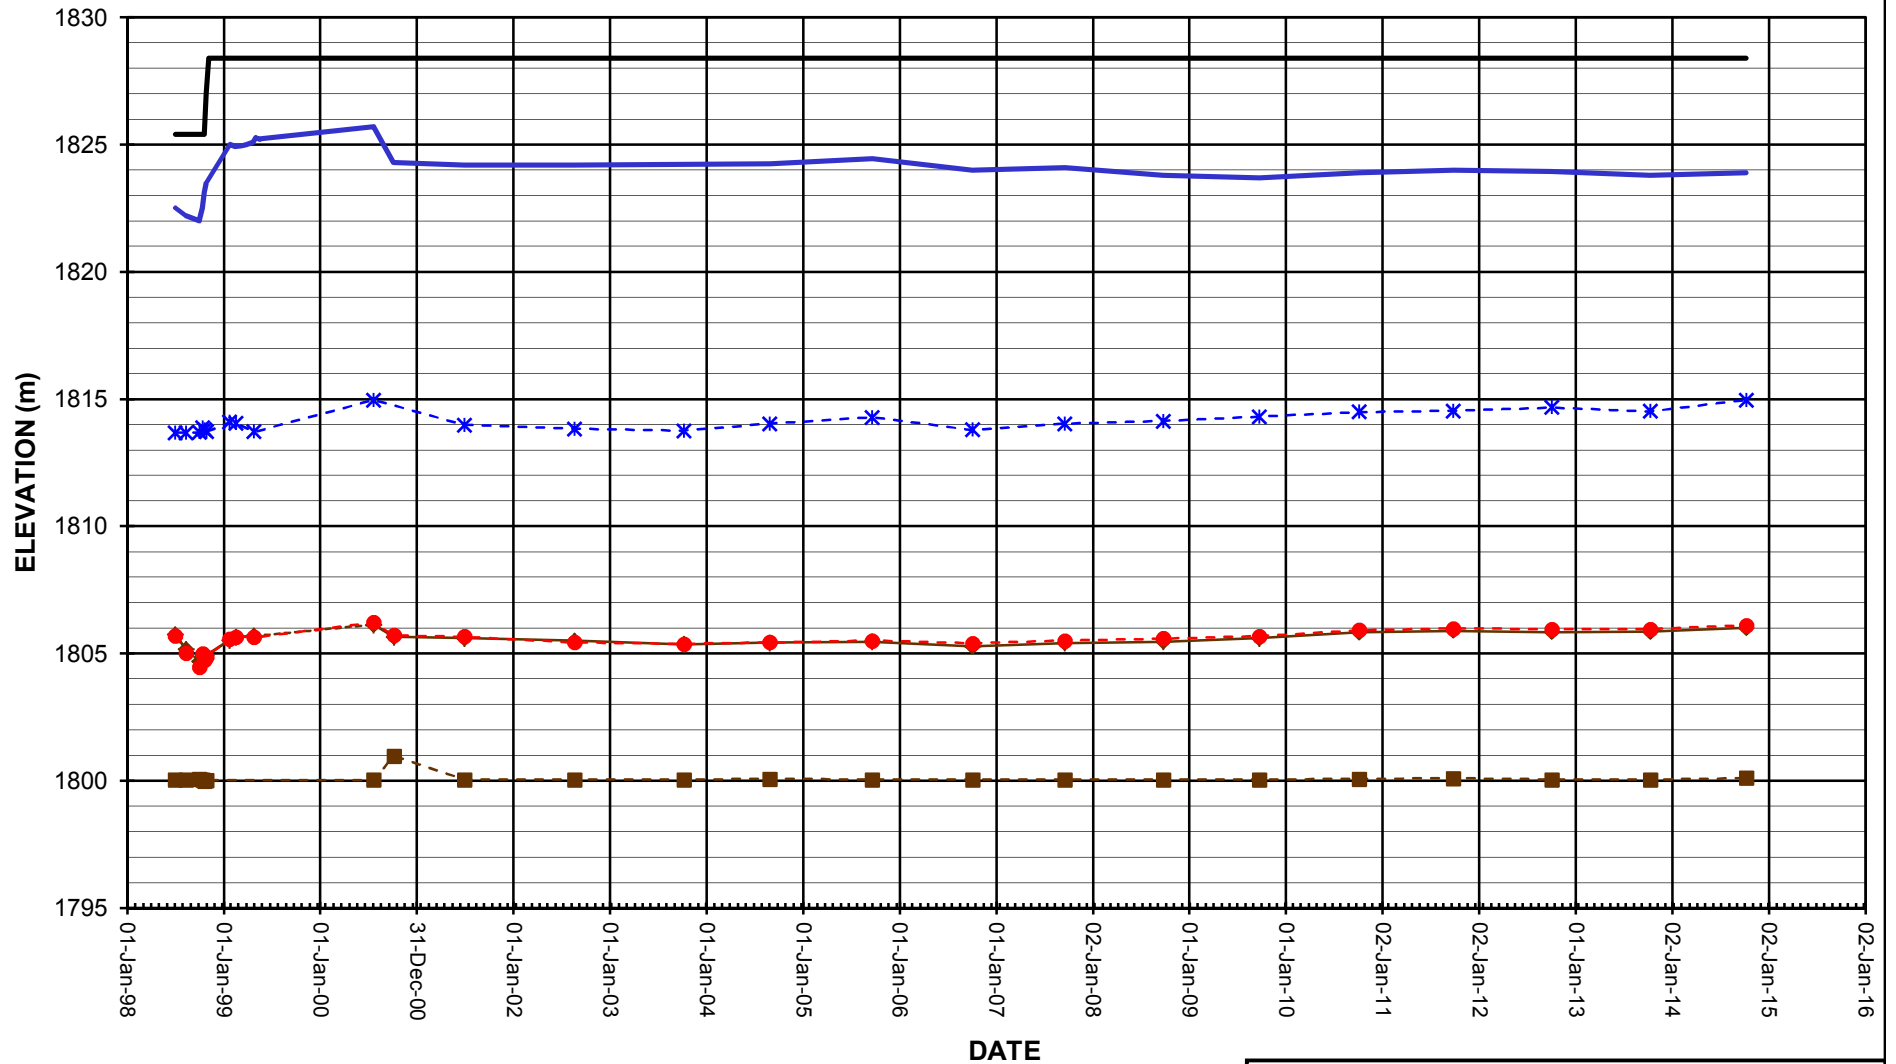
SONA RESOURCES CORPORATION	
BLACKDOME MINE	
TAILINGS STORAGE FACILITY 2014 ANNUAL INSPECTION STANDPIPE PIEZOMETER MONITORING - PLANE 3	
<i>Knight Piésold</i> CONSULTING	P/A NO. VA101-70/15
REF NO. 1	
<b>FIGURE 2.6</b>	
REV	0

**NOTES:**  
 1. DASHED LINES INDICATE ASSUMED WATER LEVELS.  
 2. PIEZOMETER 3-3 NOT FUNCTIONING.

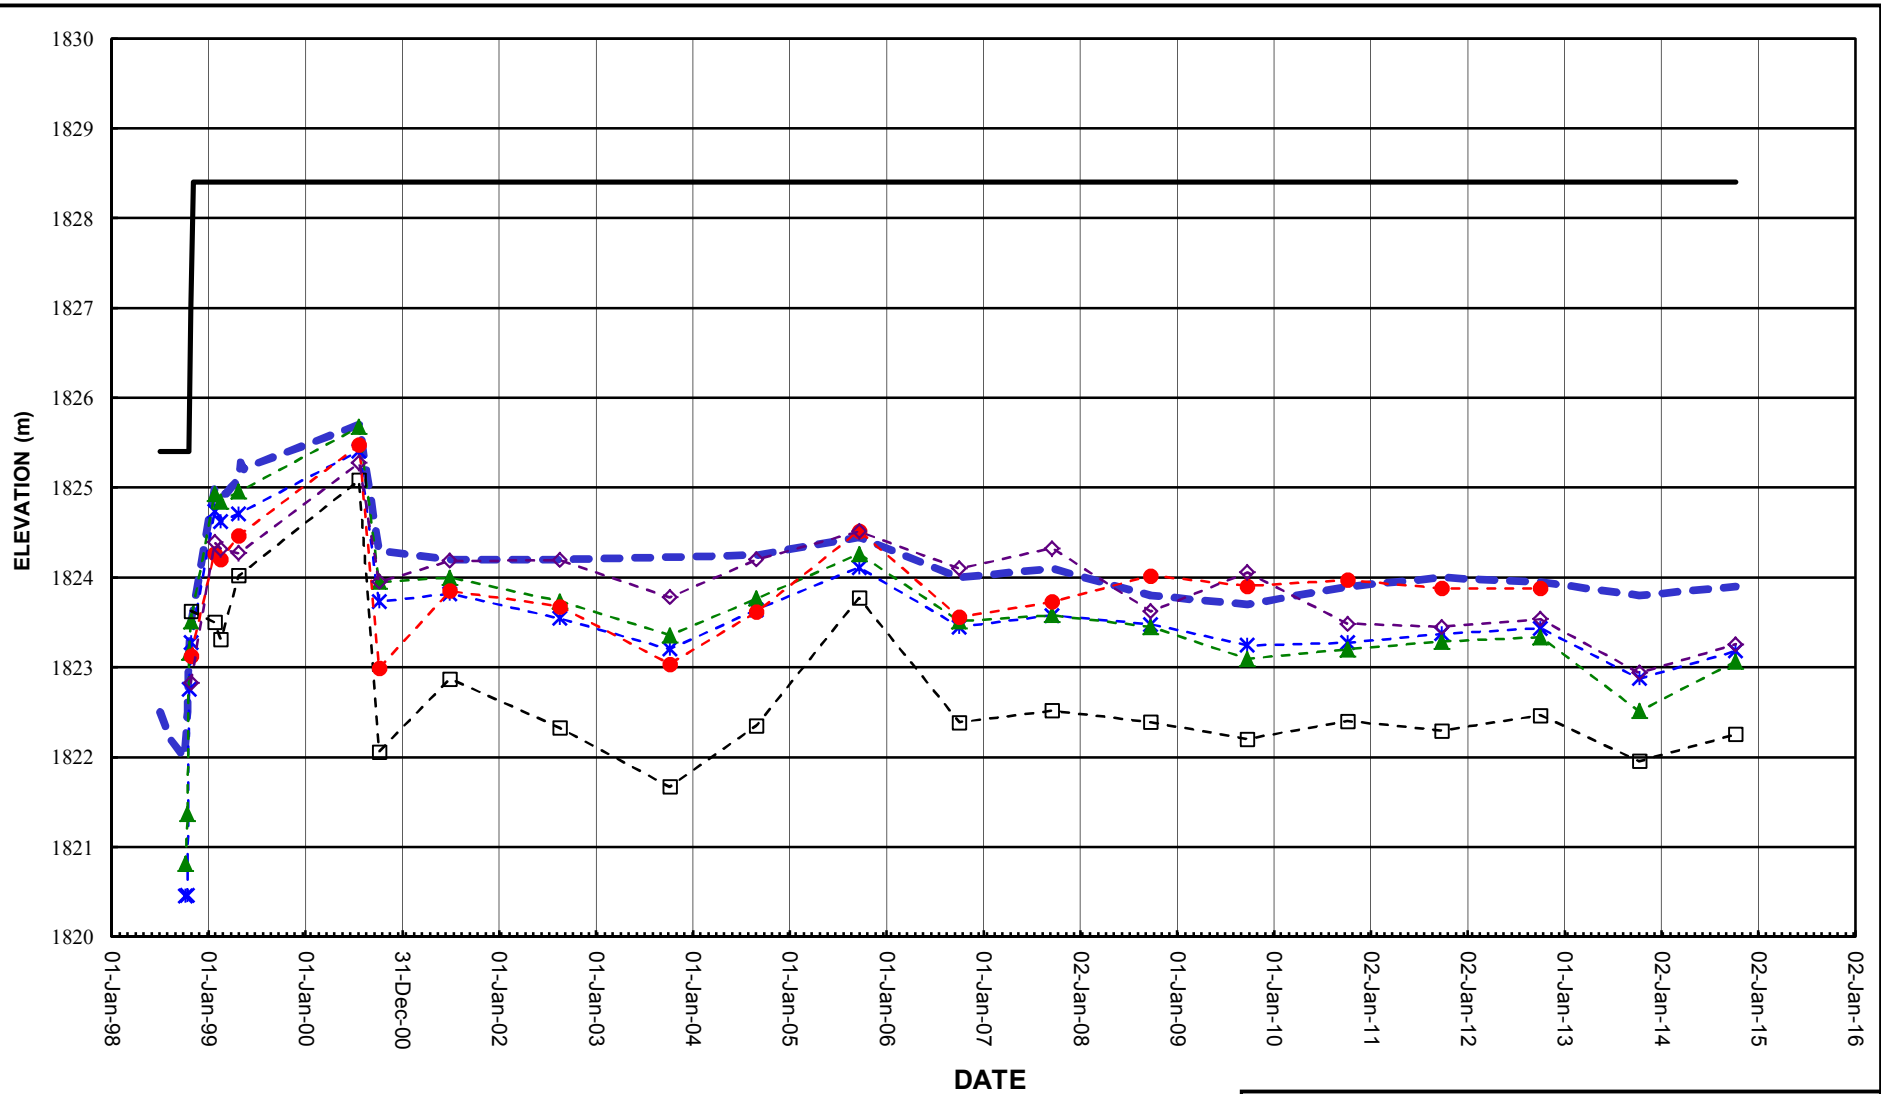
SONA RESOURCES CORPORATION	
BLACKDOME MINE	
<b>TAILINGS STORAGE FACILITY 2014 ANNUAL INSPECTION VIBRATING WIRE TAILINGS PIEZOMETERS</b>	
<i><b>Knight Piésold</b></i> CONSULTING	P/A NO. VA101-70/15
	REF NO. 1
<b>FIGURE 2.7</b>	
REV 0

**NOTES:**  
 1. DASHED LINES INDICATE ASSUMED WATER LEVELS.  
 2. PIEZOMETER T-PE1-04 NOT FUNCTIONING.

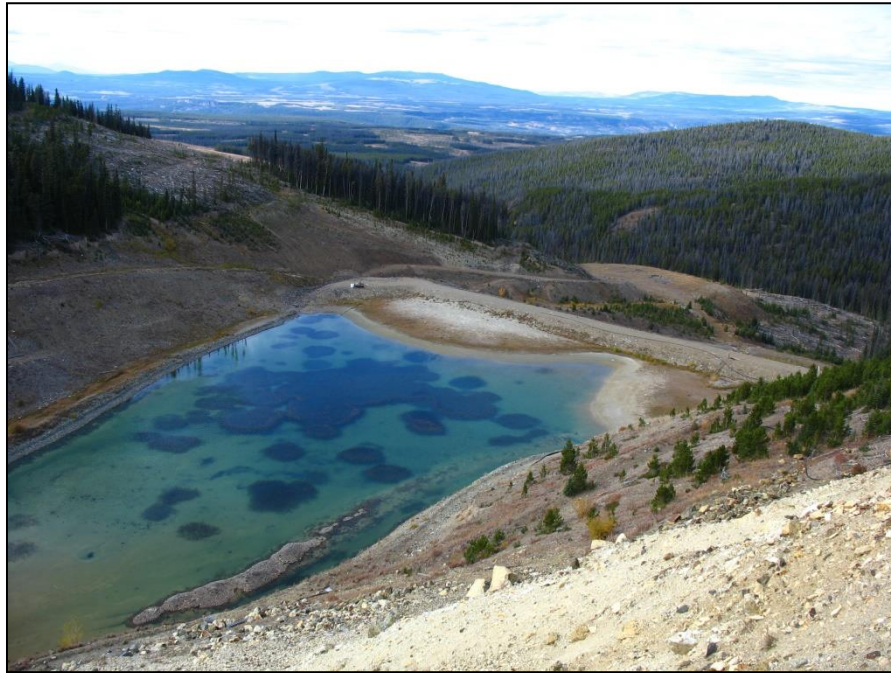
The elevation of the tailings pond at the time of the inspection was approximately 1823.9 m, which is approximately 0.1 m higher than observed in 2013. This is within the range of previously observed pond elevations. The pond elevation is slightly below the spillway invert elevation. There are no concerns with the elevation of the tailings pond.

**PHOTO 1** – View of tailings pond and embankment crest.

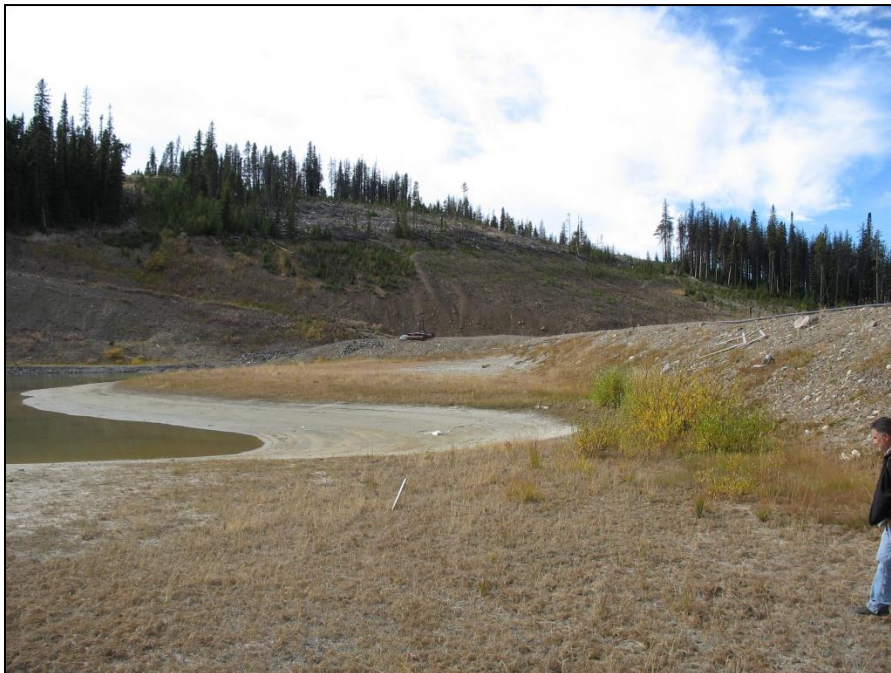
**PHOTO 2** – View of tailings beach and upstream face of embankment looking west.

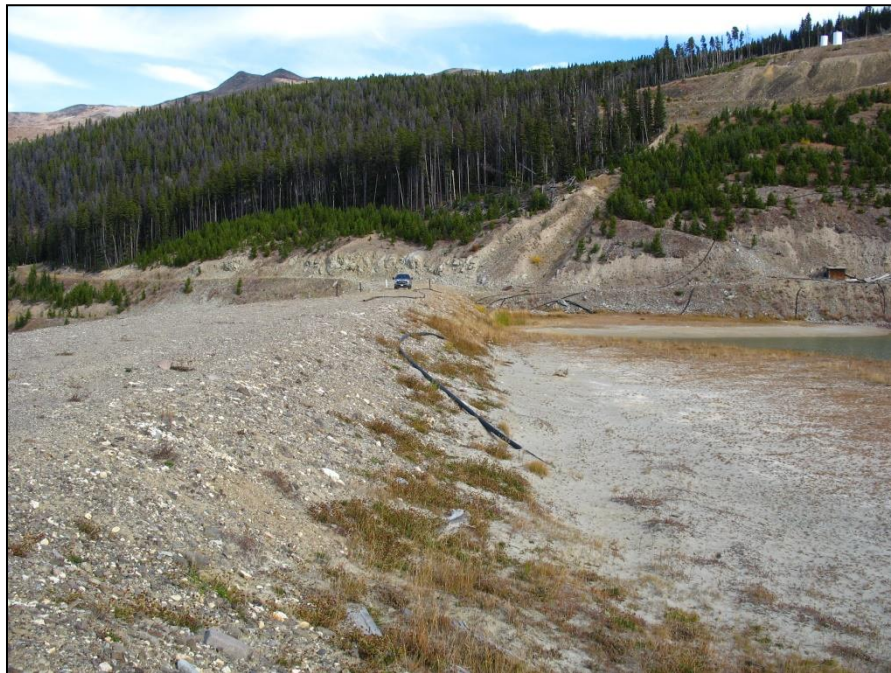
**PHOTO 3** – View of tailings beach and upstream face of embankment looking east.

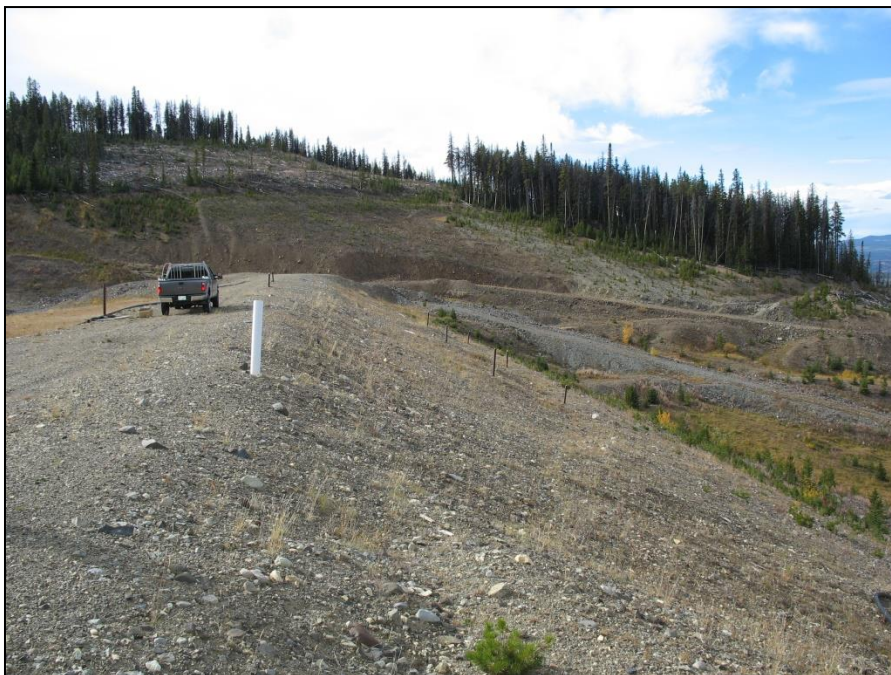
No signs of deformation were identified on the tailings embankment. The embankment slopes were approximately planar and there was no evidence of cracking, bulging or slumping in the embankment fill materials. The embankment crest appeared to be relatively level with no signs of differential settlement. There was no evidence of animal burrowing.

**PHOTO 4** – View of tailings embankment downstream slope looking east.

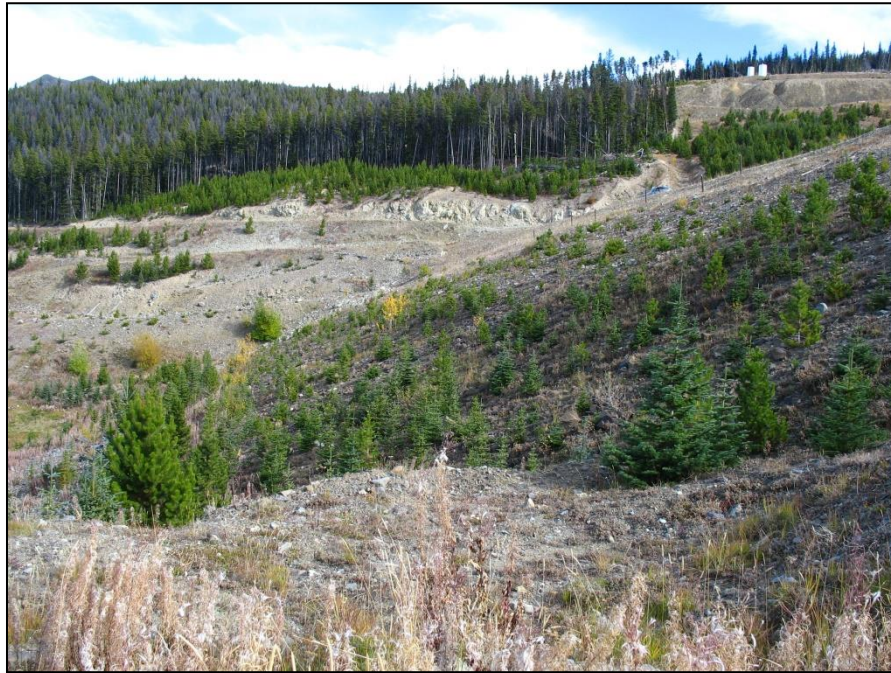
**PHOTO 5** – View of tailings embankment downstream slope looking east.

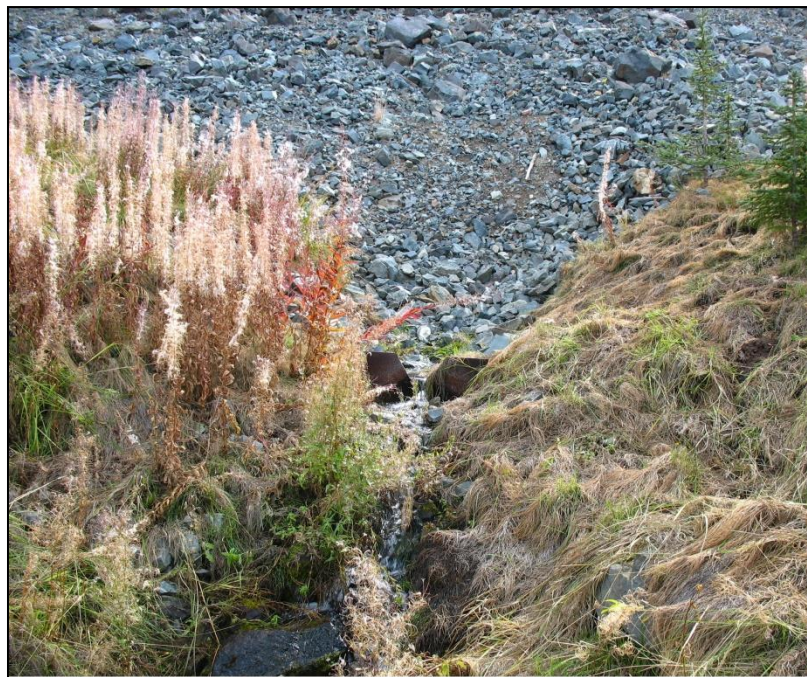
**PHOTO 6** – View of flow through Weir 1 located downstream of TSF embankment.

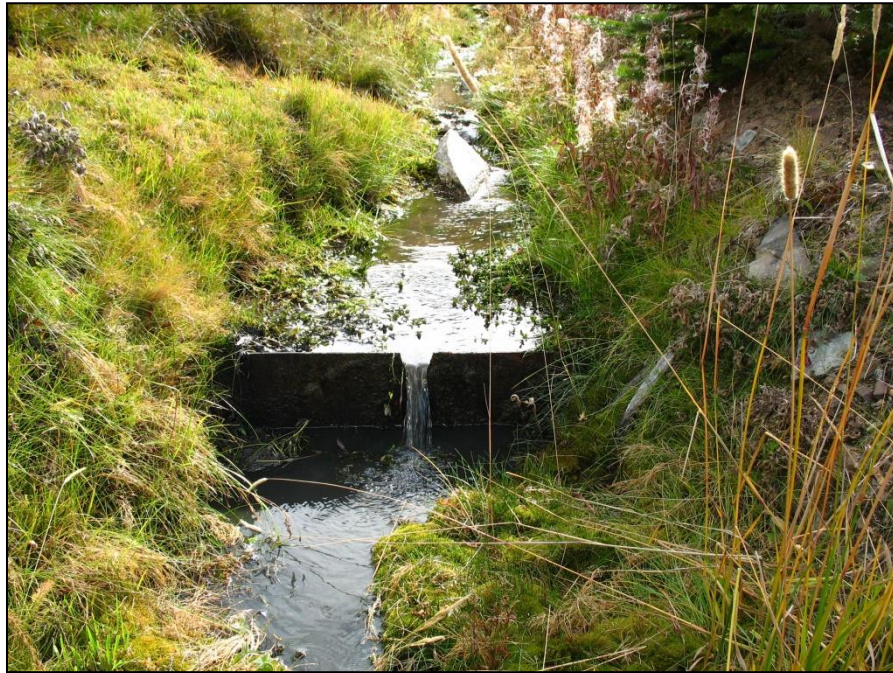
**PHOTO 7** – View of flow through Weir 2 located on east side of TSF embankment.

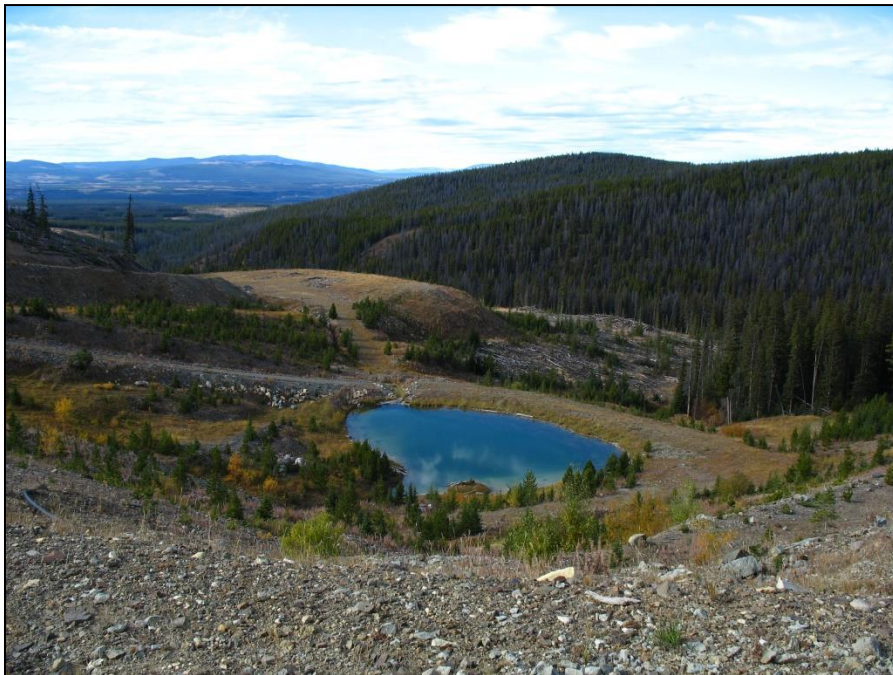
**PHOTO 8** – View of Seepage Collection and Recycle Pond.

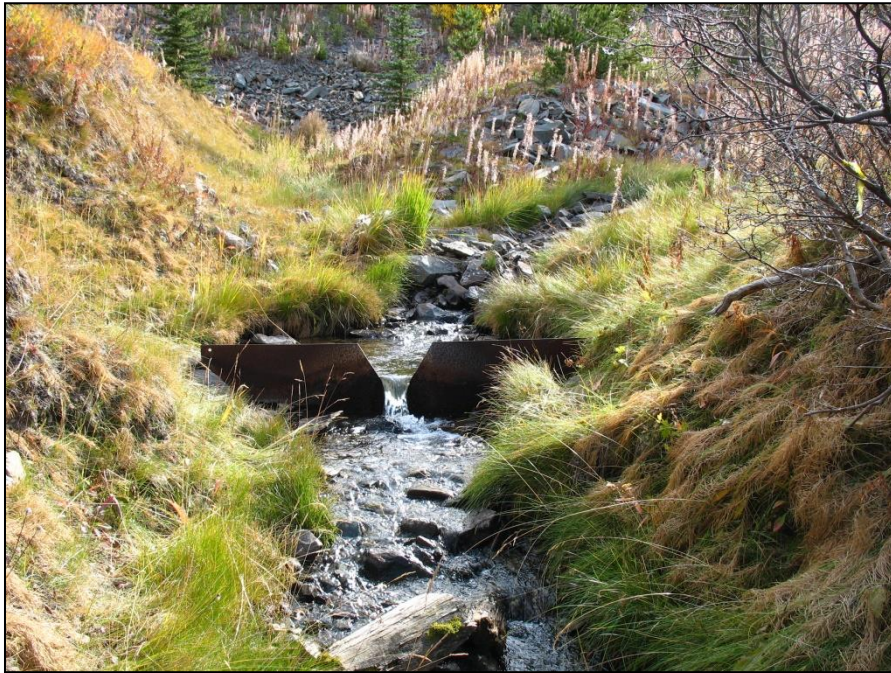
**PHOTO 9** – View of flow through Lou Creek Weir located downstream of the Seepage Collection and Recycle Pond.

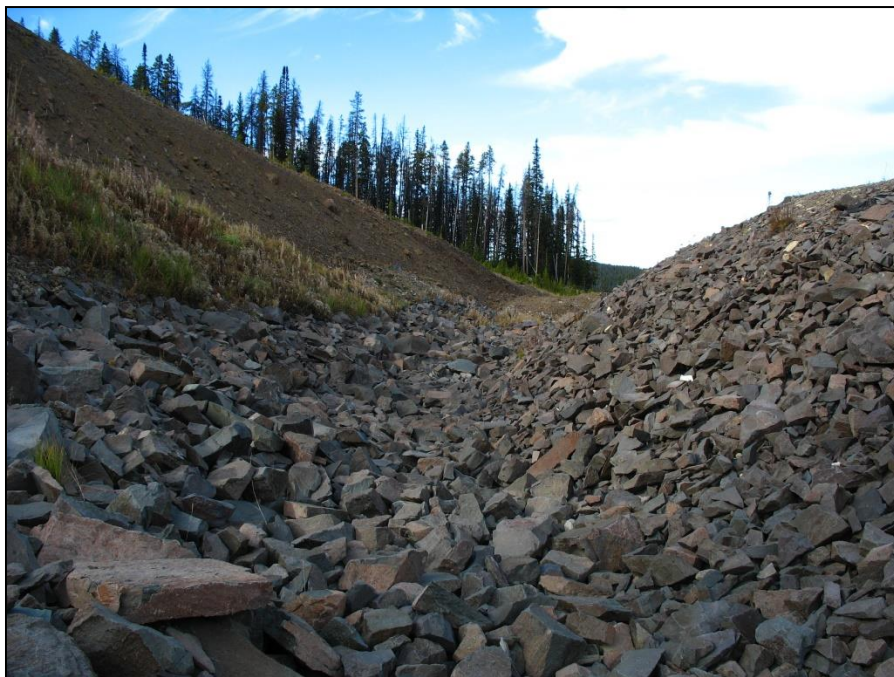
The TSF spillway was designed to pass the 200 year 24-hour storm event. There was no water discharging through the spillway at the time of the inspection. The spillway was observed to be in good condition and showed no signs of erosion.

**PHOTO 10** – View of spillway on left abutment looking downstream.

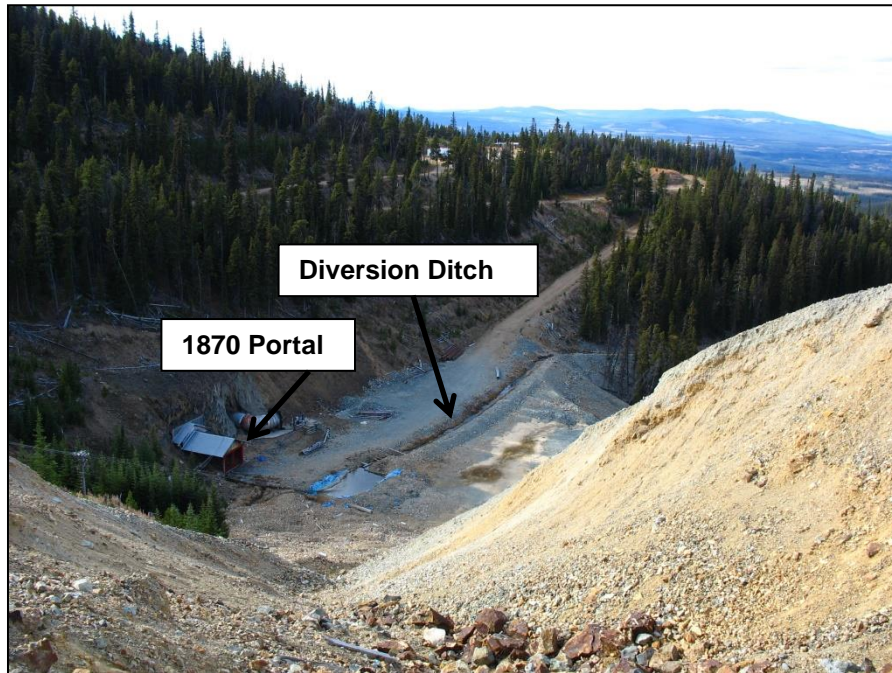
**PHOTO 11** – View of diversion ditch from 1870 Portal.

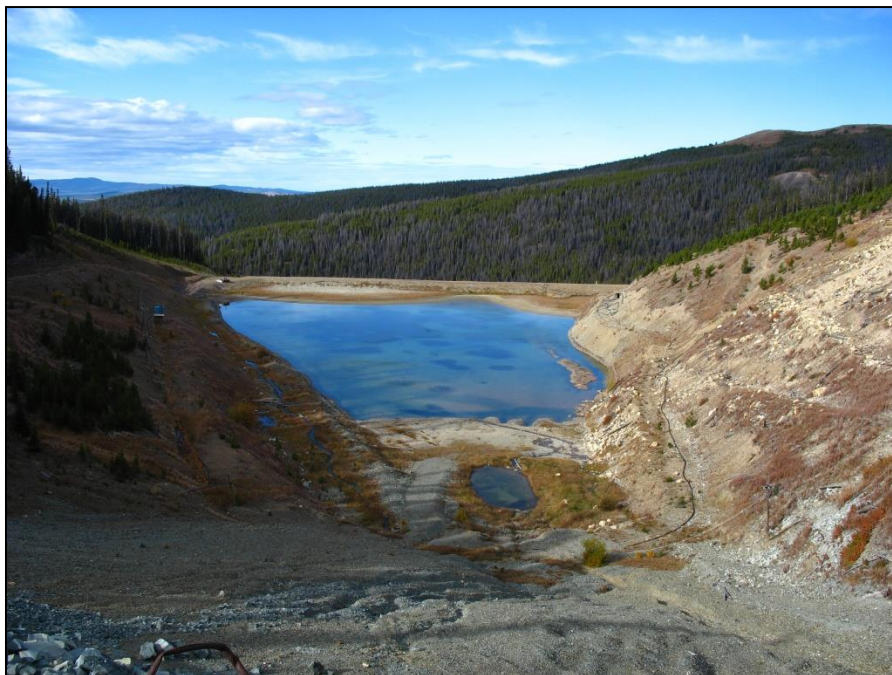
**PHOTO 12** – View of Embankment Crest from south end of the facility.

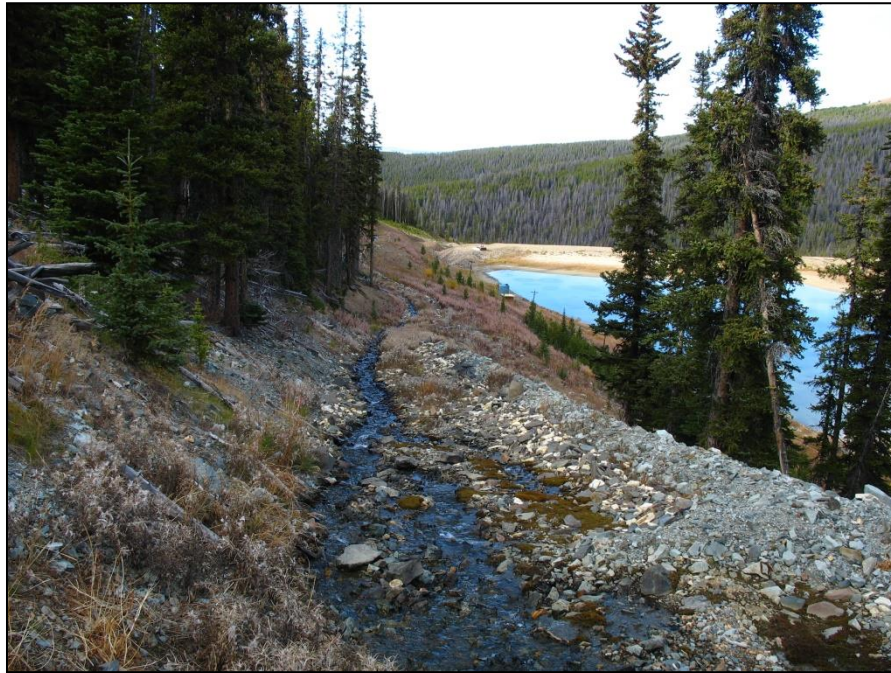
The south diversion ditch joins the TSF spillway immediately downstream of the TSF embankment crest at the left abutment. The South Diversion Ditch was in good condition and was successfully diverting water around the TSF.

**PHOTO 13** – South Diversion ditch looking downstream.

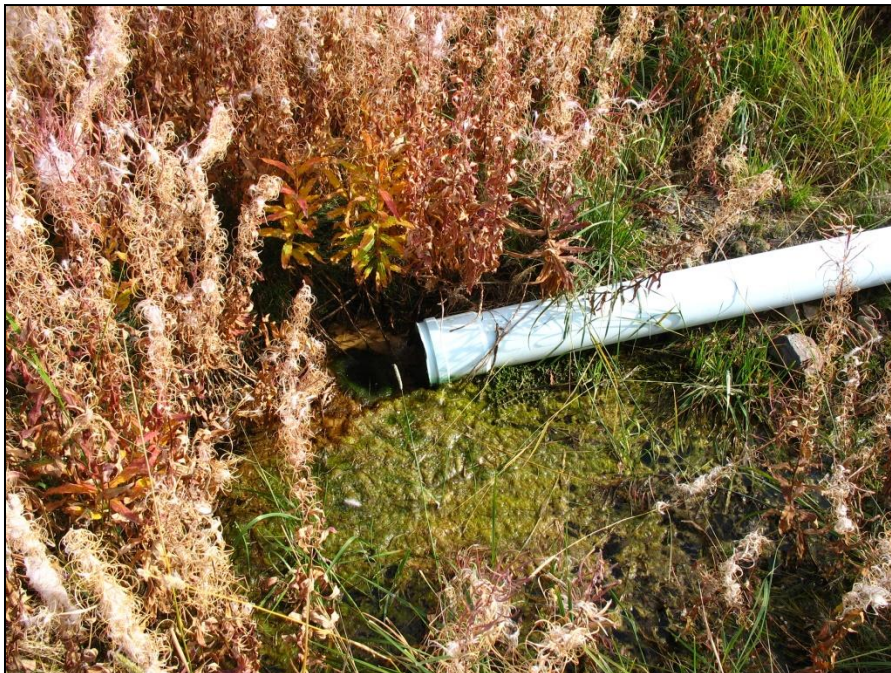
**PHOTO 14** – Flow from upstream drain discharge pipe.

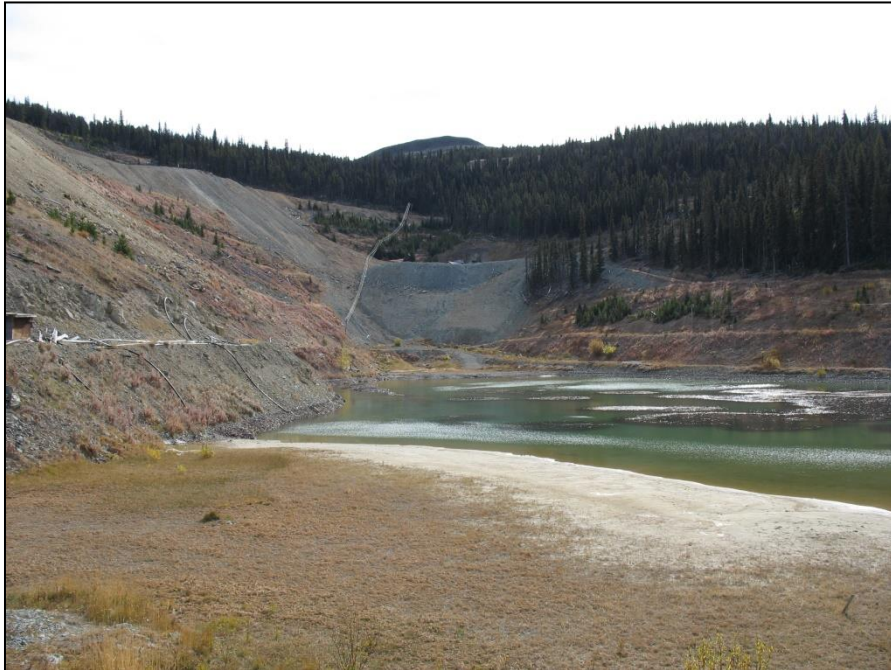
**PHOTO 15** – TSF looking upstream from crest near right abutment.

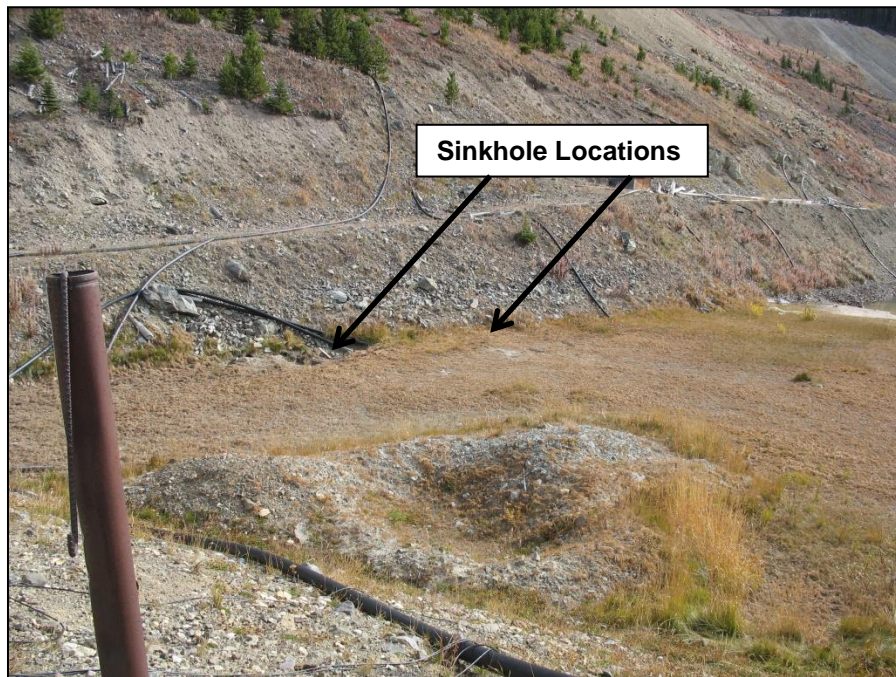
**PHOTO 16** – Tailings beach near right abutment where sinkholes have been previously identified.

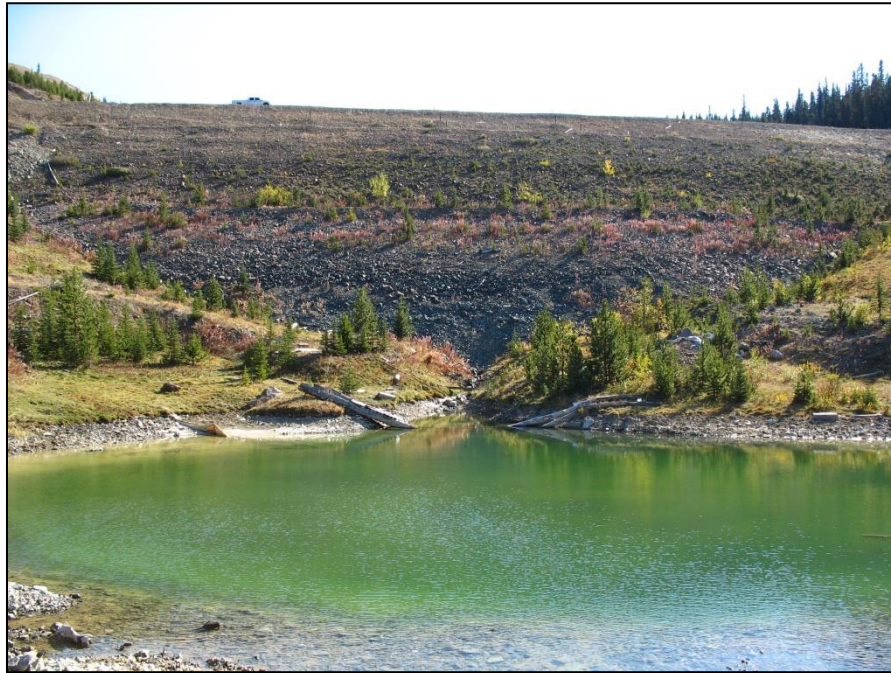
**PHOTO 17** – Downstream slope of TSF embankment with Seepage Collection and Recycle Pond in foreground. Photo from 2012.
