June 30, 2015

File No.:VA101-70/16-A.01  
Cont. No.:VA15-02703

**Re: Blackdome Mine Tailings Storage Facility Assessment - Response to Memorandum Issued by Ministry of Energy and Mines to Blackdome-Sona Resources Corp. on February 3, 2015**

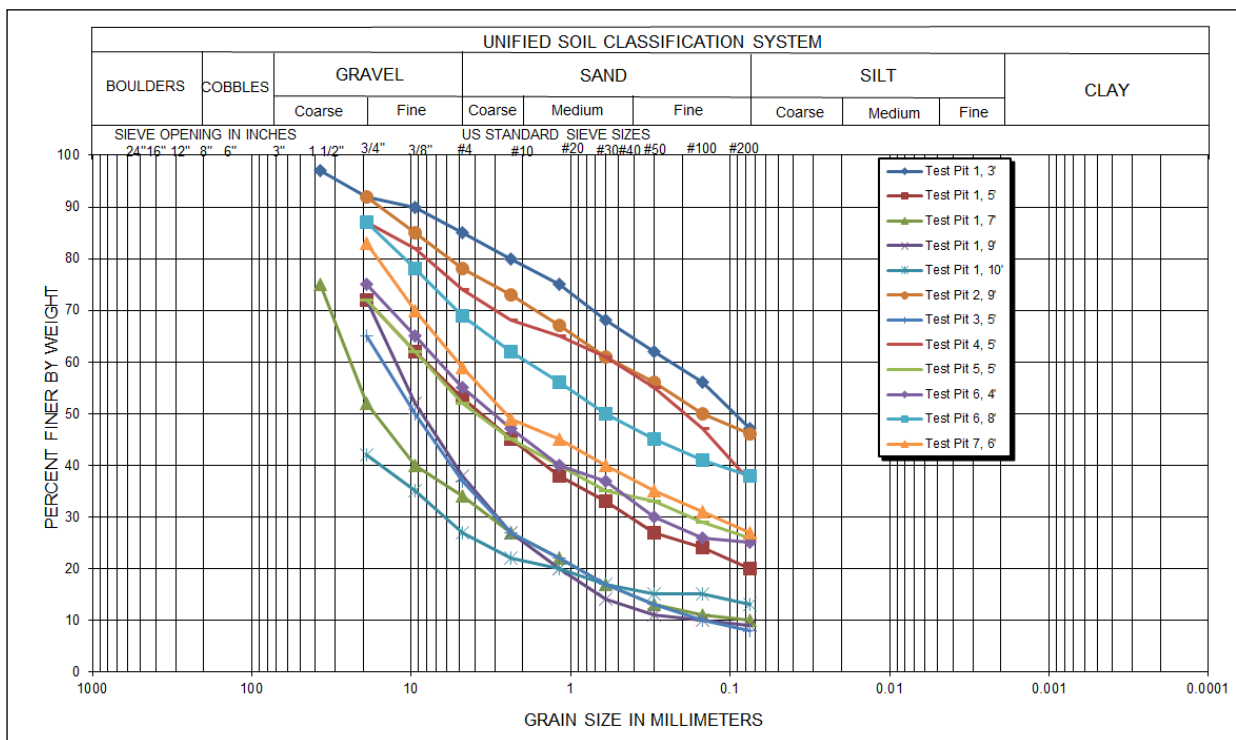
**Figure 2 Site Investigation Particle Size Distribution Summary**

The summary of gradation analyses indicates the material is glacial till in origin, not glacio-lacustrine. The material can generally be classified as well graded gravel-sand-silt mixtures with more than 12% fines, where a glacio-lacustrine deposit would be poorly graded and predominately clay and silt based. The historical data indicates a foundation of well graded gravel-sand-silt mixture which is not considered silt and clay foundation.

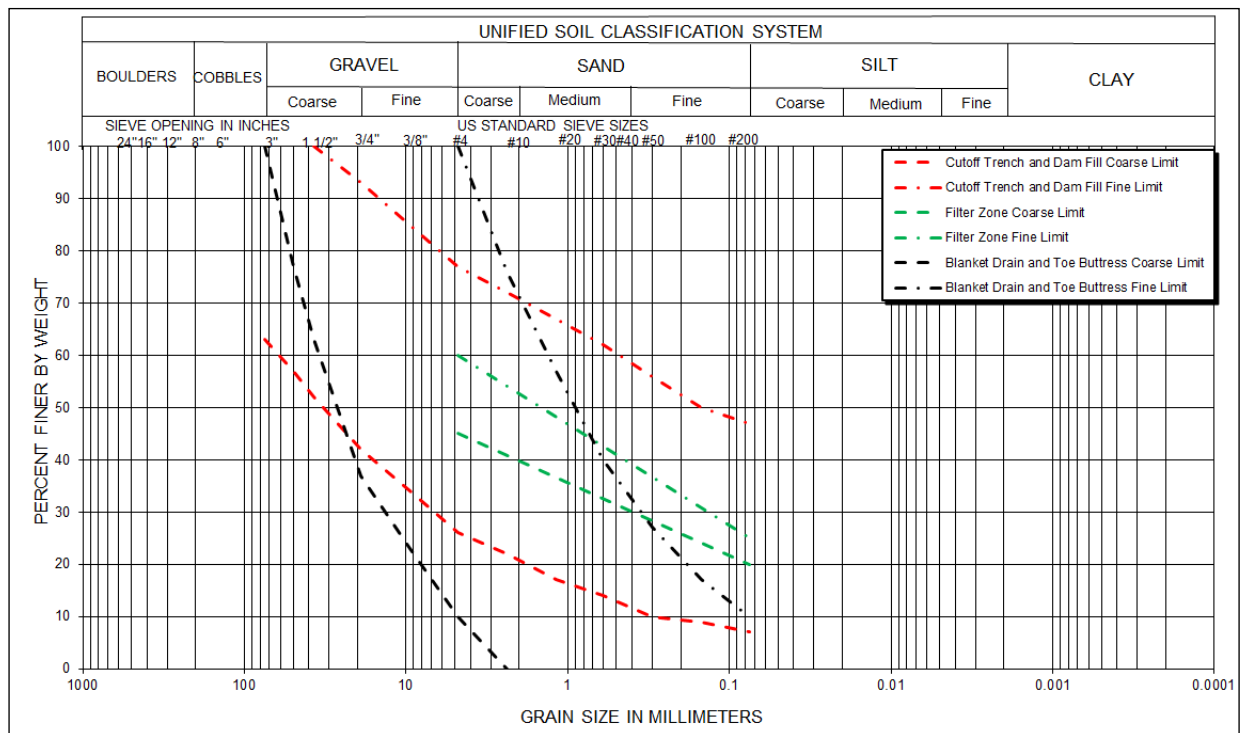
**Figure 3 TSF Embankment Fill**

The original design of the Stage 1 TSF Embankment did not incorporate a filter zone, however during construction it was found that the drain blanket rock particles were near the coarser limit of the specified gradation range and the blanket drain was overlain by a filter zone of sandy and silty gravel originating from the mill bench strippings. The filter was constructed approximately 0.8 m thick to an elevation of 1,796 m as shown on Figure 4.

The assessment concluded the filter zone met the necessary filter criteria ( $D_{15max}$  is less than 0.7 mm for category two base soils with 40 to 85% passing #200 sieve after regrading). However, the filter did not meet the permeability criteria ( $D_{15min}$  is not greater than  $4 \times d_{15}$  of the base soil or greater than 0.1 mm) and it is potentially gap graded (the ratio between the coarse and fine filter zone limits is greater than 5 for the material passing between 45 and 60% and the filter band has a coefficient of uniformity greater than 6). The assessment was not able to evaluate if the filter zone met minimum and maximum particle size or segregation criterion (relationship between  $D_{90}$  and  $D_{10}$ ) with the data provided.

The assessment included evaluation of the blanket drain to act as a filter for the filter zone which concluded the blanket drain did meet the permeability criteria and filter band limits based on the Tailings Dam Construction Report. However, the blanket drain was found to not meet the necessary filter criteria and has the potential to be gap graded and could have segregated during construction.

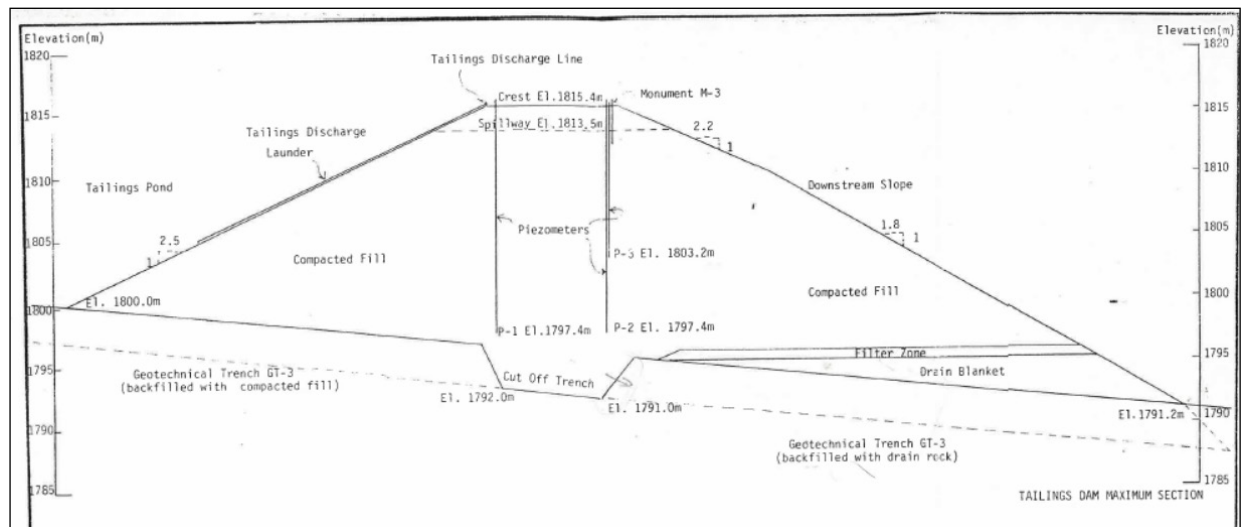
**Figure 4 TSF Embankment Cross Section**

The assessment concluded the filter zone met the necessary filter criteria. However, the filter did not meet the permeability criteria and it is potentially gap graded. The blanket drain was also found to not meet the necessary filter criteria and has the potential to be gap graded and could have segregated during construction.

The TSF will continue to be monitored during the Care and Maintenance period in accordance with the schedule outlined in the CDA guidelines. Annual inspections to date indicate the facility is functioning as designed. However, the site conditions must be re-evaluated prior to either resuming operations at the mine or shutting the mine down for closure.

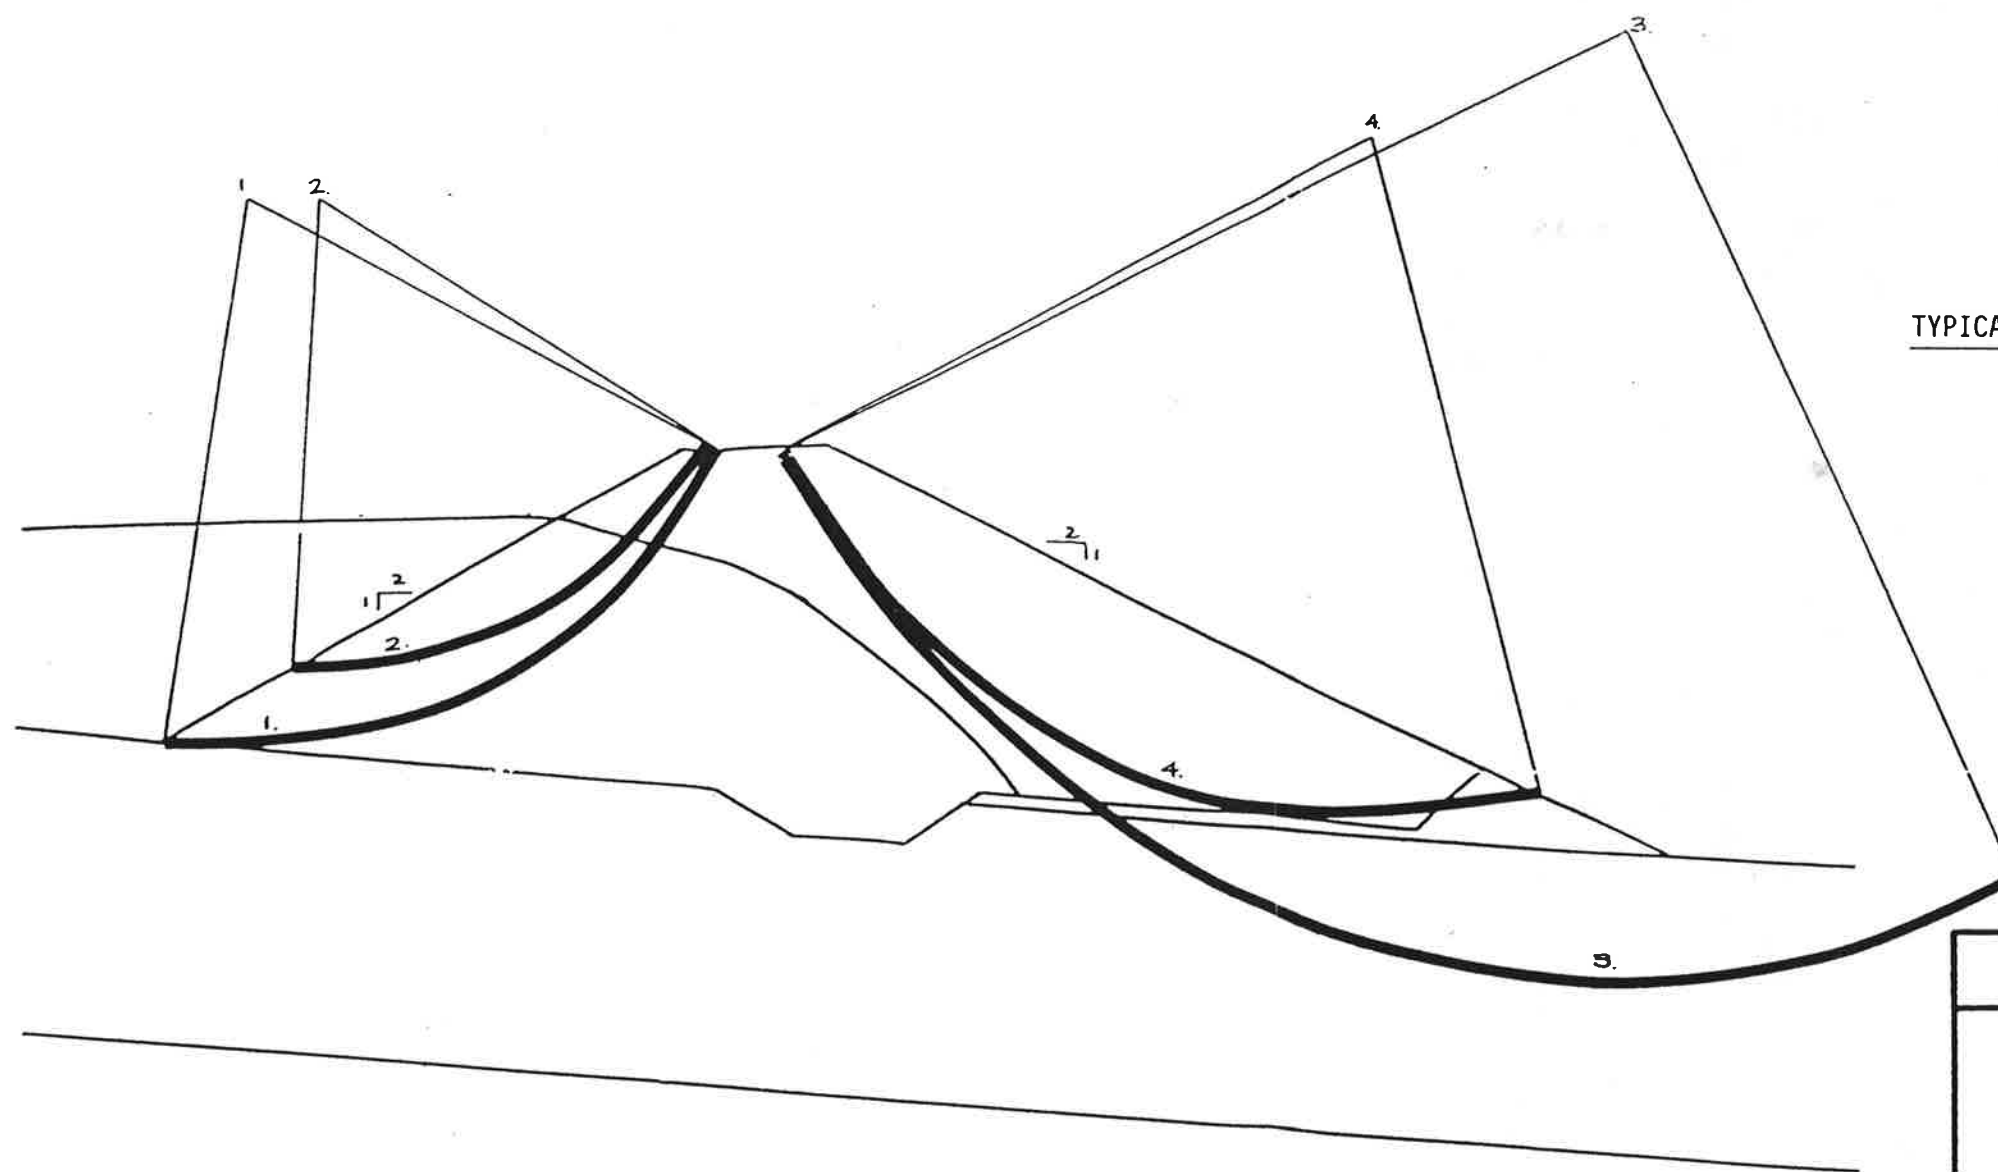
FIGURE 13

With these parameters the critical stability surfaces are similar to those presented in the report. The minimum factors of safety are:

Figure 13 of the report has been included herein, showing the critical slip surfaces. In the report the slope designation for circles 3 and 4 were shown as upstream, whereas they were actually downstream. Please correct this in the report.

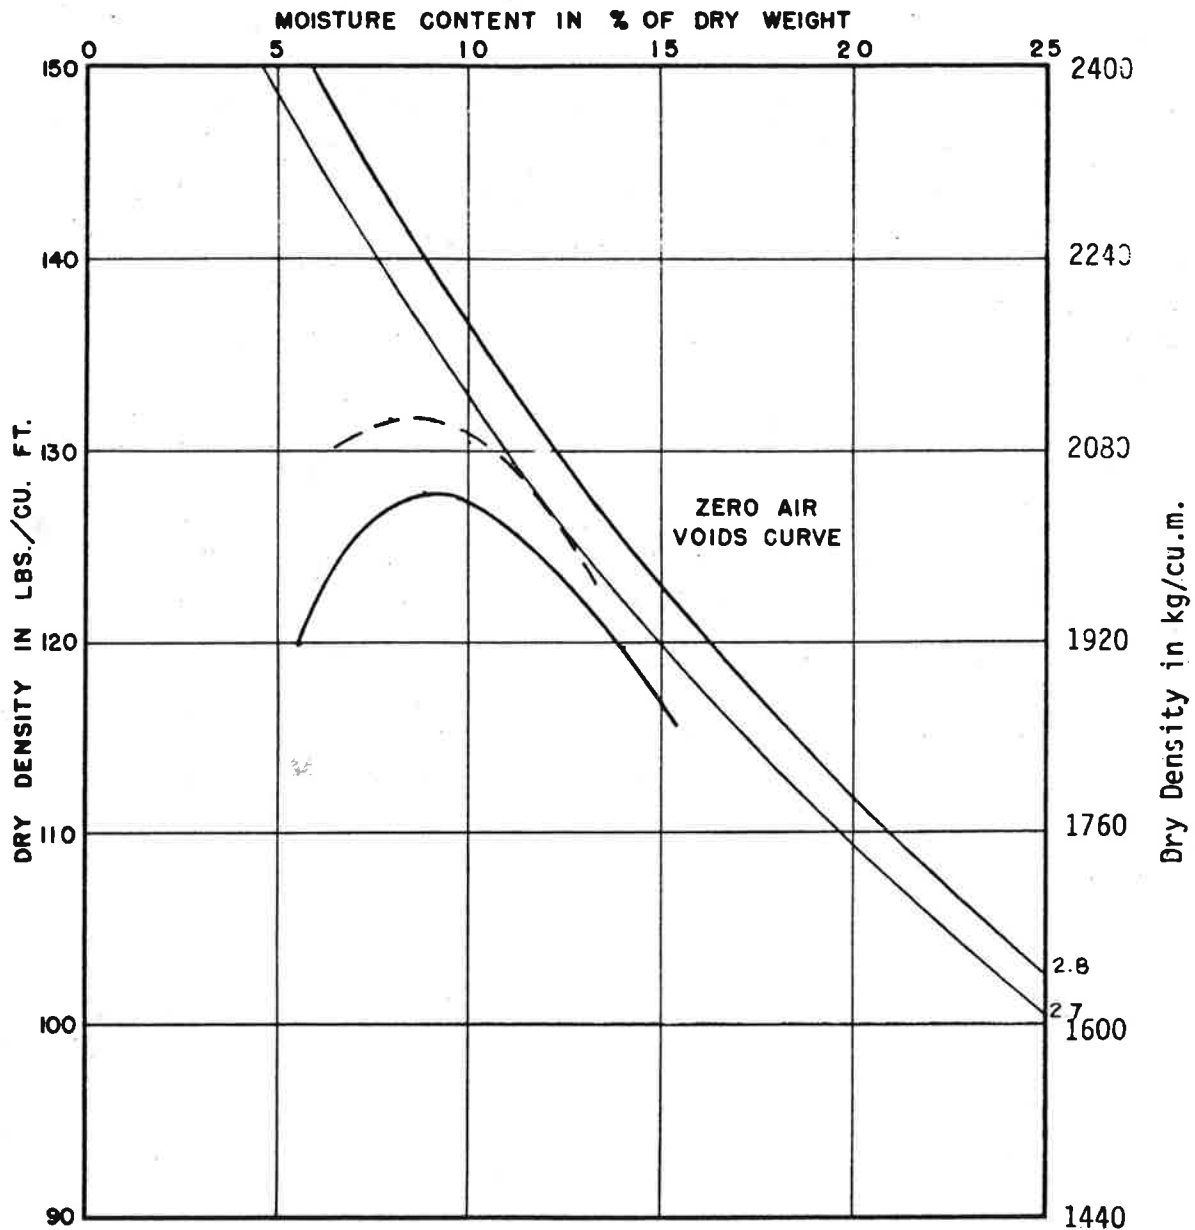
| | FILE 53-06 | FIGURE A-5 |

For completeness we have provided Figures A-5 and A-6 which present the compaction curves for the two materials, and the Mohr's strength envelopes, respectively. Figure A-5 was inadvertently omitted from the original report.

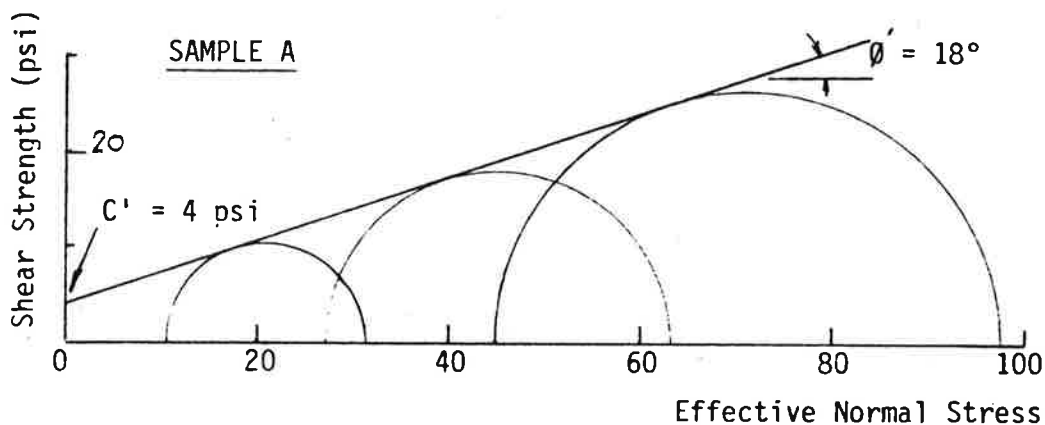
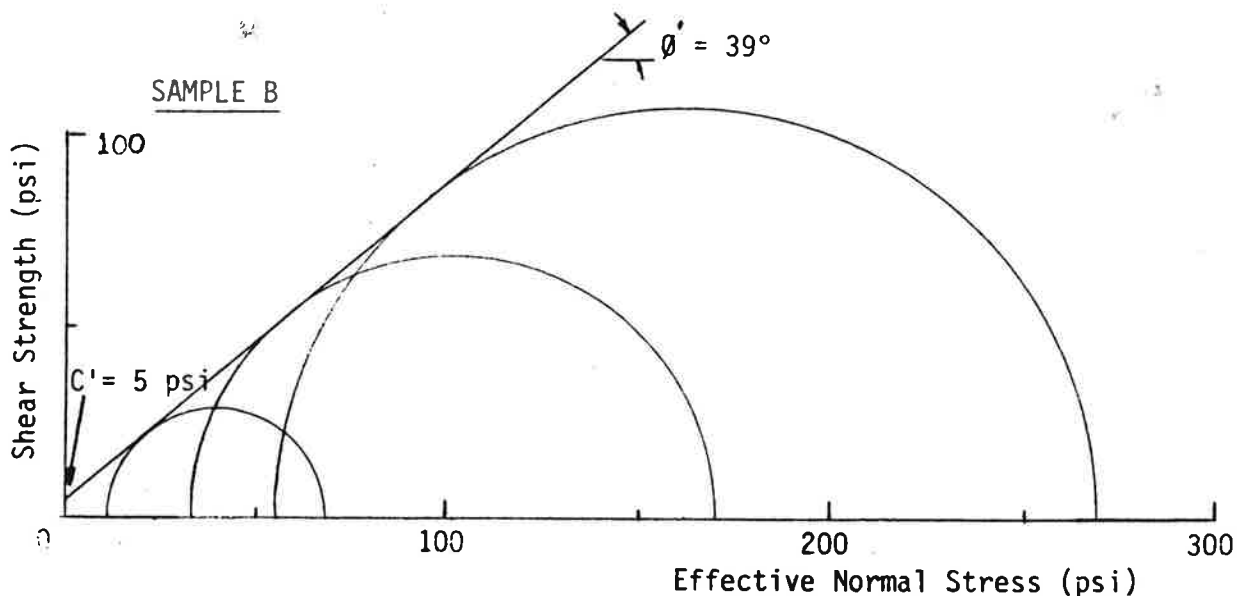
FIGURE A-6

For these latest tests, two samples were prepared, at compaction levels of 94 and 92.5 percent. The first was tested at a confining pressure of 10.9 psi. The second was tested at a confining pressure of 31.6 psi, and prior to failure reconsolidated to 59.6 psi to provide a second Mohr's circle. The results of the tests indicated much higher strength values as shown below.

We consider the results of these most recent triaxial tests to be much more representative of the average strength of the materials to be placed for the dam for the following reasons:
