BRALORNE TAILINGS STORAGE FACILITY UPDATED 2014 ANNUAL DAM SAFETY INSPECTION

NOVEMBER 21, 2014
ISSUED FOR USE
FILE: V15103090-01

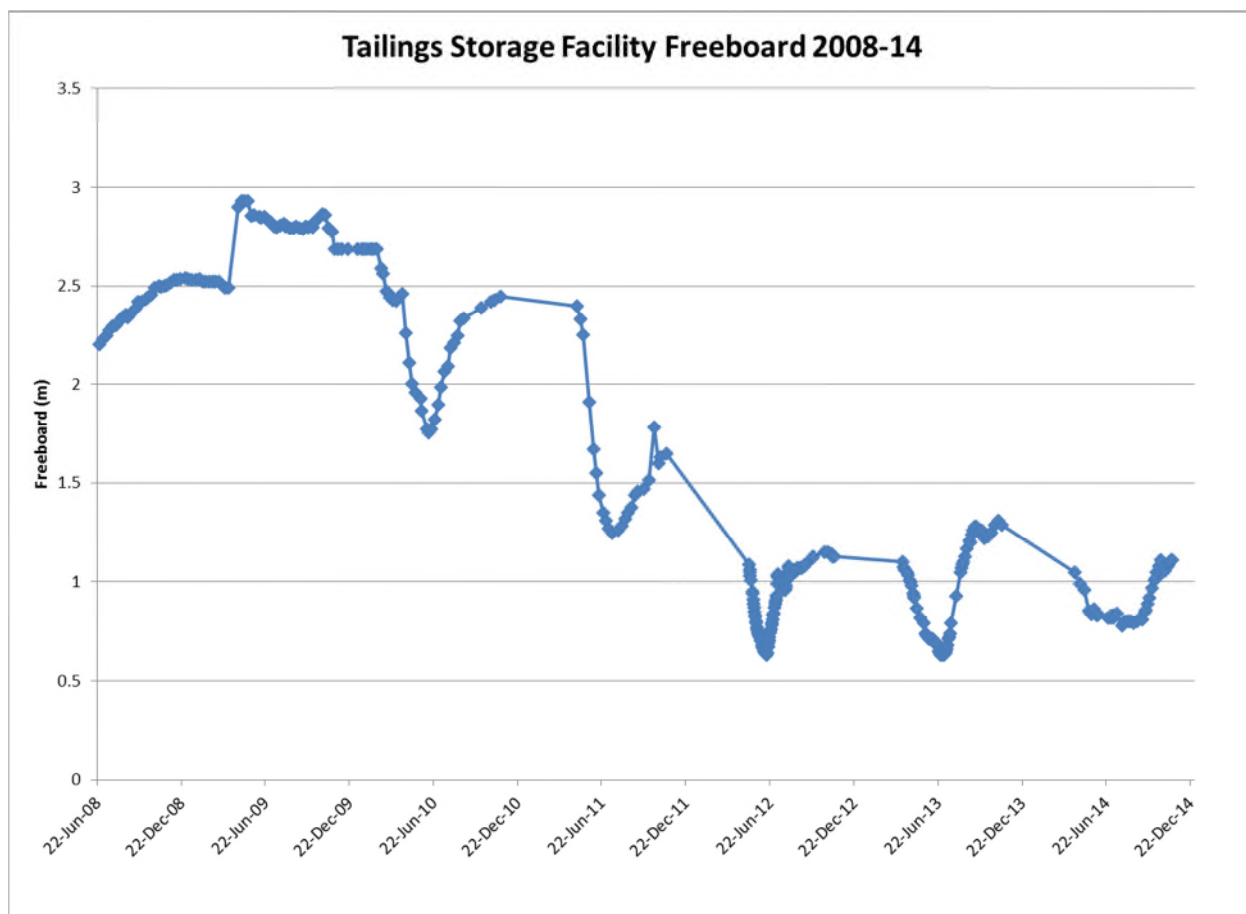
Figure 3-1 Bralorne TSF Freeboard Measurements, 2008 – 2014

The water elevation within the tailings facility varied between 3452.70 ft. and 3454.93 ft. during 2013 based on periodic staff gauge measurements. The design minimum freeboard of 1 metre (3.3 feet) (PK Reid, 2009) was exceeded for a portion of each of the last three years as shown in Figure 3-1. Bralorne advised that they treat and release water from the underground operation by utilizing the new water treatment plant, which has reduced the water loading to the tailings facility.

Bralorne was advised by the Ministry of Environment that they require additional regulatory approval before they can treat and release water from the TSF in 2014 and they are currently working towards this approval. Pond water was pumped from the tailings facility, treated, and released from June 23, 2013 until and July 31, 2013 (Bralorne, 2013). The increase in freeboard that occurred during this period is shown on Figure 3–1.

1. It is recommended that the proposed embankment raise be constructed at earliest opportunity to create adequate capacity for tailings, process water, and design storm event storage.
2. Pond water elevations should continue to be collected and reviewed as per the plan outlined below.
 - a. >1 m of freeboard = as per OMS.
 - b. 1.0 to 0.5 m of freeboard = daily monitoring (see recommendation #5).
 - c. 0.5 m to 0.3 m of freeboard = twice daily monitoring.
 - d. <0.3 m = hourly monitoring.
3. Water from in the supernatant pond should be managed to ensure that the minimum freeboard is maintained. If the recommended minimum freeboard of 1.0 m is impinged upon, Bralorne should notify the

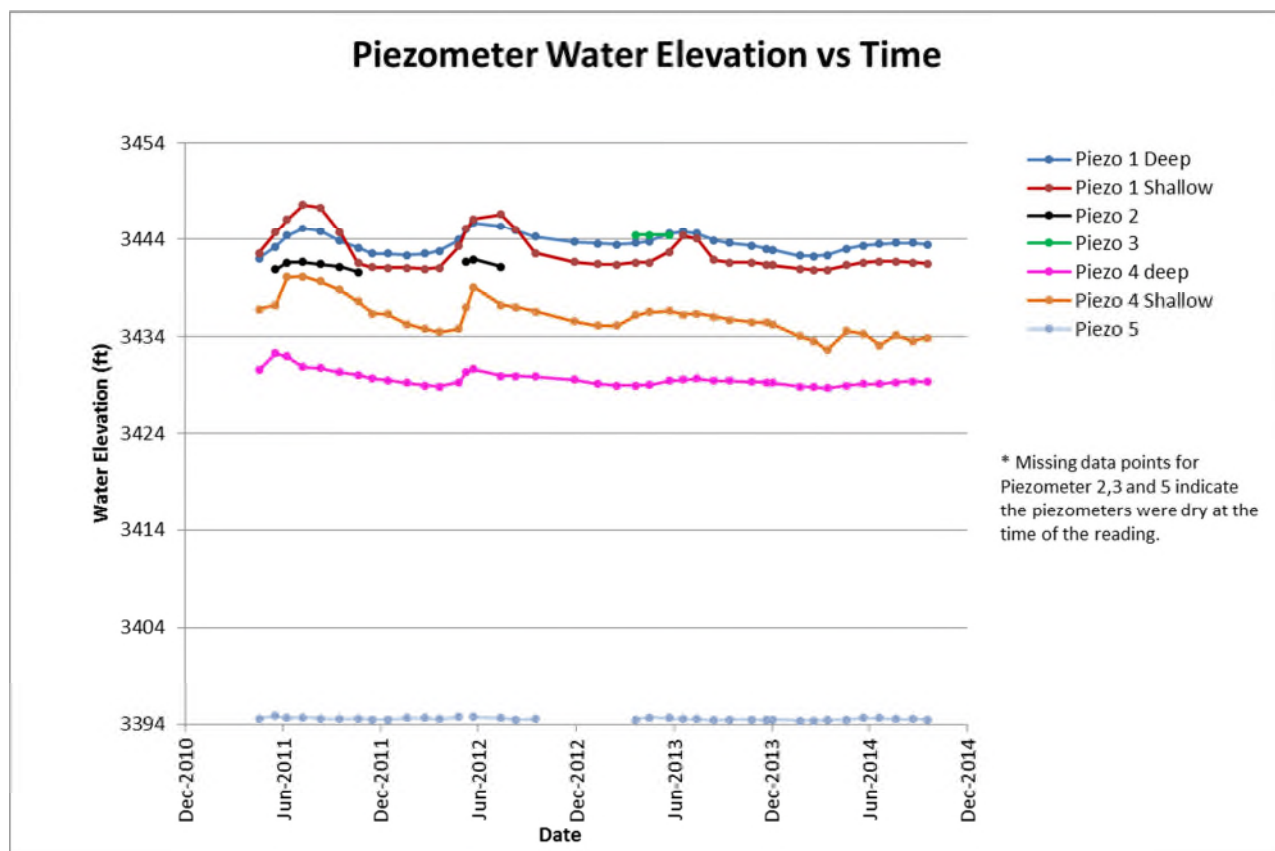
Figure 4-1 Bralorne TSF Piezometer Measurements, 2011 – Sep 2014

The water level in the piezometers was measured monthly during 2013 and 2014, as recommended in the 2012 TSF Site Inspection. The results are plotted with historical data since 2011 in Figure 4–1. The results indicate that the seasonal trends in 2013 and 2014 were consistent with previous results, and the general trend appears to be a decreasing water level in the shallow piezometers which has flattened in the last year.

These results were reviewed in relation to the phreatic surface applied in the embankment stability analyses and do not pose a concern at this time.

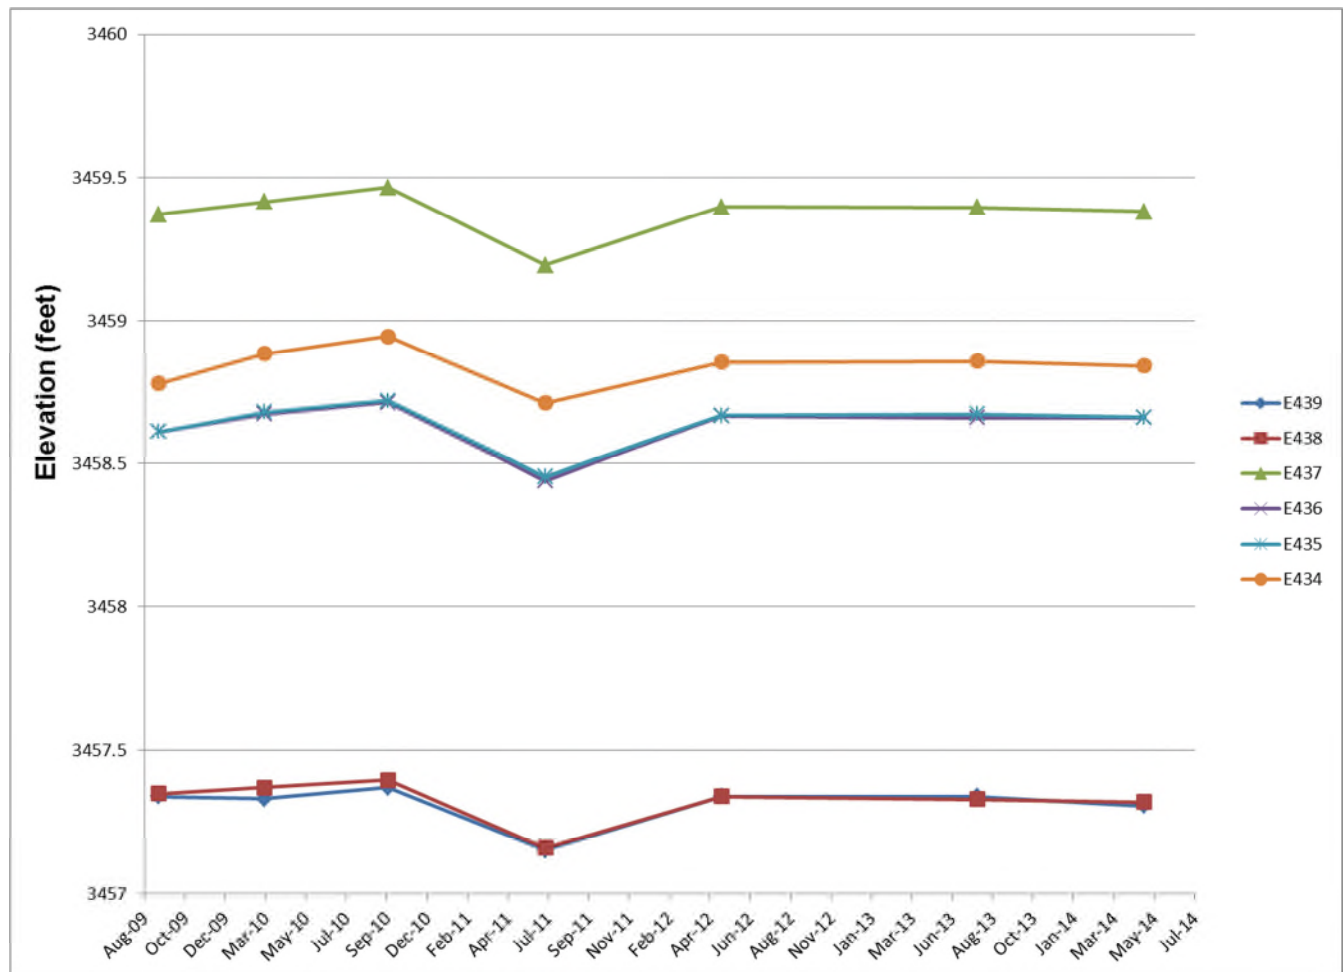
Figure 4-2 Bralorne TSF Dam Settlement Points – Elevation

Monitoring of six survey hubs established on the dam in 2008 indicates negligible settlement has occurred across the crest of the embankment. The hubs are positioned in pairs at the upstream and downstream edge of the crest at three intervals along the length of the embankment. A plot of surveyed pin elevation vs. time is shown in Figure 4-2. The current trends do not pose a concern at this time.

5. The EPP and OMS Manual should be updated to reflect the requirements of the CDA DSG.
6. Monitoring and review of the survey hubs should continue as per the OMS Manual.

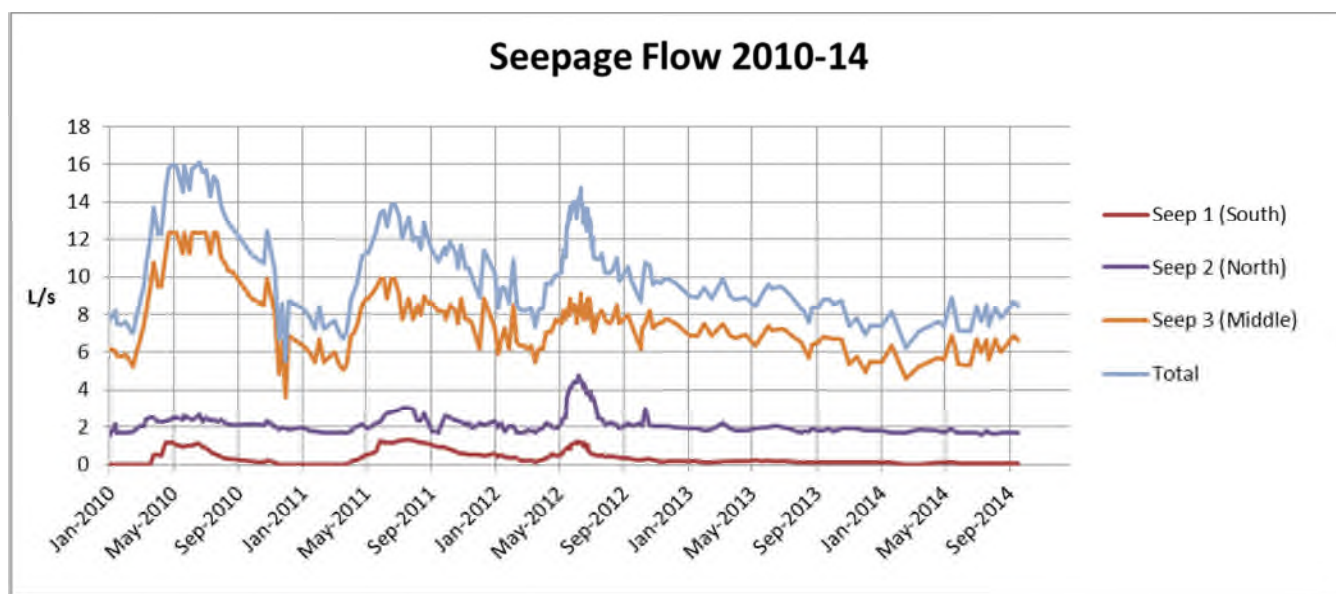
Figure 4-3 Bralorne TSF Seepage Flow Monitoring, 2008 – Sep 2014

The seepage flow measurements recorded downstream of the TSF embankment on a bi-weekly basis in 2013 and early 2014 are plotted with historical results in Figure 4-3. The results indicate that seepage flow decreased in 2013 and stabilised in 2014 as compared to seepage rates measured since 2008.

8. Seepage quality and quantity measurements should continue to be collected and reviewed.
9. It is noted that Bralorne now use a flume at Seepage 3 to monitor flow rate as approved by the Ministry of Environment. Measurements using the 5 gallon pail at the outlet pipe further downstream at SP3 should be continued to provide reference with historical measurements.

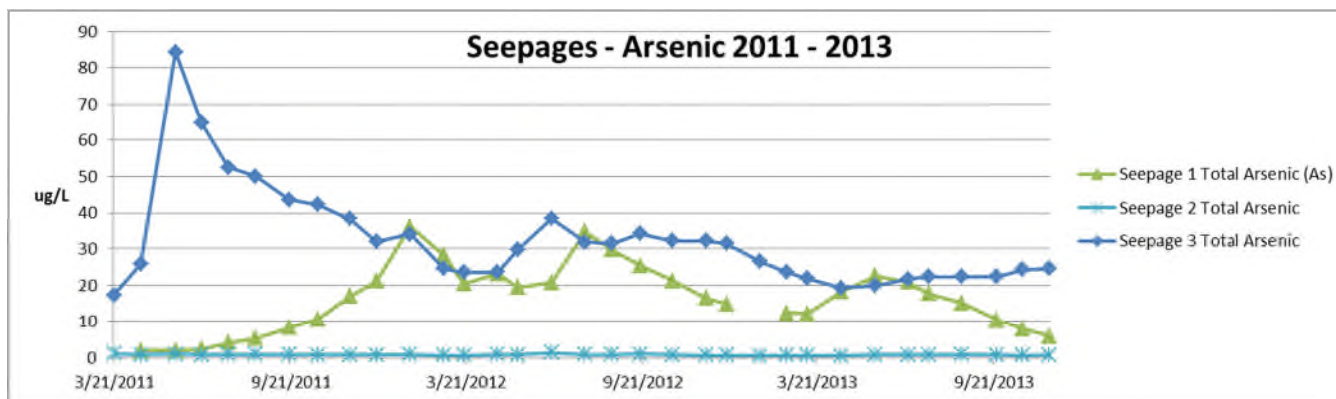
Figure 4-4 Bralorne TSF Seepage Flow As (total) Concentration, 2011 – 13

- All pH values were within the range of 6.5 to 9. The range of pH in the three seepages in 2013 was between 8.0 and 8.4 which is slightly basic and suggests that acid rock drainage is not of concern.
- Total hardness (CaCO_3) was typically over 200 mg/L which is representative of relatively hard water.
- The total arsenic concentration in the three seepage locations ranged between 0.6 ppb and 26.5 ppb. There is a decreasing trend in total arsenic concentration in these seepages since 2011 as shown in Figure 4-4 below. These arsenic concentrations are all below the Federal Metal Mining Effluent Regulation criterion of 500 micrograms/L.

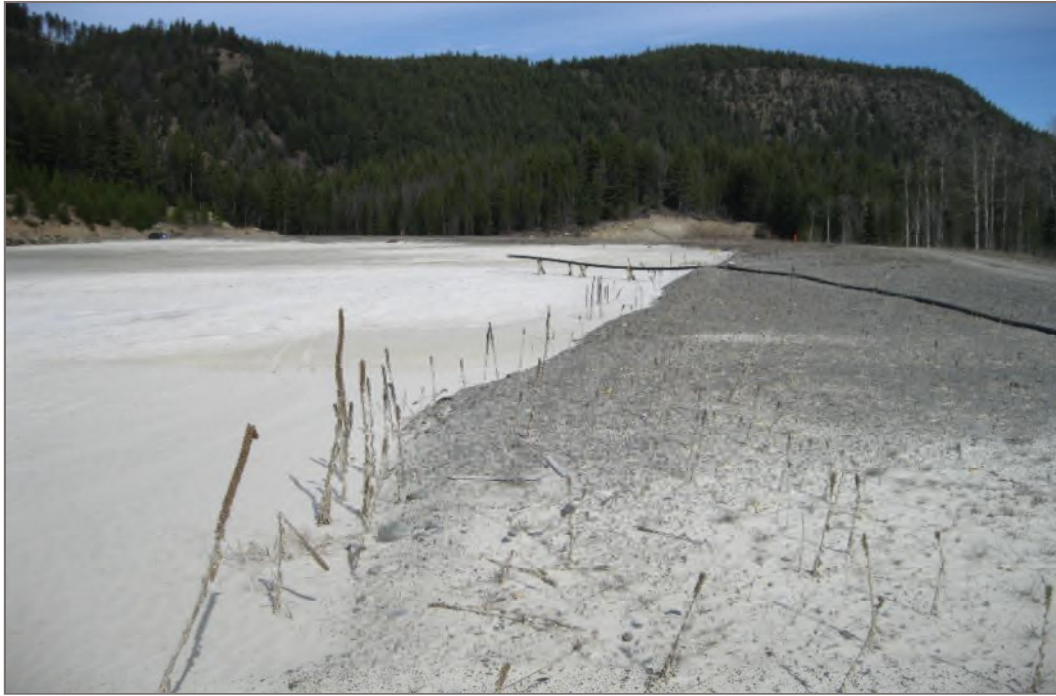
Photo 1: Embankment crest and beach development, looking north

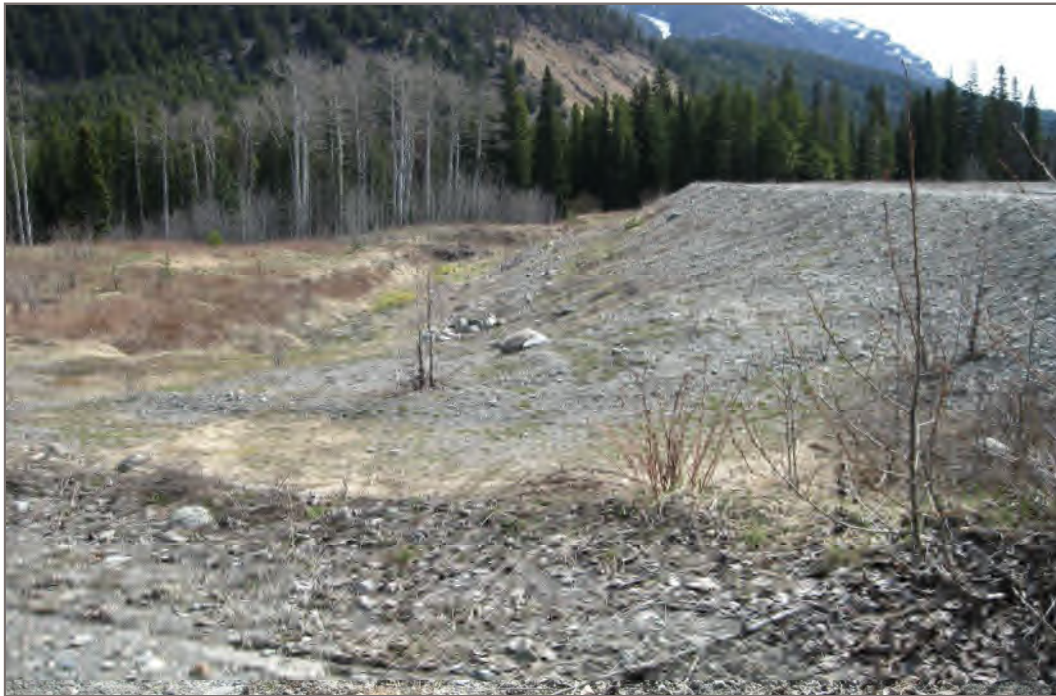
Photo 2: Downstream middle northern embankment, looking southeast

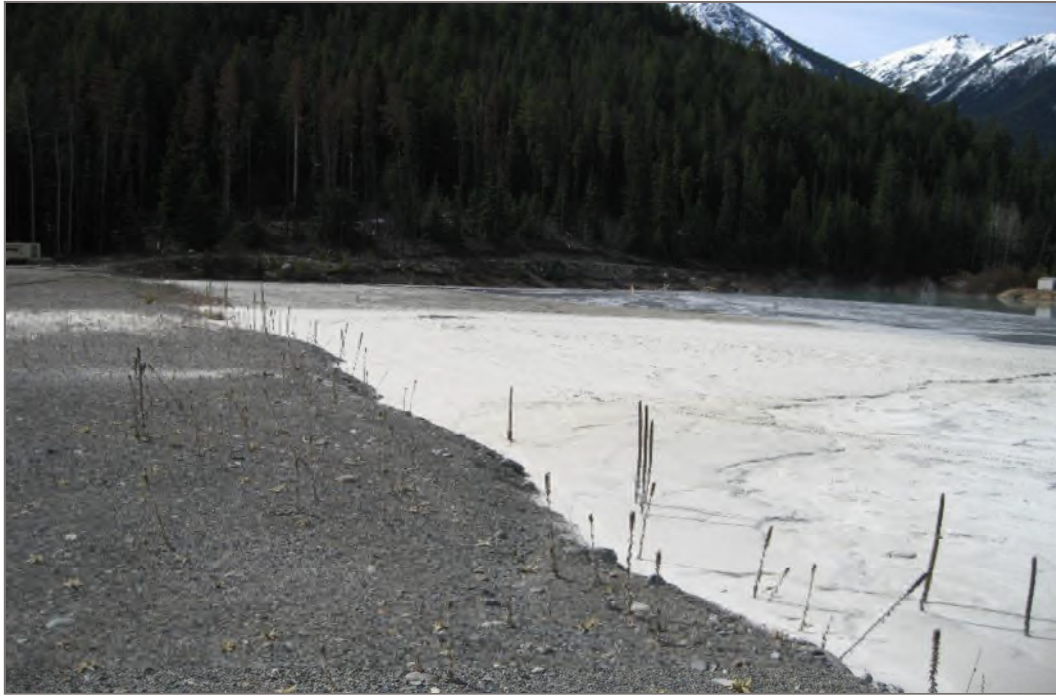
Photo 3: Embankment crest and beach development, looking toward south abutment

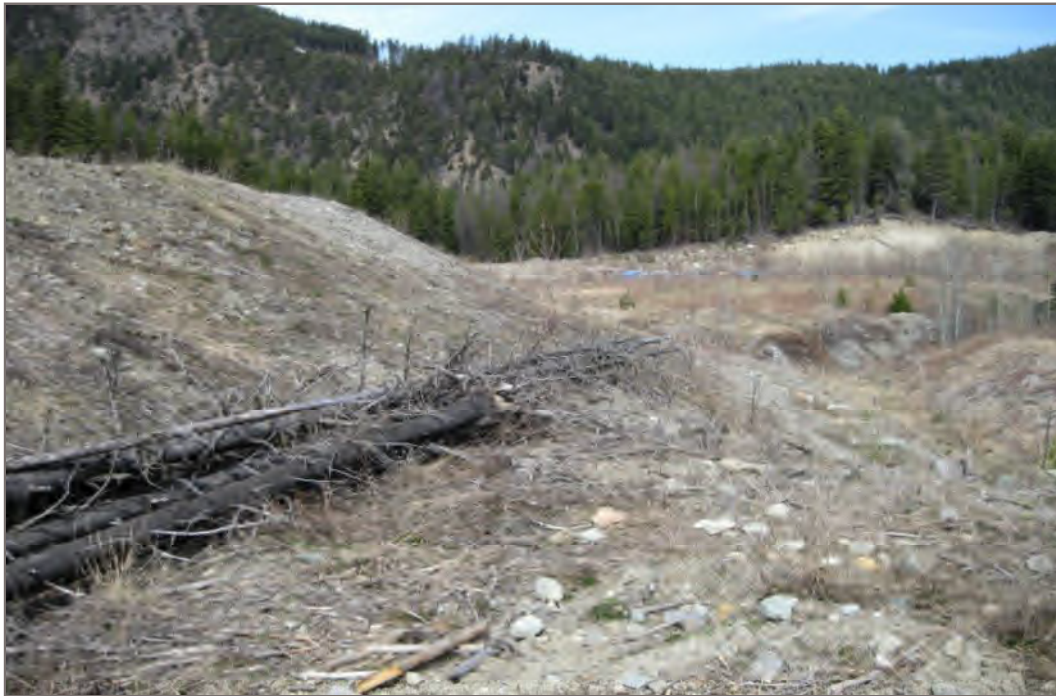
Photo 4: Downstream embankment, mid-section, looking north

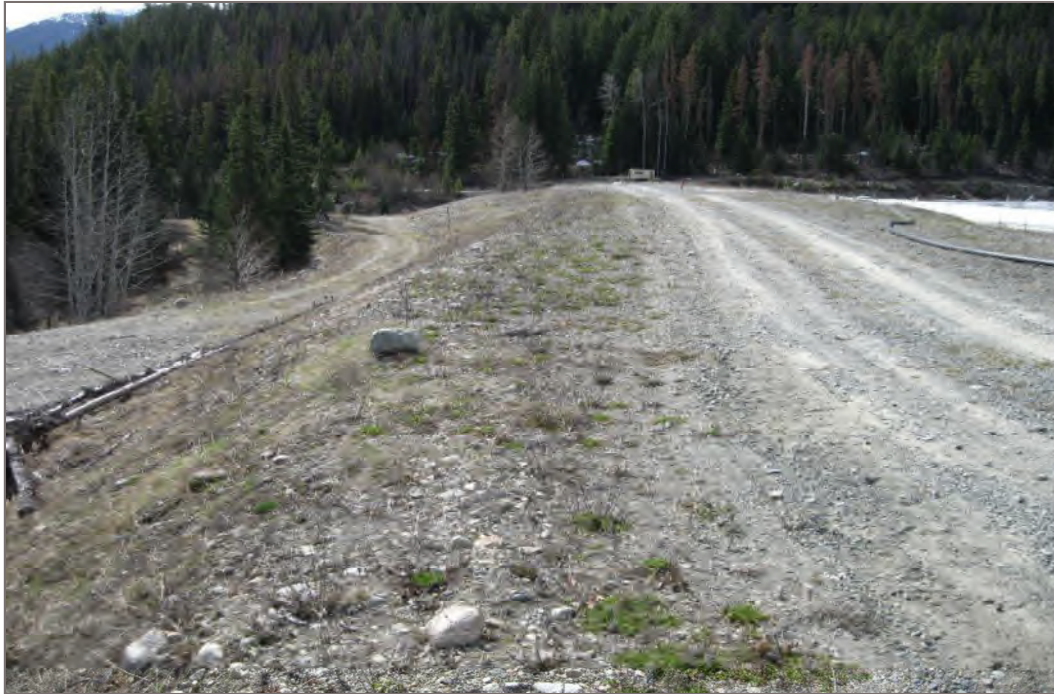
Photo 5: Downstream embankment, mid-section, looking south

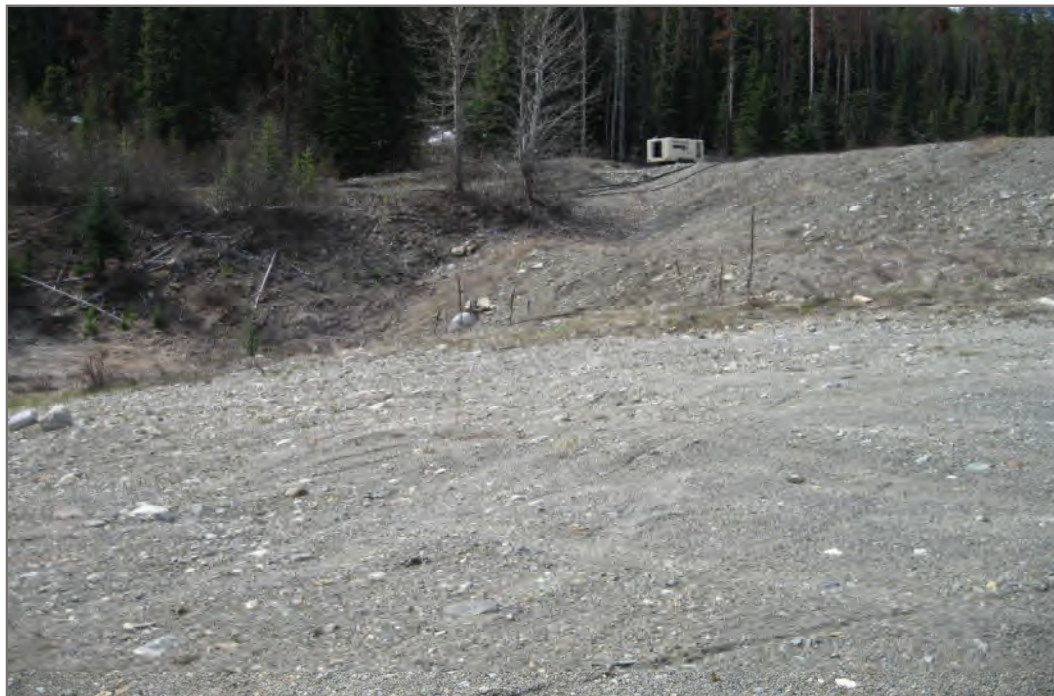
Photo 6: South abutment from below dam, looking southwest

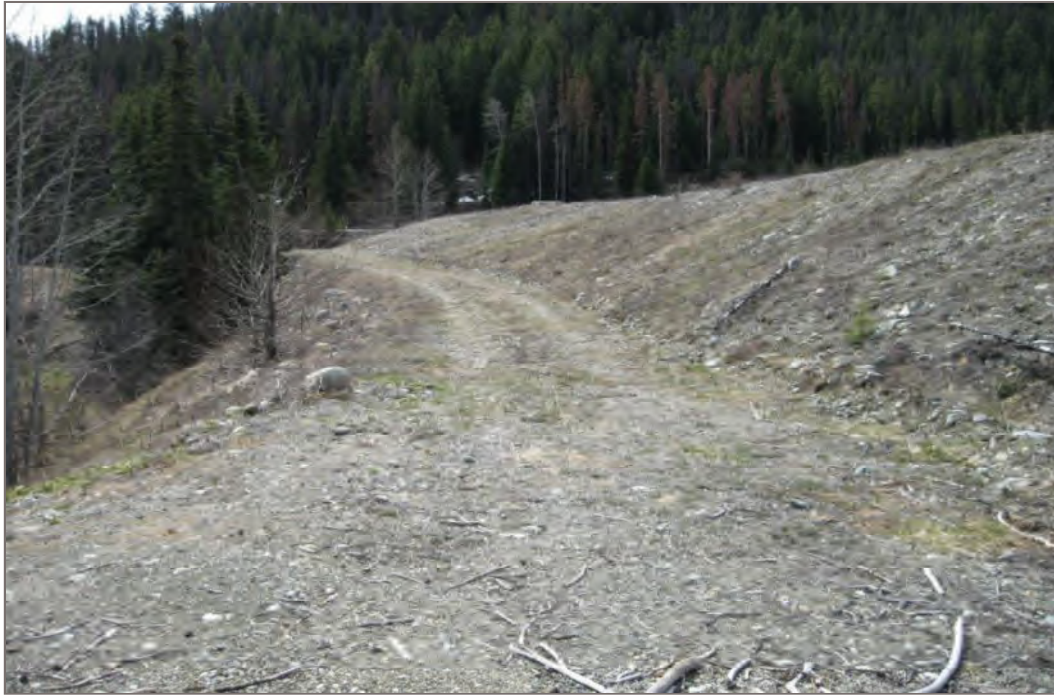
Photo 7: Downstream embankment bench, looking south – Note: variable batter slope

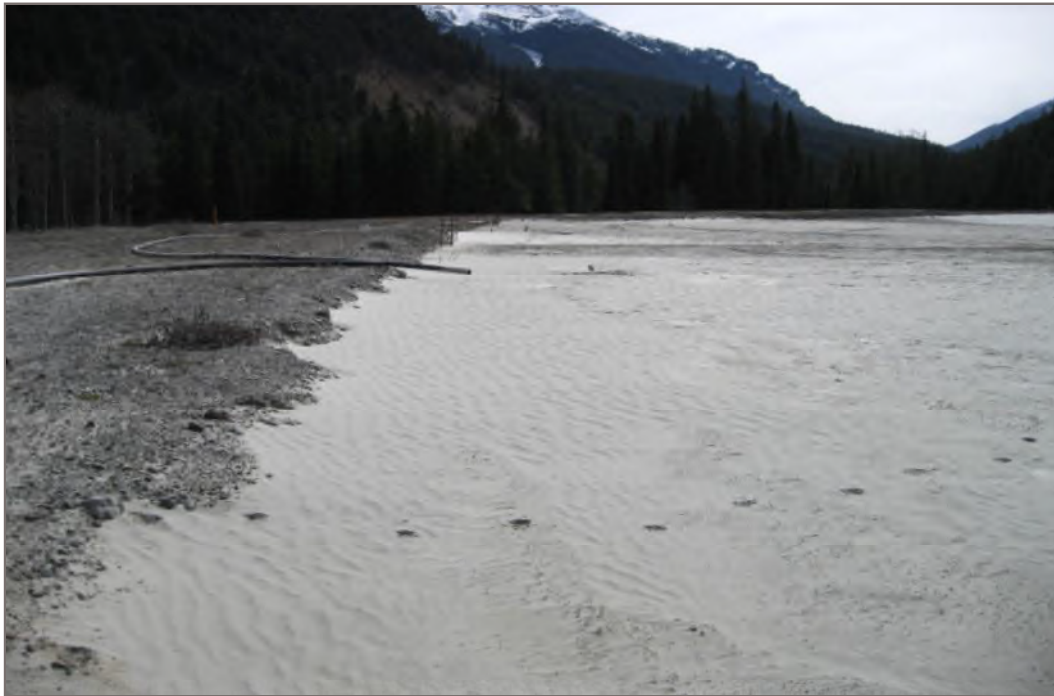
Photo 8: Tailings beach development, looking south from northern abutment

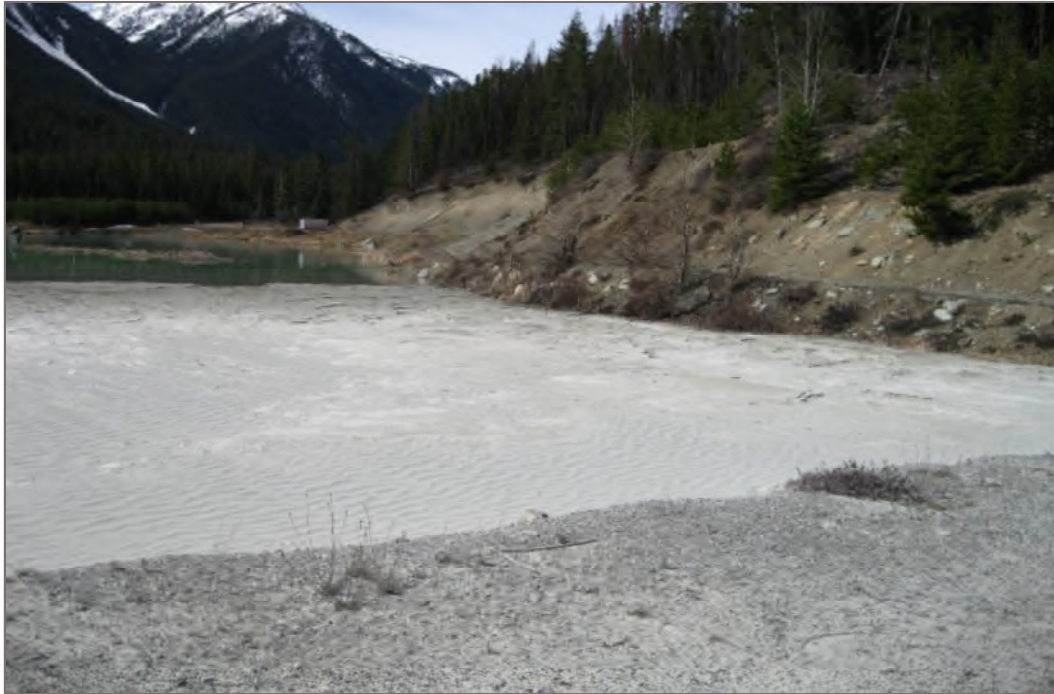
Photo 9: Tailings beach development, northern abutment looking west

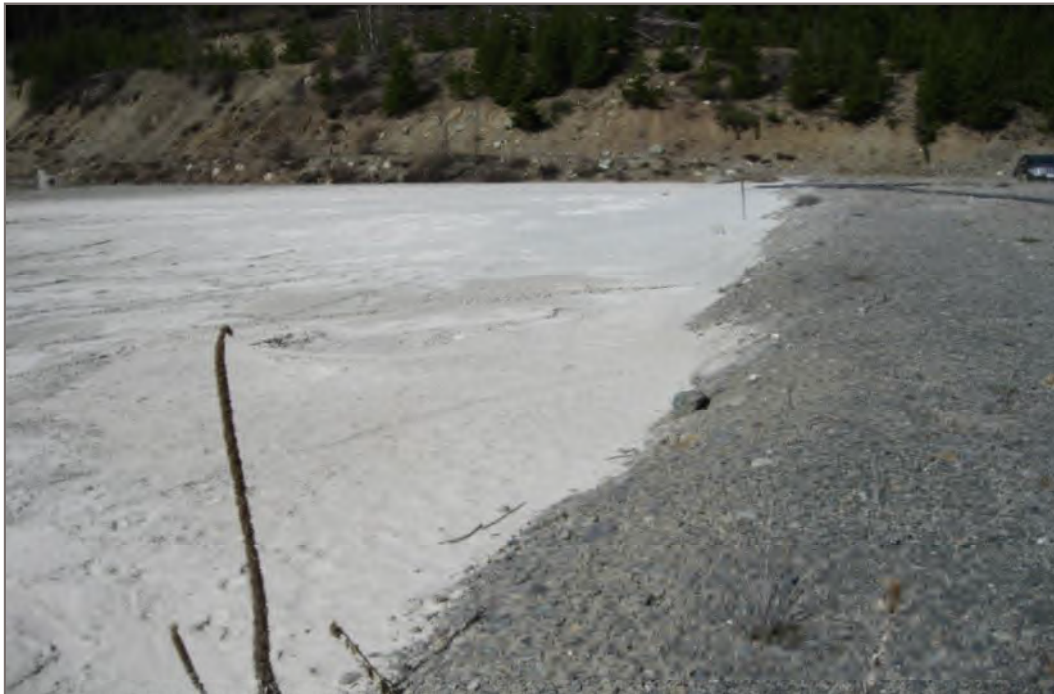
Photo 10: Tailings beach development, looking toward northern abutment

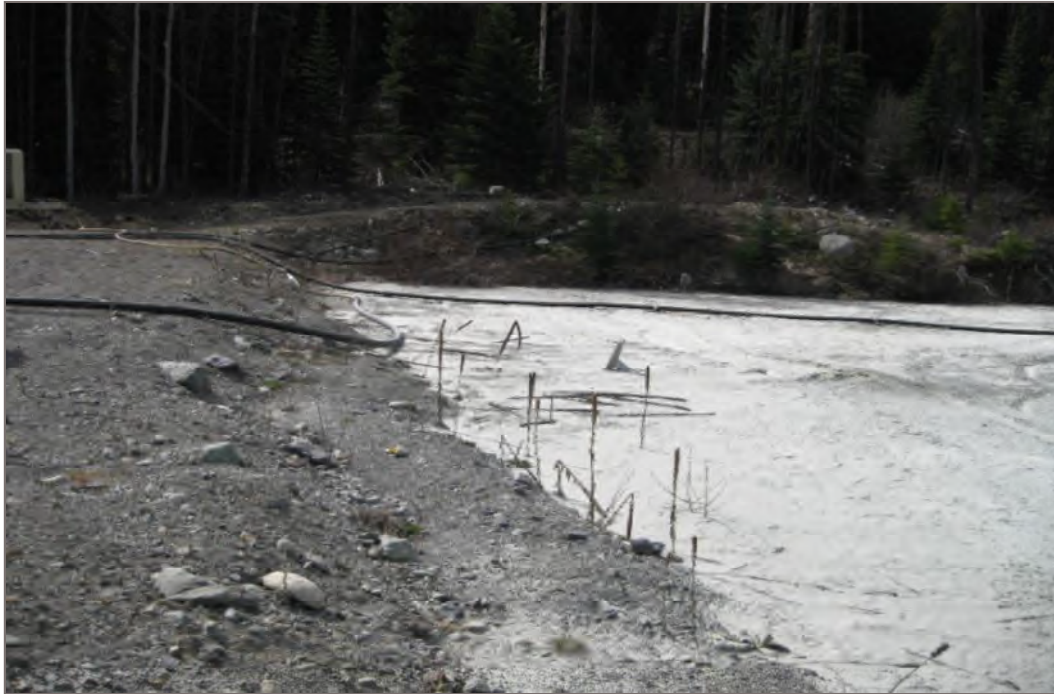
Photo 11: Tailings beach at south abutment

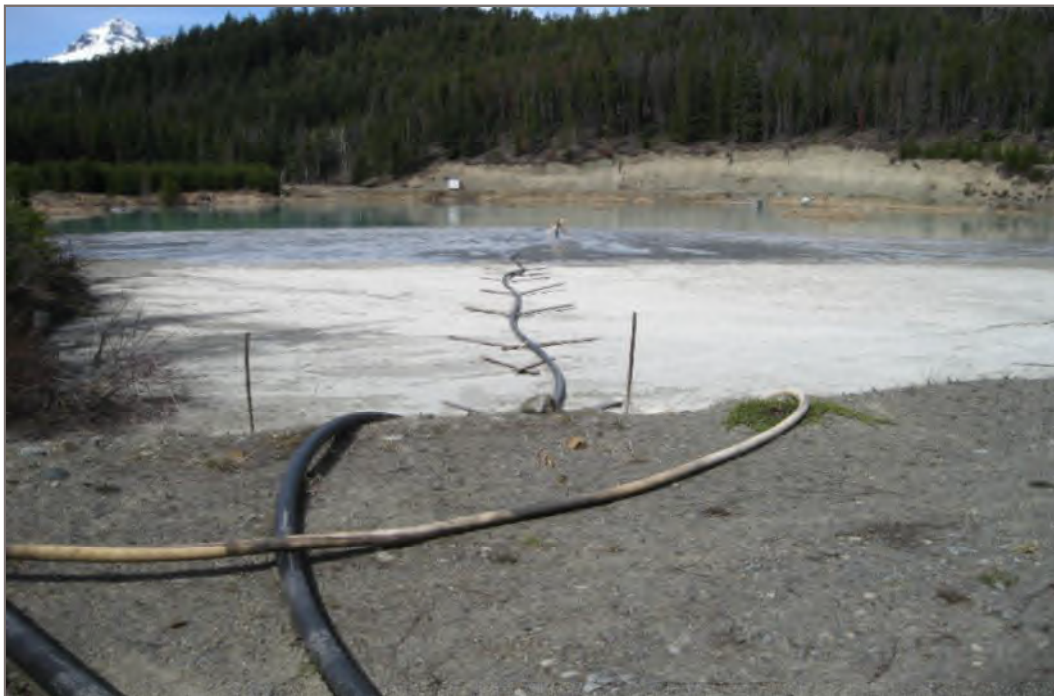
A visual assessment of the tailings storage embankment and tailings management practices was undertaken on May 1, 2014. The facility was subsequently inspected again on September 9, 2014 at the time of a borrow investigation for embankment raising construction materials. The weather on May 1, 2014 was sunny and warm, and conditions were suitable for unhindered inspection of the facility. Tailings discharge was actively occurring from a single point discharge positioned at the north end of the tailings beach. A segment of the discharge pipe had been buried under recent tailings deposition.

Photo 12: Tailings discharge – line partially buried (maintenance required)

10. During the routine inspections, the mine should monitor for evidence of 'run-on' surface water flow and consider further improvements to surface water diversion around the dam if this is observed. In addition, the slurry and water pipe lines should be visually assessed during these inspections.

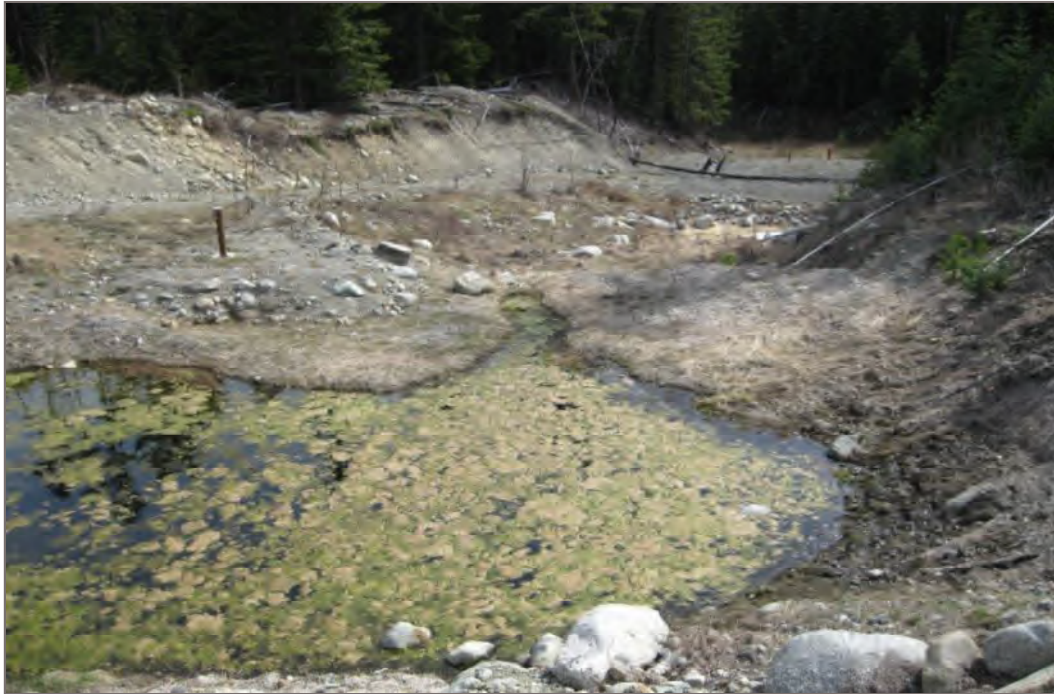
Photo 13: South seepage pond #1

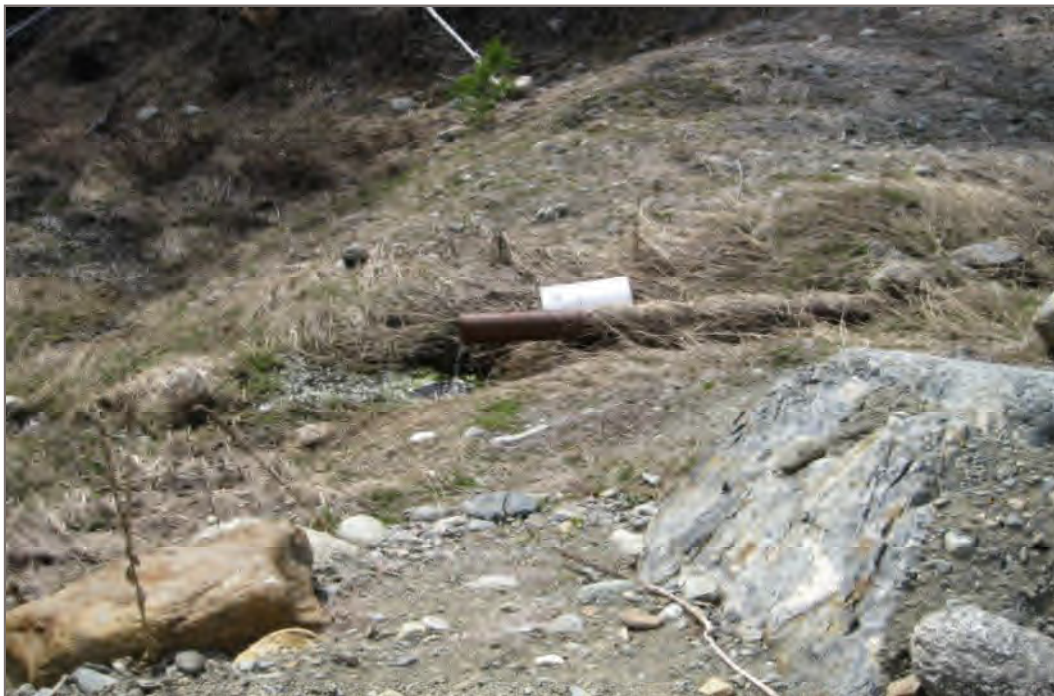
Photo 14: SP#1 south seepage monitoring point

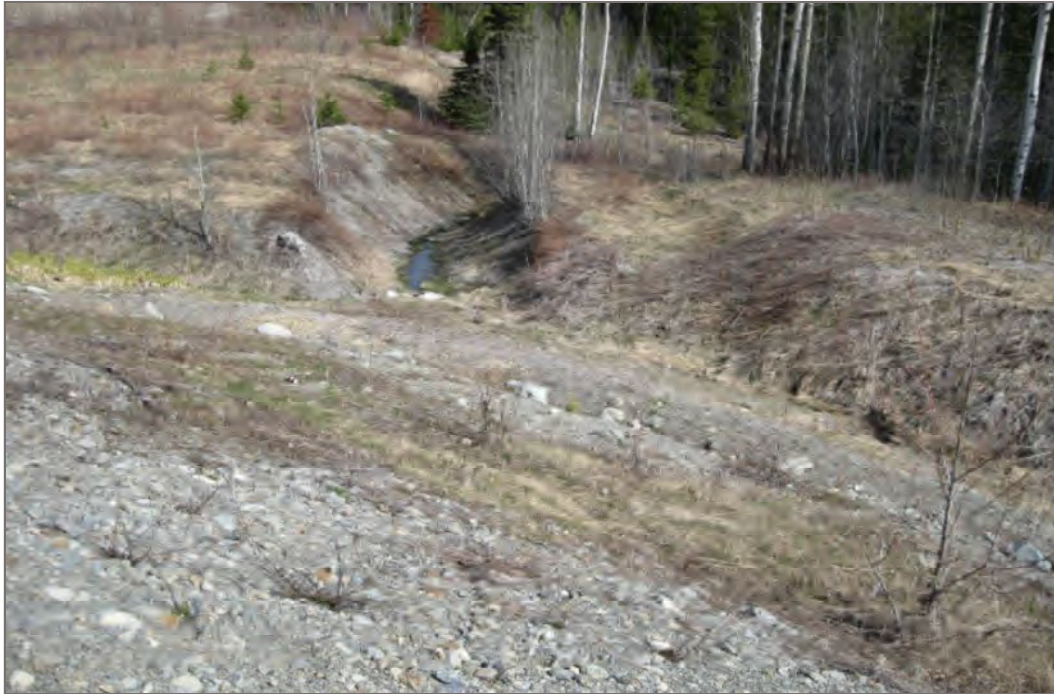
Photo 15: Looking downstream from crest at north seepage ditch (toward monitoring point SP#2)

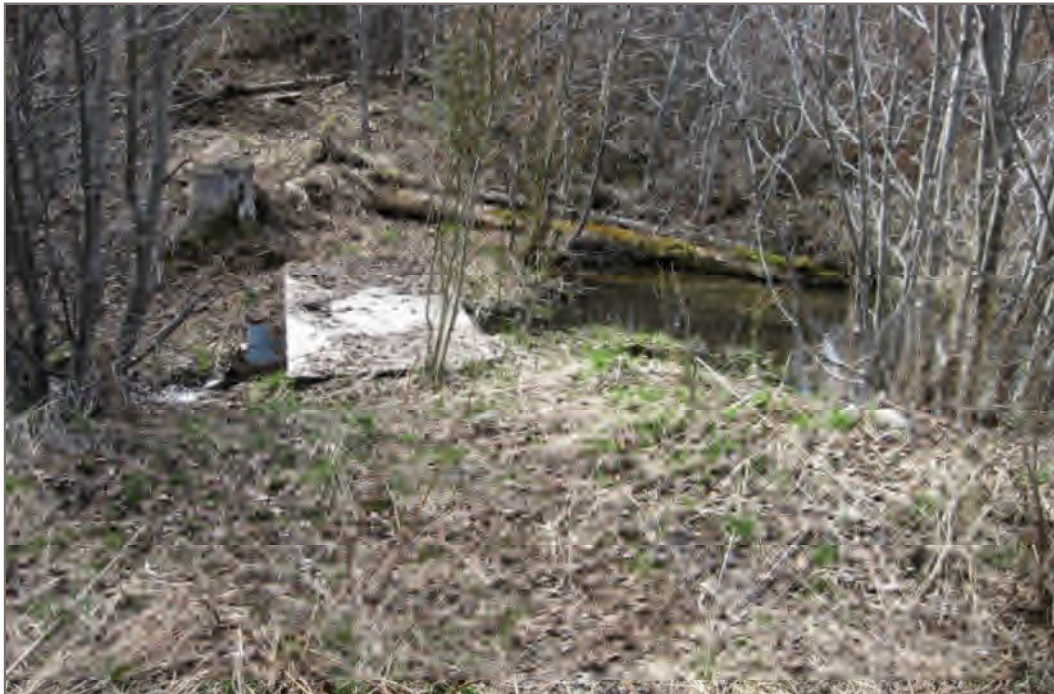
Photo 16: SP#2 north seepage monitoring point

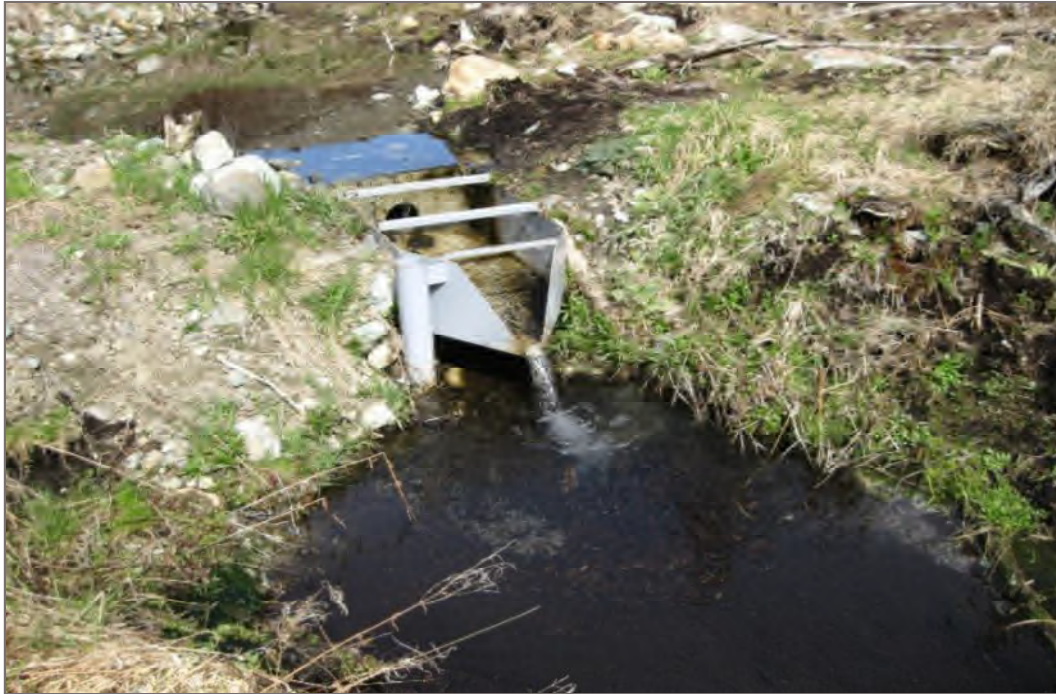
Photo 17: Weir upstream of SP#3 monitoring point

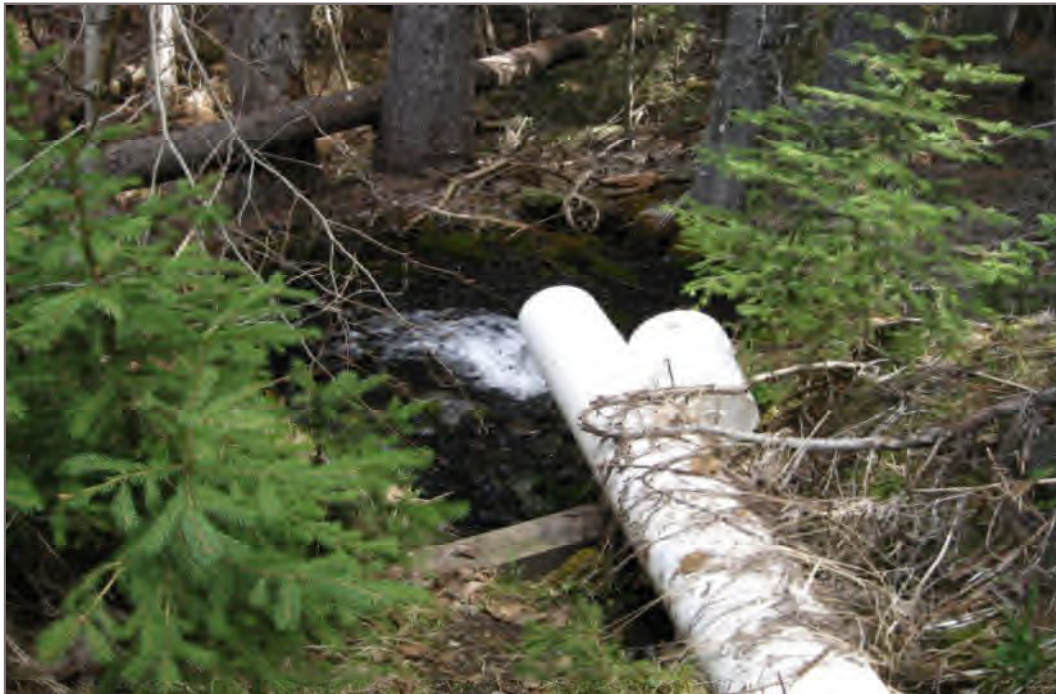
Photo 18: SP#3 monitoring point – high flow from wider contributing catchment

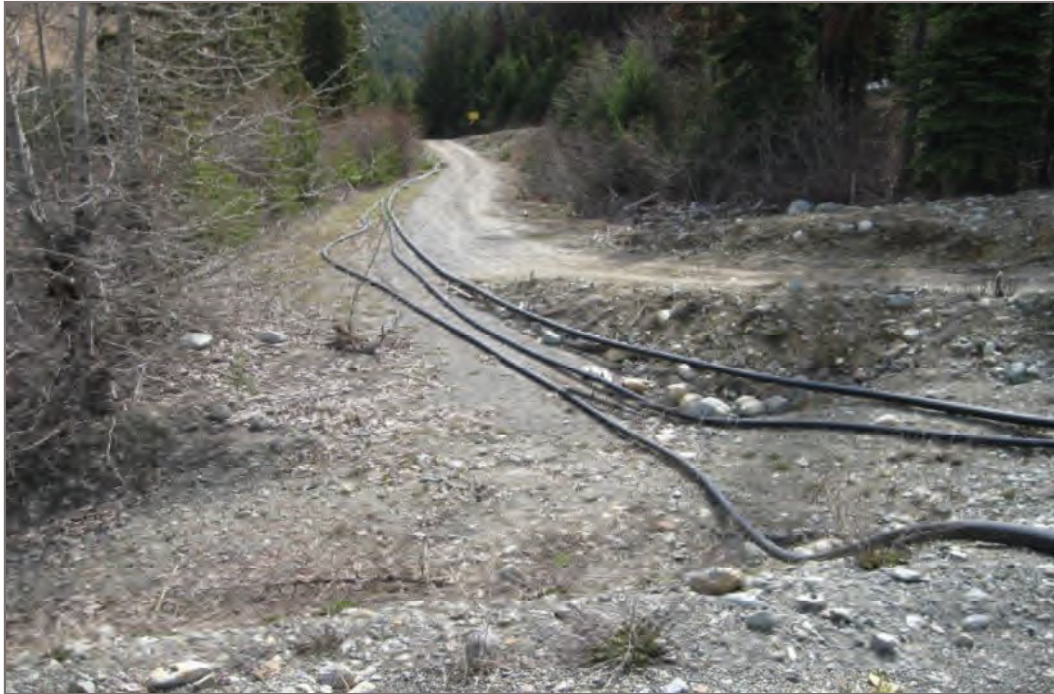
Photo 19: Tailings slurry line and underground water lines

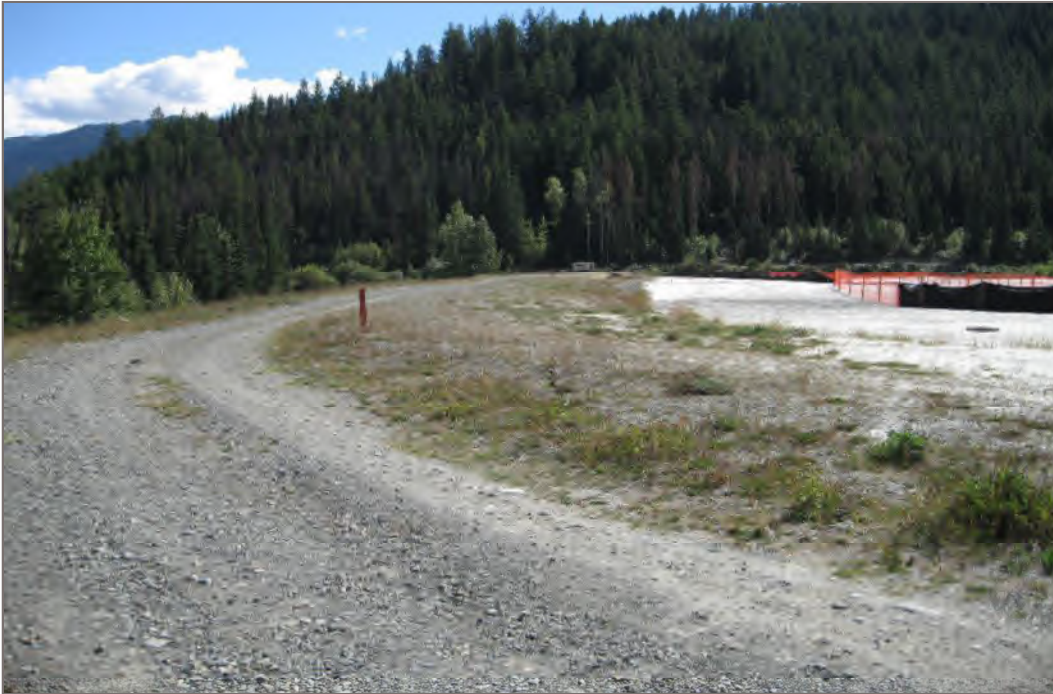
Photo 1: Embankment crest looking south

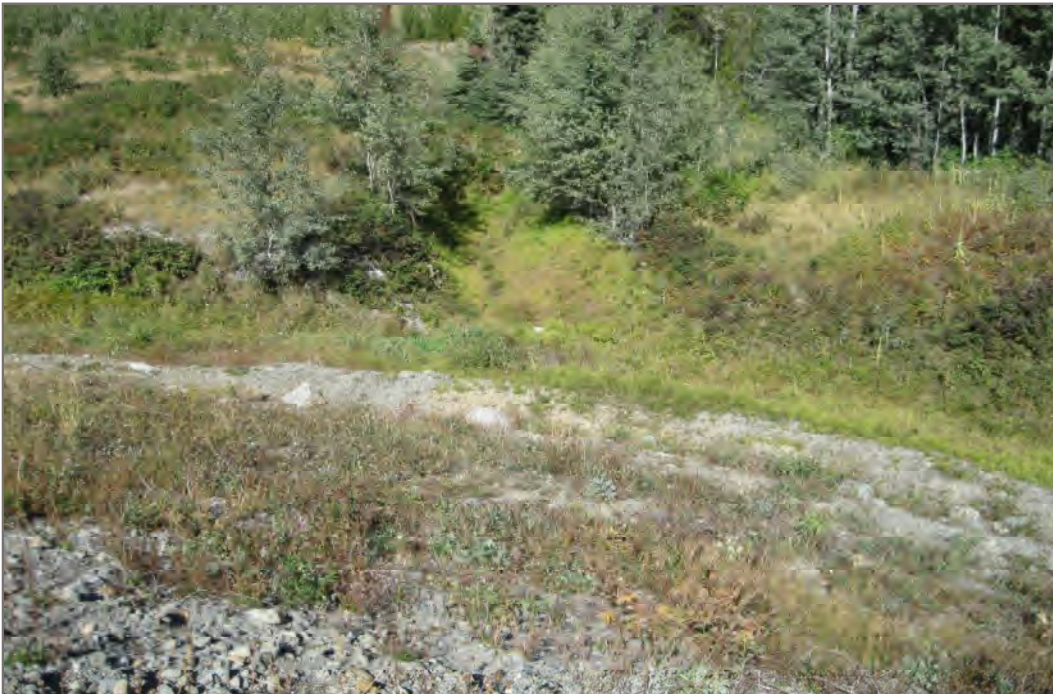
Photo 2: Looking downstream from midway along embankment crest

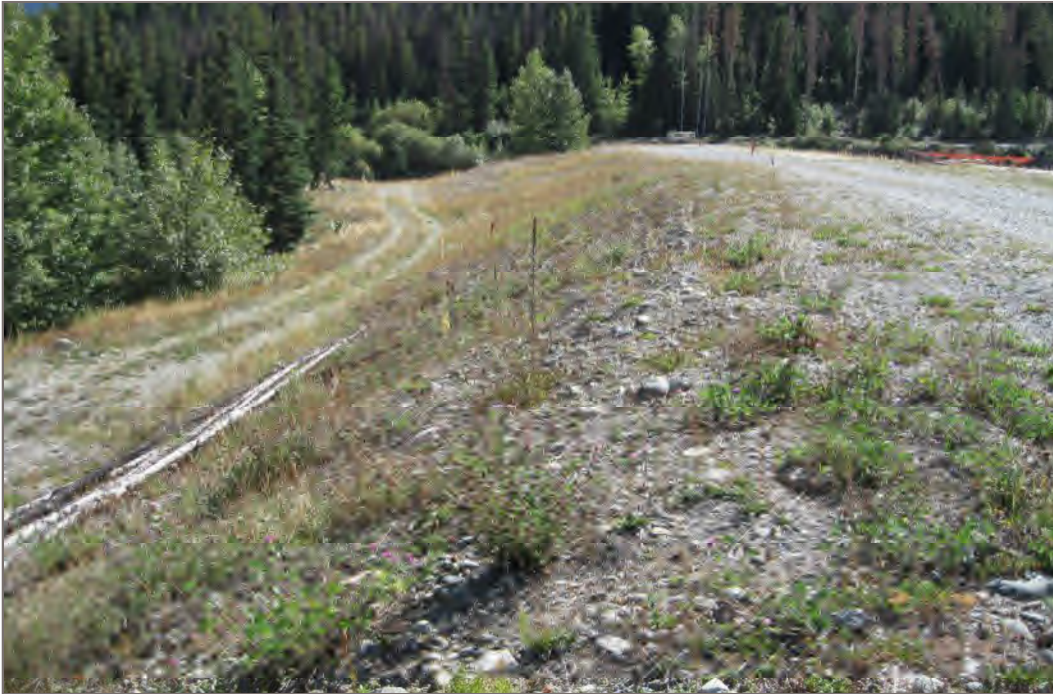
Photo 3: Looking south at embankment downstream batter
