BRALORNE TAILINGS STORAGE FACILITY UPDATED 2014 ANNUAL DAM SAFETY INSPECTION

NOVEMBER 21, 2014
ISSUED FOR USE
FILE: V15103090-01

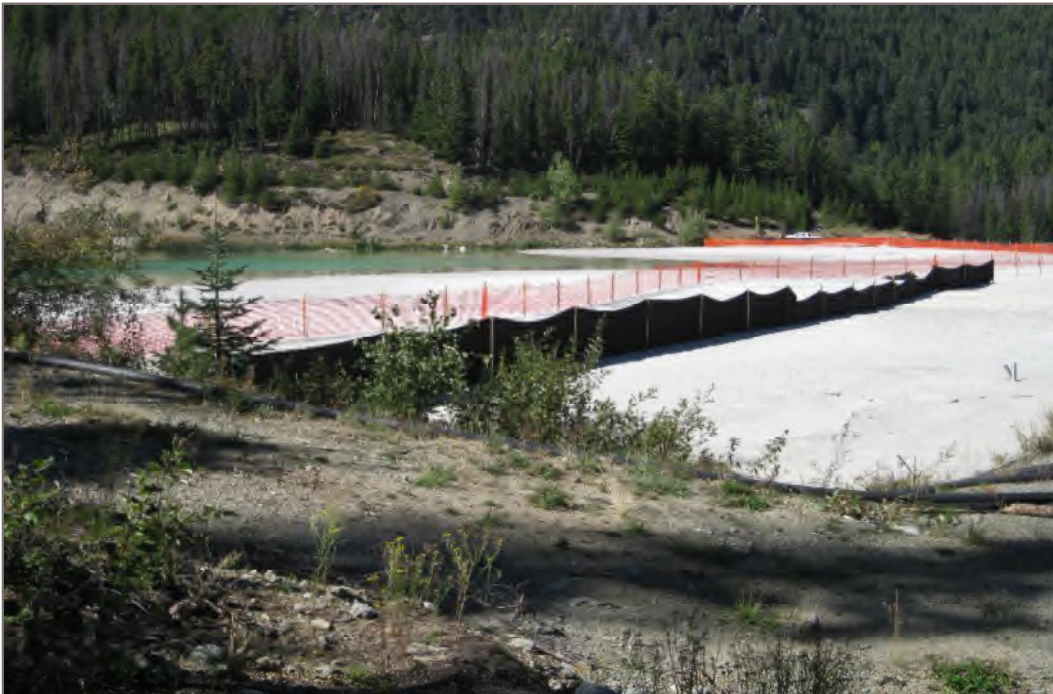
Photo 4: Tailings beach with wind fence, looking north from south abutment
