# **Teck Resources Limited**

**Bullmoose Mine**

***Tailings Storage Dam***

***2014 Dam Safety Inspection***

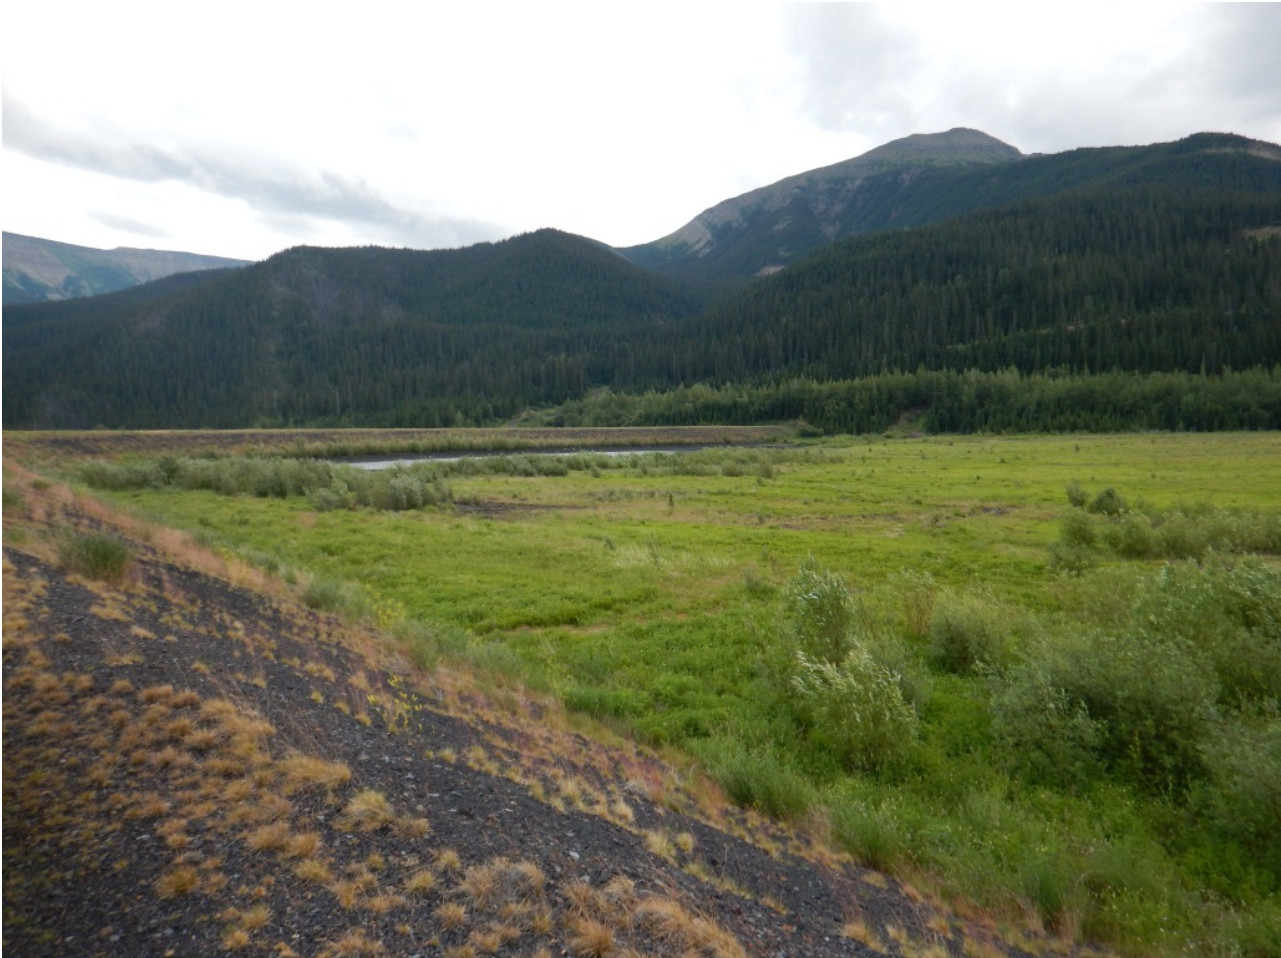
- **Upstream Slope:** Good condition. No visible sign of significant erosion or displacement (Photos I-1 to I-4).
- **West Abutment:** Good condition. The spillway is excavated through the West Abutment, no sign of erosion at abutment (Photo I-7).

**Photo I-1 Overview of vegetated tailings surface from crest, looking east. (TSF-2014-05)**

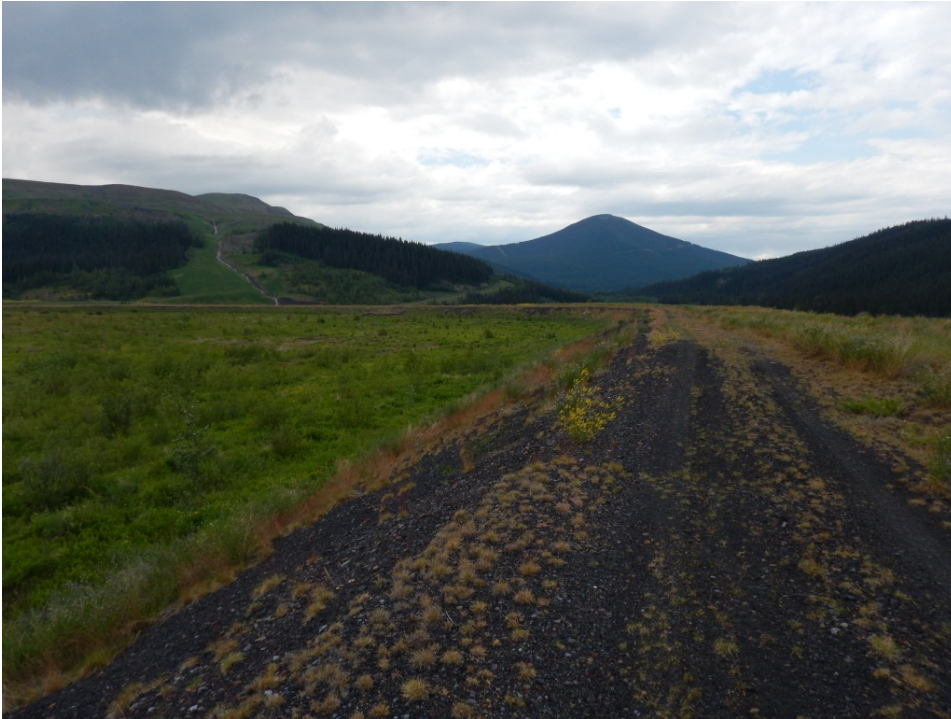
- **Dam Crest:** Good condition. No sign of lateral movement, significant differential settlement or cracking of the dam crest (Photos I-2, I-4 and I-8).

**Photo I-2 Overview of dam crest and vegetated tailings surface, looking west. (TSF-2014-05)**

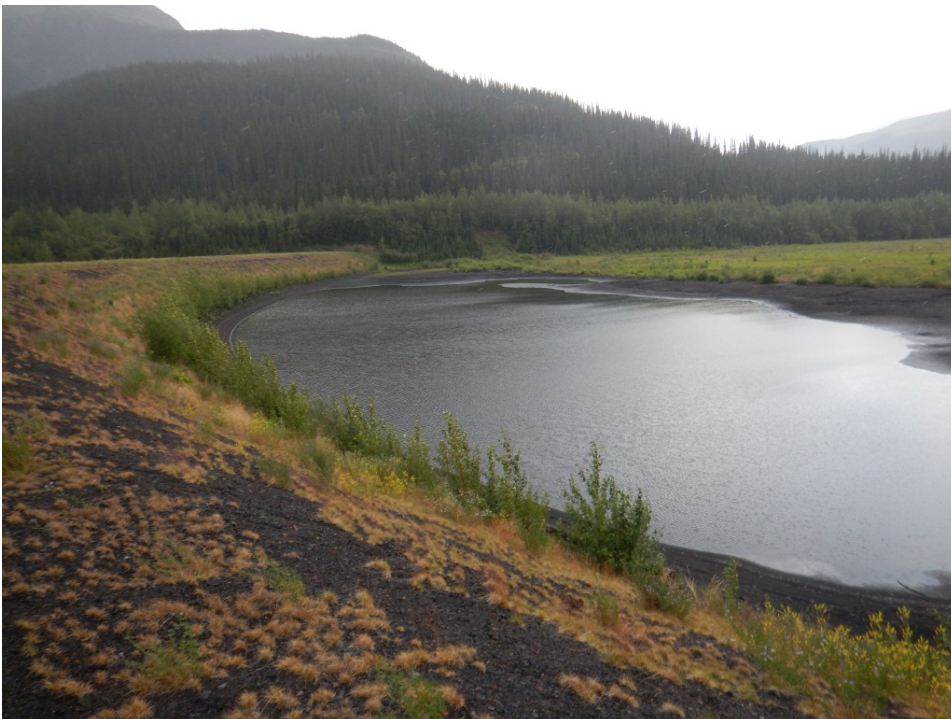
**Photo I-3 Pond on east side of impoundment, looking south. (TSF-2014-09)**

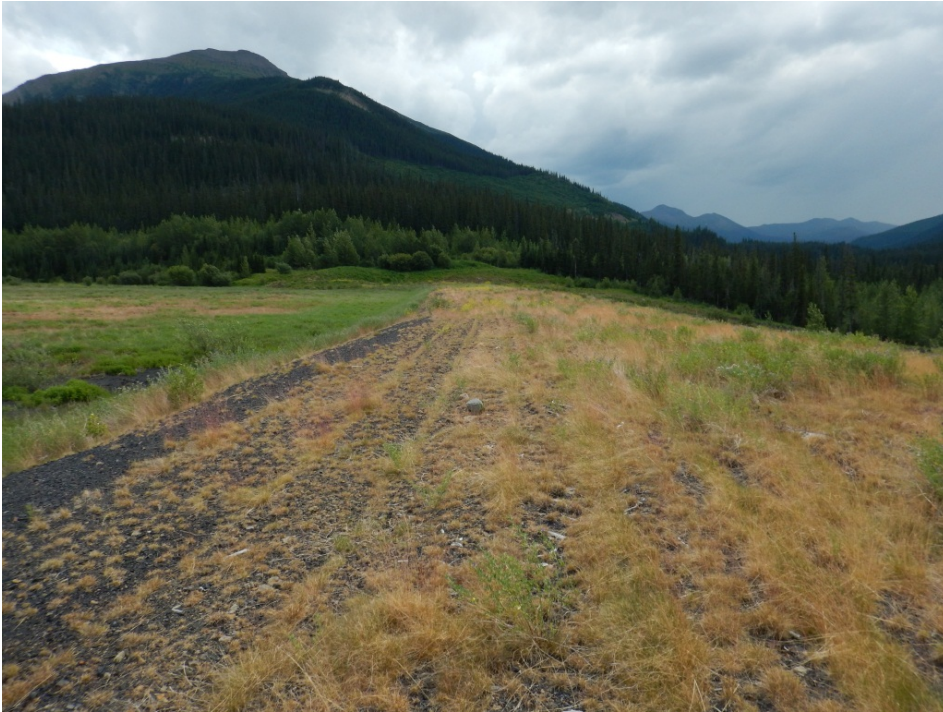
**Photo I-4** Dam crest, looking north. (TSF-2014-09)

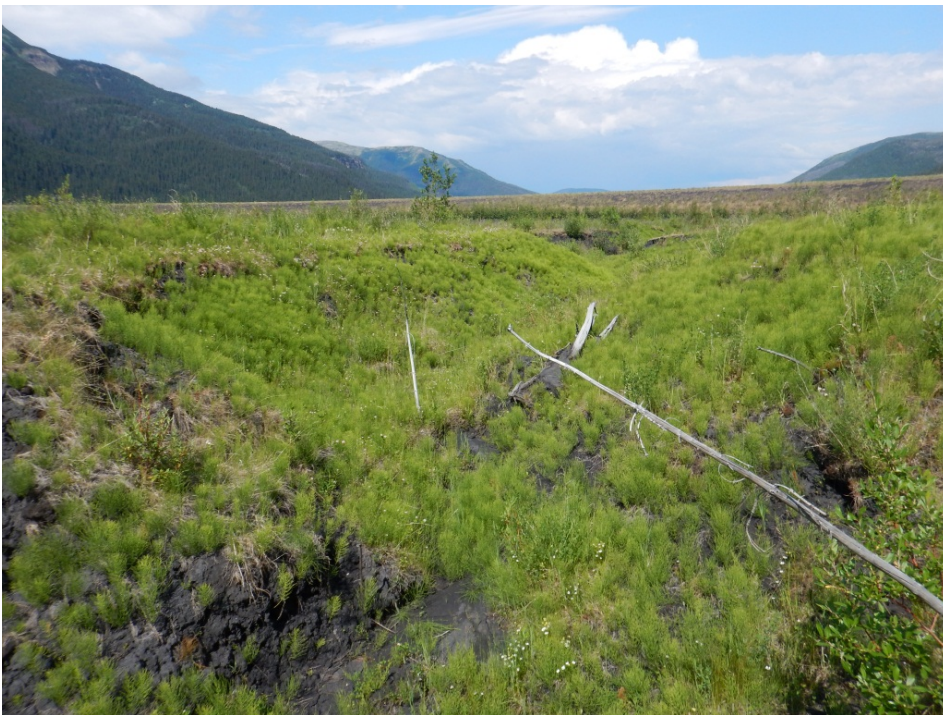
- **Depressions and Gulleys in Tailings Beach:** The 2013 DSI (KCB, 2014a) noted potential development of sinkholes and erosion gulleys in the tailings surface and recommended annual monitoring. During the 2014 DSI, the depressions in the tailings surface were inspected; there is no visual change from 2013 or evidence to support these as sinkholes. These features are believed to be local depressions caused by ponded water or differential settlement. Based on the aerial image (Figure 1) a portion of the gulleys have a meandering alignment but the “v-shaped” cross-section (Photo I-5) has the appearance of an excavated channel. Regardless of whether they are naturally forming or excavated they are partially to well vegetated and pose no identifiable risk to dam safety.

**Photo I-5** Typical vegetated gully channel in tailings surface. This gully drains to existing pond area. (TSF-2014-17)

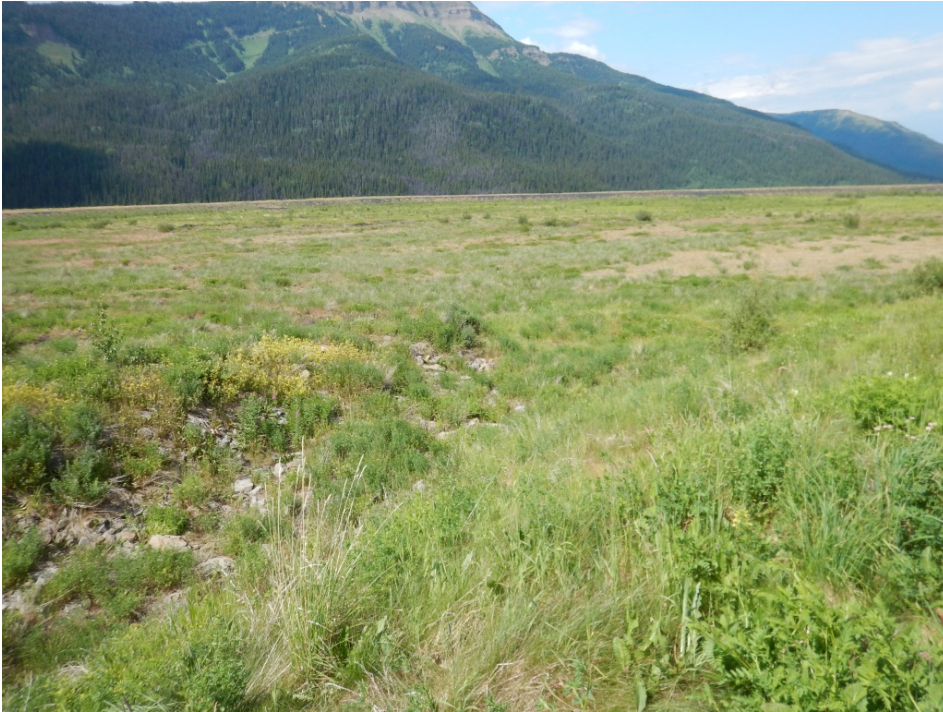
- **Spillway:** Good condition. No obstruction at the inlet but the inlet and spillway channel is vegetated (grasses and bushes) which could slightly reduce flow capacity and should be removed.

**Photo I-6 Spillway inlet area, vegetated by no obstructions. (TSF-2014-19)**

DSI-BTD-09 (2014 – Priority 3)	Spillway channel maintenance	-	Removed vegetation from the spillway inlet area and channel. Any erosion protection works damaged during the maintenance should be reinstated.	December, 2015

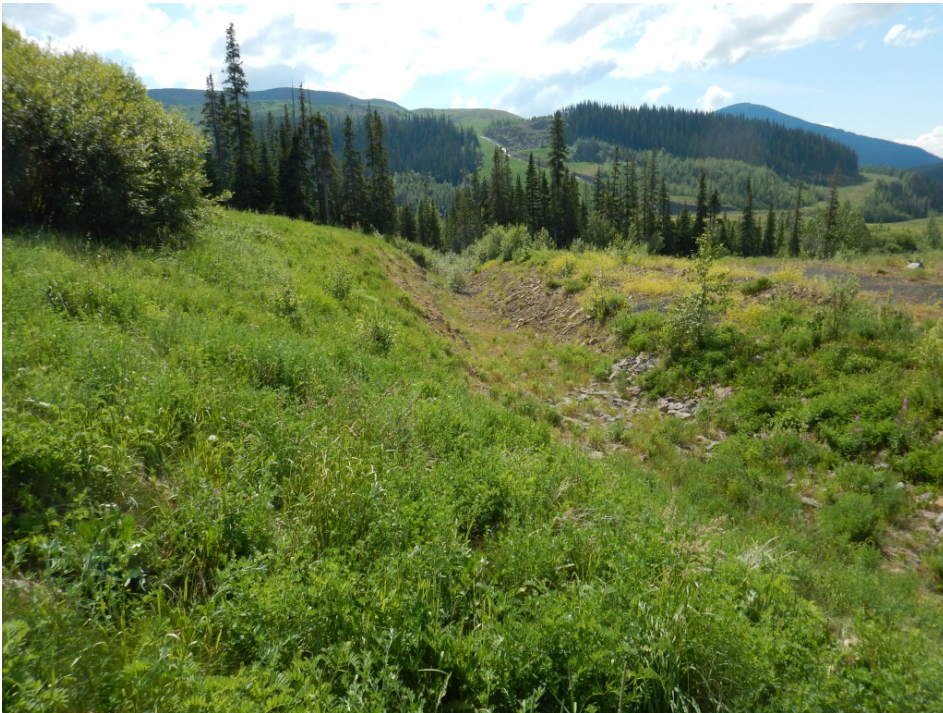
**Photo I-7 Section of spillway channel that is excavated through tailings surface and dam crest at West Abutment. (TSF-2014-19)**

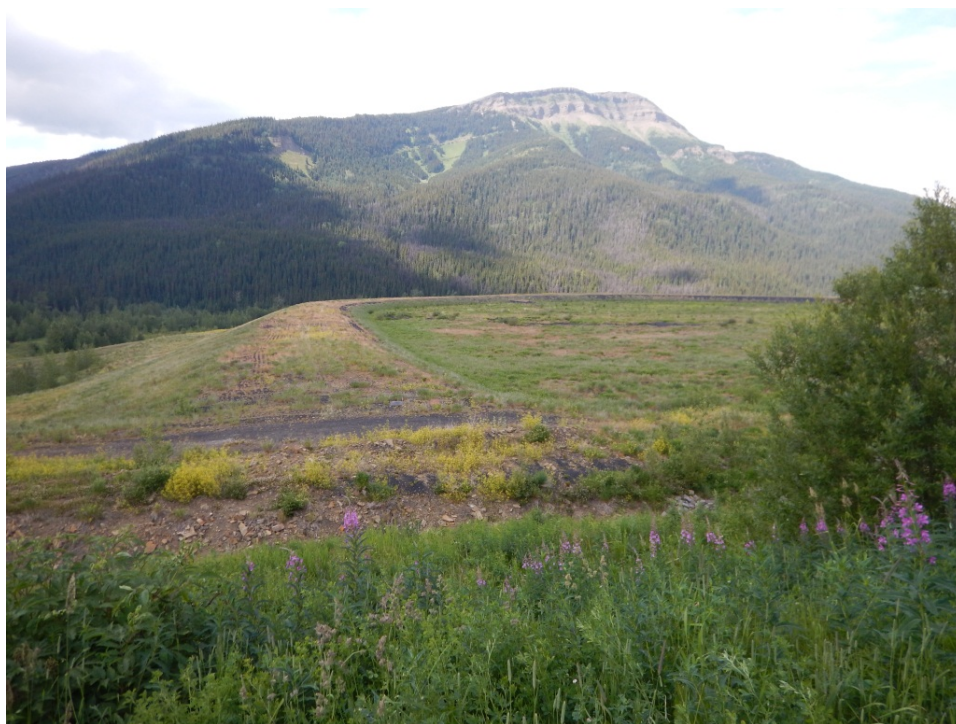
**Photo I-8** West Dam overview with spillway channel in foreground, looking north. (TSF-2014-20)

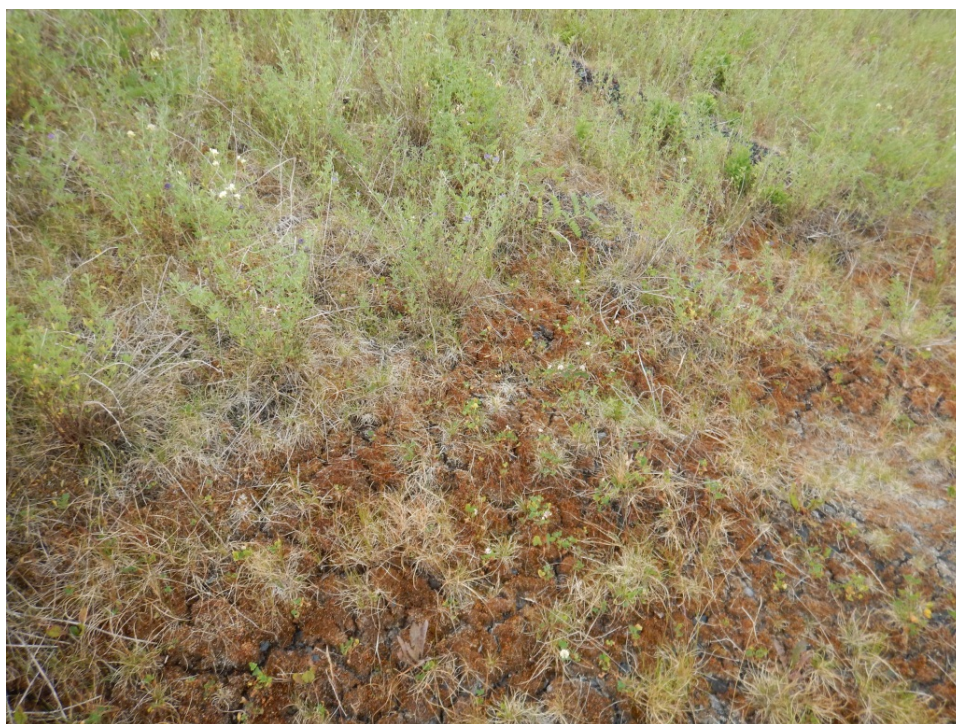
- **Downstream Slope:** Good condition. No visible sign of significant erosion or displacement, bulging at toe or crest settlement (Photos I-13 to I-18). Vegetation (grasses and moss) is well established (Photo I-9) and there is modest rilling of the downstream slope. No action required.

**Photo I-9** Typical vegetation growth on downstream dam slopes. (TSF-2014-30)

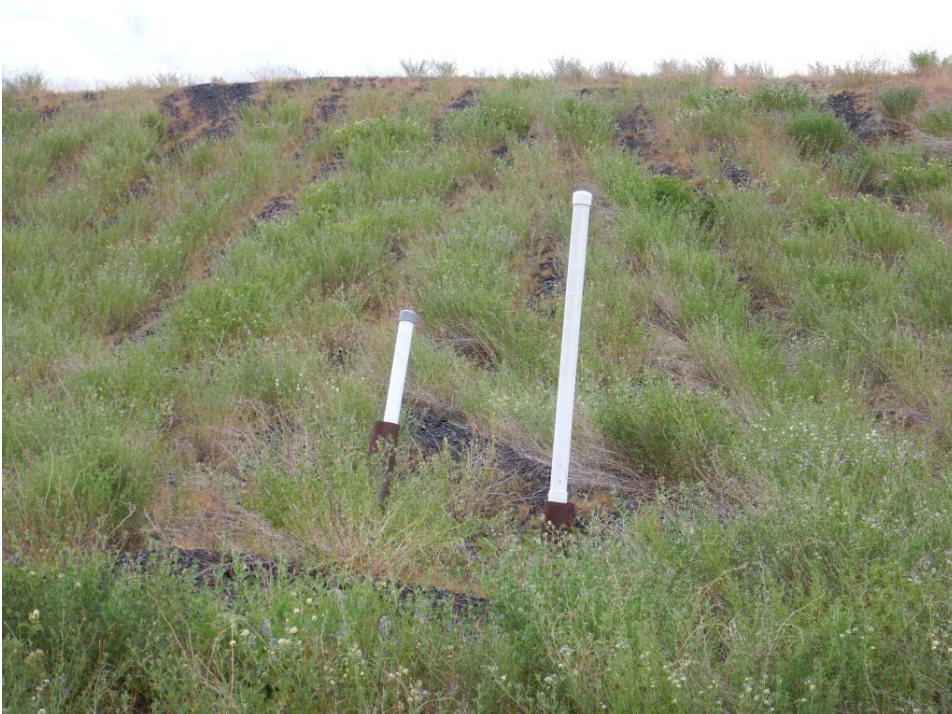
**Photo I-11** Piezometer standpipes (no labels). Shallow rilling present (<1 m deep) in well vegetated downstream slope. (TSF-2014-02)

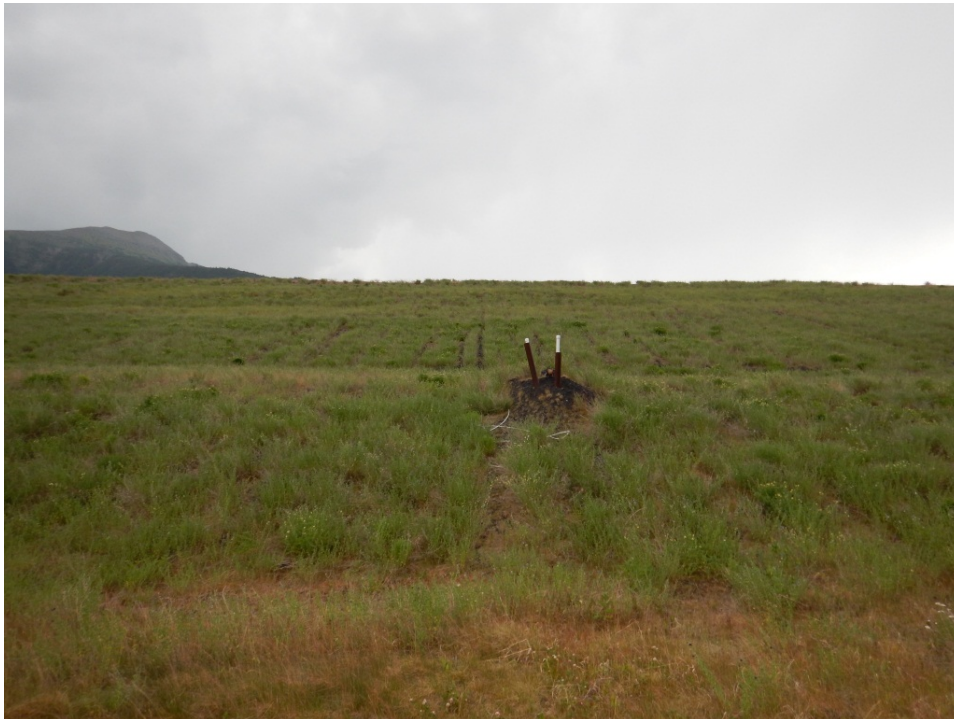
**Photo I-13 Standpipe piezometers (PB-4 and PB-5) and overview of downstream slope, looking south. (TSF-2014-08)**

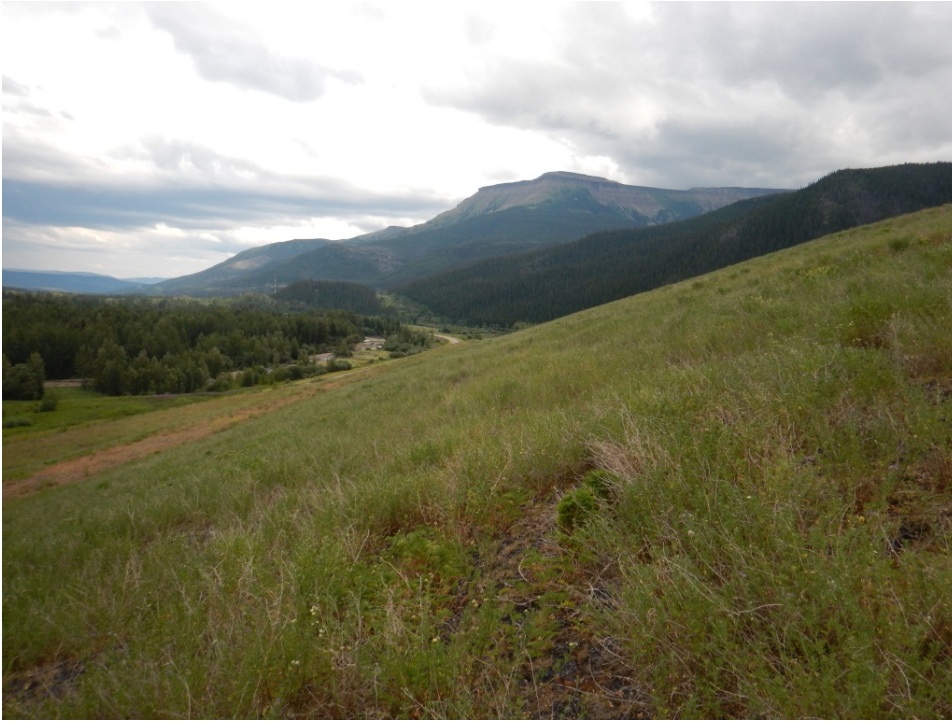
**Photo I-14 Overview of downstream slope, looking east. (TSF-2014-06)**

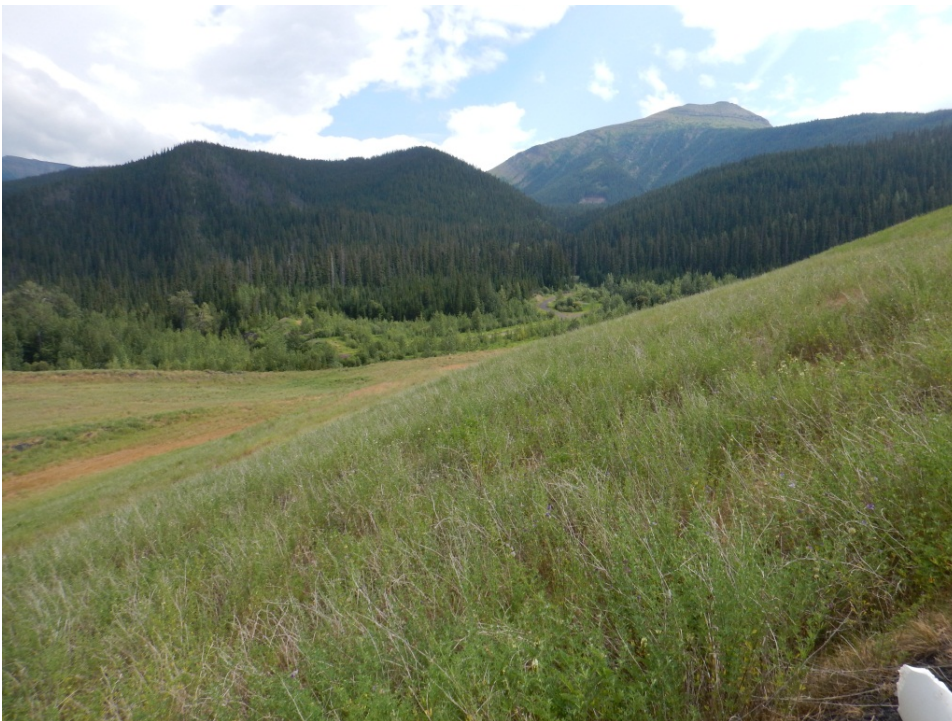
**Photo I-15 Overview of downstream slope, looking south. (TSF-2014-10)**

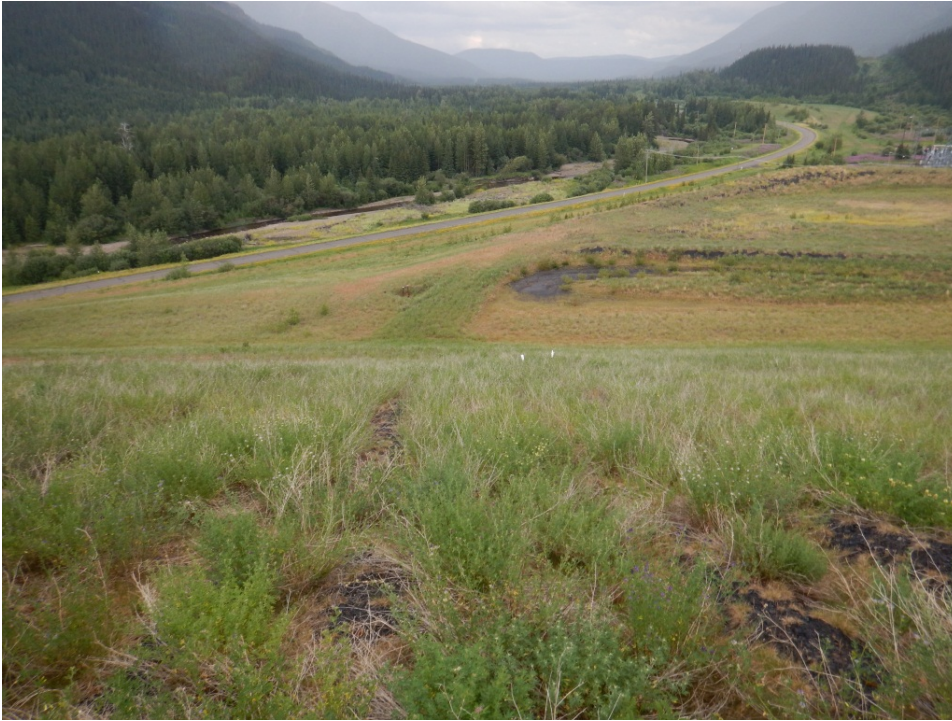
**Photo I-16** Downstream slope and toe area, looking east. Reclaimed structure, appears to be a pond, visible at dam toe. (TSF-2014-09)

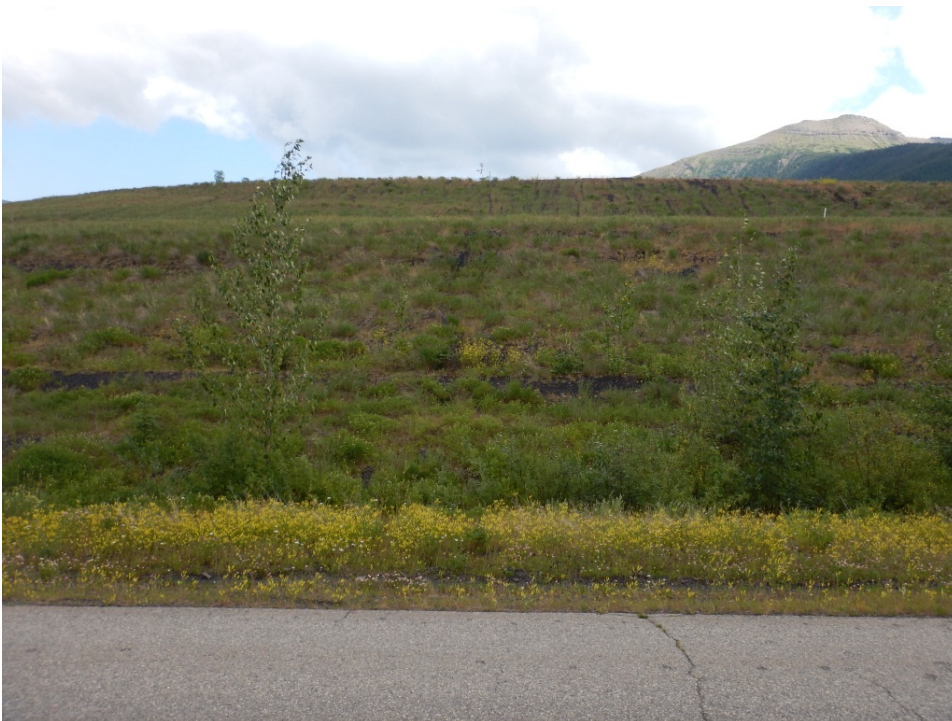
**Photo I-17** Overview of downstream slope, looking east. (TSF-2014-24)

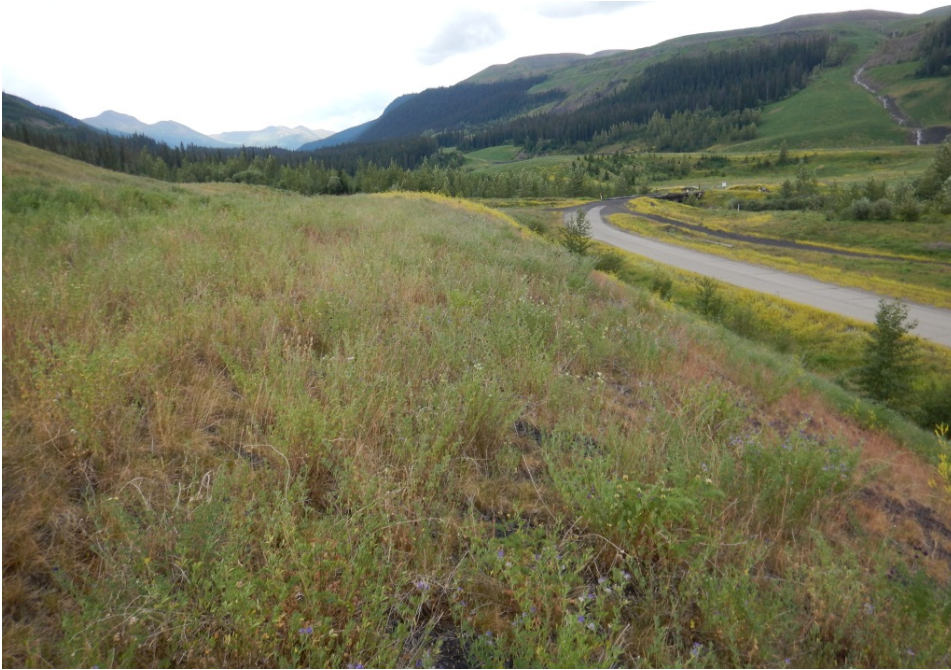
**Photo I-18 Overview of downstream slope, looking west. (TSF-2014-24)**

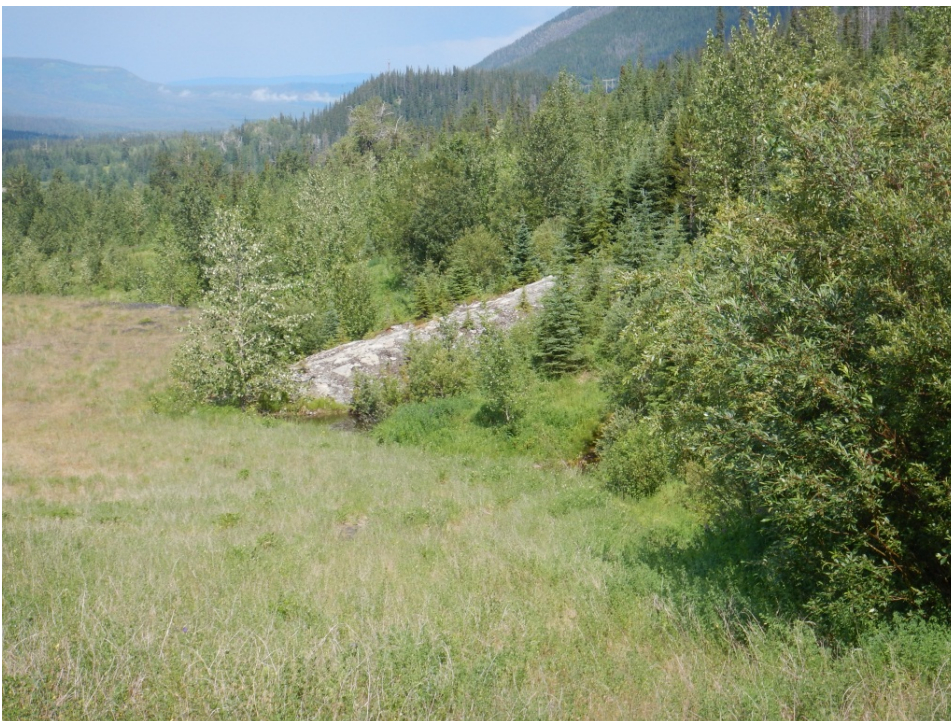
- **East Abutment:** Good condition. No visible sign of significant erosion or displacement of the natural slope (Photos I-19 and I-20).
- **Tailings Impoundment and Pond:** The impoundment is well vegetated (Photos I-1, I-5 and I-6) except for the pond area (Photo I-2). Away from the pond the tailings surface is well drained and supports human traffic (Photos I-2 and I-12). The tailings pond elevation was approximately 1115 m which is similar to other available inspection records since 2004 (KC, 2004b).

**Photo I-19 East abutment downstream slope with mine road visible (light grey structure). Local surface water flows along contact between dam fill and native ground. The area is well vegetated and no visual sign of active significant erosion. (TSF-2014-15)**

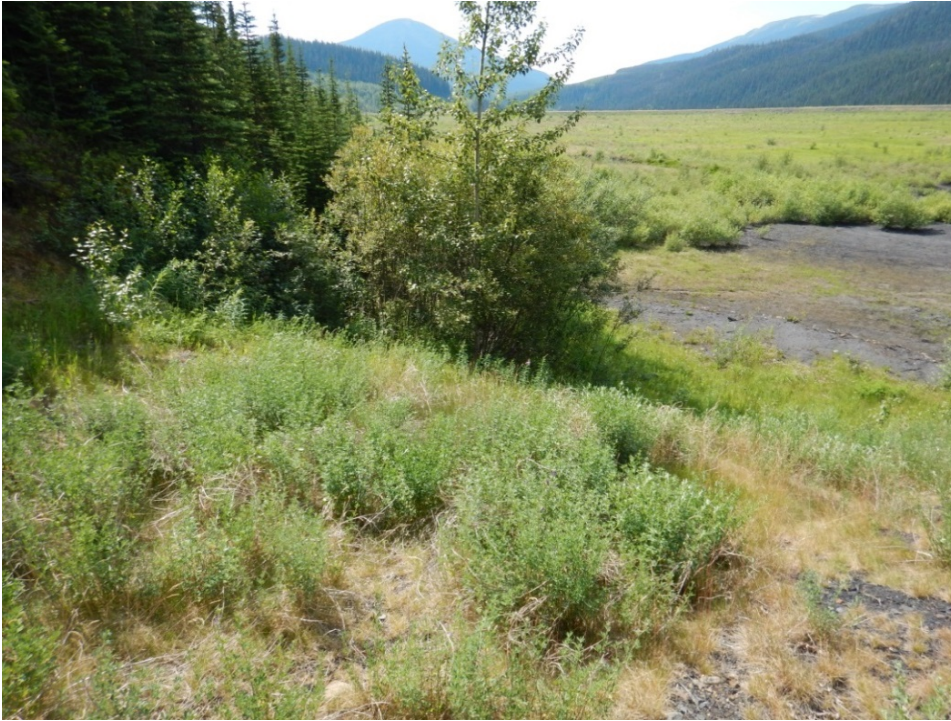
**Photo I-20 East abutment upstream slope. (TSF-2014-15)**

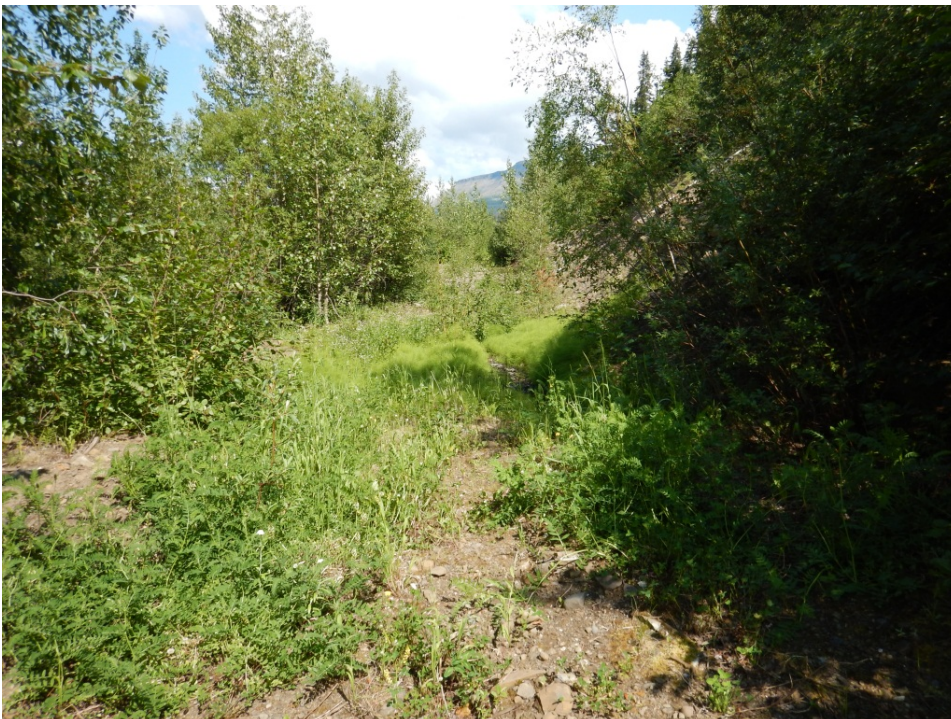
- **Upslope Diversion Ditch:** Poor condition. The ditch is heavily overgrown (Photo I-21) and was initially misinterpreted in the field as an old access road rather than the interceptor ditch. Visible signs of excessive erosion of the ditch and the area between the ditch and the impoundment. Similar pond elevation between the 2004 (KCB, 2004b) and more recent (2010 to 2014) site inspections indicate that if this ditch is not performing it is not impacting the BTD under normal flow conditions. The spillway was designed assuming that this ditch was not in place.

**Photo I-21 Diversion channel upslope of impoundment. The diversion channel is so heavily overgrown it is difficult to identify in the field. (TSF-2014-18)**
