**NEW CAROLIN GOLD CORP.  
NEW CAROLIN MINE TAILINGS STORAGE FACILITY**

**REPORT ON 2014 DAM SAFETY INSPECTION**

VA101-310/5-1  
Rev 1  
November 19, 2014

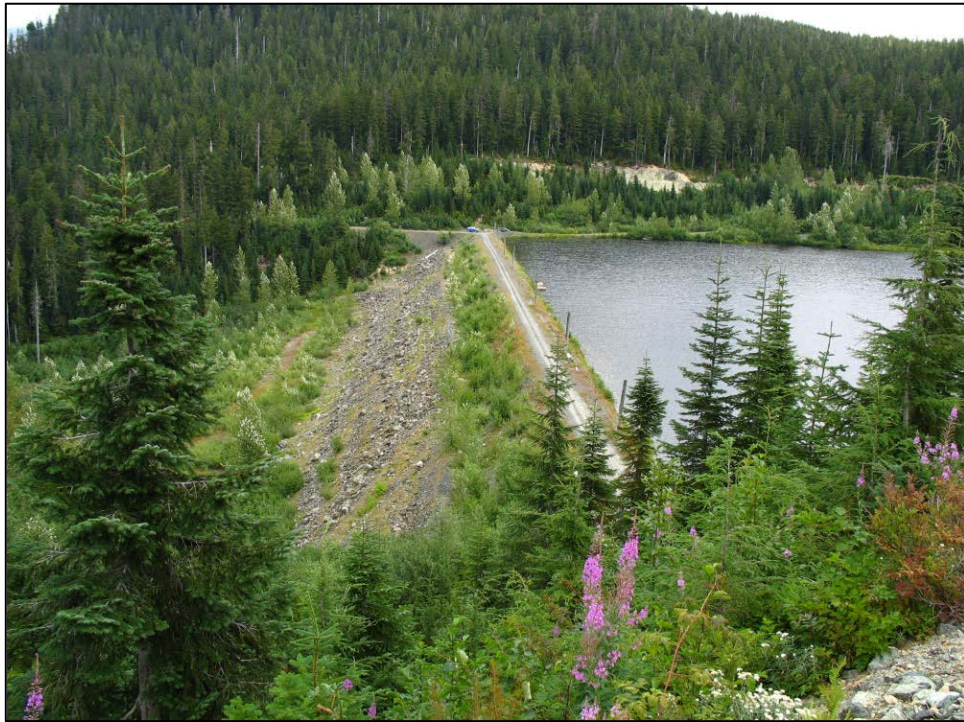
**Figure 2.1 Photo of TSF from above Left Abutment**

The TSF has not been operated since 1984 but it has not officially been closed nor been operated under Care and Maintenance conditions. It is recommended the TSF be operated under Care and Maintenance conditions, including regular inspections and monitoring of the instrumentation (once installed), until the future of the New Carolin Mine has been decided.

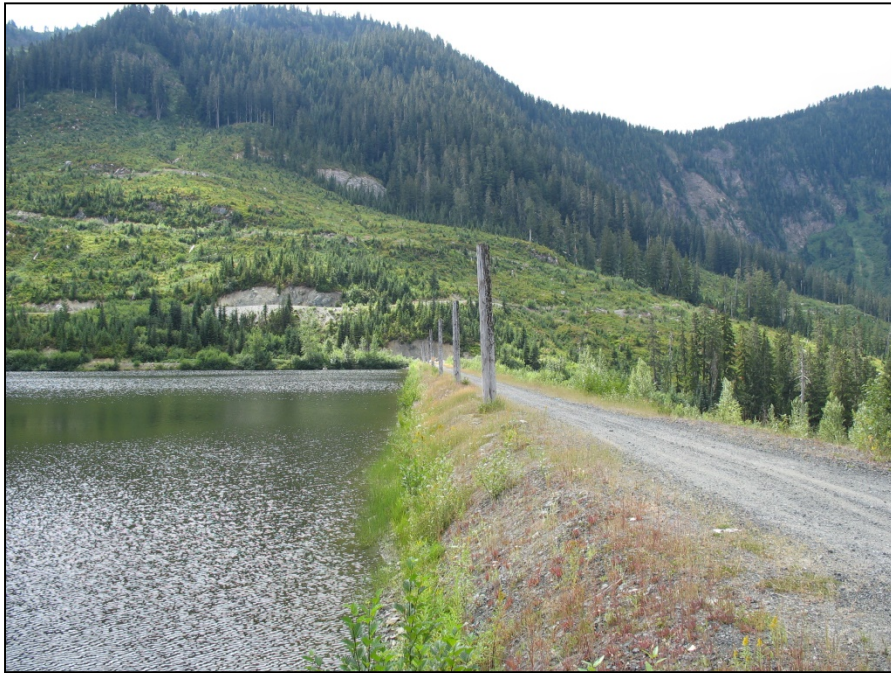
No signs of deformation were identified on the tailings embankment. The embankment slopes were approximately planar and there was no evidence of cracking, bulging, or slumping in the embankment fill. The embankment crest also appeared to be relatively level with no signs of differential settlement. There was no evidence of animal burrowing. There were no signs of wave erosion on the upstream face.

**PHOTO 1** – Embankment crest looking west.

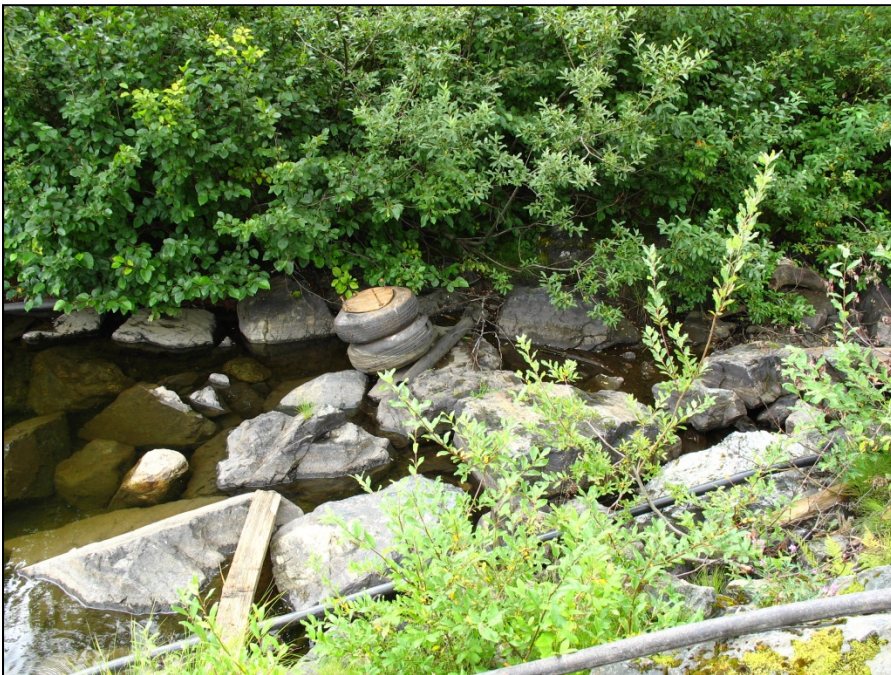
The TSF includes a spillway on the embankment west abutment. There was no flow discharging through the spillway at the time of the inspection. The spillway appeared to be in good condition, showed no signs of erosion, and appears to be effectively managing the maximum water level in the TSF. It is recommended the TSF spillway be inspected during each site visit, and any debris collected in the spillway channel removed.

The New Carolin Mine TSF spillway may be undersized to successfully pass the flood from the IDF. It is recommended a flood routing analysis be conducted to determine the discharge capacity of the spillway and to confirm, or otherwise, whether it is capable of passing storm flows from the IDF. Additionally, it is recommended a debris catch system be installed upstream of the spillway to prevent debris from entering and blocking the spillway channel.

**PHOTO 2** – TSF spillway.

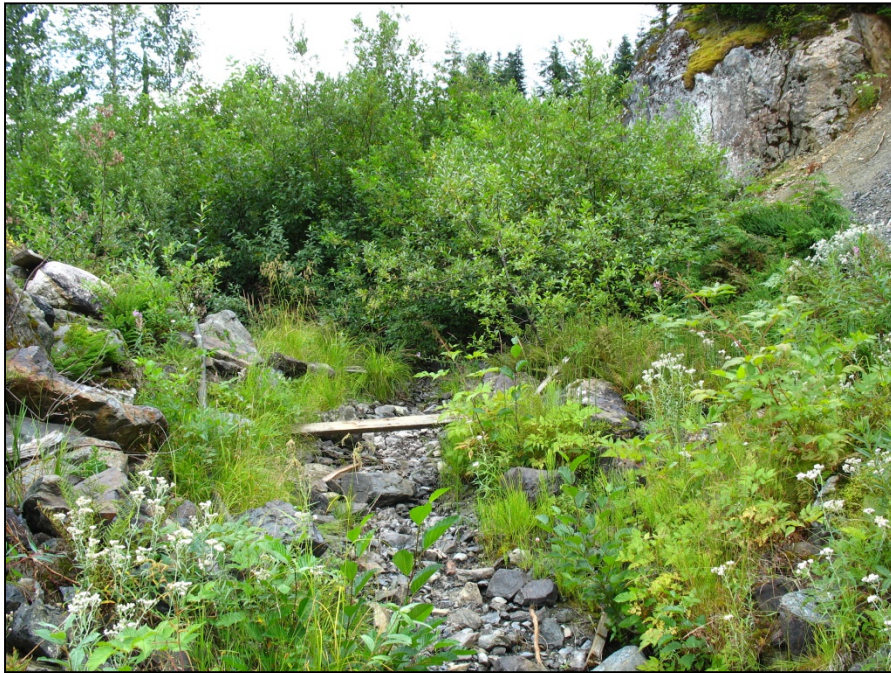
**PHOTO 3** – TSF spillway channel looking upstream.

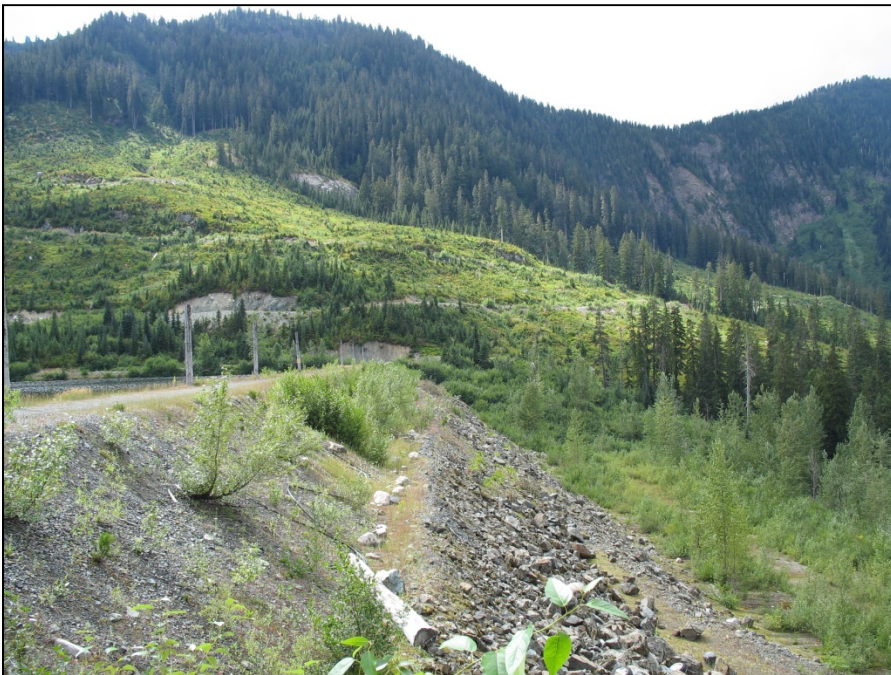
**PHOTO 4** – TSF downstream slope looking west.

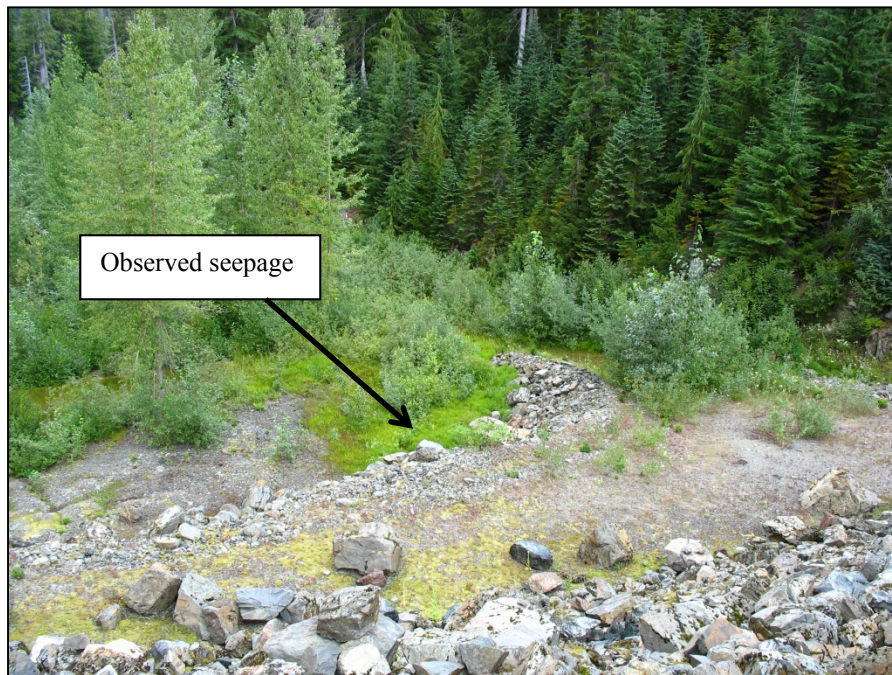
Seepage was observed along the downstream west and east abutments. This seepage has been observed in previous inspections, including during the August 12, 2014 inspection by Gerry Barcelona of the Ministry of Energy and Mines. The seepage was clear.

**PHOTO 5** – Seepage area at right abutment.

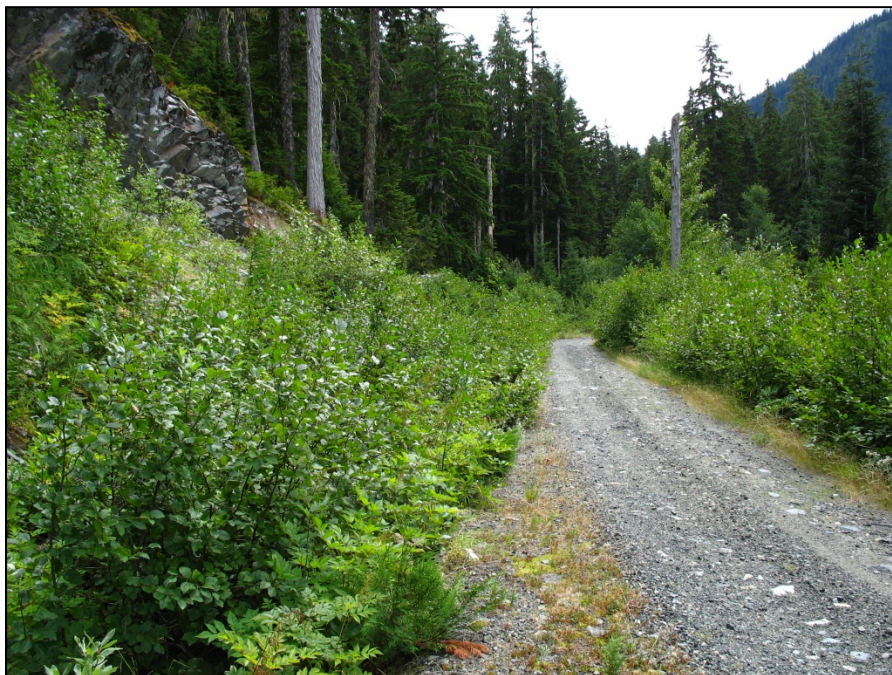
Surface runoff from outside the facility is currently being diverted around the facility by diversion ditches. These appear to be effective in diverting runoff around the facility. It is recommended the diversion ditches be inspected during each site visit and debris and vegetation in the ditches removed.

**PHOTO 6** – Access road on east side of TSF. Diversion ditch on left side of access road.

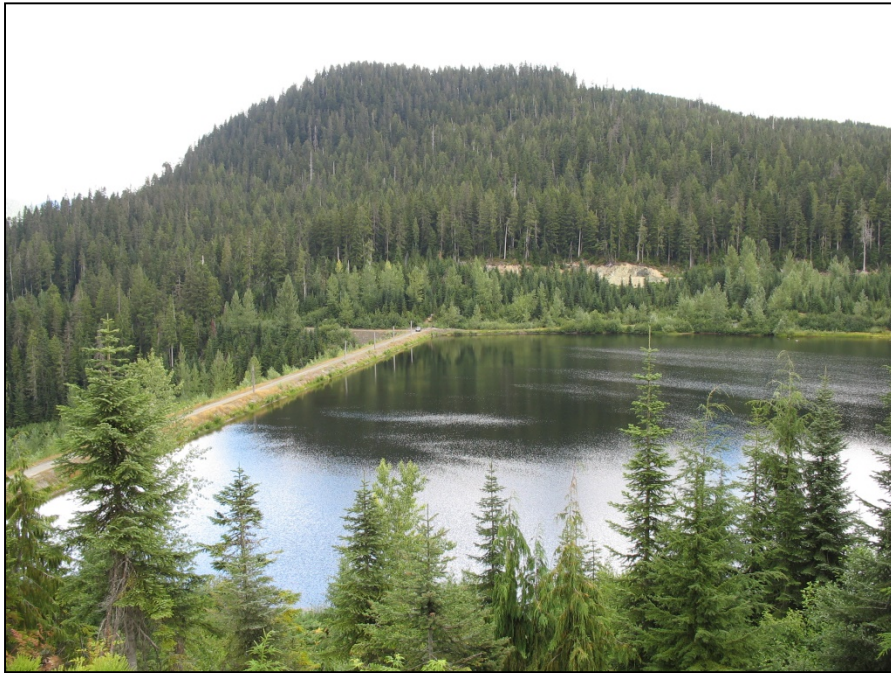
The elevation of the tailings pond at the time of the inspection was approximately 977.2 m, which is slightly below the invert elevation of the TSF. The tailings pond covers the entire facility and is up against the embankment along its entire length (similar to previous inspections). It is recommended the pond water level be lowered as recommended in previous inspection reports to reduce the phreatic surface within the dam.

**PHOTO 7** – TSF pond up against embankment. Looking East.

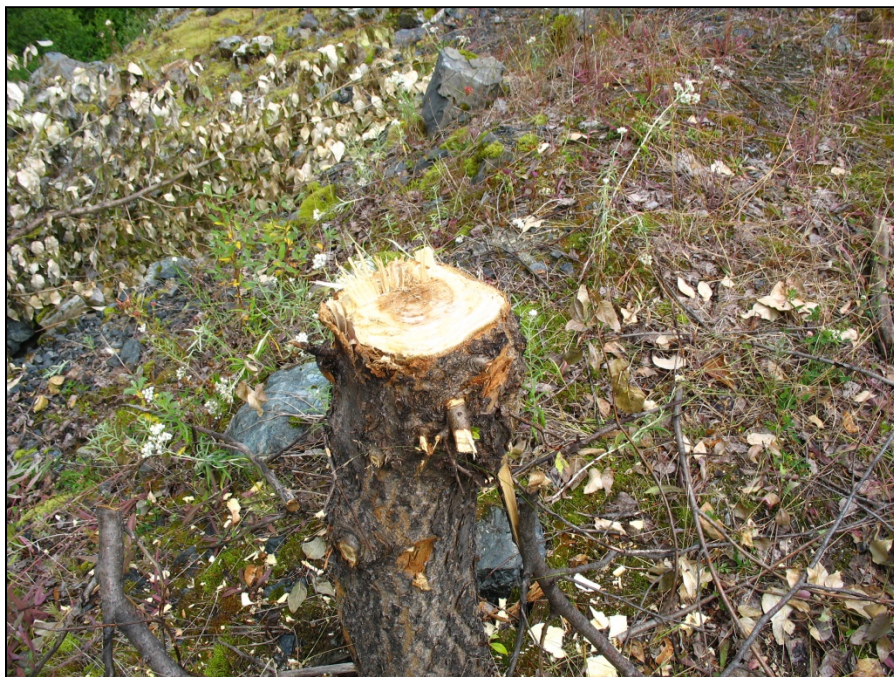
Thick vegetation is well established on the lower section of the dam. Larger trees (approximate diameter of 0.15 m) on the upper section of the dam had recently been cut down due to concerns over the dam/core zone being potentially damaged by the root system penetrating the dam, or by fallen trees uprooting large root balls. It is recommended this practice be continued with trees larger than 0.15 m in diameter being removed from the dam (above the berm).

**PHOTO 8** – recently cut tree near embankment crest.

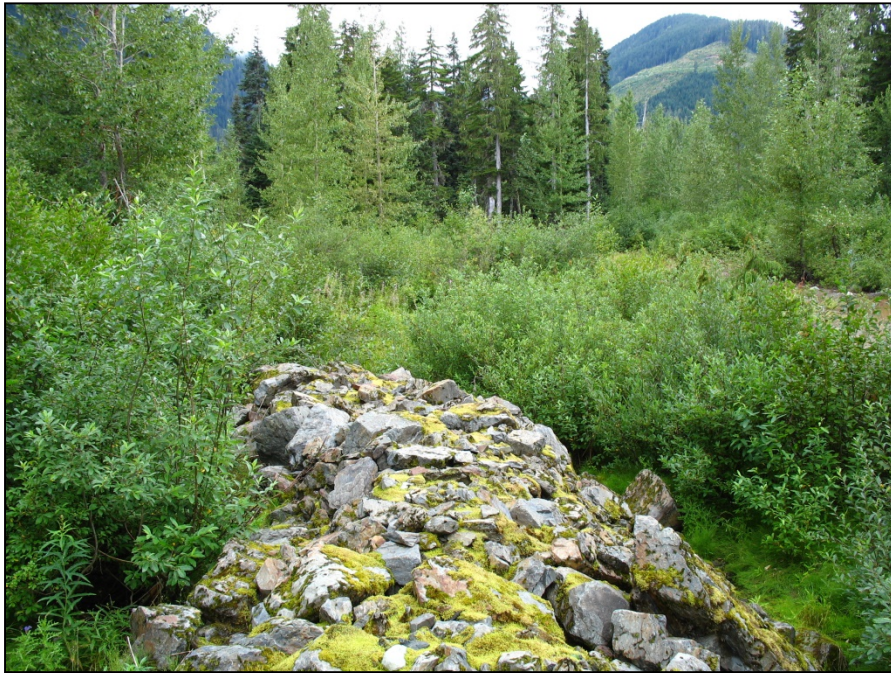
Seepage was also observed from the downstream rockfill finger drains. The seepage rates were very low, and were similar to previous inspections. The seepage was clear.

**PHOTO 9** – Downstream rockfill finger drain.

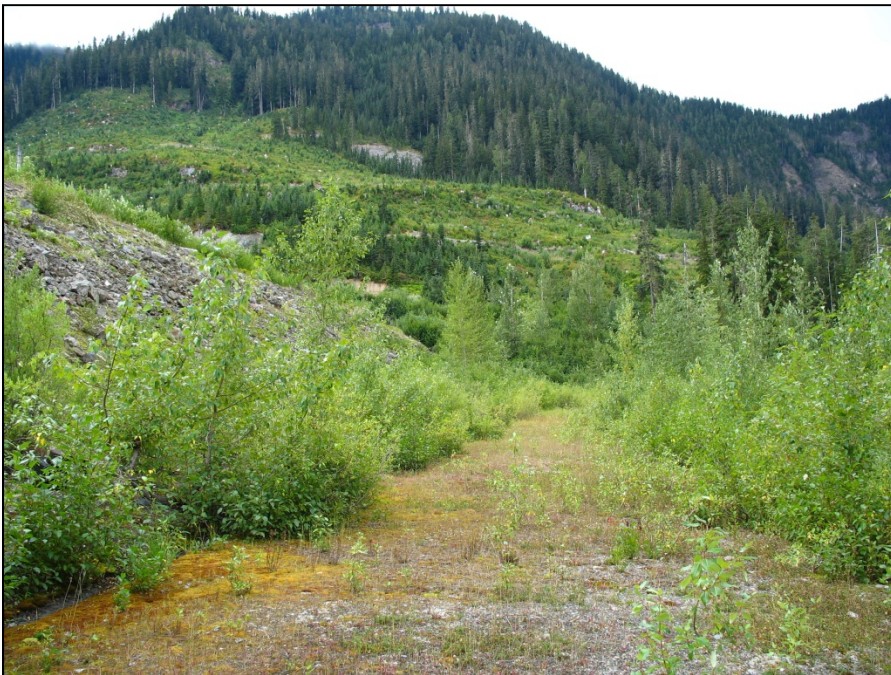
**PHOTO 10** – Top of TSF downstream berm looking west.
