Subject: 2014 Dam Safety Inspection – Huldra (Old Craigmont) Mine, Merritt, BC
Final Report
Our file: 623839-0000-4GER-0001-00

2014 Dam Safety Inspection Old Cragmont Mine

FINAL REPORT

HULDRA SILVER INC.

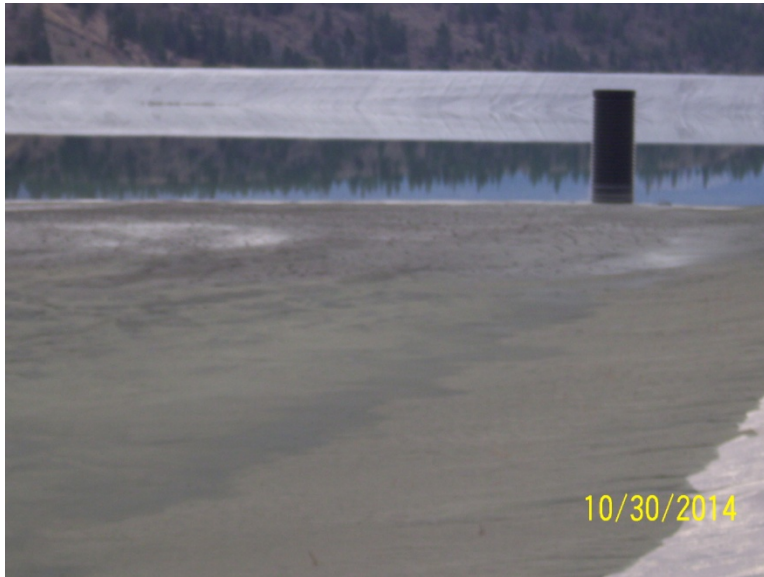
Photo 1 – Huldra Tailings Facility (Inside Pond)

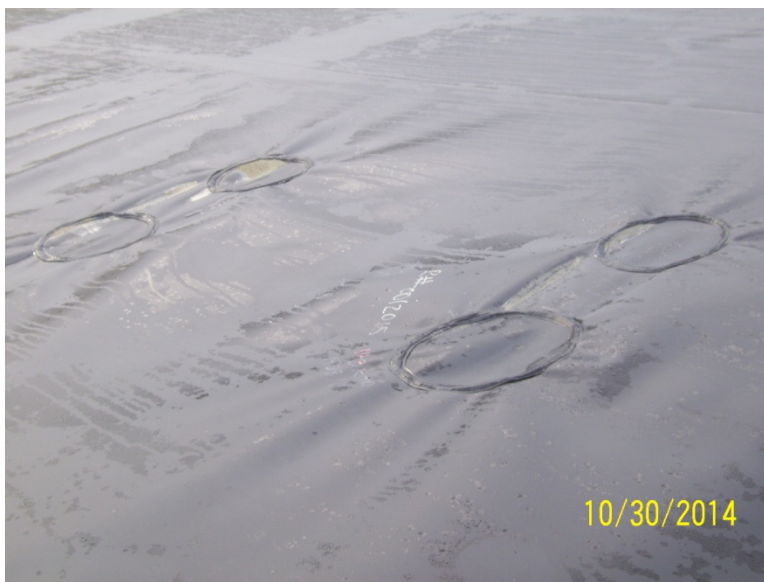
2.9 Other Unusual Conditions	<input type="checkbox"/>	<input checked="" type="checkbox"/>		
2.10 Evidence of Repairs	<input checked="" type="checkbox"/>	<input type="checkbox"/>	2	Minor repairs to liner

Photo 2 – Huldra Tailings Facility (Liner Repair)

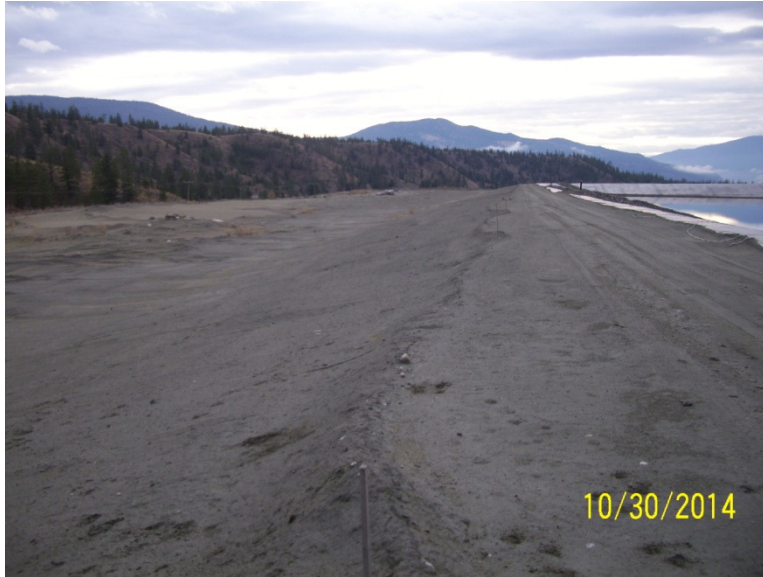
Photo 3 – Huldra Tailings Facility (Crest and downstream slope)

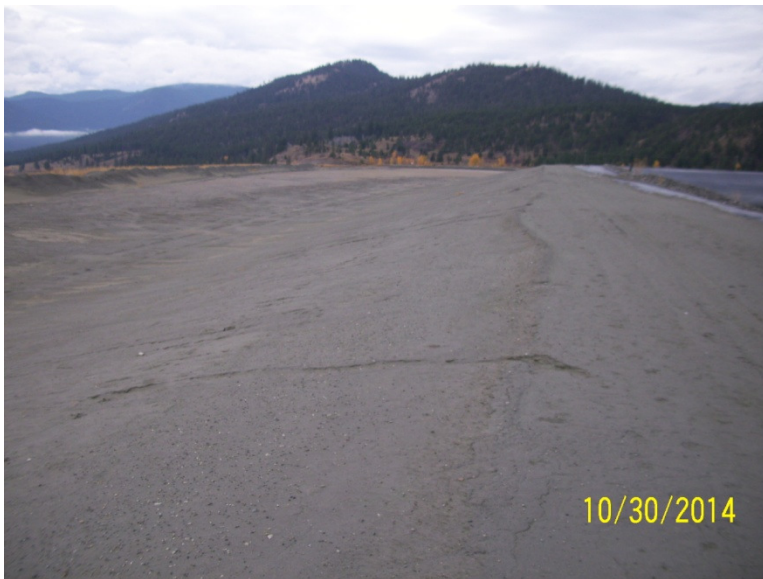
Photo 4 – Huldra Tailings Facility (Crest and downstream slope)

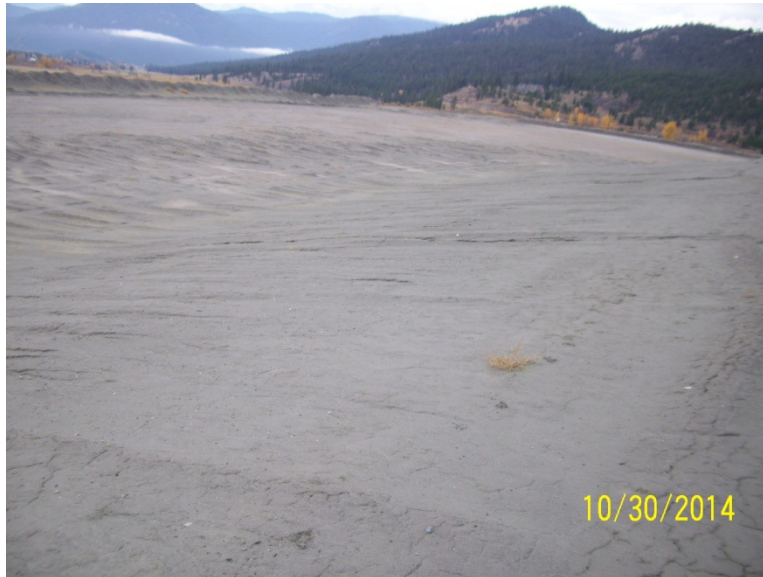
Photo 5 – Huldra Tailings Facility (Downstream Toe)

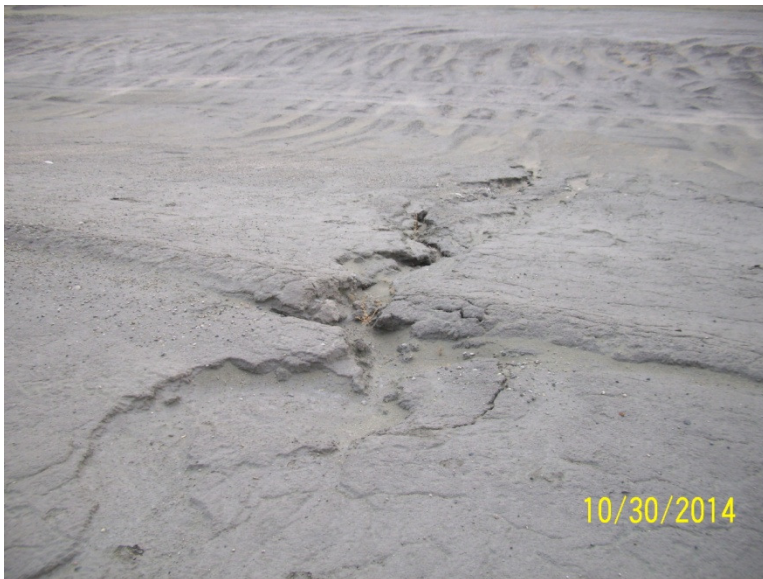
Photo 6 – Huldra Tailings Facility (Gulley in downstream slope)

- Any signs of potential distress / failures or movements shall be immediately communicated to the responsible personnel;
- Erosion gulleys should be removed by grading and smoothing off the slopes and crest areas; channelling of runoff waters in gravel ditches lined with geosynthetics at the main erosion sites could be considered as a long term solution;

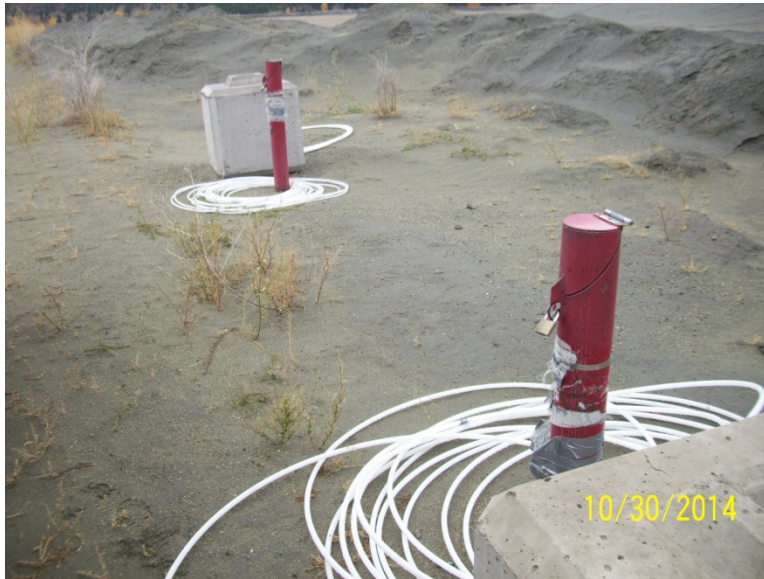
Four monitoring wells (MW01, MW02, MW03, MW04) are in place on the dykes forming the UTF. It is understood that Huldra is taking monthly readings of these wells. Readings were not provided to SLI. According to Mr. Len Haukeness of Huldra, the water level in the wells is very deep. Measuring the water level in these wells before purging and sampling the ground water could confirm this information. The monitoring of water depth in the monitoring wells should be continued and provided for review as recommended previously by AMEC (2013).

Photo 7 – Upper Tailings Facility (Monitoring Wells MW-2 and -4)

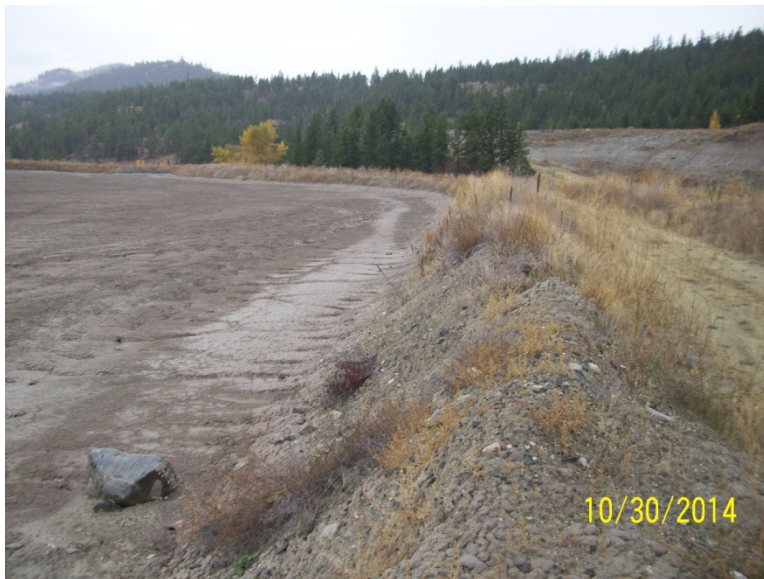
Photo 8 – Upper Tailings Facility (North Dam Upstream slope)

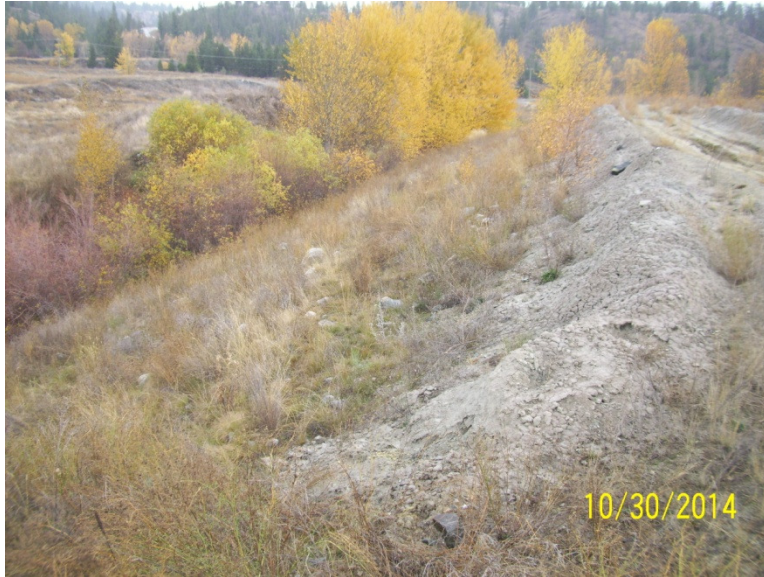
Photo 9 – Upper Tailings Facility (North Dam Downstream Vegetation)

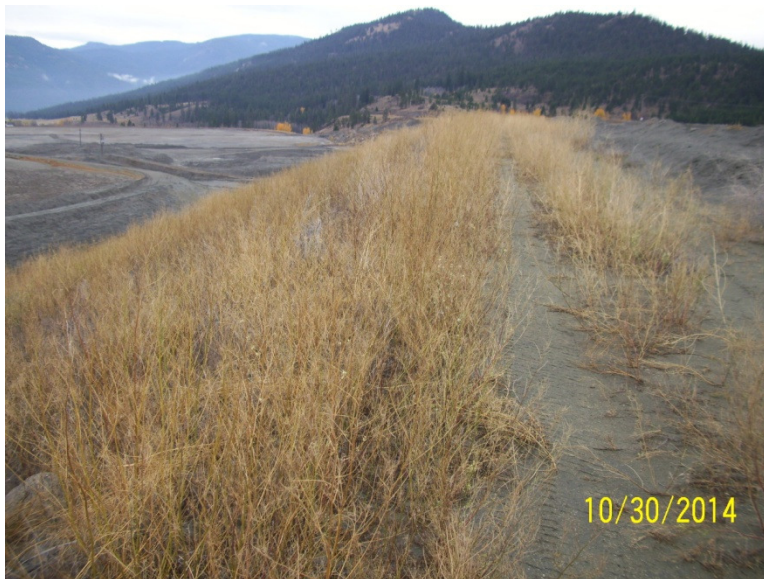
Photo 10 – Upper Tailings Facility (South Dam Crest)

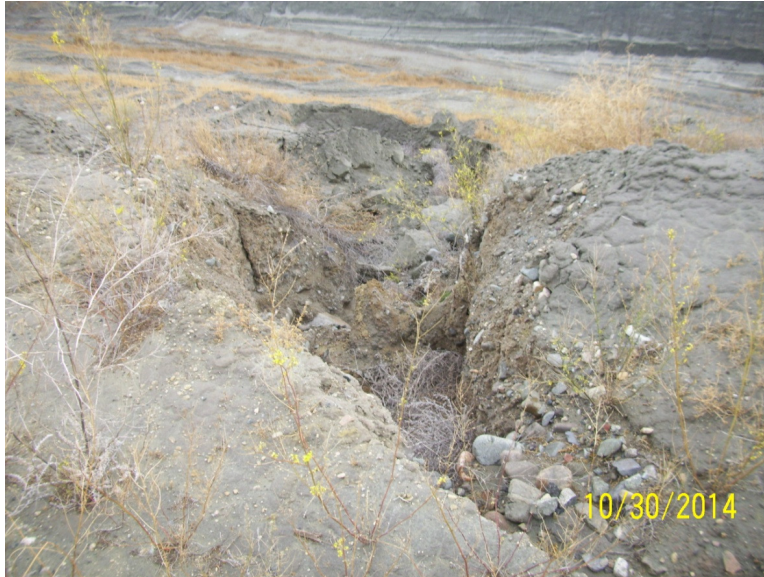
Photo 11 – Upper Tailings Facility (South Dam Downstream Gully)

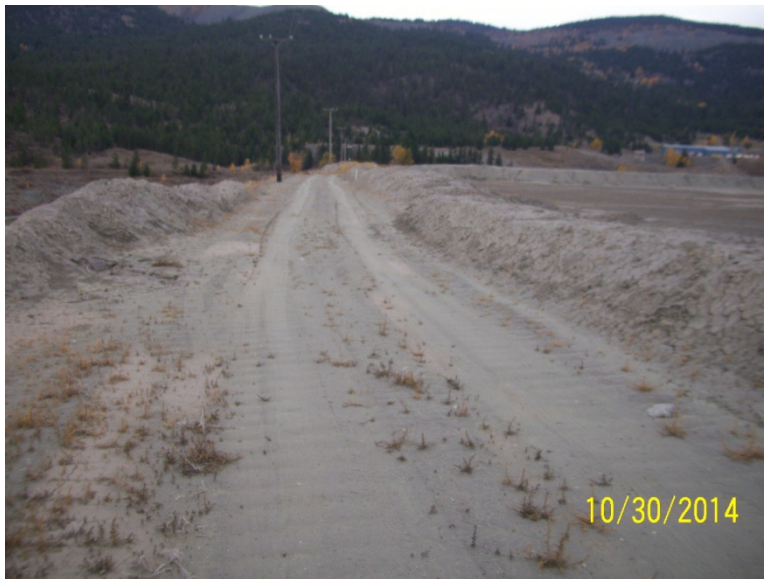
Photo 12 – Upper Tailings Facility (West Dam Crest)

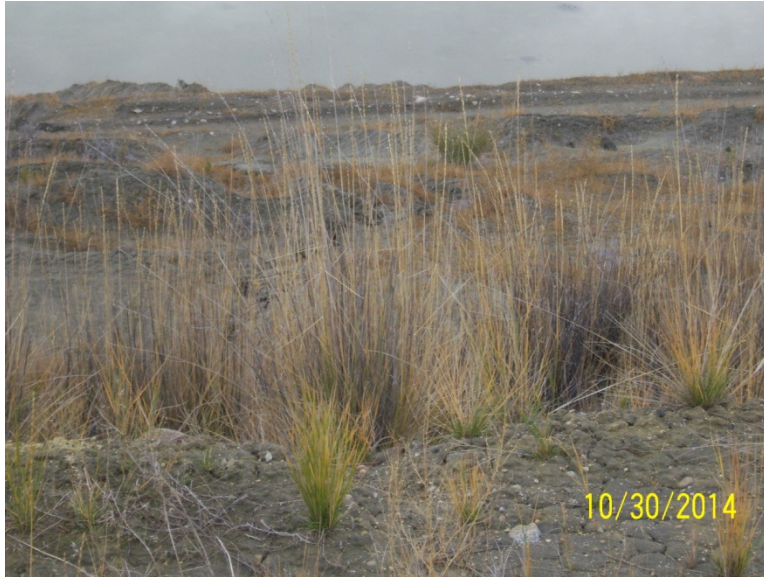
Photo 13 – Upper Tailings Facility (West Dam Downstream Vegetation)

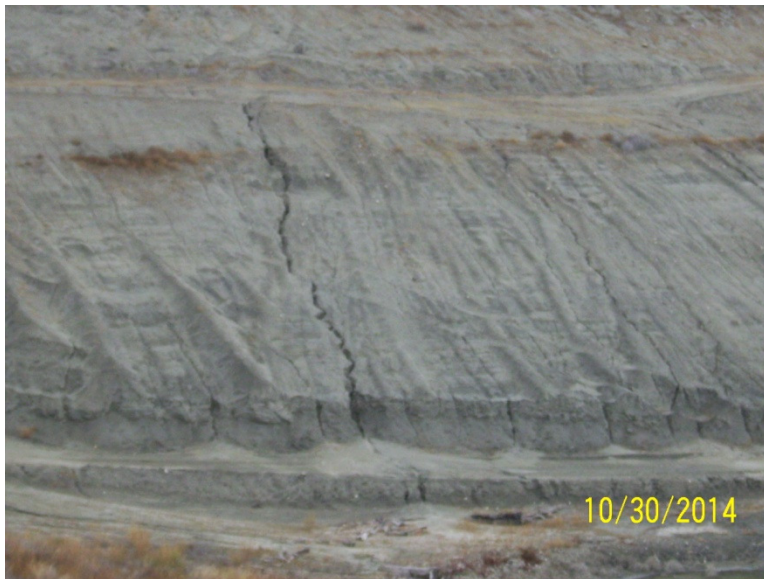
The crest and slopes appear to be in good physical condition, with no signs of seepage or instability. A few locations had the freeboard between the tailings beach and the South Dam crest less than the recommended 1 m. Some erosion gulleys were noted on the downstream slopes, although these are not considered to have an effect on the stability of the structure. The more important gulleys like the one observed in South Dam (see photo 11) should be fixed so it will not worsen although it seems that any tailings or water flowing due to a potential dam failure would be contained in the LTF. The narrow but long gully observed in the West Dam (photo 14) should be monitored to ensure it does not develop.

Photo 14 – Upper Tailings Facility (West Dam Downstream Gully)

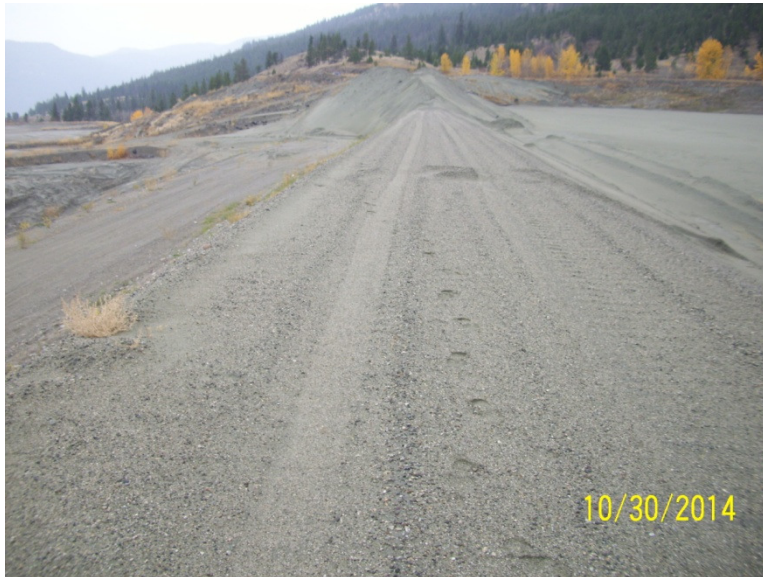
Photo 15 – West Tailings Facility (Dyke 4)

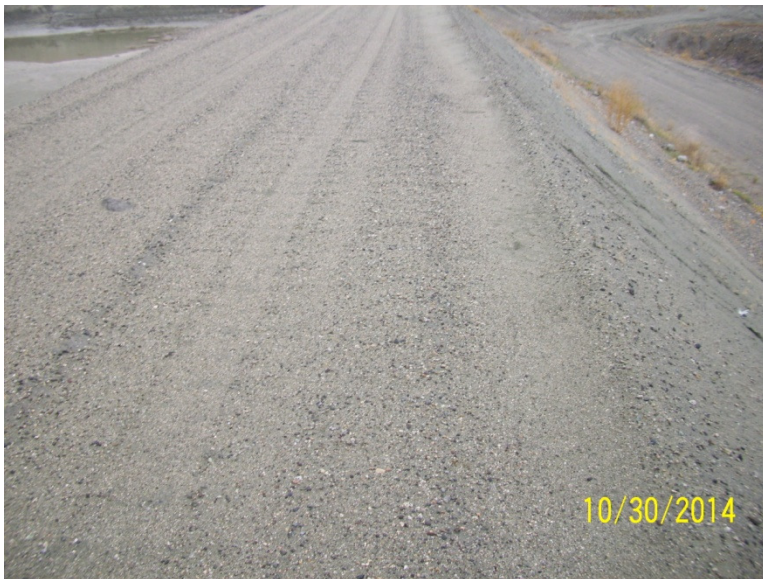
Photo 16 – West Tailings Facility (Dyke 4)

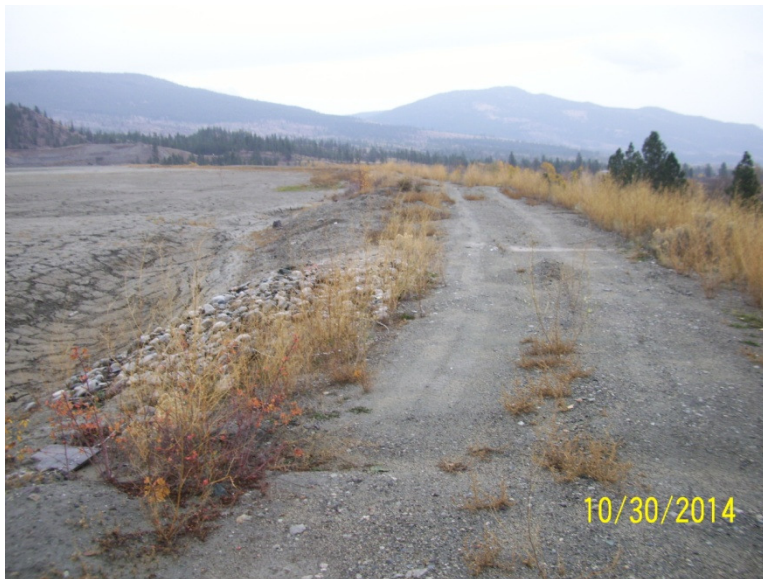
Photo 17 – Lower Tailings Facility (Crest)

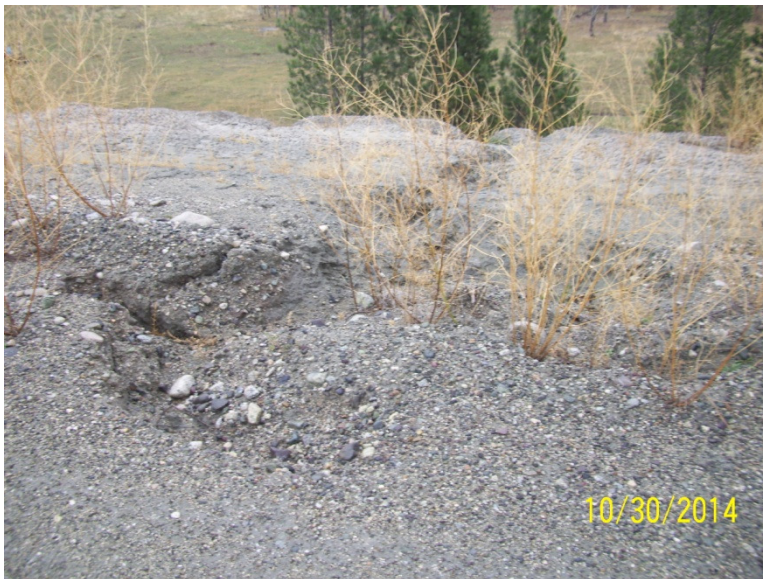
South dam downstream slopes had a few small trees. Minor erosion gulleys were observed along the downstream crest. The remainder of the crest, downstream and upstream slopes appeared to be in good condition, with no signs of structural distress or seepage.

Photo 18 – Lower Tailings Facility (Erosion on Crest)

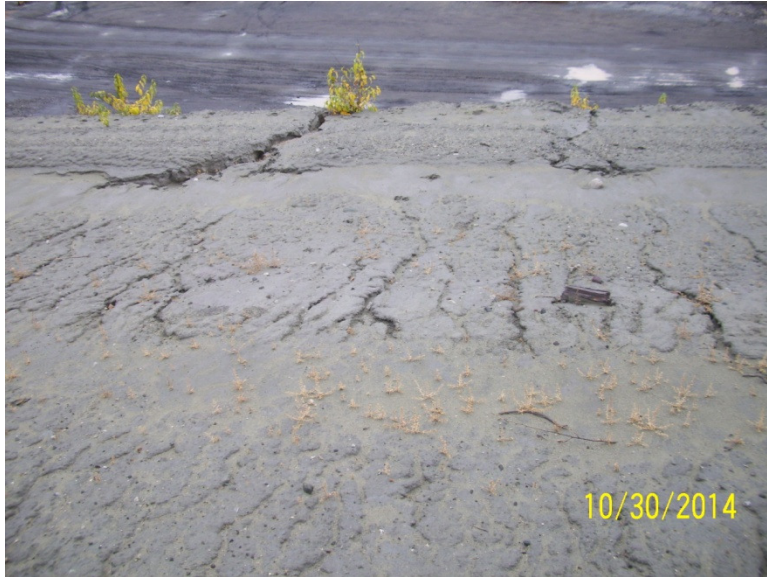
Photo 19 – Lower Tailings Facility (Downstream)

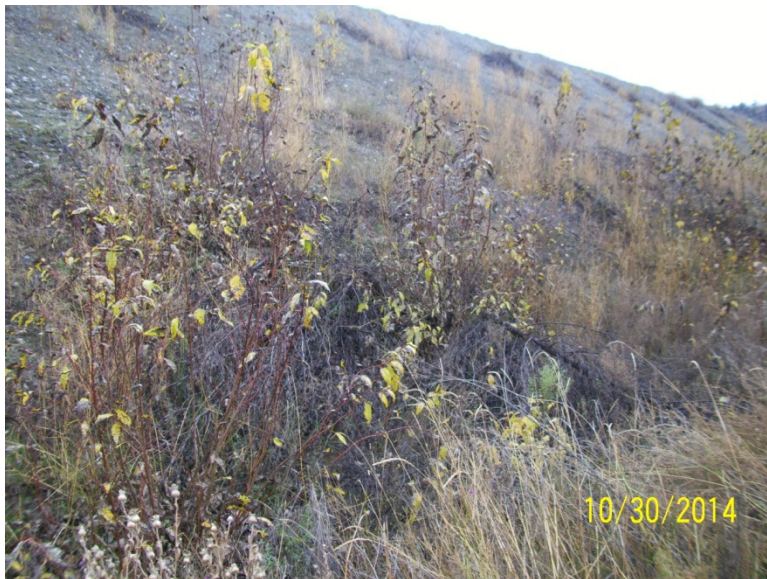
Photo 20 – Lower Tailings Facility (Downstream Vegetation)

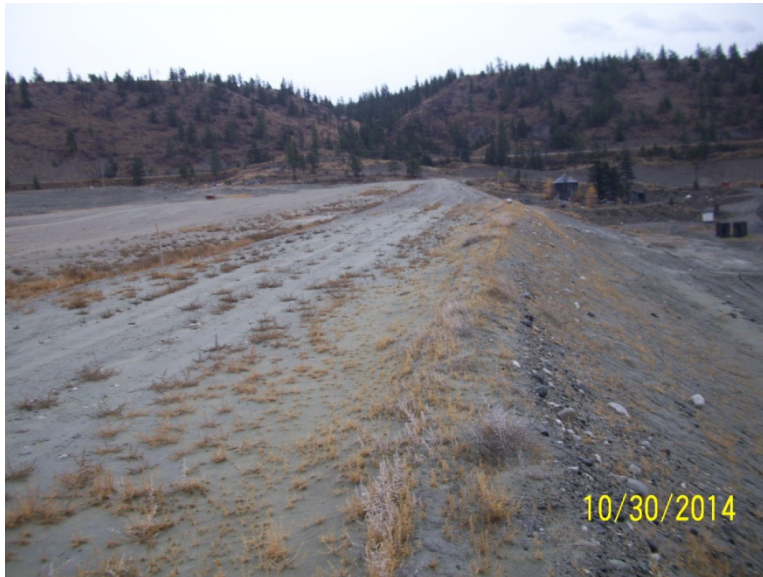
Photo 21 – Expanded Tailings Facility (Dyke 1)

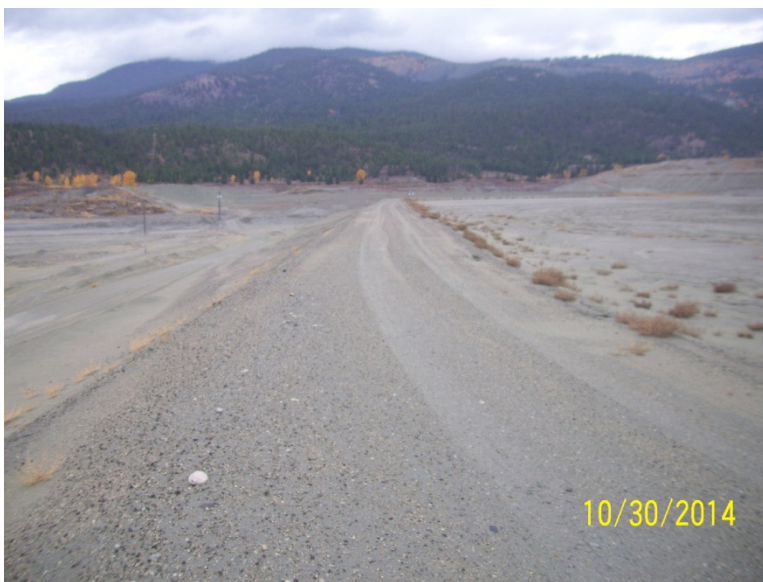
Photo 22 – Expanded Tailings Facility (Dyke 3)

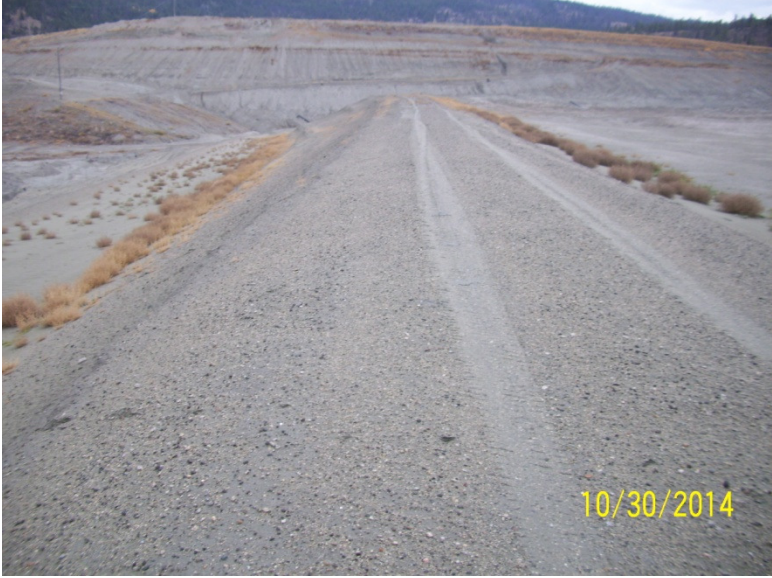
Photo 23 – Expanded Tailings Facility (Dyke 2)

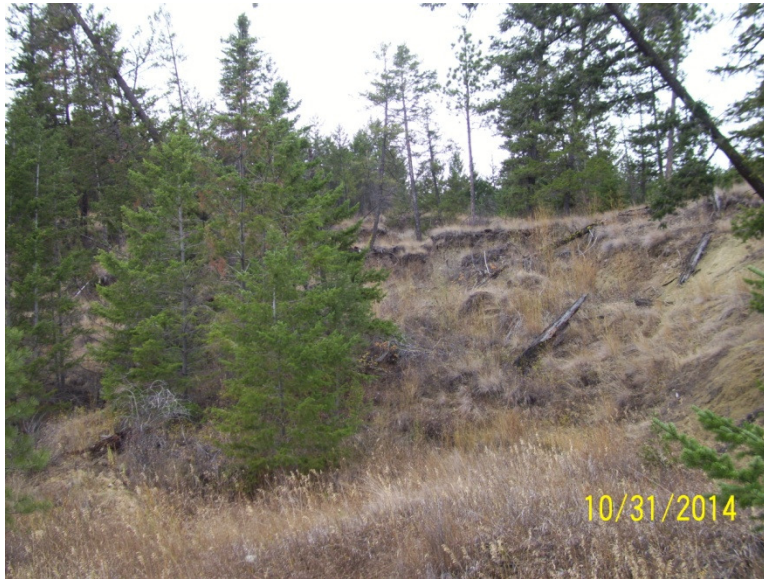
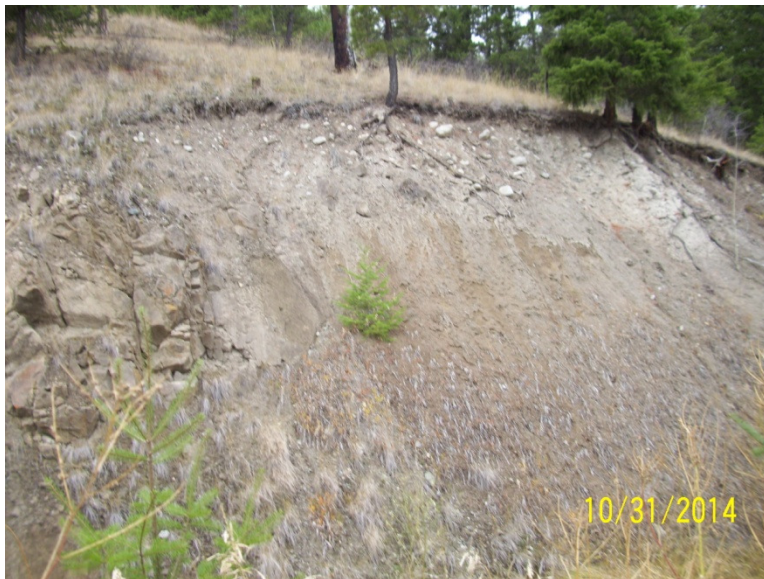
The slide does not appear to have expanded in area since the previous DSI reporting, however it should be noted that the area still seem to present the potential for further ground movement and should be investigated and studied in more detail as it could block the SCD ditch. From site discussions, it is understood that the BC Ministry of Energy and Mines has been notified of the landslide area.

Photo 24 – Strumbles Creek Diversion Landslide

Photo 25 – Strumbles Creek Diversion Landslide

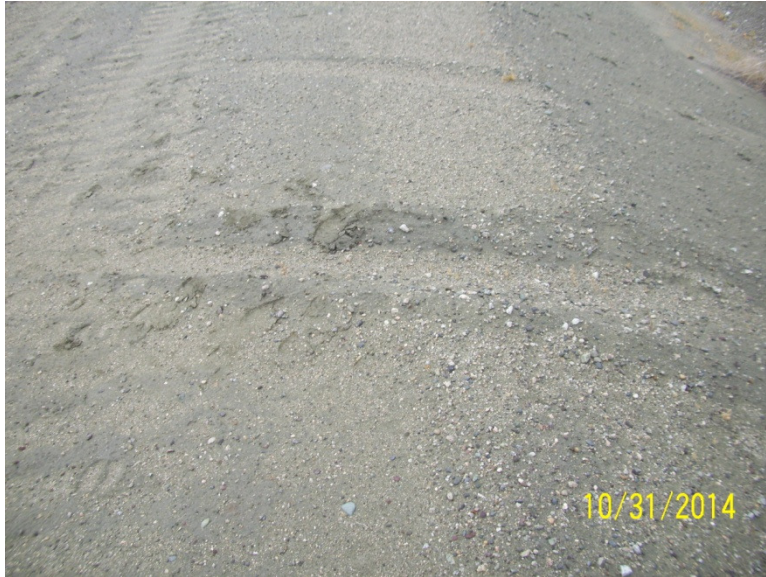
Photo 26 – West Tailings Facility (Dyke 4 Crest Erosion)

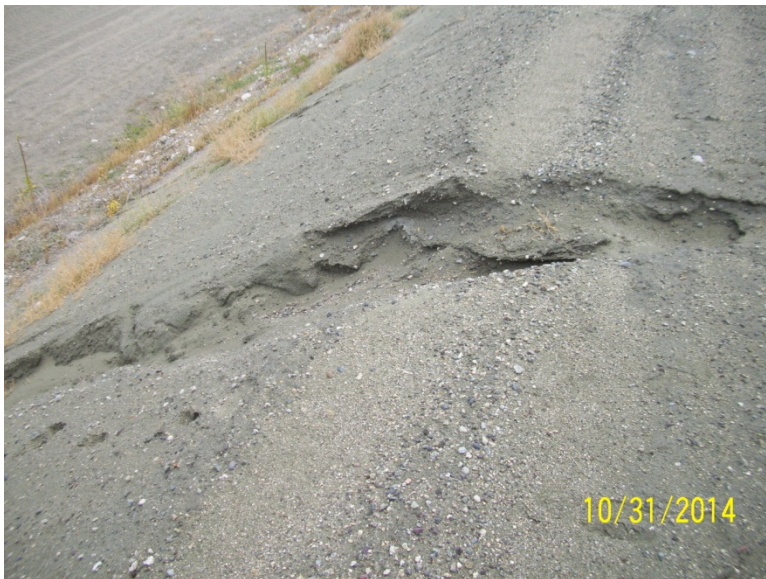
Photo 27 – West Tailings Facility (Dyke 4 Shoulder Erosion)

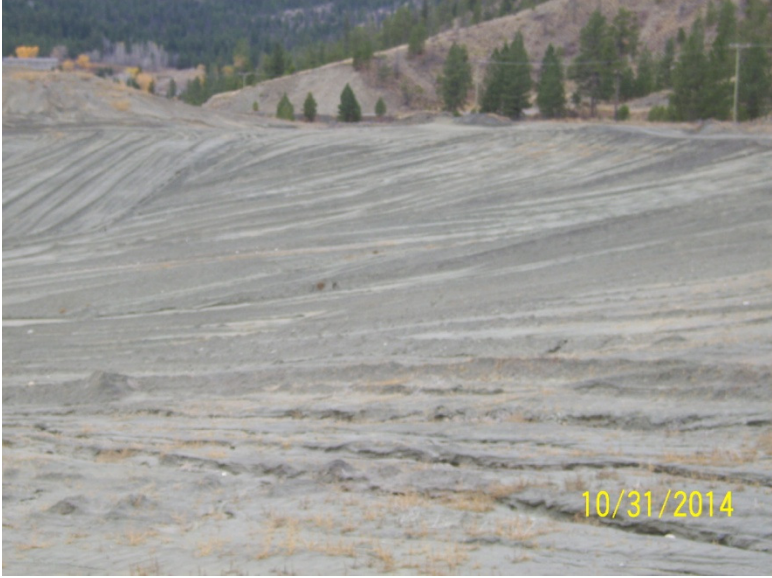
Dykes 1, 2 and 3 appear to be in good condition with minor erosion gulleys, which are considered to be benign with respect to stability of the structures. The gulleys observed by AMEC (2013) do not seem to have evolved but their periodic monitoring is still recommended. No signs of distress were observed. The steep east face also mentioned in AMEC 2013 DSI report has been re-graded and sloped back.

Photo 28 – Expanded Tailings Facility (East Face)
