## **Dankoe Mine**

# **Report on 2014 Dam Safety Inspection of Tailings Storage Facility**

**December 4, 2014**

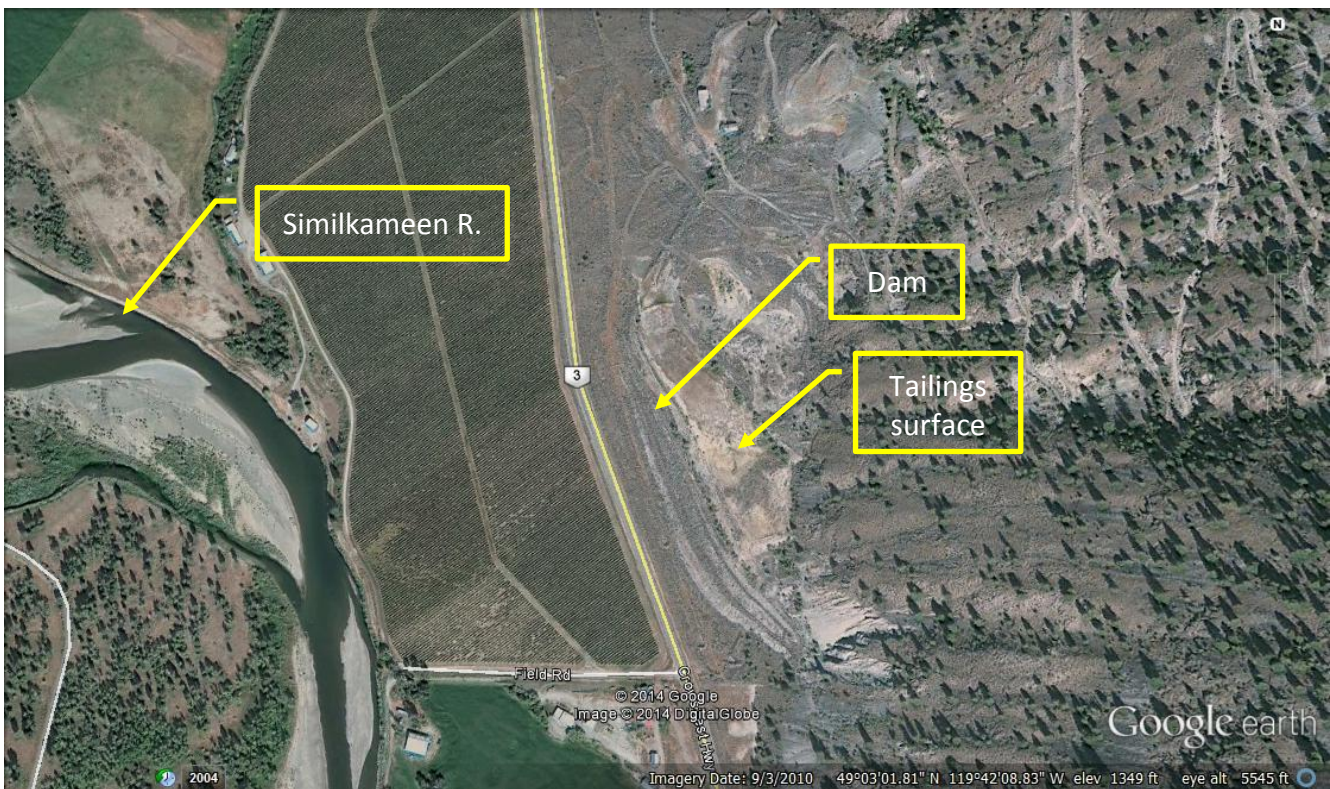
**Figure 2. Photo of Tailings Dam and TSF**

The tailings dam and TSF are aligned essentially north-south, situated parallel to Highway 3, with the toe of the dam within about 100 ft. of Highway 3. Figure 2 below shows the TSF.

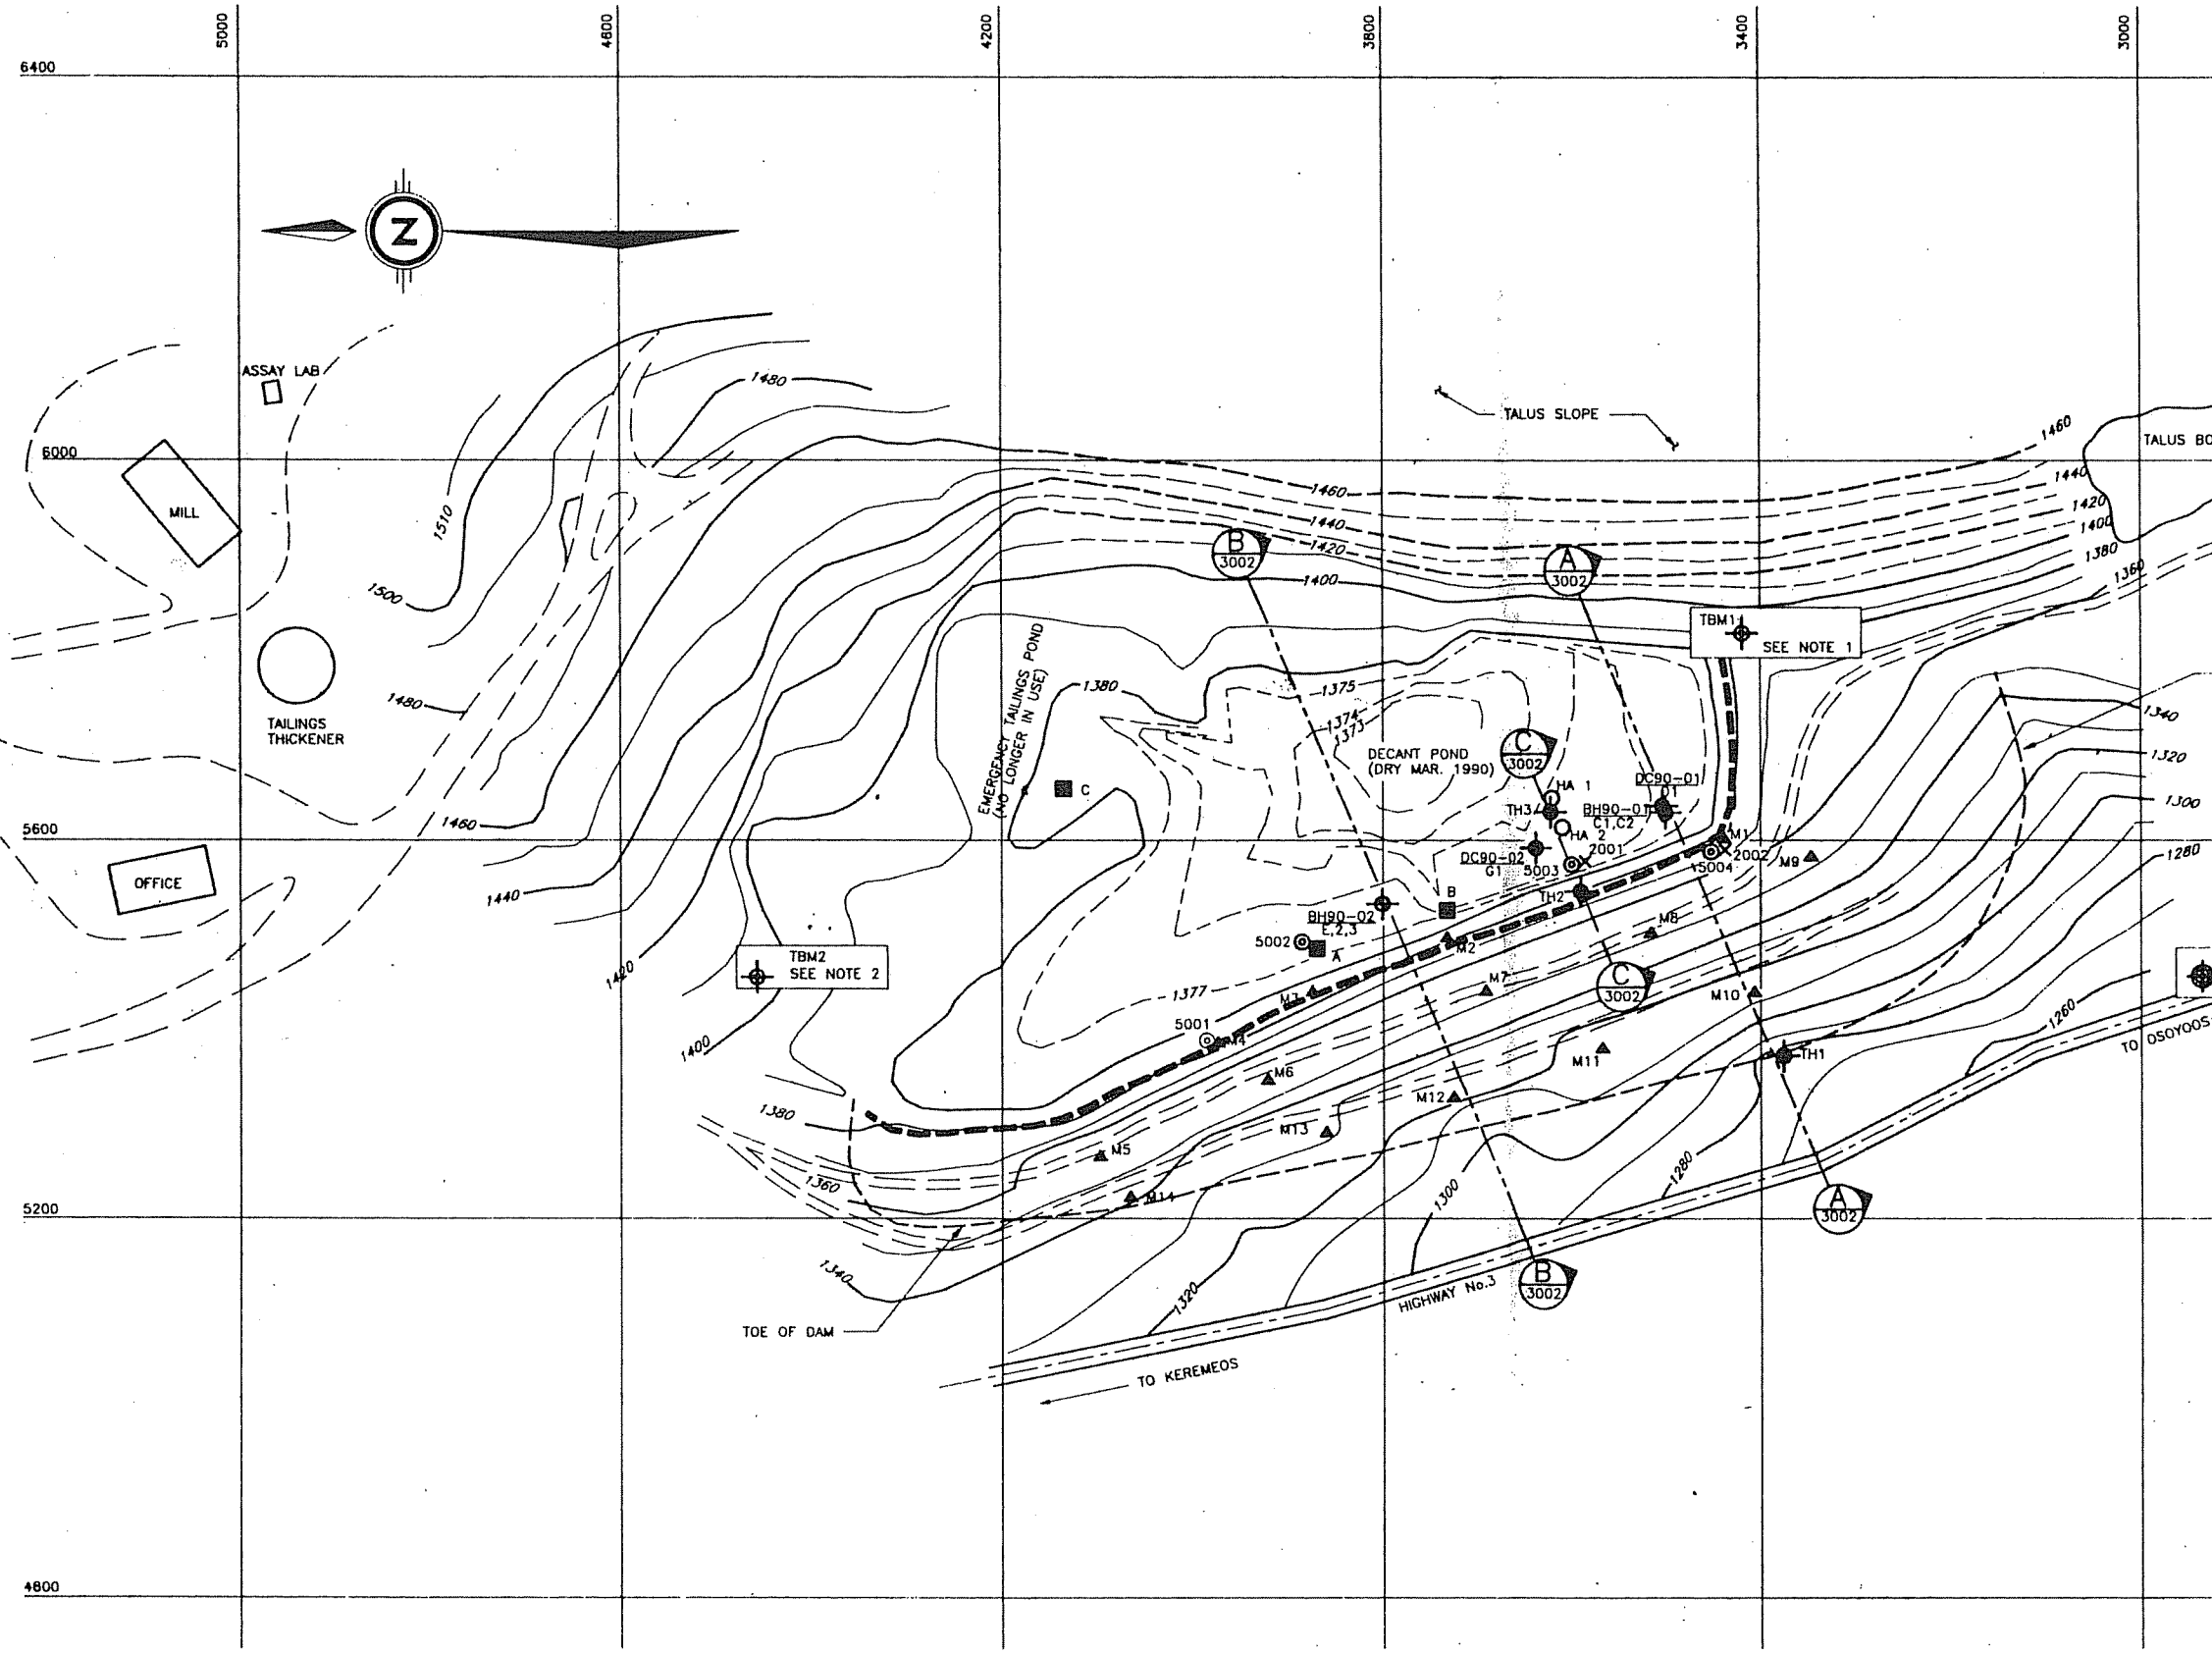
- All standpipe piezometers (total 9) were found to be intact, most with caps in place. All piezometers were found to be dry to their tip elevations.
- Approximately the northerly half of the tailings surface has been covered with gravelly soil as a growth medium and is developing natural vegetation of grasses and sagebrush. Tailings remain exposed on the southern part of the TSF and have sparse growth. There is no evidence of any wind erosion or dusting from the tailings surface.

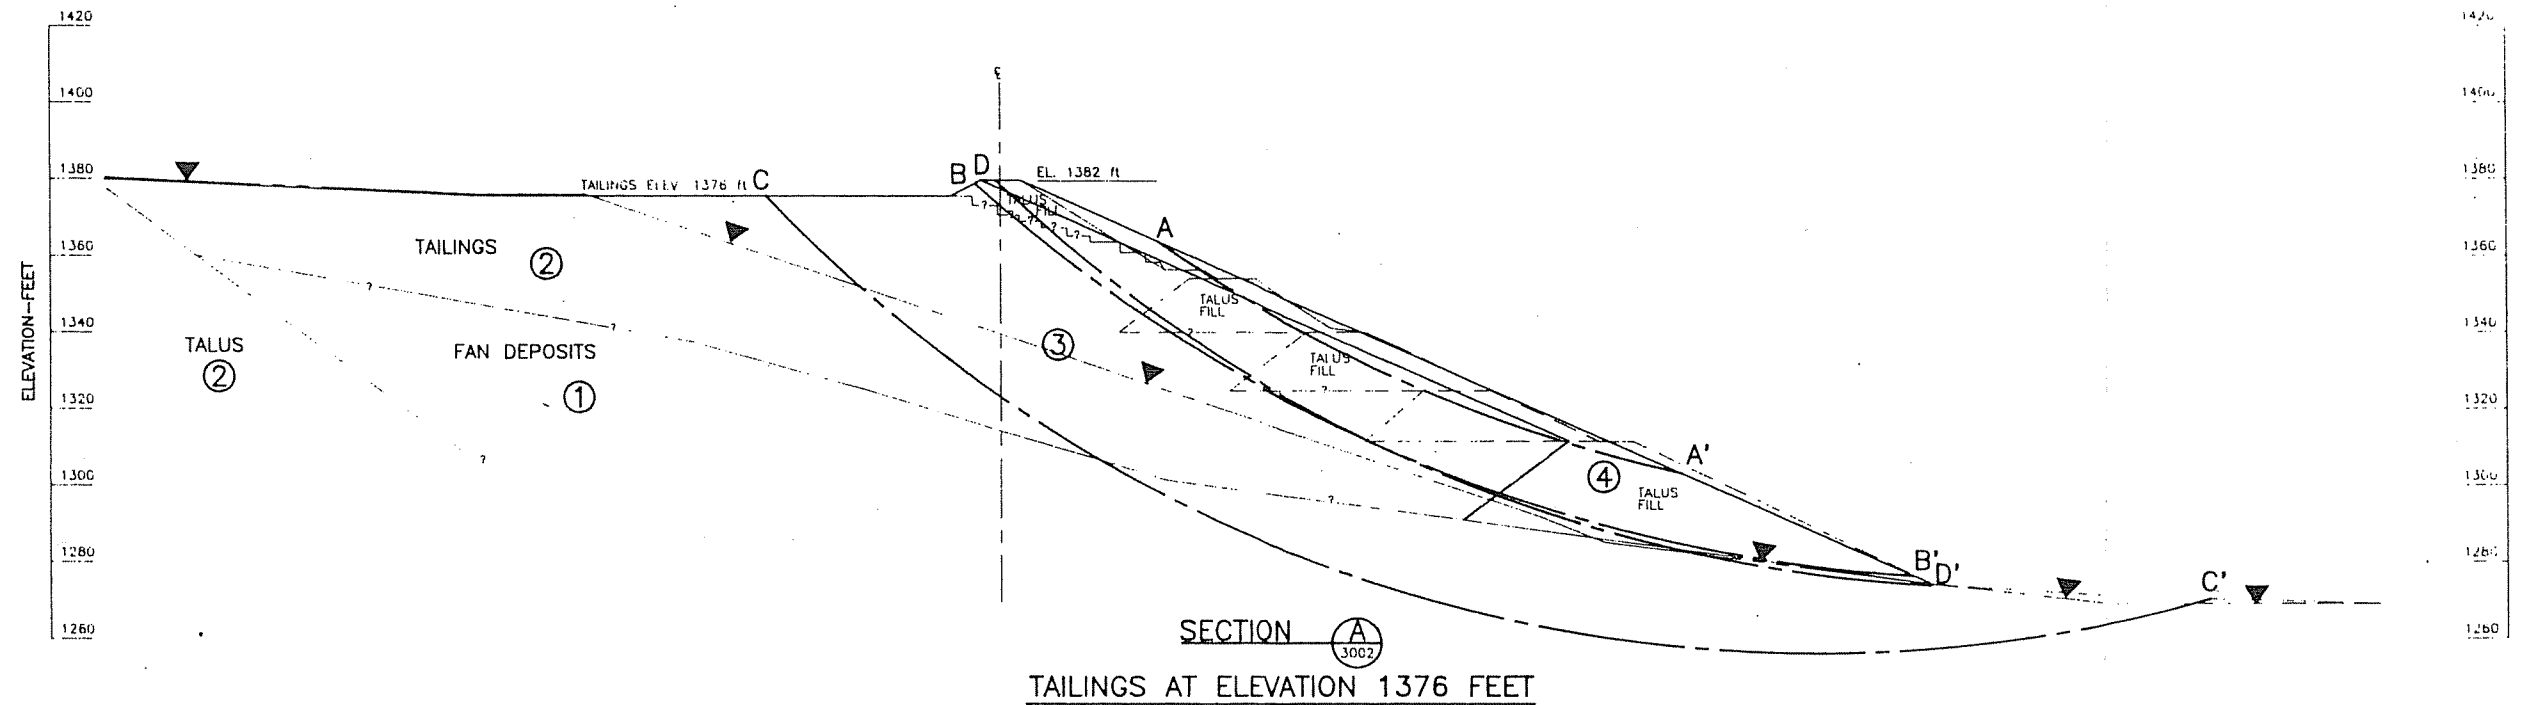
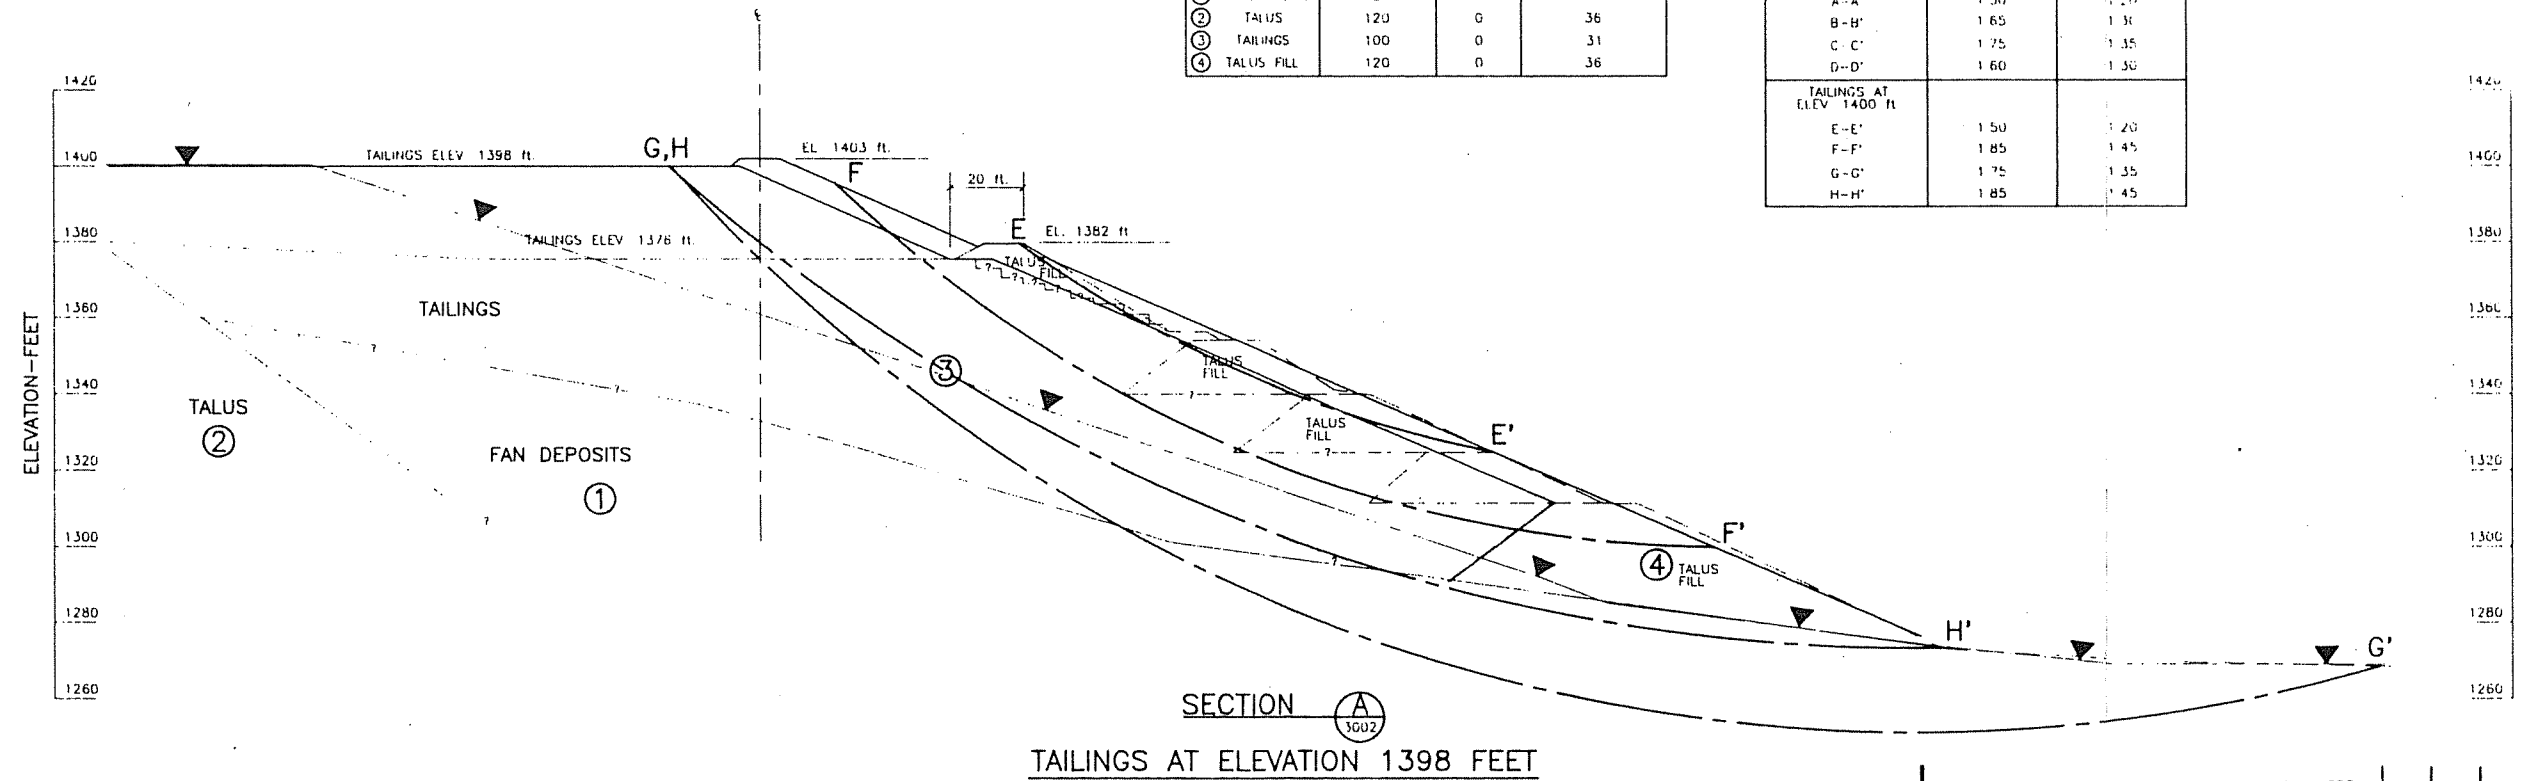
TO BE READ WITH KLOHN LEONOFF REPORT DATED MAY 11, 1990		REV.	DATE	REVISION
SCALE: 20 ft	G		HT	AS SHOWN
		PROJECT: DANKOE MINE TAILINGS		
CLIENT: DANKOE MINES LTD.		TITLE: TAILINGS DAM STABILITY ANALYSIS		
DATE OF ISSUE: MAY 11, 1990	PROJECT NO: PB144303	DWG NO: D-3006	REV.

Klohn Leonoff (1990) carried out stability analyses of the Dankoe tailings dam, both for its then current crest elevation and for a 22 ft. raise. The stability analyses applied conservative piezometric water elevations, based on operating conditions. The analyses determined that the dams had adequate factors of safety, under both static and earthquake conditions. The analysis is shown on their Drawing D-3006 in Appendix II.

The present crest elevation and dam geometry are unchanged from that analyzed by Klohn Leonoff, and piezometric elevations are lower, as evidenced by all piezometers being dry. Hence, it can be concluded that the dam remains stable.

DESCRIPTION	FACTOR OF SAFETY	
	STATIC	DYNAMIC $\alpha=0.09g$
TAILINGS AT ELEV 1376 ft		
A-A'	1.50	1.20
B-B'	1.65	1.35
C-C'	1.75	1.35
D-D'	1.60	1.30
TAILINGS AT ELEV 1400 ft		
E-E'	1.50	1.20
F-F'	1.85	1.45
G-G'	1.75	1.35
H-H'	1.85	1.45

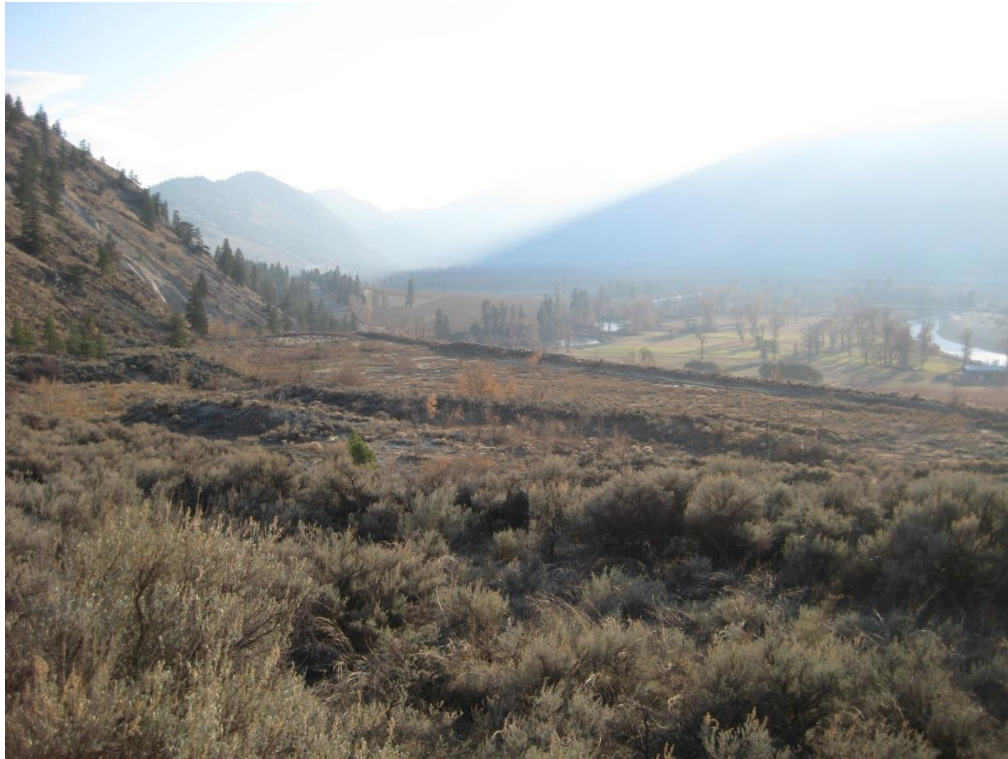
Photo 1. View of TMF looking south. Similkameen River at top right

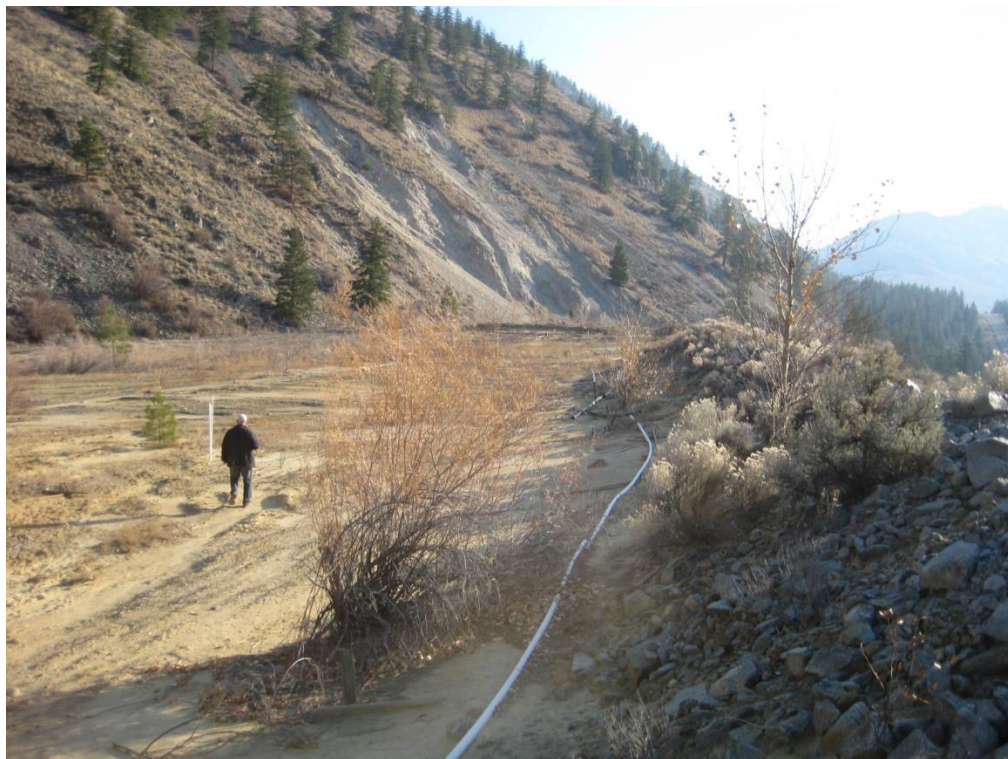
- The rockfill berm forming the dam crest remains intact. The freeboard between the tailings surface and the top of the berm was estimated at 4 to 5 ft. At the south portion of the embankment, the berm is lower, with about 3 ft. of freeboard.

Photo 2. Crest of dam looking toward south abutment. Note standpipe piezometer on left

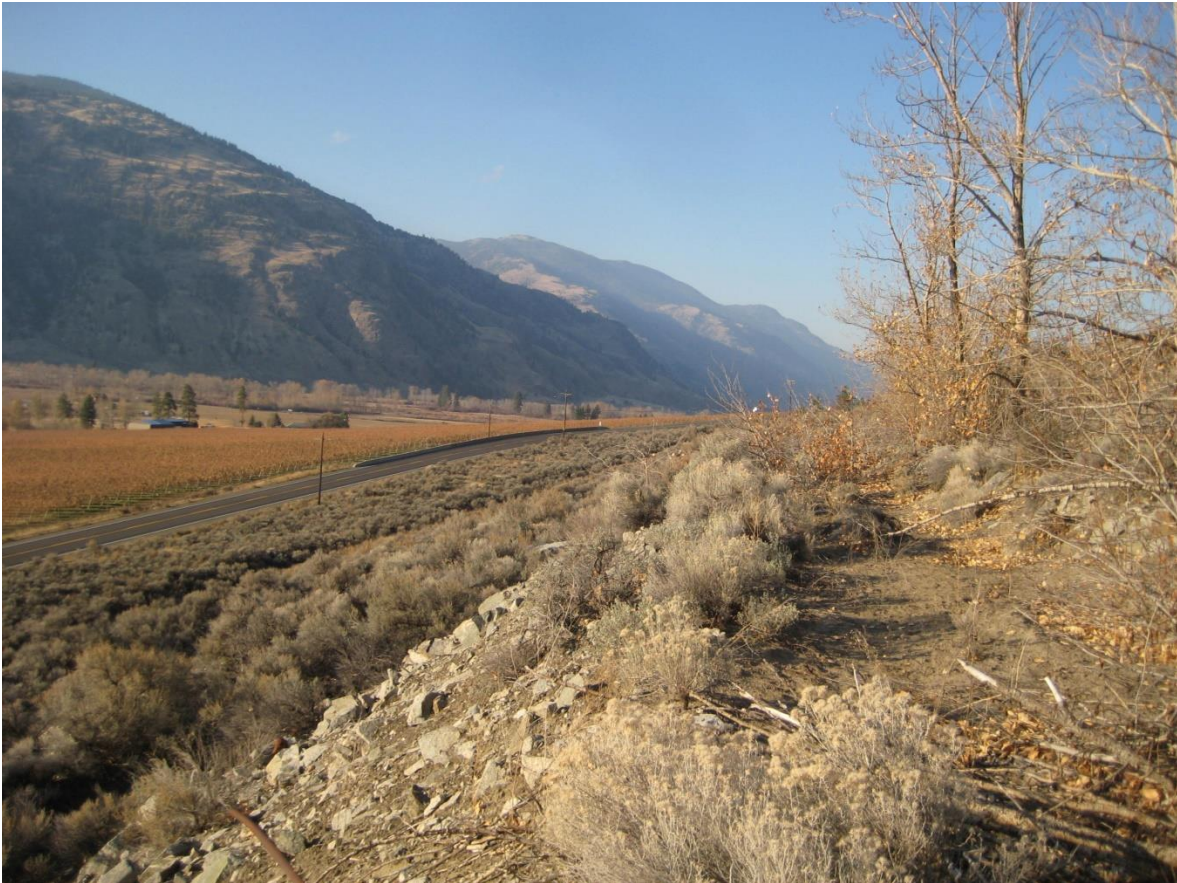
- The tailings surface was completely dry, and there was no indication that there has been any ponded water in recent years.
- The downstream slope, comprised of coarse talus material, appears stable with no signs of any deformation. There is considerable growth of sagebrush, grasses and some trees on the slope.

Photo 3. Downstream slope looking north. Highway 3 on left

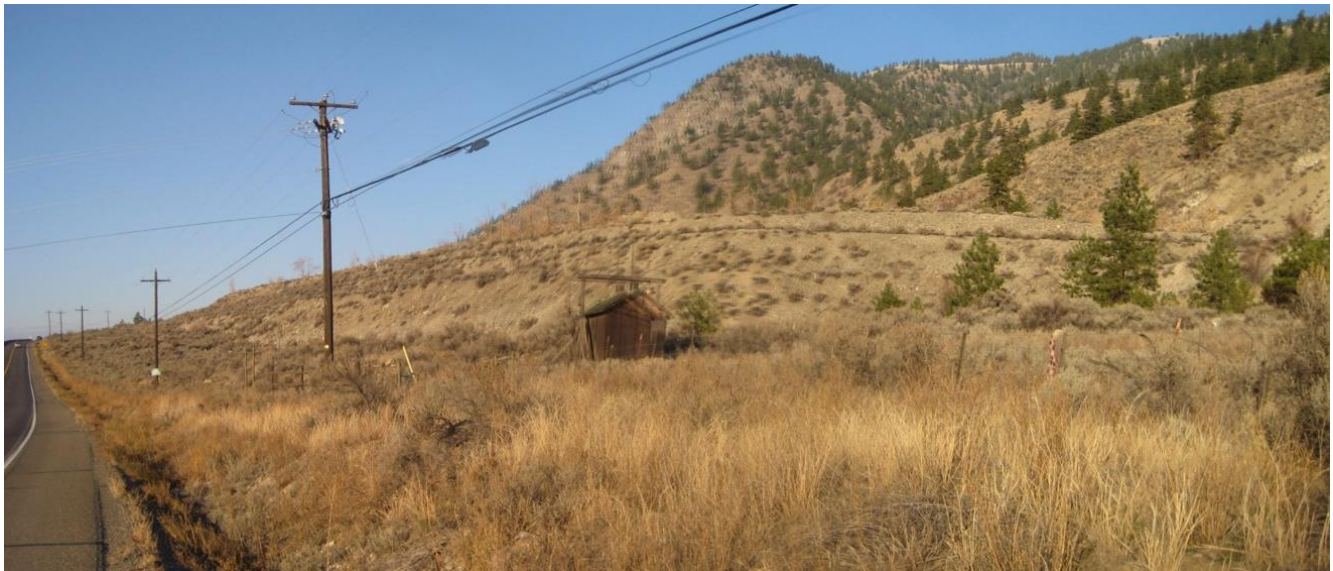
Photo 4. View toward downstream slope, taken from the shoulder of Highway 3

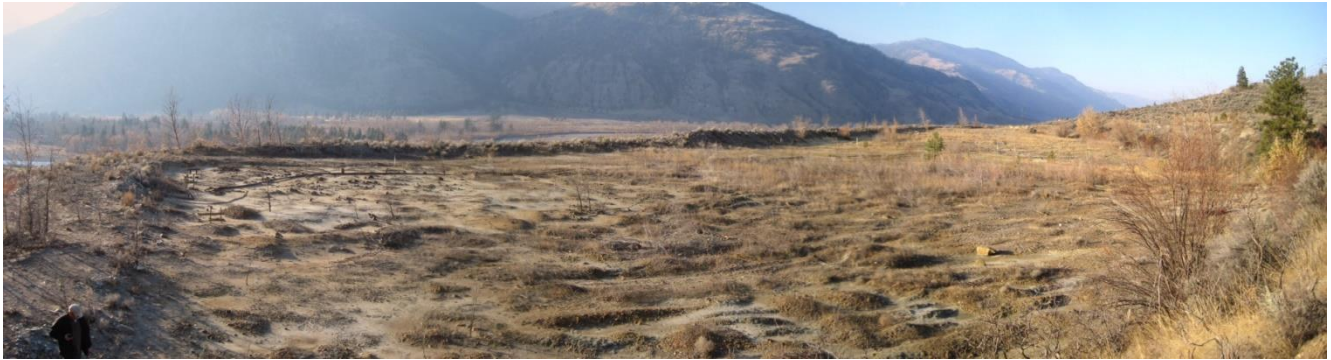
Photo 5 Panorama of tailings surface, taken from southeast abutment

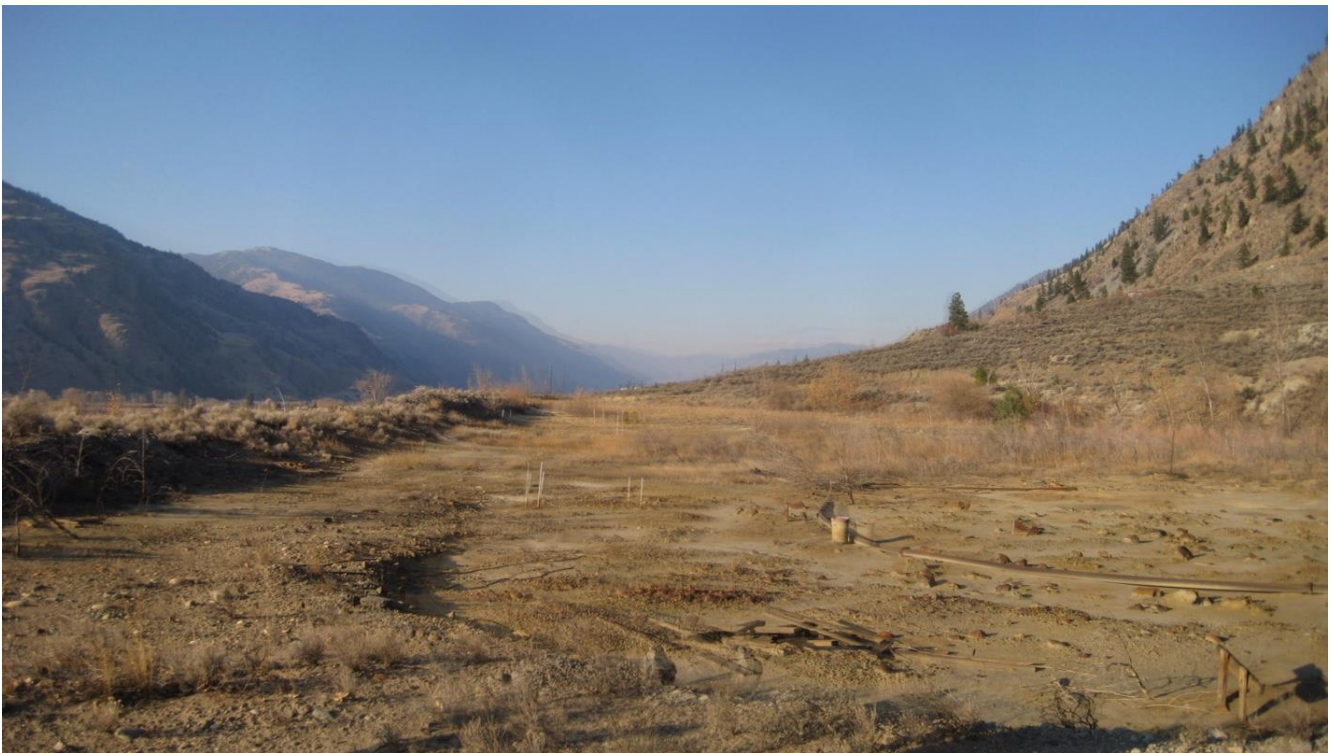
Photo 6. Tailings surface, taken from south dam crest looking north. Note standpipe piezometers.
