30 June 2015

TE153004

**Re: Teck Coal Elkview Operations Mine Tailings Lagoons  
Response to February 3, 2015 Memorandum from MEM**

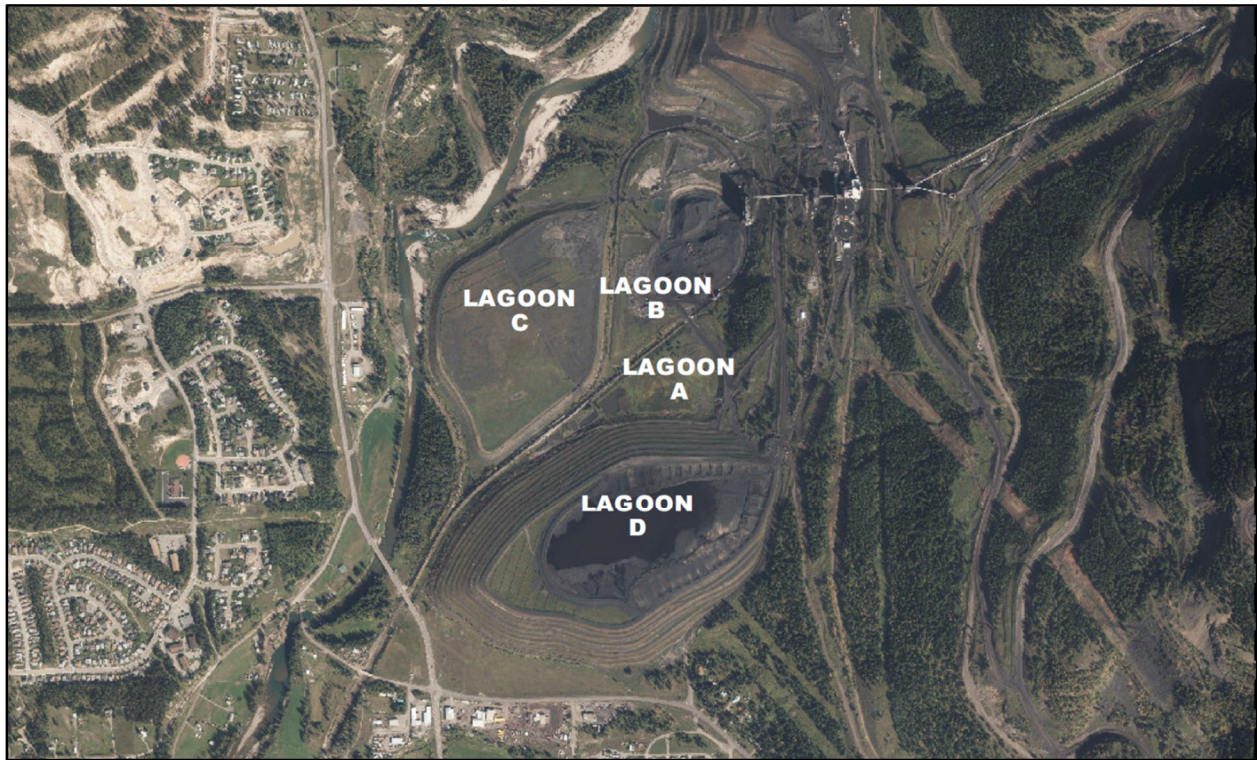
**Figure 2      Site plan of Lagoons A, B, C and D**

There are two “ring dyke” tailings dams of significance: Lagoons C and Lagoon D. Lagoon C has been inactive since 1987 and has been used as an emergency water decant facility for Lagoon D as well as periodic pond sediment storage. Lagoon D has been used since the early 1970’s, however with the commissioning of the WFTF for storage of fine refuse materials in 2006, Lagoon D has now become an operating backup storage option for when tailings cannot be sent to the WFTF. There is roughly 500,000 tonnes of tailings storage remaining in Lagoon D under current operating conditions (AMEC, 2014). The largest of the lagoons, Lagoon D, is approximately 57 m in height (crest elevation of 1166 m) while Lagoon C is approximately 21 m in height (crest elevation of 1128 m).

The Elkview Lagoons tailings storage area is located near the confluence of the Elk River and Michel Creek on a terrace at the base of the Harmer Ridge (Figure 2). Before the lagoons were built, the elevation of the original ground in the area varied from 1109 to 1113 m at Lagoon C (Golder, 1996a) and 1111 m to 1128 m at Lagoon D (Golder 1996b), which was partially constructed on a higher alluvial terrace. The Elk River near the lagoons is at approximately elevation 1110 m.

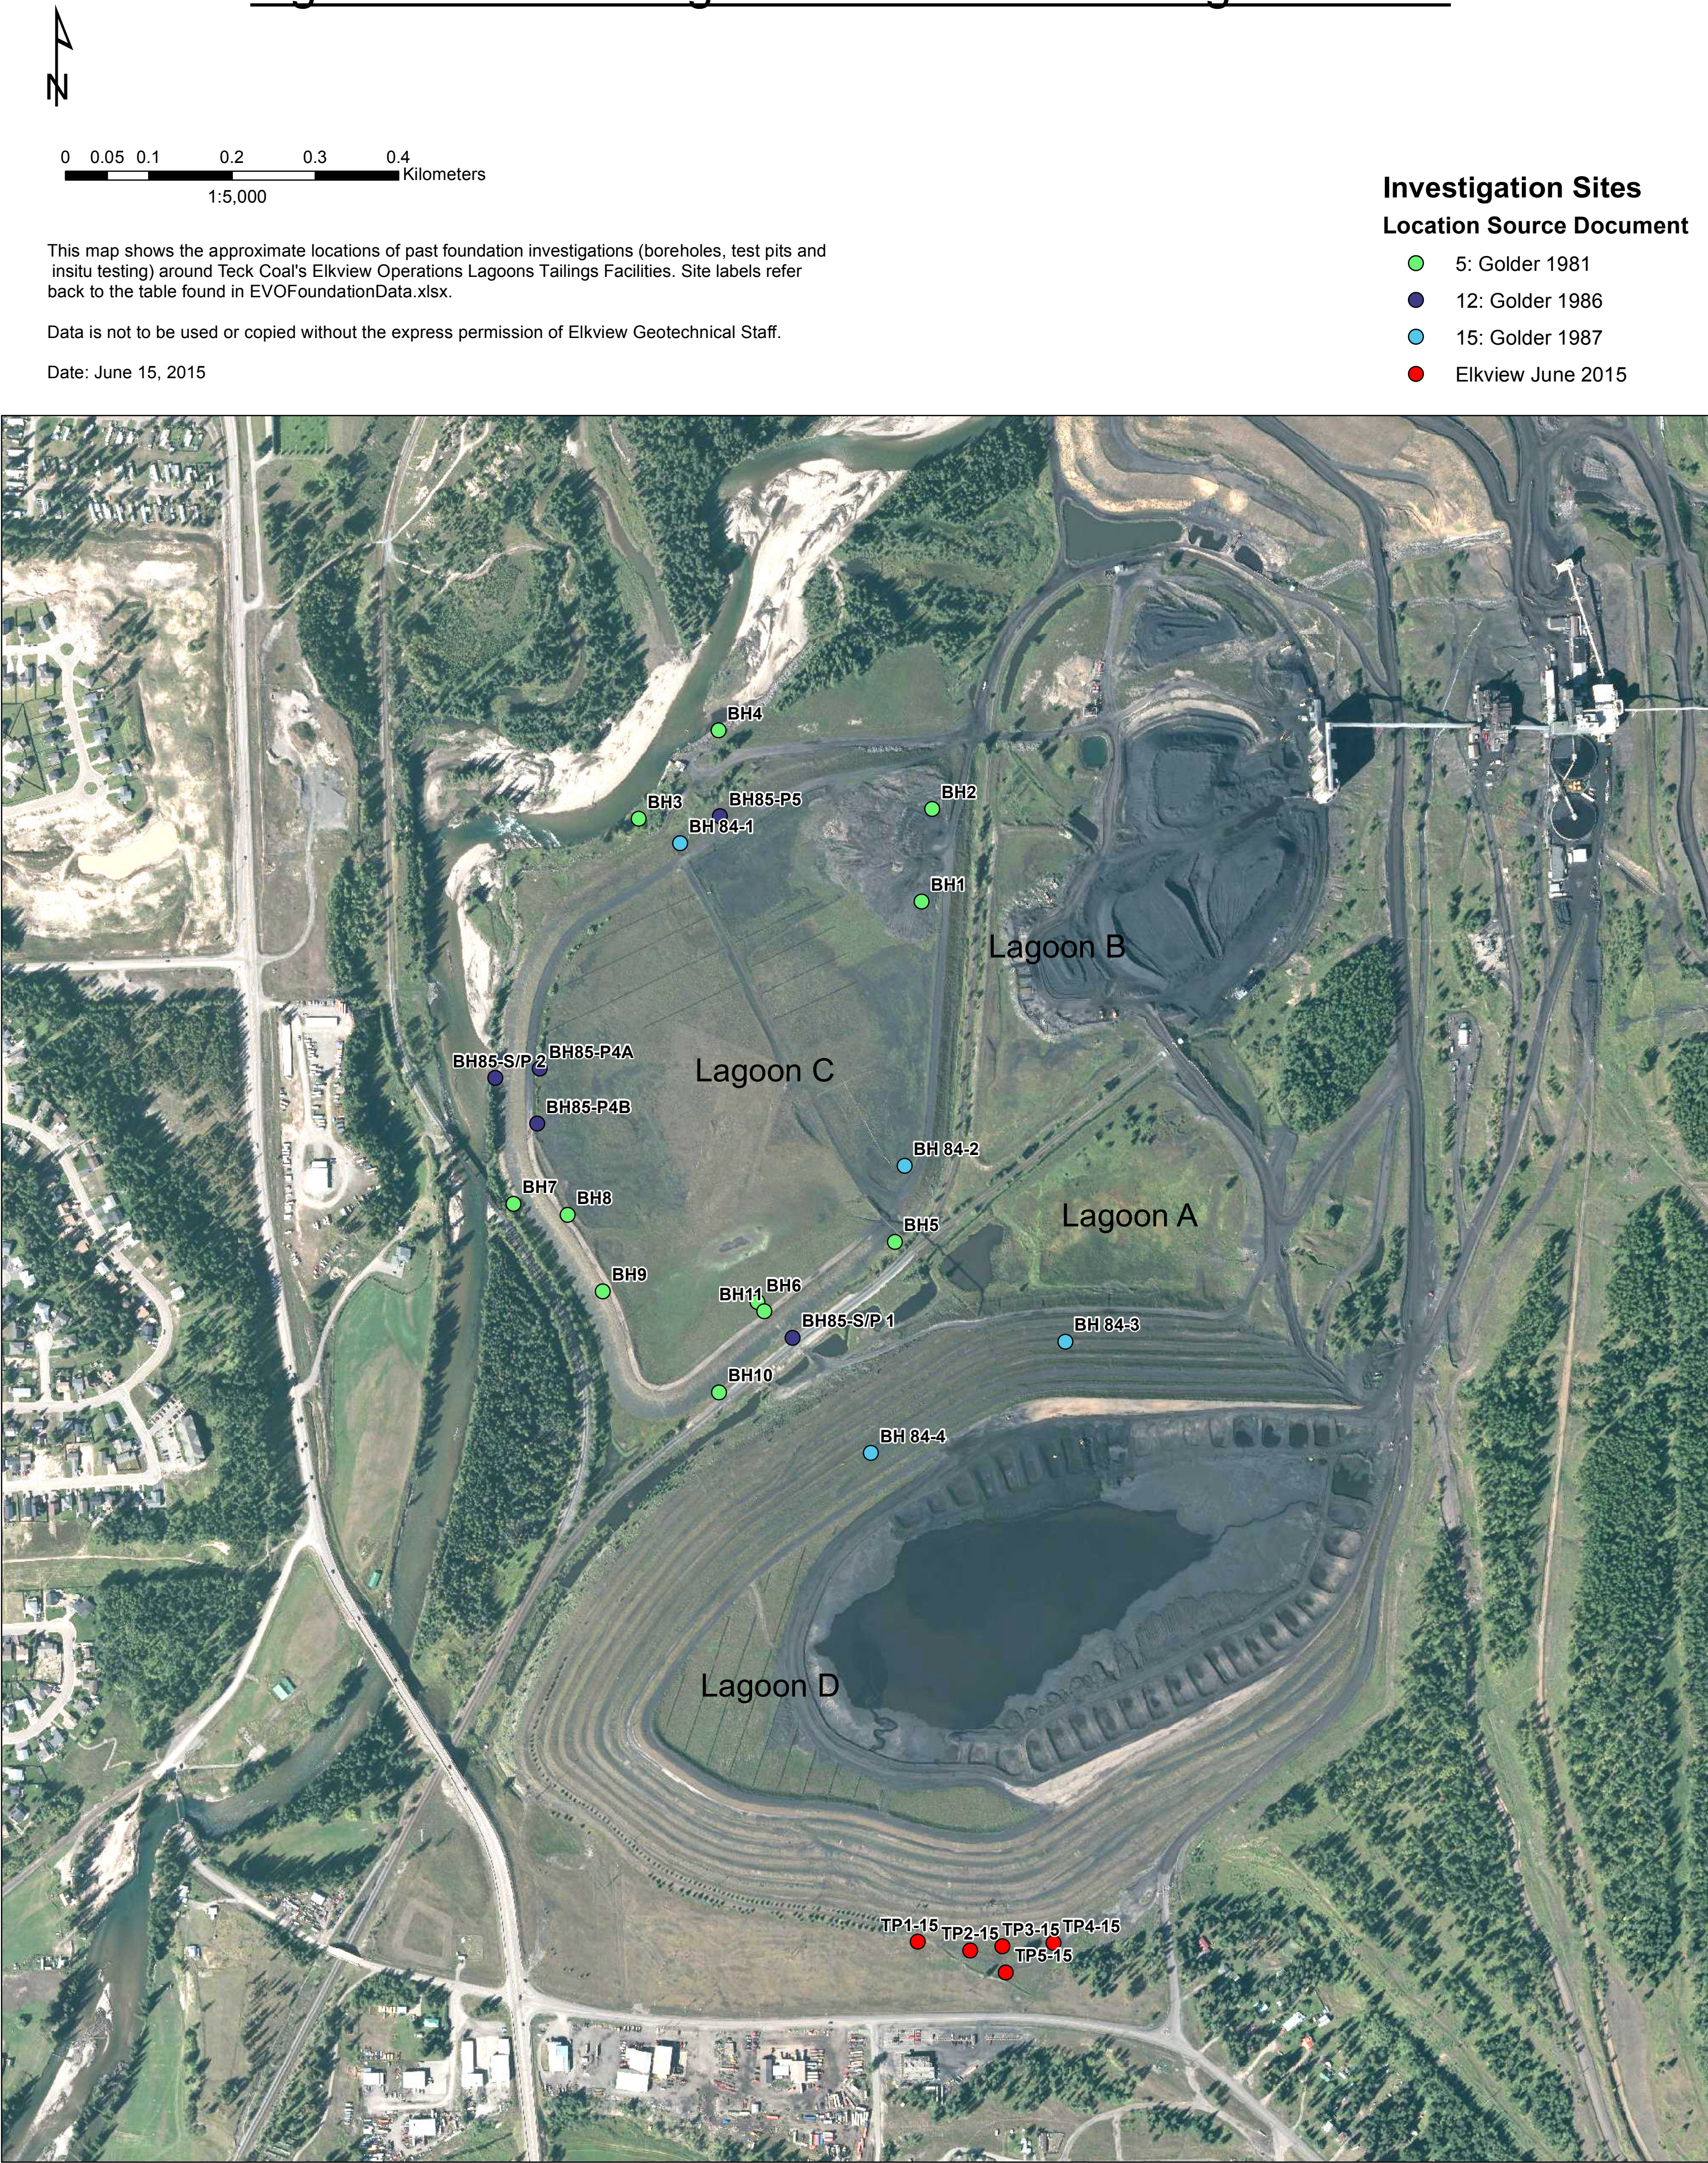
Figure 3: Elkview Lagoon Foundation Investigation Sites

Figure 3 shows the location of boreholes and test pits that have been advanced into the foundations of the Lagoons.

Based on the boreholes and test pits, the lagoons are underlain by approximately 3 to 6 m of sand and gravel, followed by a highly variable thickness (15 m to 80 m) of clayey silt to sandy silt, interpreted to be floodplain deposits. Below the silts is another layer of sand and gravel underlain by bedrock (Golder 1996a). The clayey to sandy silt (floodplain deposits) did not exhibit the laminated texture typically found in the glaciolacustrine deposits located on the north side of the Elk River.

The clayey silt was consistently reported as stiff to very stiff and test results confirm that the foundation soils were slightly over-consolidated prior to the construction of the lagoons. The over-consolidation of the soils has reduced to some degree with the added overburden of the lagoons and it is possible the soils may behave with some contractancy during shear, but the additional loading since the site investigations completed in the 1980's is expected to result in greater undrained shear strength than the values used in stability analyses to-date.
