19 June 2015

**Goldcorp Canada Ltd.**

**Re: Equity Silver Mine Tailings Facility  
Response to February 3, 2015 Ministerial Orders**

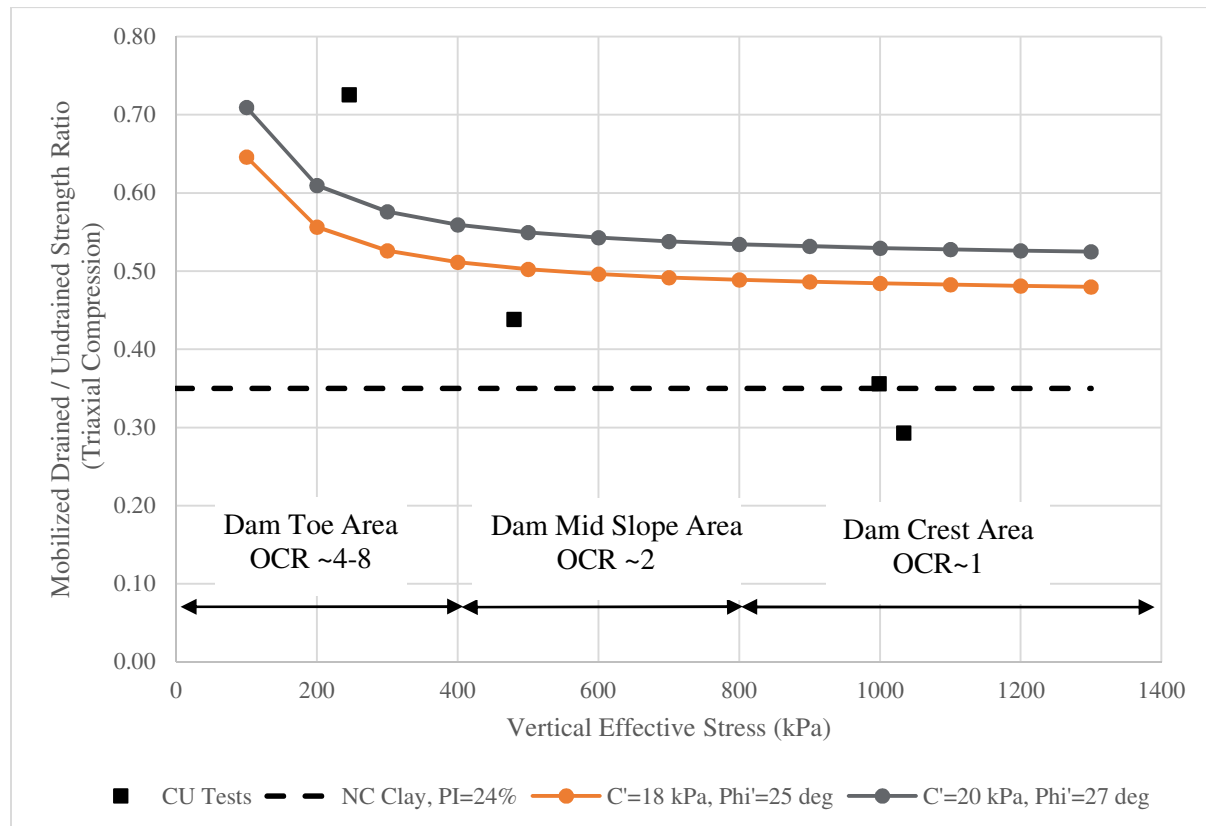
**Figure 1.2: Equity Silver CU Triaxial Test Data**

Figure 1.2 presents a summary of the undrained strength ratios (undrained shear stress / initial vertical effective stress) based on the CU TC data discussed above. For comparison, a line denoting the typical triaxial strength of NC clay with  $PI=24\%$  (Ladd 1991) is also plotted on Figure 1.2 which validates the NC test behavior of the clay till around 1000 kPa. Rough effective stress ranges are also indicated for areas of Dam No.1 which suggests that the upper portion of the dam foundation may in fact now be normally consolidated.

As shown on Figure 1.2 the use of an effective friction angle and cohesion based on the CU triaxial testing is expressed as the mobilized drained strength divided by the effective stress to permit a direct comparison with the undrained strength ratios interpreted from the triaxial test data. A comparison of these ratios suggests that using effective stress parameters would be appropriate up to about 500 kPa but then tends to over predict the strength behavior of the till as compared to the CU testing. Thus above about 500 kPa it is more appropriate to consider an undrained strength ratio decreasing to the NC Clay line when performing stability analyses.

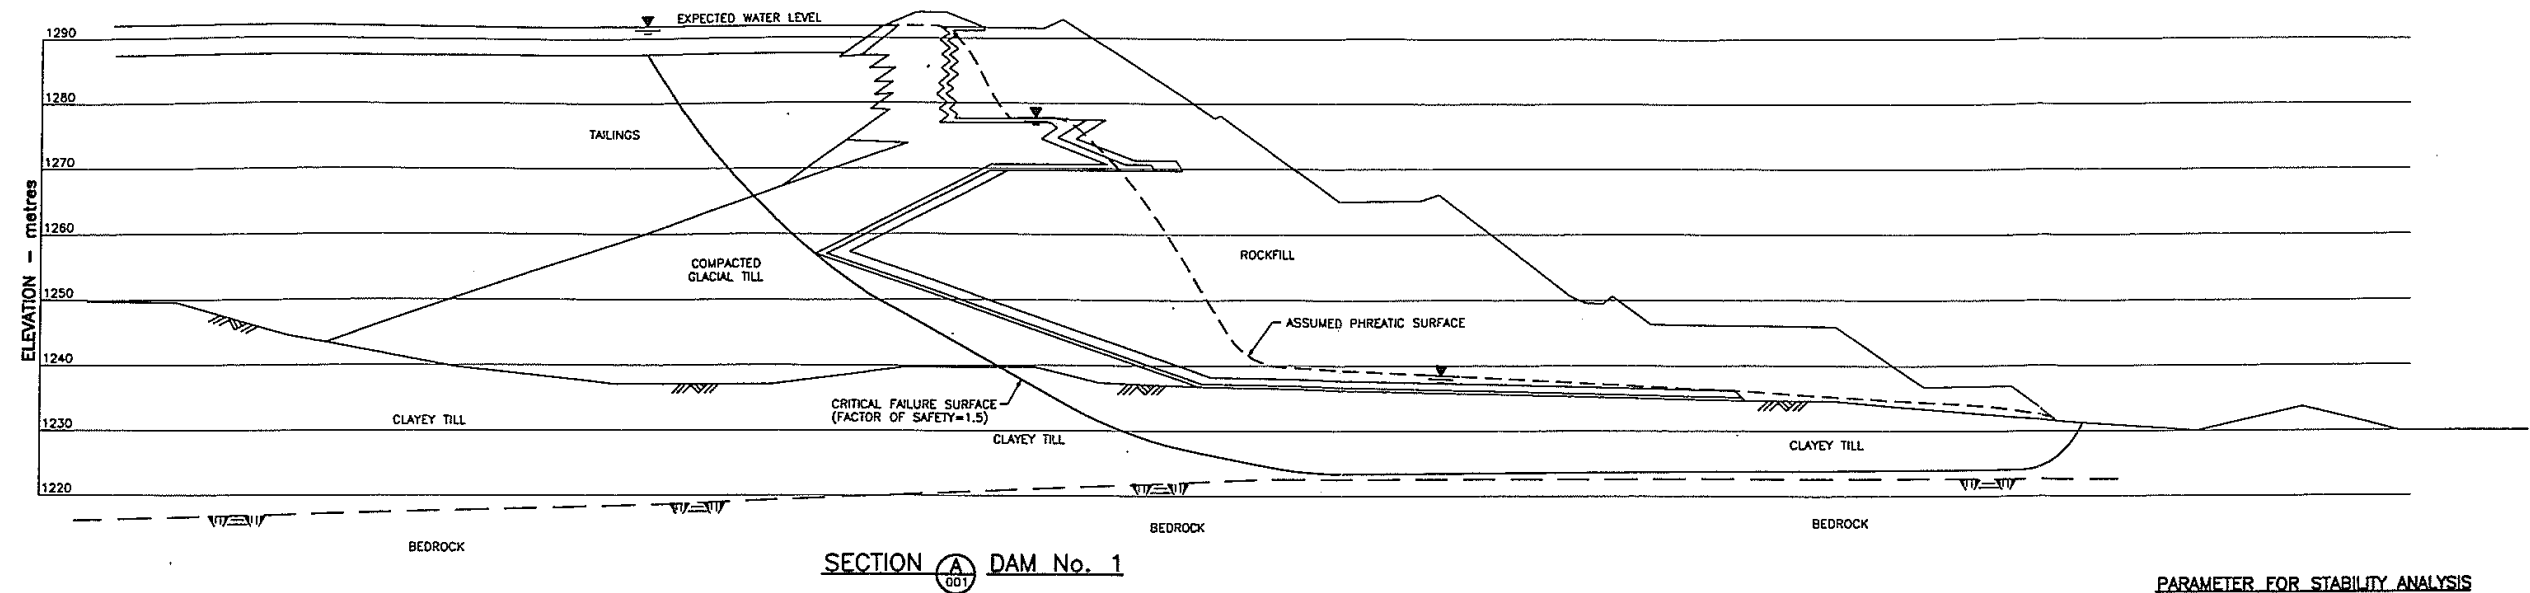
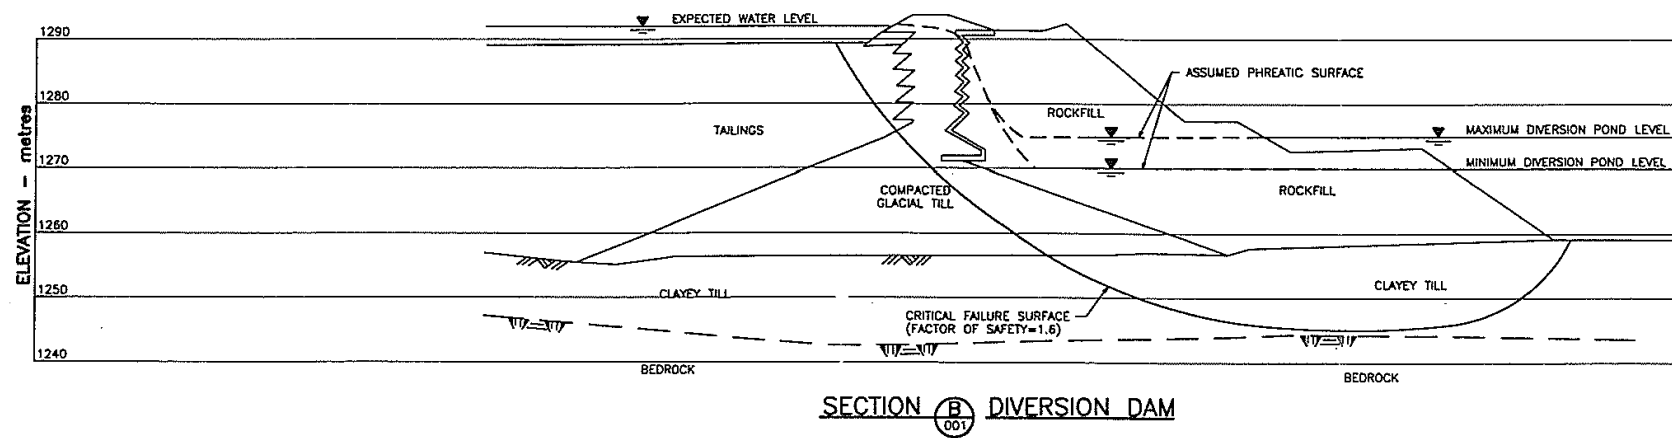
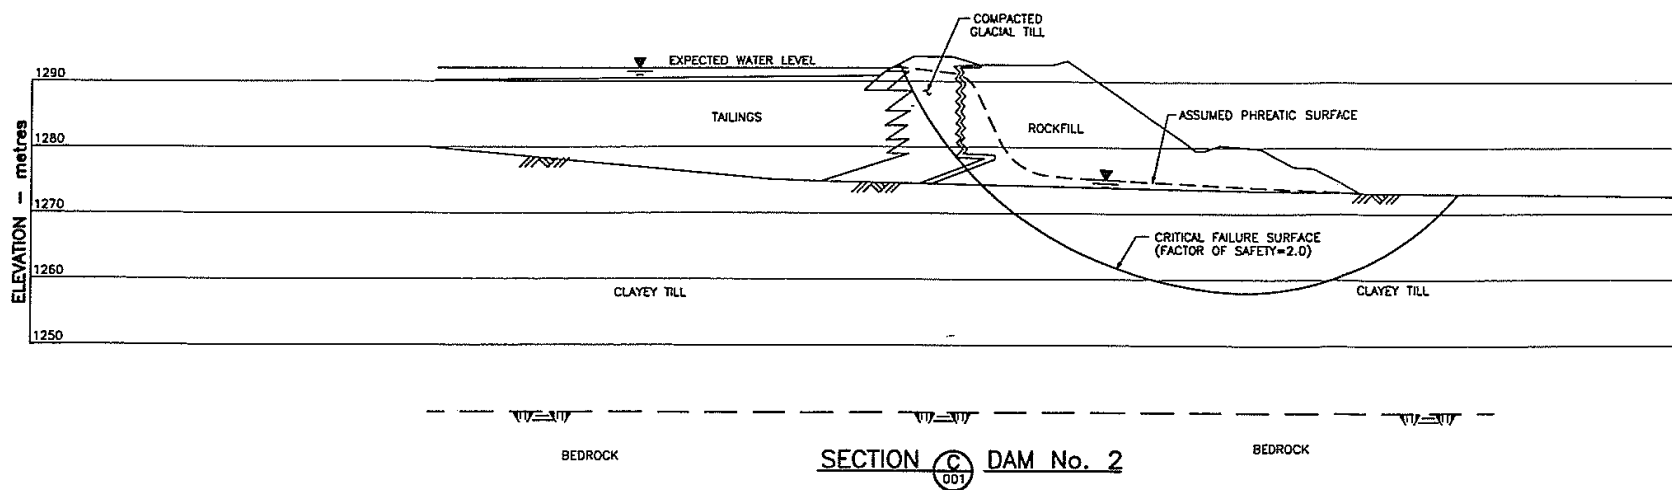
In 1990, a stability assessment update was performed (Klohn Leonoff 1990) in which the previous laboratory testing data from 1981 was reassessed and the strength parameters revised to an effective friction angle of  $27^\circ$  and an effective cohesion of 20 kPa. The rationale for this strength increase is not clear (no data or detailed discussion found within the available historical documents). The then as-built configuration of the dams was again reviewed as part of the 1993 annual review (Klohn 1994) using the 1990 revised strength parameters, which indicated acceptable levels of safety for the final dam configurations (Figure 3).

(Figure 3) was reproduced using Slope/W (Version 2012). The foundation clay till was zoned based on effective stress level to allow for application of consolidation level dependant shear strength ratios. As shown on Figure 3 the shape of the critical slip surface is forced to be nearly horizontal through the clay till by the shallow bedrock which is more characteristic of DSS than TC. Thus the TC CU strength ratios were multiplied by a linear scaling factor of 0.71 (DSS strength ratio of 0.25 for normally consolidated clay with PI=24%, Ladd 1991) to account for the more dominant DSS behaviour in the dam foundation.

The resulting stability model suggests that the static FoS for Dam No. 1 could be lower than 1.5 depending on the level of overconsolidation remaining in the foundation till and the pore pressure regime within the embankment, both of which are currently uncertain. This would also have a corresponding effect on the seismic stability of the dams.

It is important to note that the maximum Dam No. 1 section shown on Figure 3 is applicable to roughly a 150 m wide area in the middle of the dam such that three dimensional effects may not be overly significant. Similar behaviour could be occurring at the other two dams but likely to a lesser extent as Dam No. 2 and the Diversion Dam are roughly half the height of Dam No. 1. The previous stability analyses results for these dams are likely valid although there is not enough information on the foundation conditions for those dams to be conclusive.

Equity has already planned to perform an instrumentation installation campaign for the dams in 2016 to supplement their existing dam safety surveillance program with piezometers and inclinometers in Dam No. 1. This would be a good opportunity to gain additional information on the foundation conditions of all three dams to close the knowledge gaps identified herein. It is recommended that such drilling into the foundation be used to validate the previous geological models and a revised stability assessment be performed for all three dams.
