01 December 2014  
Final Report

Eskay Creek Gold Mine Site (Closed)  
Albino Lake Waste Rock Storage Facility  
Dam Safety Inspection Report

## 2010 ALBINO LAKE DAM INSPECTION

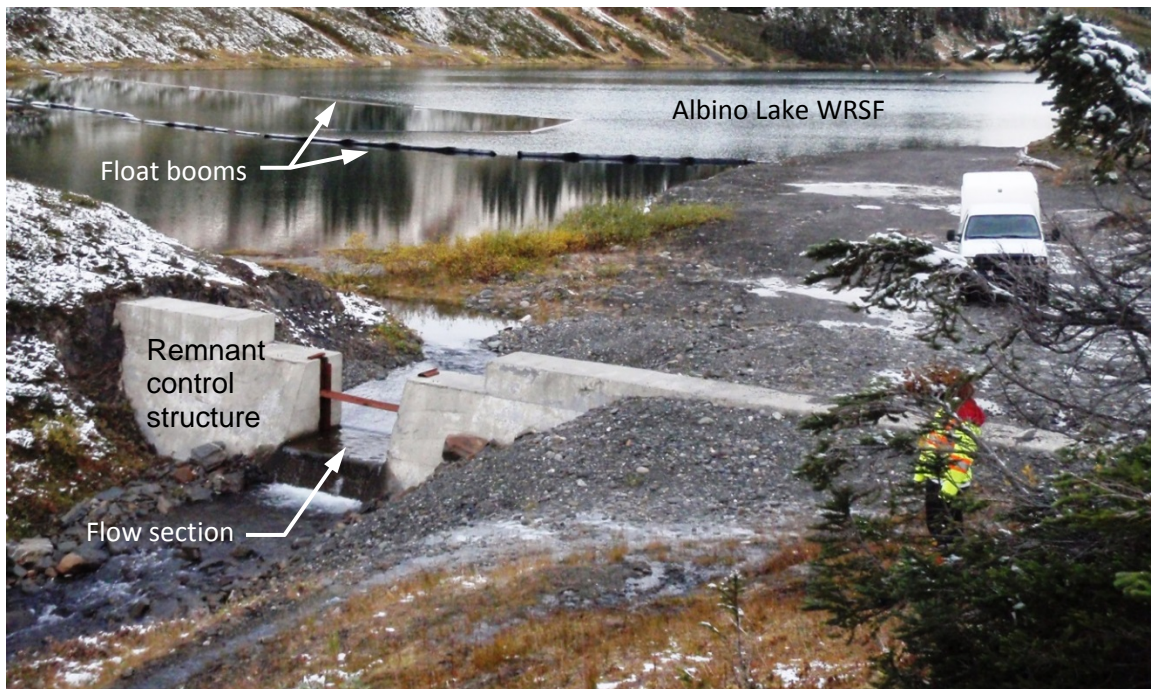
There were no changes to the stability of the concrete wall and wooden-log control structure during its brief service life, and the remnant concrete walls of the now-decommissioned structure appear to be in sound condition. Since decommissioning of the control structure in 2010, there have been no changes to surface water control in the Albino Lake WRSF.

Figure 2. Remnant control structure at the south end of the Albino Lake WRSF.

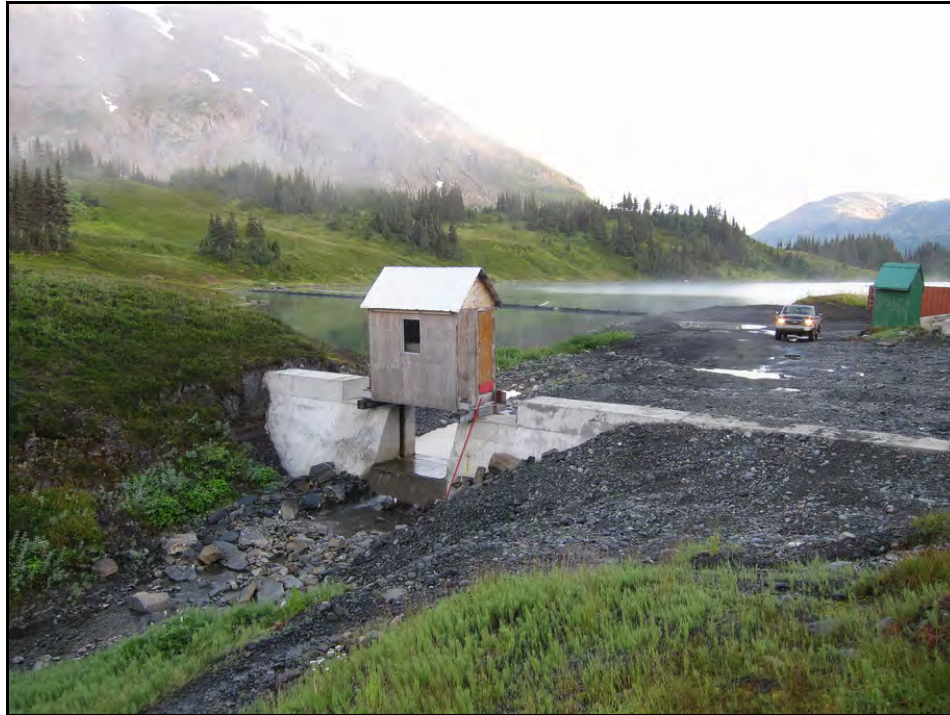
The condition of the dam appears to be as noted in the previous inspection reports. The concrete is in good condition with no apparent sign of seepage through the dam body below the lake level. The water level at the time of inspection was 0.02 m above the bottom of the stop-log slot.

**PHOTO 1** – Downstream face of Albino Lake Dam.

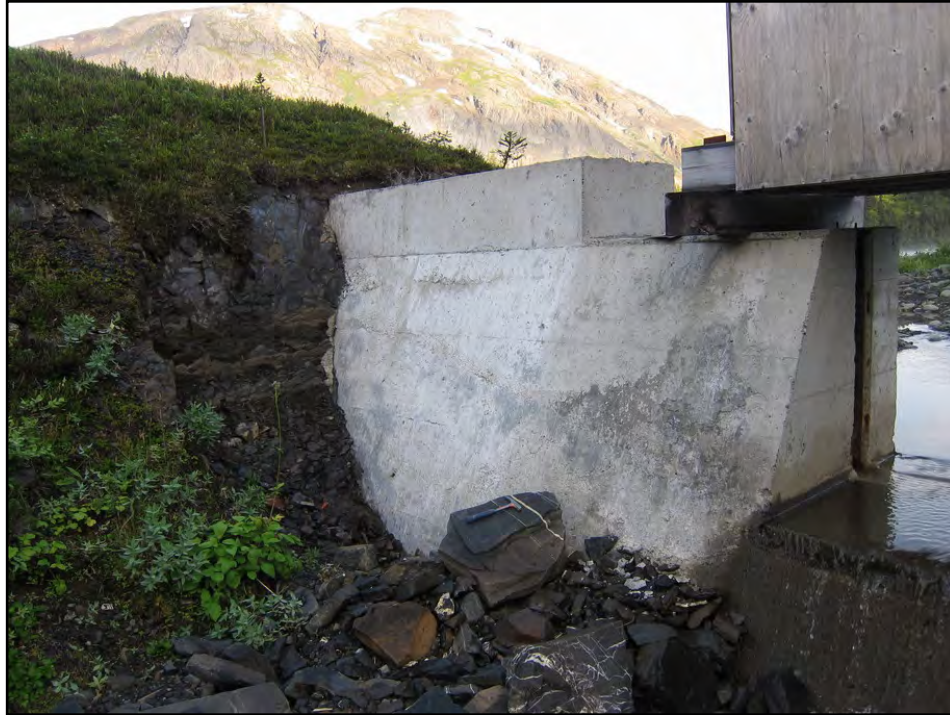
The right abutment was found to be in satisfactory condition with a good contact between the concrete and bedrock (Photos 3 and 4). No seepage was observed, which may be attributed to the relatively low lake level. An inspection at higher lake levels, i.e. during times of impounding, would provide a more meaningful characterization of the concrete/bedrock contact.

**PHOTO 3** – Downstream right abutment.

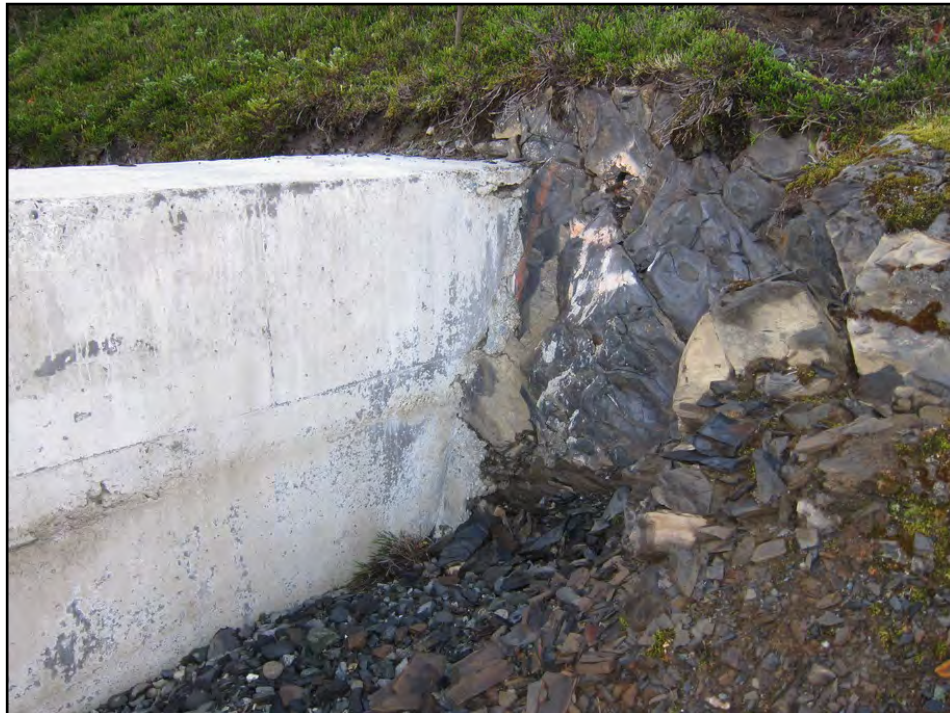
**PHOTO 4** – Upstream right abutment.

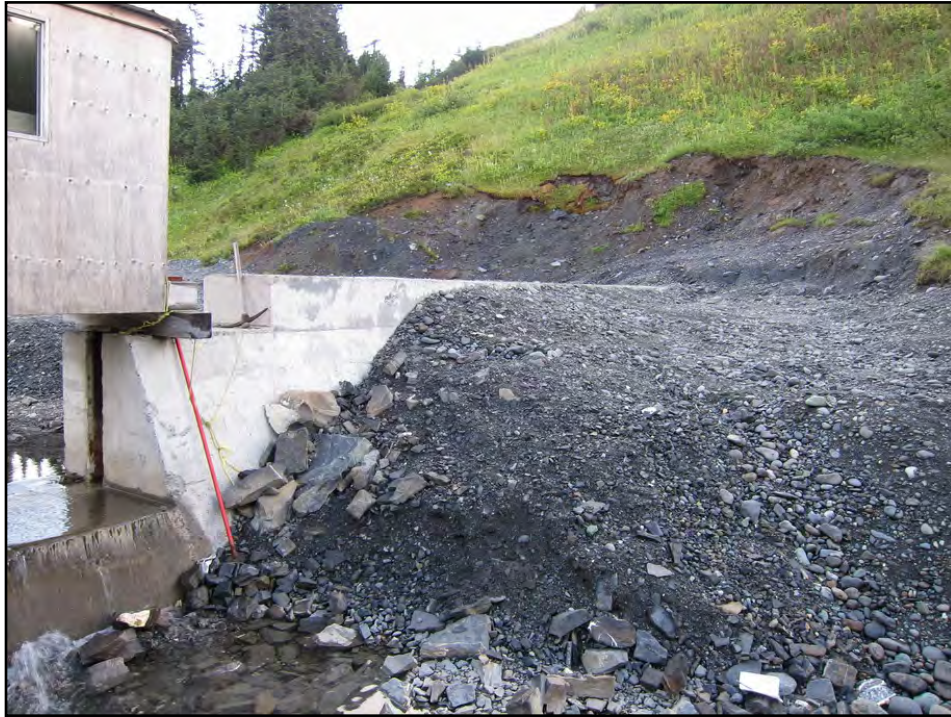
**PHOTO 5** – Downstream left abutment (buried).

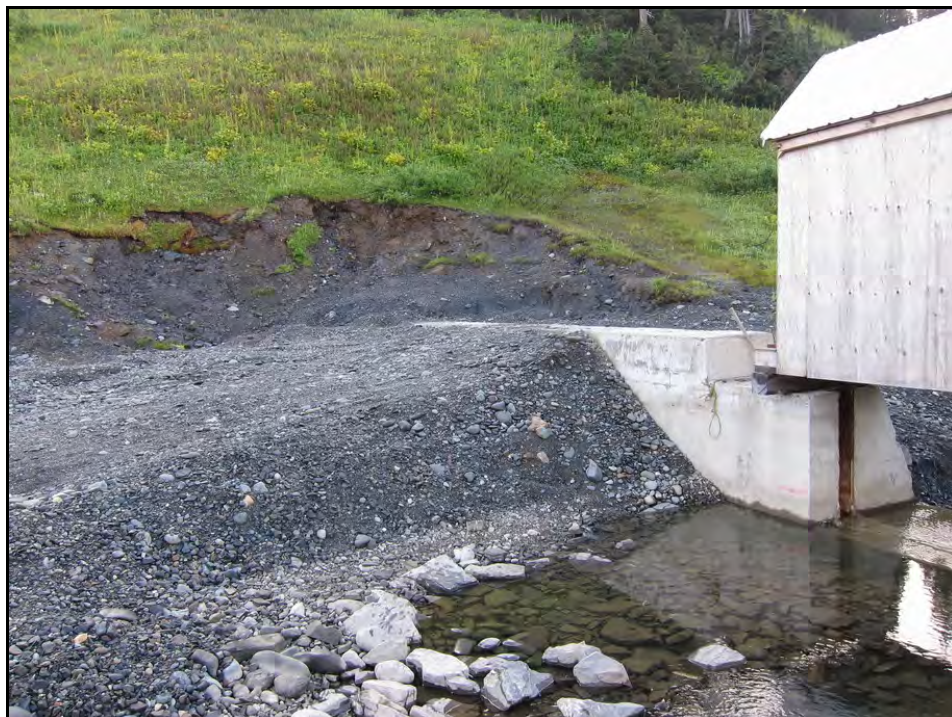
**PHOTO 6** – Upstream left abutment (buried).

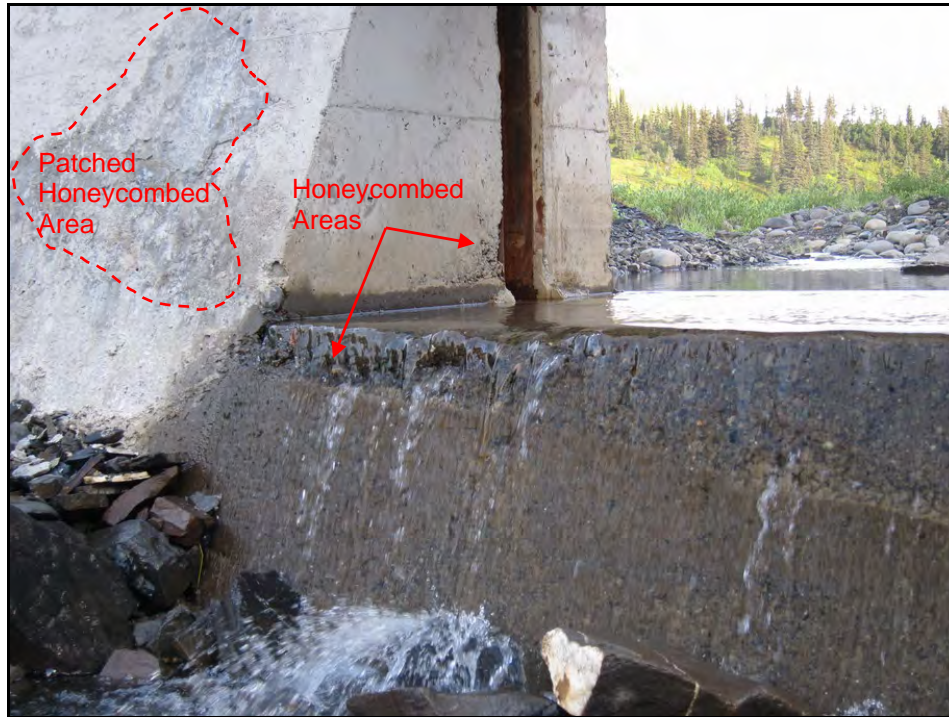
The concrete was in good condition and no signs of apparent leakage were noted. Some surface patching of previously noted honeycombed areas was observed on the downstream face and is performing satisfactorily (Photo 7). Some honeycombed areas were noted below the brink of the stop-log slot and also adjacent to the steel channel for the stoplogs. The concrete is sound and satisfactory for the intended purpose.

**PHOTO 7** – Honeycombed areas below stop-log slot and next to steel stop-log guide.

1. The surface drains on the left abutment hill slope should be re-established and maintained to divert runoff from the hill away from the dam.
2. The honeycombed areas below the brink of the stop-log slot and next to the stop-log guide do not require maintenance at this time. These areas have been noted for re-evaluation at the future inspections.

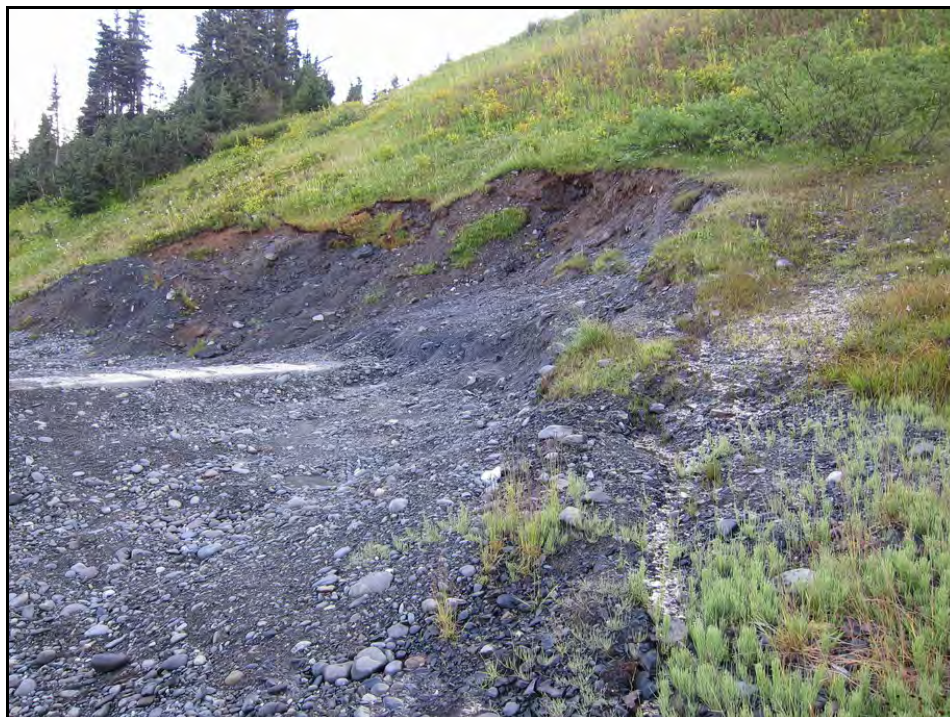
Surface drains on the left abutment hill slope were noted features in the previous inspection report; however, there was no distinct channels observed during this inspection.

**PHOTO 8** – Excavation on left abutment hill slope.

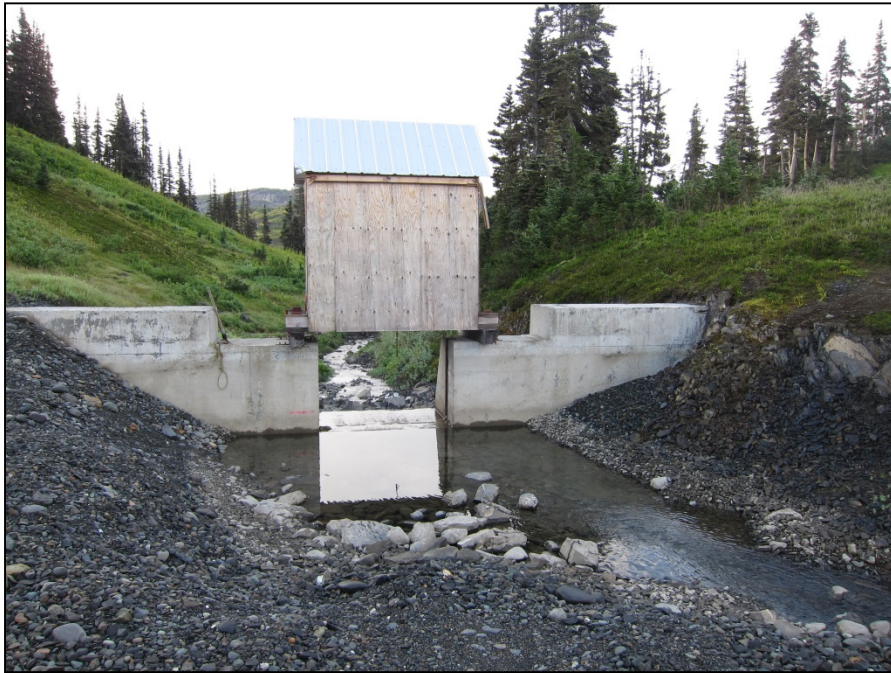
**PHOTO 1** – Albino Lake Structure with Stop-Log Hoist Structure (2010).

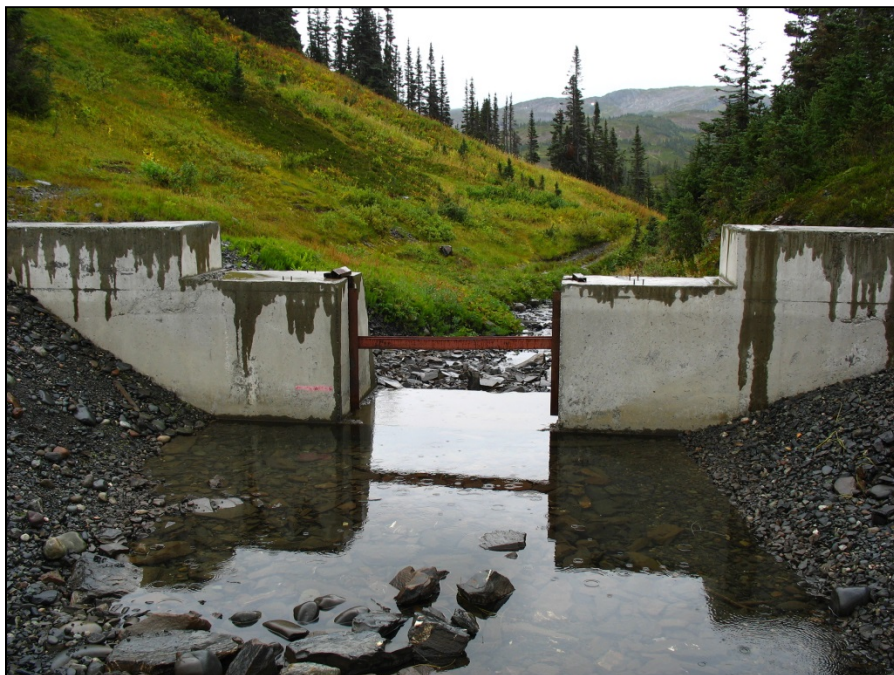
**PHOTO 2** – Albino Lake Structure without Stop-Log Hoist Structure (2013).

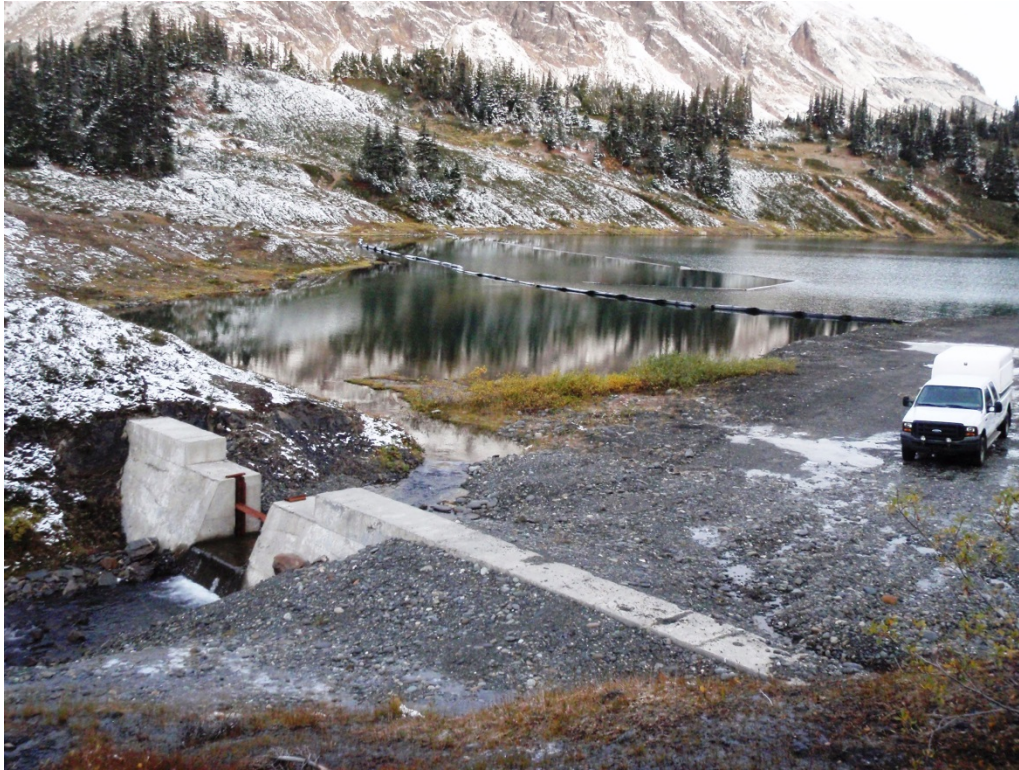
Albino Lake WRSF looking northwest over decommissioned control structure, with the concrete invert section approximately 160 mm below the lake water surface elevation.

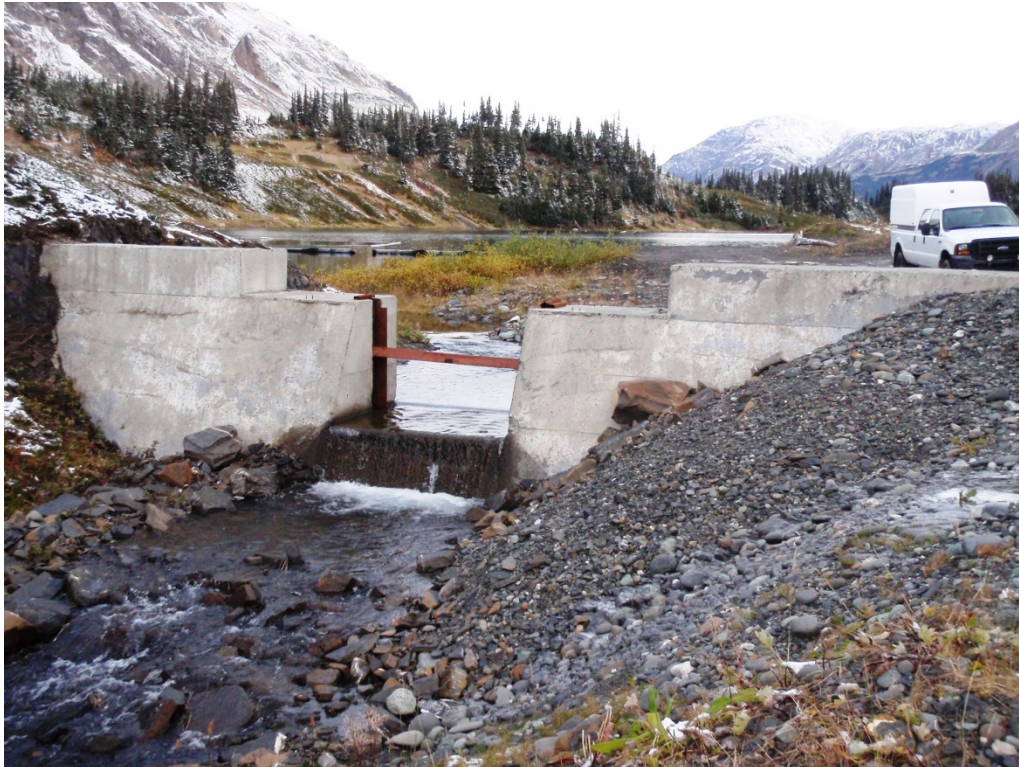
View looking upstream (north) through decommissioned control structure towards Albino Lake WRSF.

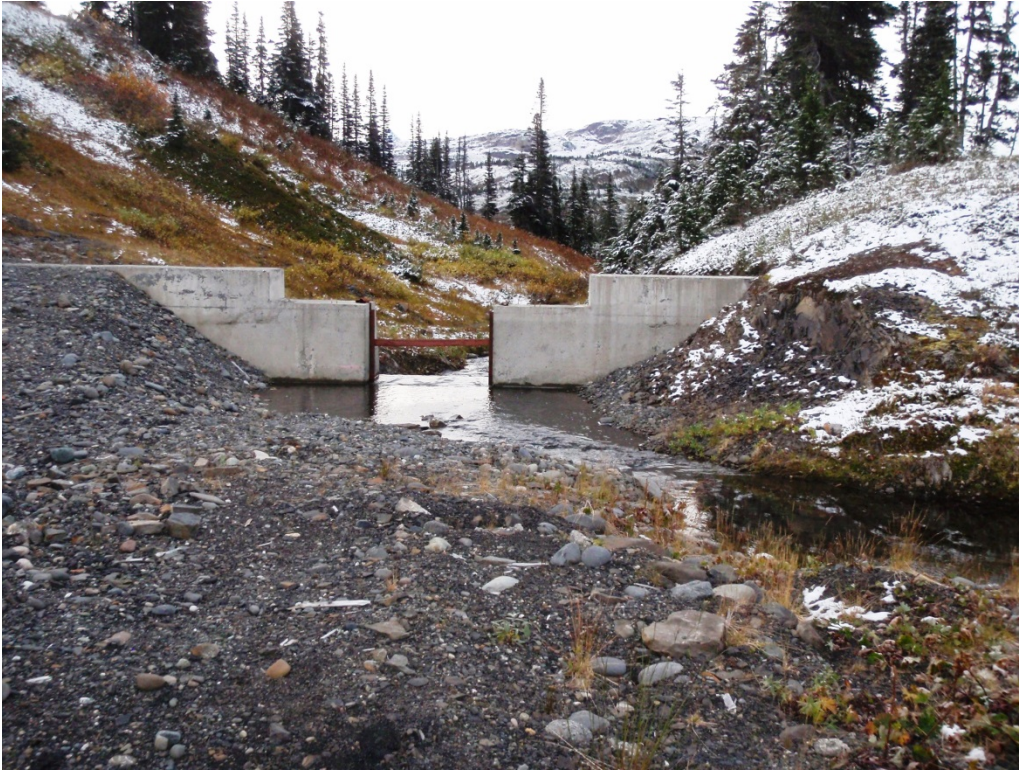
View looking downstream (south) through decommissioned control structure.

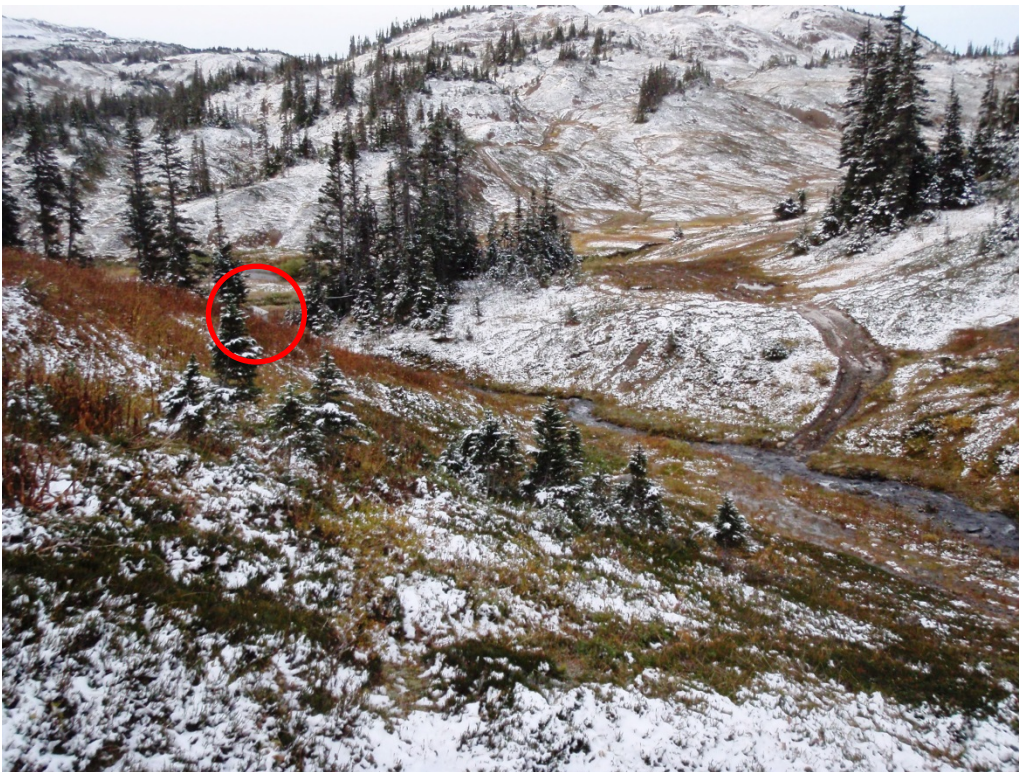
View looking southeast of natural channel and area downstream of Albino Lake WRSF; red circle indicates location of rectangular, sharp-crested weir station.
