June 30, 2015

Reference No. 1522835-2015-083-L-Rev0-1000

**RESPONSE TO MINISTRY OF ENERGY AND MINES MEMORANDUM DATED FEBRUARY 3, 2015
REGARDING THE FORDING RIVER OPERATIONS TAILINGS STORAGE FACILITIES**

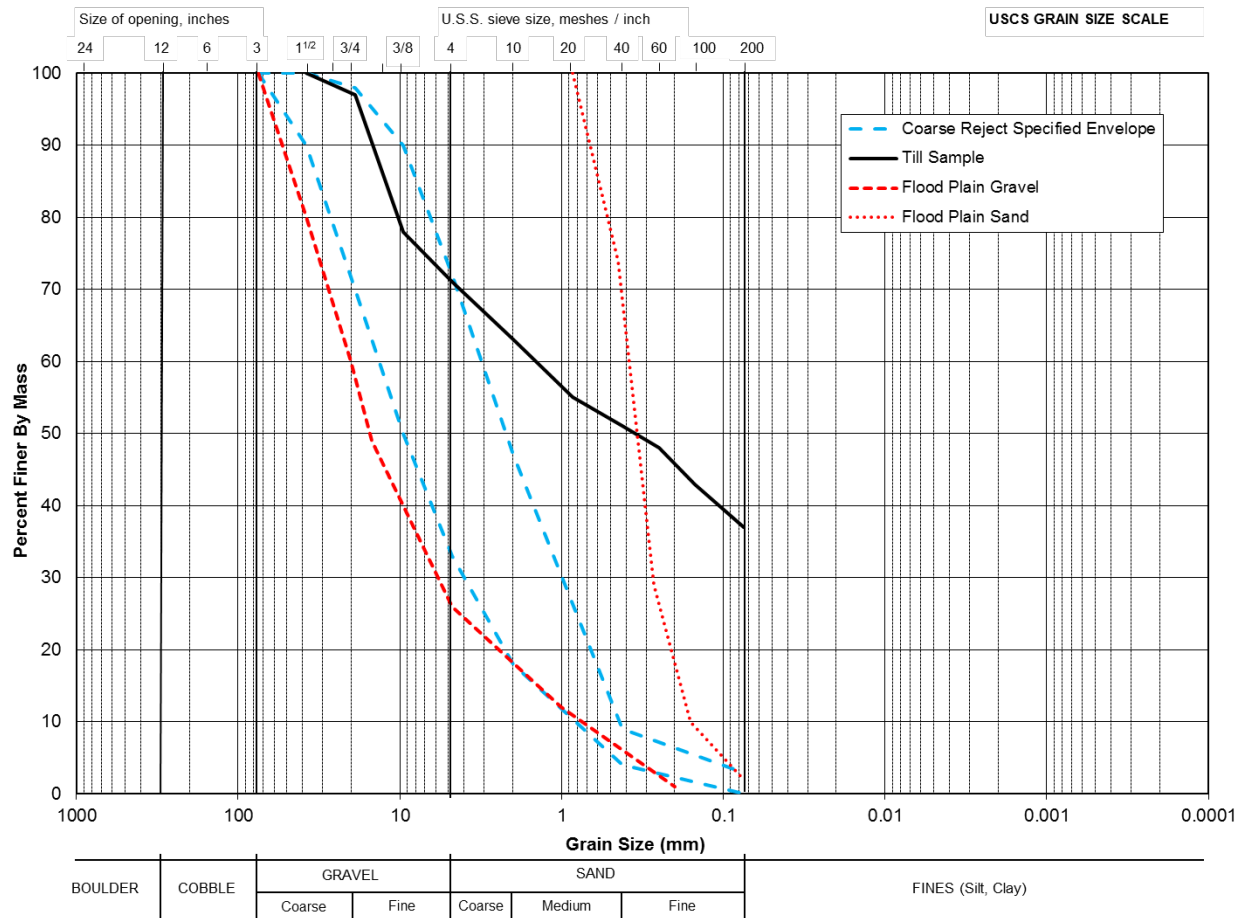
Chart 1: Specified Gradation Envelopes and Specific Samples for Filter Compatibility Assessment

Gradation of the CR material is presented in Chart 1, and it can be noted that the CR material does not always meet the Sherard criteria, as the coarse limit of the envelope has a $D_{15(\text{filter})}$ equal to about 1.5 mm, which exceeds the specification of 0.7 mm. However, Golder (1973) included an assessment that demonstrated the breakdown of the CR material during compaction, which reduced the $D_{15(\text{filter})}$ of the material from 0.95 mm to 0.68 to 0.57 mm (within specification).

Gradation of the expected range of foundation sand and gravel materials is presented in Chart 1, and it can be noted that the coarse limit of the flood plain gravel does not meet the Sherard criteria, as the $D_{15(\text{filter})}$ of the gravel is about 1.5 mm, which exceeds the specification of 0.7 mm. However, the flood plain gravel is generally mixed with the flood plain sand, which would reduce the effective $D_{15(\text{filter})}$ size.

The compatibility between the till (base soil) and the CR shell or flood plain sand and gravel (filter) met the filter compatibility criteria for two of the three methods checked. The internal stability of the CR shell was confirmed. Based on the performance of the dam over the last 45 years, piping due to filter incompatible material is not expected to be an issue.

The gradation of the underlying flood plain sand and gravel should be confirmed via sampling from the planned 2015 drilling program.

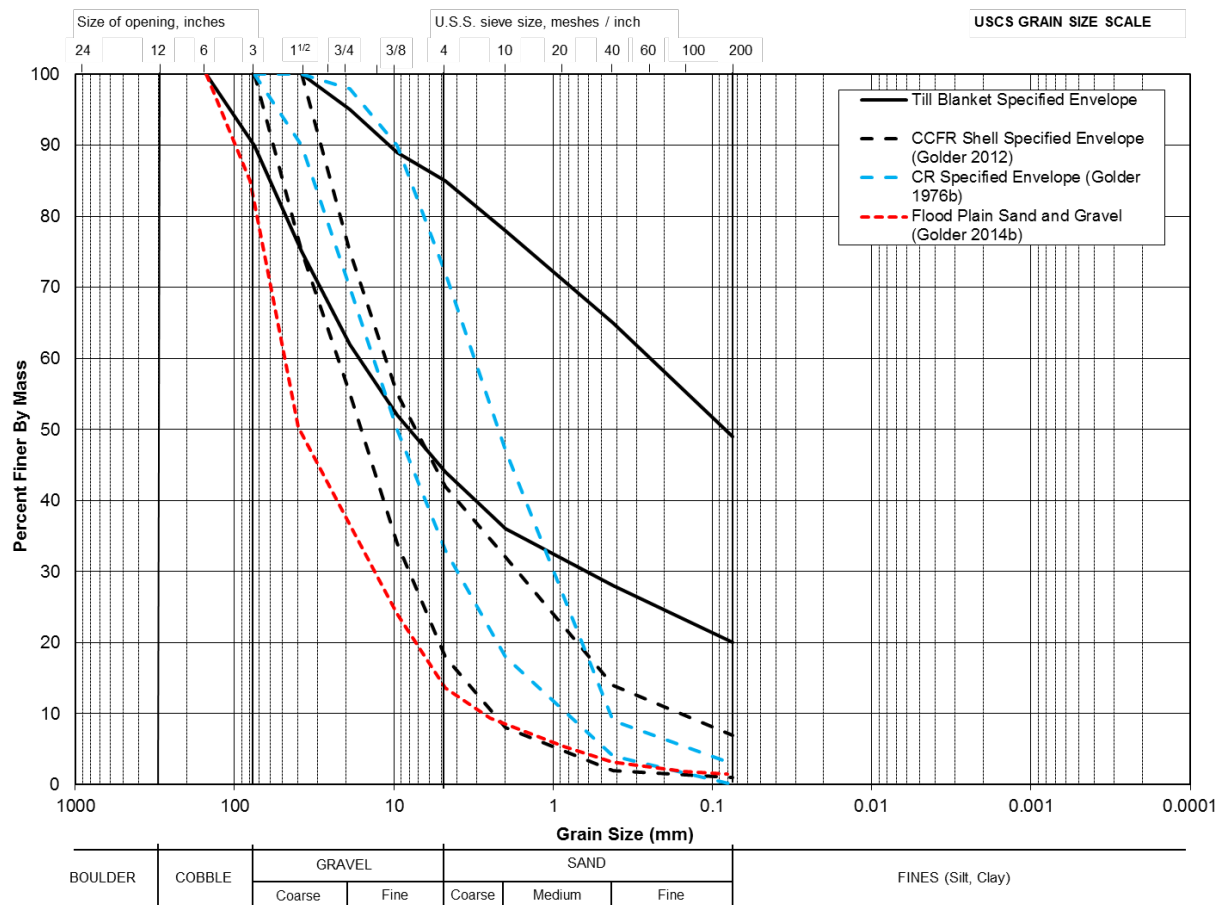
Chart 2: Specified Gradation Envelopes and Samples for Filter Compatibility Assessment

Gradation of the CR and CCFR materials are presented in Chart 2, and it can be noted that the materials do not always meet the Sherard criteria, as the coarse limit of the envelopes has a $D_{15(\text{filter})}$ which exceeds the specification of 0.7 mm. Breakdown of the CR and CCFR materials occurs during compaction, which is expected to reduce the $D_{15(\text{filter})}$ of the material somewhat, but some materials may still not meet the Sherard criteria.

Gradation of a sample of flood plain sand and gravel is also presented in Chart 2, and it can be noted that the materials do not always meet the Sherard criteria, as the $D_{15(\text{filter})}$ of the sand and gravel is about 5 mm, which exceeds the specification of 0.7 mm. The $D_{15(\text{filter})}$ of the flood plain sand and gravel was identified as being between 0.1 mm and 1.0 mm in KWL (1976), which is closer to meeting the criteria.

Based on the performance of the dam over the last 37 years, piping due to filter incompatible materials is not expected to be an issue. Continual seepage is evident at the toe of the STP dam, particularly along the West Dam, and has been reported for many years. Cloudy seepage water can indicate internal erosion, but records of the seepage from the STP indicate clear water. Regular inspections for evidence of increased seepage and piping should continue. Seepage from the STP dams should be collected as per the recommendation in the 2014 annual dam safety inspection (Golder 2014c) and monitored for particulate prior to the 2016 freshette.

The seepage from the STP dams should be collected as per the recommendation in the 2014 annual dam safety inspection (Golder 2014c) and monitored for particulate prior to the 2016 freshette.
