### **Dam Safety Inspection, Gallowai Bul River Mine Tailings Storage Facility, Bull River, BC**

**Bul River Mineral Corp.**

**November 24, 2014**

**Project 623505**

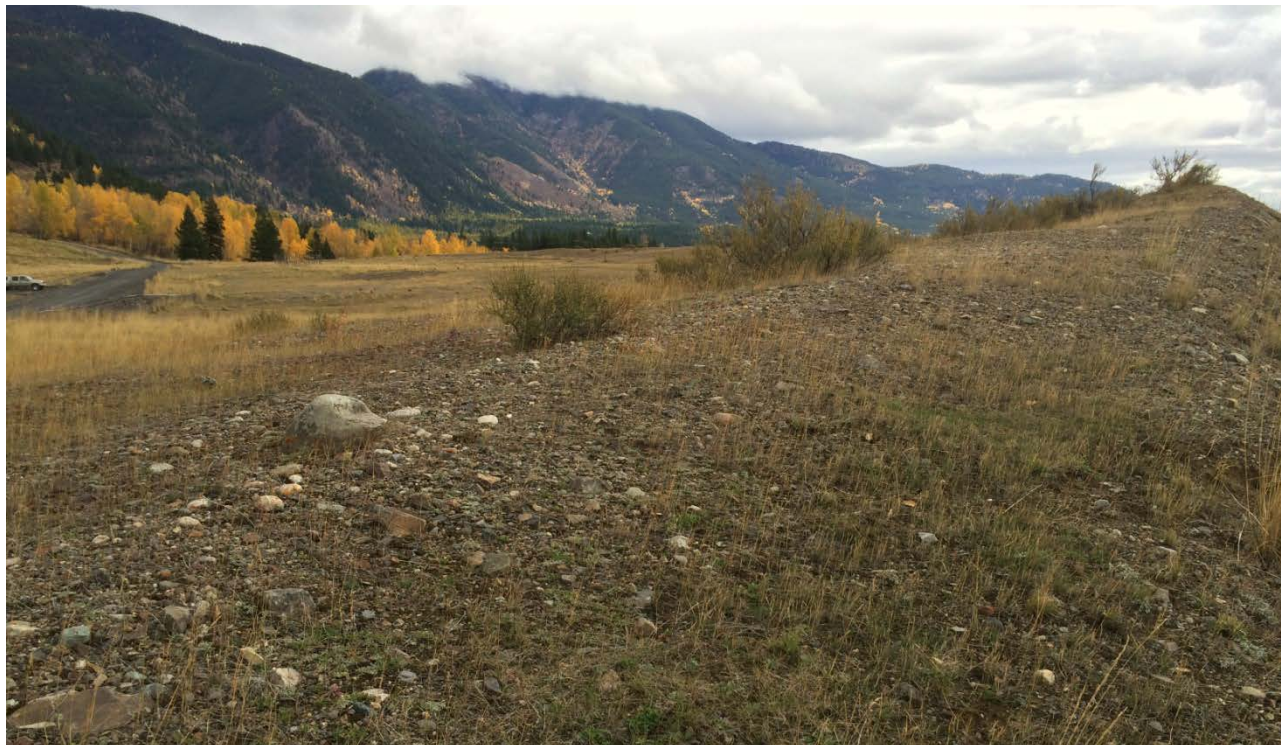
and 6 (see Photograph 3). The downstream face was sloped  $31^{\circ}$ . A natural draw, possibly a former side channel of Burntbridge Creek was located west of this location and some surface water was flowing (1 m wide, 0.1 m deep) down to a culvert under the Bull River Road. The haul road ditches conveyed surface water to this gully.

**Photograph 3:** At WP 4 looking southeast toward WP 5. The dam crest is sloped uphill along its centerline and sloped back down toward the north and the former pond area.

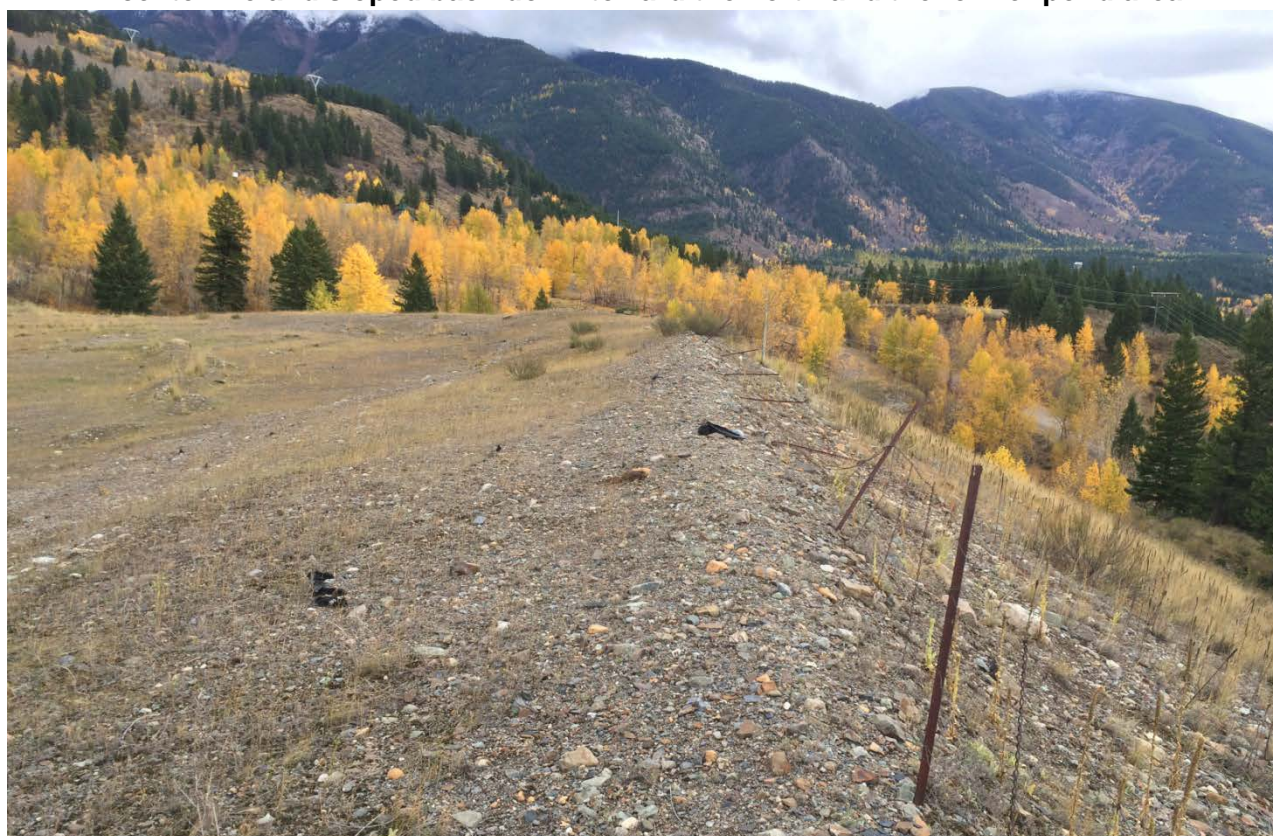
- At WP 10, the downstream face of the embankment was  $29^{\circ}$  for approximately 25 m to 30 m along slope to where the interpreted transition to original native ground was located. Below that point, natural slopes were approximately  $31^{\circ}$  down to the Bull River Road and the terrain was forested with interior douglas fir trees. The slopes and TSF crest appeared to be stable and no evidence of seepage or cracking or bulging was evident.

**Photograph 4:** At WP 10, looking east. The downstream dam face is inclined at 29° for approximately 25 to 30 m along slope. Natural slopes below the TSF at WP 10 are 31°.

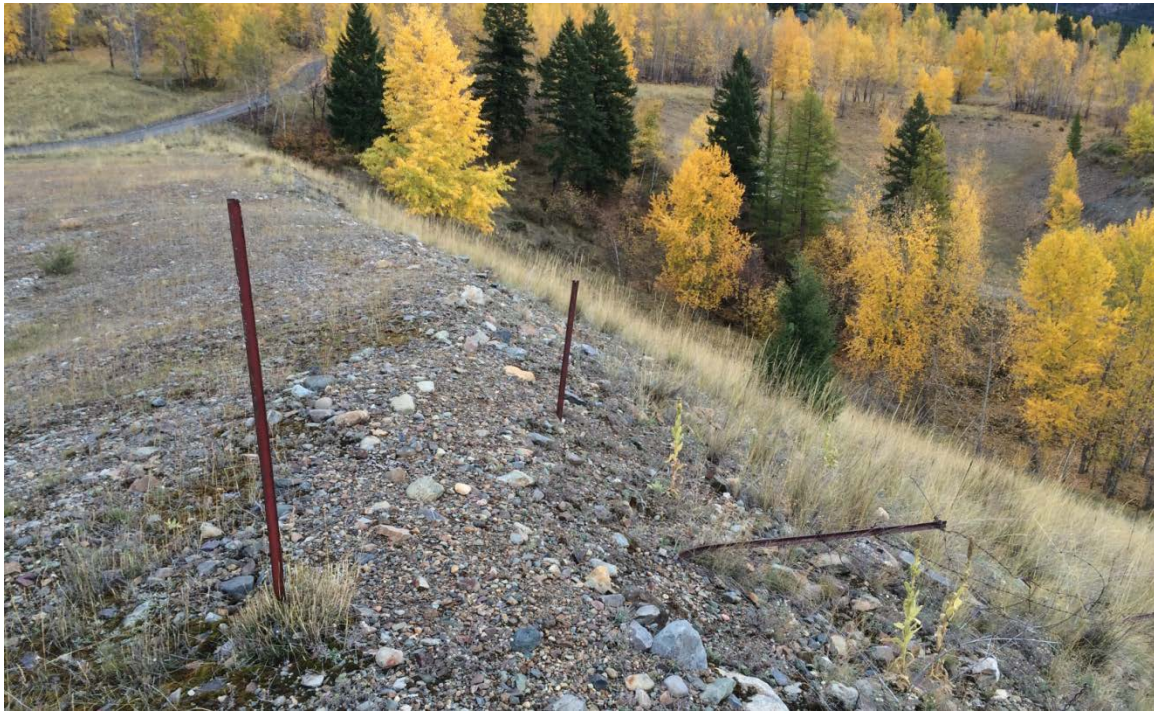
**Photograph 5:** At WP 11, looking east to a natural gully. The haul road linking the portal and dumps to the mill is visible in the left background and the Bull River Road is in the right background. Surficial soils were gravelly sand with some silt and cobbles. Slopes were stable.

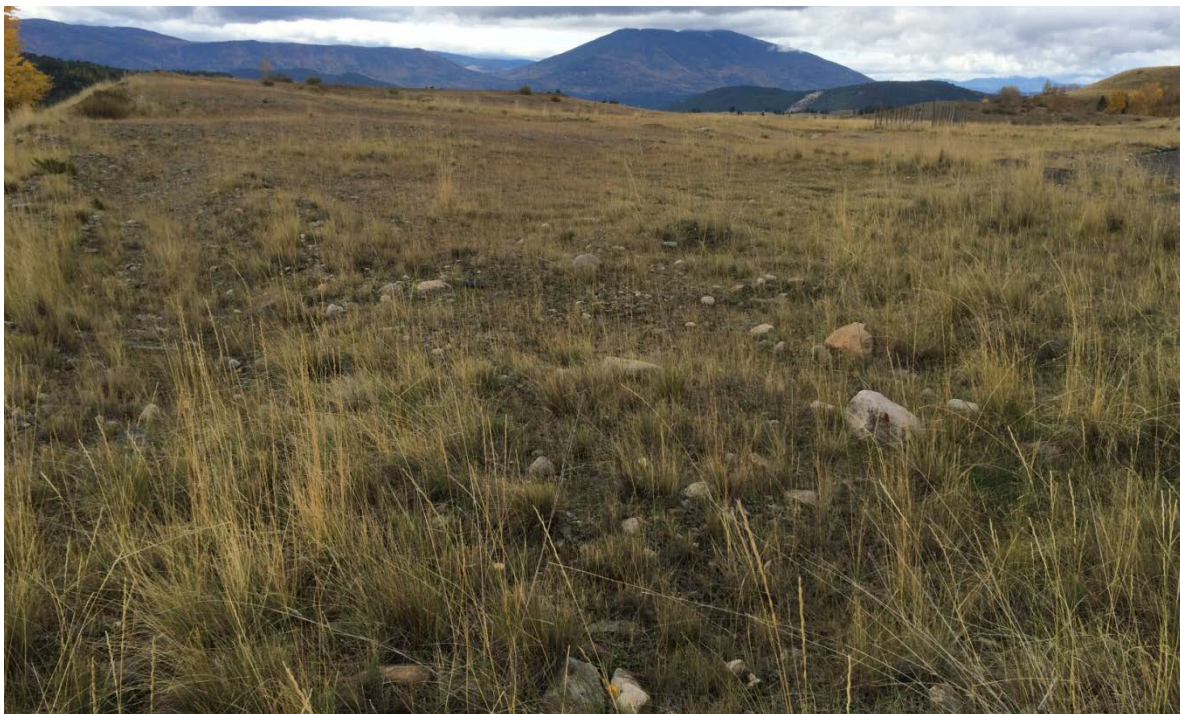
- WP 12 was plotted near the east abutment of the TSF dam. This location was a low point with the TSF surface graded to the area along with the haul road. However, no evidence of surface water flows from recent years was observed (see Photograph 6).

**Photograph 6:** Looking southwest from WP 12 at the low point near the east abutment. The ground surface slopes down to this point and the east gully is located to the left of the photograph.

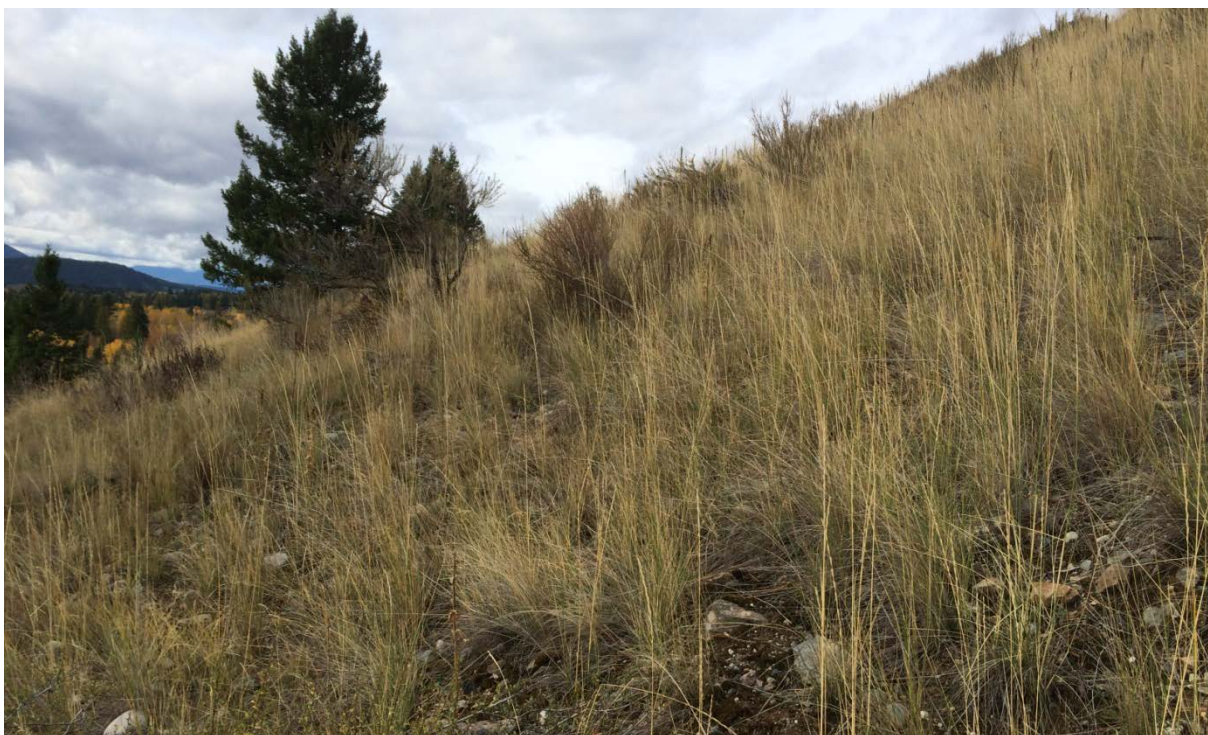
- WP 14 was estimated to be the transition point between the dam downstream toe and natural ground surface. The slopes were  $26^{\circ}$  up the downstream face and  $27^{\circ}$  overall down toward the Bull River Road. The ground on the dam face and natural ground was dry and no evidence of seepage was observed.

**Photograph 7:** At WP 14, looking west along the transition between the TSF downstream dam face and original ground. The slopes were 26 to 27°, in dry conditions.

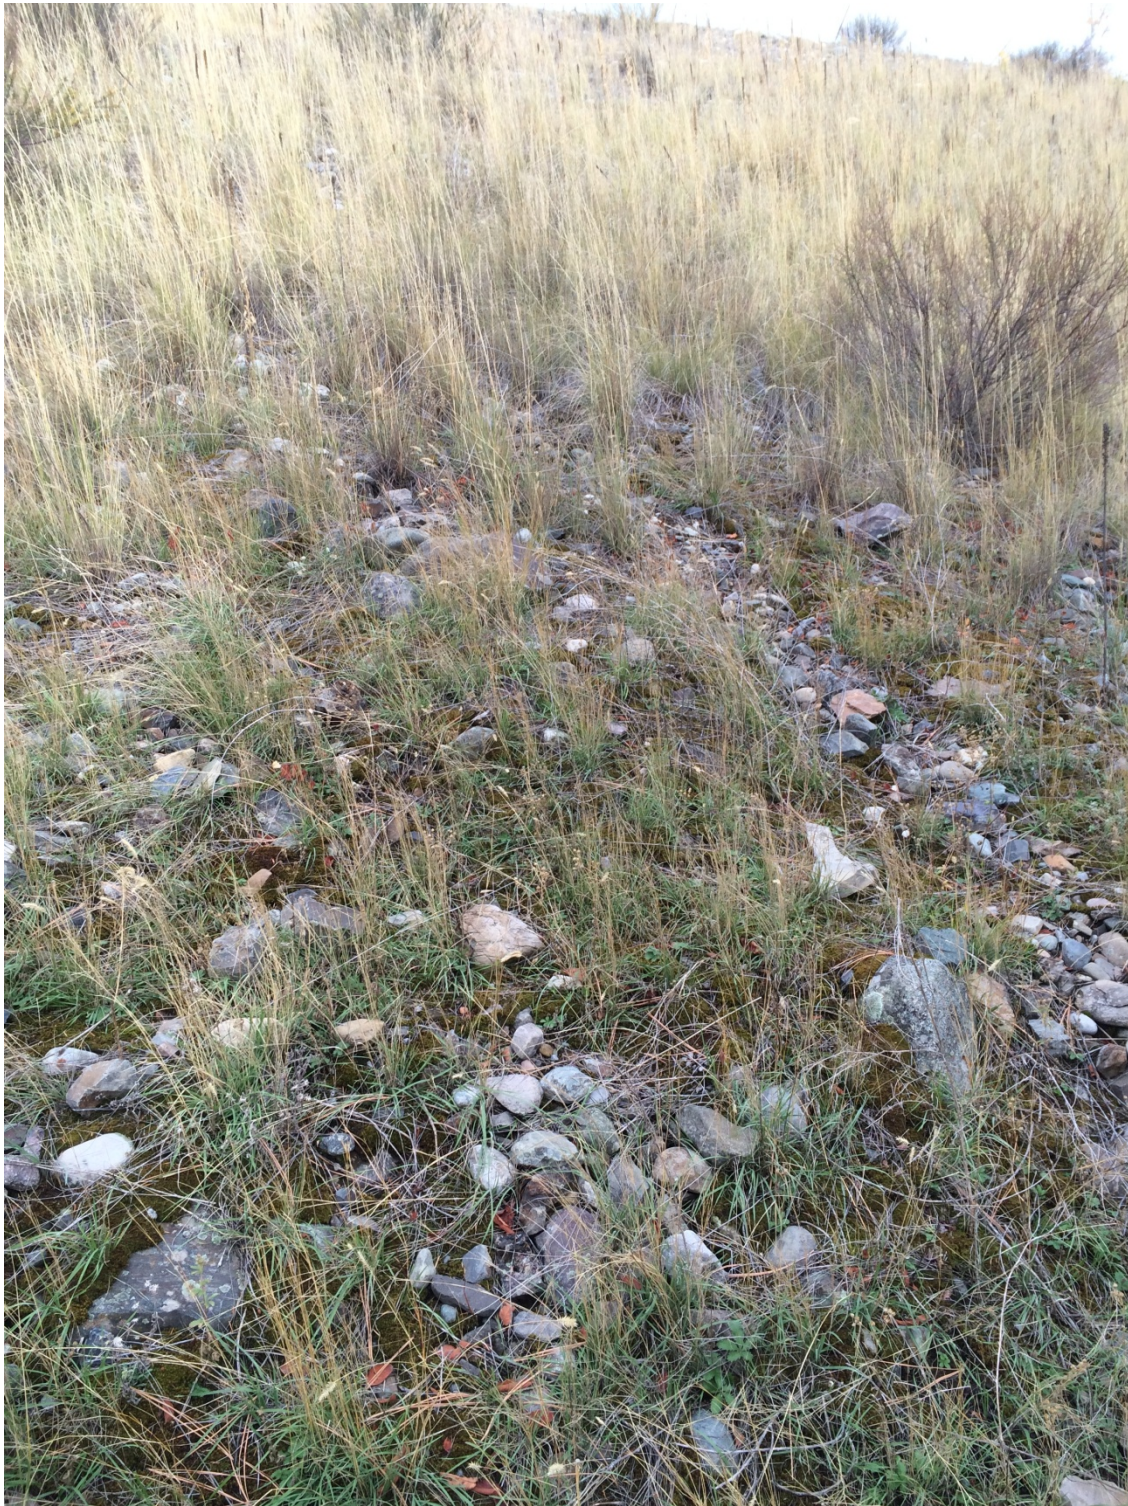
- At WP 15, the ground surface appeared to have small amounts of moss and some different, lush vegetation that was not present in adjacent areas of dry ground. There was no evidence of seepage or surface flows and the site had an exposed south aspect. The area is depicted in Photograph 8. The natural ground surface down to the Bull River Road was dry and sloped  $29^{\circ}$  (see Photograph 9). The downstream dam face was sloped up  $27^{\circ}$  to the north. The area was interpreted to have some amount of increased soil moisture

content compared to most of the remainder of the TSF dam. The moist area was discrete and localized, approximately 6 m along the slope fall line and 3 to 4 m along contour.

**Photograph 8:** At WP 15, looking north up the downstream dam face. Some moss was present on the ground surface in this area, which was estimate to be at the dam foundation elevation. Potential very light seepage or moisture evaporation may be occurring in this area. No active seepage or vegetation such as horsetail was observed. Ground conditions downslope to the Bull River Road were dry.

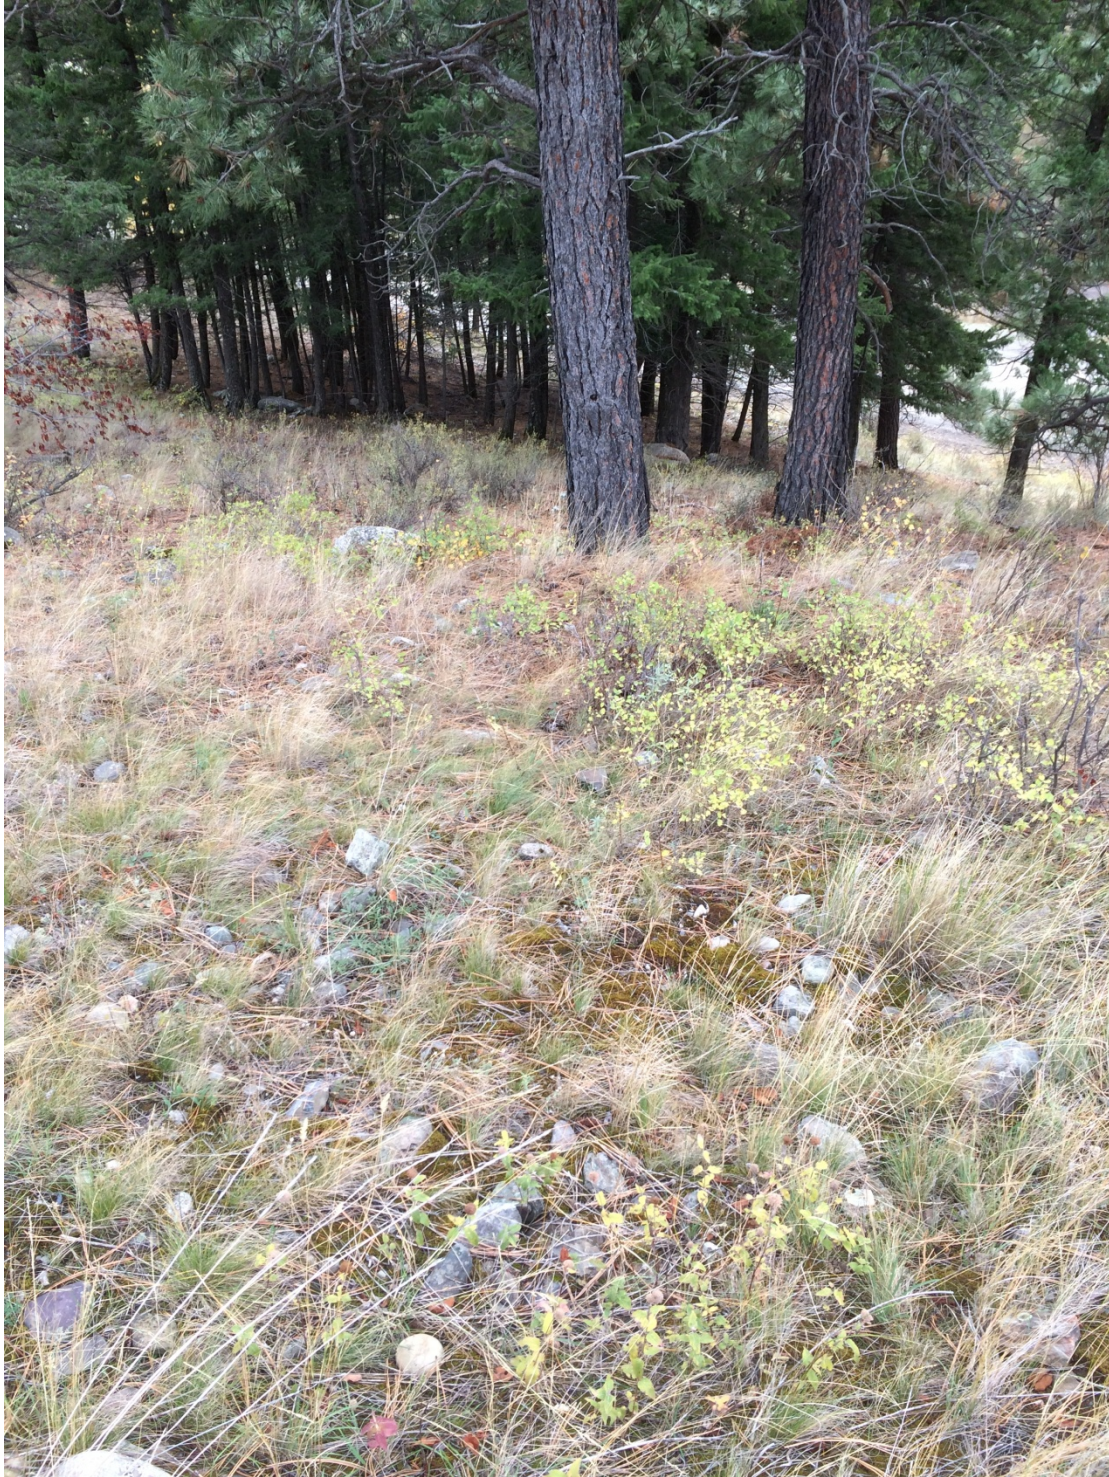
**Photograph 9: Slopes down to the Bull River Road at WP 15, showing the moss covered slopes in the foreground and dry terrain sloped 29° in fir and ponderosa pine forest.**

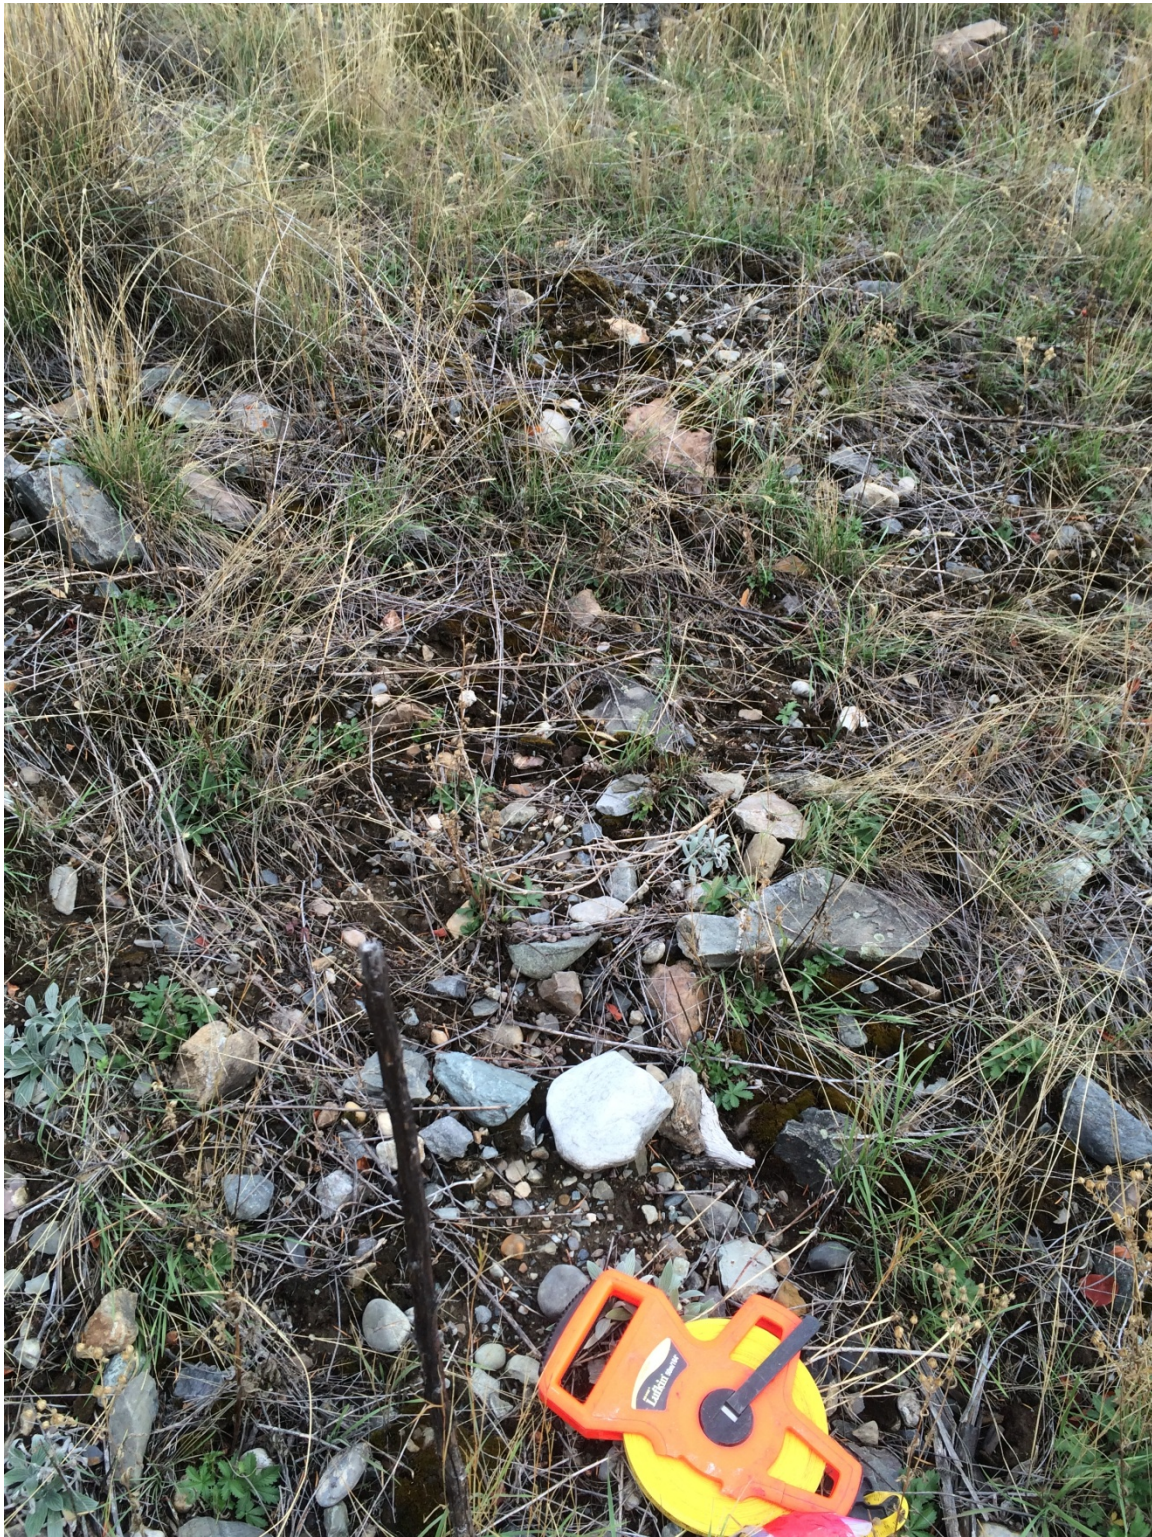
- At WP 16, another area of potential higher moisture content conditions in the surficial soils was observed (see Photograph 10). The slopes appeared to be stable and no evidence of seepage was found. The slopes were inclined 28° down to the Bull River Road and 26° up the TSF downstream face. Similar to the location at WP 15, the moist area was localized and small. Dry ground conditions were prevalent between WP 15 and WP 16.
- At WP 18 a small bench was situated near the base of the TSF dam. The area was dry and appeared stable. The ground was sloped 32° down to the southwest.

**Photograph 10: At WP 16, the second discrete location of surficial moss and more lush vegetation is depicted.**

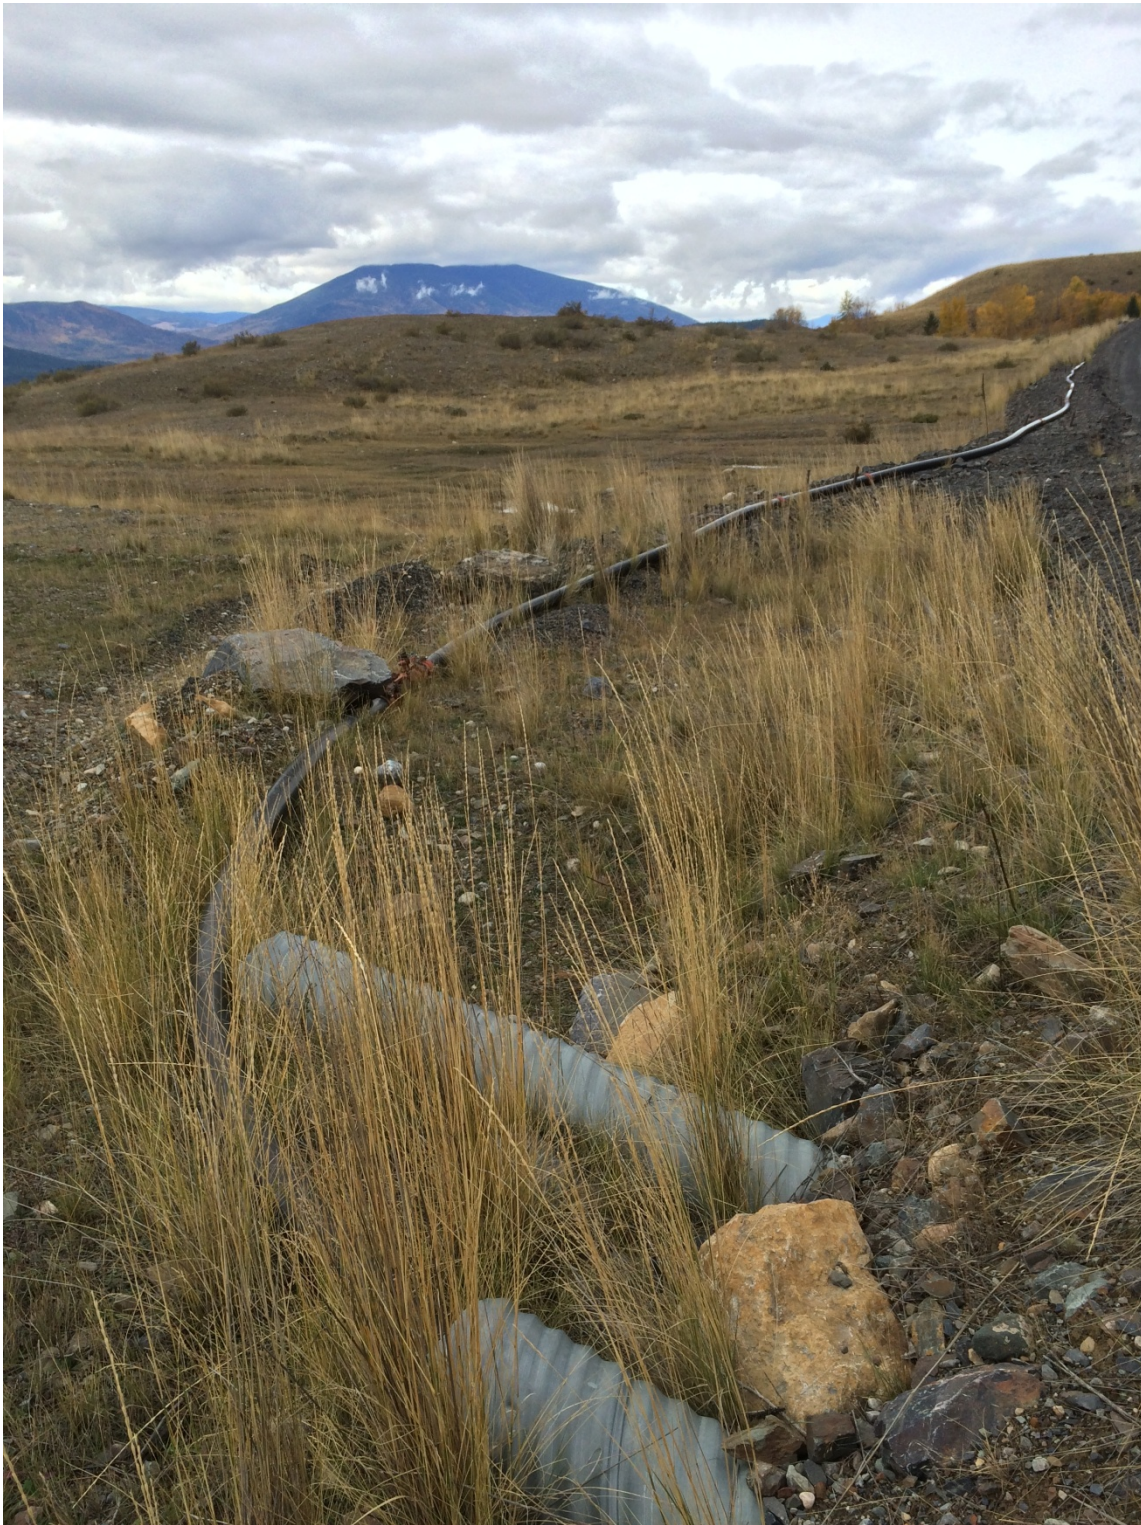
**Photograph 11: Looking west near WP 1 at pipelines from the old open pit, under the road through a culvert and west toward Burntbridge Creek.**

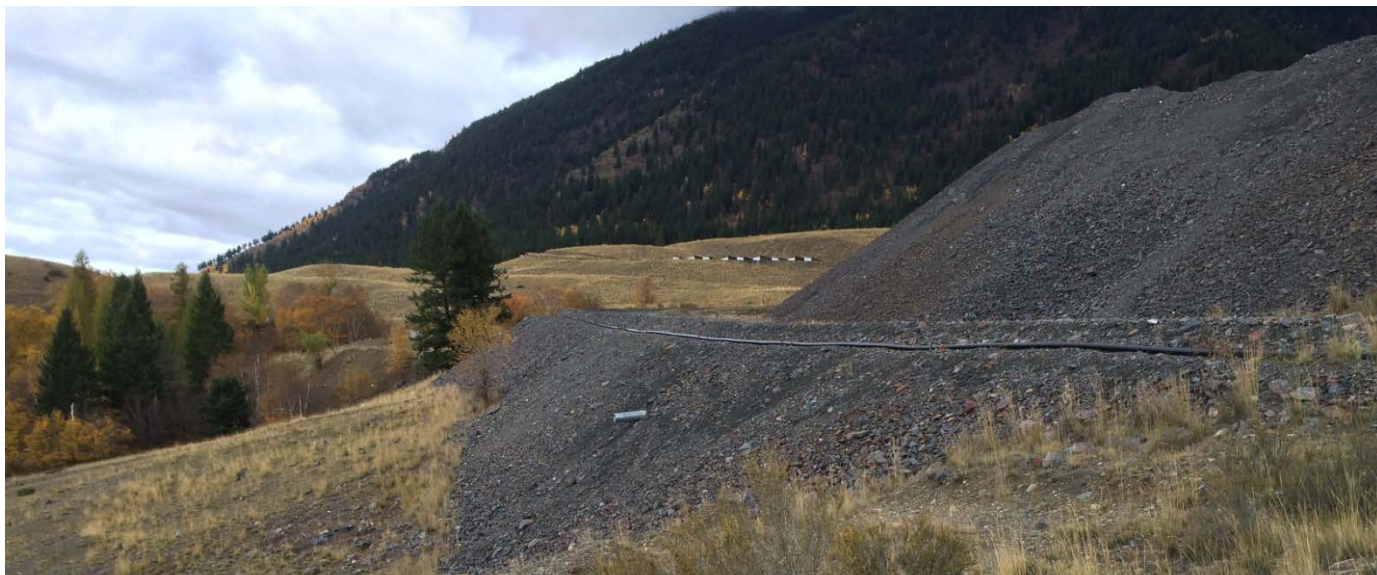
**Photograph 12:** From WP 4 on the TSF dam crest, looking northwest to the haul road and black pipe conveying water from the old open pit pumphouse. The discharge location is at facilities in the background area, and into an old side channel of Burntbridge Creek. The culvert in the middle foreground discharges ditch water from the upslope (north) side of the haul road and its catchment is up to the background and right of the photograph.

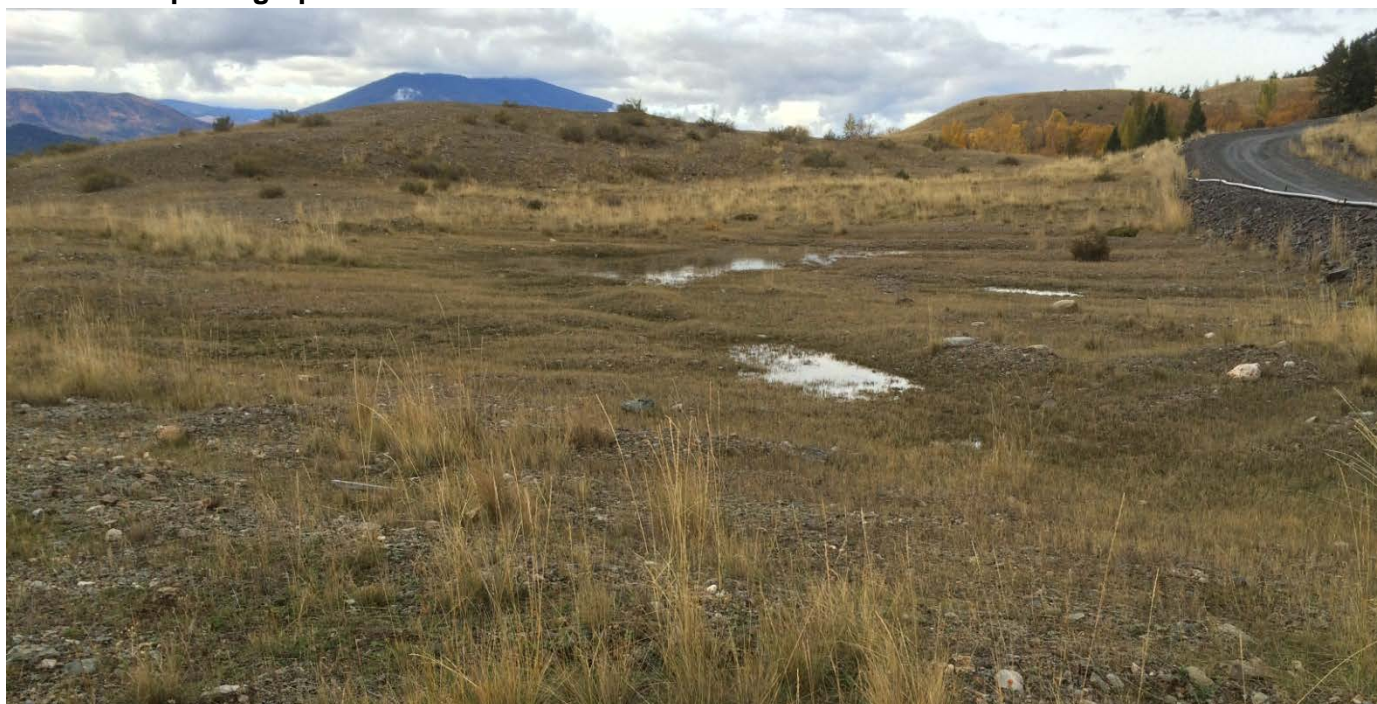
**Photograph 13:** At WP 8, looking west toward some small ponded water areas on the soil cover surface. The weather had been rainy in recent days, and water is reported to pond in this area on a regular basis after rainfall.

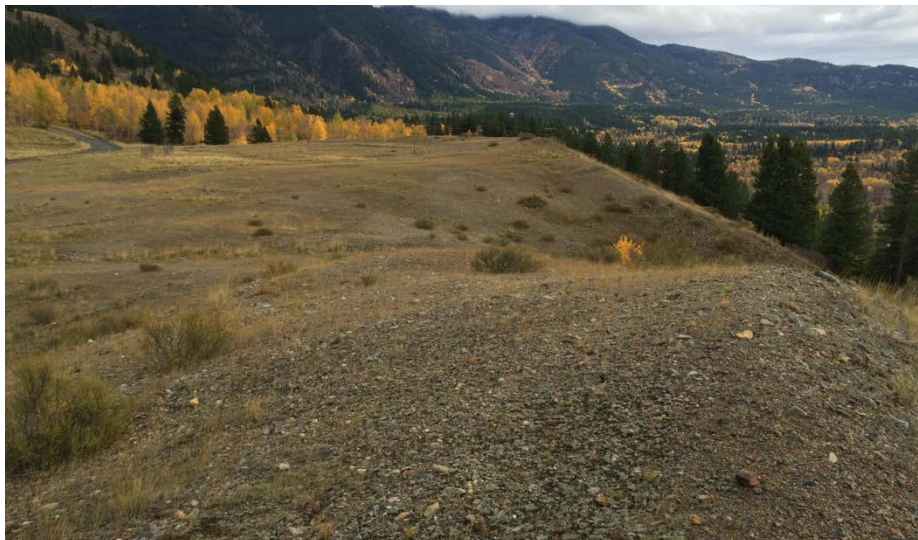
**Photograph 14:** At WP 5, the dam crest high point, looking east. The TSF is generally sloped down to the north away from the dam; however, a gully was present west of the middle of the dam, draining down to the south (right). The catchment for the gully surface water is limited to a semi-circular area at its head, estimated at 1500 to 2500 m<sup>2</sup>.

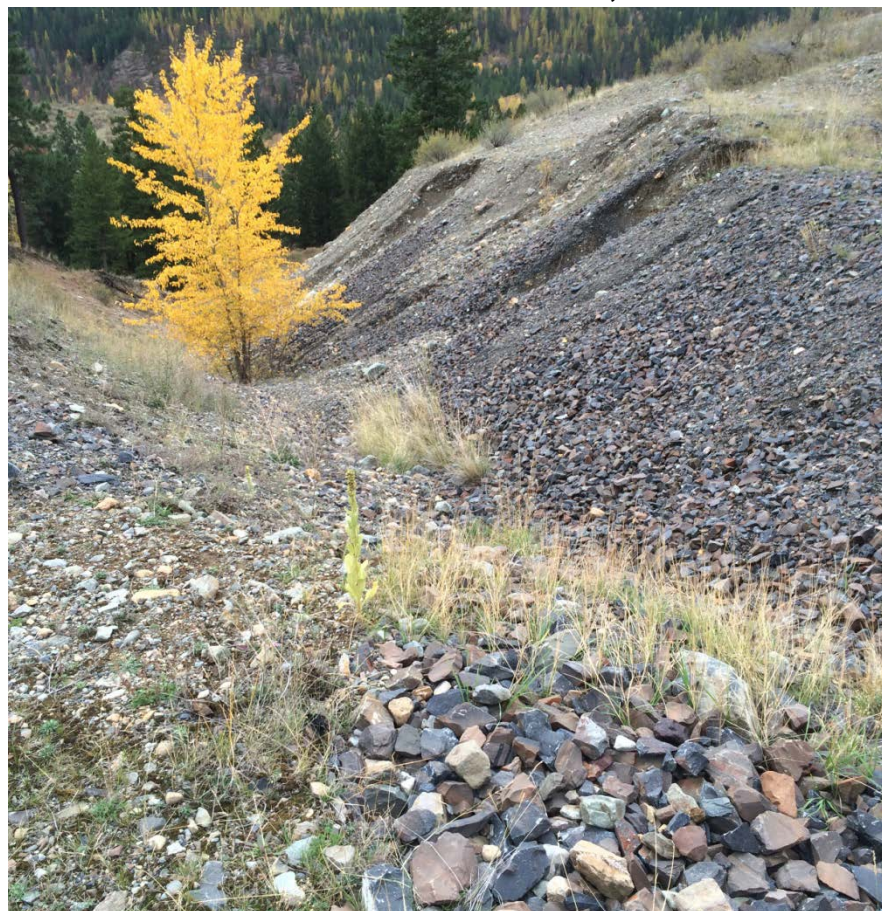
The gully sidewalls were steep during our site inspection on October 16, measured at 36° to 37°. The east sidewall, while steep, did not appear to have recent instability, however thin sliver failures of small volumes were observed on the western sidewall, as depicted in Photographs 15 and 18. Some argillite waste rock had been placed on the upper slopes, likely from works reported to have been performed in 2000. The waste rock veneer on the upper slopes appeared to be performing adequately.

**Photograph 15:** View down the gully at WP 7. The Bull River Road is barely visible in the background. The west (right) sidewalls experience small surficial failures. The road ditch contained small volumes of washed gravels and sands, and a pullout on the road contained some dumped materials, likely originating from ditch cleanout.

The flattened gully sidewalls would reduce the probability and magnitude of any future sliver failures; cross berms in the gully channel would help to mitigate potential sediment transport from freshly exposed slopes disturbed by the excavator. The exposed slopes should be treated by methods such as seeding with grass, placement of geosynthetics such as seeded coconut matting, or angular rock cover. The site should be monitored and photographed to check on progress of the mitigative works and any areas that require additional works.

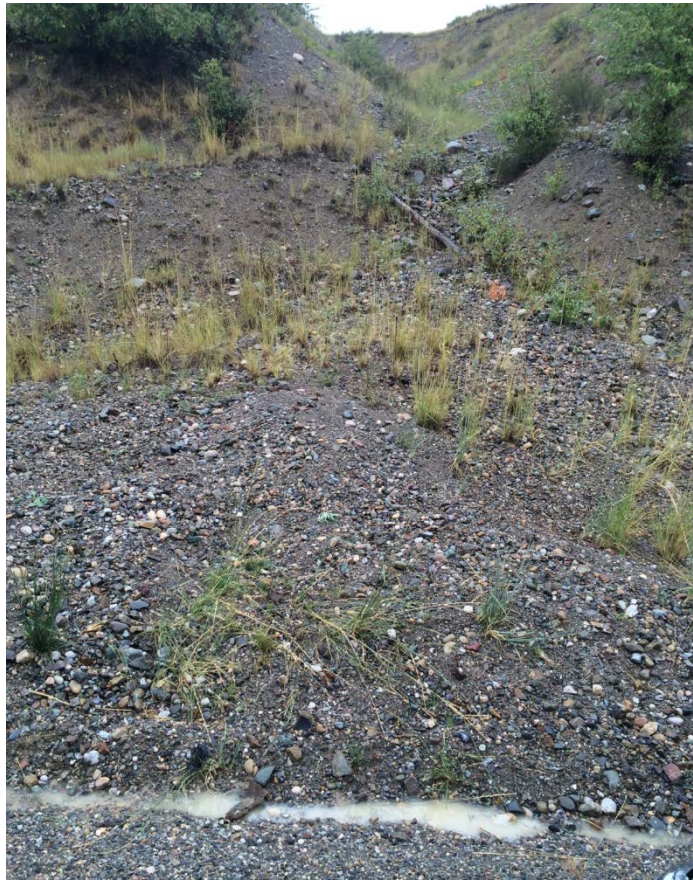
Based on evidence of fresher deposits of gravel and sand in the Bull River Road ditch, some mitigation work on the gully sidewalls and near the gully head catchment perimeter is recommended as described in later sections.

**Photograph 16:** View uphill from Bull River Road to small deposit in ditch from erosion, taken during a rainfall on September 3, 2014.

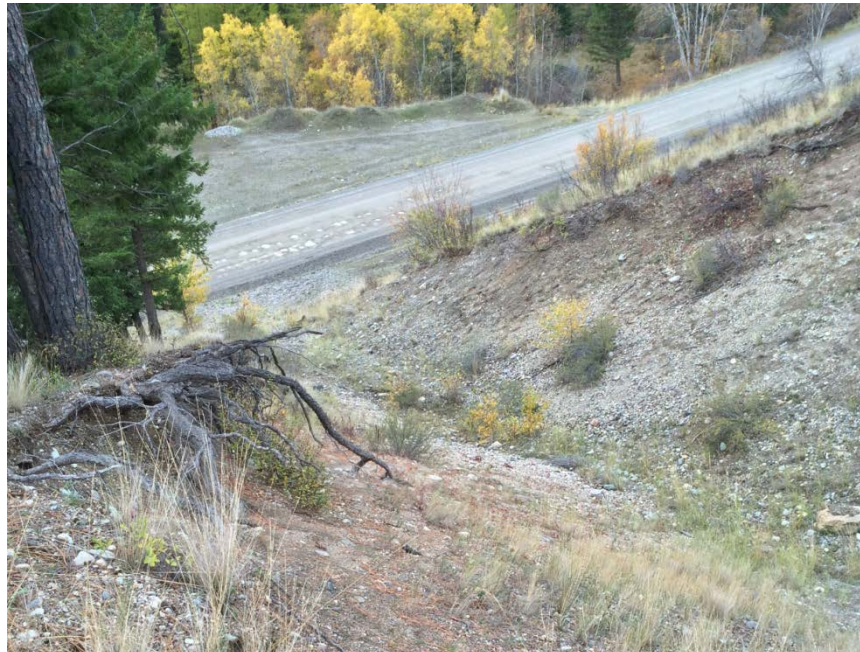
**Photograph 17:** View down the gully southwest from WP 17 to the Bull River Road and small deposits in the ditch. Stockpiles of older and fresh gravels on the pullout indicate possible cleanout from previous episodes. The pullout itself may be constructed from levelled, larger events.

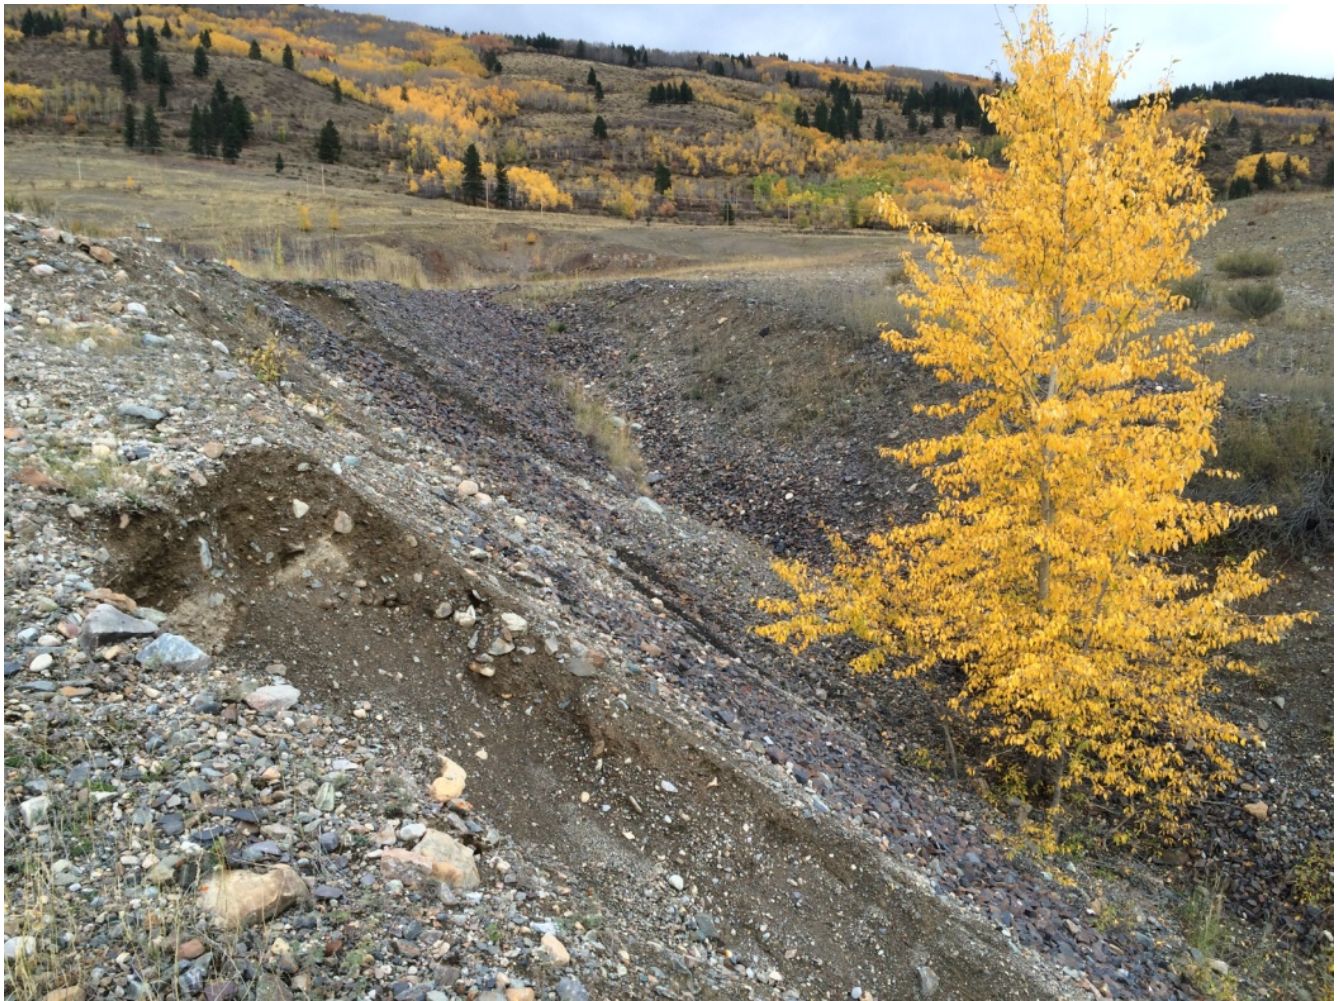
**Photograph 18: At WP 6 looking east across the gully with sliver failures in the west sidewall.**
