November 26, 2014

INDEPENDENT REVIEW OF 2014 DAM SAFETY INSPECTION REPORT

Giant Nickel Tailings Dams

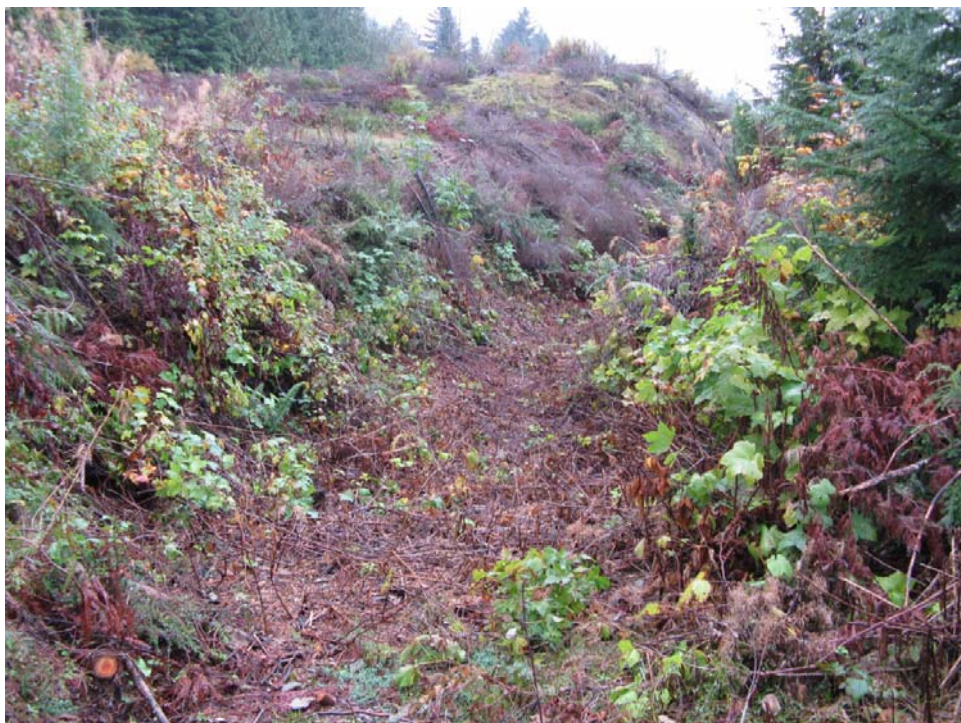
- The channel spillway at the dam centre line is clear of vegetation, but the channel connecting the small pond in the Lower Tailings Pond to the channel spillway should be cleared of vegetation. The concrete spillway structure was generally clear of vegetation, but the inlet channel should be checked and cleared of debris, as needed (it is understood this was cleared on October 21, 2014).
- The downstream slopes of both the Upper Tailings Dam and the Lower Tailings Dam are covered in trees. While this is not considered to be a concern for the structures at Giant Nickel, it is recommended that the trees be cleared to allow inspection of the toe of the dams.

Photograph 1: Channel Spillway at North End of Lower Dam, October 21, 2014

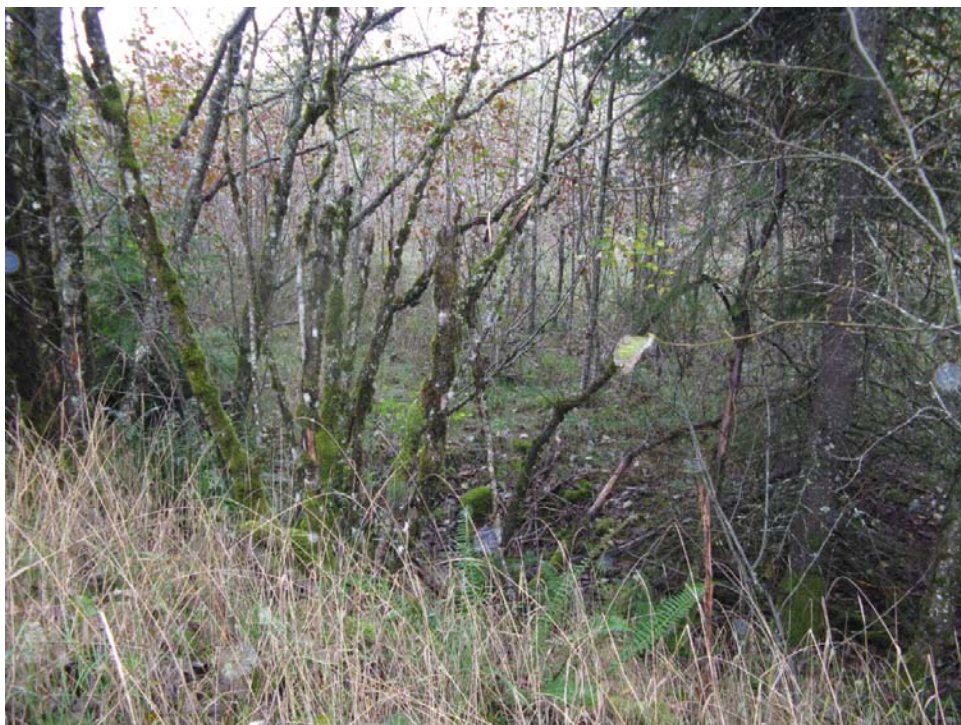
Photograph 2: Channel on Lower Pond to Spillway, October 21, 2014

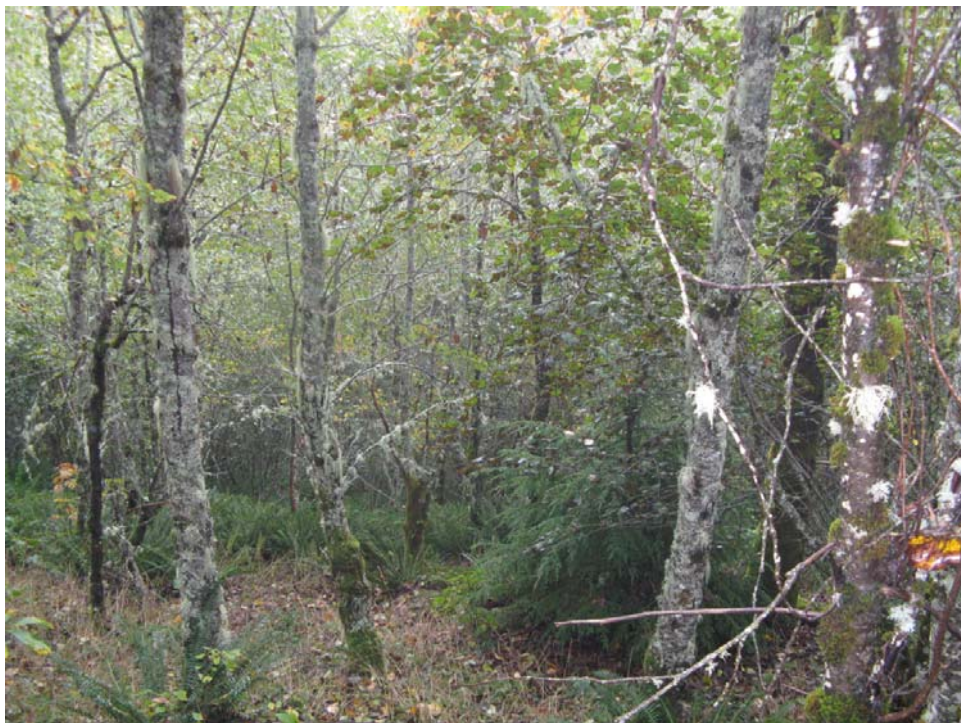
Photograph 3: Downstream Slope, Lower Dam, October 21, 2014

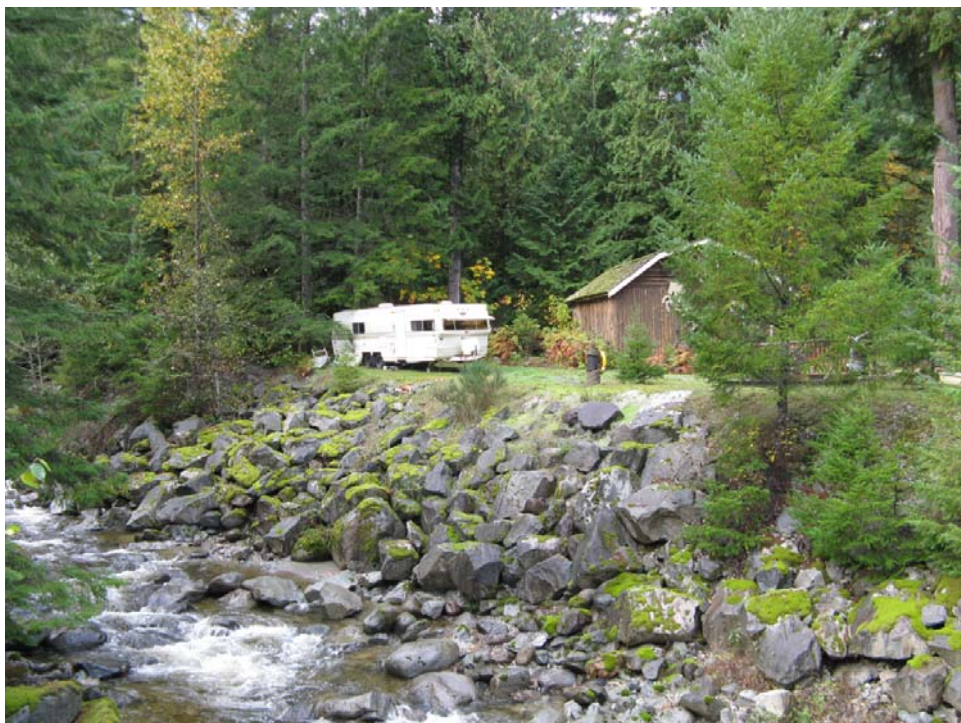
A dam breach study (in progress) indicates that a breach would have significant impact on several dwellings below the facility beside Stulkawhits Creek and on the nearby Highway 1 and the CN Main line railway. In addition, given the proximity of the Fraser River, it is anticipated that for a potential dam failure, tailings and failure debris would reach the Fraser River and result in significant negative impacts to fish habitat.

Photograph 4: Dwelling at Highway, October 21, 2014
