**BARRICK GOLD INC.  
GIANT NICKEL MINE**

**TAILINGS FACILITY  
2014 DAM SAFETY INSPECTION REPORT**

VA101-93/4-1  
Rev 0  
November 25, 2014

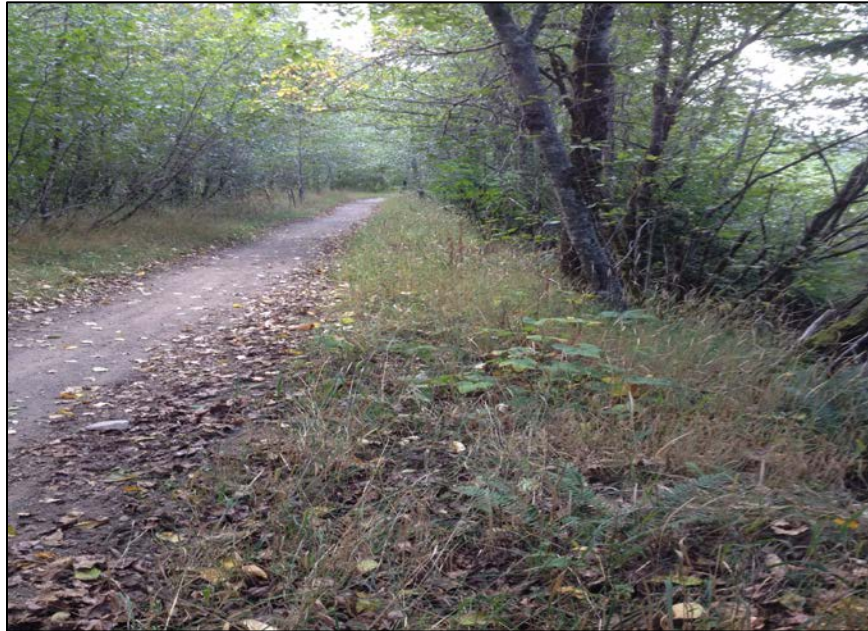
Significant revegetation has occurred across the tailings facility, particularly around the downstream slopes of the tailings dams. Although some areas were difficult to inspect there were no obvious signs of embankment instability, mass movement or uncontrolled seepage observed during the site inspection. The embankment crests are generally in a good condition. Photo 1 shows the trail along the embankment crest of the Lower Tailings Pond. Photo 2 shows the revegetated downstream slope of the Lower Tailings Pond.

**PHOTO 1** - Lower Tailings Pond - Embankment crest (looking south)

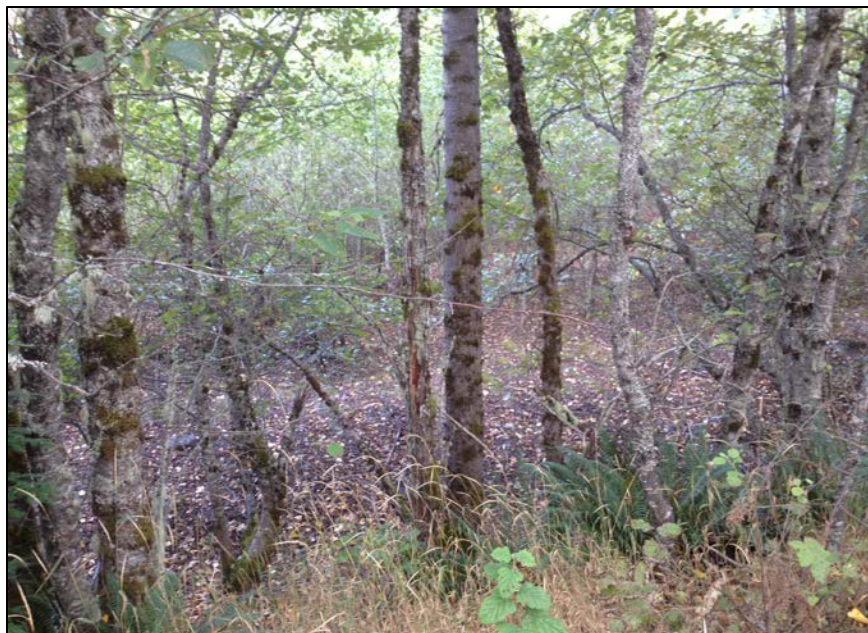
**PHOTO 2** - Lower Tailings Pond - Reclaimed downstream slope (looking east)

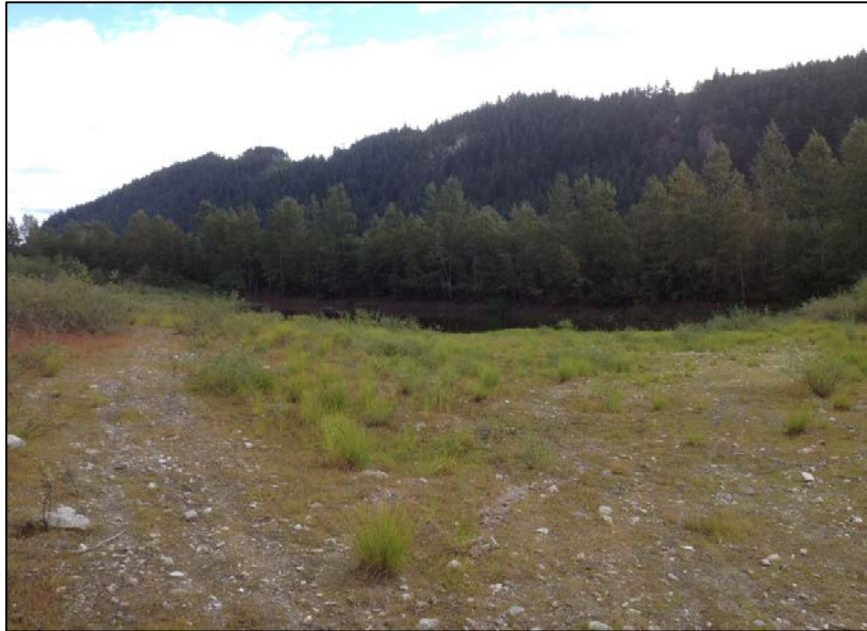
However, it should be noted that this stability assessment did not consider the impact of the current pond on the surface of the Lower Tailings Pond. The stability of the eastern embankment will need to be checked if regrading of the capped tailings surface to remove this pond and prevent future ponding is not implemented.

**PHOTO 3** - Lower Tailings Pond - Capped tailings surface in foreground with water pond and eastern embankment behind (looking east)

Barrick Gold has examined options to regrade the capped tailings surface to prevent ponding in the Lower Tailings Facility (remove the existing pond) and to direct all drainage to a channel spillway. Knight Piesold has recently completed a review of the current drainage conditions of the tailings facility and developed conceptual drainage plans to eliminate ponding from the surface of the facility, and provide an upgraded closure spillway capable of safely passing the PMF.

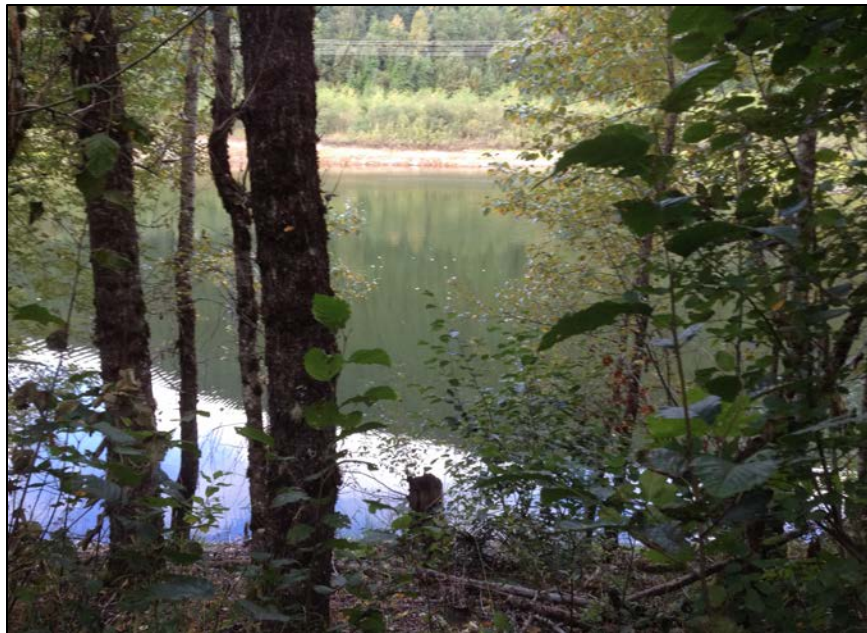
**PHOTO 4** - Lower Tailings Pond - Water pond adjacent to eastern embankment

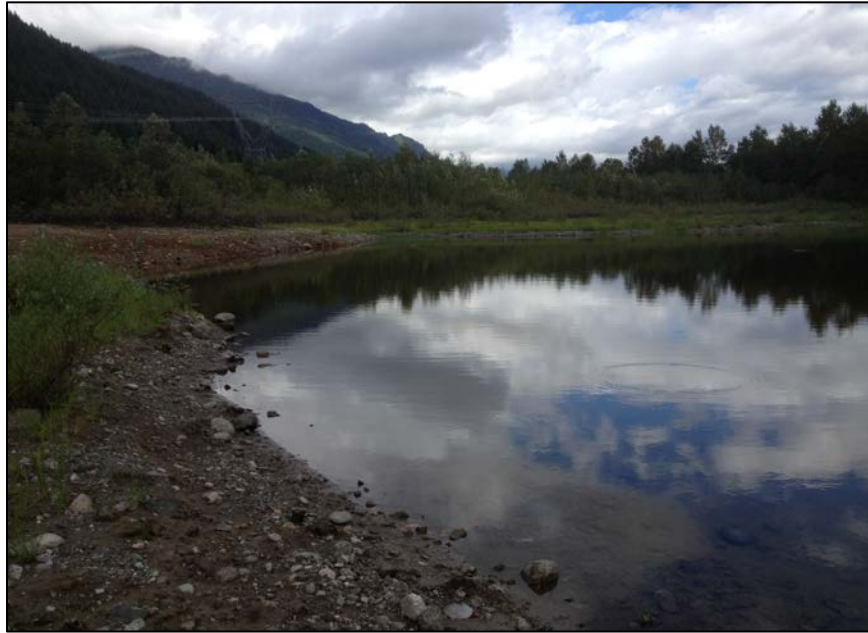
**PHOTO 5** - Lower Tailings Pond - Water pond on tailings surface (looking north)

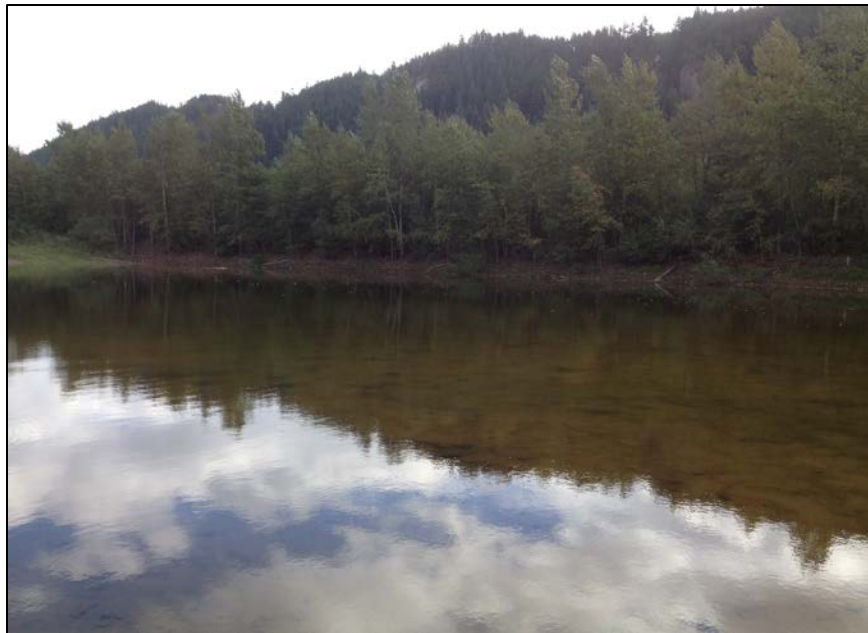
**PHOTO 6** - Lower Tailings Pond - Water pond with eastern embankment behind (looking east)

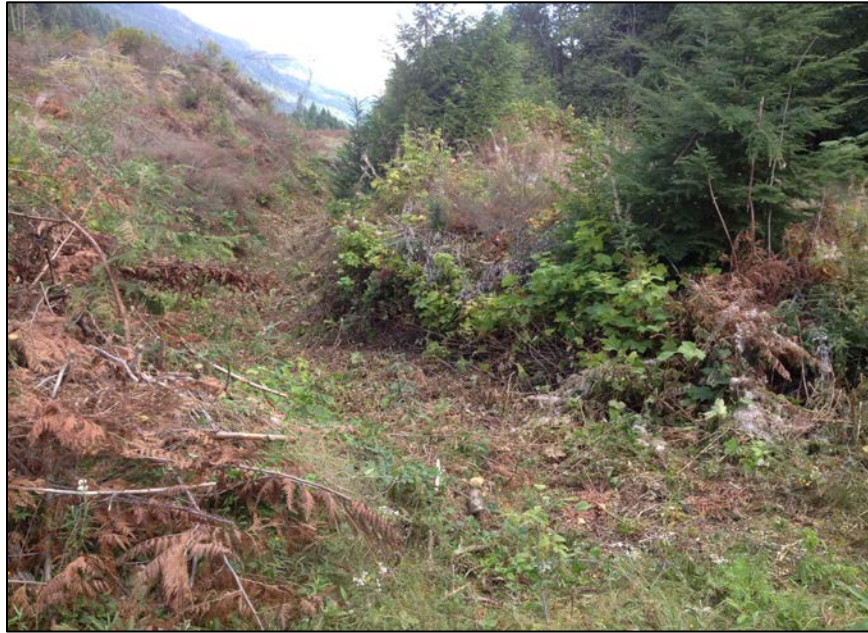
- The channel spillway, in a condition of partial blockage with vegetation and debris, will permit the safe passage of a flood event with a return period of approximately 1,000 years. This is achieved assuming full blockage of the concrete decant spillway structure. If only a partial blockage of the concrete decant spillway is assumed, the system capacity is increased to approximately the 1 in 10,000 year flood, although there is no remaining freeboard for this scenario. A similar capacity is achieved by the channel spillway alone, if it is assumed to be cleared of vegetation and debris. If both the channel spillway and concrete decant spillway are cleared and returned to their original full capacity, the combined spillway system will be able to safely pass a flood event with a return period of approximately 10,000 years, with adequate freeboard.

**PHOTO 7** - Lower Tailings Pond - Channel Spillway (looking downstream)

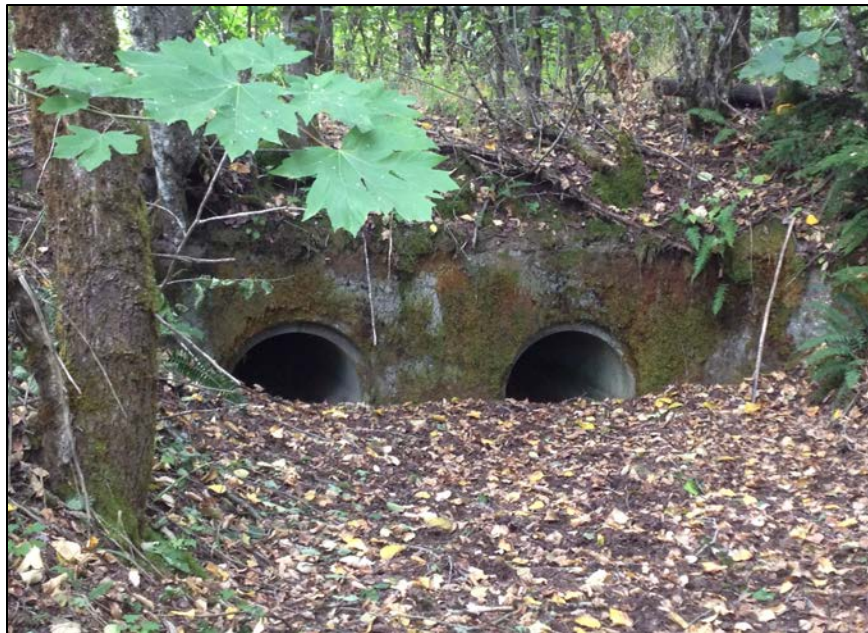
The channel spillway was generally clear of bushes and debris at the time of the site inspection. The concrete decant structure is partially blocked by debris at the inlet. Periodic clearing of vegetation and debris from the channel spillway is necessary to maintain flow capacity and prevent potential blockage during a large flood event. Removal of debris at the inlet area of the concrete decant structure will increase the available discharge capacity. Regrading the capped tailings surface to prevent ponding (including the pond on the Lower Tailings Facility surface) and to direct all drainage to a channel spillway capable of passing the PMF will satisfy the water management objectives for a tailings dam in the Passive Closure phase.

**PHOTO 8** - Lower Tailings Pond - Concrete Decant Spillway Structure (looking downstream)

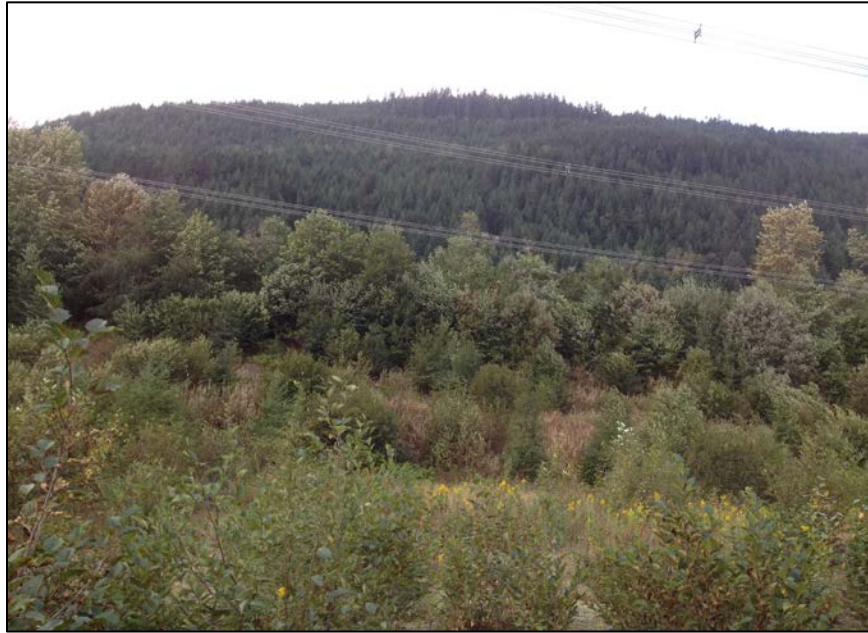
The downstream embankment slopes for the Upper Tailings Pond are shown by Photos 9 and 10. Ponding of water was observed along the downstream embankment toe of the Lower Berm at the southern end of the Upper Tailings Pond (see Photo 11). To ensure long-term performance of the dam and satisfy Passive Closure objectives this area will need to be appropriately graded to eliminate ponding of water and direct surface drainage away from the toe of the embankment.

**PHOTO 9** - Upper Tailings Pond - Downstream embankment slope (looking west)

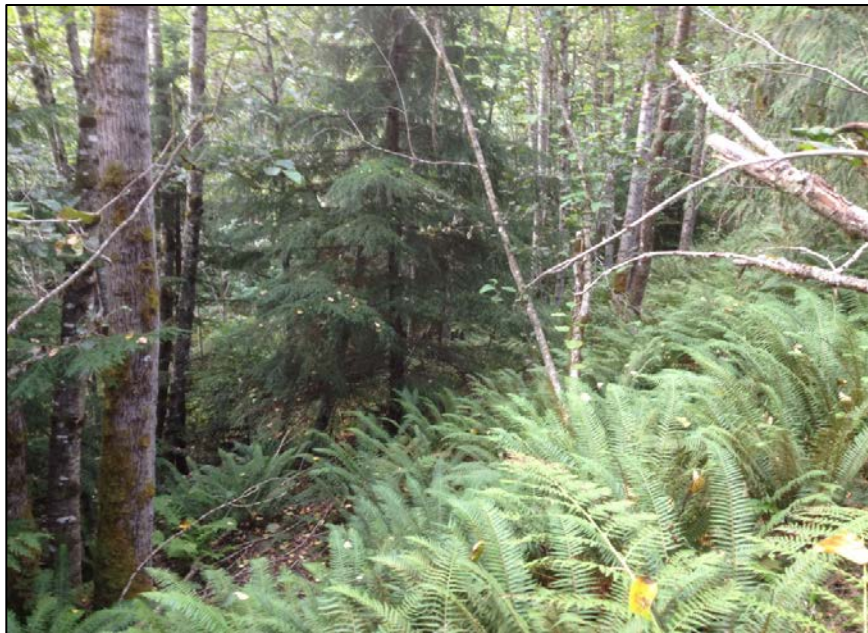
**PHOTO 10** - Upper Tailings Pond - Reclaimed downstream slope at Lower Berm

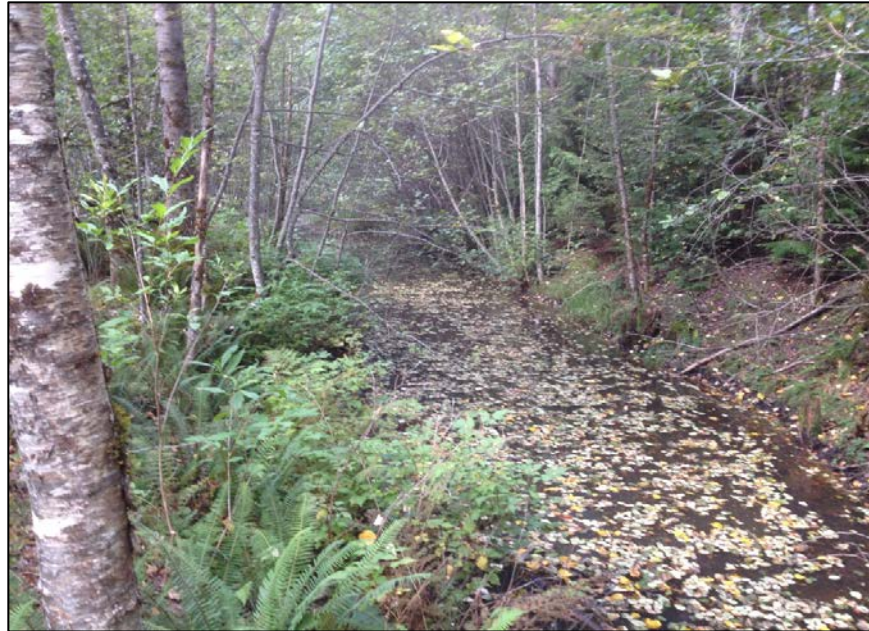
**PHOTO 11** - Upper Tailings Pond - Downstream of Lower Berm

- Ponding of water was observed along the downstream embankment toe of the Lower Berm at the southern end of the Upper Tailings Pond. To ensure long-term performance of the dam and satisfy Passive Closure objectives this area will need to be appropriately graded to eliminate ponding of water and direct surface drainage away from the toe of the embankment.

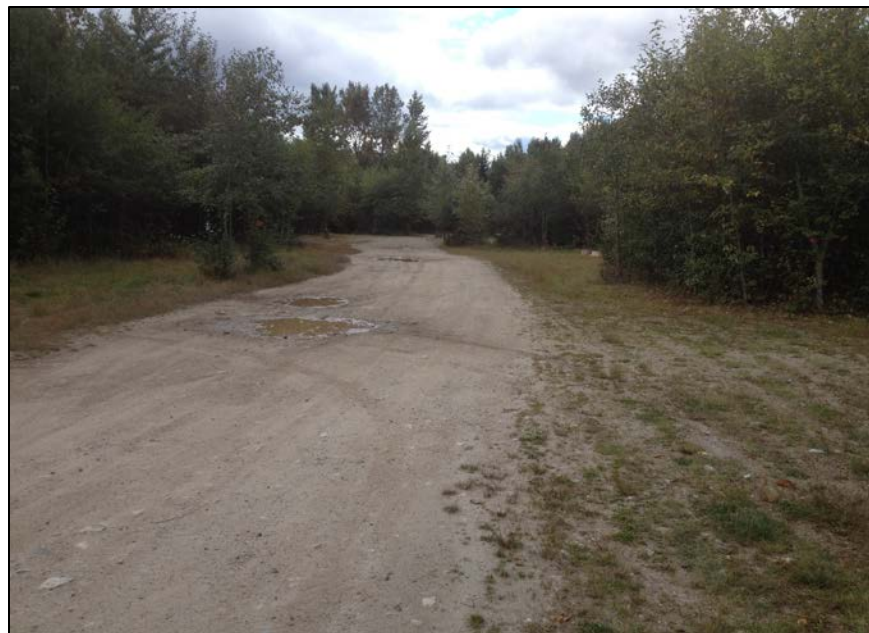
**PHOTO 12** - Upper Tailings Pond - Access along capped and reclaimed tailings surface
