**NORTH AMERICAN METALS CORP.
GOLDEN BEAR MINE**

**TAILINGS STORAGE FACILITY AND HEAP LEACH FACILITIES
REPORT ON 2014 DAM SAFETY INSPECTION**

VA101-65/7-1
Rev 0
October 20, 2014

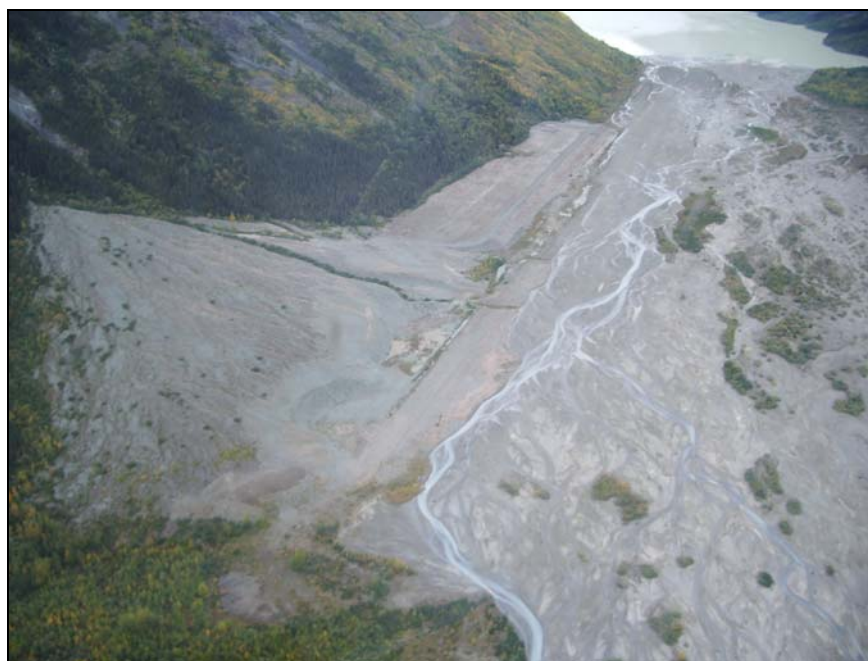
- No signs of instability, such as cracks or deformation were observed in the embankment crest and fill slopes or the cover capping material.
- Limited surface runoff from the north slope flows onto the closure cover and infiltrates into the tailings pile and is subsequently collected in the groundwater drainage system. The cover remains dry and firm, and vegetation has established on the surface.

PHOTO 1 – Overview of Tailings Storage Facility (Looking East)

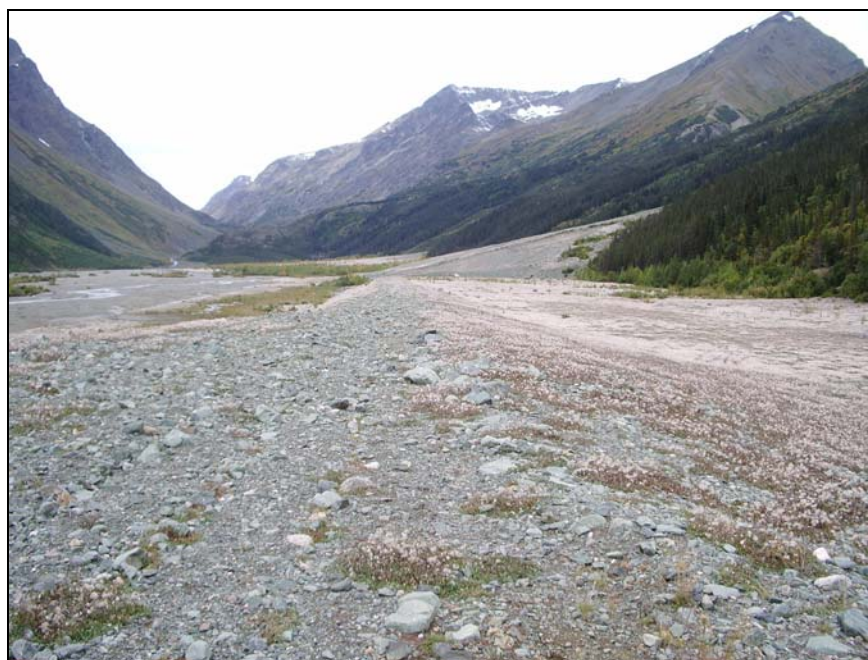
PHOTO 2 – Reclaimed Embankment Crest (Looking West)

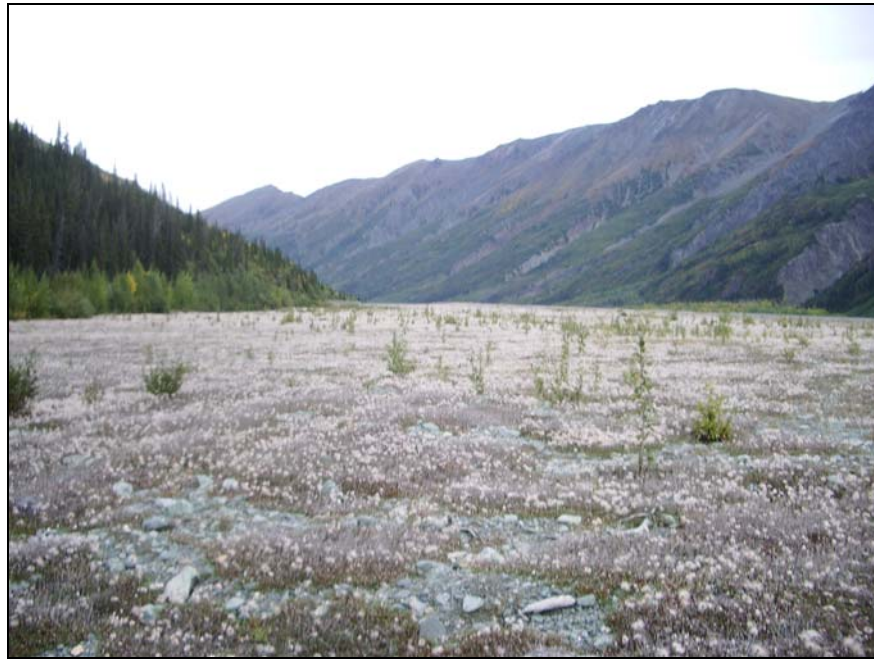
PHOTO 3 – Reclaimed Tailings Facility Surface (Looking East)

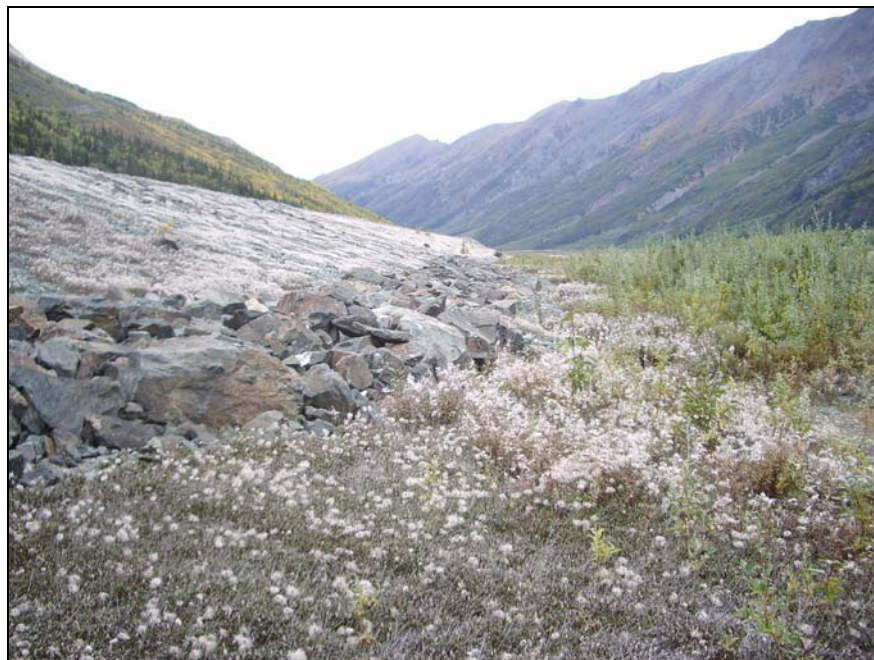
- No signs of erosion from surface water runoff were noted at the entire facility.
- No evidence of flow through the overflow spillway was noted.
- The groundwater outlet pipes continue to discharge into the open channel. The flow was visually estimated at 250 to 400 US gpm during the inspection.

PHOTO 4 – Riprap Erosion Protection along Toe of Downstream TSF Embankment Slope (Looking East)

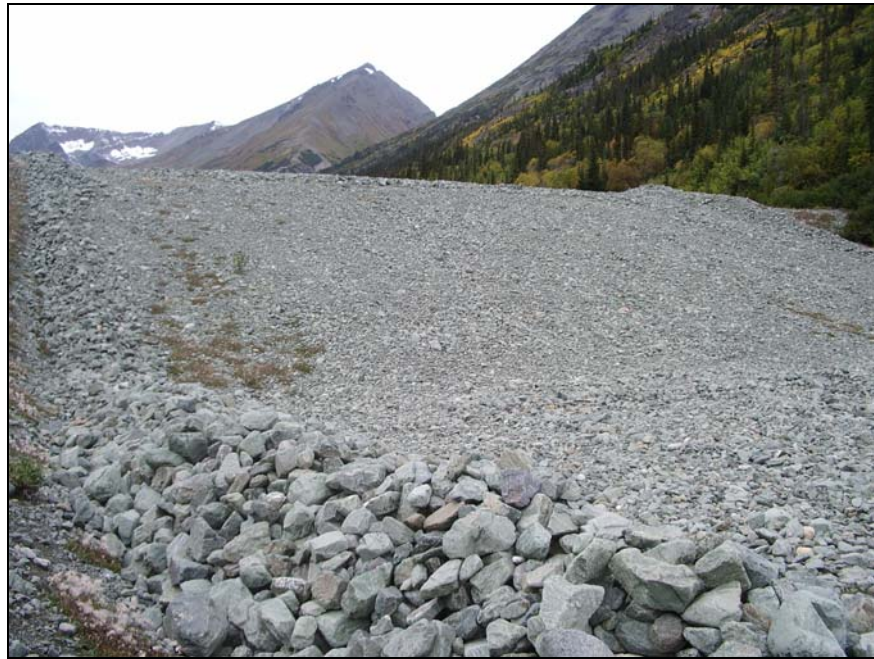
PHOTO 5 – Riprap Erosion Protection in TSF Spillway Channel (Looking West)

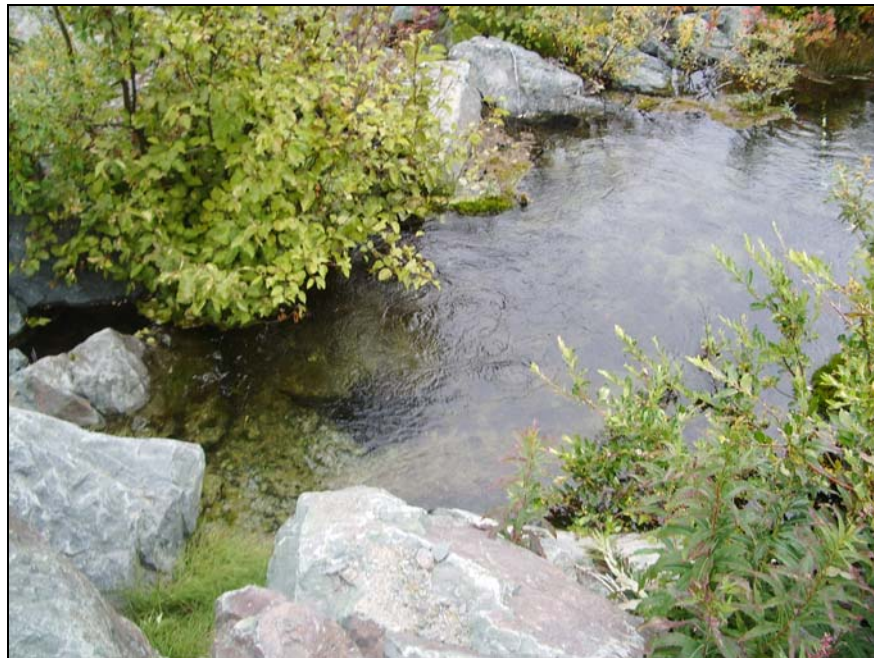
PHOTO 6 – Groundwater Discharge Point at TSF (Looking West)

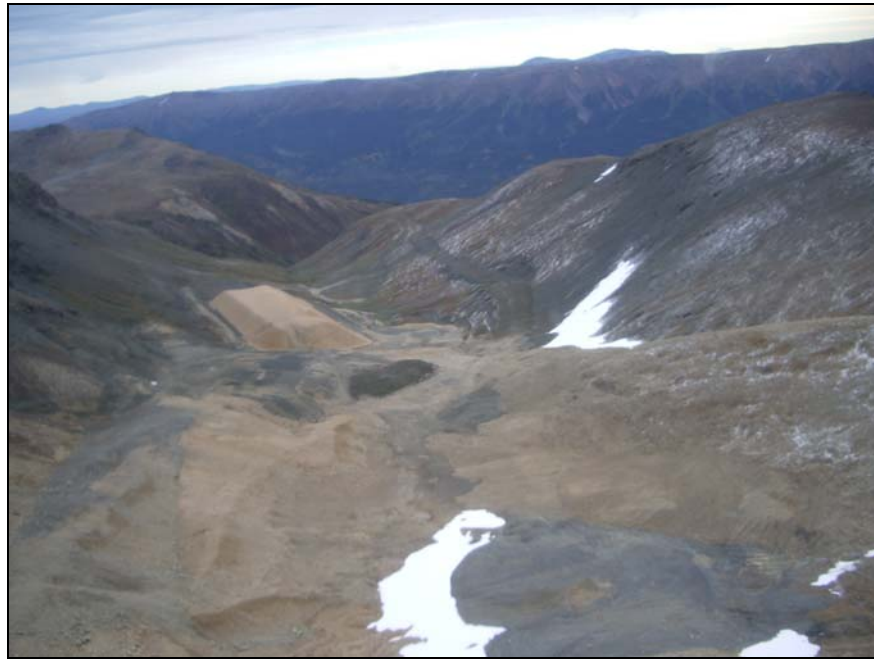
- No signs of instability were observed in the crest and slopes of the heap leach facility.
- No signs of erosion from surface water runoff were noted at the reclaimed heap leach facility, crest, slopes or regarded water storage dam area.
- The V-Notch outlet drain functions well and satisfies the closure design objectives. The discharge flow was visually estimated at 5 to 10 US gpm during the inspection.

PHOTO 7 – Overview of Fleece Bowl Heap Leach Facility (Looking East)

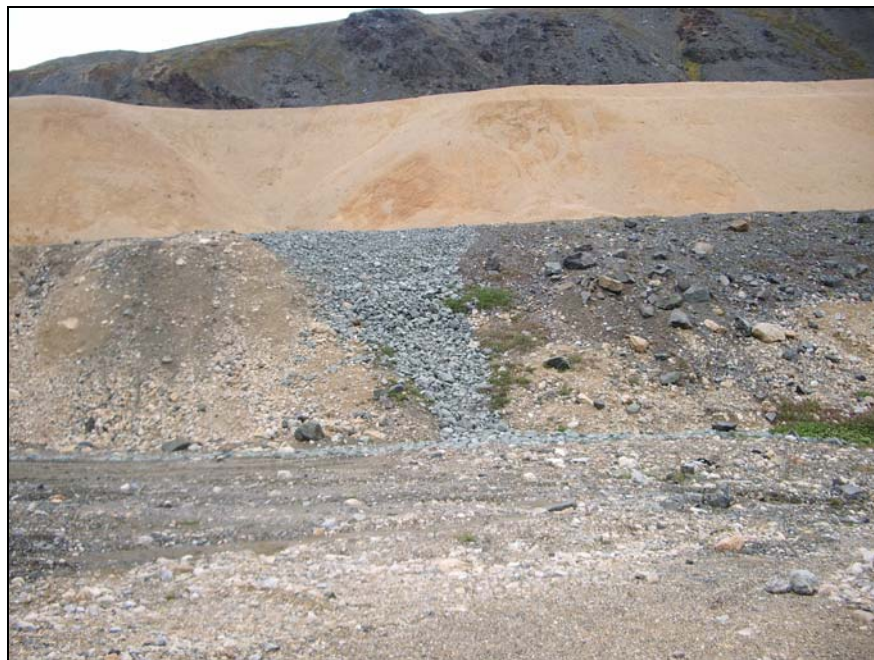
PHOTO 8 – Fleece Bowl Heap Leach Facility V-Notch Outlet Drain in Confining Embankment (Looking West)

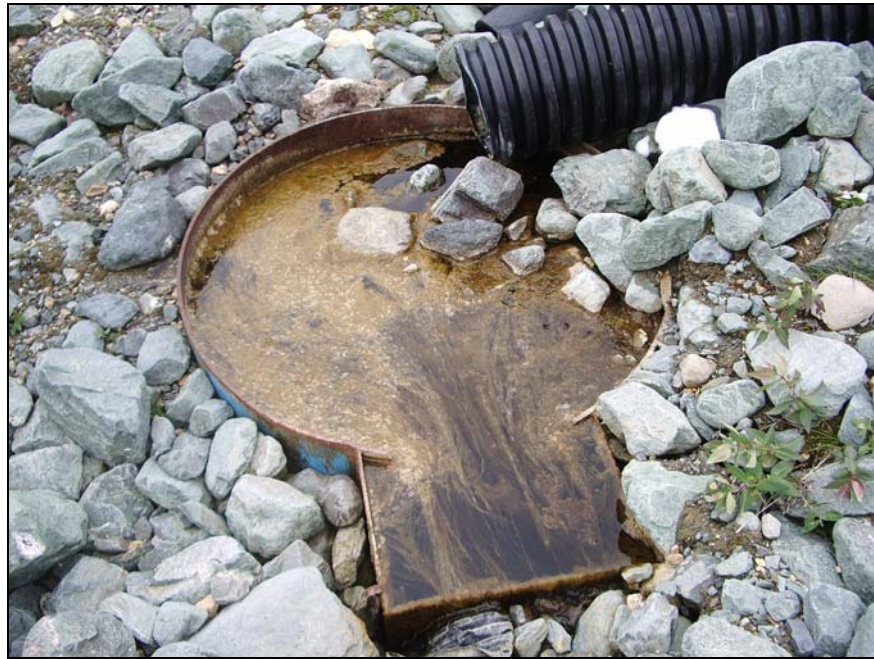
PHOTO 9 – Water Flow from Fleece Bowl Heap Leach Facility V-Notch (Looking South)

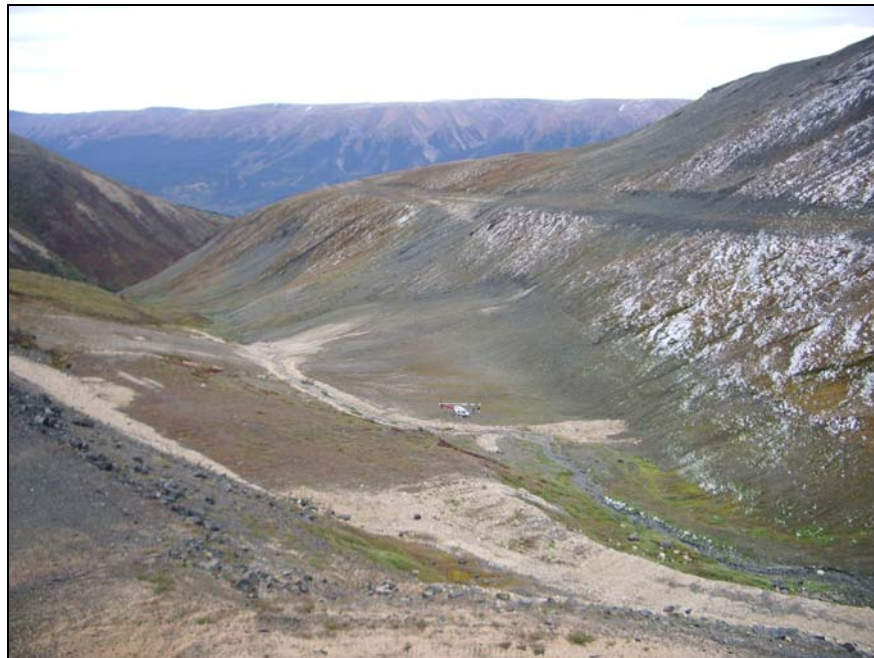
PHOTO 10 – Reclaimed Water Storage Dam Area (Looking East)

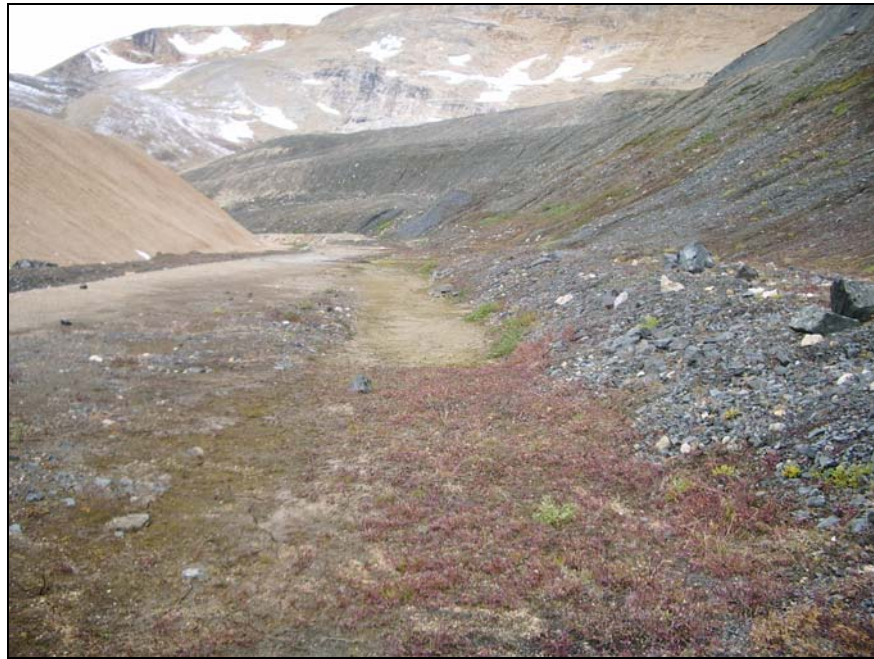
PHOTO 11 – Reclaimed Bench at Fleece Bowl Heap Leach Facility
(Looking West)

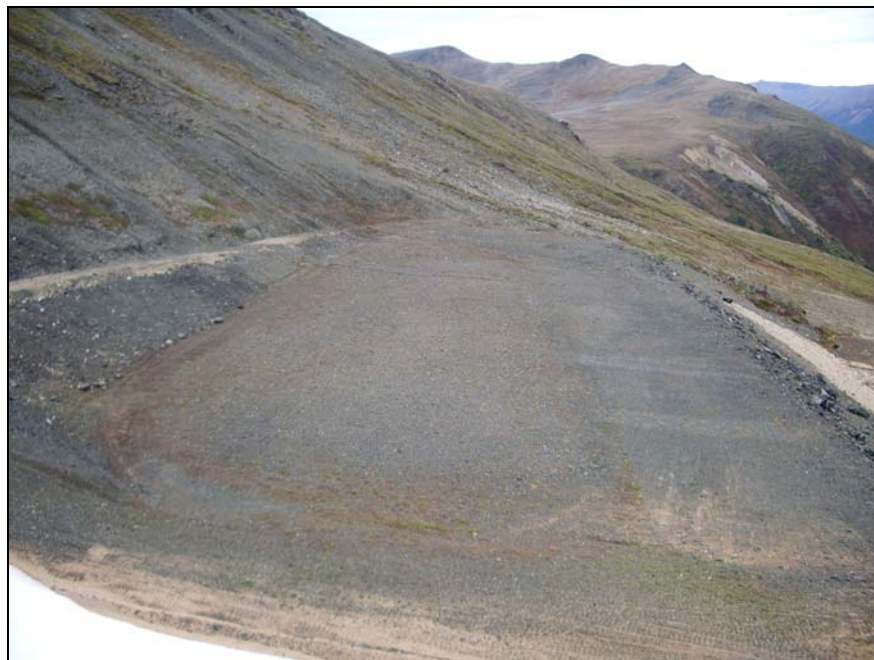
PHOTO 12 – Re-graded Fleece Bowl Events Pond Area (Looking East)

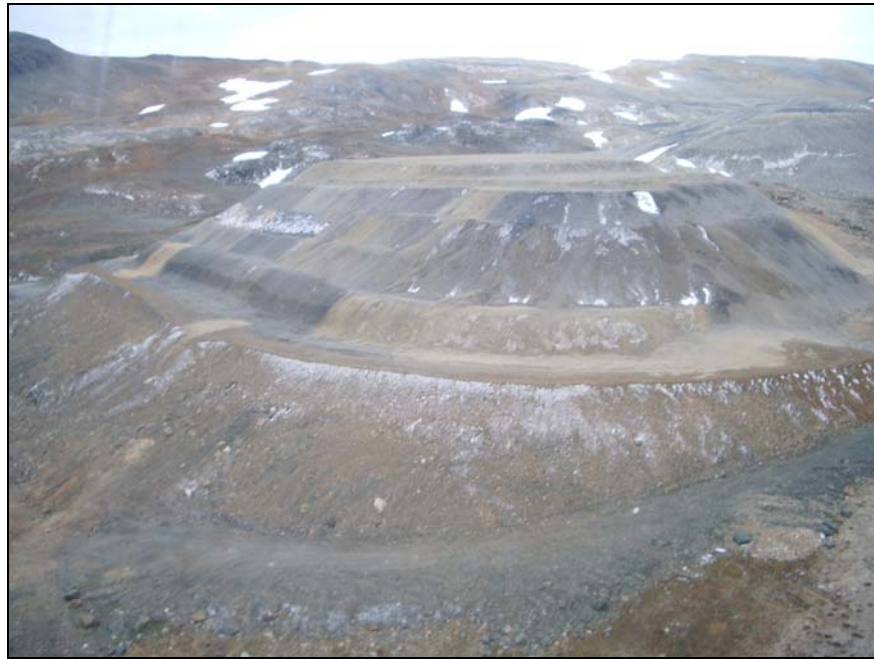
- No signs of instability were observed in the crest and slopes of the heap leach facility.
- No signs of erosion from surface water runoff were noted at the reclaimed heap leach facility.
- The V-Notch outlet drain functions well and satisfies the closure design objectives. The outlet flow was visually estimated at 1 to 2 US gpm during the inspection.

PHOTO 13 – Overview of Totem Creek Heap Leach Facility (Looking North)

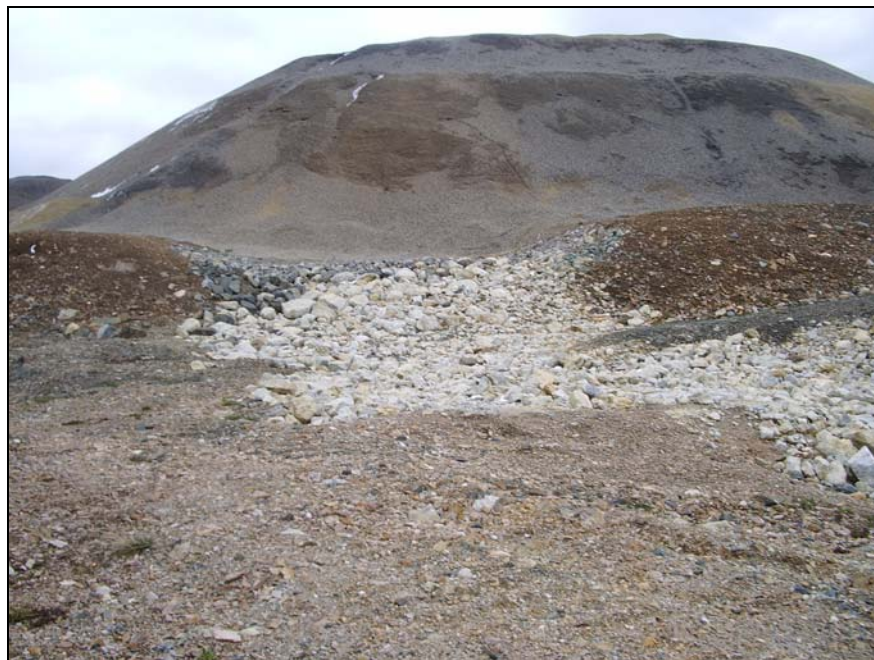
PHOTO 14 – Totem Creek Heap Leach Facility V-Notch Outlet Drain in Confining Embankment (Looking South)

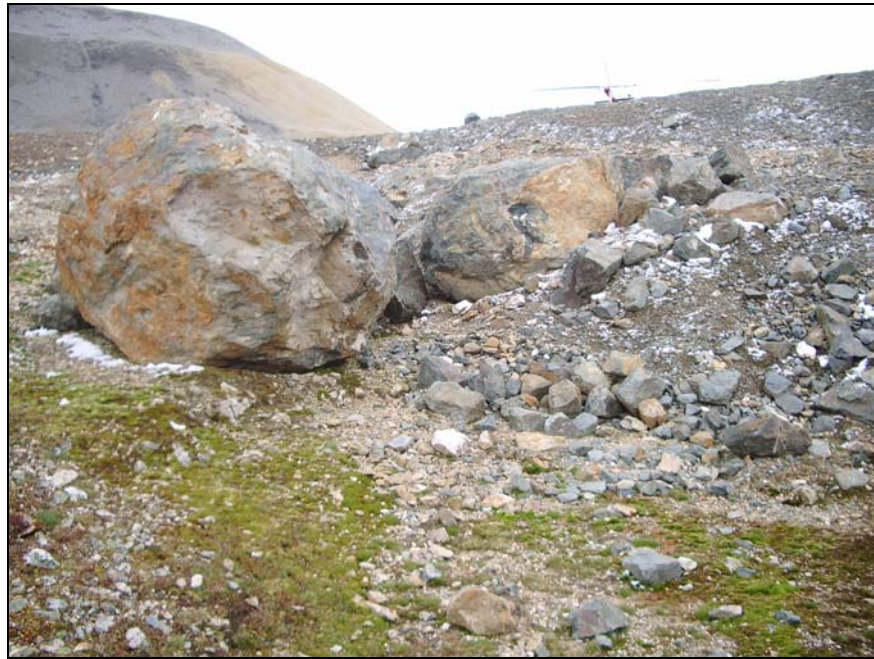
PHOTO 15 – Water Flow from Totem Creek Heap Leach Facility V-Notch Outlet Drain (Looking South)

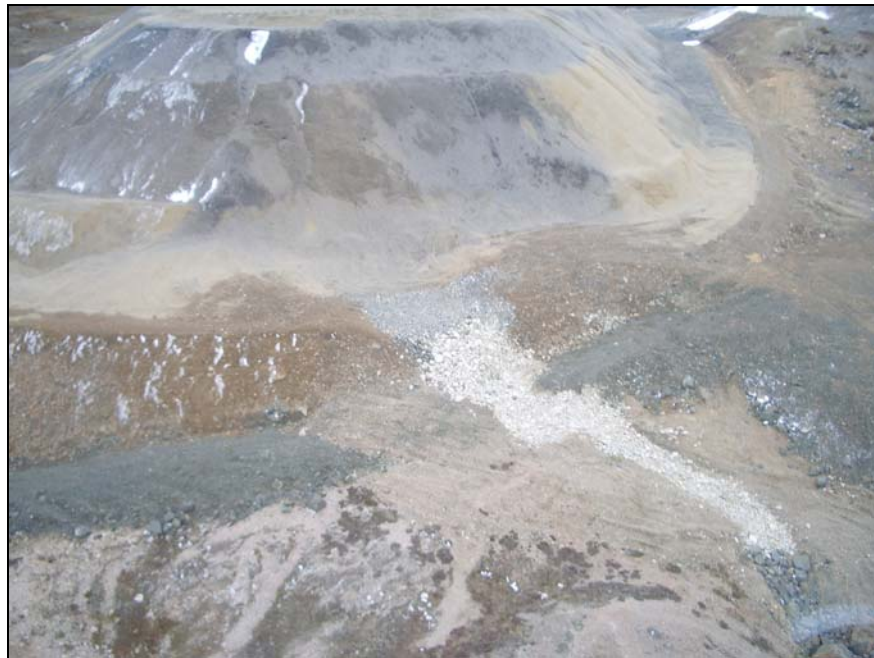
PHOTO 16 – Totem Creek Facility V-Notch Discharge Point into Existing Swale (Looking South)

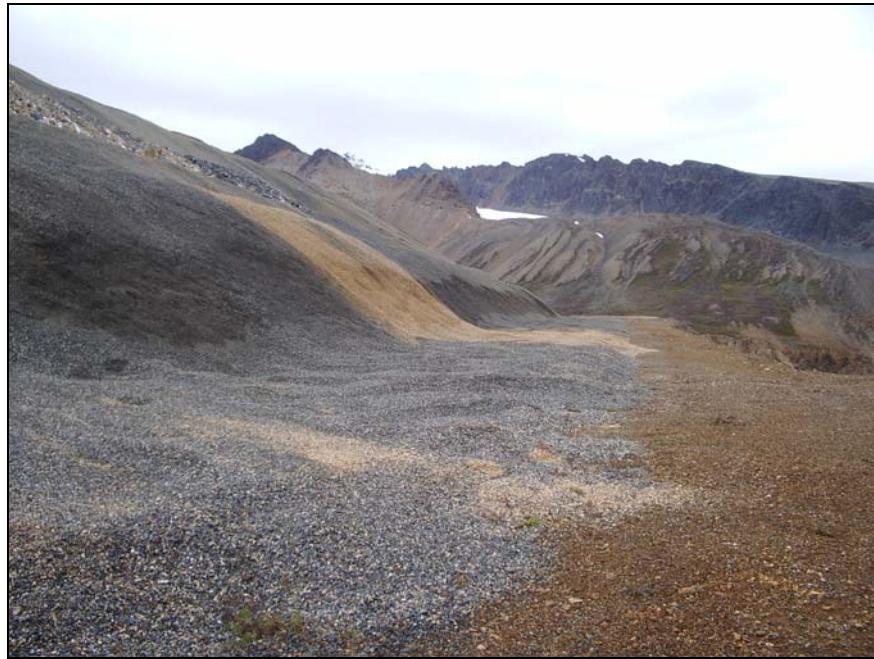
PHOTO 17 – Reclaimed Confining Embankment at Totem Creek Heap Leach Facility (Looking South)

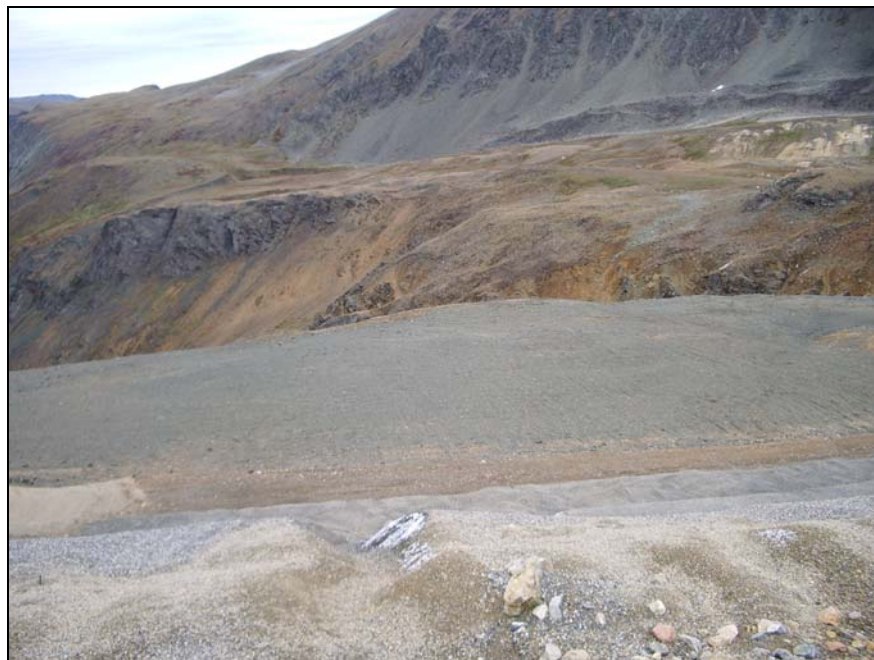
PHOTO 18 – Re-graded Totem Creek Events Pond Area (Looking Northeast)
