Barkerville Gold Mines Ltd.

Goldstream Tailings Storage Facility

Background Report for Response to MEM Memorandum

June 2015

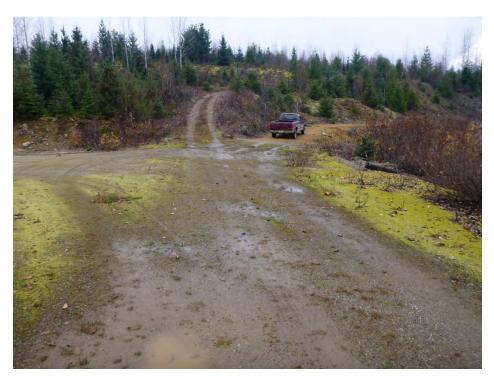
Photo 2 – Right abutment area and crest of West Dam. Photo taken facing north. BGM caretaker indicated a former Emergency Spillway at right abutment of dam with slightly lower elevation than crest of dam.

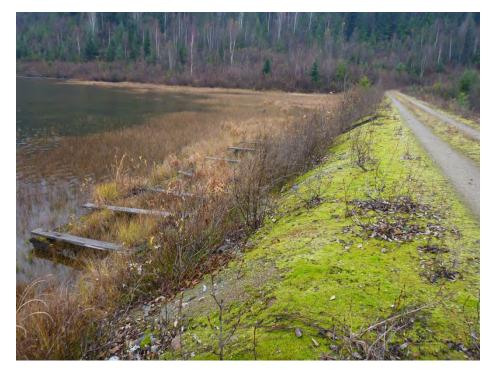
Photo 5 – Crest and upstream slope of West Dam. Photo taken from near mid-point of crest, facing south. Note deteriorated wood structure formerly used to support tailings discharge in middle of TSF.

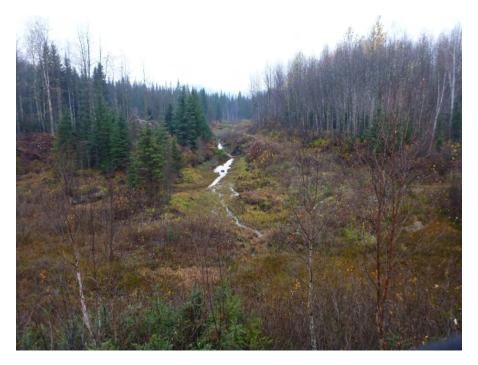
Photo 8 – Downstream toe area at former Virginia Creek channel. Photo taken from mid-slope location on West Dam, facing west. Beaver damming has started shortly after recent removal of previous beaver dams.

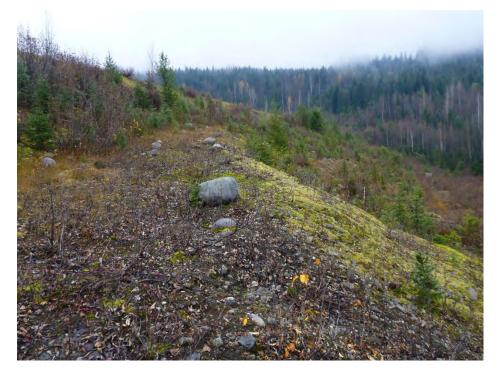
Photo 9 - Access ramp on downstream slope of West Dam, near right abutment. Photo taken from near right abutment, facing south. Note tree and shrub growth on downstream slope of dam.

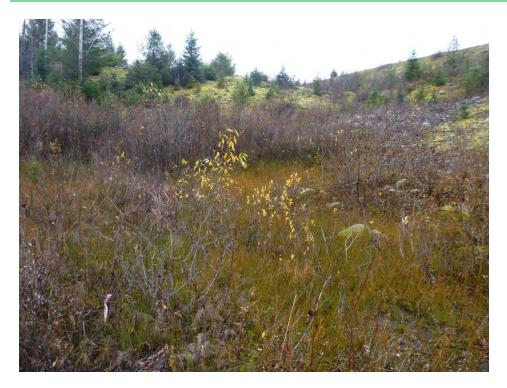
Photo 13 – Seepage area on lower portion of right abutment fill – native ground contact of West Dam. Photo taken facing north east. Note density of vegetation and hydrophilic vegetation.

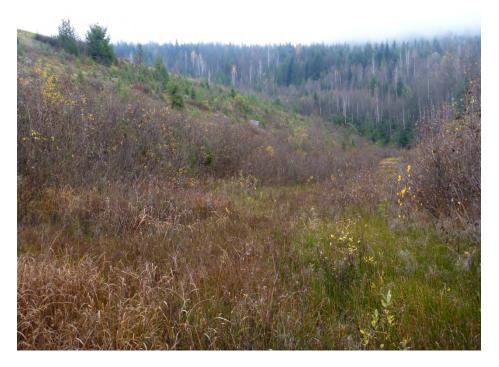
Photo 14 – Downstream toe area of West Dam. Photo taken from right abutment toe area, facing south. Note density of shrubs (willows, alders) at toe of dam.

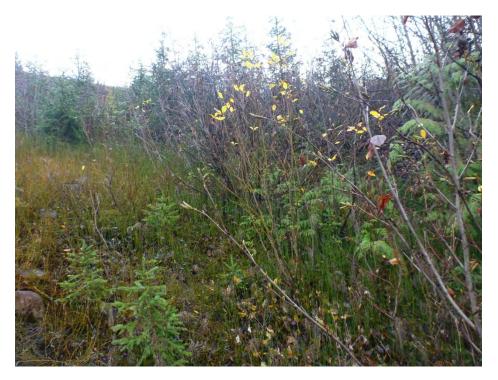
Photo 16 – Seepage zone and hydrophilic vegetation ground at seepage zone located near left abutment just above toe area. Photo taken facing south east up left abutment of West Dam.

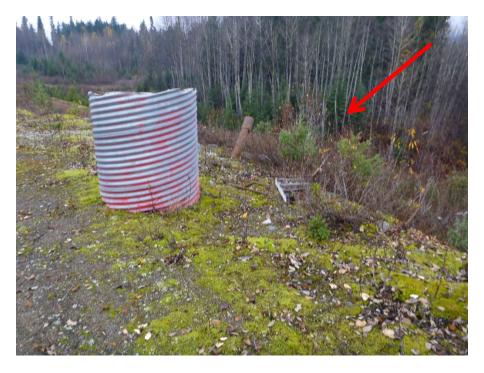
Photo 21 – Damaged (but still functioning) piezometer at crest of North Dam. Corrugated steel pipe protection was relocated during routine maintenance and red arrow indicates accidently damaged piezometer. Photo take facing north west.

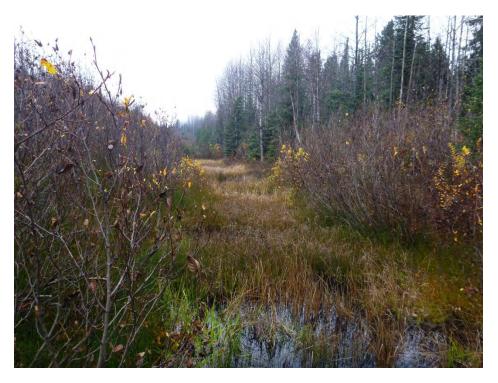
Photo 26 – Downstream toe of North Dam near right abutment. Photo taken facing west. Note ponded water at toe and dense vegetation at downstream toe of dam.

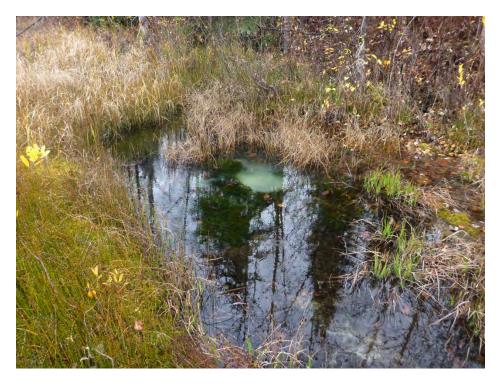
Photo 28 – Turbid water plume at base of pond of water at downstream toe of North Dam. Pond located at approximately 50 m from right elbow of dam. Photo taken facing northwest.

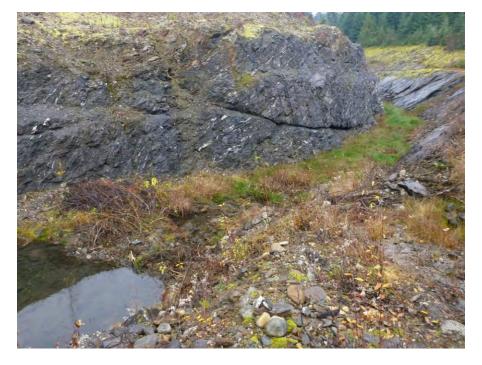
Photo 29 – Emergency Spillway control section. Photo taken facing north east. Note accumulation of debris at control section due to beaver activity and stockpile of previous beaver dam materials to right of control section.

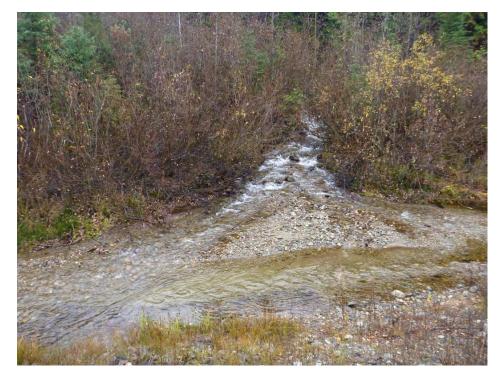
Photo 33 – Confluence of tributary stream and East Diversion ditch. Photo taken facing south. Note alluvium building up in diversion ditch.

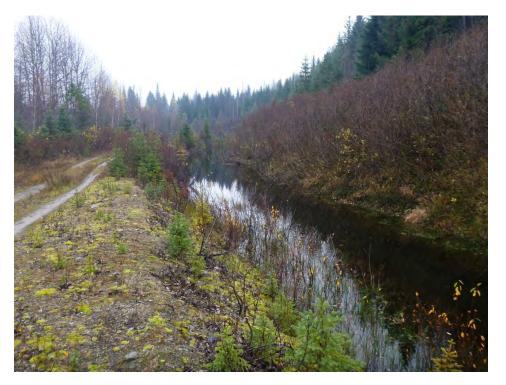
Photo 34 – East Diversion ditch with water backed up due to beaver damming. Photo taken facing east.

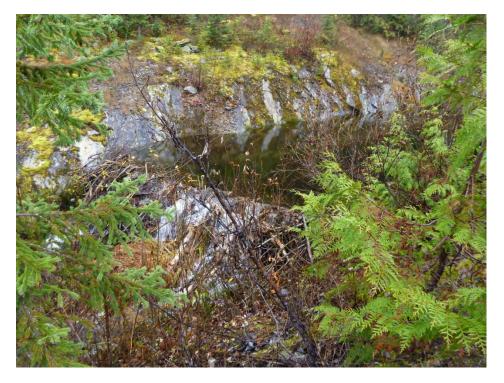
Photo 35 – The larger of two beaver dams in the East Diversion Ditch. Photo taken facing south west.

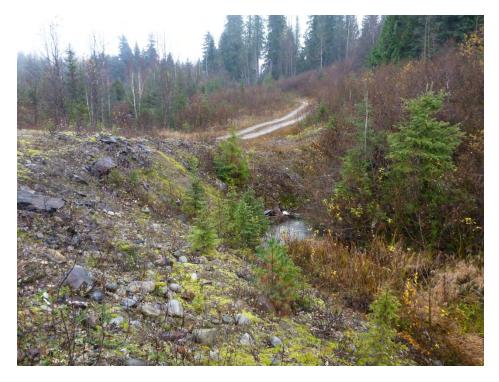
Photo 36 – Access road crossing East Diversion ditch. Photo taken facing north east. Note twin culverts, low crest of access road to permit ditch flow overtopping and woody debris at inlet of culverts.

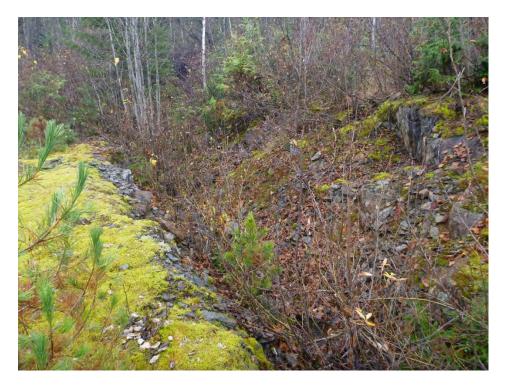
Photo 37 – Virginia Creek Diversion Ditch upstream of south TSF access road. Photo taken facing south east. Note willows/alders growing in channel.

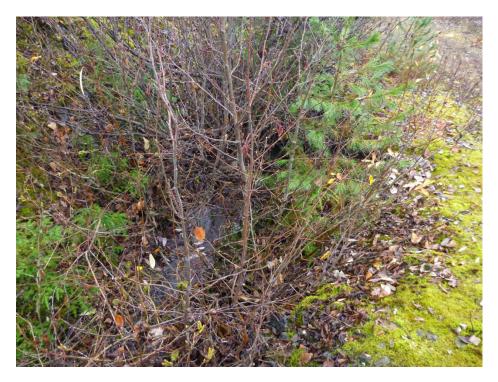
Photo 38 – Inlet to Virginia Creek Diversion Ditch culvert crossing access road to south of TSF. Photo taken facing north west. Note density of willows/alders at inet of culvert.
