**Reference: Granisle Mine Site
2014 Dam Safety Inspection**

GRANISLE MINE SITE
2014 DAM SAFETY INSPECTION
FINAL REPORT

November 2014

AMEC File: TE143006

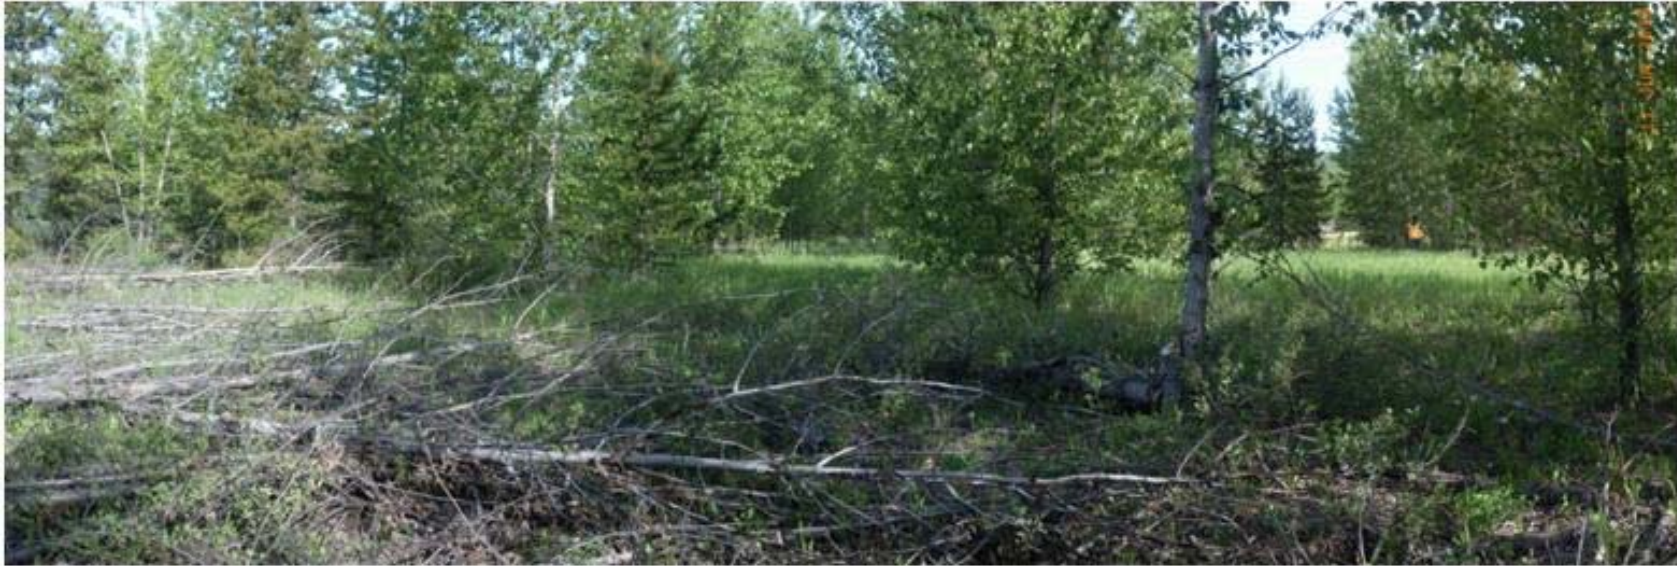
Photo C-1: View of the tailings beach. Looking north-east from the crest at the left end of Dam 1 (the segment that is oriented NW-SE). Note that tailings beach is well vegetated. (11 June 2014)

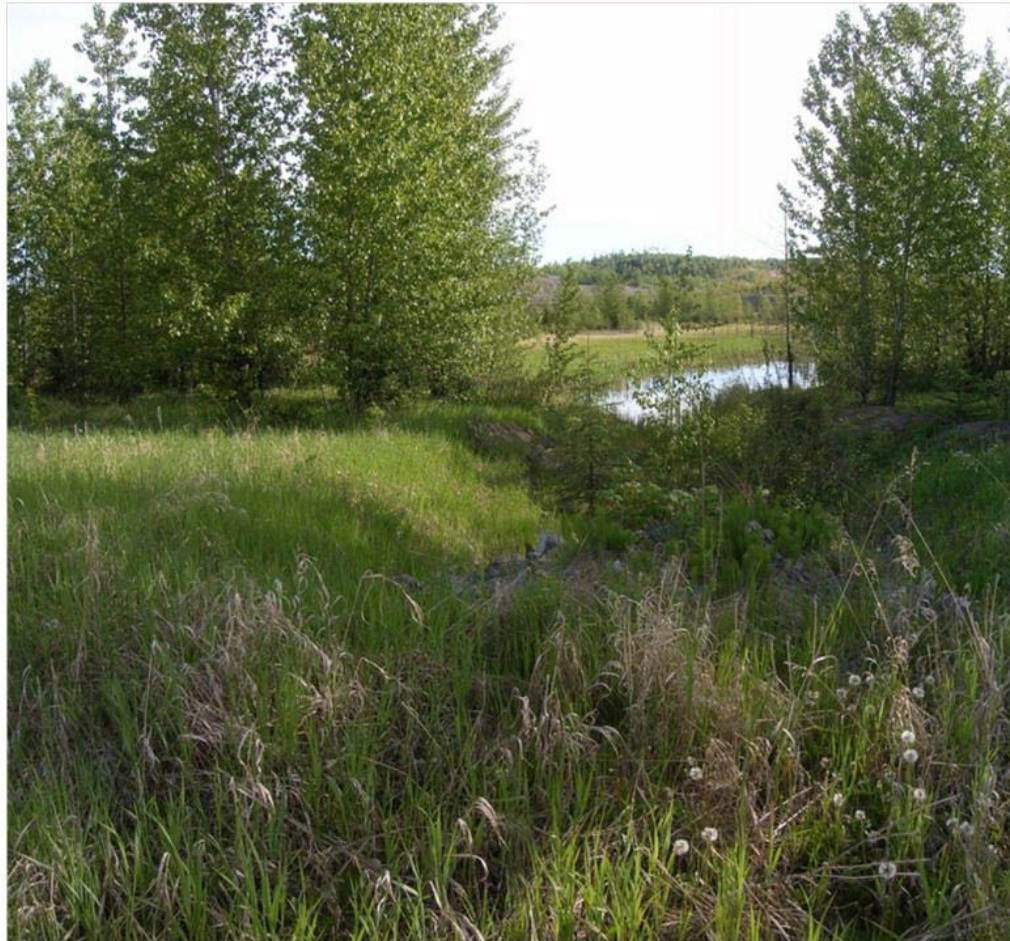
Photo C-2: View of the tailings beach and pond, looking east from the crest, near the north-west end of the segment that is oriented NW-SE. Note that tailings beach is well vegetated and pond is well away from the crest. (11 June 2014)

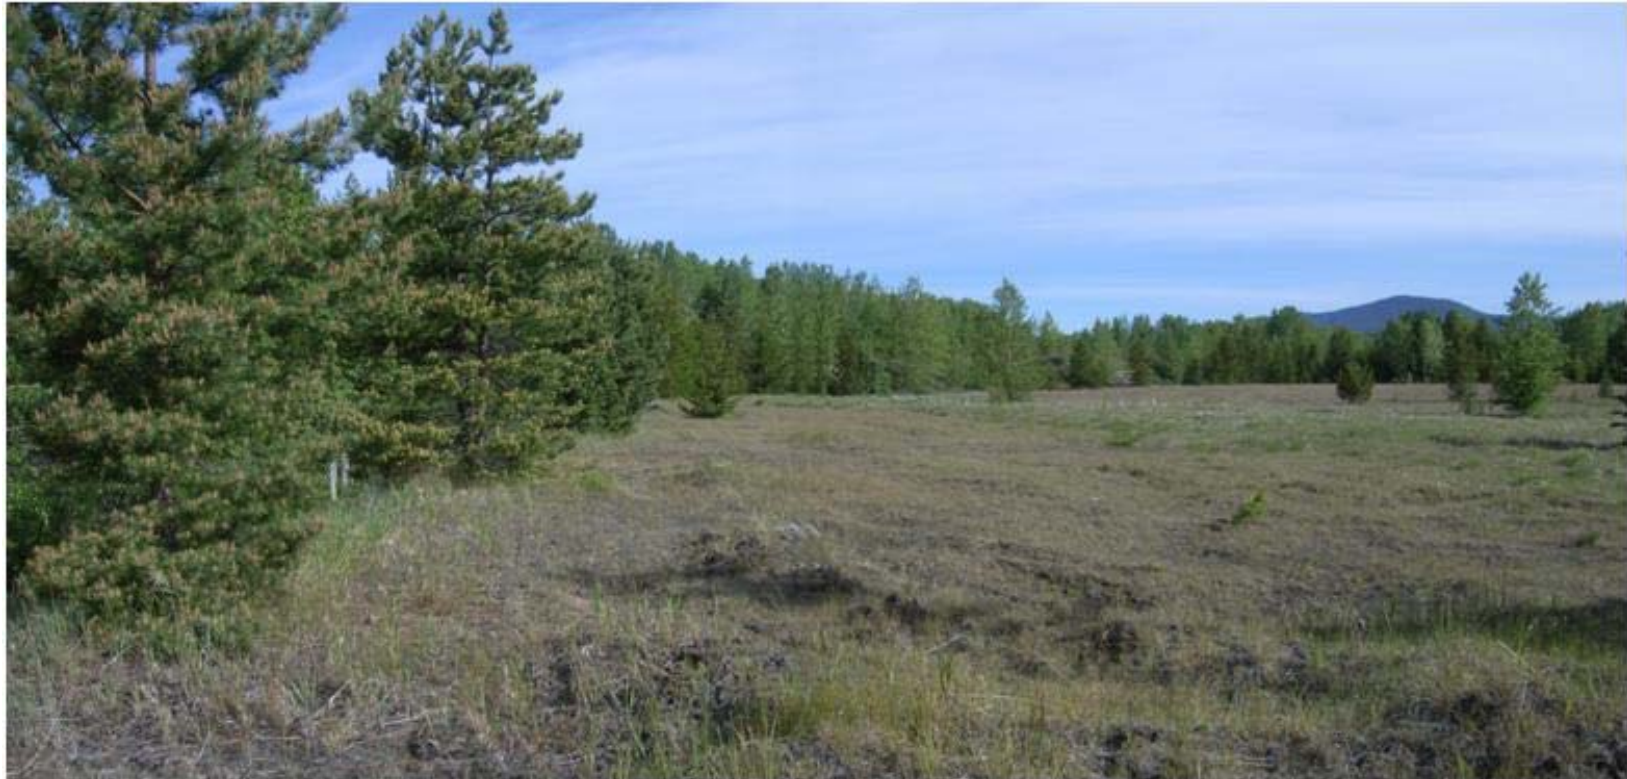
Photo C-3: View of the upstream beach for the segment of the dam that is oriented NW-SE. Looking north-west from about one third along the dam segment. The dam crest is on the left. The downstream slope of the dam is located on the west side of the photo but is heavily vegetated and difficult to see. (11 June 2014)

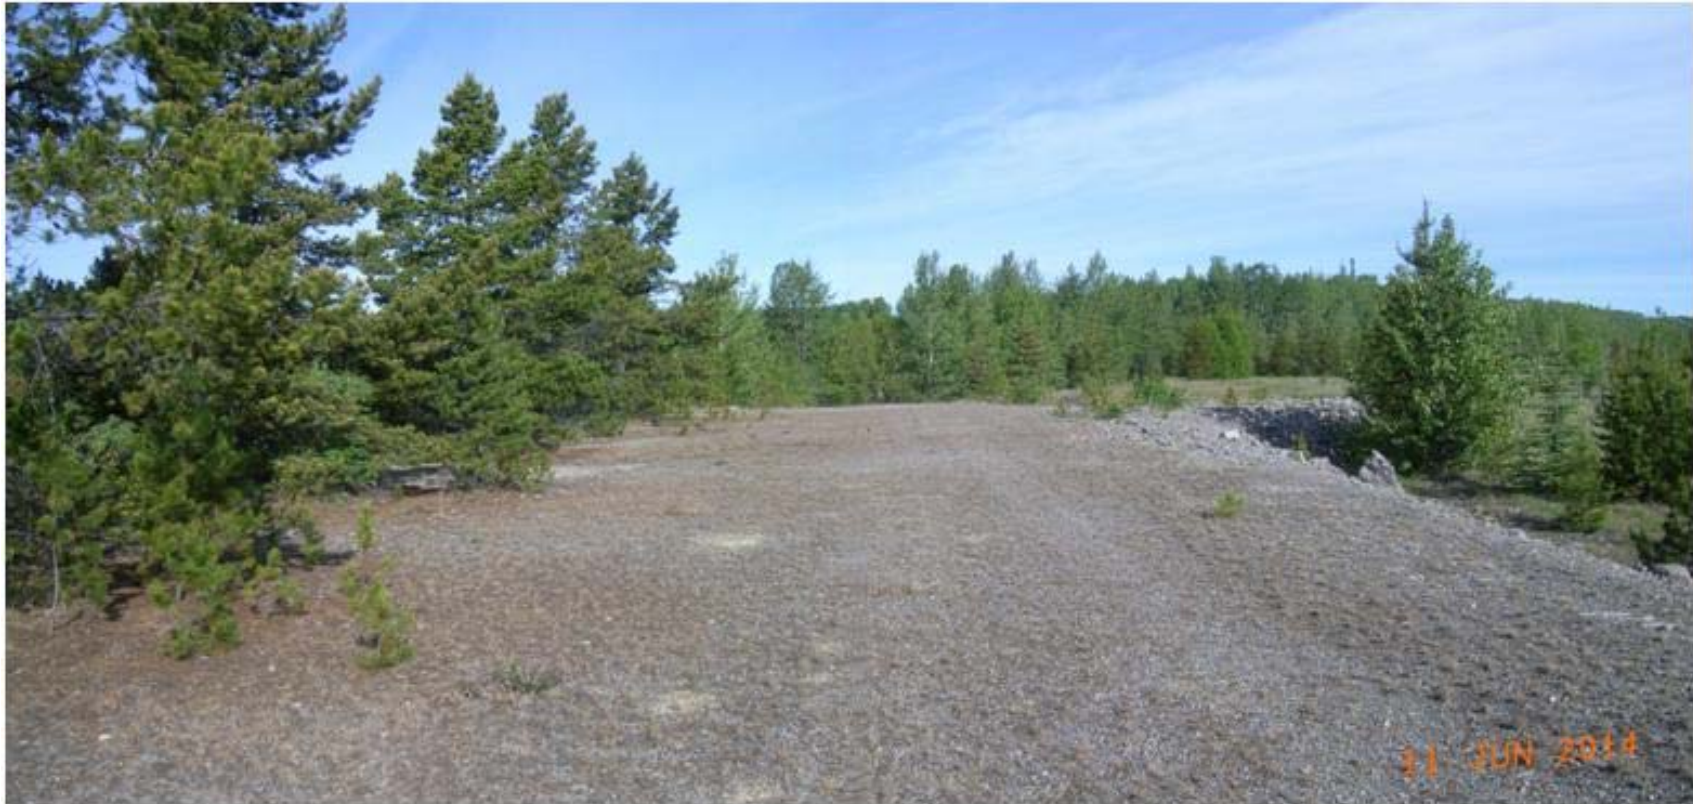
Photo C-4: View of the crest of Dam 1, looking north-west along the segment of the dam that is oriented NW-SE. In the background is a depression that will act as a spillway. See the next photo. (11 June 2014)

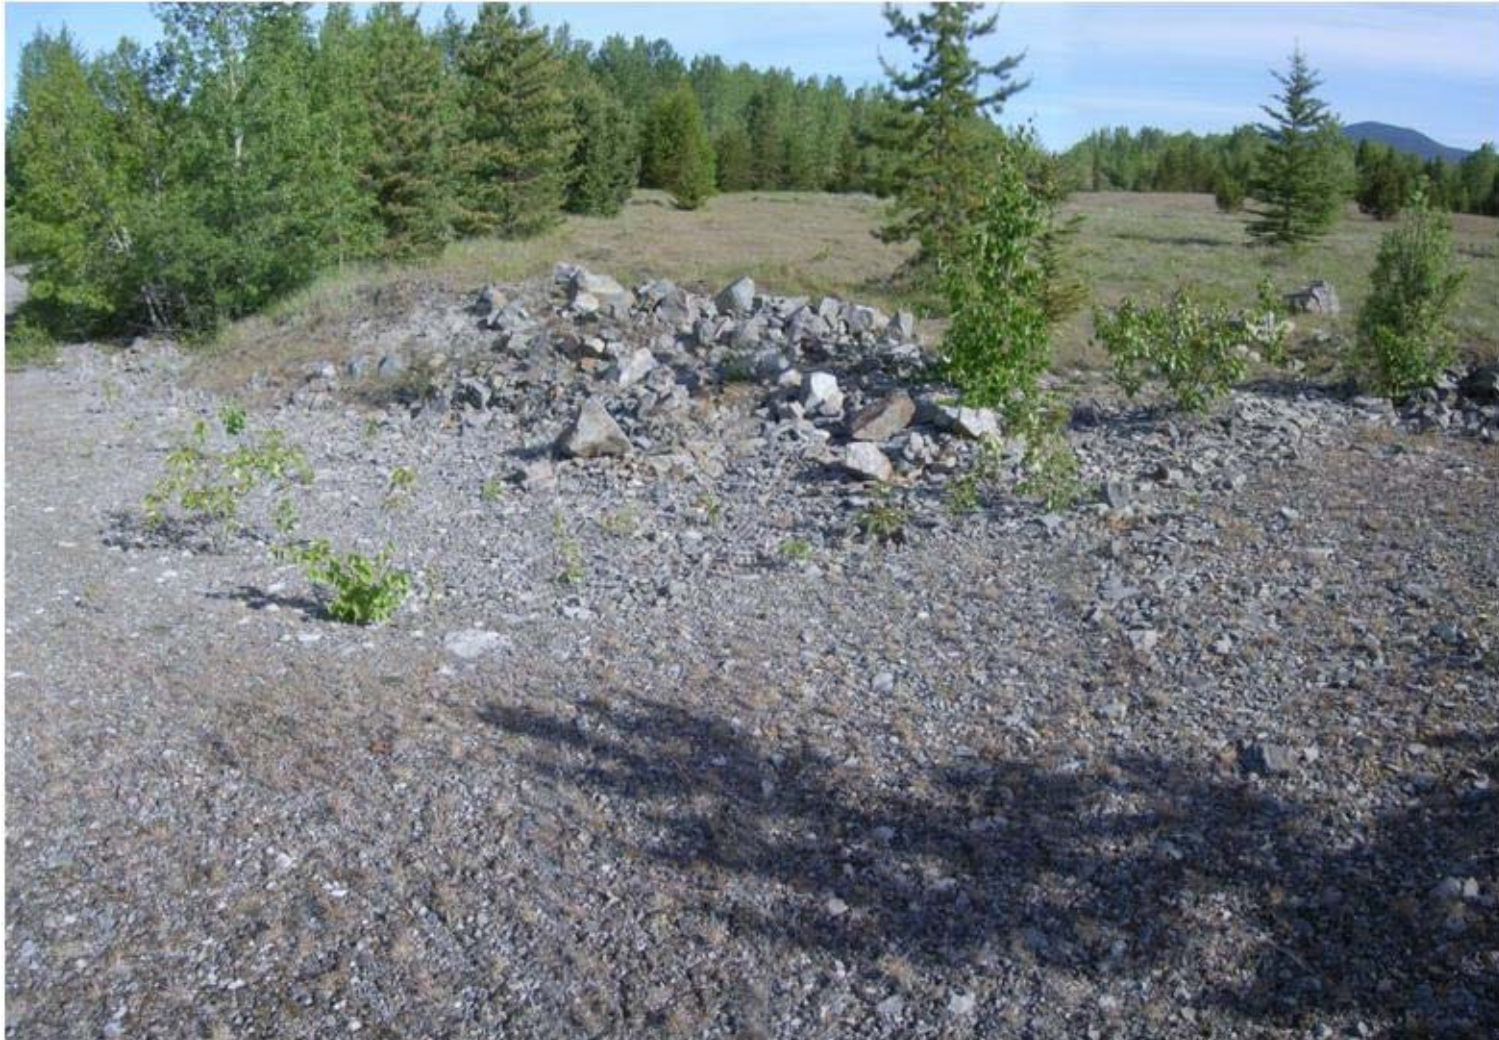
Photo C-5: View of the depression in central portion of Dam 1 that will act as a spillway. Looking north-west. According to Glencore, this feature was not intended to be a spillway, but it could act as such. (11 June 2014)

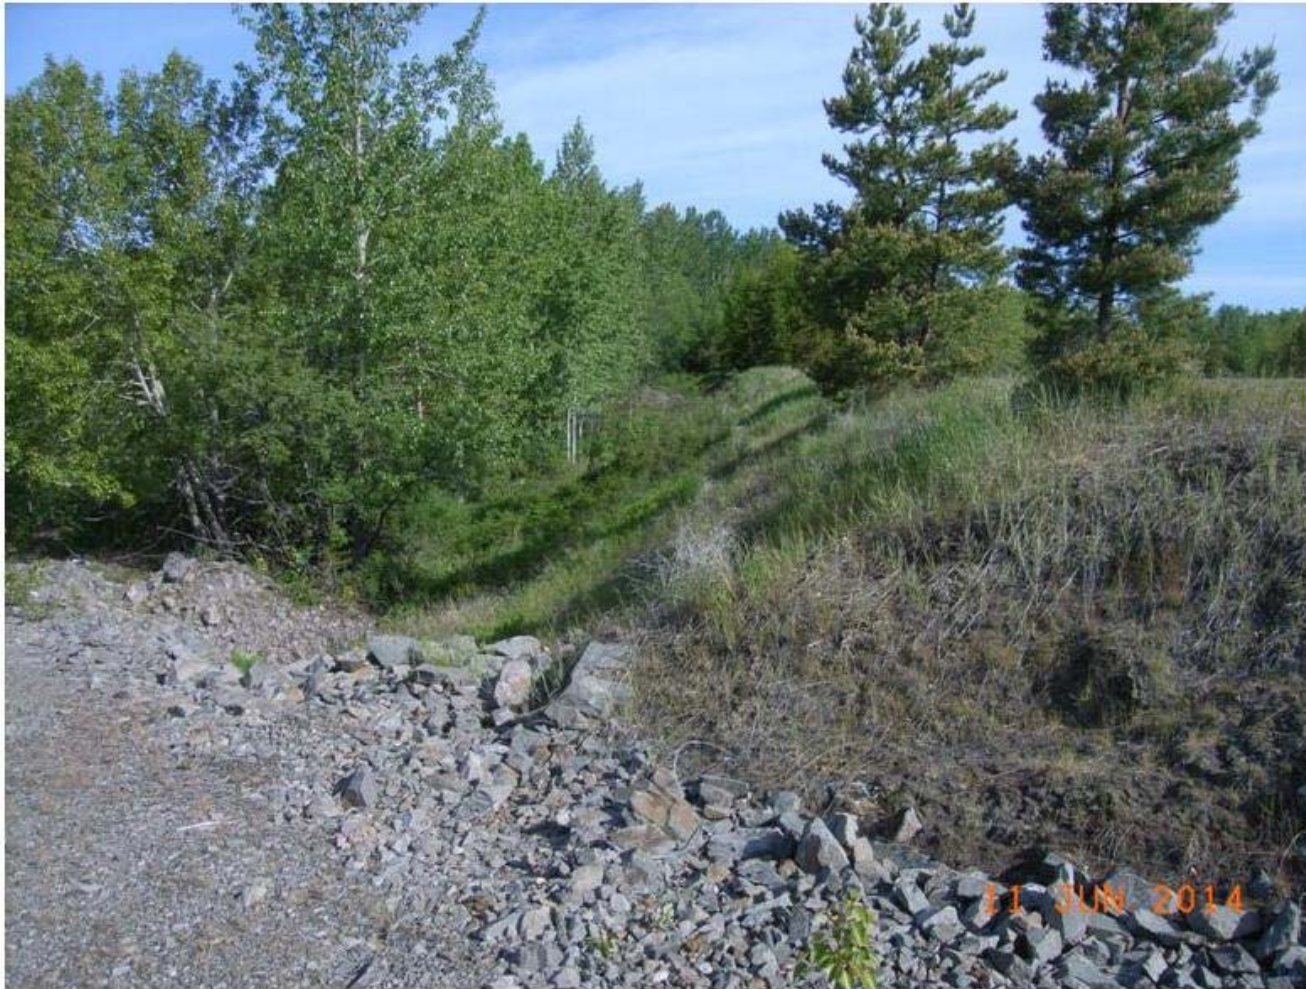
Photo C-6: View of the downstream discharge channel of the depression that could act as a spillway, looking north-west from the crest of Dam 1. (11 June 2014)

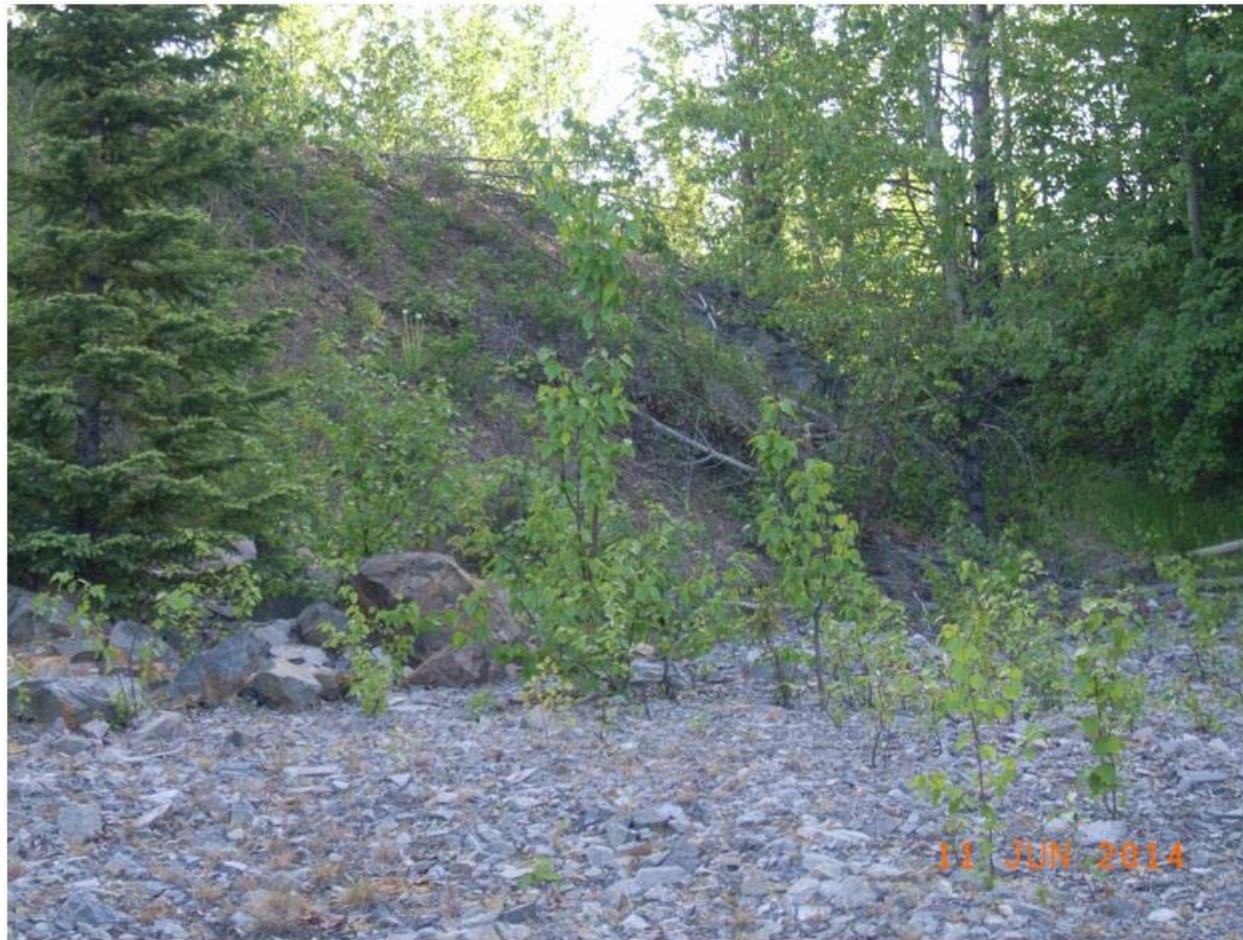
Photo C-7: View of the downstream slope at left abutment, looking north-east from beyond the toe of Dam 1. Note that the downstream slope of the dam is heavily vegetated, but it is not a concern. The actual spillway for the dam is located on the right side of the photo, note the depression, but it is covered in vegetation. (11 June 2014)

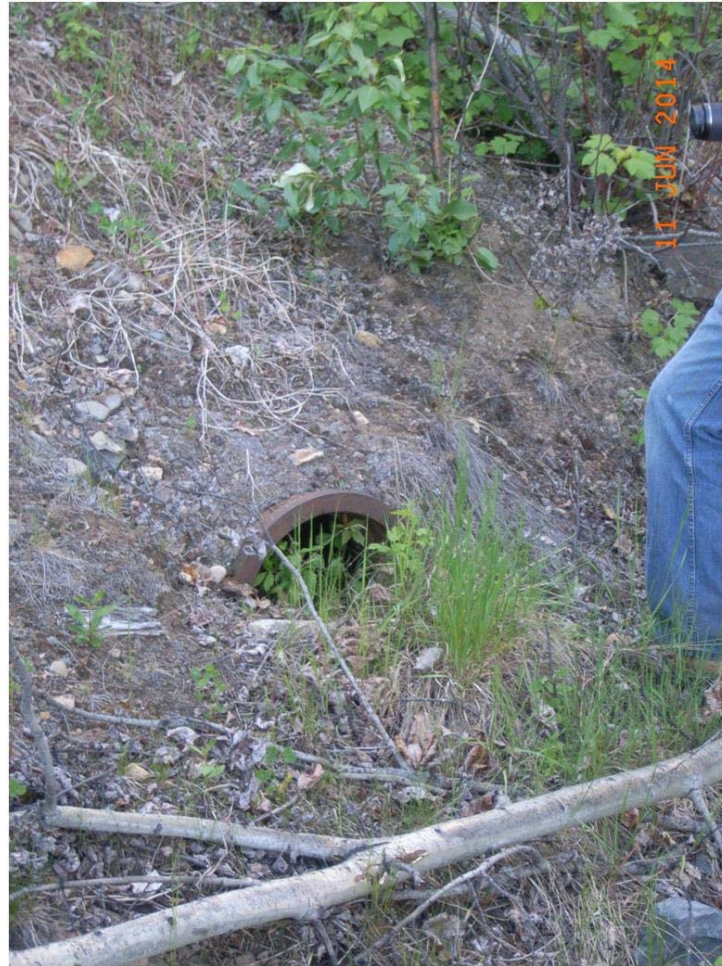
| No. | 2014 DSI Observations | Change from 2013 | Concern? |
|---|--|---|---|
| 1 | A cast iron pipe was noted buried in the toe of the downstream slope, near the left abutment. This was the discharge of a former decant pipe that was decommissioned. Pipe condition within the dam is unknown. | No | No |

| Observed Features | Yes | No | Photo # | Comment / Note # |
|--|---|---|---|---|
| 5.10 Other Unusual Conditions | X | | C-8 | Buried steel pipe from former decant structure daylight at the downstream toe near the abutment |

Photo C-8: View of a cast iron pipe located at the toe of the downstream slope of Dam 1, near the left abutment. This was a former decant pipe from the pond that had been decommissioned. There was no evidence of seepage around the pipe. Looking north-east from the toe of Dam 1. (11 June 2014)

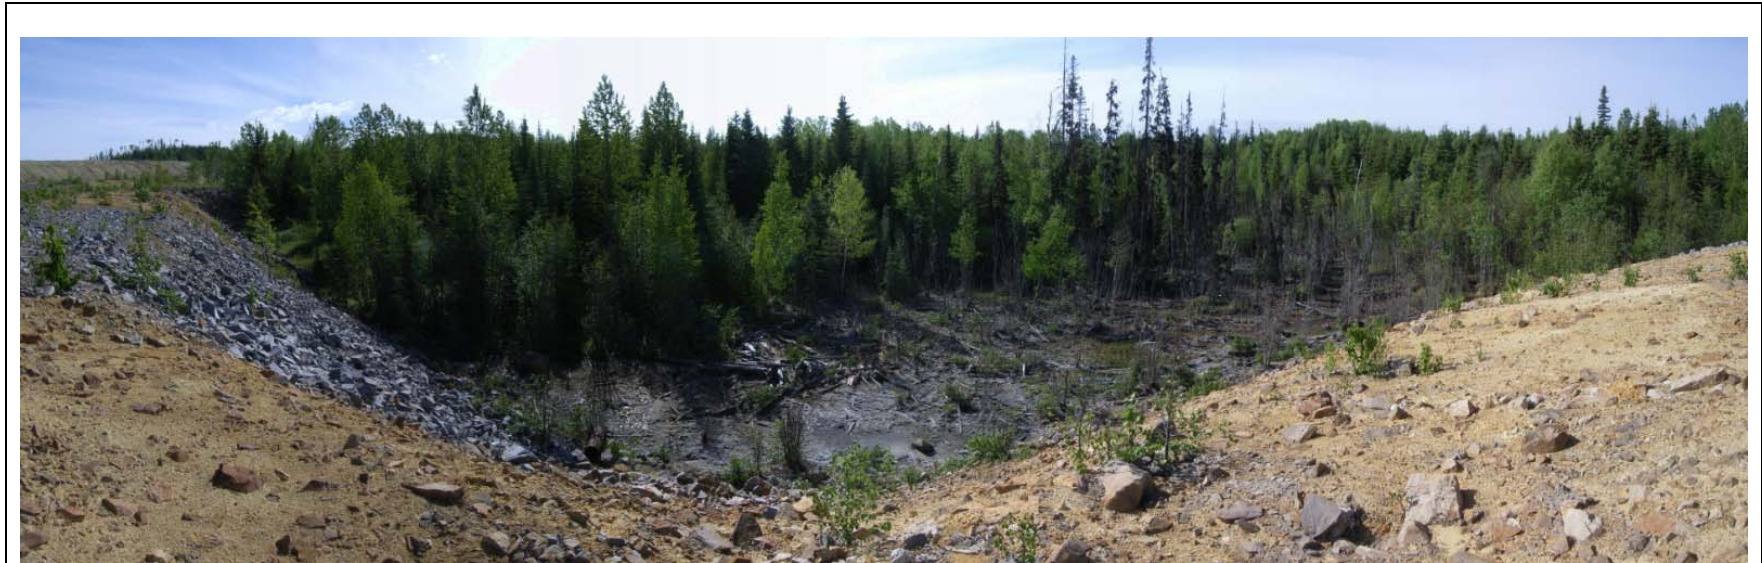
Photo D-12: View of the downstream toe of Dam 5, looking south. Some seepage evident, not a concern. (11 June 2014)
