**Teck Coal Ltd.**

**Greenhills Operations**

***Dam Safety Inspection Report  
Independent Third Party Review***

**Greenhills Operations – Dam Safety Inspection Report  
Independent Third Party Review**

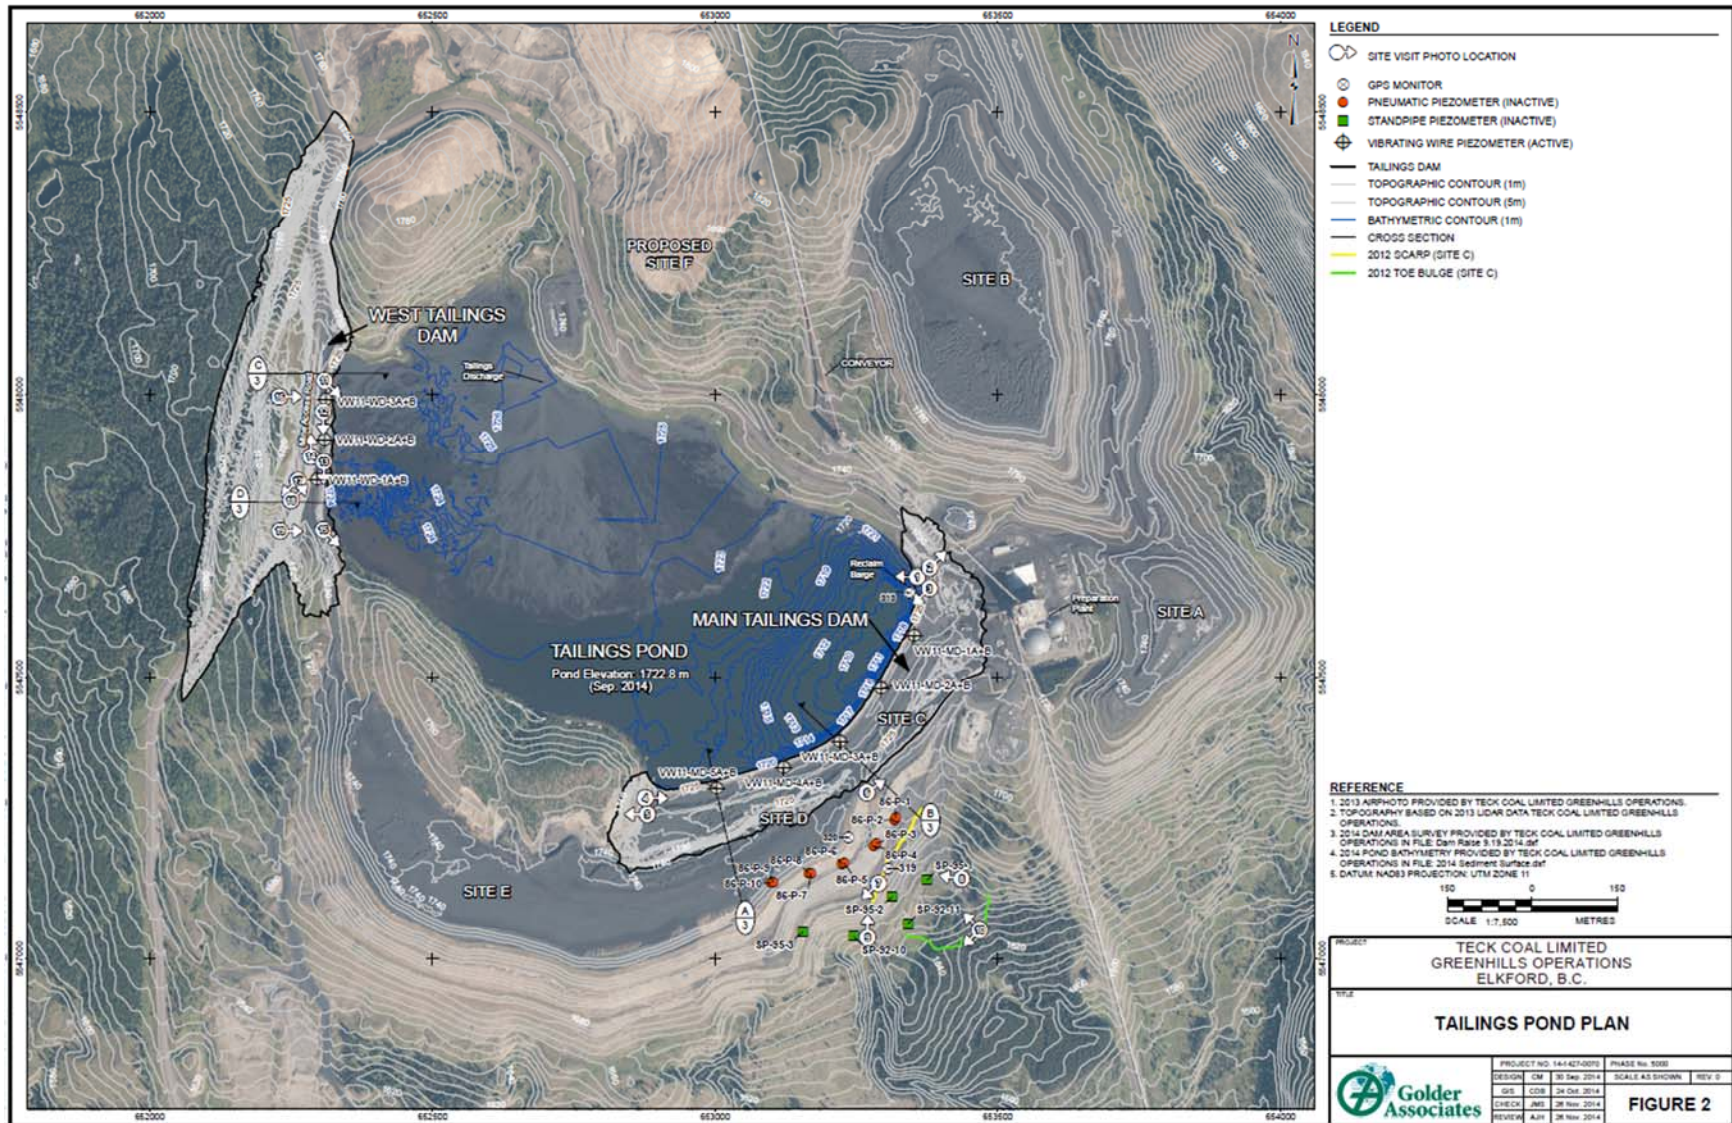
Figure 2.1 Plan of TSF

The GHO Tailings Storage Facility consists of two dams, the Main Tailings Dam (MTD) to the southeast and the West Tailings Dam (WTD) to the west as shown in plan on Figure 2.1. The MTD, a zoned earthfill dam, has been raised several times and is approximately 45 m high. The WTD is also a zoned earthfill dam that has been raised various times, and is approximately 16 m high. Both dams are composed of a 6 m wide zone of compacted clay till on the upstream face with compacted coarse refuse bulk fill making up the rest of the structure.

Several consecutively joined large coarse refuse dumps (Refuse Dump Sites A to E) are downstream of the MTD). Sites C and D are located immediately downstream of the MTD. Although the stability of the dam does not depend on the dumps, they give significant additional support.
