June 29, 2015

Reference No. 1528359-2015-072-L-Rev0-1000

**RESPONSE TO MINISTRY OF ENERGY AND MINES MEMORANDUM DATED FEBRUARY 3, 2015,  
REGARDING THE GREENHILLS OPERATIONS TAILINGS STORAGE FACILITY**

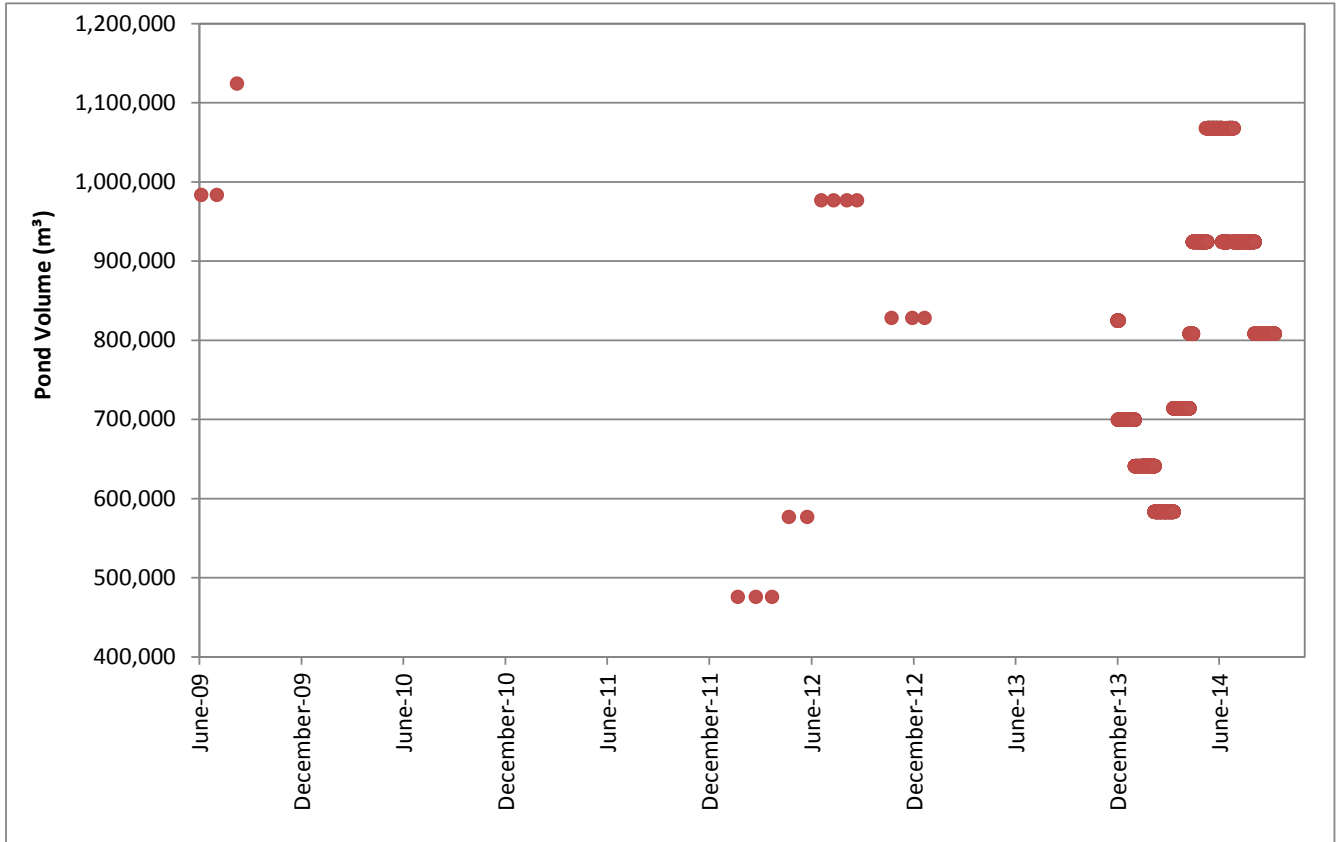
Chart 1: Observed Tailings Pond Free Water Volume Over Five Years

No surplus mine water is stored in the GHO tailings facility. The free water in the GHO tailings facility is required for the plant processes and is therefore not considered surplus. The total volume of free water in the tailings facility has been relatively consistent over recent years at about 1 million m<sup>3</sup>.

The estimated total free water in the pond in the last five years (excluding water entrained the pore spaces of the tailings) is shown in Chart 1.

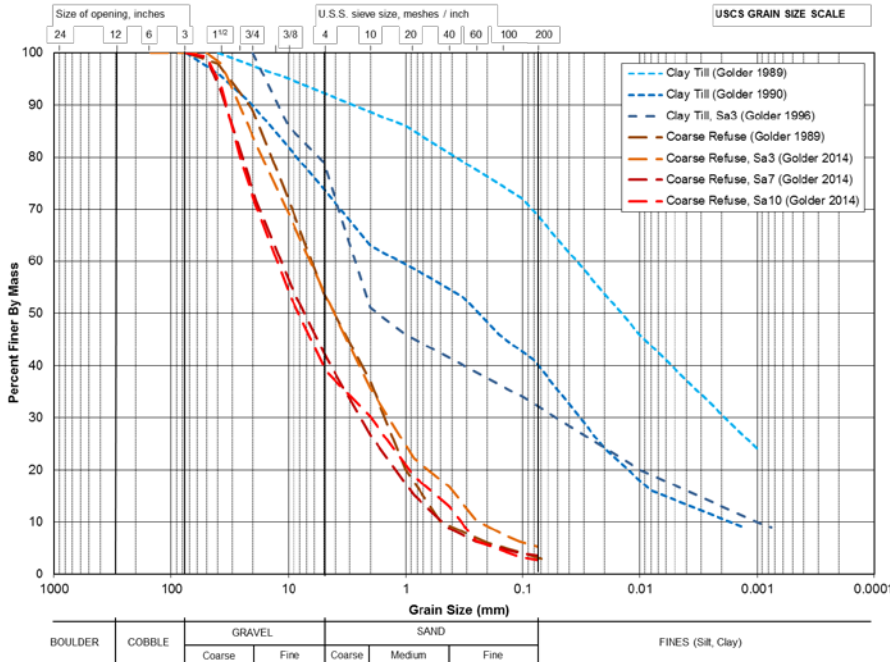
Chart 2: Coarsest and Finest Gradations of Clay Till and Coarse Refuse for Filter Compatibility Comparison

Of the 11 clay till blanket samples and 13 coarse refuse samples from available construction reports (Golder 1989, 1990, 1992, 2015), the coarsest and finest gradations of each material are shown in Chart 2.

The filter compatibility between the clay blanket material and coarse refuse shell material was reviewed based on grain size distributions of 11 clay blanket samples and 13 coarse refuse samples from available construction reports from 1989, 1990, 1992, and 2014 (Golder 1989, 1990, 1992, 2015).

Ten of the 13 coarse refuse (filter) gradations met the filter criteria, with 3 gradations slightly outside of the Sherard criteria ( $D_{15} = 0.85$  mm compared to the criteria of  $D_{15} \leq 0.7$  mm). All samples met the accepted filter criteria in use at the time of the original design.

The internal stability of the coarse refuse filter was assessed based on an update to the original Kenney-Lau criteria by Li and Fannin (Kenney and Lau 1985; Li et al. 2009). The coarse refuse gradations meet the updated Li-Fannin criteria.

The coarse refuse material that makes up the shell of the Main and West dams met the design criteria that were in place at the time of design and construction, generally meets current filter design criteria with some exceptions, and is considered internally stable per the Li-Fannin criteria. Based on the performance of the dam, internal erosion or piping due to filter incompatible materials is expected to be a low risk. However, for future construction, specifications for the coarse refuse placed adjacent to the clay blanket will be formalized, and quality control of the materials placed during construction will be performed to confirm conformance with current design criteria.
