Klohn Crippen Berger

Greenwood Gold Project

Tailings Storage Facility - Dam Safety Review

November 25, 2014

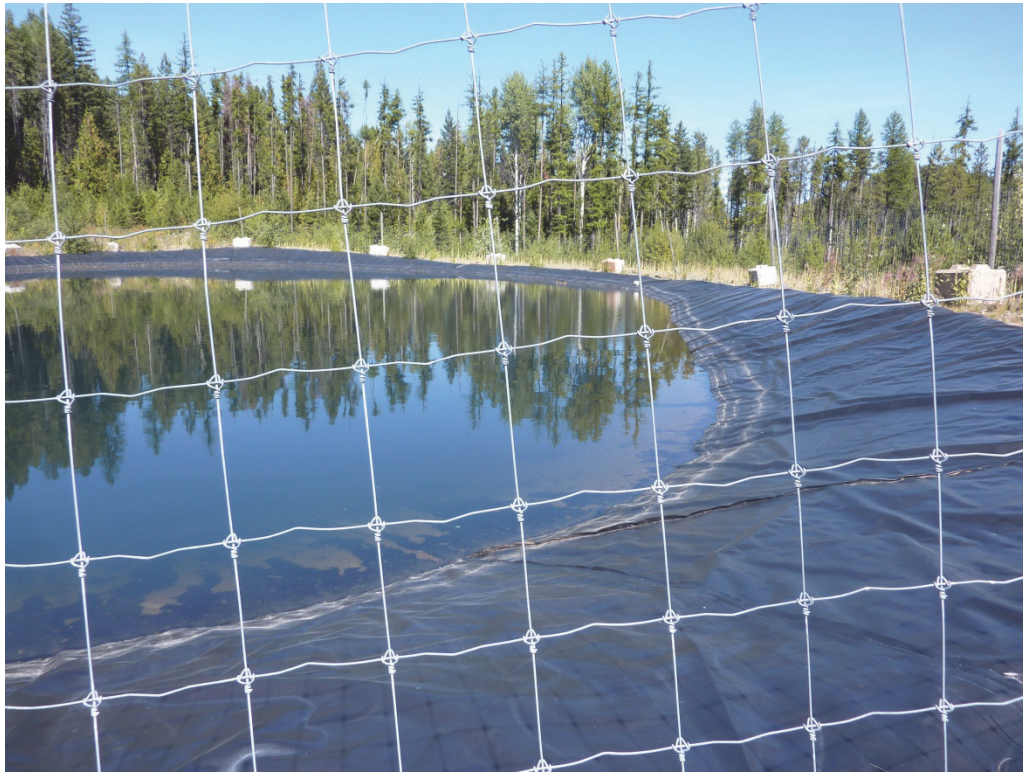
The entire water storage pond is lined with a 40 mil thick LLDPE geomembrane (see Photo III-1). The geomembrane is in very good condition with no visible tears or punctures. The geomembrane extends to the upstream crest of the embankment and appears to be anchored in a trench at the embankment crest. No UV light degradation of the LLDPE is apparent from visual observations.

Photo III-1 – Emergency Water Storage Pond – Liner and Dam Crest

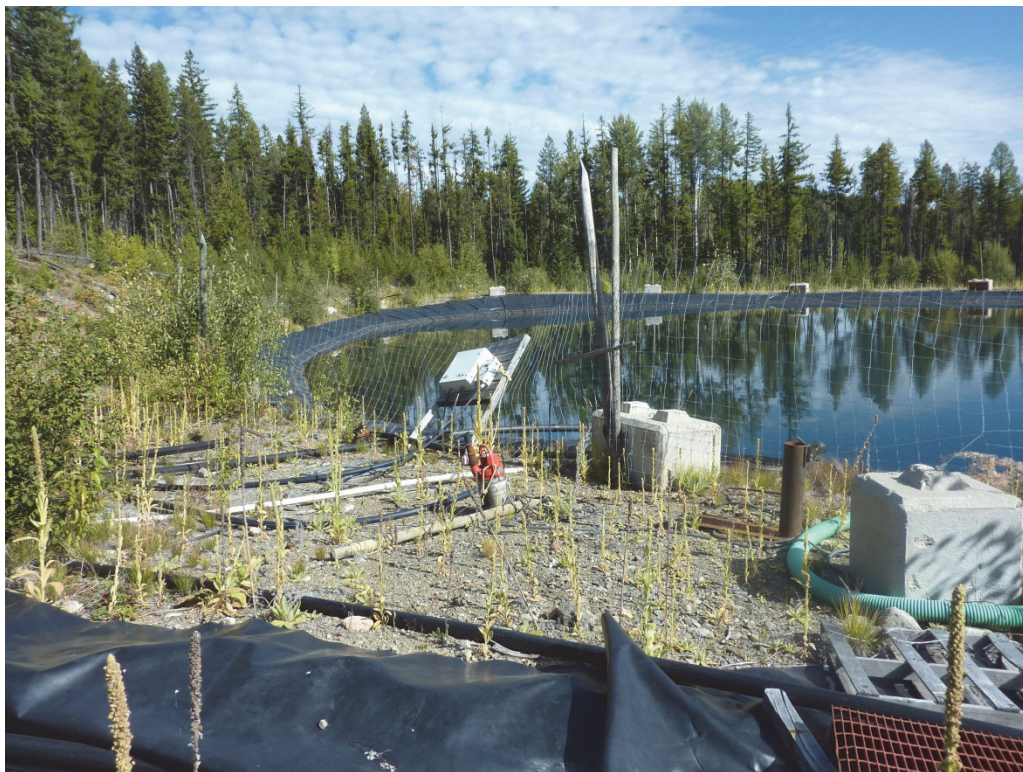
The entire pond area is enclosed with 2.1 m high light wire fencing supported by wooden posts to prevent animal ingress. The fencing is in good condition with one local area of low fence height on the southwest side where the power panel is leaning against the fence (see Photo III-2). The power panel supports and the fence should be repaired. Huakan removed the electrical panel and tightened the sagging fence subsequent to the site visit and provided photographic evidence.

Photo III-2 – Emergency Water Pond – Power Panel Leaning Against Fence

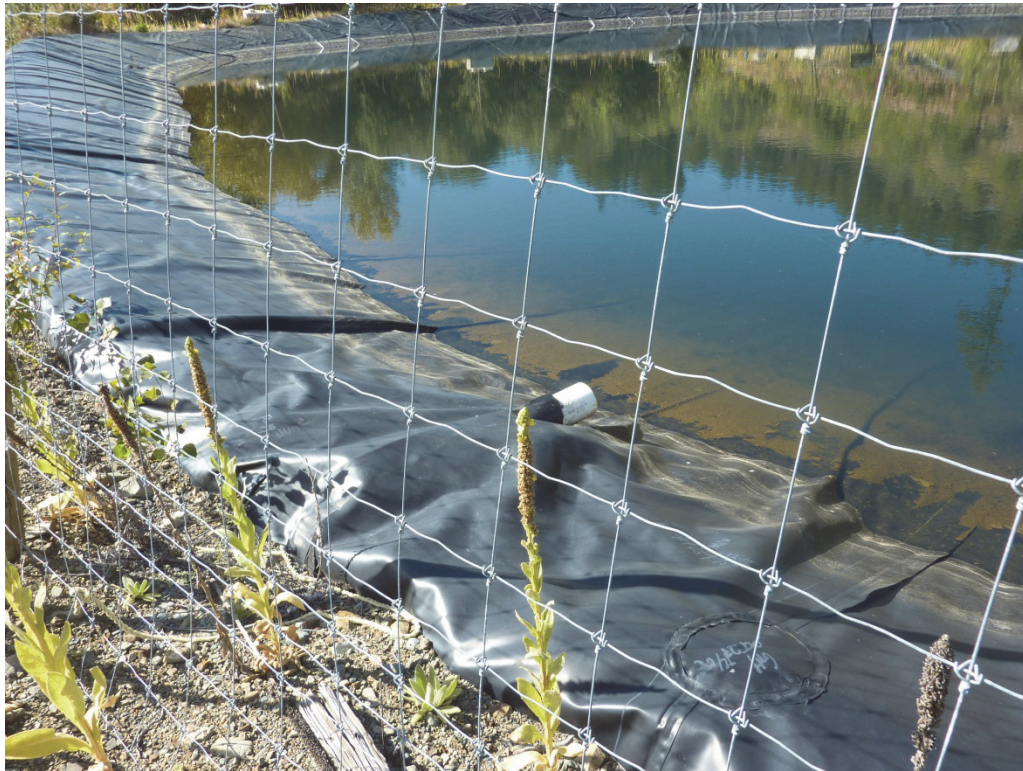
Photo III-3 – Emergency Water Pond - PVC Outlet Pipe

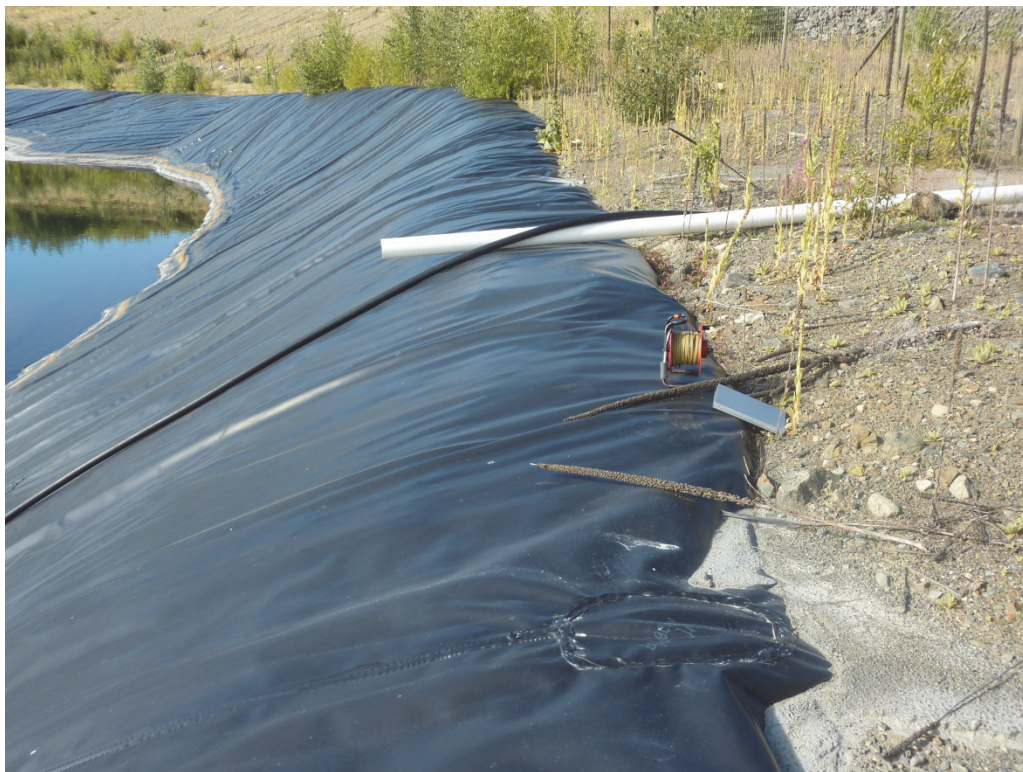
Photo III-4 - Emergency Water Pond - PVC Outlet Pipe Discharge at Tailings Pond

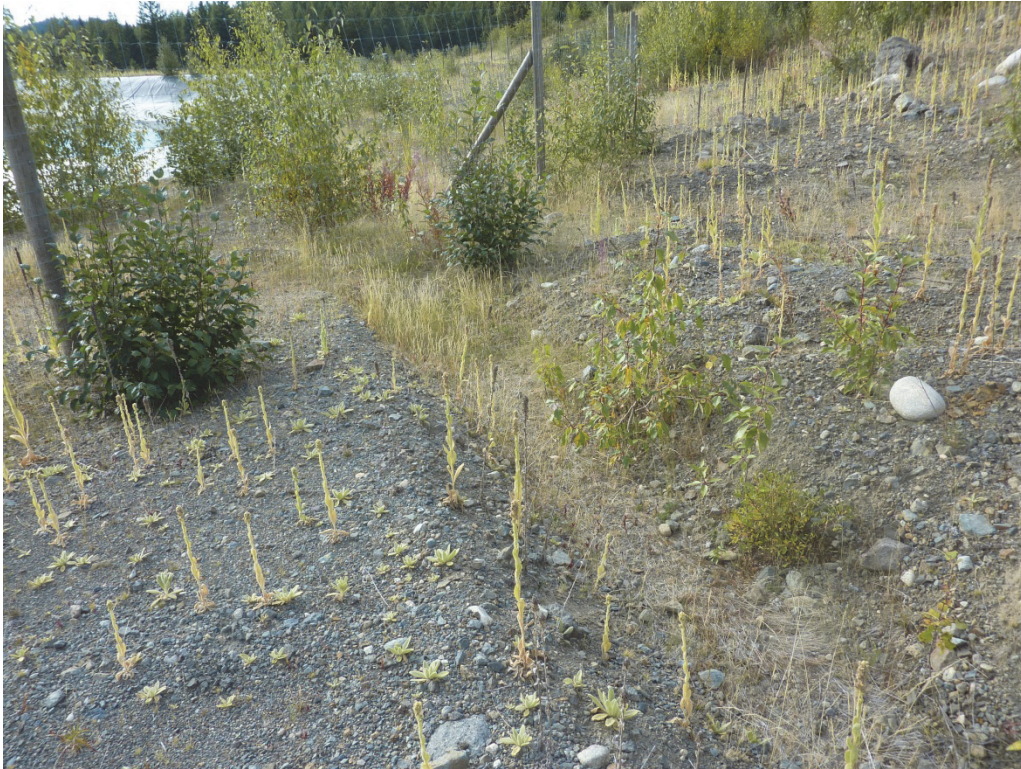
The surface water diversion ditches have some shrub and small tree growth (see Photo III-5). Minor erosion is evident in the steeper gradient sections. Sand has been deposited in the lower gradient sections of the diversion ditches around the perimeter of the tailings pond and reduces the flow capacity. The vegetation should be cut, the ditches cleaned out to re-establish the design cross-sections and riprap lining installed to reduce erosion as recommended in the 2008 design report (KCB 2008c). Subsequent to the September 11-12, 2014 DSR site visit, Huakan reports that they have cleaned out the sections of the diversion ditch that were filled with sand. Rip rap lining has not been installed to reduce erosion.

Photo III-5 – Surface Water Diversion Ditch

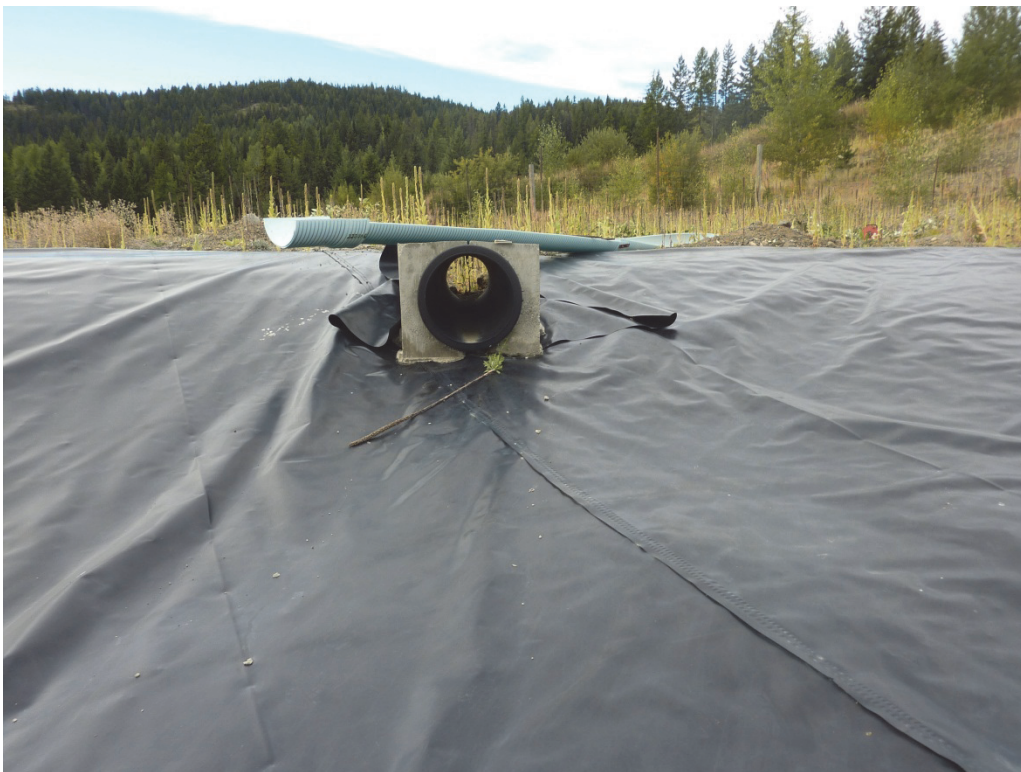
Photo III-6 – Tailings Pond – Surface Water Inlet Culvert at Southwest End of Dam Embankment

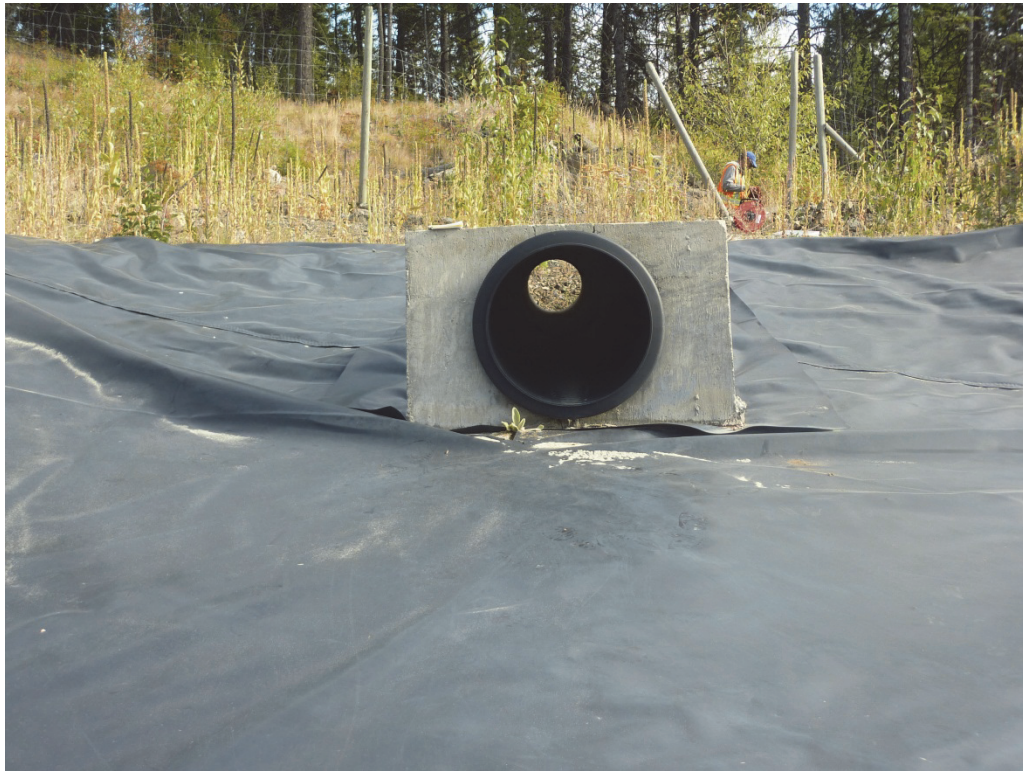
Photo III-7 – Tailings Pond – Surface Water Inlet Culvert at Northeast End of Dam Embankment

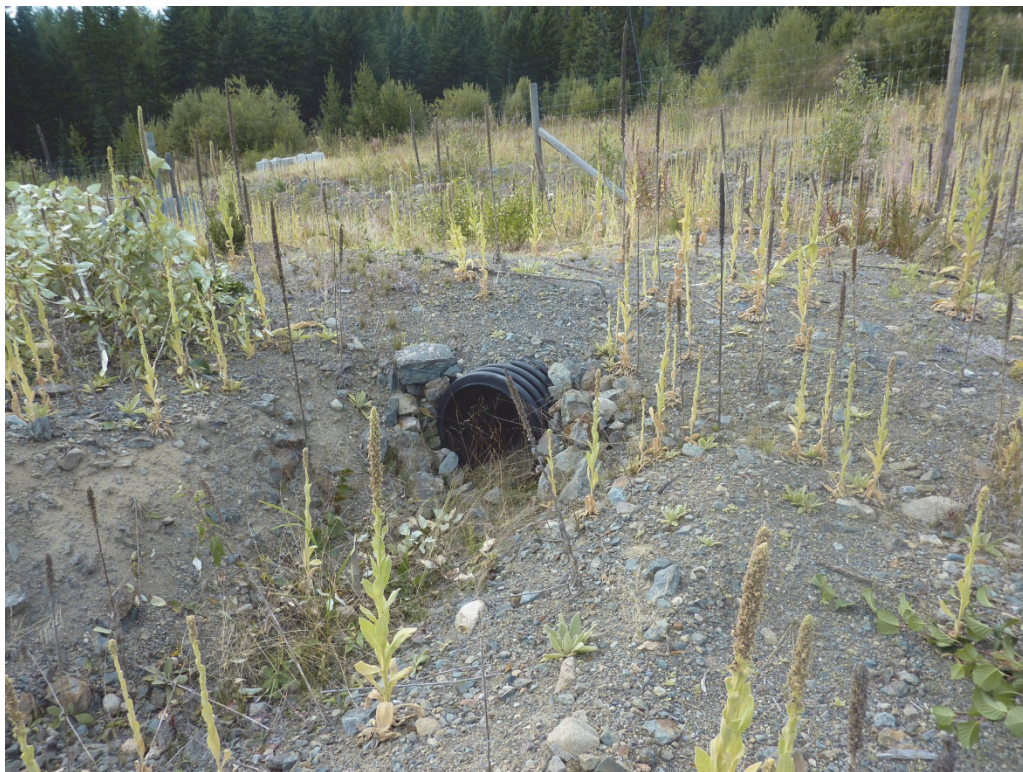
Photo III-8 – Tailings Pond – Bypass Channel and Culvert at Southwest End of Dam Embankment

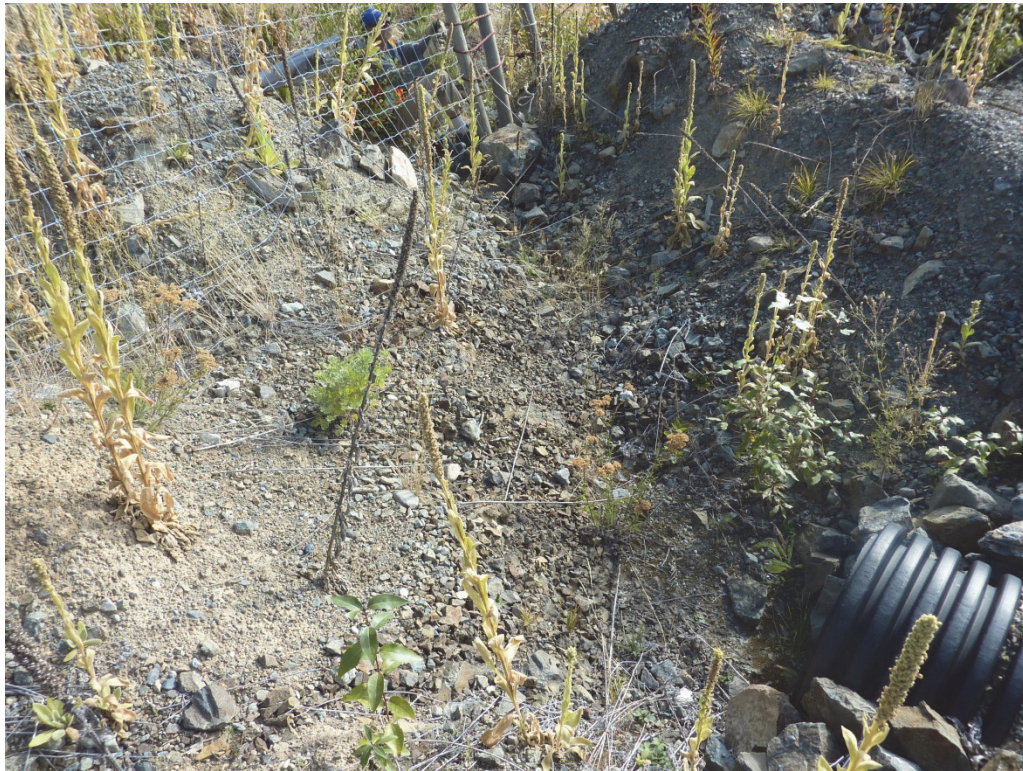
Photo III-9 – Tailings Pond – Bypass Channel at Northeast End of Dam Embankment – Inlet Culvert at Bottom of Photo

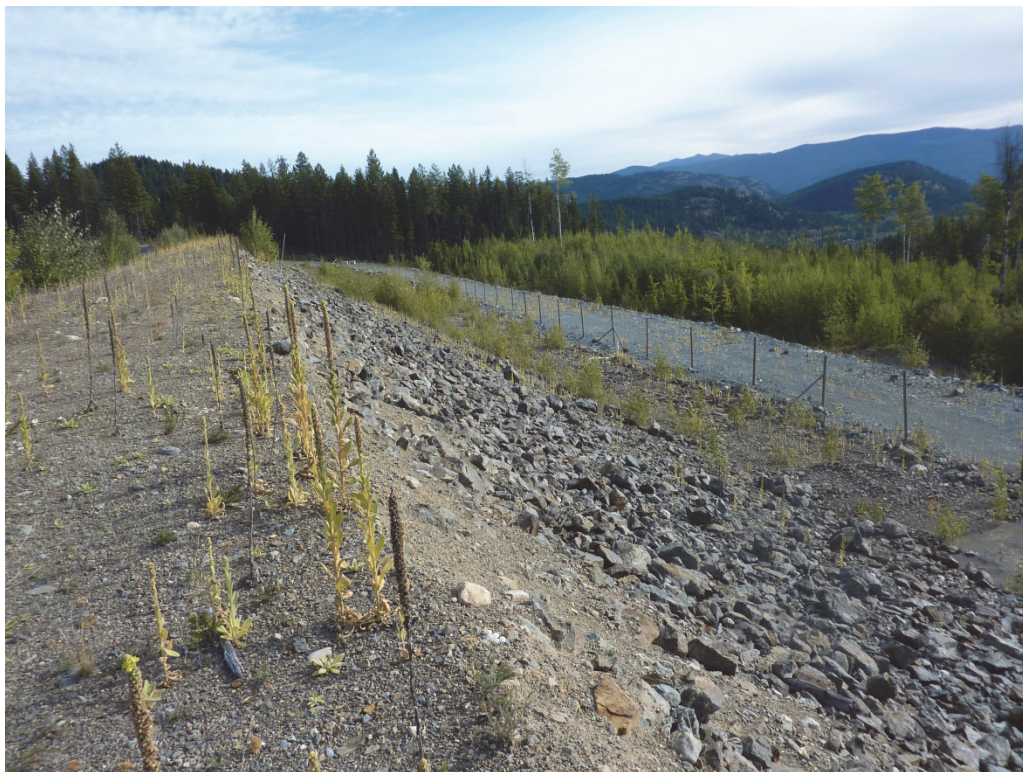
The downstream slope is comprised primarily of rockfill with an overall slope of nominally 2H:1V and a 5 m wide toe berm. The dam is in good condition with no indications of cracking, instability, bulging, or surface water erosion. The downstream slope and toe area were dry. Scattered small trees have grown on the downstream slope and toe area, which should be cut as part of the maintenance program. Larger trees have grown downstream of the toe berm as shown in Photo III-10.

Photo III-10 – Tailings Pond – Dam Crest and Downstream Slope

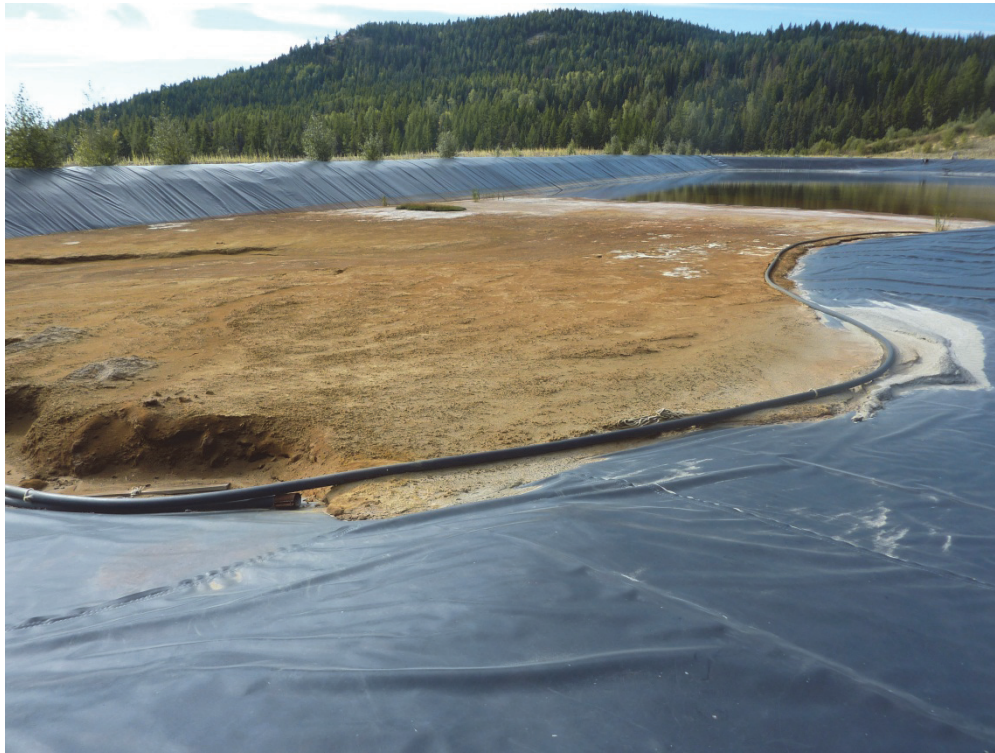
The entire tailings pond is lined with a LLDPE geomembrane (see Photo III-11). The geomembrane is generally in very good condition. The geomembrane extends to the upstream crest of the embankment and is anchored in a gravel filled trench. No UV light degradation of the LLDPE is apparent from visual observations. However, the liner was not designed for long-term UV exposure and the condition of the geomembrane should be monitored.

Photo III-11 – Tailings Pond – Geomembrane liner viewed from northeast corner looking southwest.

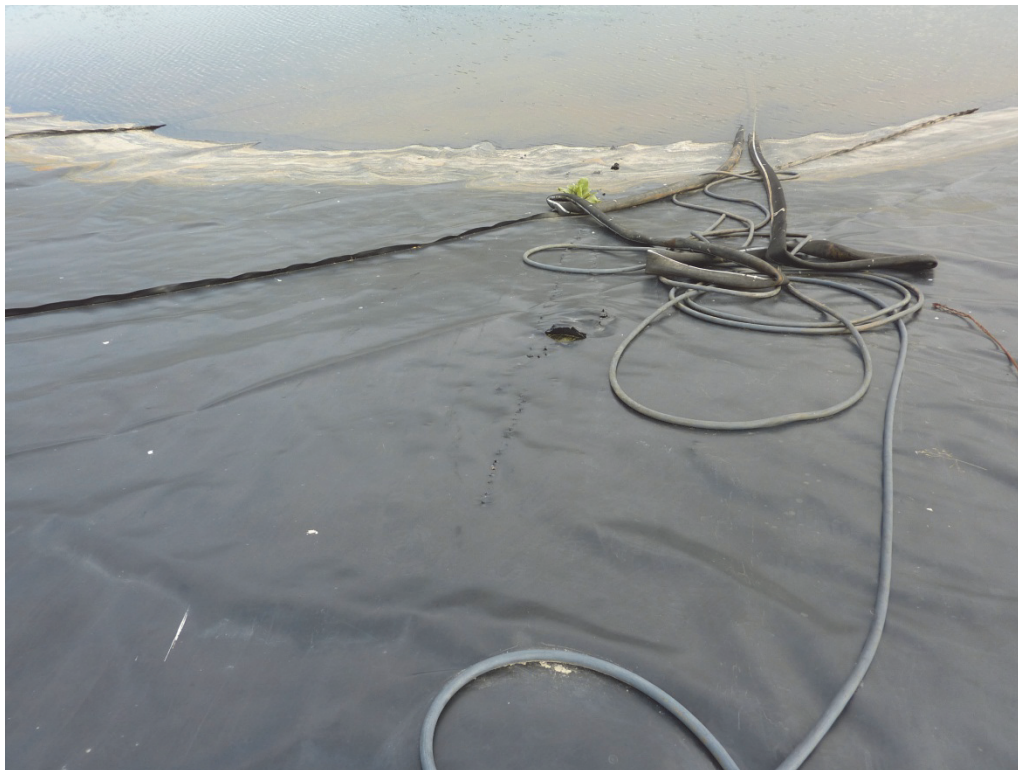
Local punctures and tears were noted in the southwest corner of the impoundment (Photos III-12 and III-13) where the reclaim pump was located during mill operations in 2008. The damage was likely

Photo III-12 – Tailings Pond – Small tears in geomembrane at SW corner. Note reclaim pump power cable and discharge hose are still present.

caused by installation and removal of the reclaim pump. A small tear in the liner was also observed in the northeast corner of the pond at the location of the culvert inlet pipe (Photo III-14). The geomembrane liner should be inspected and minor punctures and tears should be repaired using a sealant approved by Nilex, the geomembrane supplier.

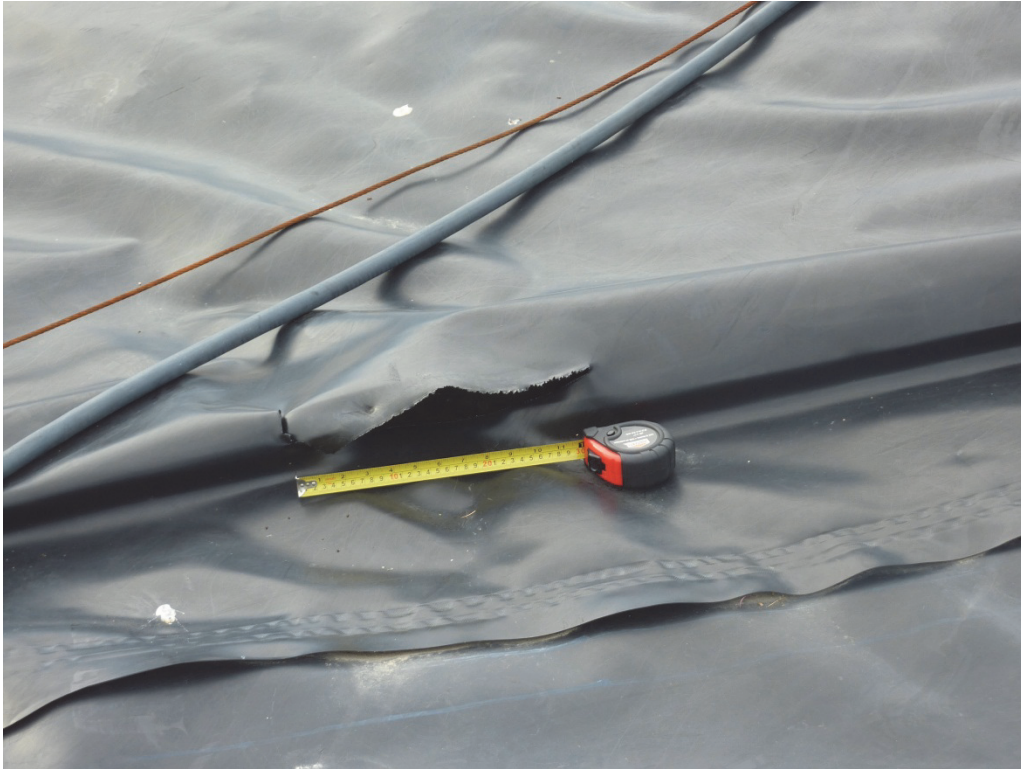
Photo III-13 - Tailings Pond – Close-up of small tear in geomembrane at SW corner.

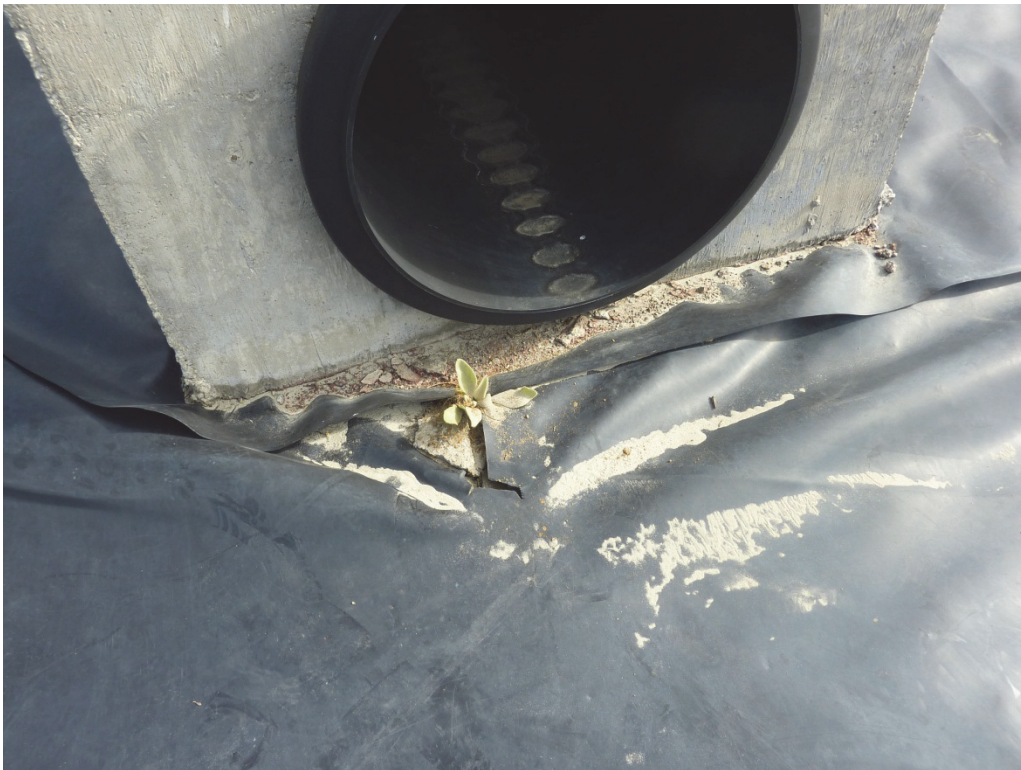
Photo III-14 – Tailings Pond – Tear in geomembrane liner at culvert inlet in northeast corner

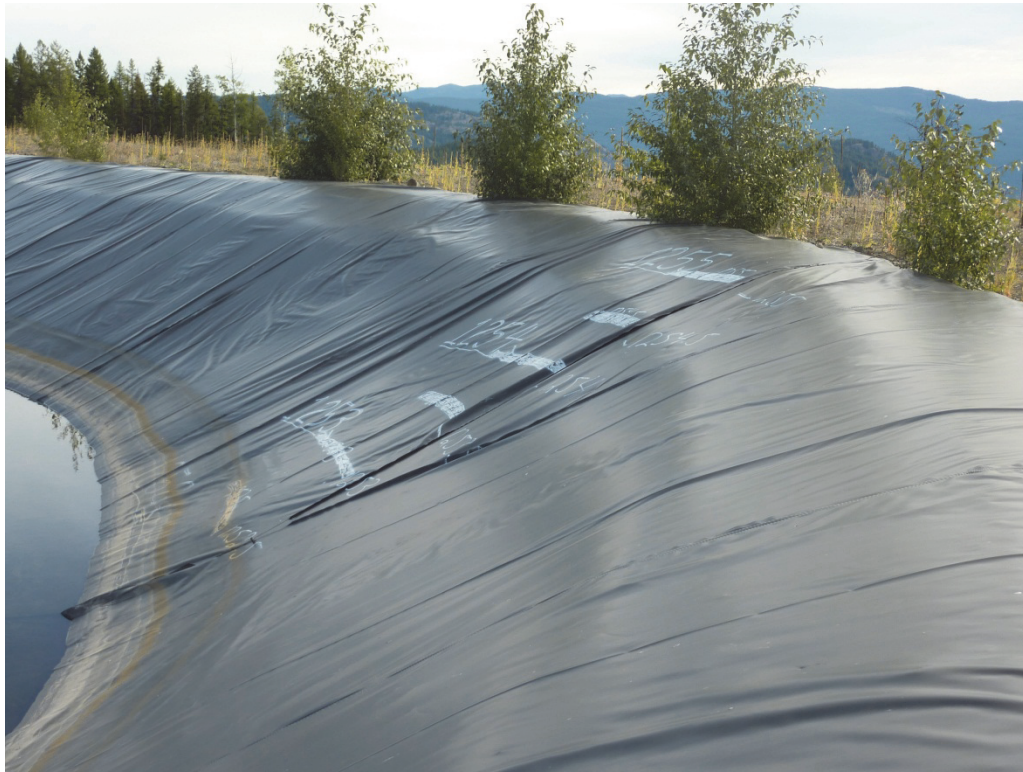
Photo III-15 – Tailings Pond – Reservoir Level Marks Spray Painted on Geomembrane Liner

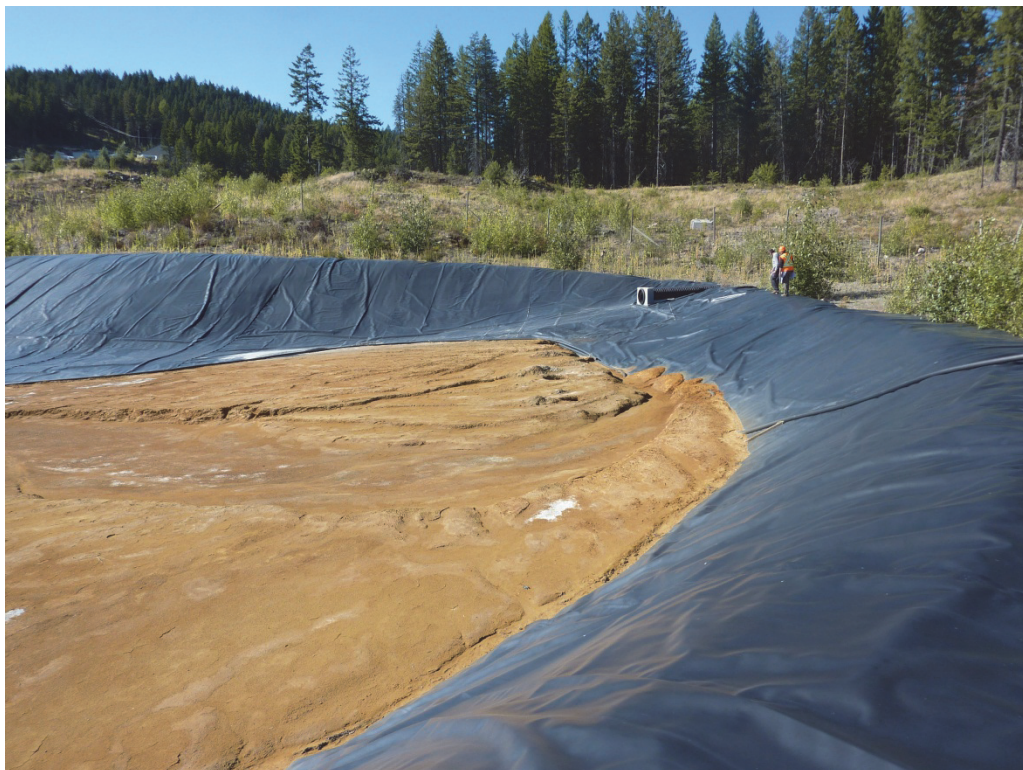
Photo III-16 – Tailings Pond – Tailings Beach Spigot Point in Northeast Corner
