# 2014 FORMAL ANNUAL DAM INSPECTION OF HB MINE TAILINGS STORAGE FACILITY SALMO, BC

SEPTEMBER 15, 2014  
ISSUED FOR USE  
FILE: K13103109-03

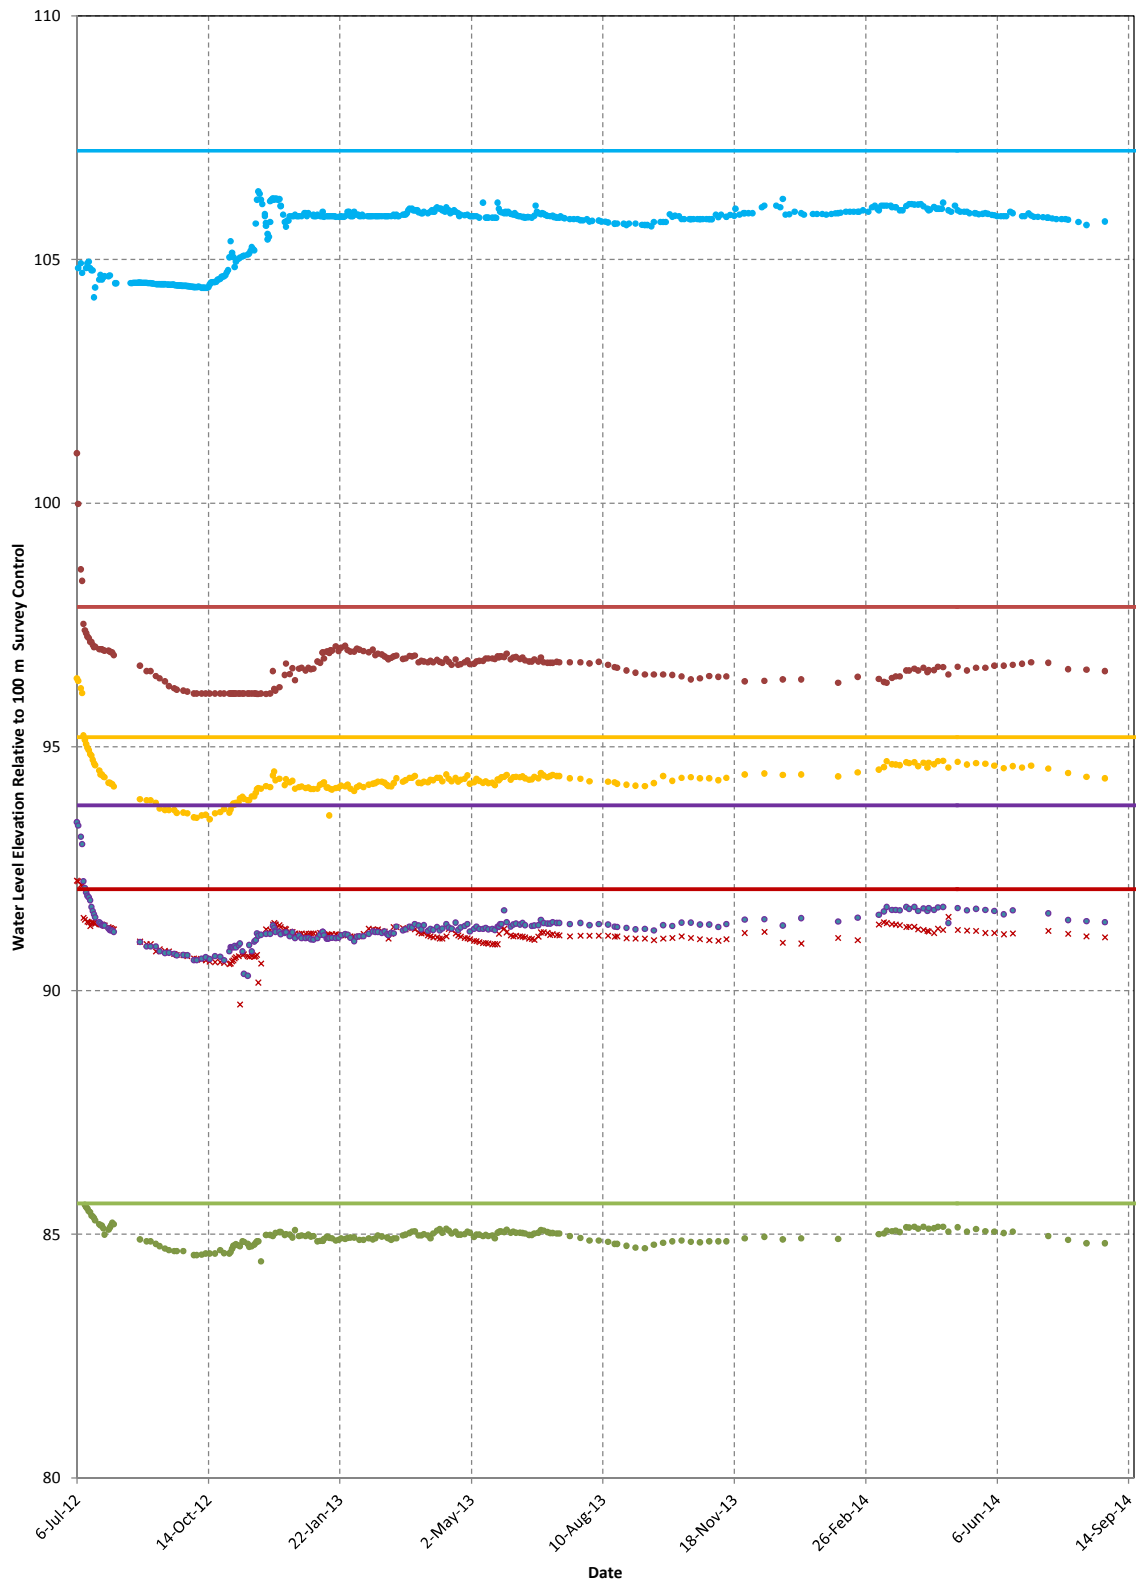
The readings recorded during the site inspection, along with those undertaken by RDCK over the past 12 months are presented on the attached Figure 3.2b.

Based on the review of current and historical piezometer readings, no significant changes were noted, and therefore, it is assumed that the interior drainage of the dam is still functioning as intended.

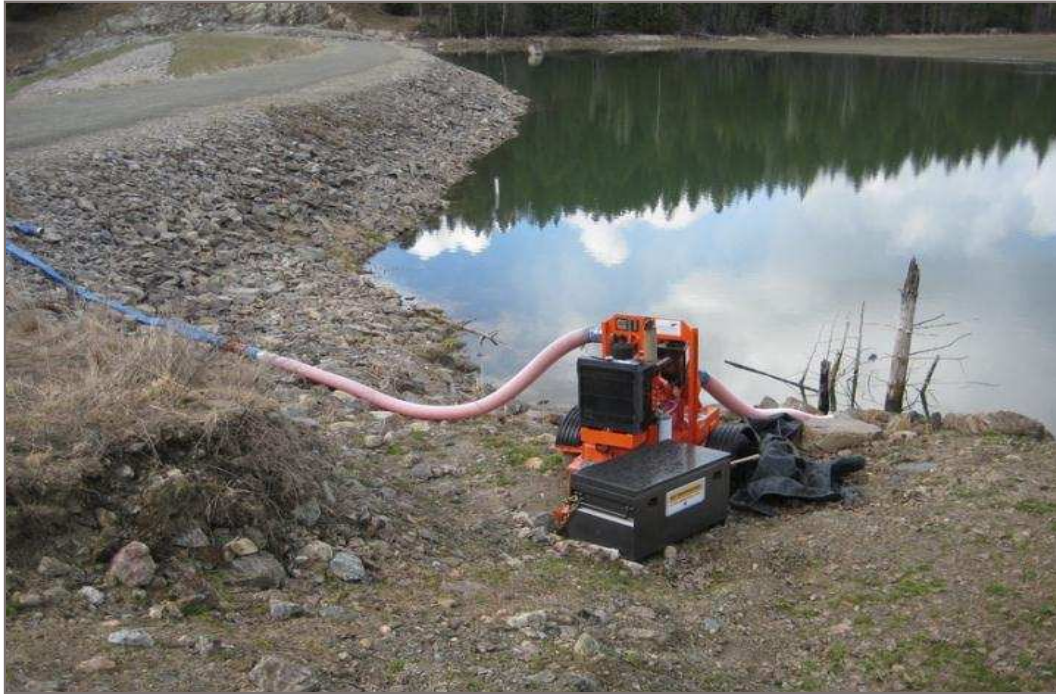
- An emergency draw down pump is positioned at the left abutment of the dam. From conversations with RDCK staff it is understood that it is tested twice a year (Photo 1).

**Photo 1:** Emergency draw down pump at left abutment of the dam.

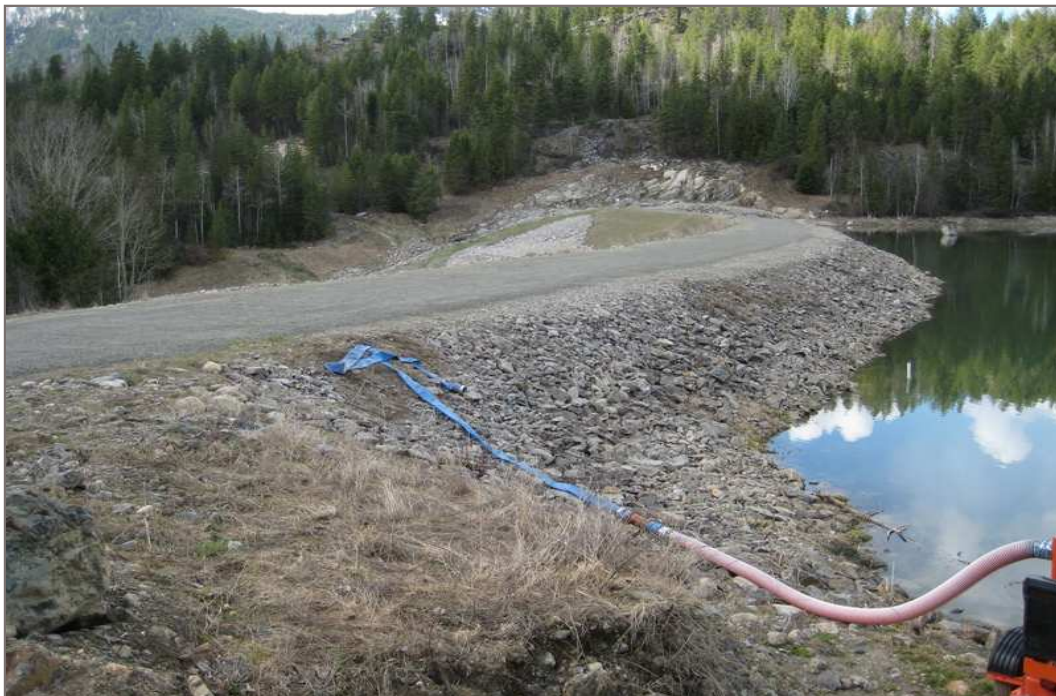
- The dam has been recreated since the 2013 Dam Safety Review (Photo's 2 and 7).
- Brush vegetation that was growing on the upstream slope of the dam has been removed (Photo 2).

**Photo 2:** Dam crest and upstream slope from left abutment. Note recreated since 2013 Dam Safety Review, and vegetation removed from upstream slope.

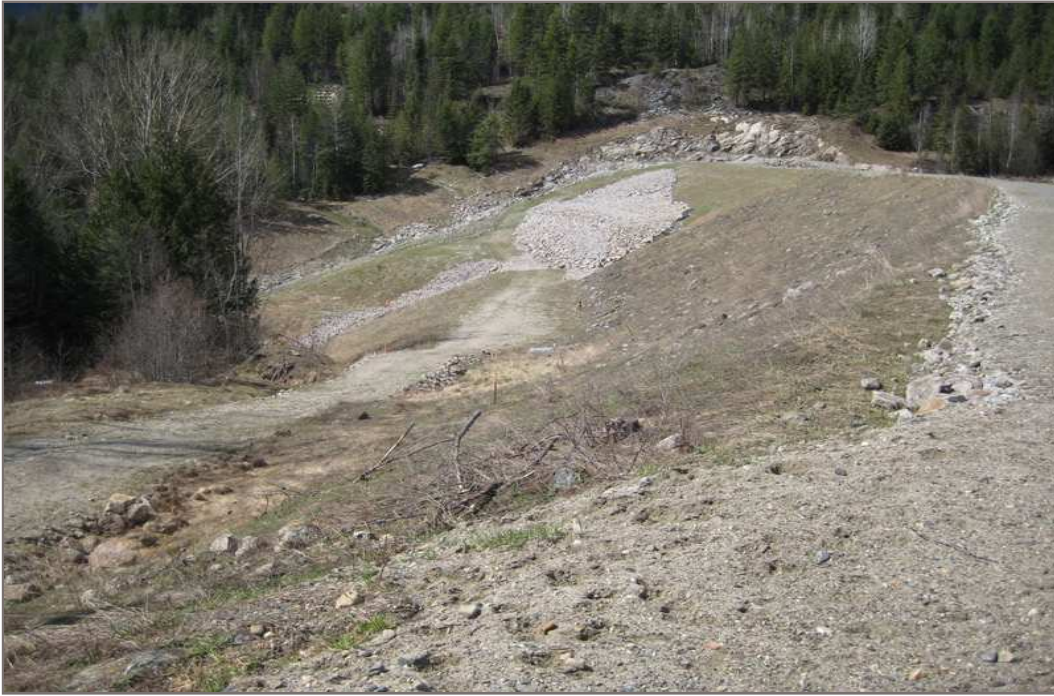
**Photo 3:** Downstream slope from left abutment.

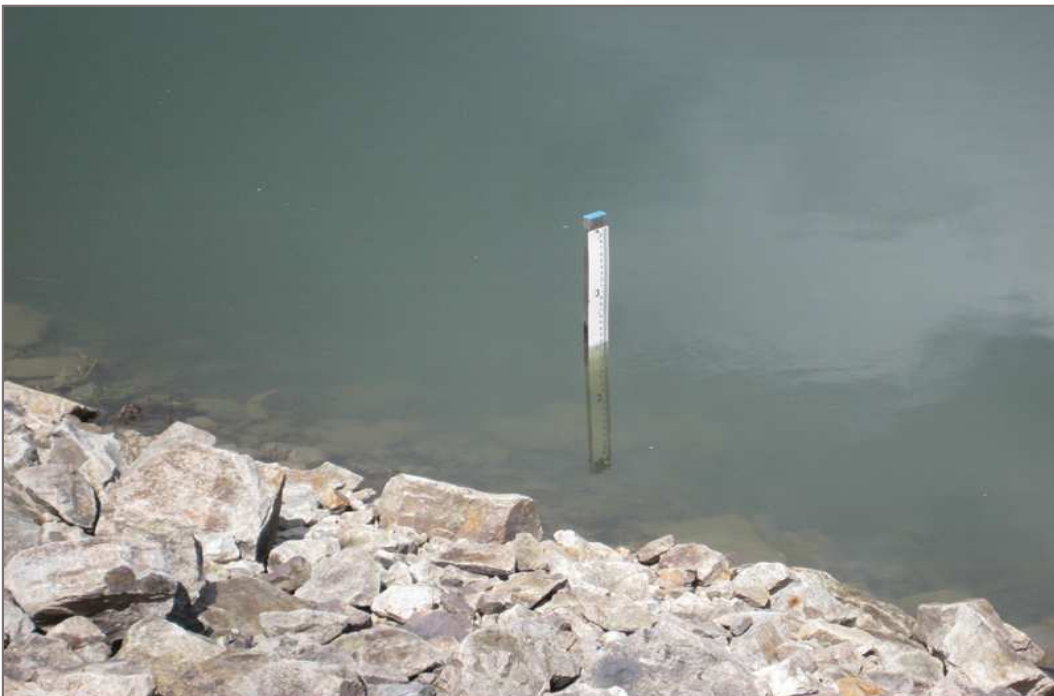
- The existing reservoir staff gauge is in imperial units and is proposed to be replaced by RDCK with a metric gauge (Photo 4).
- The rip-rap on the upstream slope of the dam has moved exposing the underlying filter fabric (Photo 5).

**Photo 4:** Reservoir level gauge.

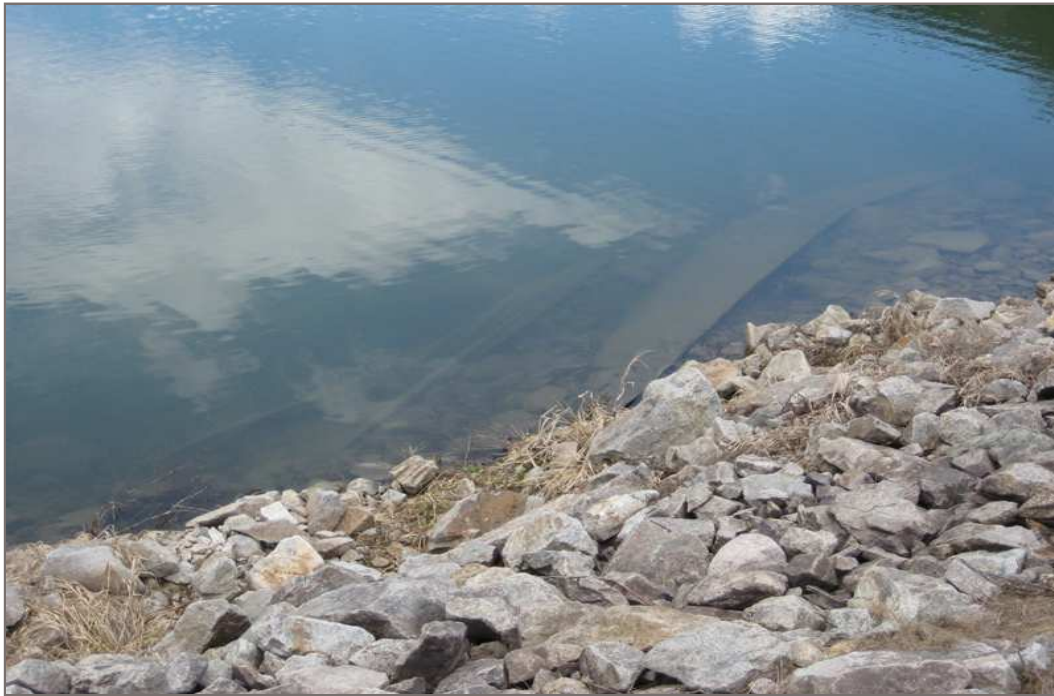
**Photo 5:** Rip-rap moving on upstream slope, exposing geotextile.

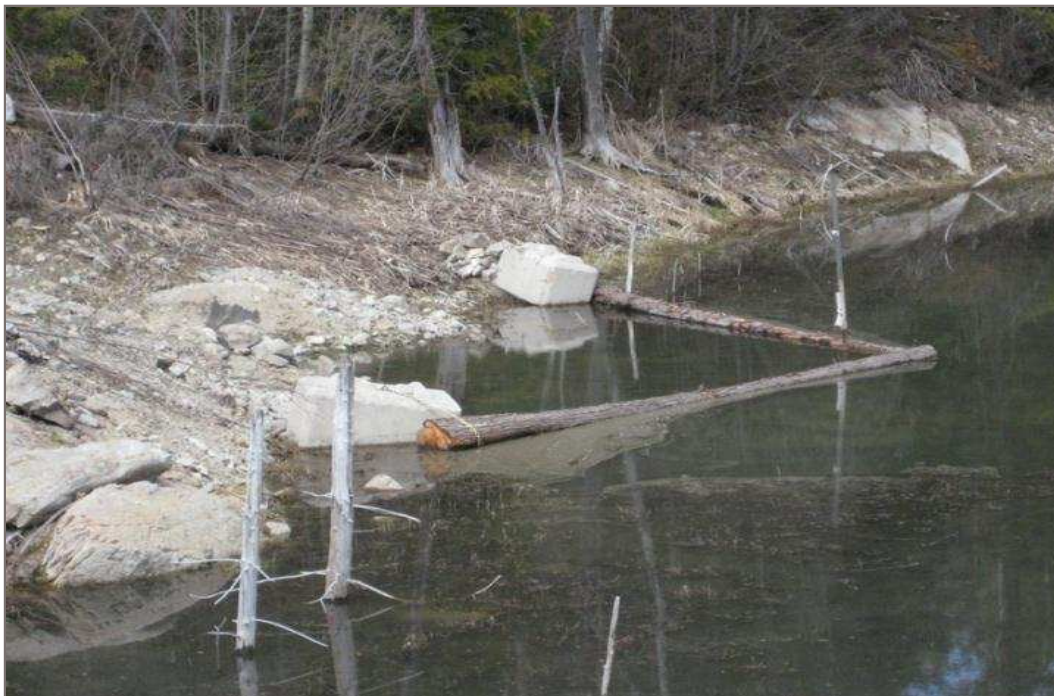
- A log boom is in place at the spillway channel entrance (Photo 6).
- Warnings signs have been placed at both the left and right abutments of the dam (Photo 7).

**Photo 6:** Log boom in place.

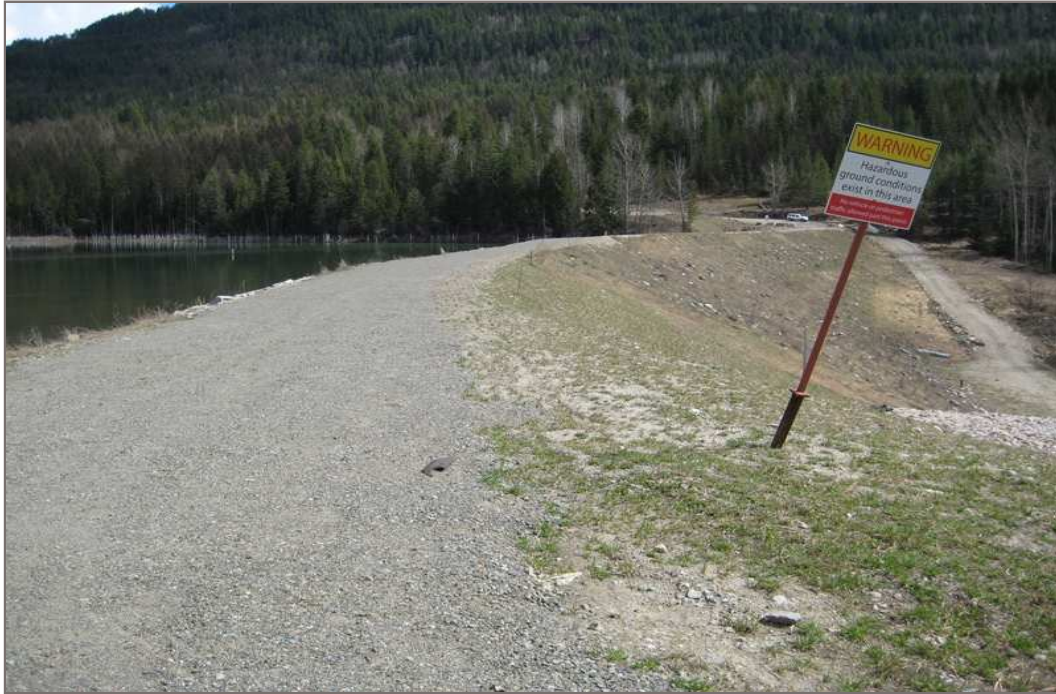
**Photo 7:** Dam crest from right abutment. Note warning sign in place.

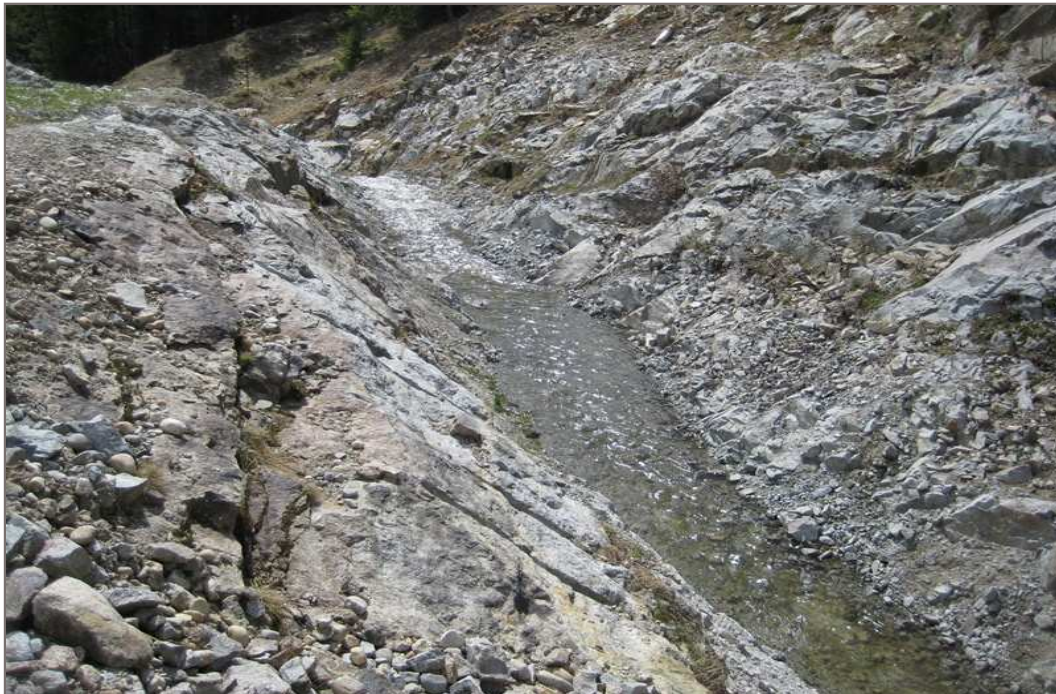
**Photo 8:** Spillway channel at right abutment.

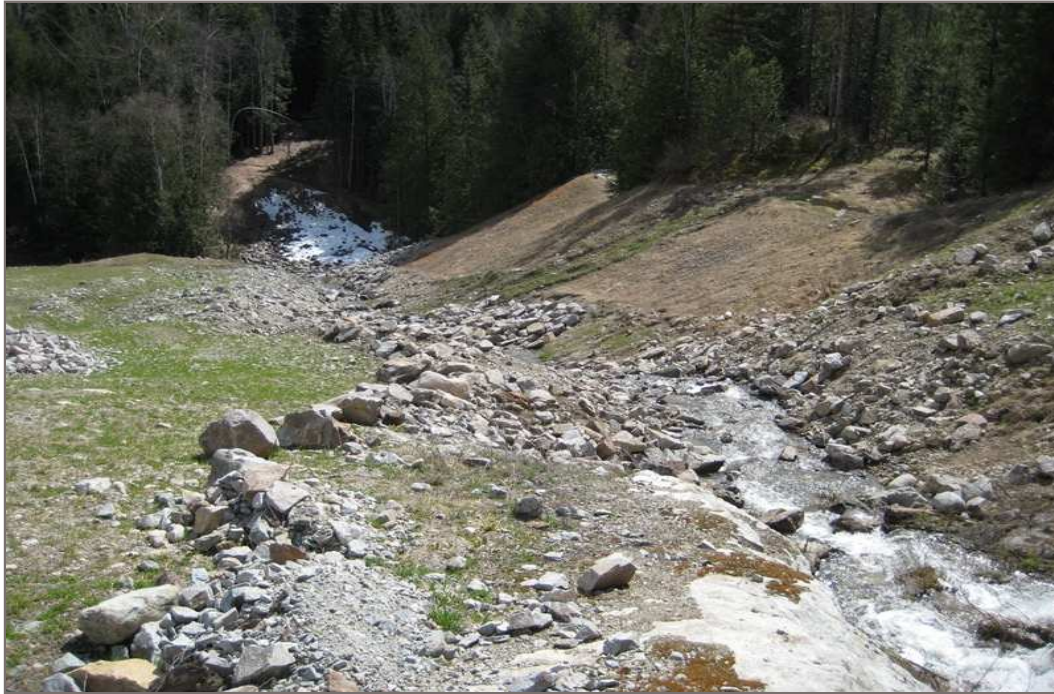
- Some rip-rap used in the 2012 dam repair has been replaced in the spillway outlet channel and some check dams constructed (Photo's 9 and 11).
- The top of the toe berm, in proximity to Piezometer P3, is dry.

**Photo 9:** Spillway outlet channel.

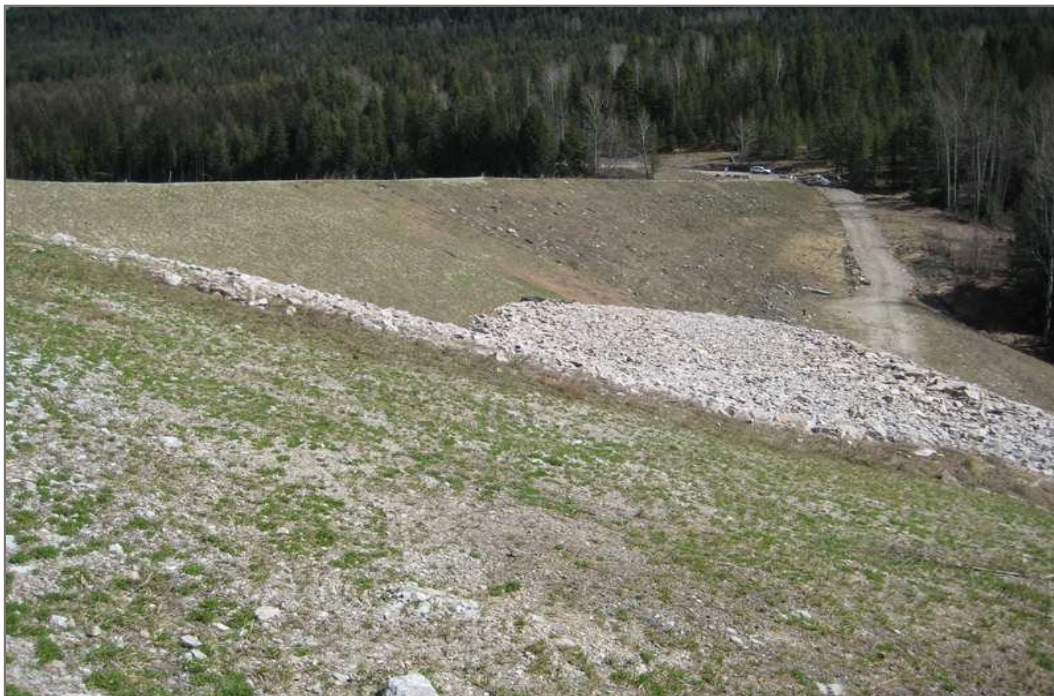
**Photo 10:** Downstream slope of dam from right abutment.

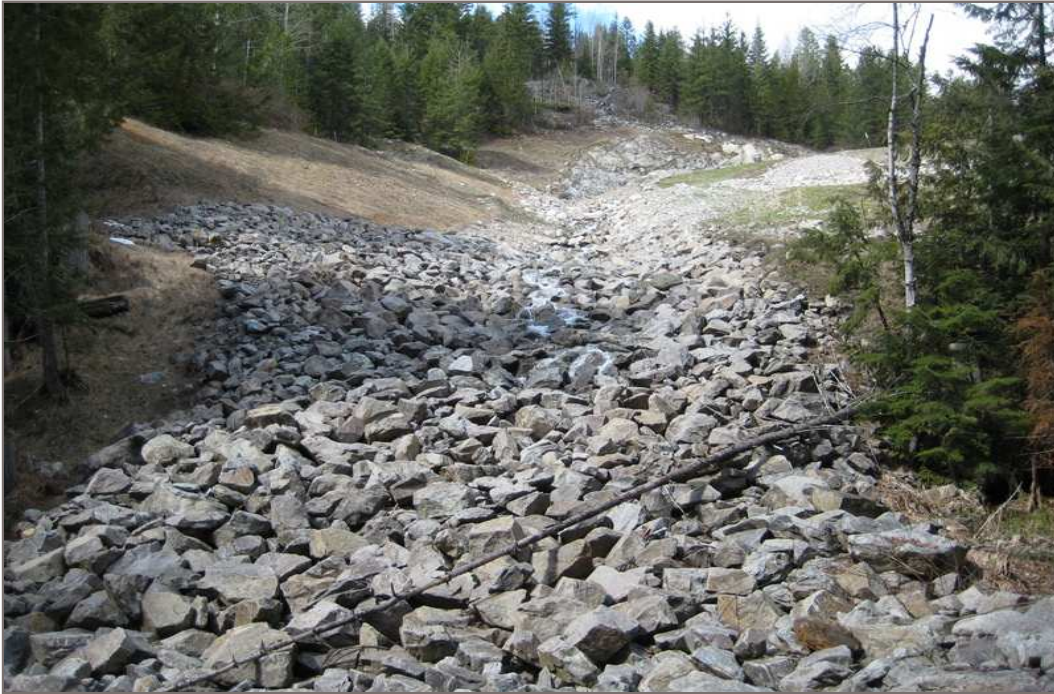
**Photo 11:** Spillway outlet channel.

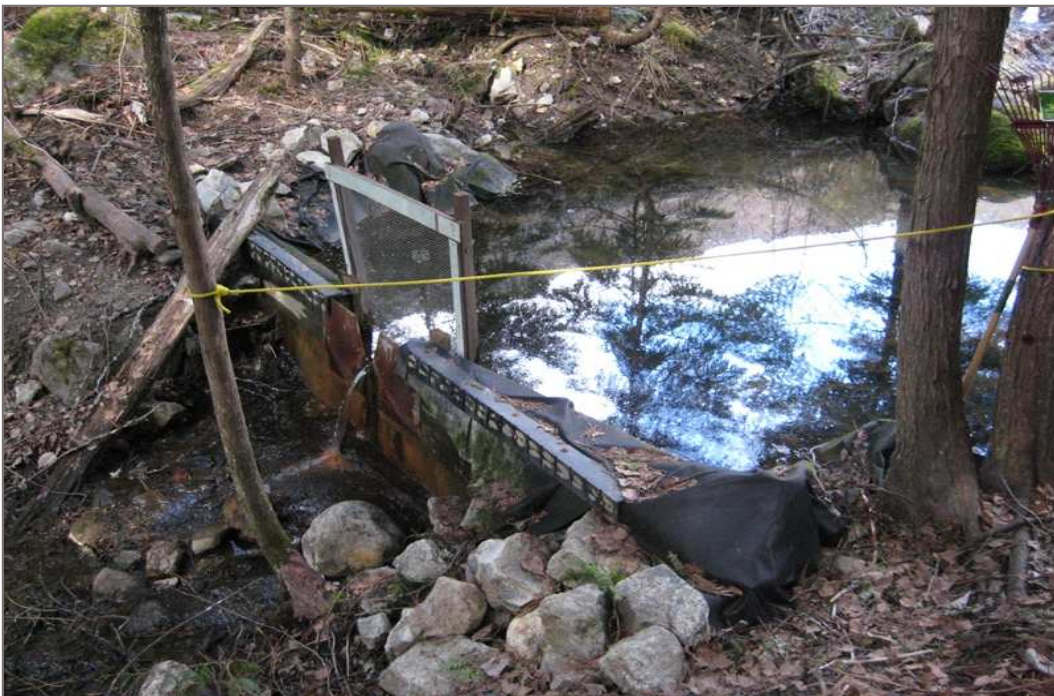
**Photo 12:** V-Notch weir located at left abutment toe of dam.

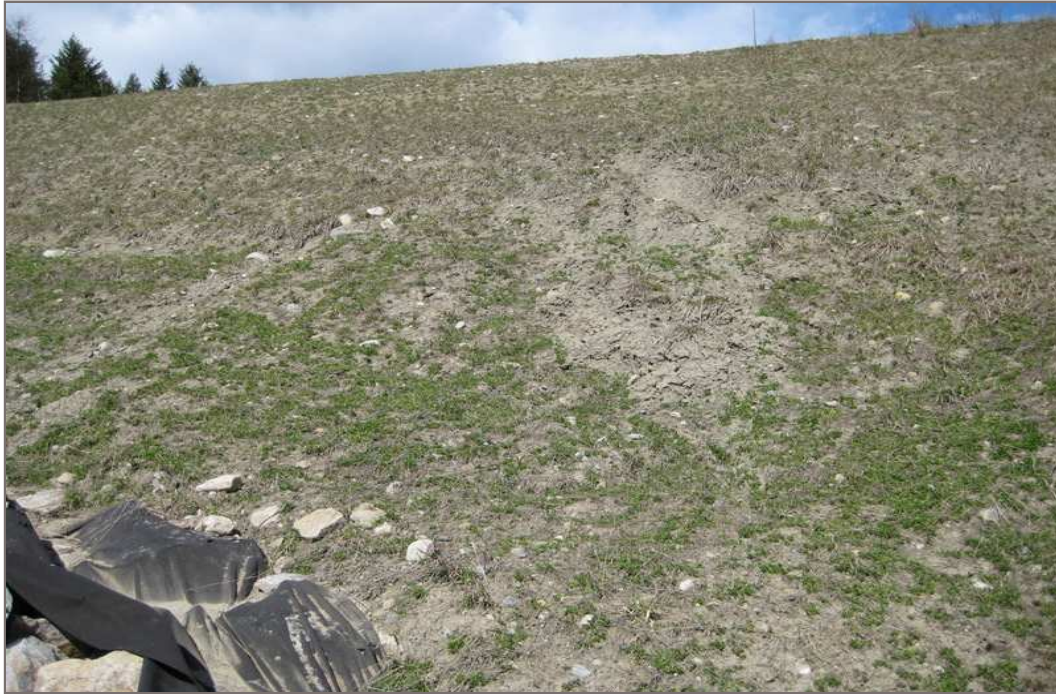
- Seepage observed at the left abutment toe is clear.
- A minor surface slough occurred during the 2014 freshet above the right abutment toe berm. No active seepage was observed in the area at the time of the dam inspection (Photo 13).

**Photo 13:** Shallow slump above right toe berm.

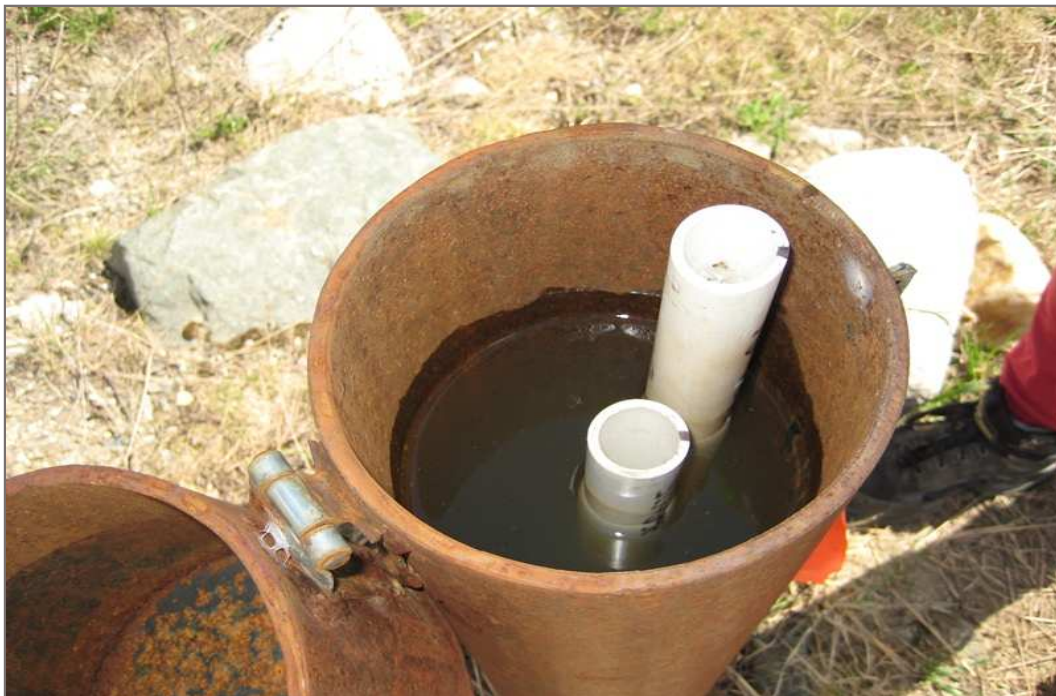
- Water is pooling (assumed to be due to condensation) in the P5/P6 piezometer casing (Photo 14).

**Photo 14:** Water ponded in P5/P6 piezometer casing.

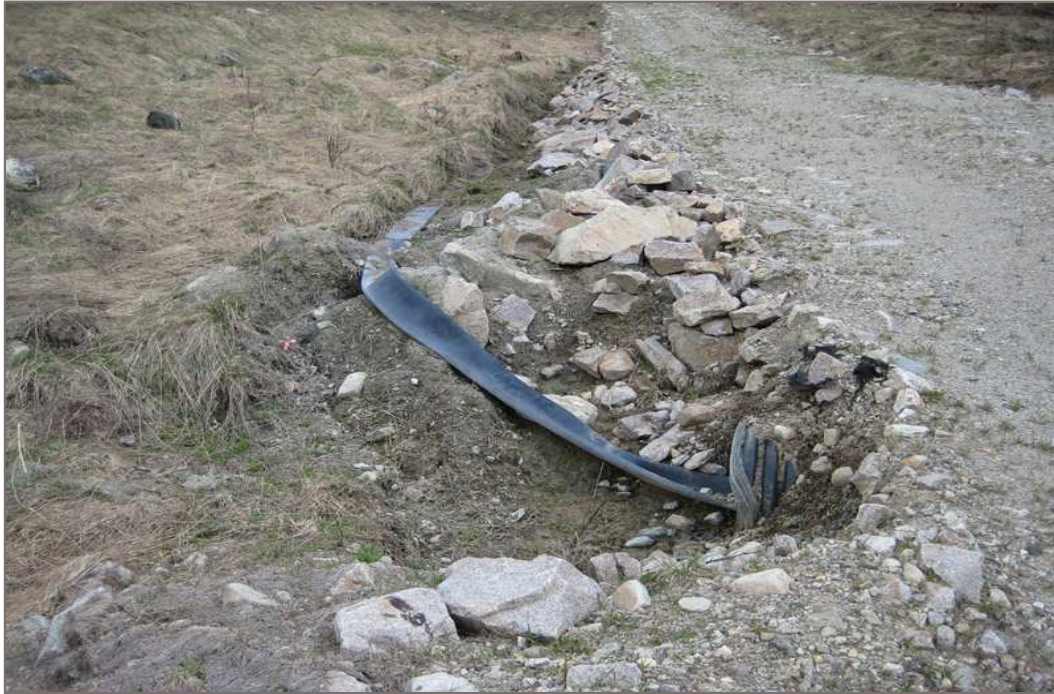
**Photo 15:** Emergency drawdown pump hose.
