# DAM SAFETY REVIEW OF HB MINE TAILINGS STORAGE FACILITY SALMO, BC

**Regional District of the Central Kootenay**

MAY 28, 2014

FILE: K13103109-01

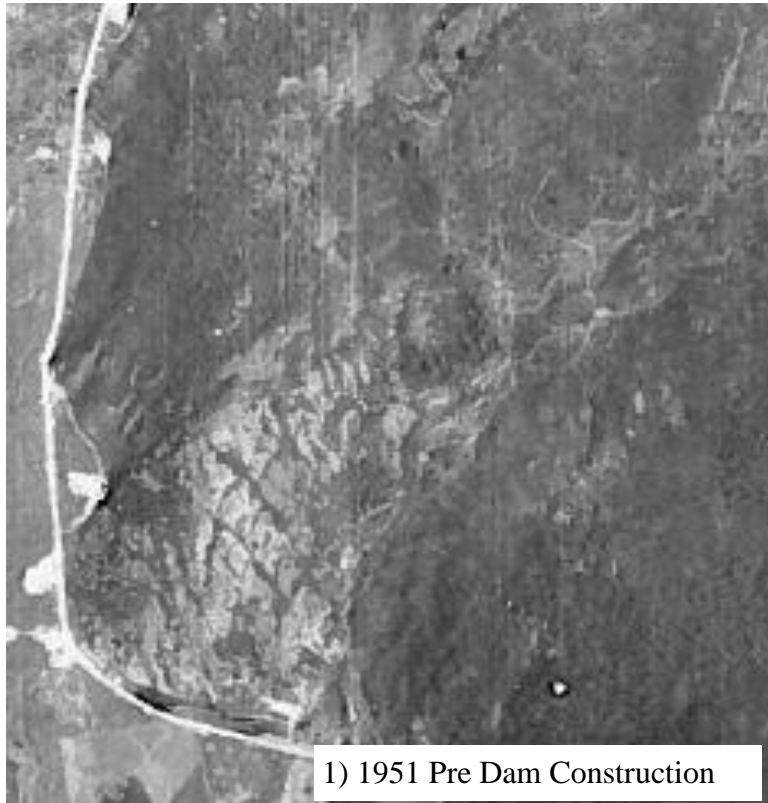
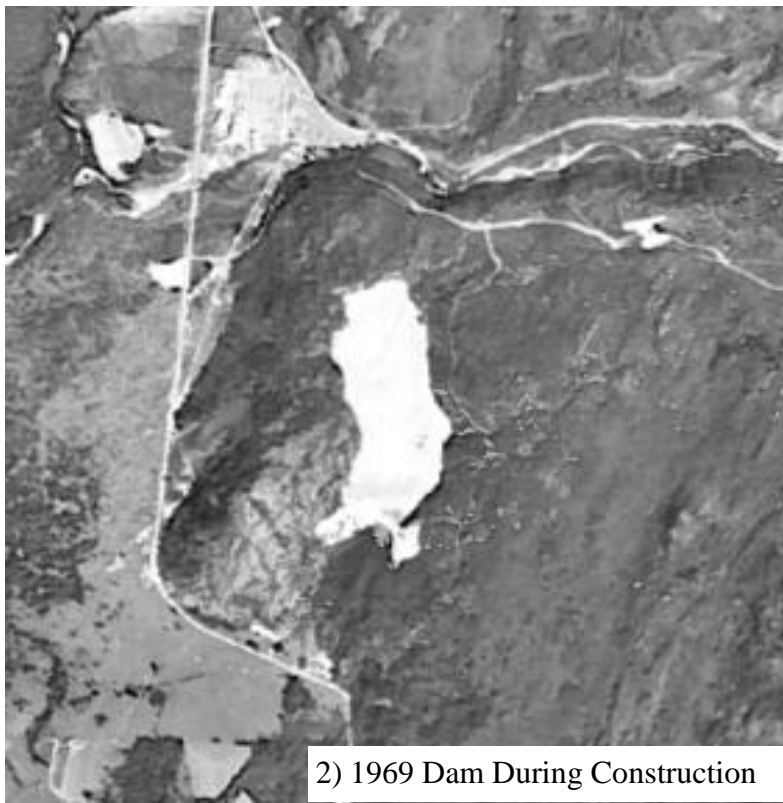
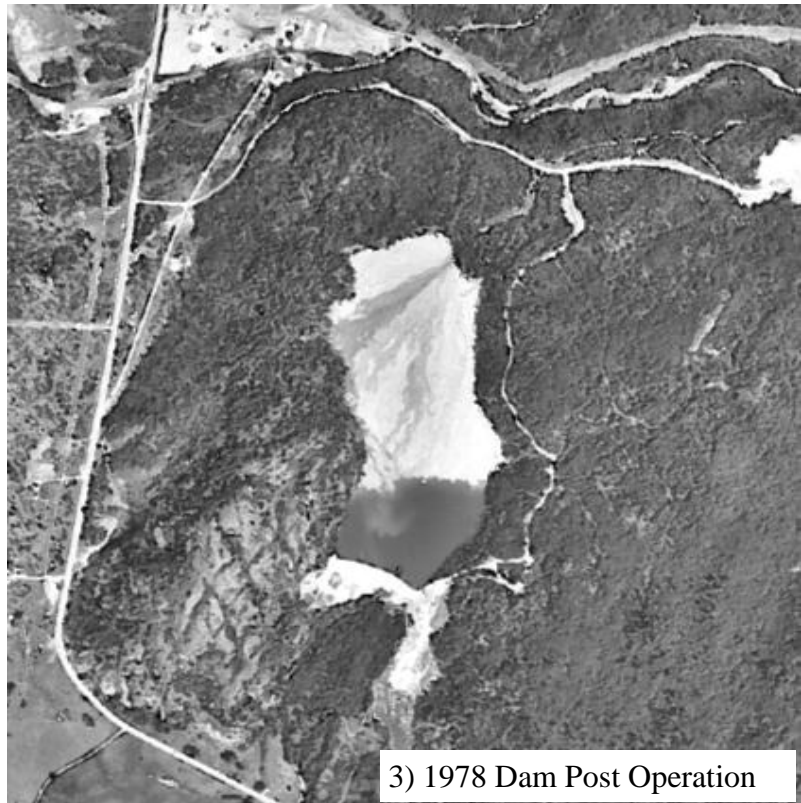
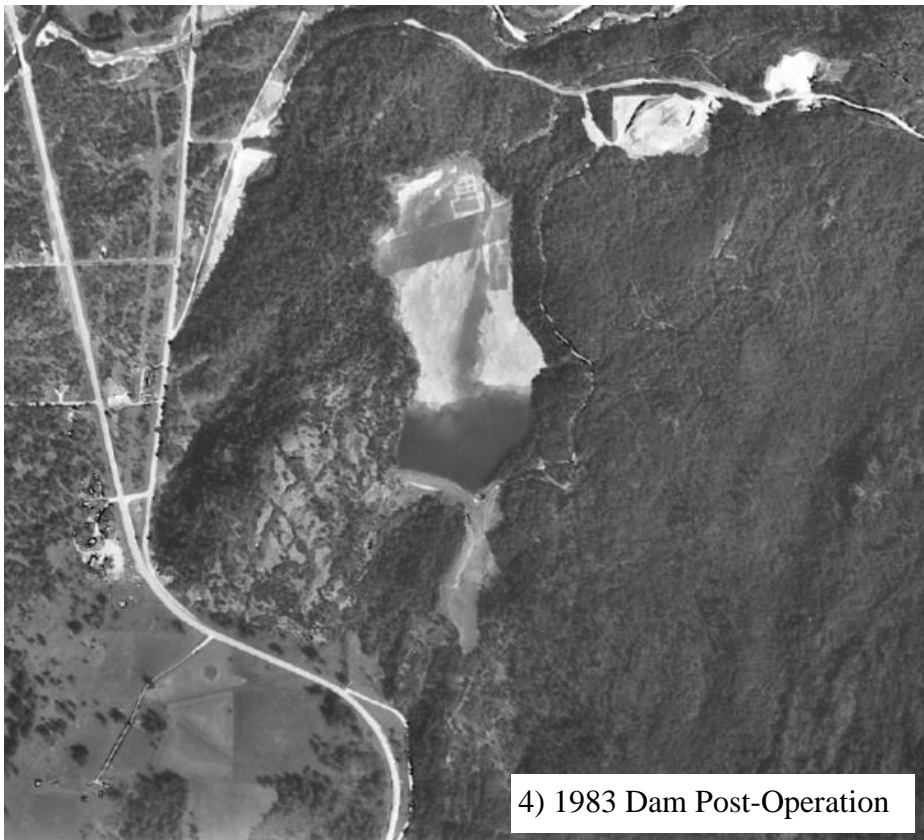
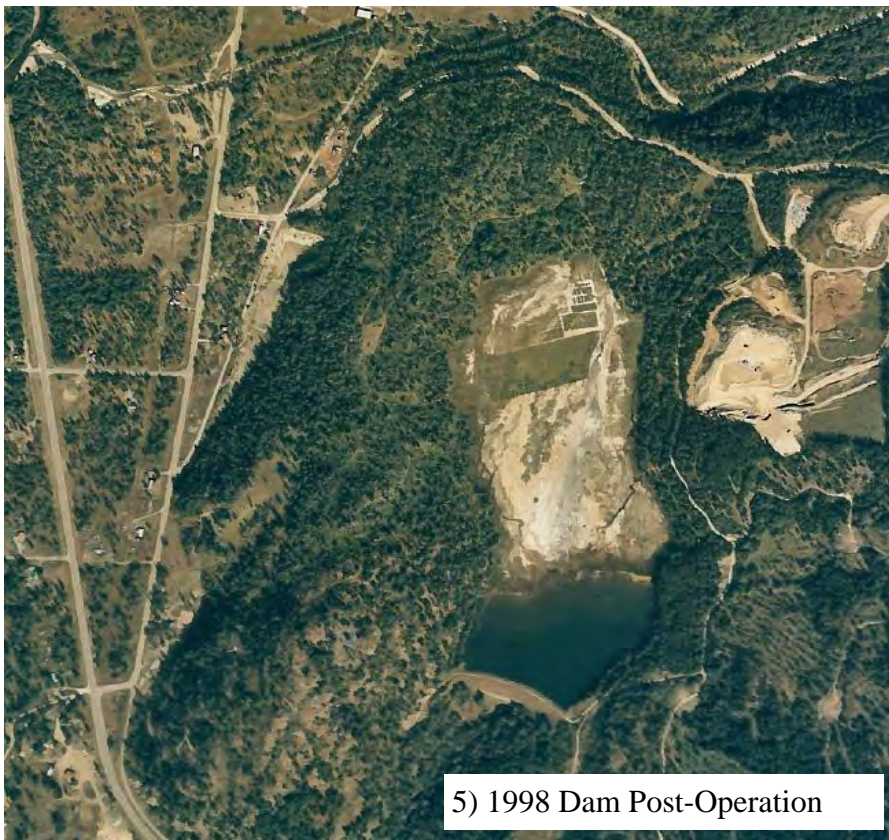
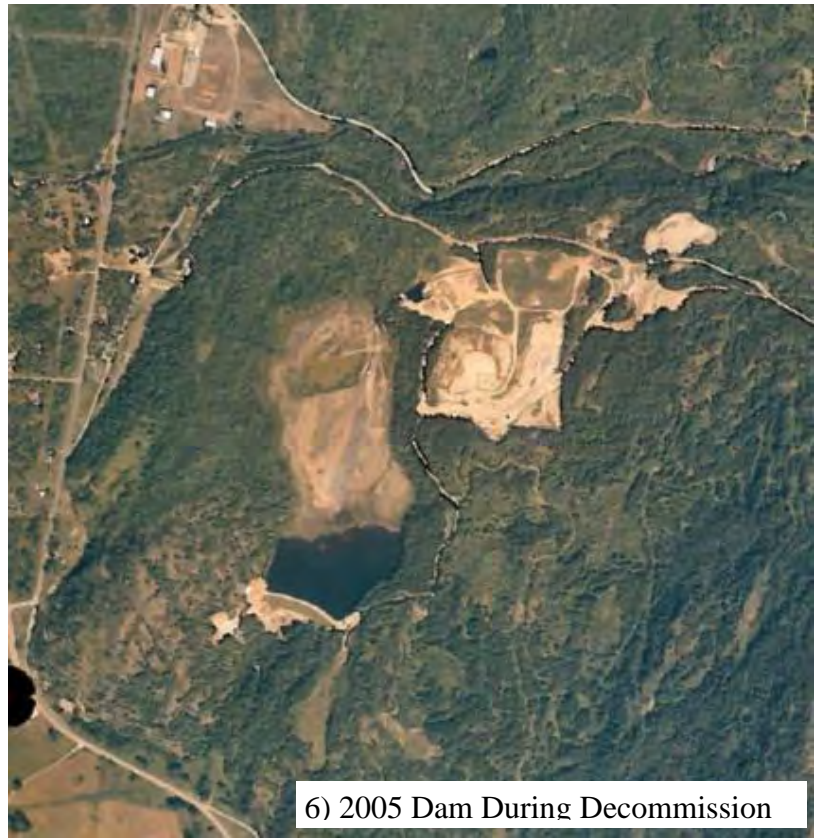
Figure 3.3

- The earliest available aerial photograph was prior to the initial construction of the dam indicating the nature of the original surface conditions.
- Several different stages of the dam construction are evident.
- No obvious signs of historical or current slope instability of the impoundment sides slopes were observed in the review.

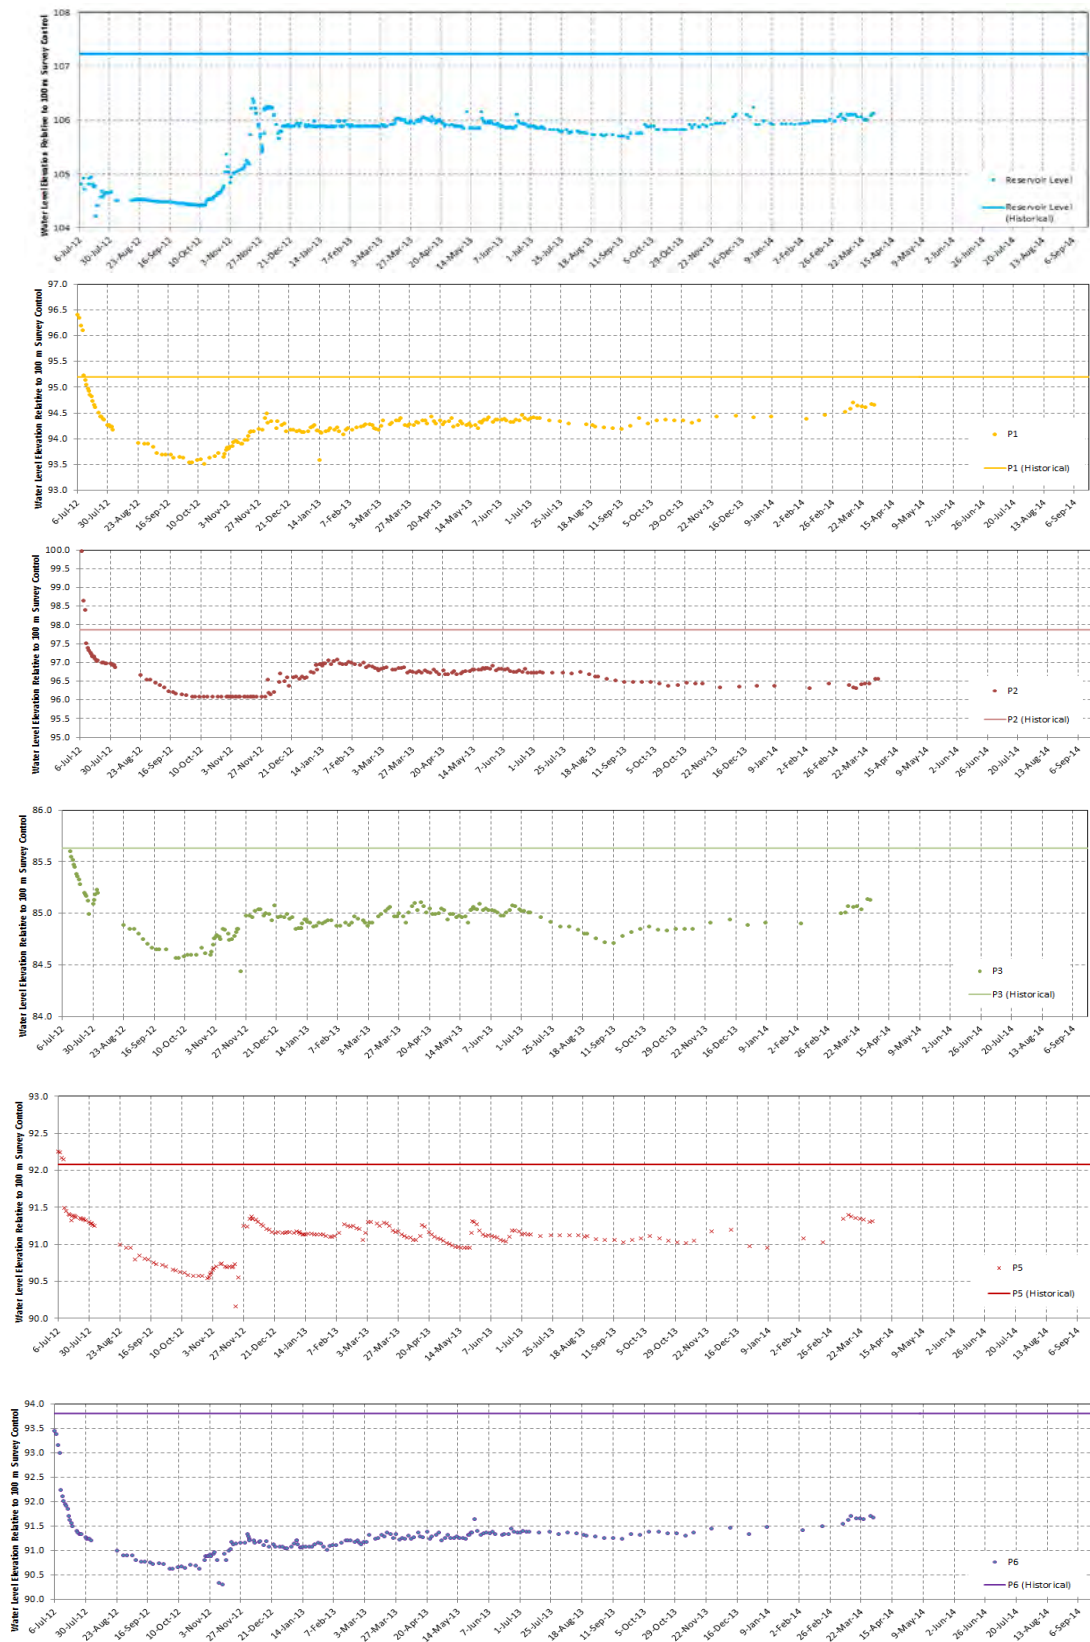
Figure 3.7b

The locations of the piezometers are shown on the attached Figure 3.7a and the water level readings can be seen on the attached Figure 3.7b. Review of the data for the past 12 months indicates that there is an approximate correlation between the pond level and the hydrostatic pressures in the embankment.

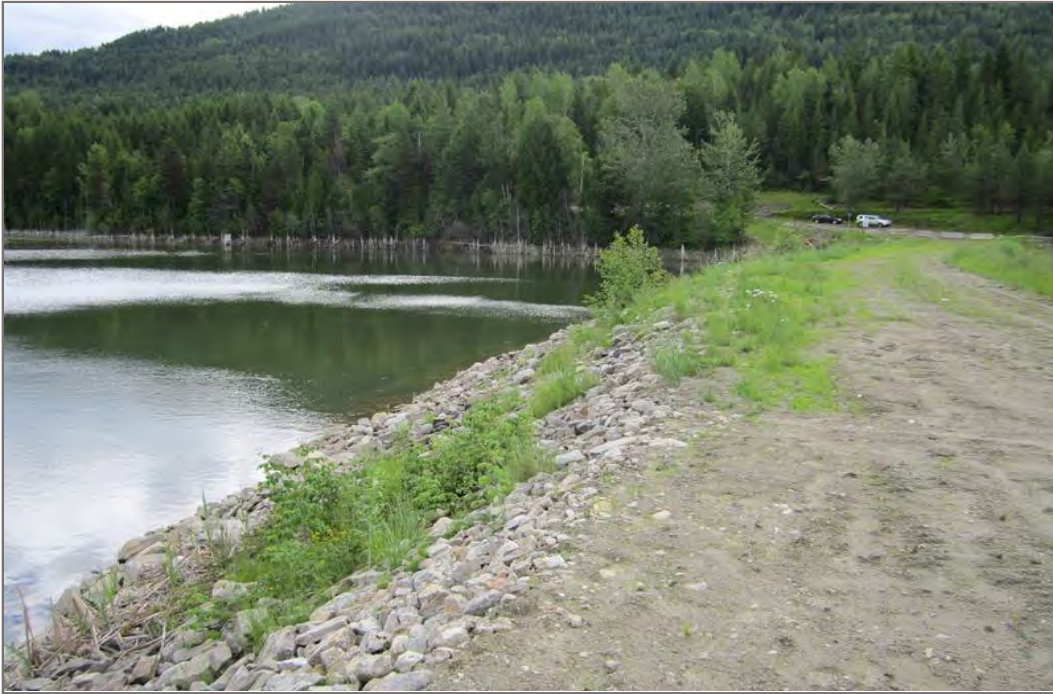
Site Reconnaissance	<ul style="list-style-type: none"><li>Some brush vegetation is growing in the upstream slope of the dam.</li><li>Minor rutting from vehicle traffic noted on the dam crest.</li><li>Minor animal activity (tracks) was noted on the dam crest.</li><li>The spillway channel inlet has no log boom.</li><li>Noted rip-rap protection missing in spillway outlet channel.</li></ul>	<ul style="list-style-type: none"><li>The brushy vegetation of the upstream slope of the dam should be removed (High).</li><li>The rip-rap protection missing in spillway outlet channel should be replaced (Very High).</li><li>A log boom should be installed across the spillway inlet channel entrance (Very High).</li></ul>
Consequence Classification	<ul style="list-style-type: none"><li>The dam breach inundation mapping indicates that a total area of approximately 0.73 km² would be impacted in the event of a dam breach, including the Crowsnest Highway (BC 3) depositing approximately 714,000 m³ of tailings.</li><li>One permanent residence and the Crowsnest Highway where there is likely to be a temporary population are situated in the immediate downstream flood inundation zone where flood levels are expected to reach several metres, where an estimated potential loss of life of three people would occur in the event of a dam breach assuming a warning of less than 15 minutes.</li><li>Economic consequences resulting from an failure of the embankment including, cleanup of deposited tailings, restoration of contaminated land and reconstruction of the HB Dam have estimated to be in the range of \$45.7 M to \$83.4 M.</li></ul>	<ul style="list-style-type: none"><li>Based on the estimated economic loses that would occur due to a breach of the dam it is recommended that the consequence classification of the HB Dam is increased to "Very High". However any decision to modify the consequence classification rating must be confirmed by the Ministry of Energy and Mines (Very High).</li></ul>

**Photo 1:** Crest of dam – observed rutting from vehicle traffic and minor animal activity

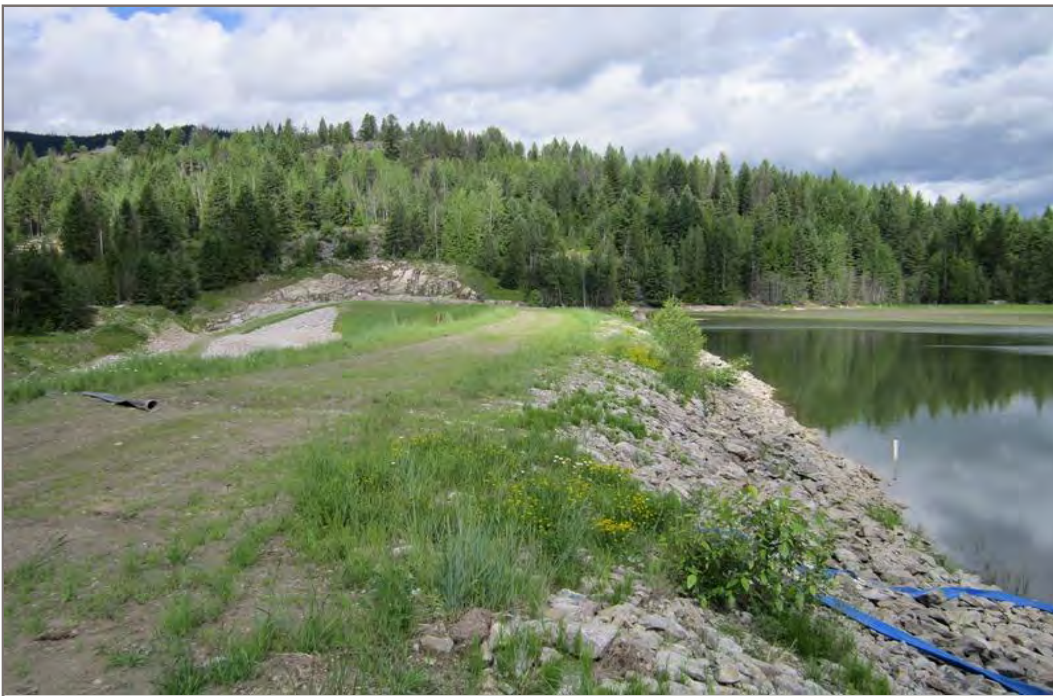
**Photo 2:** Upstream Face – vegetation/brush/tree growing on the upstream face of the dam

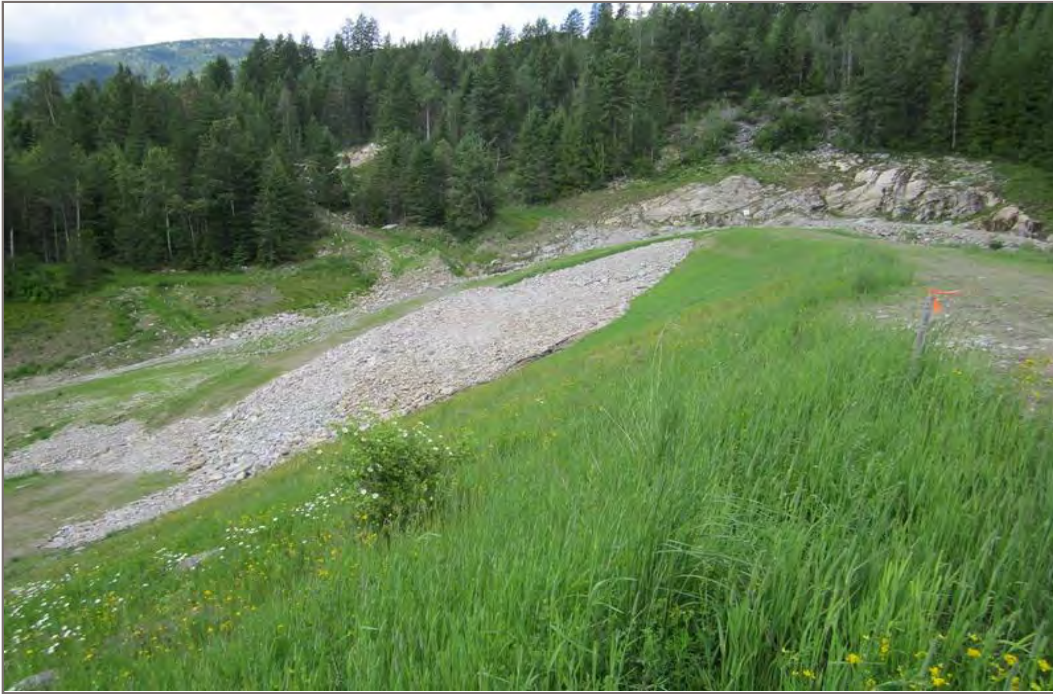
The embankment slough was repaired by reconstructing the core material to its original height and width using locally sourced glacial till. A shear key was built at the toe of the sloughed area and a coarse rock blanket was placed over on the downstream face of the reconstructed core material, a v-notch weir was also installed at the toe of the dam (Tetra Tech EBA 2012).

**Photo 3:** Downstream Face – observed new rock blanket at slough

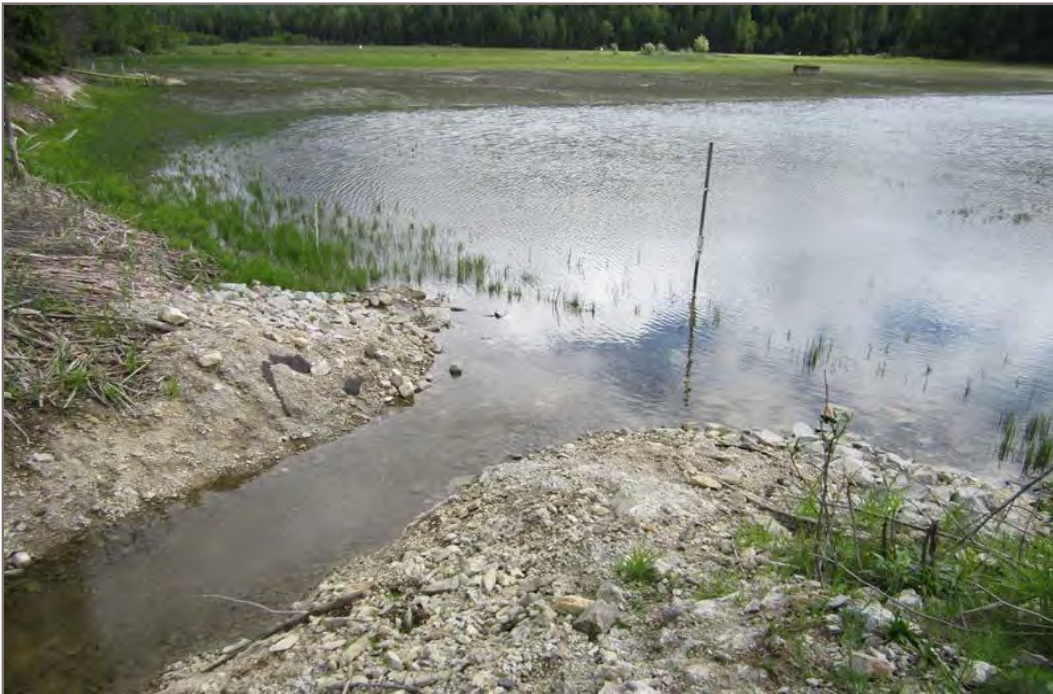
**Photo 4:** Spillway - bottom width measured to be 1.7 m

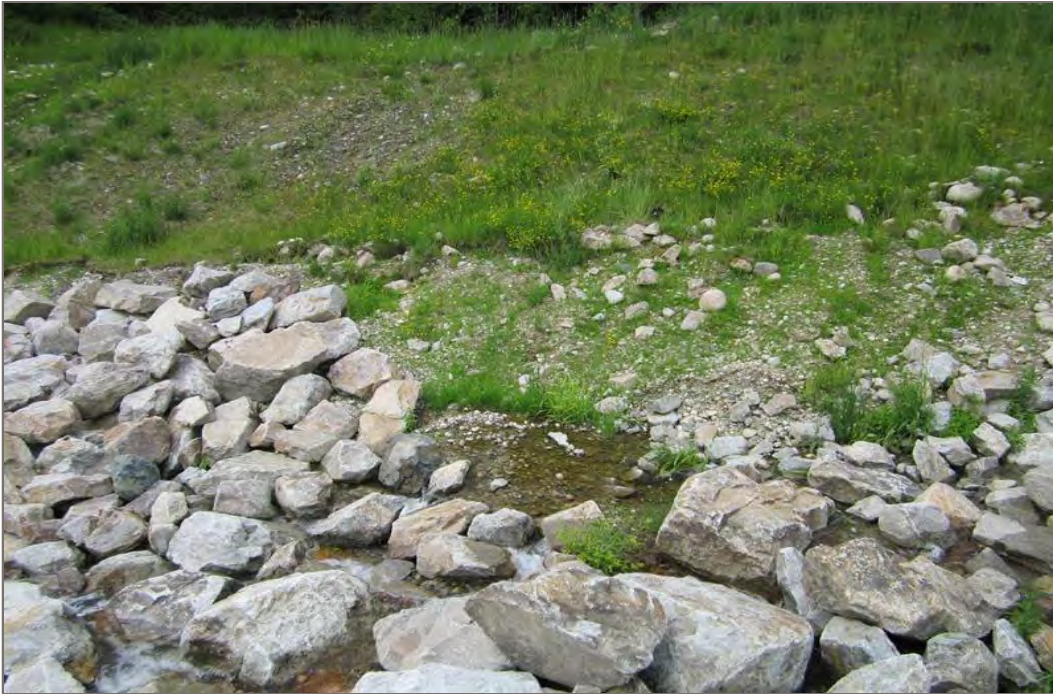
**Photo 5:** Spillway Channel – noted missing rip-rap protection on the right bank of channel (used for the slough repair)

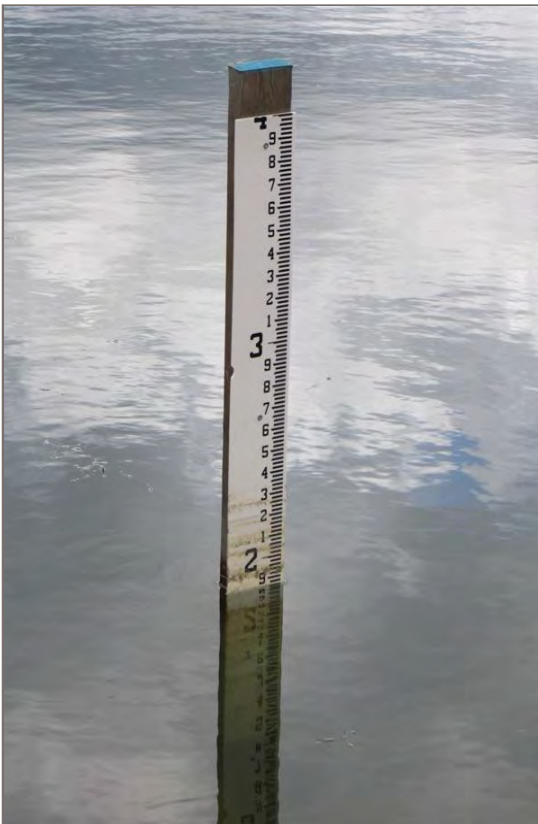
**Photo 6:** Reservoir – staff gauge reading of water level was 1.85 ft. (approx. 709.58 m amsl)

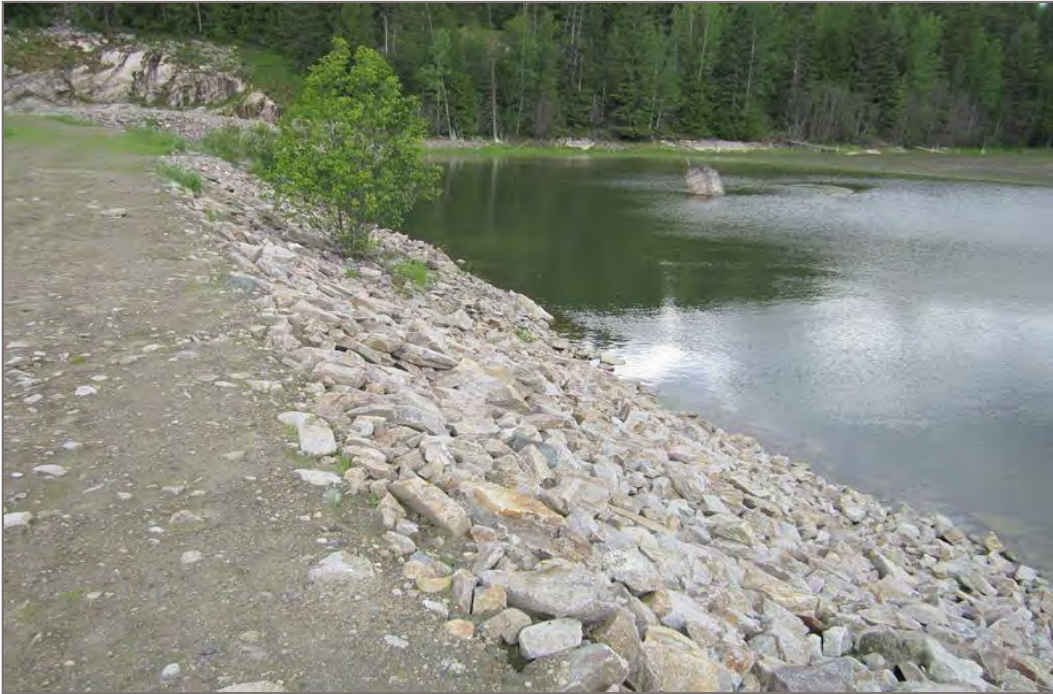
**Photo 7:** Reservoir – remains of abandoned decant structure (severely damaged)

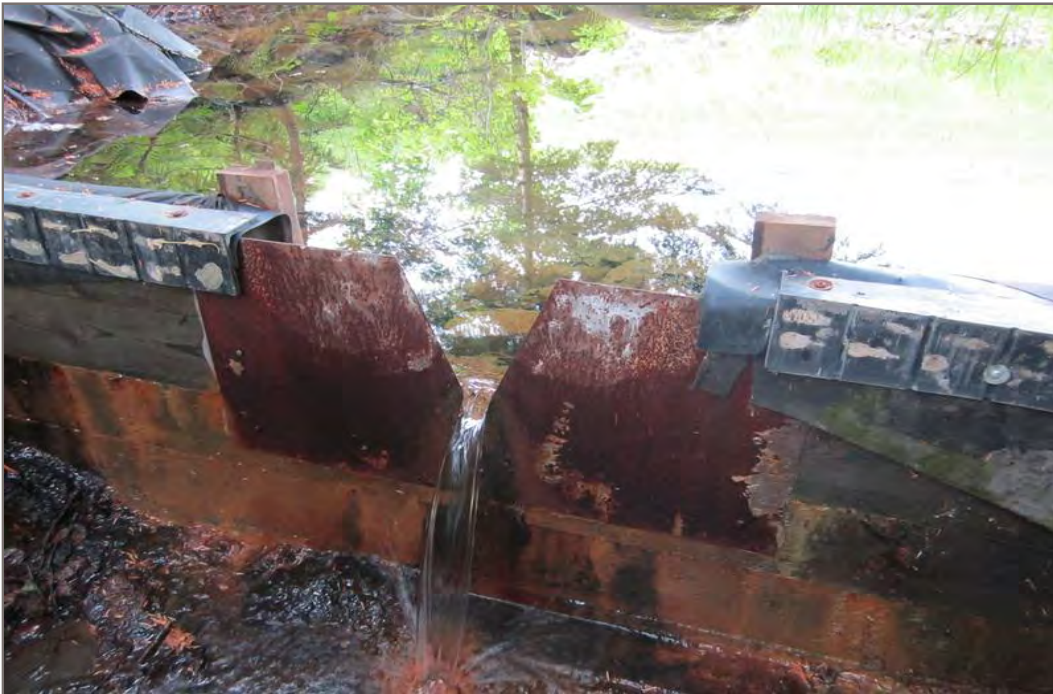
**Photo 8:** V-notch weir located downstream of the east embankment to measure seepage estimates

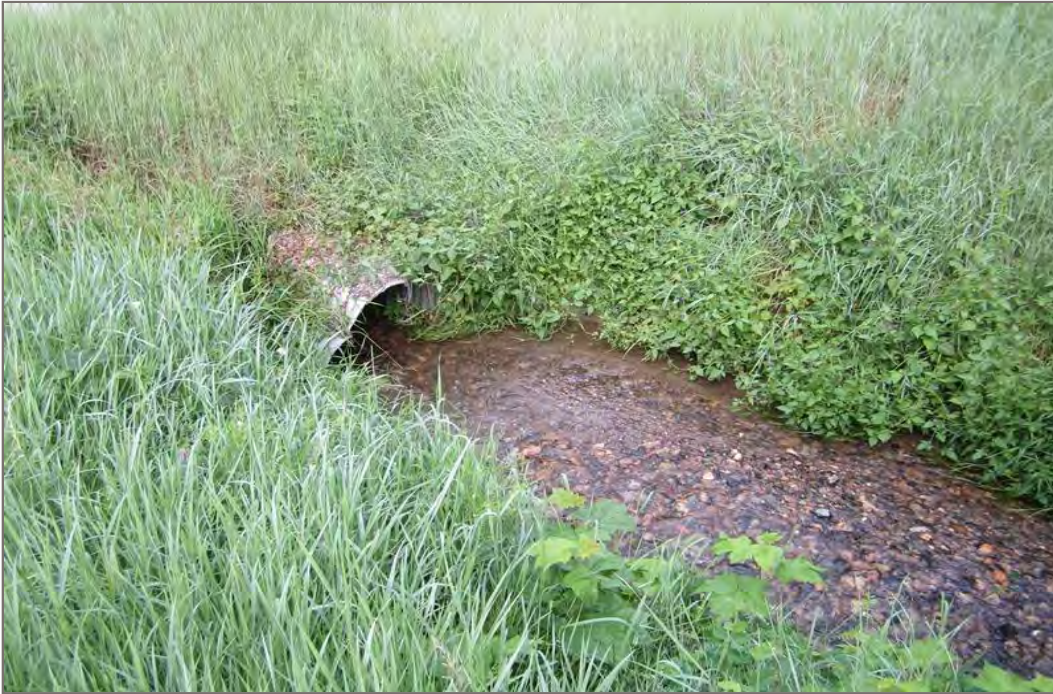
**Photo 9:** Dam outlet flows downstream under a culvert under Highway 3
