June 25, 2015

Teck Highland Valley Copper Partnership
P.O. Box 1500
Logan Lake, British Columbia
V0K 1W0

HVC Tailings Dams - Bethlehem Main (No. 1) Tailings Storage Facility
Response to MEM Memorandum - February 3, 2015

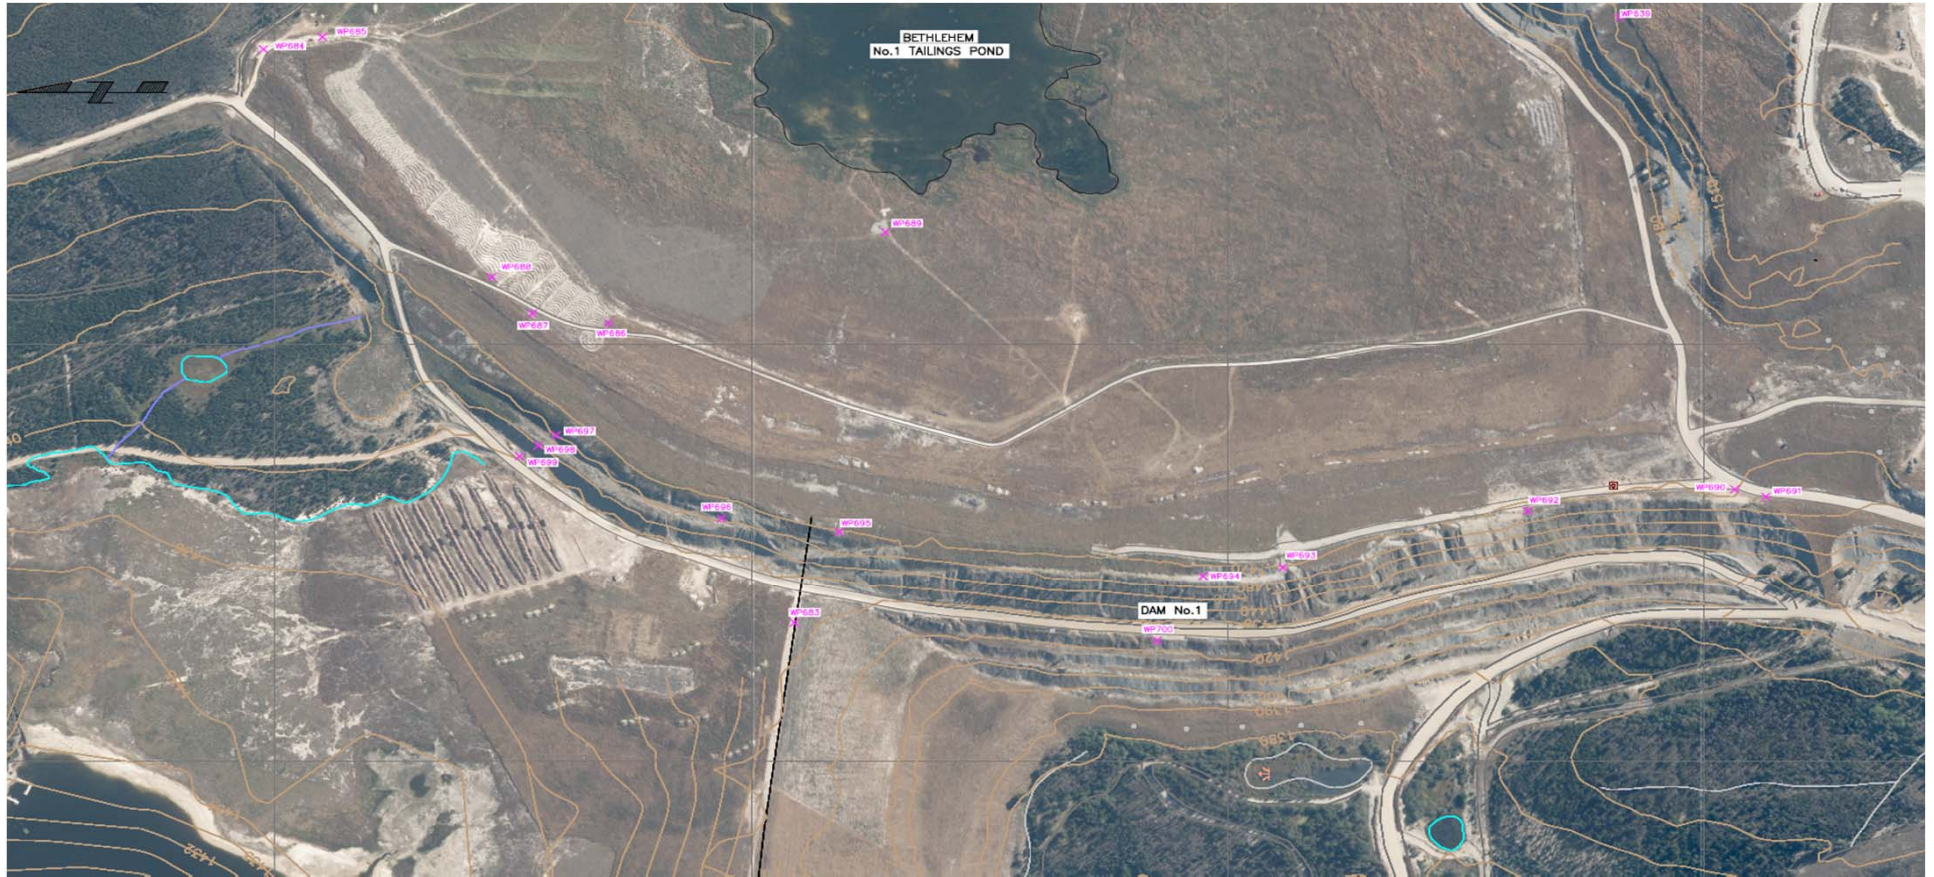
PROJECT	HVC TAILINGS DAMS RESPONSE TO MEM MEMORANDUM	
TITLE	BETHLEHEM TSF NO.1 DAM NO.1	
PROJECT No.	M02341A87	No. 2

Dam No. 1 is a sand and rockfill dam with a rockfill downstream shell and upstream cycloned sand construction. The dam has a maximum height of 96 m and overall length of 1.9 km. The sandfill crest is nominally 3 m to 4 m higher than the rockfill. The dam was originally designed by Ingledow and Associates, with additional design and construction by Gepac and Fellhauer Consultants, with Klohn Leonoff Limited taking over in 1982. Construction began in 1963 with a 6 m high starter dam constructed of a short till dyke plus cycloned sand. The dam was raised in succeeding years by placing rockfill on the crest and on the downstream slope and placing spigotted or cycloned tailings on the upstream side. When the dam crest reached El. 1462.9 m, a 76 m wide rockfill toe berm to improve stability was added, with a crest width of about 15.24 m at El. 1429.4 m. The rockfill crest was raised to El. 1472 m in 1972. The dam was completed to El. 1476.9 m in 1983 by upstream construction with cycloned sand.

Two glacio-lacustrine clay layers in 4 boreholes were identified in the foundation footprint of Dam No. 1. The upper layer was approximately 1 m thick near the original ground surface upstream of the dam centerline in one borehole. The lower layer is approximately 0.5 m to 3 m thick, from 15 m to 17 m depth below the original ground surface under the downstream toe of the dam.

The clay layers are described as clay with silt and sand laminae, with relatively high moisture content which is similar to the Mount Polley glacio-lacustrine unit.

The dam design assumed a competent till foundation and did not initially allow for a soft surficial layer. During construction in the late 1960's, tension cracks and movement occurred on the main dam fill, because of weak surficial foundation soils. Where exposed, the surficial soils were removed and a rockfill toe berm was added to the dam in 1970 to 1971, buttressing the dam against these weak surficial foundation conditions. However, removal of the lower clay layer was not documented and we do not believe that it was removed.

- The overall extent and strength of the clay layers described above are unknown, including susceptibility to seismically induced triggering of undrained behaviour. The assessment of potential deformation following a seismically induced undrained response was based on conservative assumptions. Additional evaluation is warranted once site data is available.

- The following plan is recommended to address this gap:
 - ♦ Drill at least one hole to verify presence or absence of a silt or clay layer and collect undisturbed samples for laboratory strength testing.

- ♦ Stability and seismic displacement analyses are already planned to address this concern, as reported under previous recommendation DSI-BM-02 (2014), and will incorporate information from the additional drill hole and related lab testing. The analyses will assess potential for seismic undrained response of any discovered clay layers.

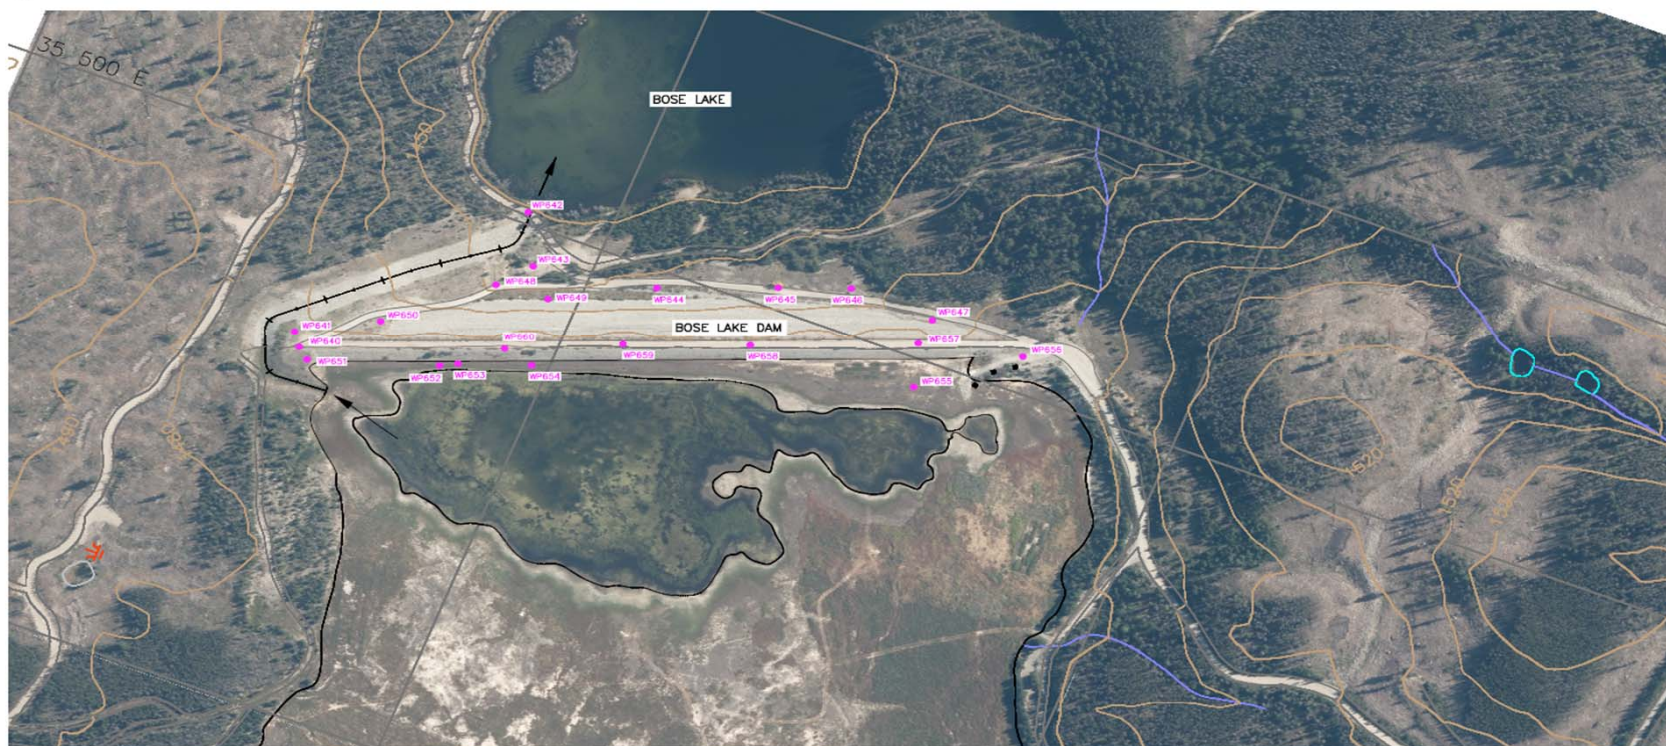
TITLE
**BETHLEHEM TSF NO.1
BOSE LAKE DAM**

Bose Lake Dam is located in a saddle at the eastern extent of the TSF. The dam was originally designed by Gepac (1972). Fellhauer Consultants designed a 3 m raise (1981). Klohn Crippen Consultants Ltd designed the closure spillway (1994). The dam was constructed in stages with the last

stage completed in 1981 to El. 1475.1 m or approximately 1.5 m lower than the Dam No. 1 crest. It is constructed of compacted, low hydraulic conductivity, glacial till with a rockfill downstream toe and filter drains to control seepage. The dam has a maximum height of 34 m and an overall length of 650 m.

There is no evidence in the design reports or investigations of glacio-lacustrine or lacustrine soils. Bose Lake Dam is located on a bedrock saddle with till blanket where there is limited likelihood of lacustrine soils due to the shallow depth to bedrock.

As there is no indication of clay layers under the Bose Lake Dam, the design is considered appropriate. The dam is regularly inspected and there are no indications of stability issues.
