November 25, 2014

INDEPENDENT REVIEW OF 2014 DAM SAFETY INSPECTION REPORT

Huckleberry Tailings Dams

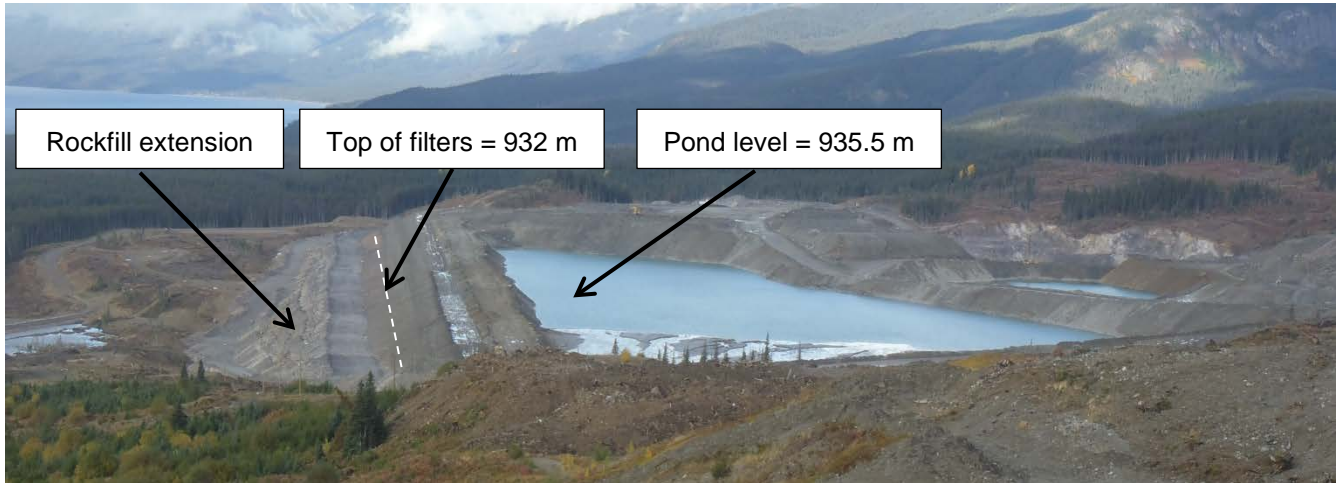
Photograph Showing Relationship of Pond Level, Till Core, Filters and Rockfill at TMF-3

At the time of Golder’s site inspection, the placement of filters and rockfill to the TMF-3 Main Dam and Saddle Dam was lagging behind the placement of till core.

This situation (October 6, 2014, data) is shown graphically below and in Photograph 13 in Appendix A.

Golder agrees with BGC that impoundment of water above the level of protected filters represents a potential dam safety concern. Sustained operation of the dam with a core not protected by filters and not supported by rockfill may result in the potential for piping failures or unintended downstream movement and cracking of the core. Maximum allowable pond levels for future construction should be reviewed with BGC.

In October 2014, BGC Engineering Ltd. provided an assessment of the potential dam safety hazard presented by this scenario (Appendix K of BGC 2014) and provided maximum allowable pond levels for filters at El. 932 m. Mitigation measures were developed by HML and BGC to reduce the pond level in TMF-3 to levels that do not present a dam safety concern. The mitigation plans are considered appropriate. It is further understood that raising of the filters and rockfill is in progress at the time of writing, and that filters are expected to be above the pond water level by early December and at about El. 940 m in January 2015. Ongoing implementation of the mitigation strategies (particularly reducing the pond level and raising the filters and rockfill) should be given high priority.

Golder recommends that HML and BGC should review the water management strategy, tailings deposition plan, and dam raise schedule for filter and rockfill placement. This should include review of the sensitivity of the TMF-3 system to changes in water management strategies, such as varying rates of reclaim.

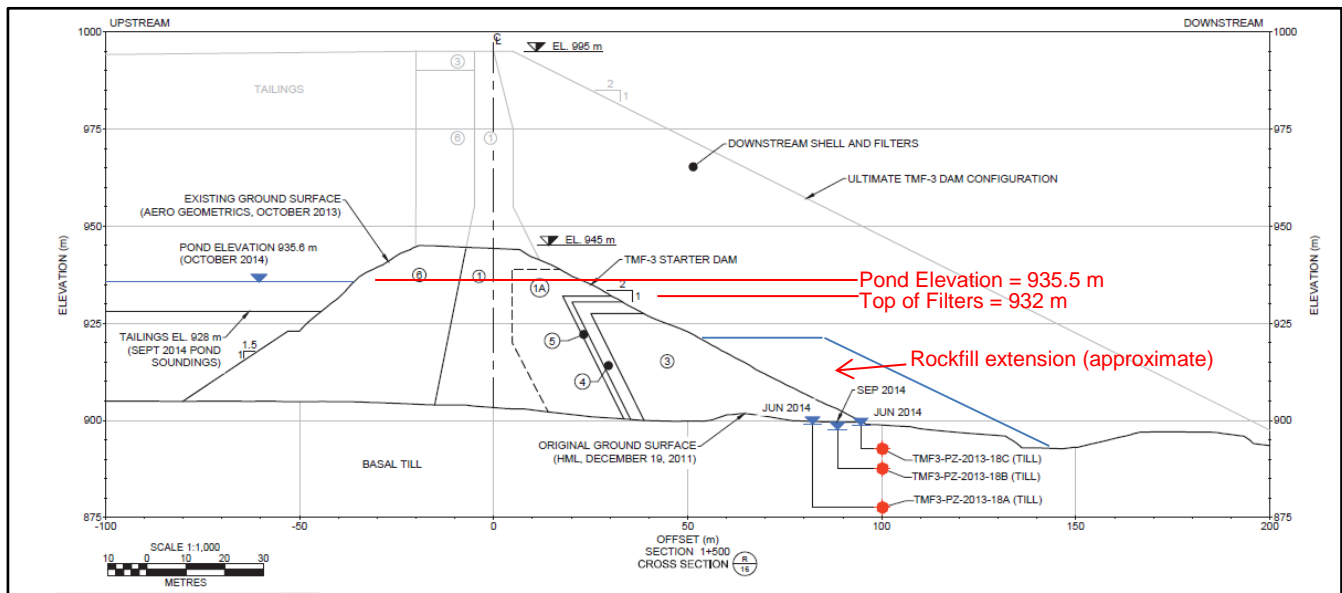
TMF-3 Cross-Section at Sta 1+500 (modified from BGC 2014)

On October 6, 2014, BGC reported the following elevations for the TMF-3 Dam:

| ■ Zone 1 till core | 945 m |
| ■ top of weighted filter zone | 932 m |
| ■ pond elevation | 935.5 m |

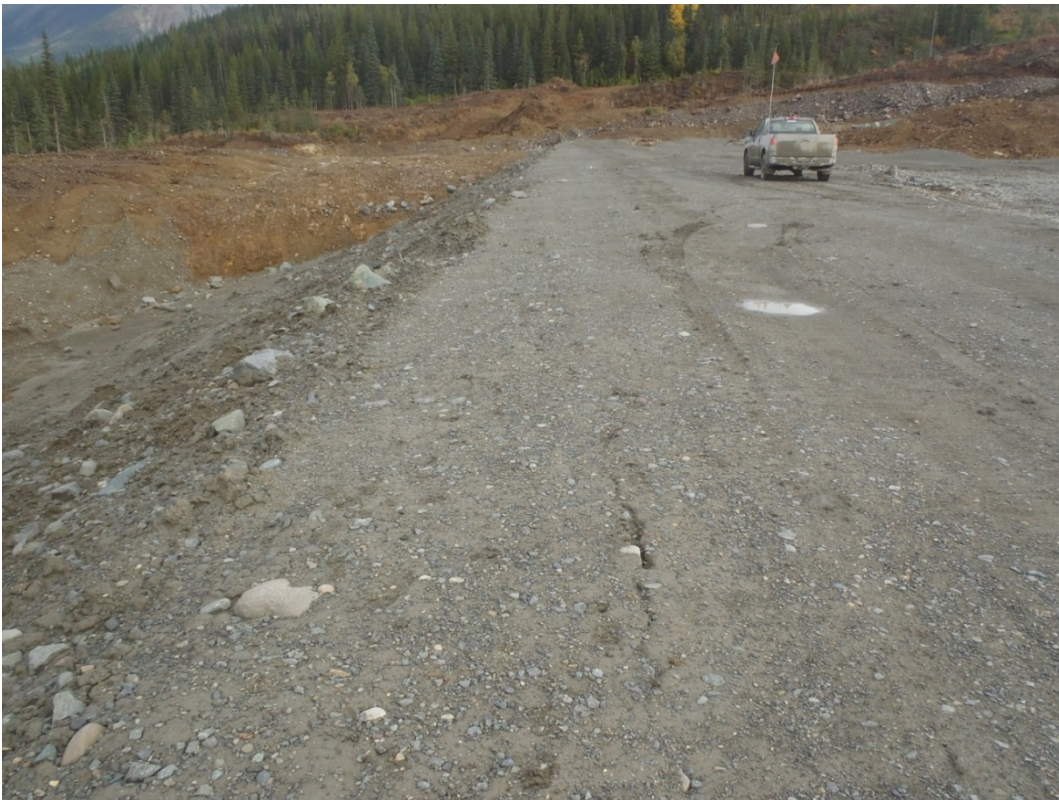
- The placement of filters and rockfill is lagging behind the placement of low-permeability core materials in the Main Dam and Saddle Dam of TMF-3. This was noted in the DSI report (BGC 2014). This issue is discussed further in Section 4.3.
- Some cracking of the core has occurred on the TMF-3 Saddle Dam, which extends about 2 m into the core (Photographs 17 and 18 in Appendix A). The lack of rockfill support and potentially lower compaction near the downstream edge of the till are likely to be contributing factors to the cracking. Cracking of this nature was noted in the 2014 DSI report (BGC 2014), and BGC noted that the cracking will be remediated during the fall 2014 construction. This item does not present a dam safety concern provided that the remediation is performed in advance of the pond level reaching the cracked portion of the till.

Photograph 17: TMF-3 Saddle Dam Tension Crack at Downstream Crest. The crack is above the pond level and does not present a dam safety concern provided that repairs are performed in advance of the pond level reaching the level of the crack.

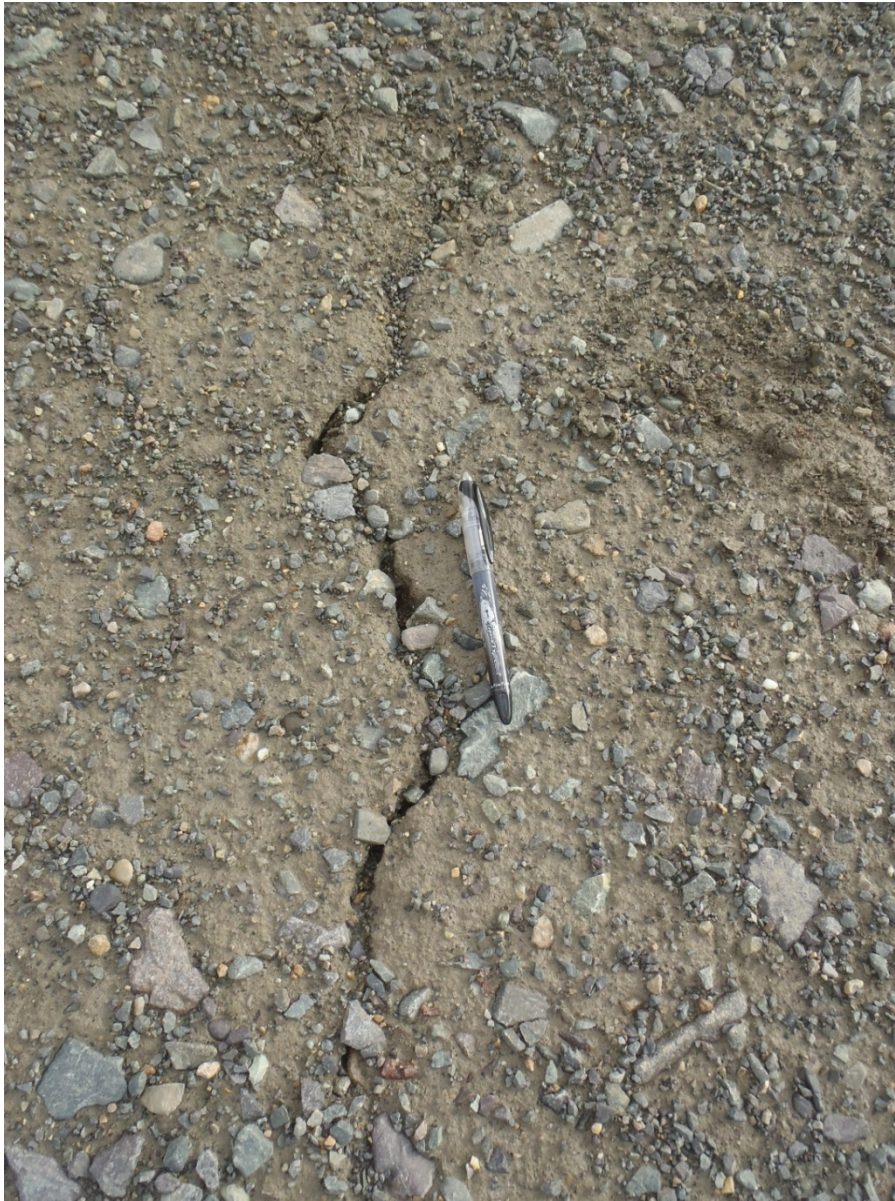
Photograph 18: TMF-3 Saddle Dam Tension Crack at Downstream Crest. The crack is above the pond level and does not present a dam safety concern provided that repairs are performed in advance of the pond level reaching the level of the crack.
