June 30, 2015  
Project No.: 1193-005-C

Mr. Kent Christensen, P.Eng. – General Manager  
Huckleberry Mines Limited  
PO Box 3000  
Houston BC, V0J 1Z0

**Re: Letter of Assurance Request, Huckleberry Mine, BC**

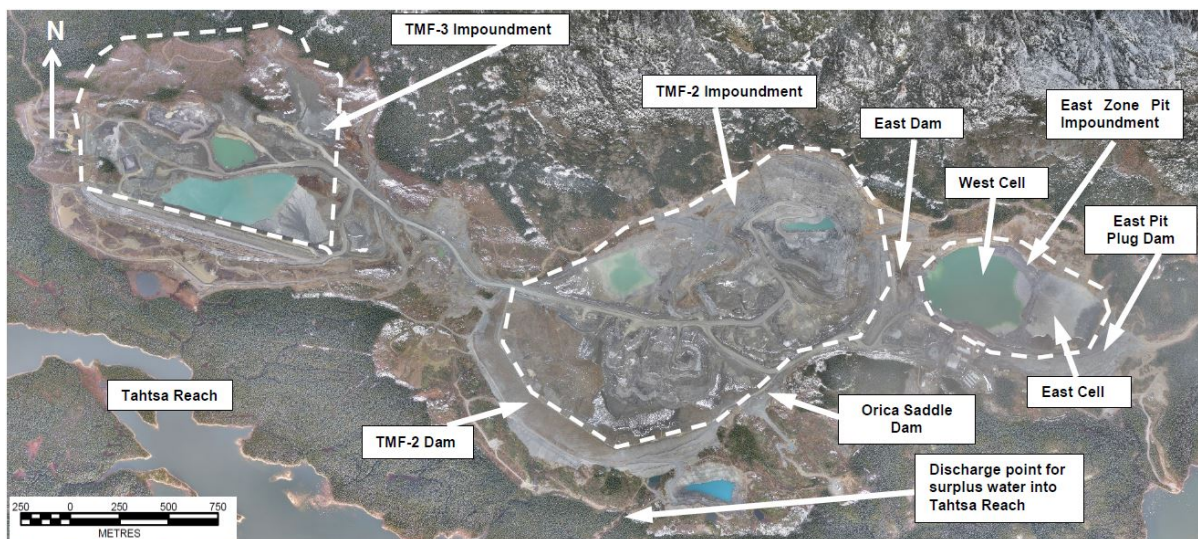
**Figure 1-1. Aerial view of the Huckleberry Mine site (October 2014). Approximate limits of the three tailings impoundments (East to West: East Zone Pit, TMF-2, and TMF-3) indicated.**
