# **British Columbia Ministry of Energy and Mines**

## **2014 Dam Safety Inspection**

### ***Good Friday and Jumbo Tailings Storage Facilities Red Mountain Mine***

November 28, 2014

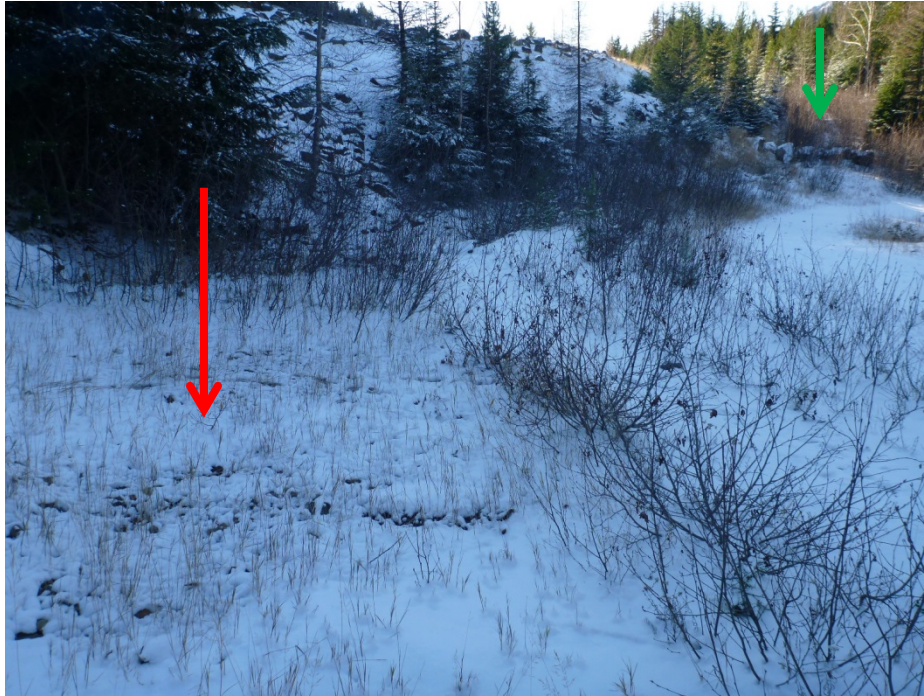
- The downstream slope of the dam consists of a rockfill slope with rockfill particles up to approximately 1.0 m in size. Seepage was visible in the downstream toe area of the West Limb near the right abutment as well as in the northern portions of the downstream toe ditch. The toe access road along the West Limb toe to the southwest corner of the South Limb is becoming overgrown with willows/alders. The rockfill buttress/toe berm repair of the natural slope below the South Limb of the dam appears to be in good condition with no obvious deformations. The downstream slope does not appear to have changed from what is shown in figures included in Appendix I. Deciduous and coniferous trees are growing sporadically on the downstream face of the dam (Photos 1 through 9).

Photo 1 – Good Friday, right abutment area of West Limb dam. Photo taken facing south. Red arrow indicates seepage area melting thin cover of snow that fell the night before the inspection. Green arrow indicates boulder barricade of toe access road.

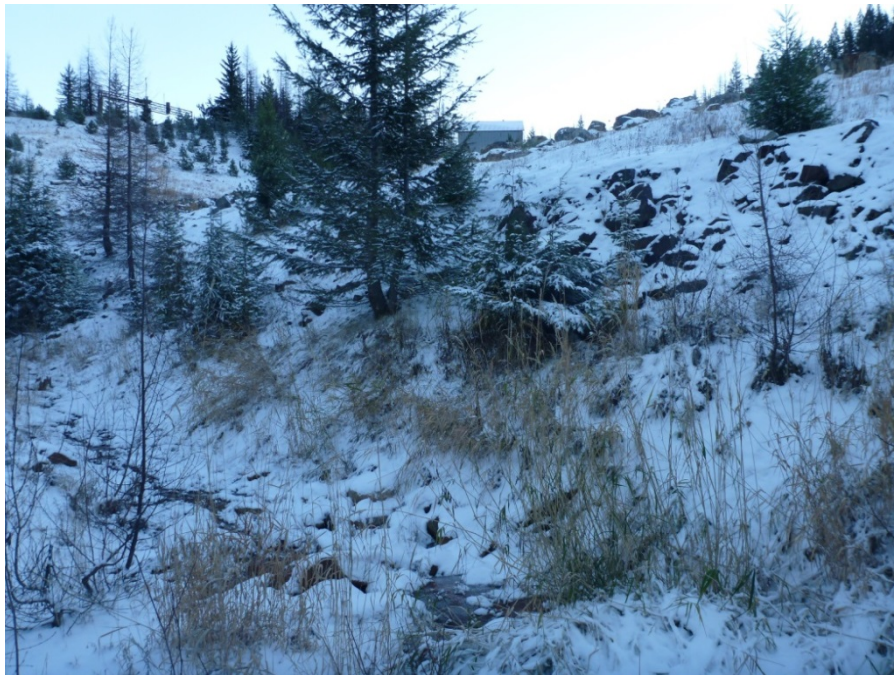
Photo 2 – Good Friday, West Limb of dam. Photo taken facing north approximately 100 m from right abutment. Note seepage in drainage ditch at toe of dam and abandoned mine plant buildings on ridge.

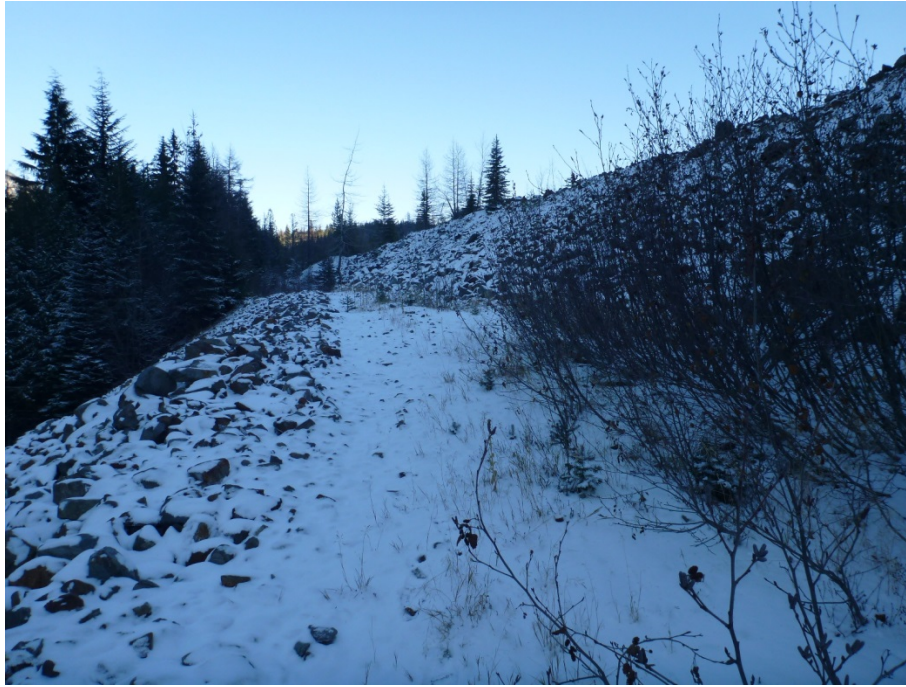
Photo 5 – Good Friday, downstream toe area. Rockfill buttress repair of natural slope instability exacerbated by an overtopping event prior to reclamation of tailings facilities. Downstream slope of South Limb of dam located to right of photograph.

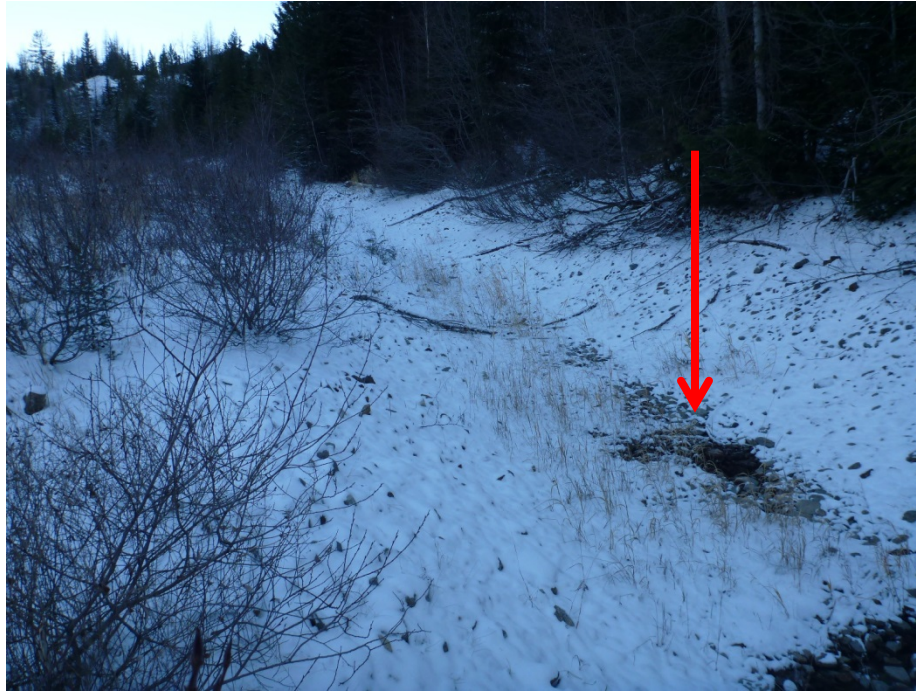
- The drainage channel on the reclaimed tailings surface appears to be in good condition. Some seepage from the slope above the TSF was flowing through the drainage channel in the southern half of the channel (Photos 16 through 19). Evidence of high water marks were not observed during the inspection due to snow cover.

Photo 17 – Good Friday drainage channel. Photo taken facing north from approximate mid-point of channel length. Red arrow indicates surficial water flow, believed to be collected seepage from adjacent slope.

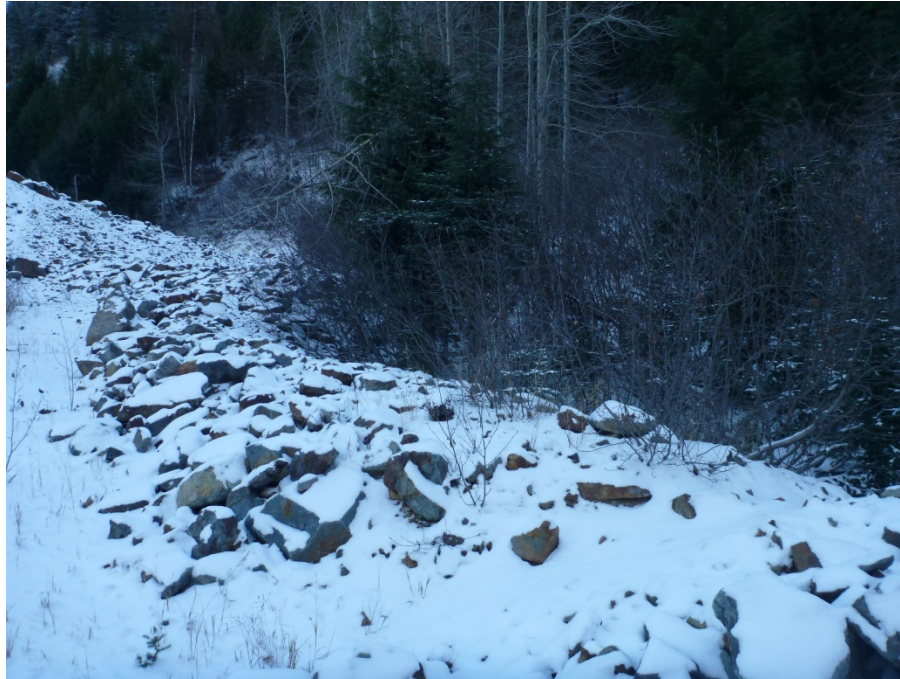
- The spillway on the left abutment of the TSF dam appears to be in good condition. Evidence of high water marks was not observed during the inspection. However, willows/alders and small coniferous trees were noted to be growing in the spillway channel beyond the downstream toe of the dam which would impede water flow through the channel. There appears to be a small instability of a natural slope beyond what is believed to be the downstream limit of the slope drain system constructed as part of the reclamation works. This instability does not appear to pose a risk of blocking the spillway channel (Photos 20 through 22).

Photo 21 – Good Friday spillway at left abutment of dam. Photo taken facing north. Note trees growing in spillway channel and rockfill training berms to guide spillway discharge in channel.

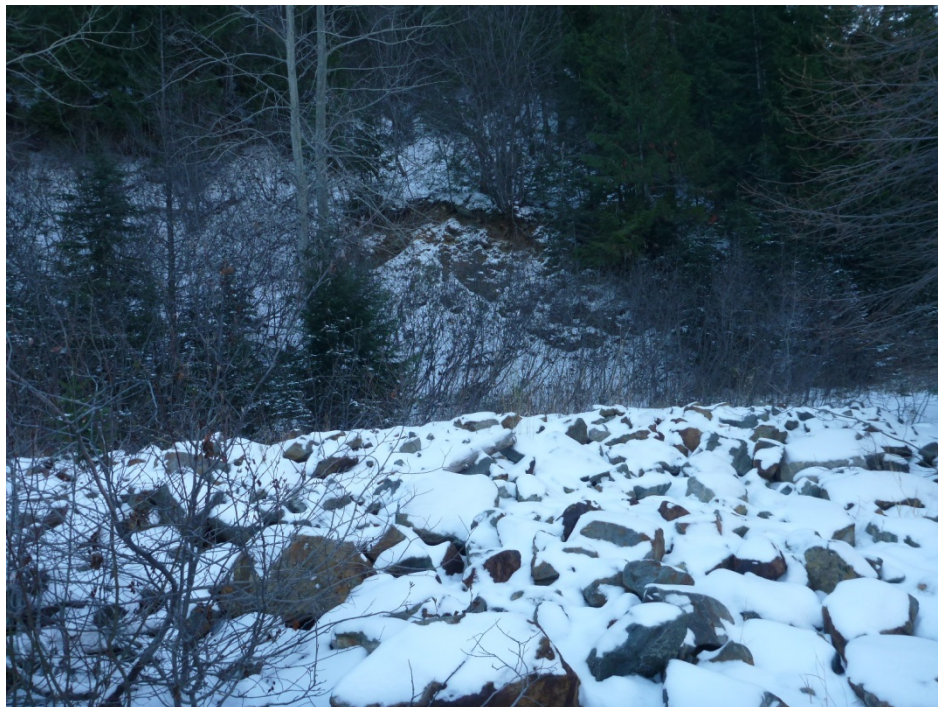
Photo 22 – Minor instability of slope near spillway channel. Instability appears to be located downstream of drains installed in this slope during reclamation work (drains not visible through snow).

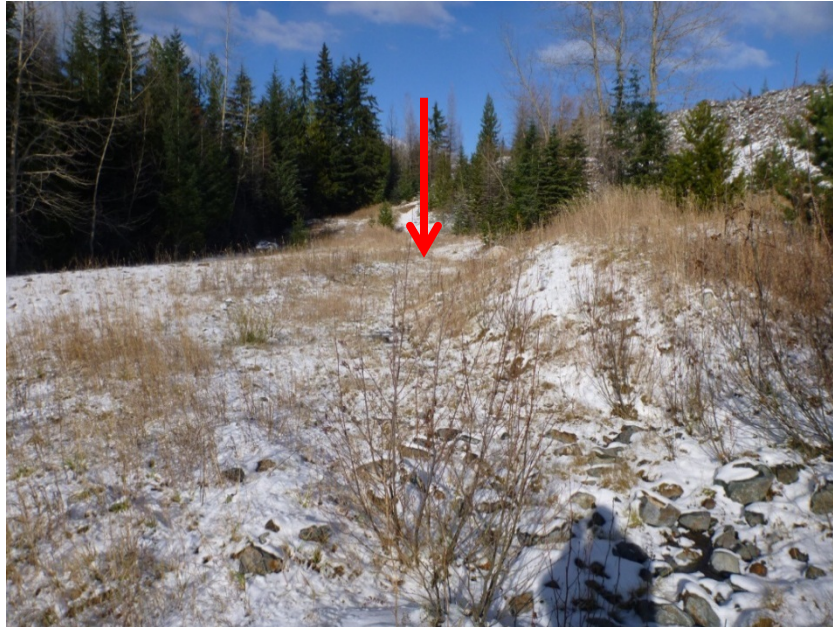
- The reclaimed borrow area downstream of the South Limb of the dam appears to be well vegetated with grass cover. A seepage and/or drainage collection swale was observed at the southwest corner of the South Limb of the TSF dam. Some seepage was observed at the base of this channel through the snow cover approximately 10 m beyond the downstream toe of the dam. Additional seepage was observed approximately 15 to 20 m beyond the downstream toe of the dam that drained towards a cobble and boulder filled drainage ditch that appears to have been constructed to collect seepage. The collected seepage was captured by a drainage ditch that extended down to the creek channel draining from the spillway. Water was ponded up to depths of 0.15 m in this location (Photos 27 through 29).

Photo 27 – Good Friday drainage swale from South Limb of dam. Photo taken facing north. A drainage swale with an earthen berm has been constructed to direct seepage from the dam toe through the borrow area. Red arrow shows where seepage was noted at the base of the swale 10 m beyond the downstream toe of the dam.

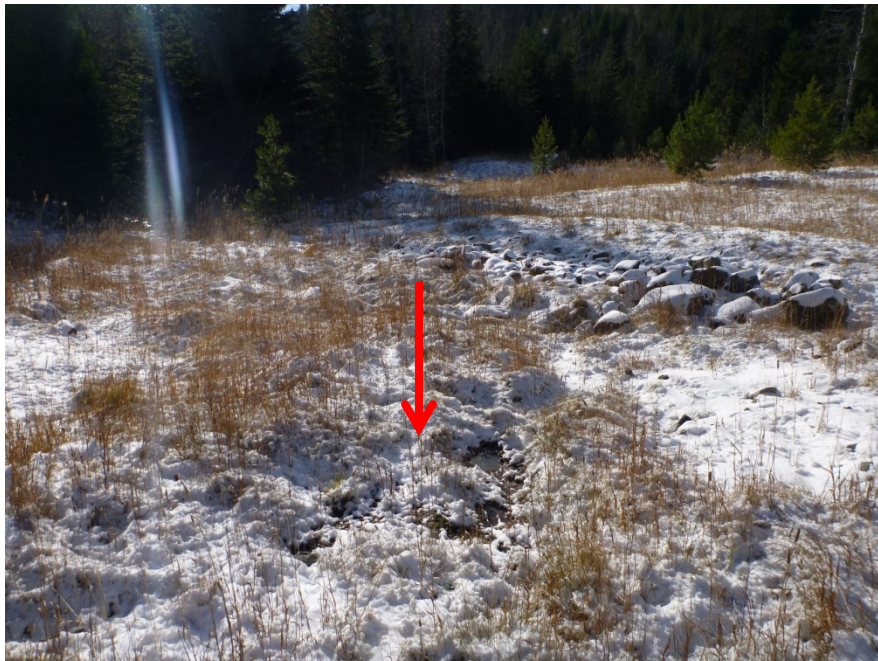
Photo 28 – Good Friday borrow area downstream of South Limb of Good Friday TSF. Photo taken facing south towards confluence of seepage area with flows from spillway. Red arrow indicates seepage flowing over ground surface towards rip rap lined seepage collection channel.

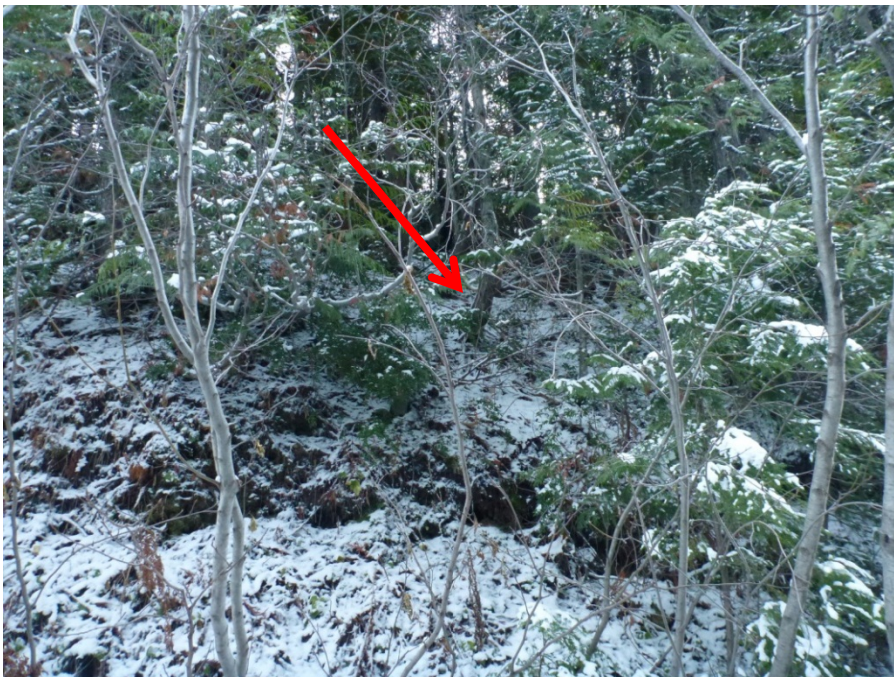
- The south access road downslope of the Good Friday TSF appears to have been constructed using a side hill cut and fill method of construction. As a result, the cut slope below the TSF dam appears to have caused or exacerbated some surficial shallow instability as indicated by trees with bent trunks (Photo 30).

Photo 30 – Good Friday West Limb, downslope of downstream toe area. Photo taken facing east from access road from Hwy 3B. Natural slope between access road and downstream toe of West limb shows signs of surficial instability, possibly associated with the cut slope for the road. Red arrow indicates tree with bent trunk associated with slow movements of slope surface.

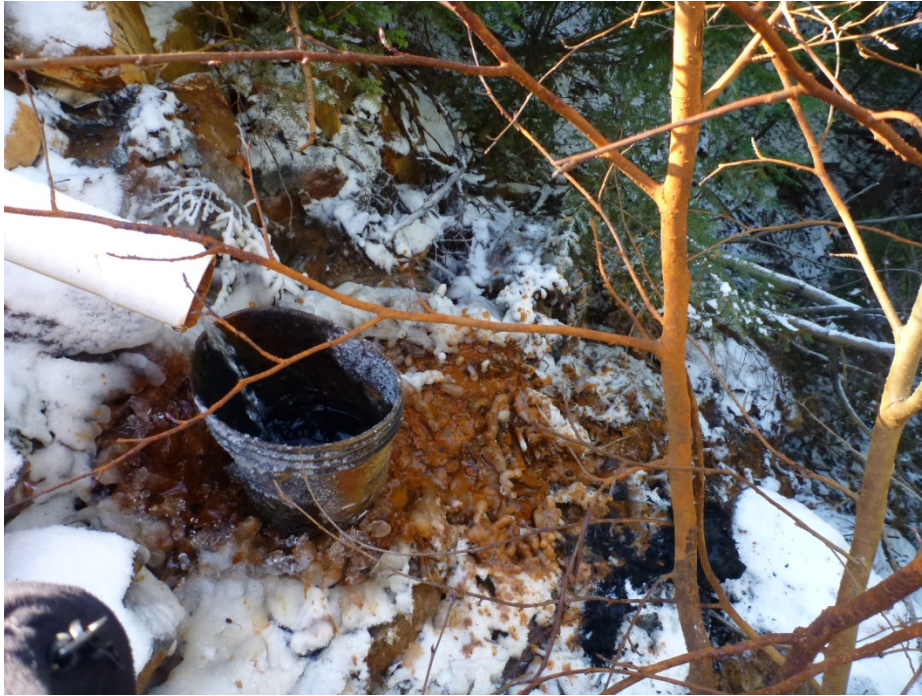
Photo 31 – Good Friday seepage measurement site 16 for measurement and sampling. Site is located across access road to Jumbo from right abutment of Good Friday dam.

Seepage is occurring around the seepage collection pipe at Seep #16 which could indicate that historical flows that were concentrated into the pipe are now diffused over a wider area. As a result, the seepage rate recorded at this site may not be reliably compared to previous readings. The v-notch weir readings could be affected by the freezing conditions and generally clogged upstream area at the time the readings were taken. The organic debris upstream of the v-notch weirs should be removed during the next site visit.

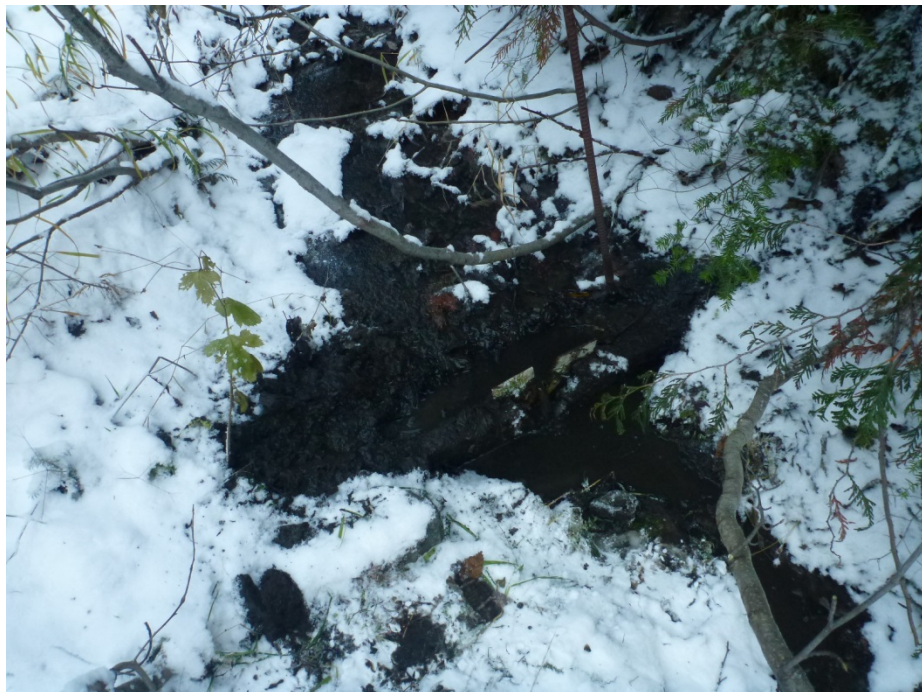
- The v-notch weirs were located and found to be completely clogged with partially frozen leaves and twigs. The debris was cleaned out about 100 mm upstream of the weir and the height of water passing through the v-notch weir was recorded. The water flowing through the weir was clear several minutes after the weir was cleared of debris (Photos 32 and 33).

Photo 32 – Good Friday v-notch weir at seepage monitoring and sampling Site 17. Weir has become clogged with leaves and organic matter since initial installation.

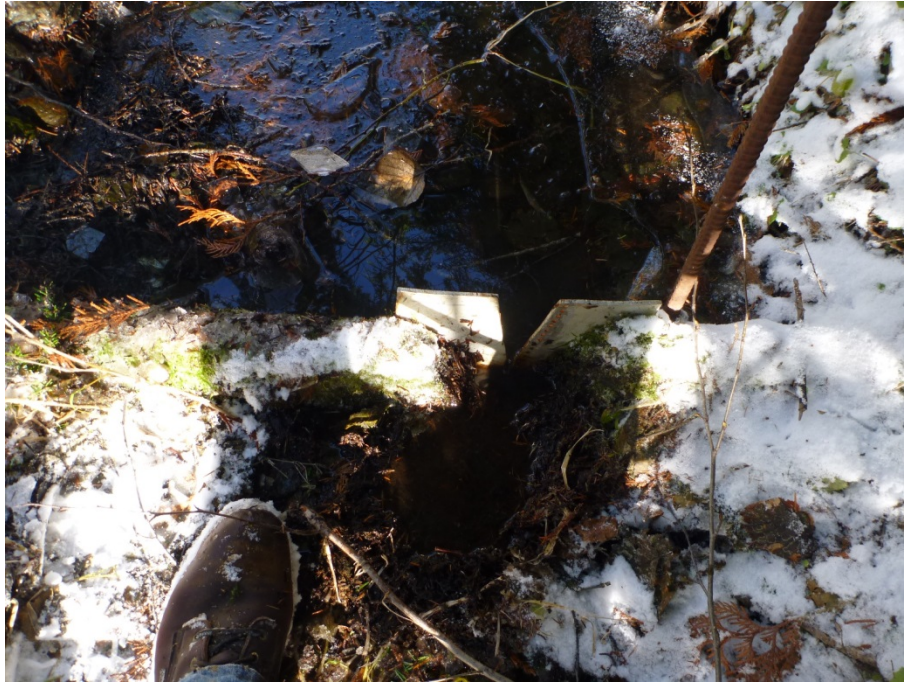
Photo 33 – Good Friday v-notch weir at seepage monitoring and sampling Site 18. Weir has become clogged with leaves and organic matter since initial installation.

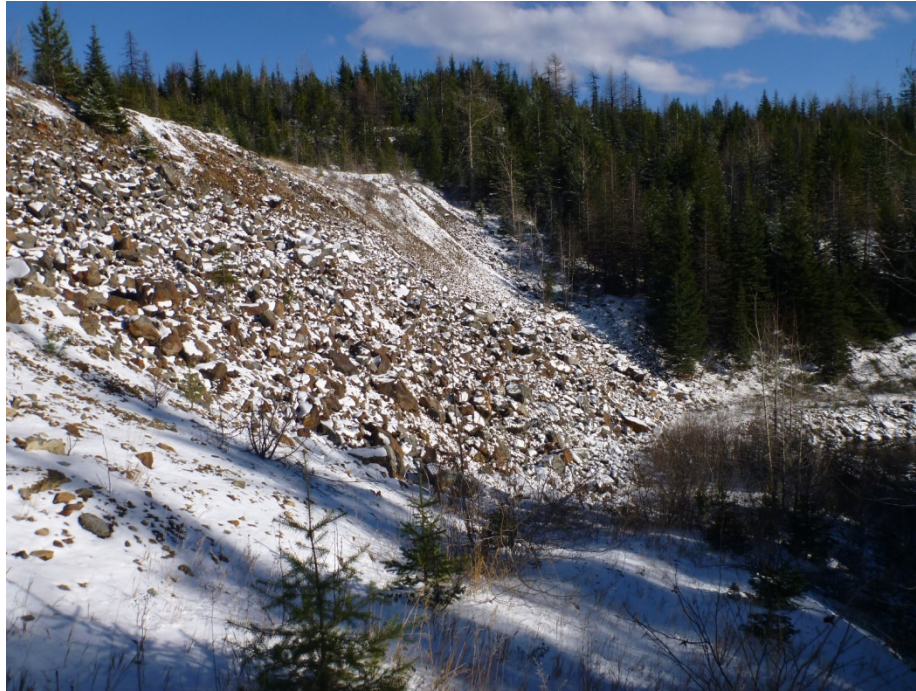
Photo 41 – Jumbo Dam downstream slope. Photo taken from access route located at downstream toe of dam at right abutment. Note uneven surface of dam fill on slope face which appears to be due to original grading of dam during initial construction.

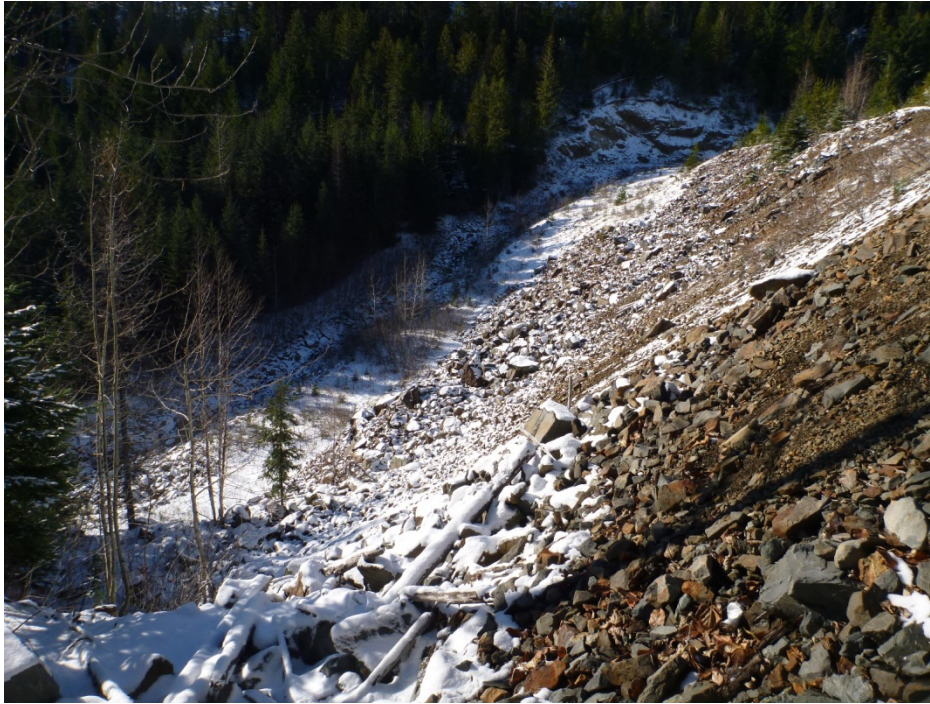
Photo 43 – Jumbo Dam downstream slope. Photo taken facing west from upper left abutment. Note uneven slope surface which is believed to be from original construction of dam.

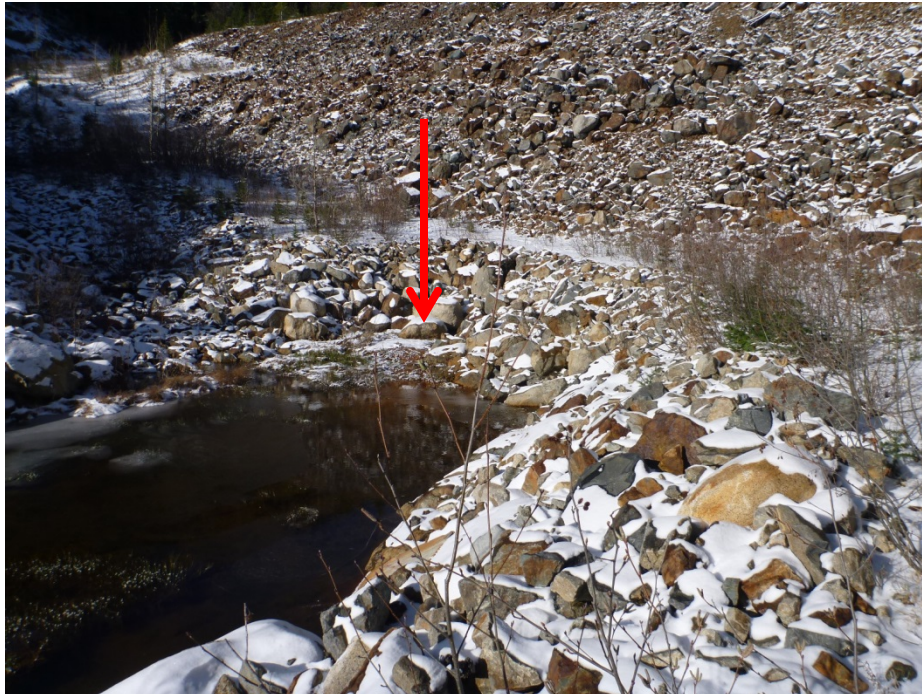
- There is a deposit of loose, soft red silt with trace to some fine sand on the upstream portion of the spillway stilling basin. Dark grey silt is located at an appropriate depth of 10 cm. Clear seepage can be seen entering the stilling basin from the upstream side as well as vertically from the base of the stilling basin. The silt is actively being deposited in this location as it is burying vegetation growing in the stilling basin at this area is being buried by silt. This is the approximate outlet location of the 600 mm CMP that diverted Little Sheep Creek flows beneath the Jumbo TSF. The base of the stilling basin is covered with silt except at the outlet where rip rap particles are exposed on the bottom of the basin (Photos 44 through 47).

Photo 44 – Jumbo Spillway stilling basin. Photo taken facing north west. Red arrow indicates location of seepage and associated deposit of red silt with trace to some fine sand (believed to be tailings).

In general, the Good Friday and Jumbo TSF dams appear to be in good condition, with the exception of the seepage and deposit of silt at the downstream toe of Jumbo Dam. However, the snow cover was sufficient to obscure the slopes and toe area of the Good Friday TSF, especially in the West Limb area. The degree of snow cover on the crest and slopes of Jumbo Dam was less due to the orientation and location of the TSF that results in it getting more sunlight during the day. However, the snow cover obscured the downstream toe area. As such, a follow up inspection should be conducted in the spring of 2015 after the snow has melted.

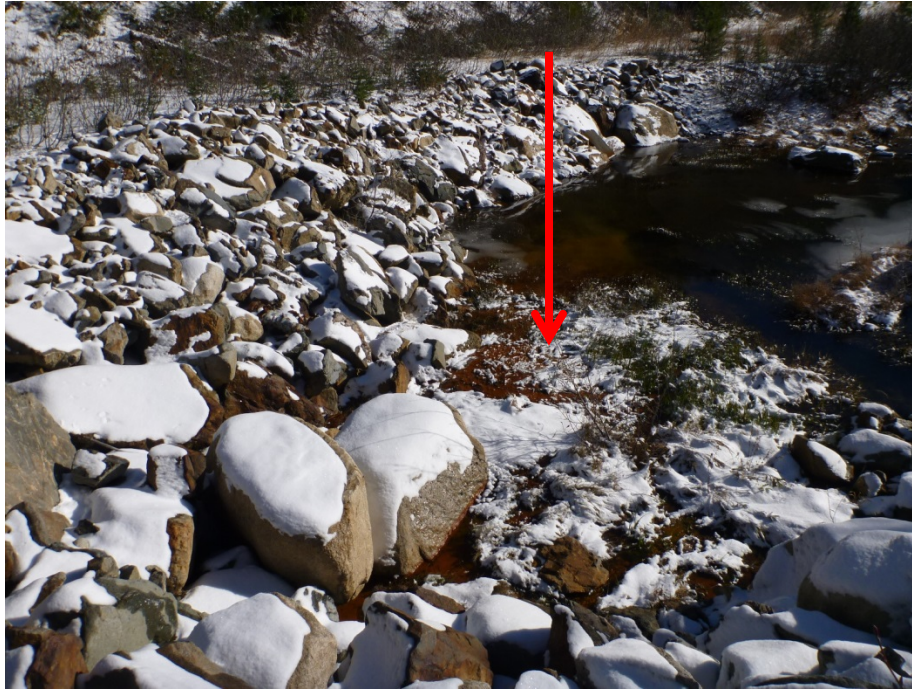
Photo 45 - Jumbo Spillway stilling basin. Photo taken facing south east. Red arrow indicates location of seepage and associated deposit of red silt with some fine sand (believed to be tailings).

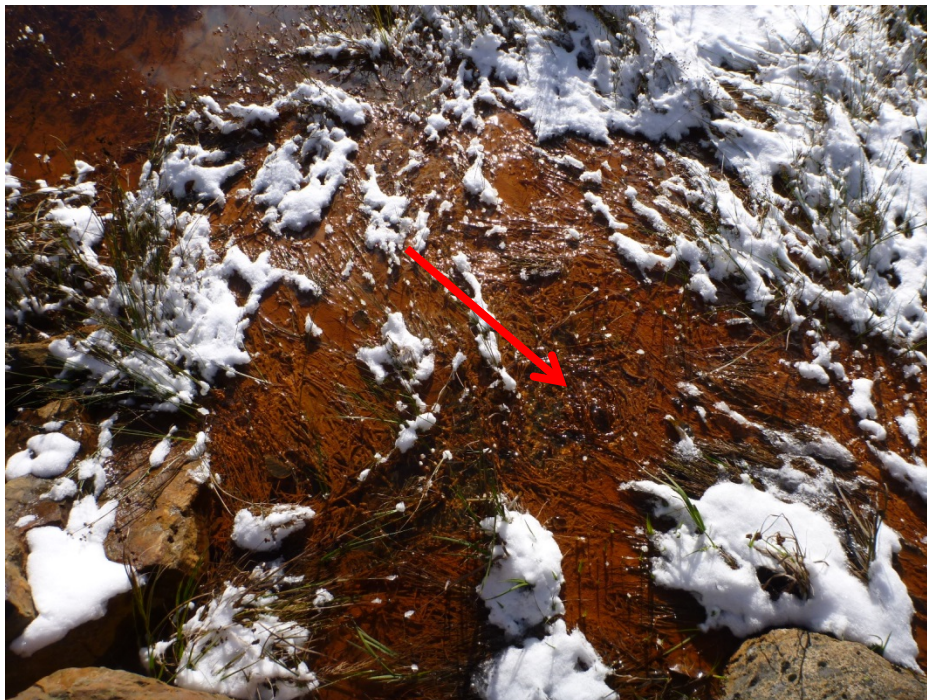
Photo 46 - Jumbo Spillway stilling basin. Seepage is entering stilling basin from the bottom and depositing red silt (believed to be tailings) over vegetation that is growing on surface of silt. Red arrow indicates one seepage discharge point. Seepage is clear.

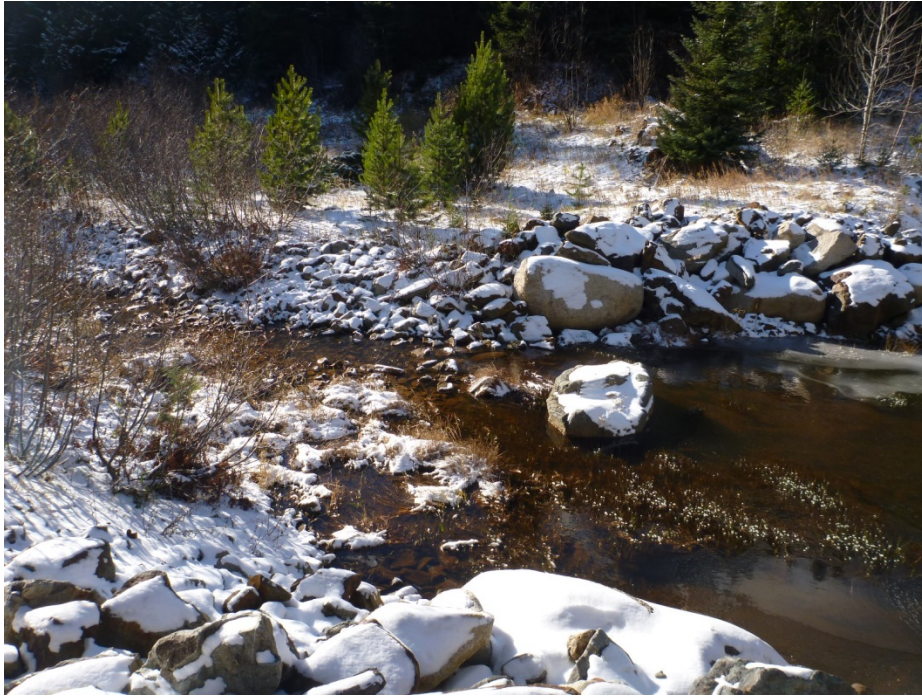
Photo 47 – Jumbo stilling basin outlet and discharge channel. Photo taken facing west. Rip rap is only visible at bottom of stilling basin near outlet.

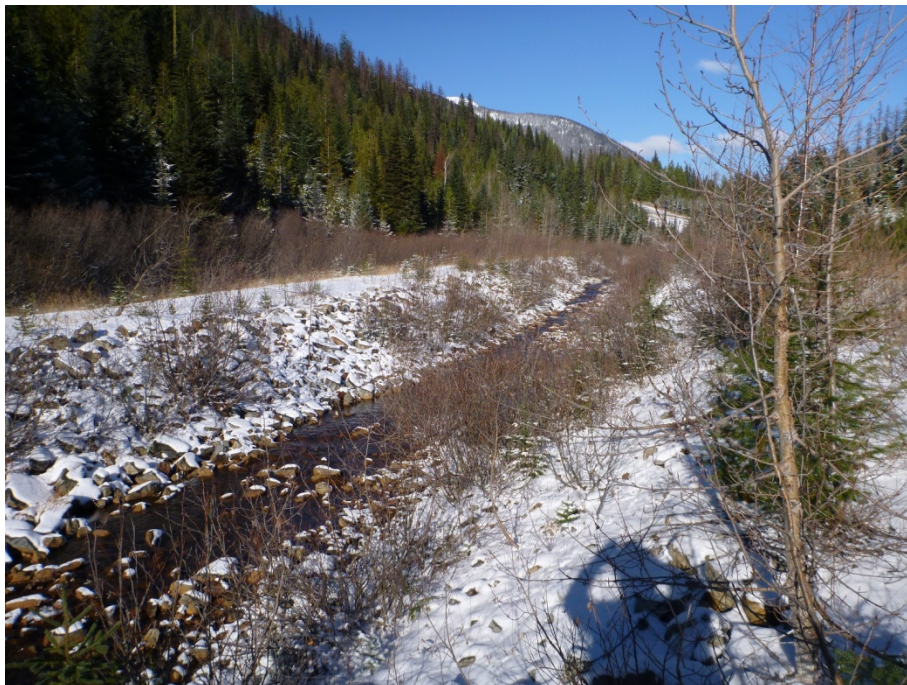
- The guide berms to direct surface water flow into the drainage channel at the head of the TSF (north end of TSF) are in good condition and appear to be functioning as intended (Photo 48).
- Willows and alders are growing on the channel side slopes. Limited grassy vegetation was growing in occasional locations in the middle of the drainage channel. Flowing water in the drainage channel was approximately 10 cm deep. Evidence of high water marks on vegetation growing at the edge of the channel indicates previous high water about 10 cm above current levels (Photos 49 through 51).

Photo 50 – Jumbo drainage channel on reclaimed tailings surface. Photo taken facing north approximately two thirds of channel length from entrance to channel shown in Photo 47. Note shrubs and alders/willows growing on channel slopes.

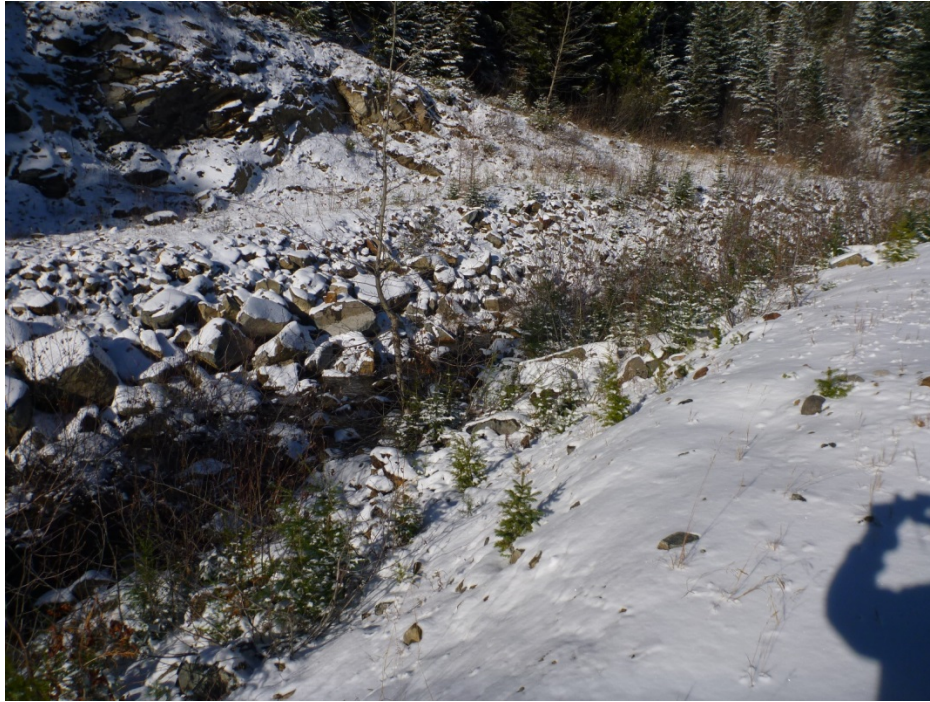
Photo 51 - Jumbo drainage channel entering spillway. Photo taken facing north west at crest of dam near right abutment. Note shrubs and alders/willows growing on channel slopes.

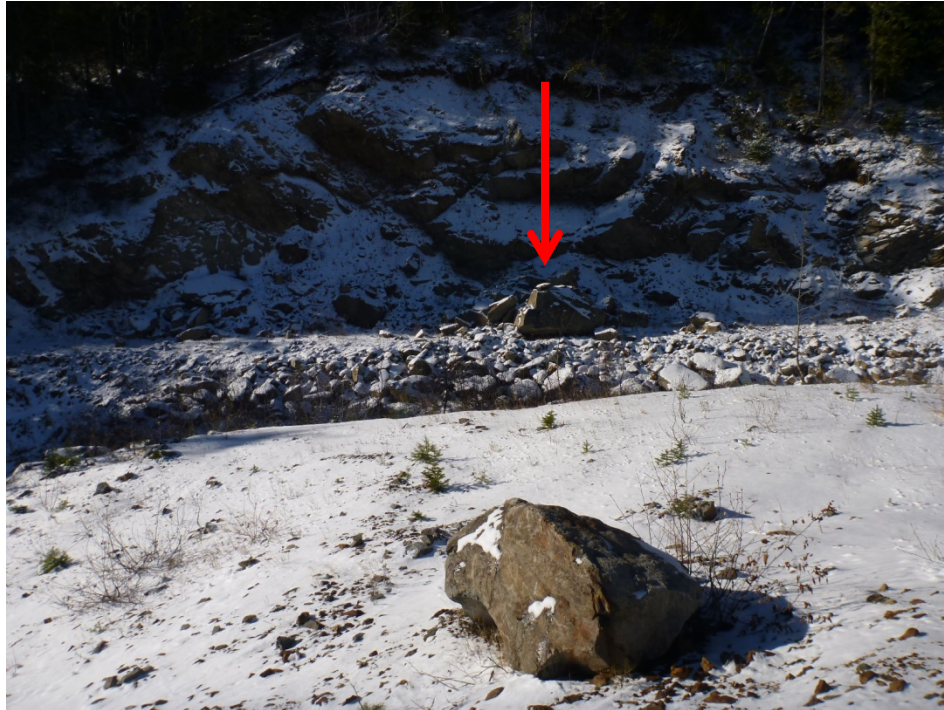
- The spillway on the right abutment appears to be in good condition. Evidence of high water marks were not observed during the inspection. However, willows/alders and very small coniferous trees are growing on the side slopes of the channel at the spillway crest. Small trees and shrubs are also growing on the channel side slopes along the downstream toe to the spillway stilling basin. There is a rock fall of about 5 m<sup>3</sup> on the right bank of the spillway channel where it was excavated into a bedrock slope at the right abutment of the dam. The debris from this fall has collected on the bench above the channel with no other material accumulating in the spillway channel (Photos 52 through 53).

Photo 52 – Jumbo spillway at crest of dam. Photo taken facing west. Red arrow indicates rock fall debris near spillway channel from adjacent bedrock excavation.

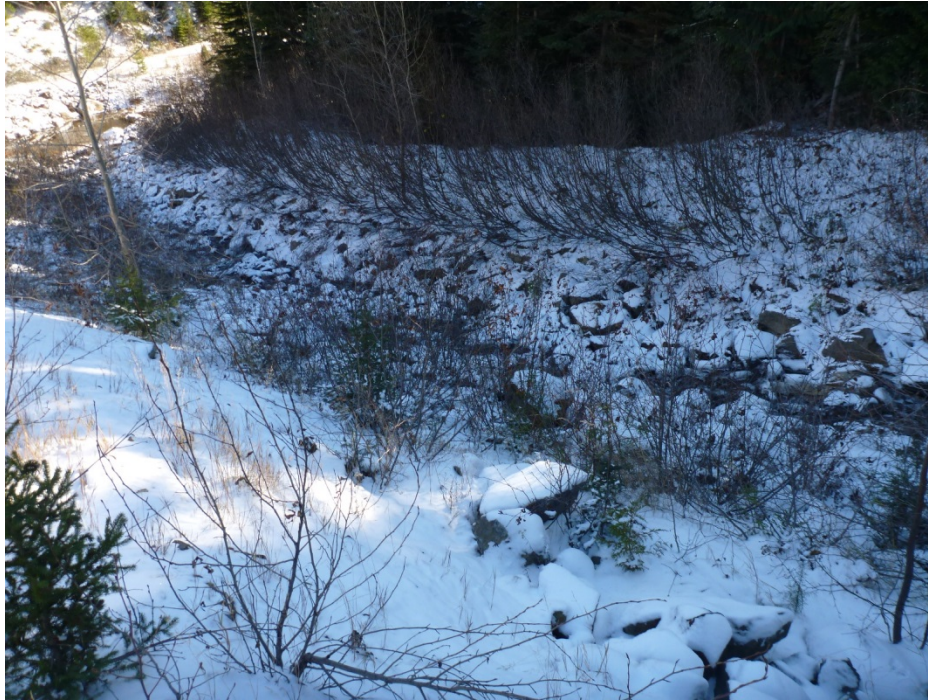
Photo 53 – Jumbo spillway channel approximately 20 m upstream of stilling basin. Photo taken facing south east. Note alders/willows growing on and near channel slopes.

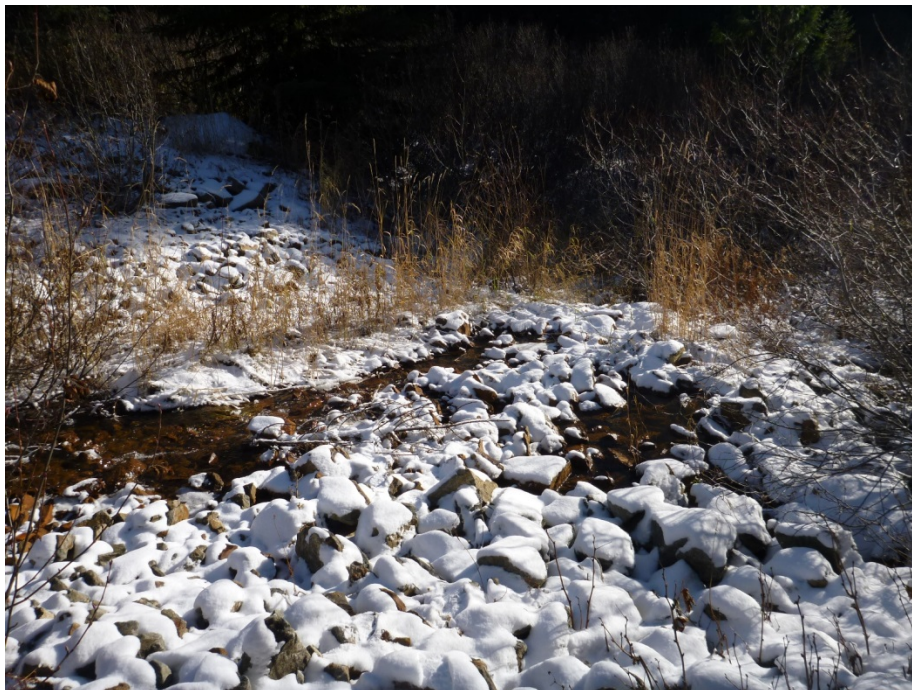
- There is a 0.3 m depression in the surface of the reclaimed tailings above the former Little Sheep Creek diversion culvert that failed in 1999 and deposited tailings at the toe of the dam. Red silt at a seepage discharge zone was noted at the toe of the TSF dam in the stilling basin near the former outlet of the Little Sheep Creek diversion culvert;
- A rockfall of about 5 m<sup>3</sup> has occurred with rock debris located adjacent to the spillway channel near the crest of the TSF dam; and
- The rip rap Sediment Control weir downstream of the stilling basin has been damaged by discharge flows with a channel being eroded through the weir.

Photo 54 – Jumbo discharge channel sediment berm. Photo taken facing south downstream of stilling basin. The rip rap berm is not clearly defined and rip rap appears to have been dislodged with a channel being eroded through the berm.

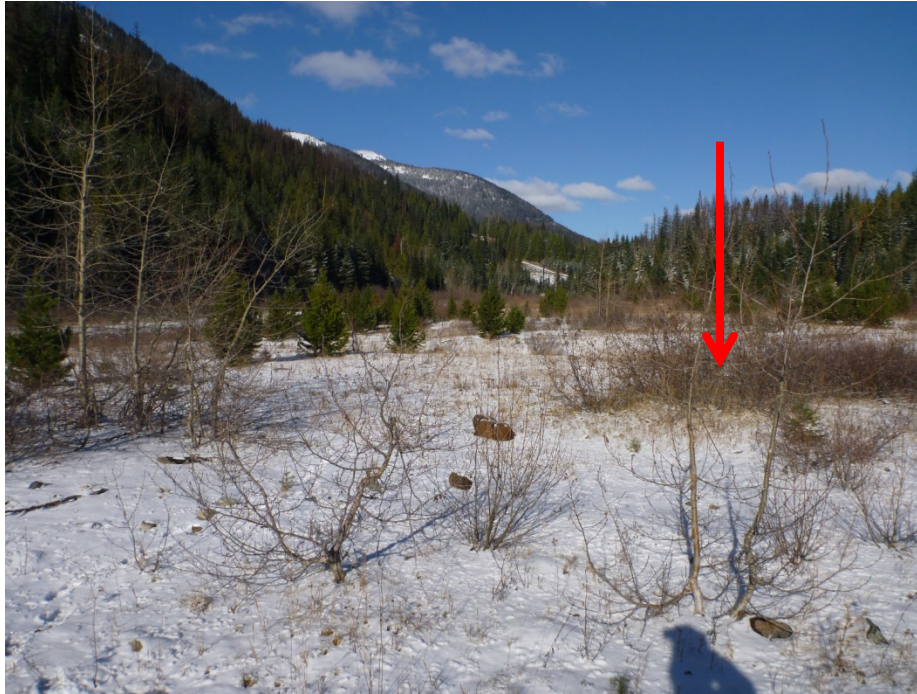
- There appears to be a 0.3m deep depression in the general area of the 1999 sinkhole where the 600 mm CMP failed and caused tailings to be transported beneath the dam through the CMP to the dam toe. There is a drainage swale leading to the diversion channel from this area. The general area of the former decant location is generally level with no obvious surface depressions (Photos 55 and 56).

Photo 55 – Jumbo reclaimed tailings surface. Photo taken facing north. Red arrow indicates depression located near site of 1998 sinkhole where tailings were transported under dam through corrugated metal pipe passing beneath tailings impoundment.

- The snow cover at the time of inspection hindered assessment of the physical state of the dams and reclaimed tailings surfaces. From what KCB could observe, the TSF dam structures appear to be in good condition, with the exception of potential tailings release at the Jumbo TSF;
- There may still be periodic loss of tailings via the Little Sheep Creek CMP, which should be investigated;
