19 June 2015

AuRico Gold Inc.  
110 Yonge Street, Suite 1601  
Toronto, ON M5C 1T4

**Re: Kemess South Tailings Storage Facility  
Response to February 3, 2015 Ministerial Orders**

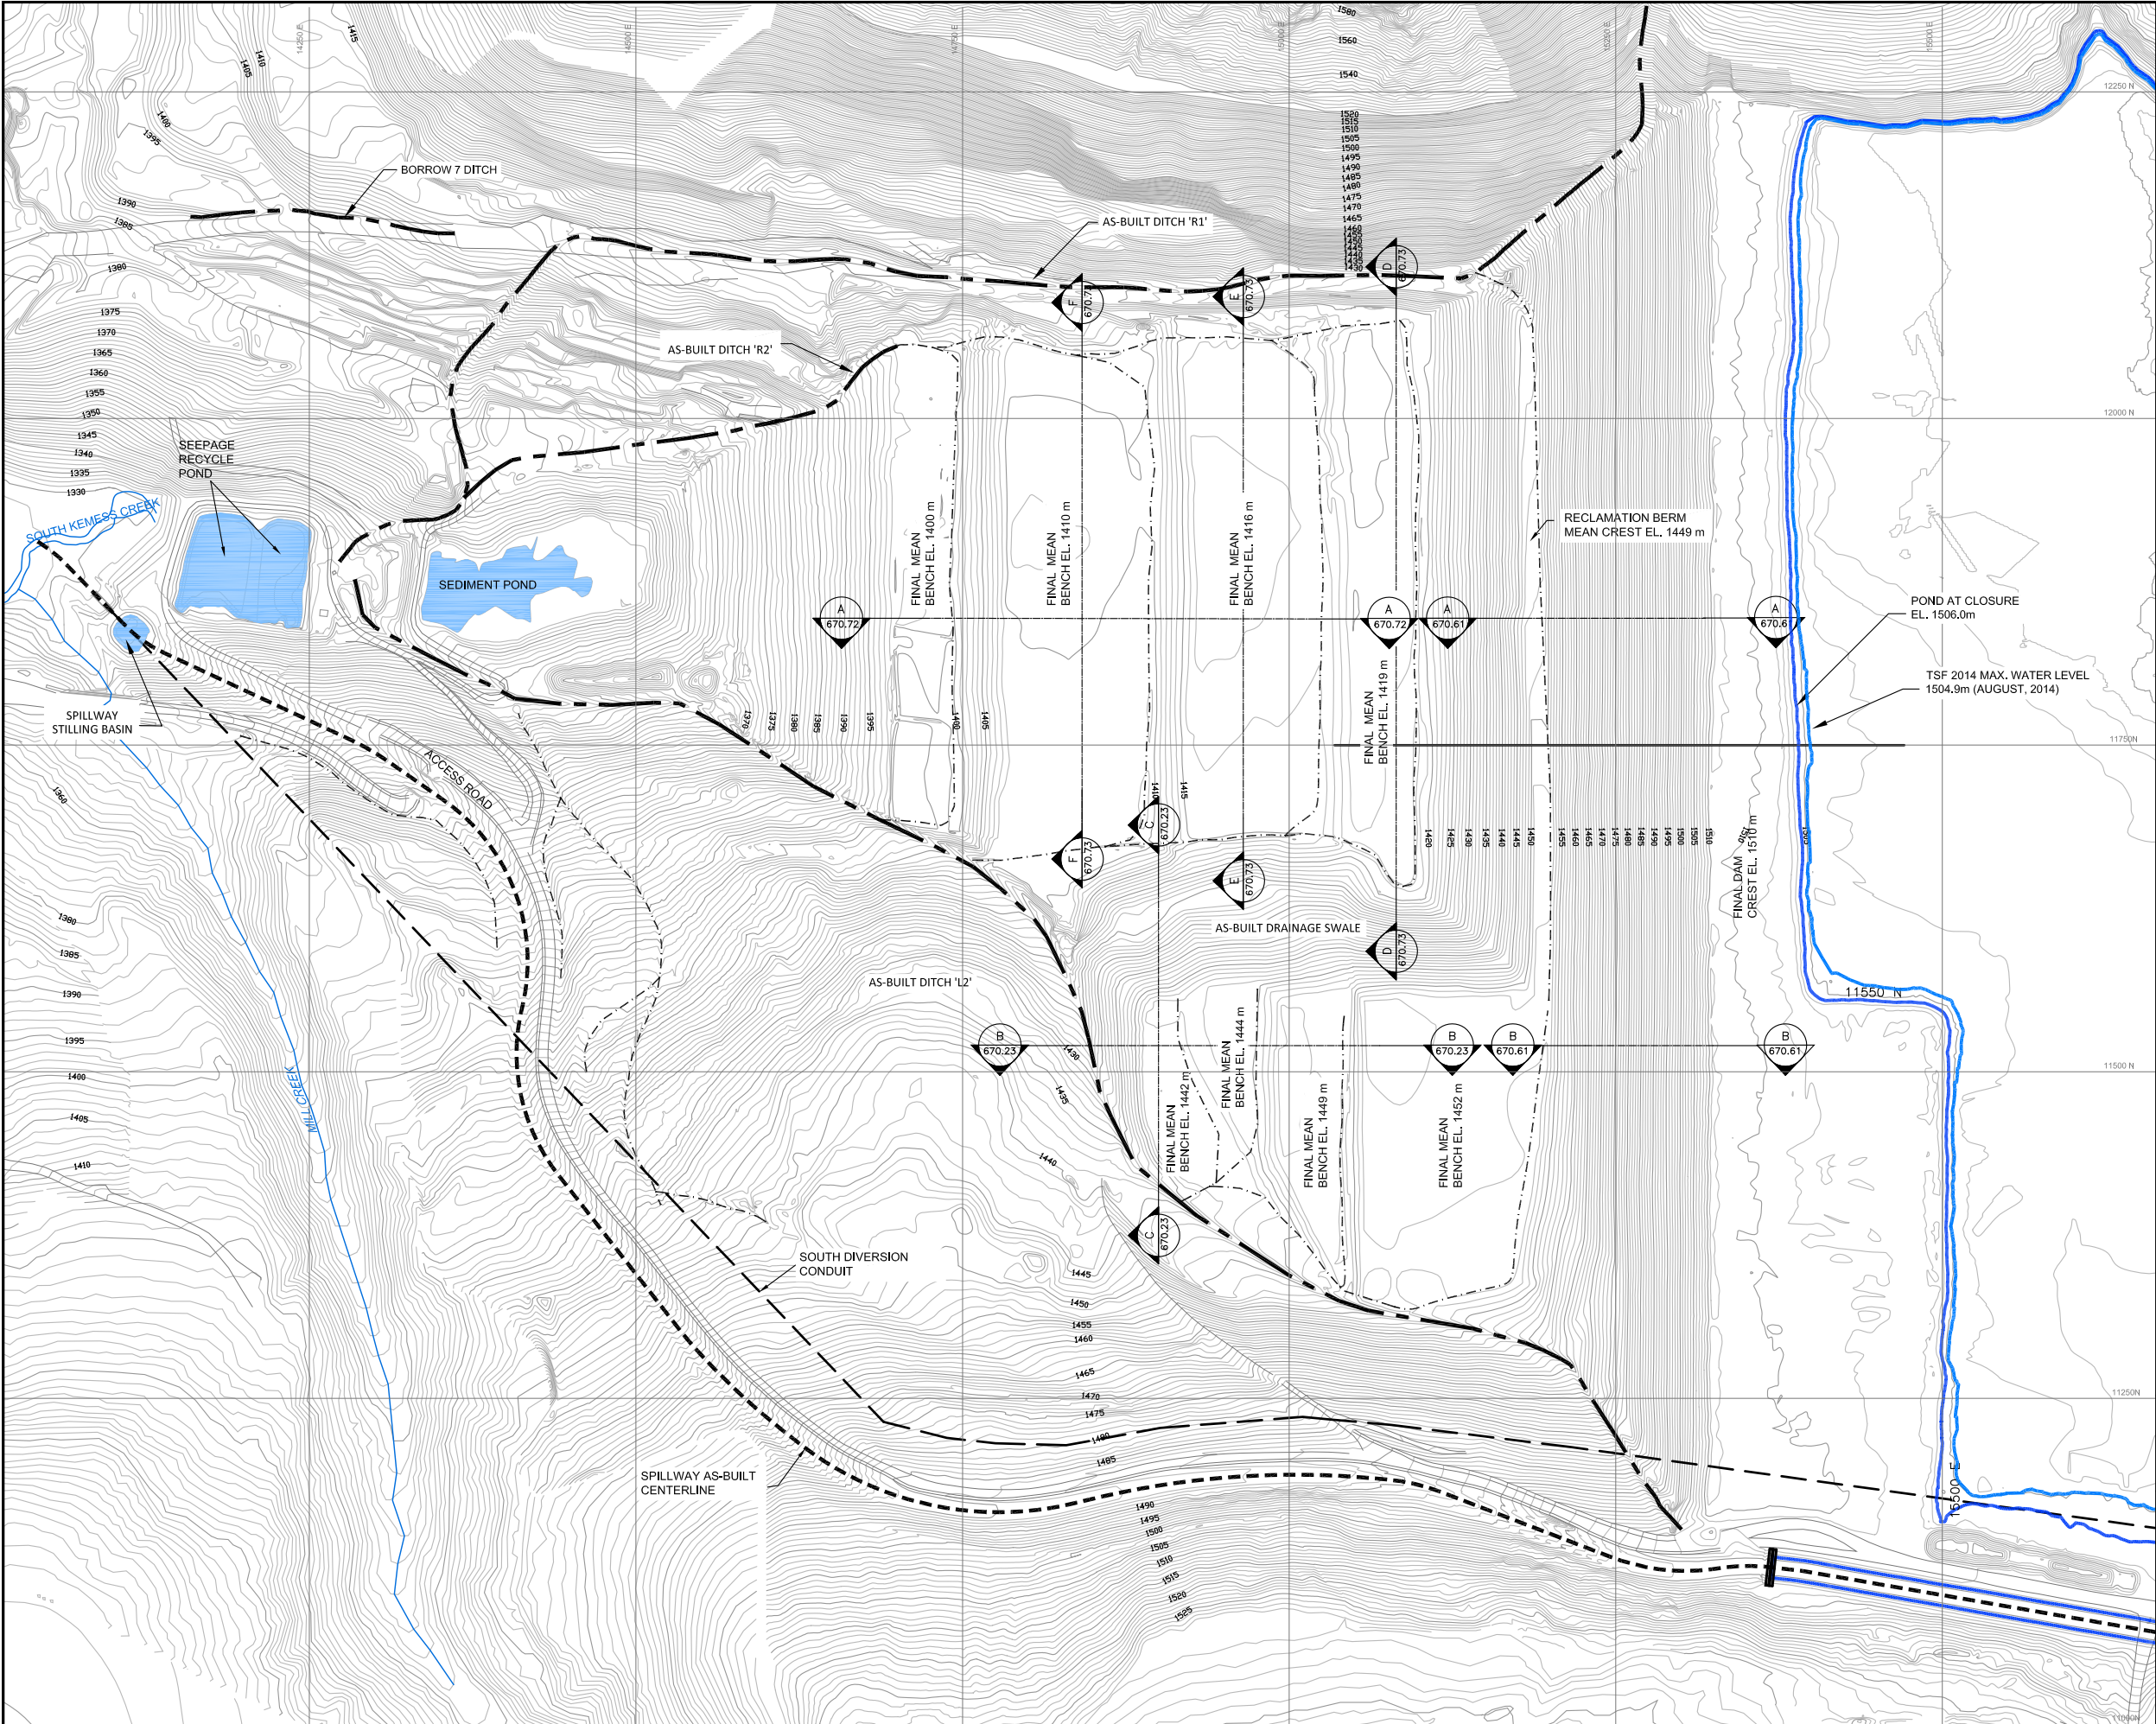
TITLE: **FINAL DAM AS-BUILT PLAN**

As previously noted the above-water beach was completed to its design closure configuration in 2009 as shown on drawing 800.2. The beach design configuration was defined based on northings and eastings such that from the south abutment to N11,550 m, the above-water tailings beach should extend as far east (upstream) as E15,500 m and north of N11,550 m, the beach should extend as far upstream as E15,400 m. This configuration provides beach widths measuring roughly 165 m wide at the southern end of the dam and 50 to 65 m wide at the northern end of the dam as designed. The shoreline of the final beach was armored in 2010 up to 2 m above the FSL with a three layer erosion protection system grading from 0.3 m mean diameter riprap to sand and gravel overlaying the cycloned sand beach (AMEC, 2011).

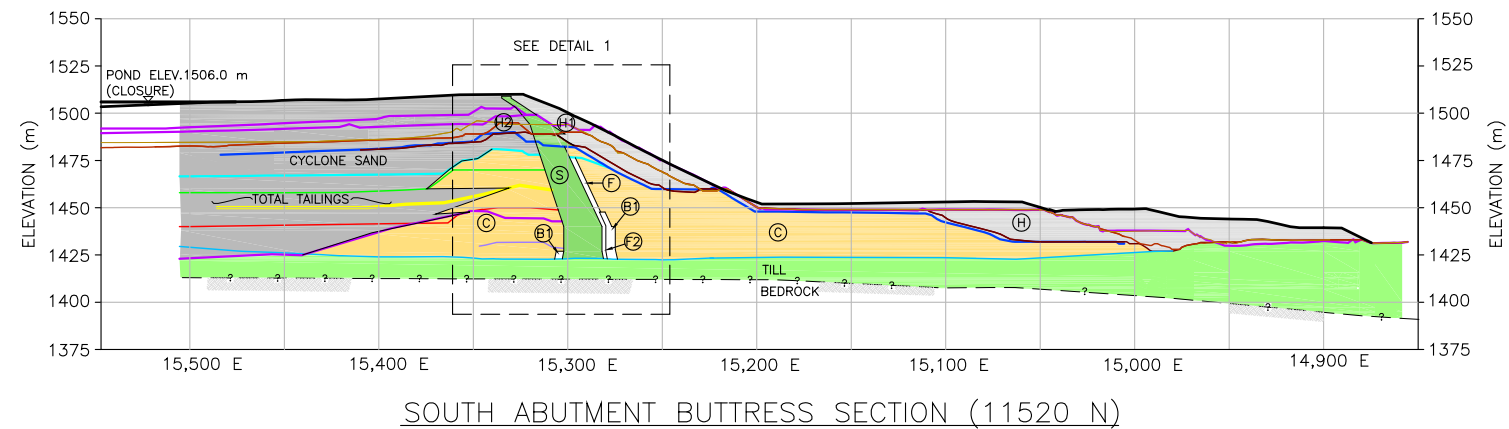
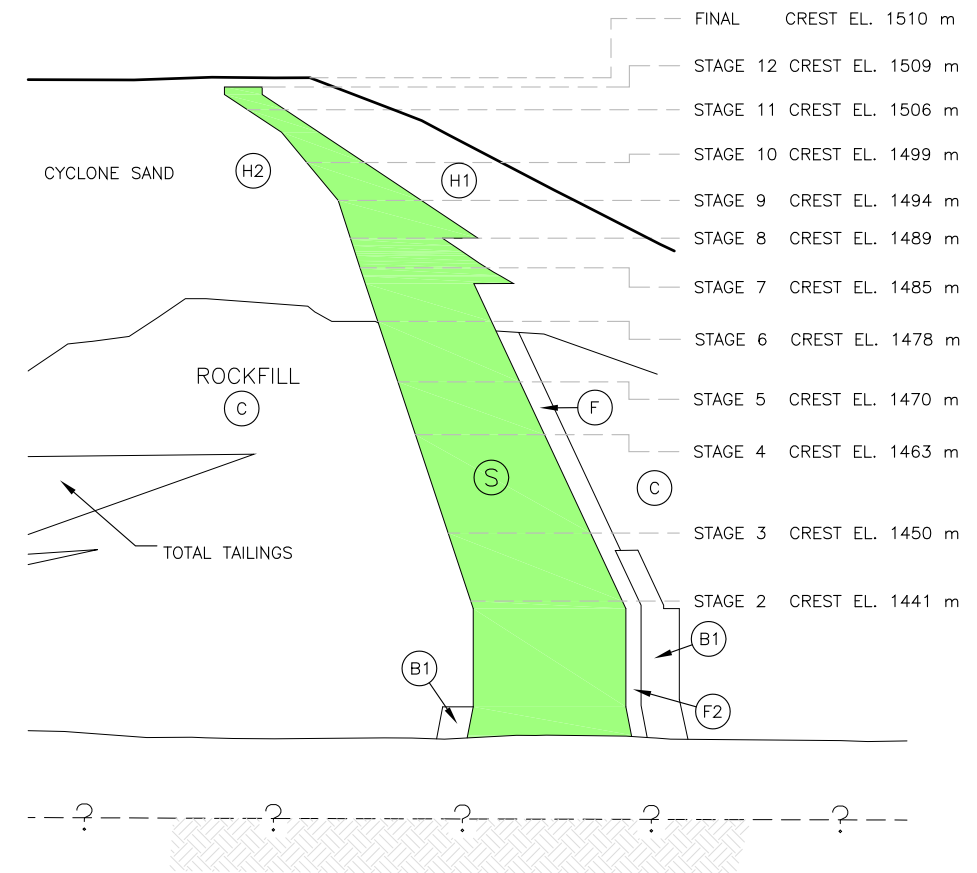
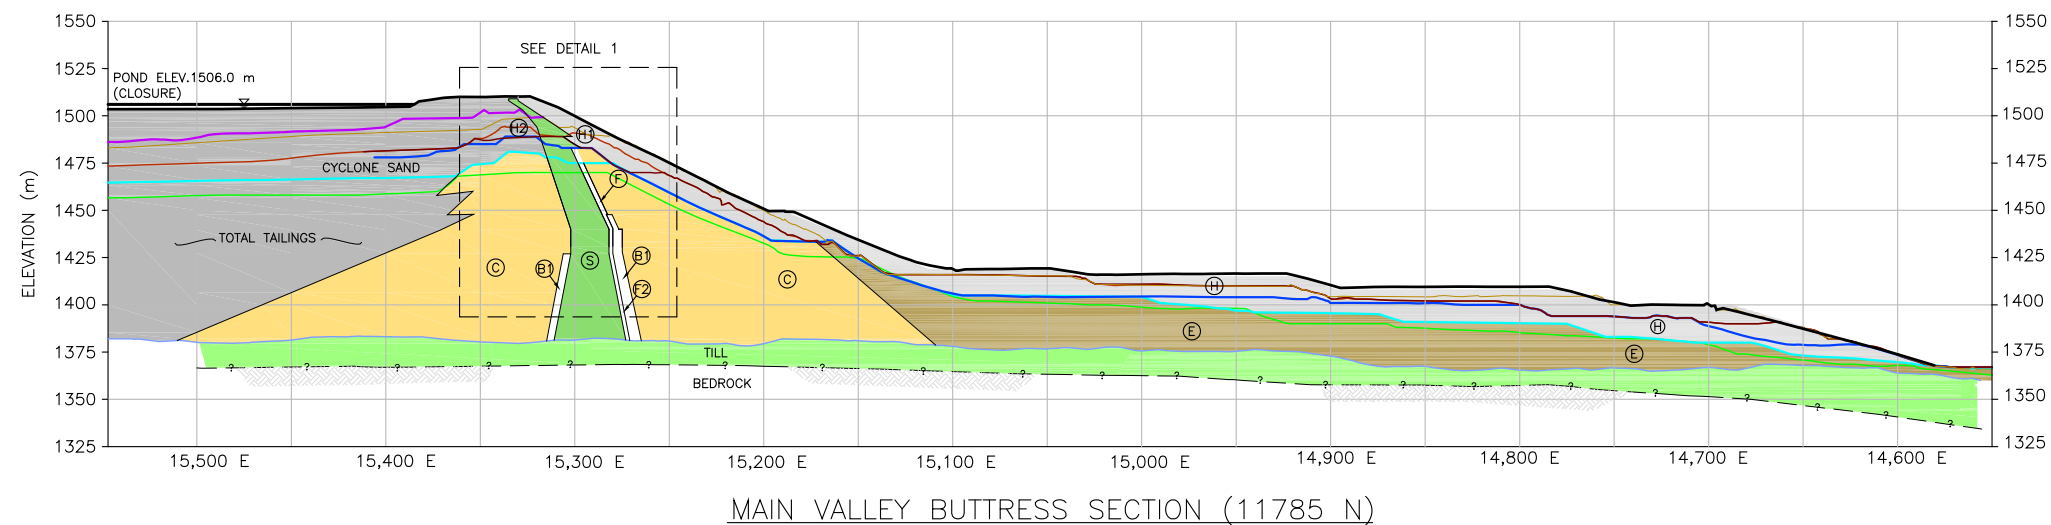
A similar level of conservatism is applied to the south abutment buttress design section (refer to drawing 2010.1) which yields quite conservative factors of safety due to the fact that the GLU is modelled as a continuous infinite layer below the entire south abutment buttress, which, based on past field investigations, is not the case. The GLU is known to be discontinuous in the south abutment area and completely absent south of 11,440N. Furthermore, based on the irregular buttress geometry as shown in drawing 800.2, approximating the south abutment buttress as an infinite two-dimensional section further increases the conservatism of the results. Even though the stability of the south abutment is considered to be a three-dimensional issue, the two-dimensional approximation results in factors of safety that meet the dam closure requirements. No further analyses are considered necessary.
