# **Cheni Mine**

## **Lawyers Tailings Storage Facility**

### ***2014 Dam Safety Inspection***

November 28, 2014

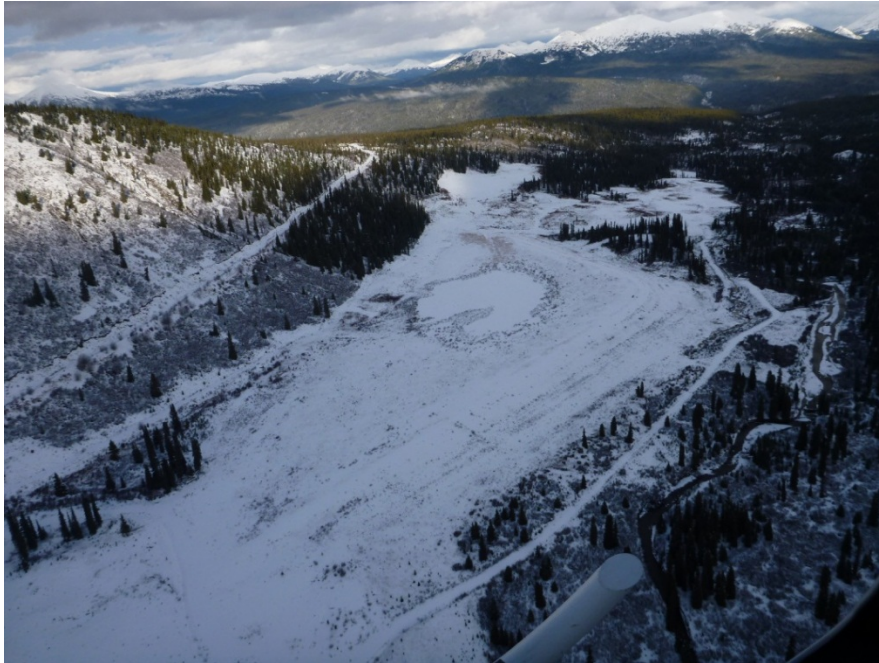
- There is a depression in the middle of the reclaimed tailings surface. This area appears to correspond to the former location of the supernatant pond just before mine closing. However, the extent of the depression exceeds the estimated size of the supernatant pond presented on the Piteau drawing "Plan of Tailings Impoundment" included in Appendix I. The greater size might be due to increased compressibility of tailings close to the former supernatant pond location. Cat tails and other hydrophilic or aquatic vegetation were noted around the edge of the depression which indicates that water can pond on the reclaimed tailings surface for a prolonged period of time during warmer months.

Photo 1 – Aerial oblique view of TSF facing north. Note depression in middle of reclaimed tailings surface.

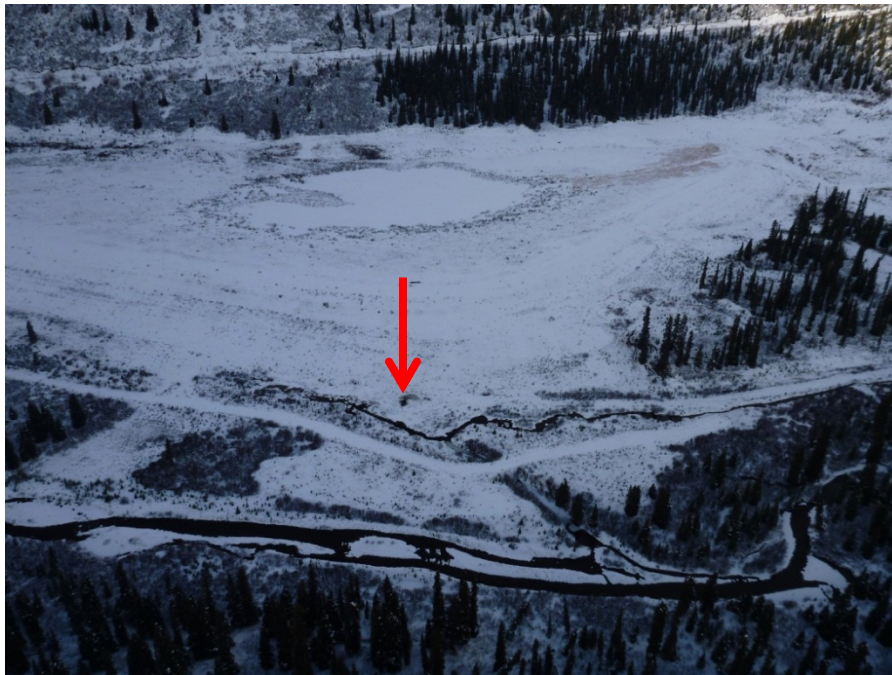
Photo 2 - Aerial oblique view of TSF facing west. Note former location of Lawyers Creek near toe of TSF and road embankment between realigned Lawyers Creek and toe of TSF. Red arrow indicates seepage pond location (Seep-1 identified by Piteau, 1997) beyond downstream toe of dam at apex between limbs.

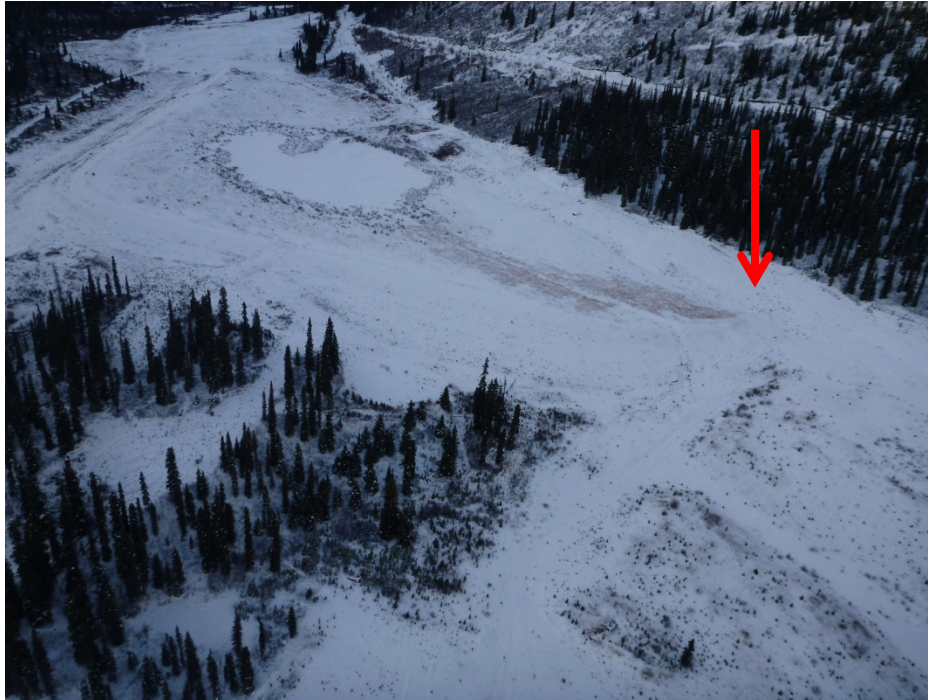
Photo 3 – North limb of TSF dam. Photo taken facing south from helicopter. Red arrow indicates location of spillway and channel.

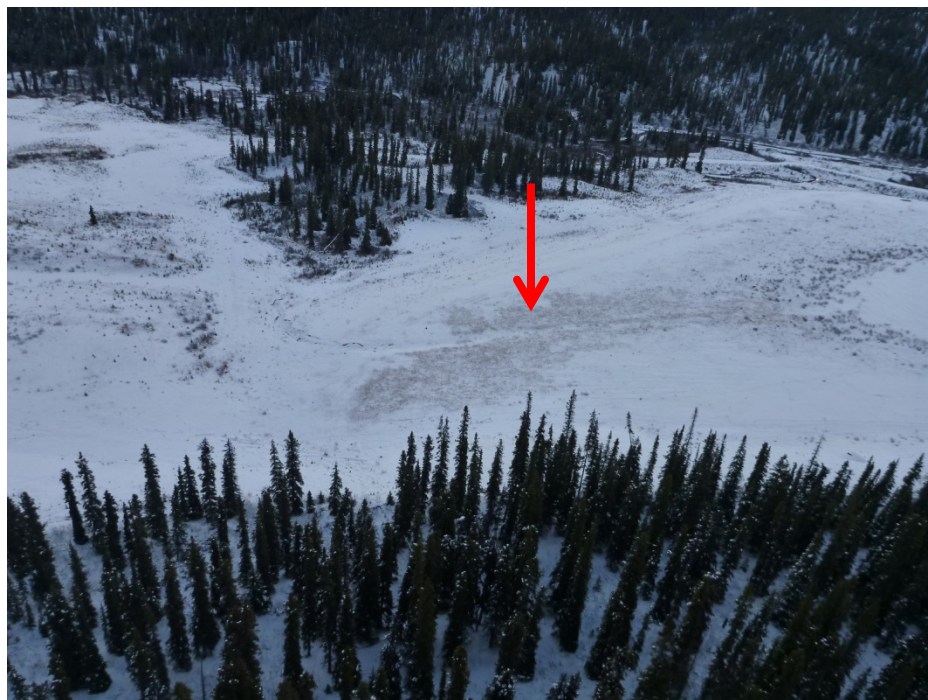
Photo 4 – Drainage swale from former location of supernatant pond. Photo taken facing east from helicopter. Red arrow indicates location of drainage swale.

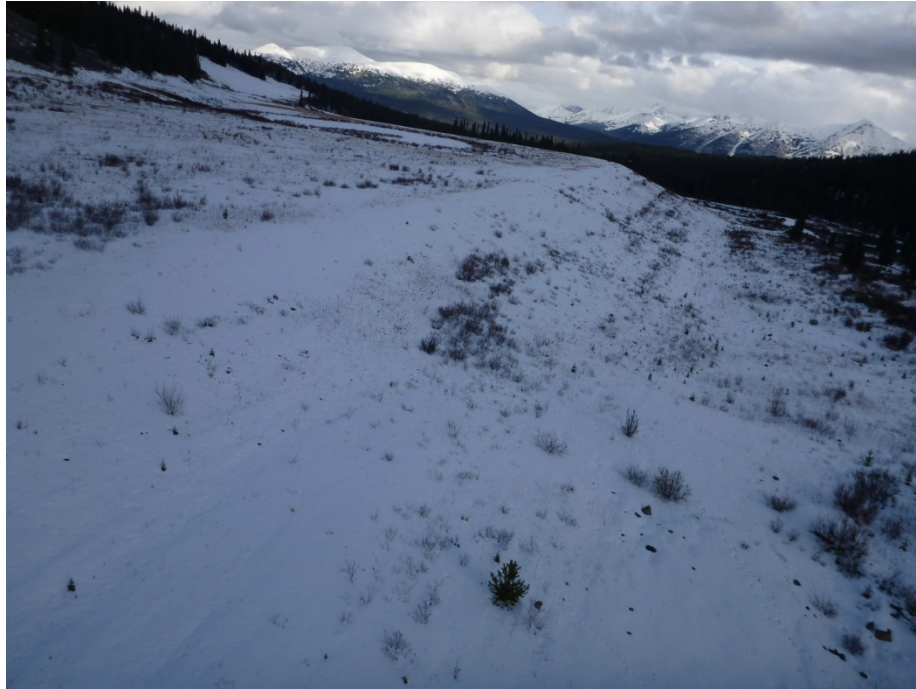
Photo 5 – View of downstream slope and crest of south limb of TSF dam. Photo taken facing northeast from helicopter.

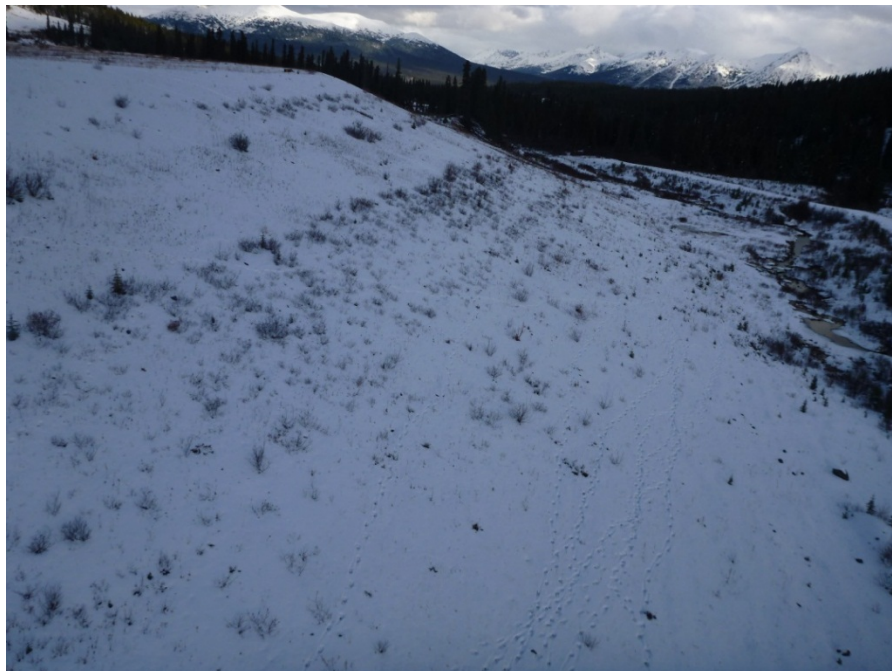
Photo 6 – View of downstream slope and crest of south limb of TSF dam at apex between south and north limbs. Photo taken facing north from helicopter. Note creek located beyond downstream toe of TSF dam.

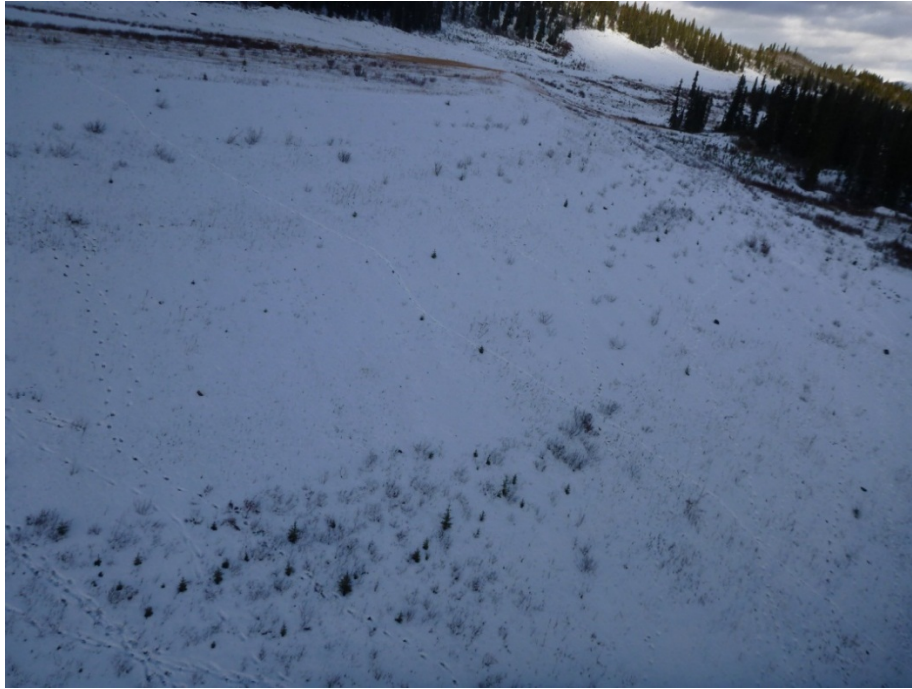
Photo 7 – Downstream slope at apex of south and north limbs of TSF dam. Photo taken facing northwest from helicopter.

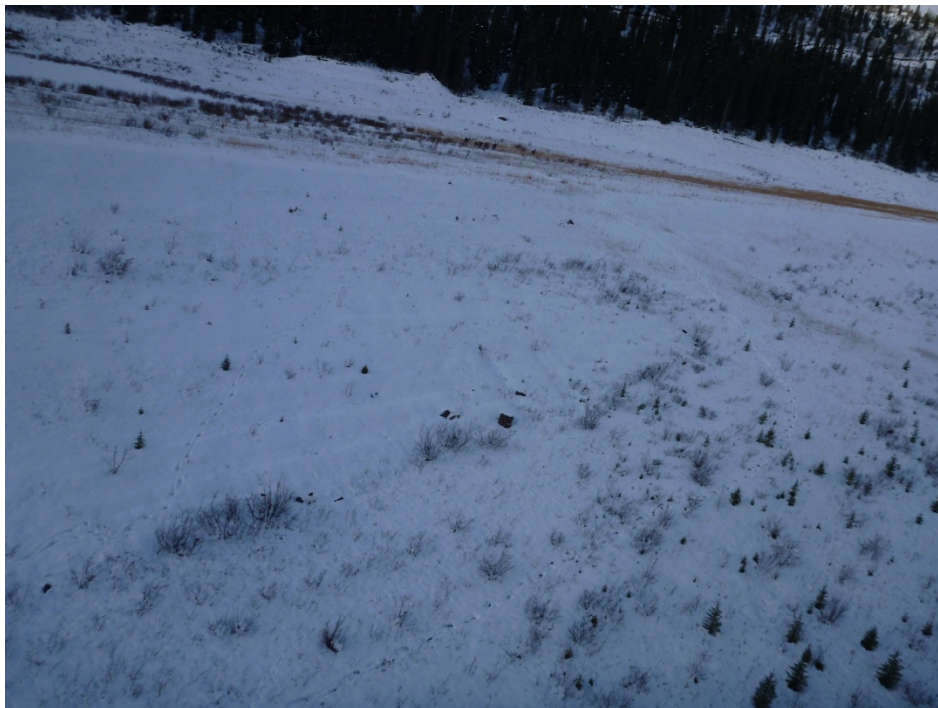
Photo 8 – Downstream slope and crest of north limb of TSF dam. Photo taken facing west from helicopter.

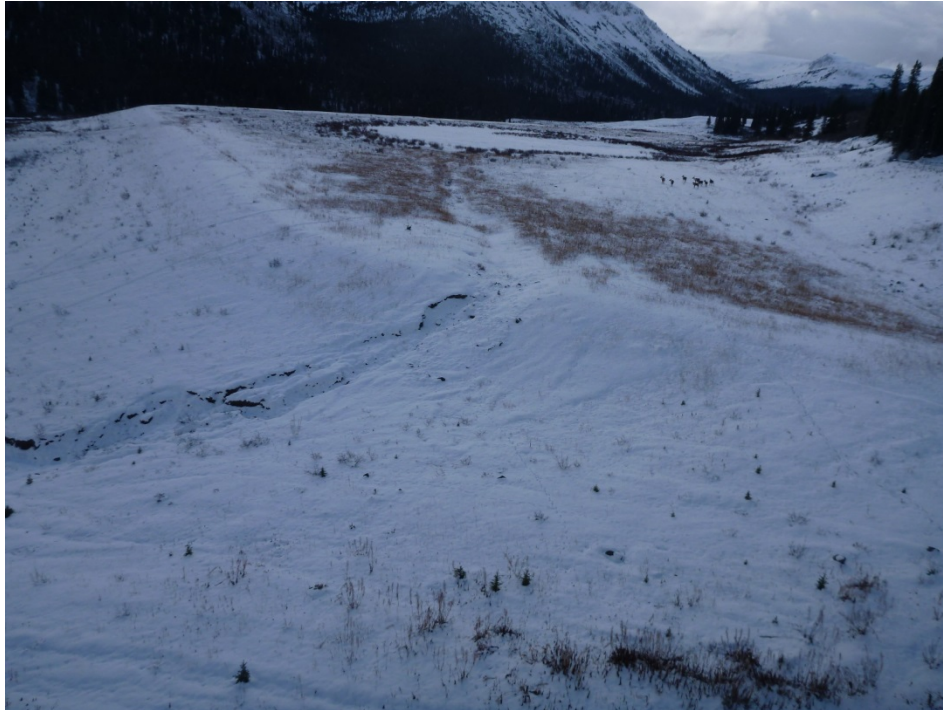
The armouring for the spillway channel has failed and erosion of the downstream slope and dam crest is occurring, which can be expected to get worse with time and eventually start eroding tailings. The grading and drainage of the TSF surface will require updating to accommodate the IDF appropriate for the Classification of the TSF.

Photo 9 – Erosion at spillway channel extending up downstream slope of TSF dam to crest. Photo taken facing southeast from helicopter. Note caribou foraging on reclaimed tailings surface.

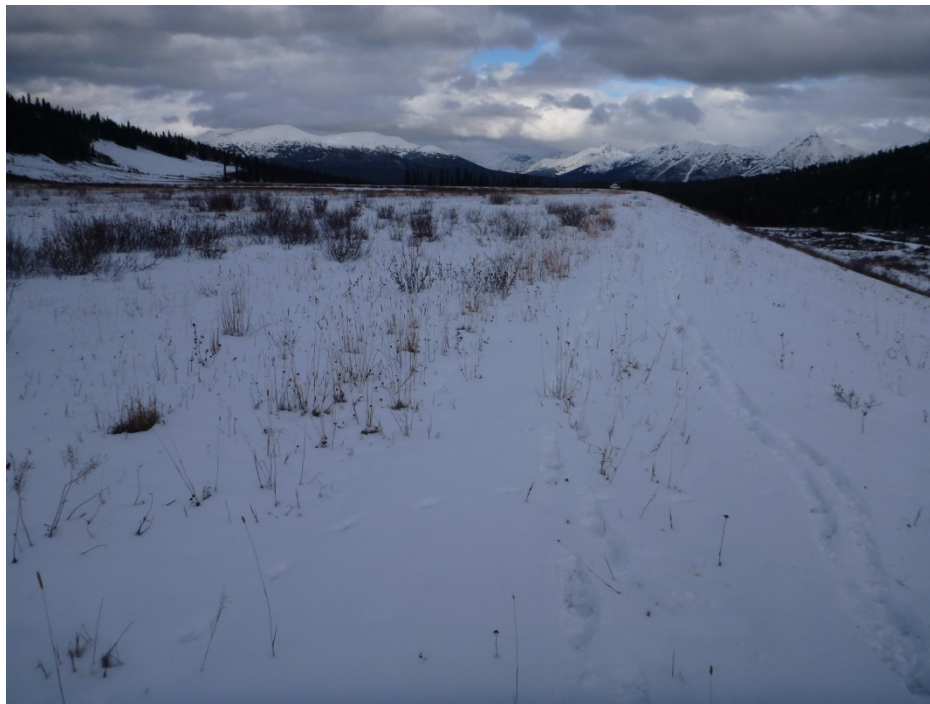
Photo 10 – Crest of south limb of TSF dam. Photo taken facing northeast.

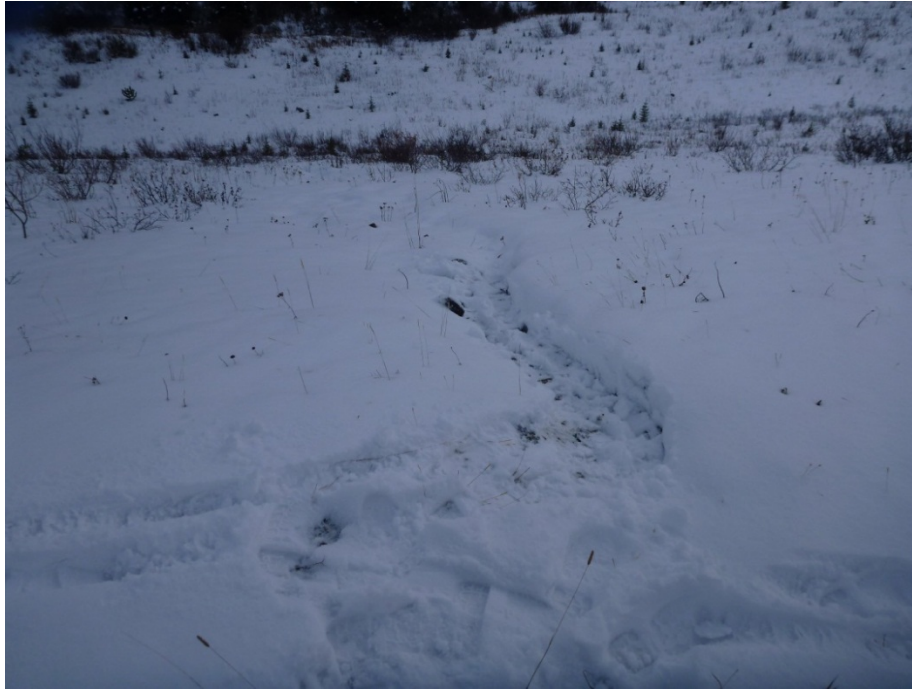
The TSF surface water drainage system is inadequate for rainfall and snow melt conditions experienced to date. Additionally, the settlement of the tailings has resulted in the drainage swale and spillway channel not being the lowest point on the TSF surface. As a result, water currently ponding on the surface increases the amount of water that infiltrates into the capped tailings. Surface water flow is overtopping the dam near the right abutment and creating erosion rills which will get larger with time.

Photo 11 – Downstream slope of south limb of TSF dam near right abutment. Photo taken facing west. One of two erosion rills extending from crest to 1/3 embankment height at this location has been cleared of snow.

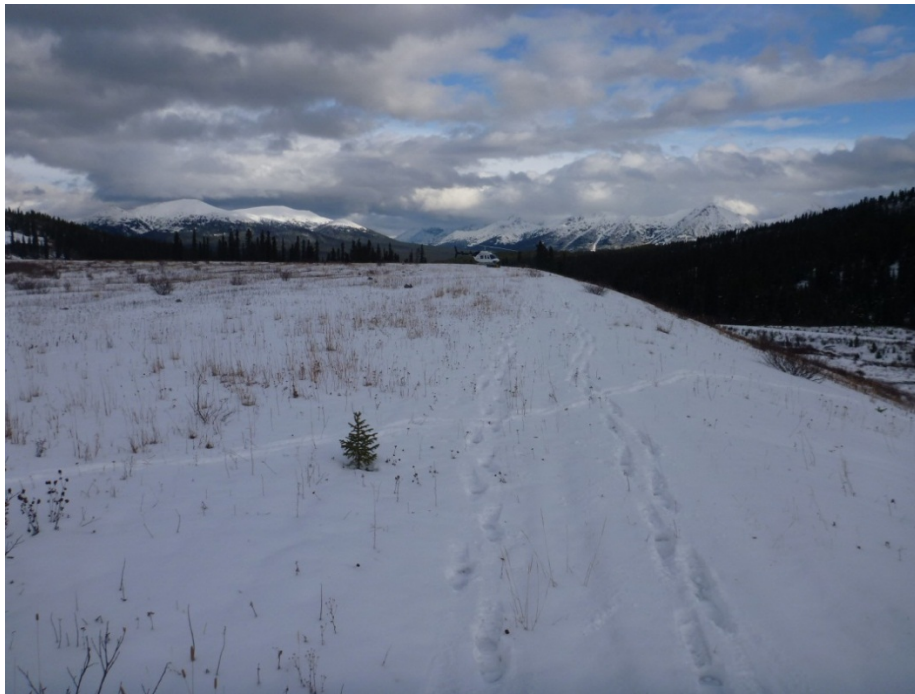
Photo 12 – Crest of south limb of TSF dam at approximate mid-point of limb. Photo taken facing northeast.

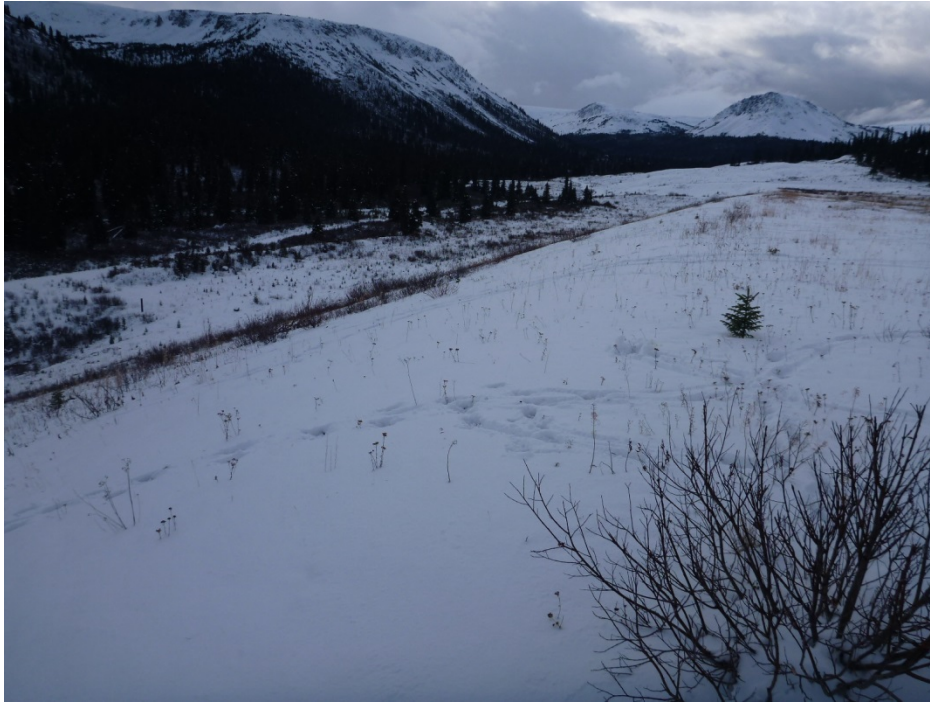
Photo 13 – Crest and downstream slope of south limb of TSF dam viewed from apex with north limb. Photo taken facing southwest.

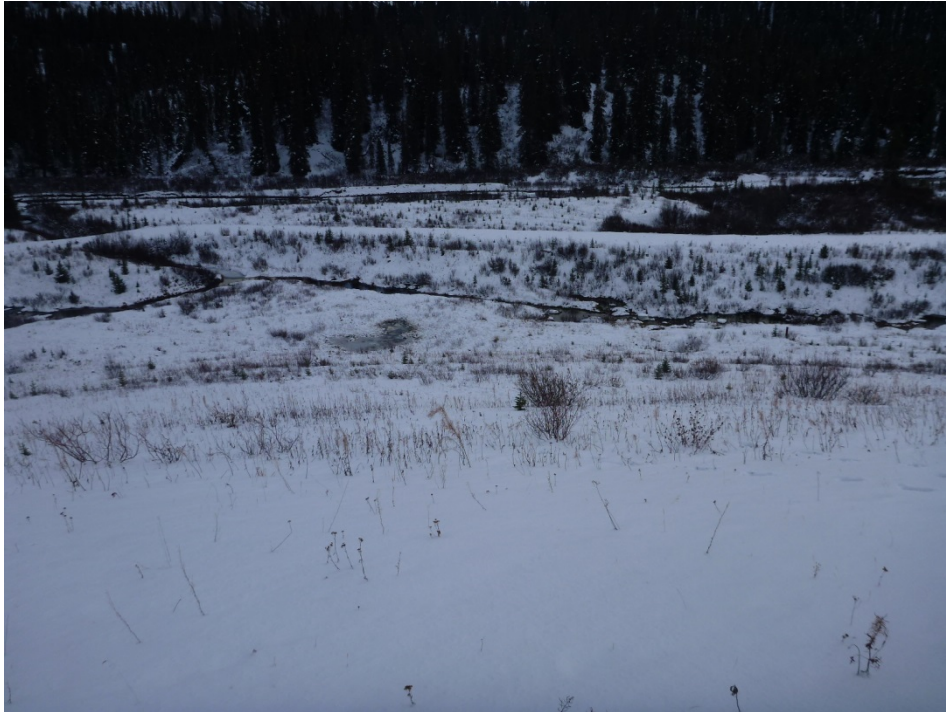
Photo 14 – Downstream slope of TSF dam at apex. Note creek of flowing water beyond toe area. Photo facing east.

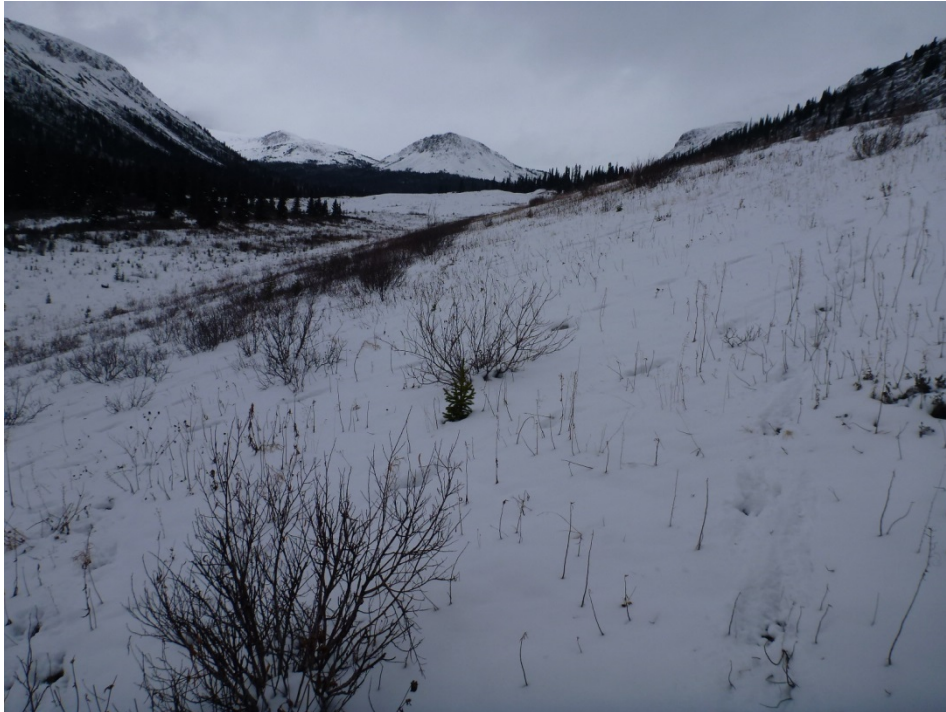
Photo 15 – Downstream slope of south limb of TSF dam. Photo taken facing southwest.

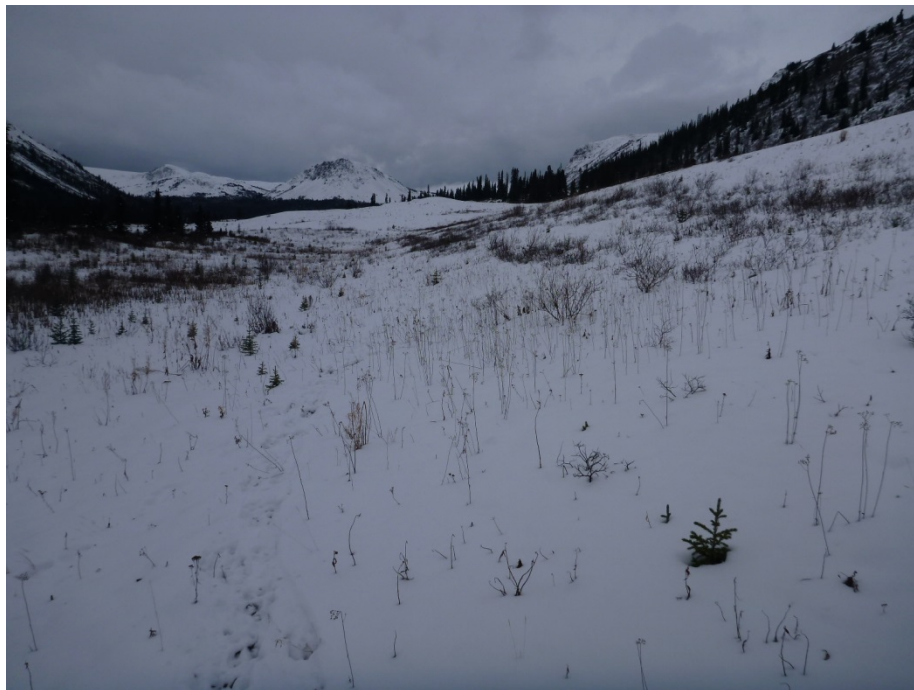
Photo 16 – Downstream slope of south limb of TSF dam. Photo taken facing southwest.

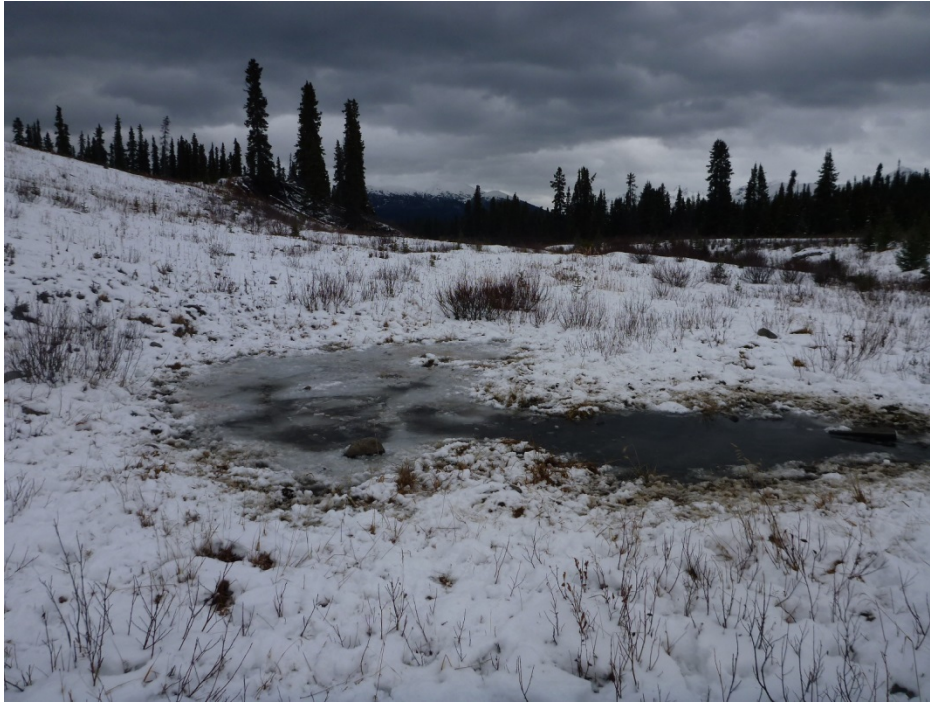
Photo 17 – Ponded water from seepage at toe of TSF dam. Photo taken facing north. This site is believed to be Seep-1 identified in the last inspection report (Piteau, 1997).

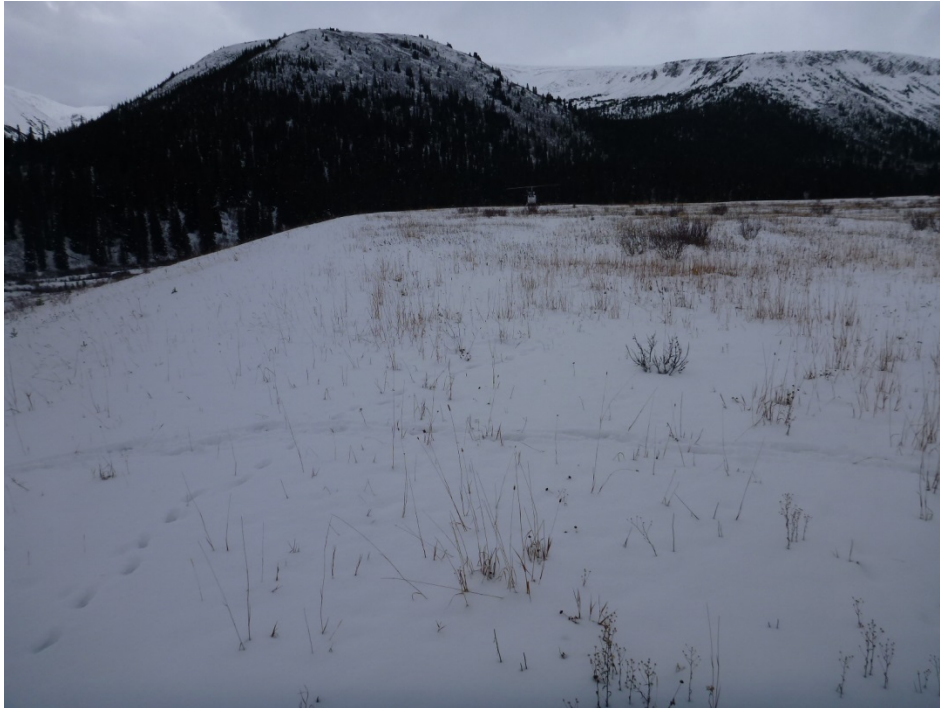
Photo 18 – Crest of north limb of TSF dam. Photo taken facing southeast.

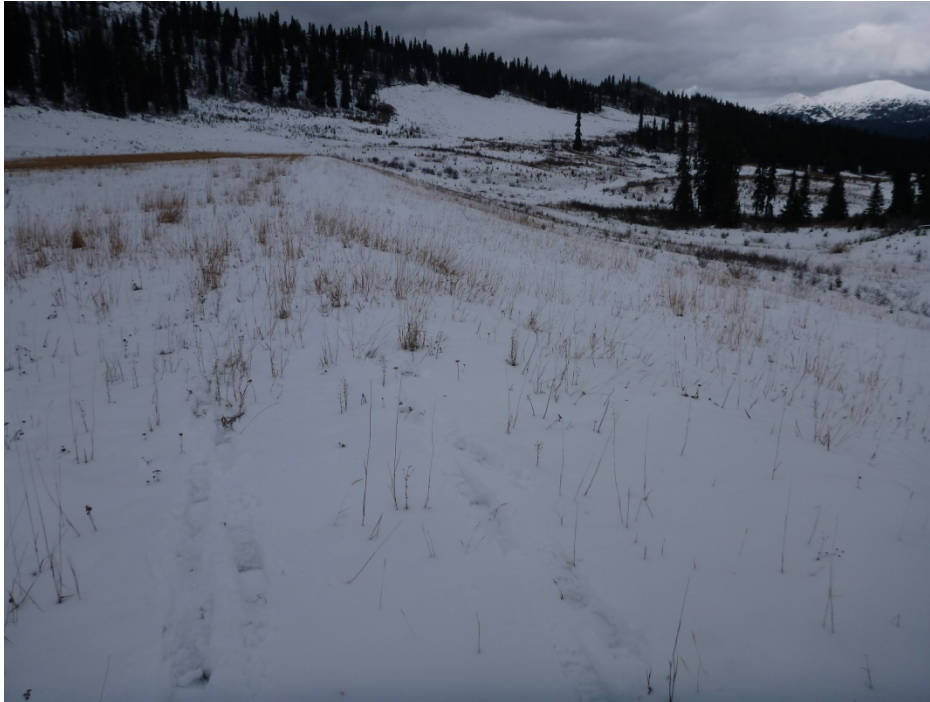
Photo 19 – Crest and downstream slope of north limb of TSF dam. Photo taken facing northwest.

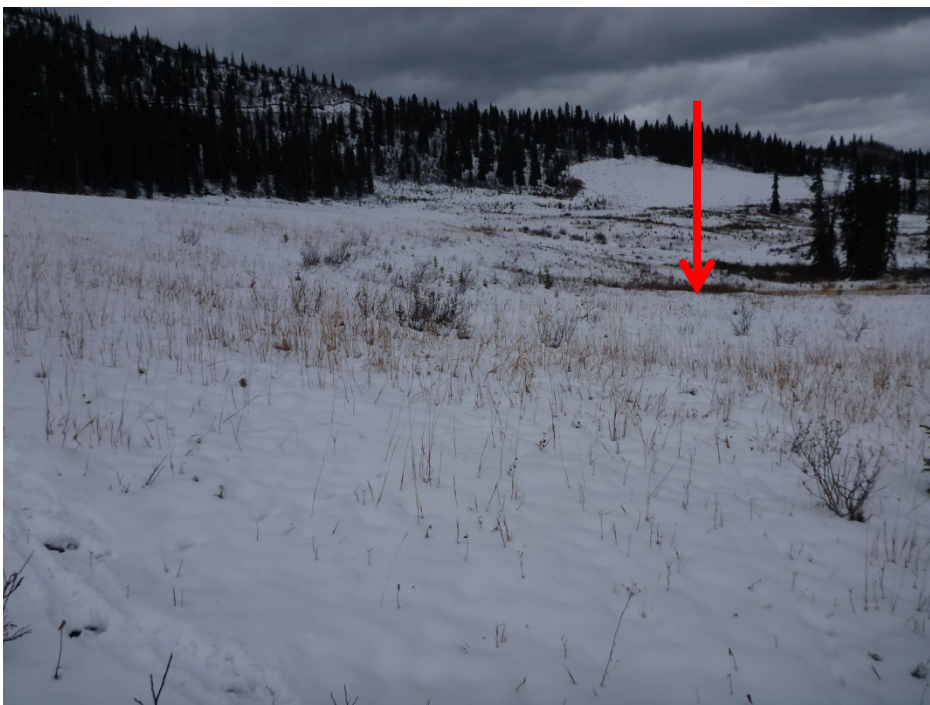
Photo 20 – Downstream slope of north limb of TSF dam. Photo taken facing northwest. Red arrow indicates natural high ground between apex of embankment and left abutment.

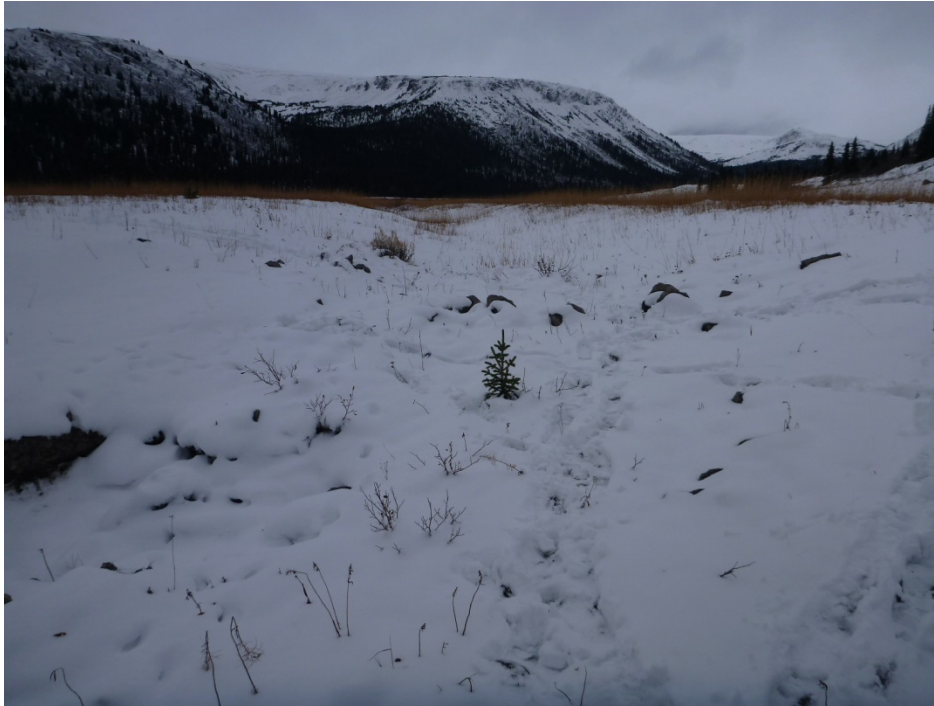
Photo 21 – Spillway control section through crest of dam with drainage swale in background. Photo taken facing south.

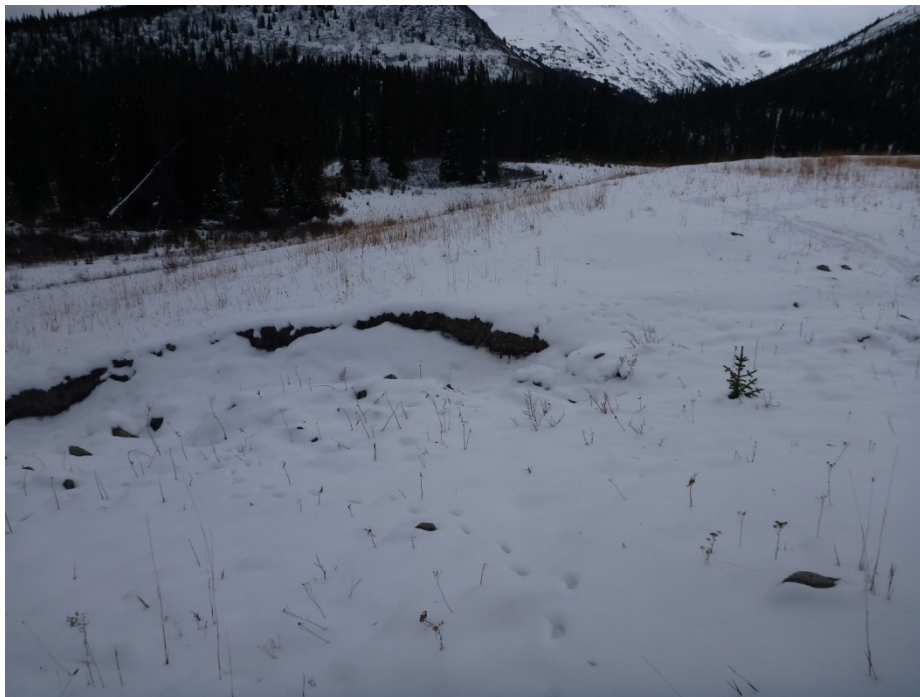
Photo 22 – Spillway channel erosion at downstream crest of dam. Photo taken facing southeast.

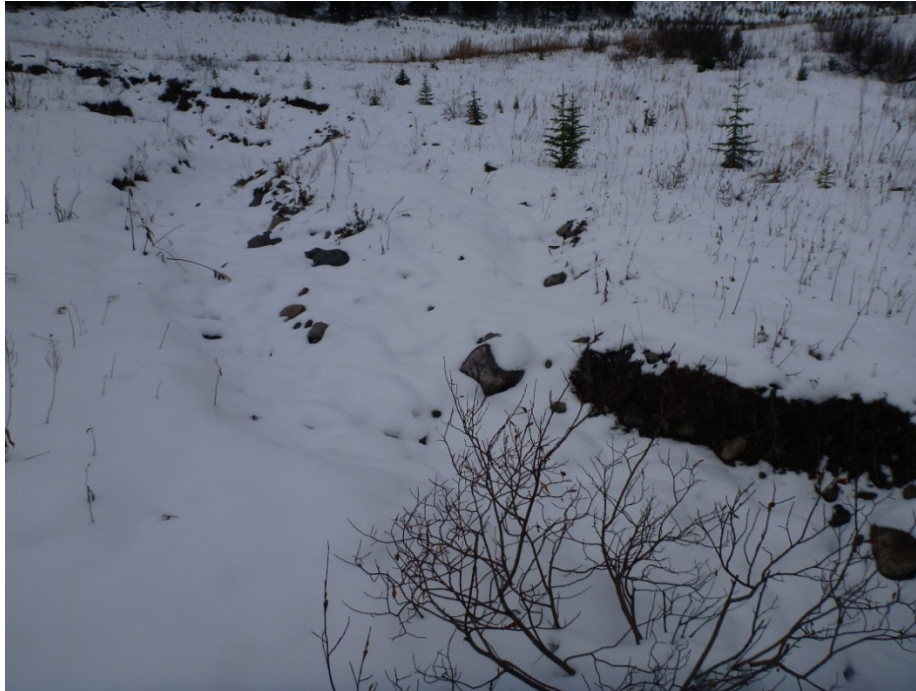
Photo 23 – Spillway channel erosion on downstream slope of TSF dam and on natural ground beyond downstream toe. Photo taken facing northeast.

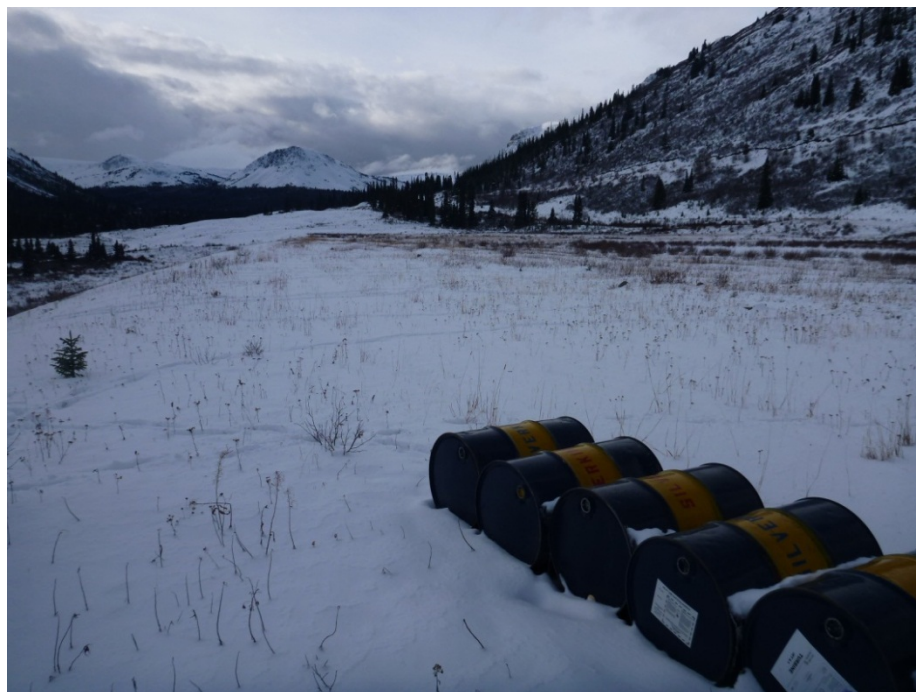
Photo 24 – Reclaimed tailings surface with depression in background. Photo taken facing southwest. Note density of vegetation is greater on top of reclaimed tailings surface than on dam slopes and crest. Fuel drums are for helicopter operations in the area.

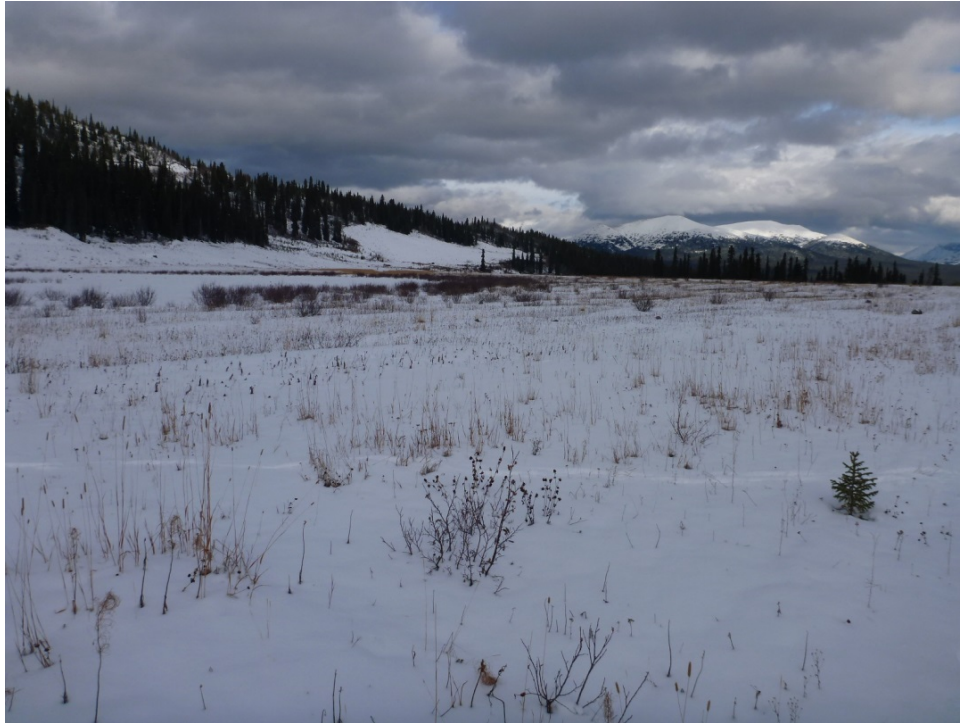
Photo 25 – Reclaimed tailings surface with depression in background. Photo taken facing north.

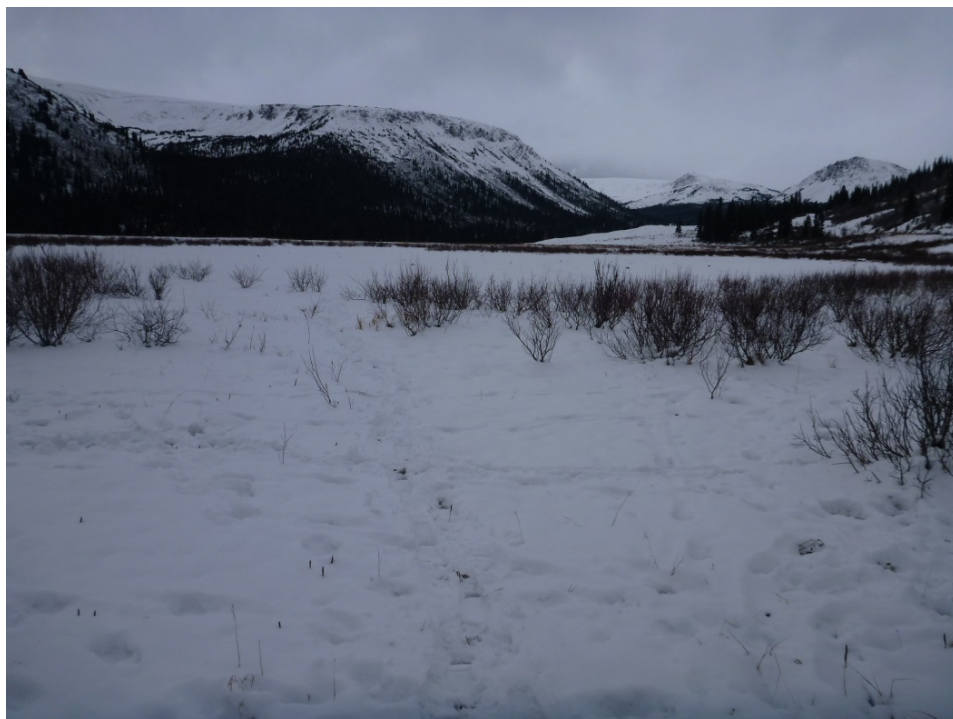
Photo 26 – Reclaimed tailings surface and depression. Photo taken facing south.
