NEW AFTON PROJECT

2014 Annual Inspection Tailings Storage Facility

FINAL
November 28, 2014

BGC Document No.:
RP-0921011.0124

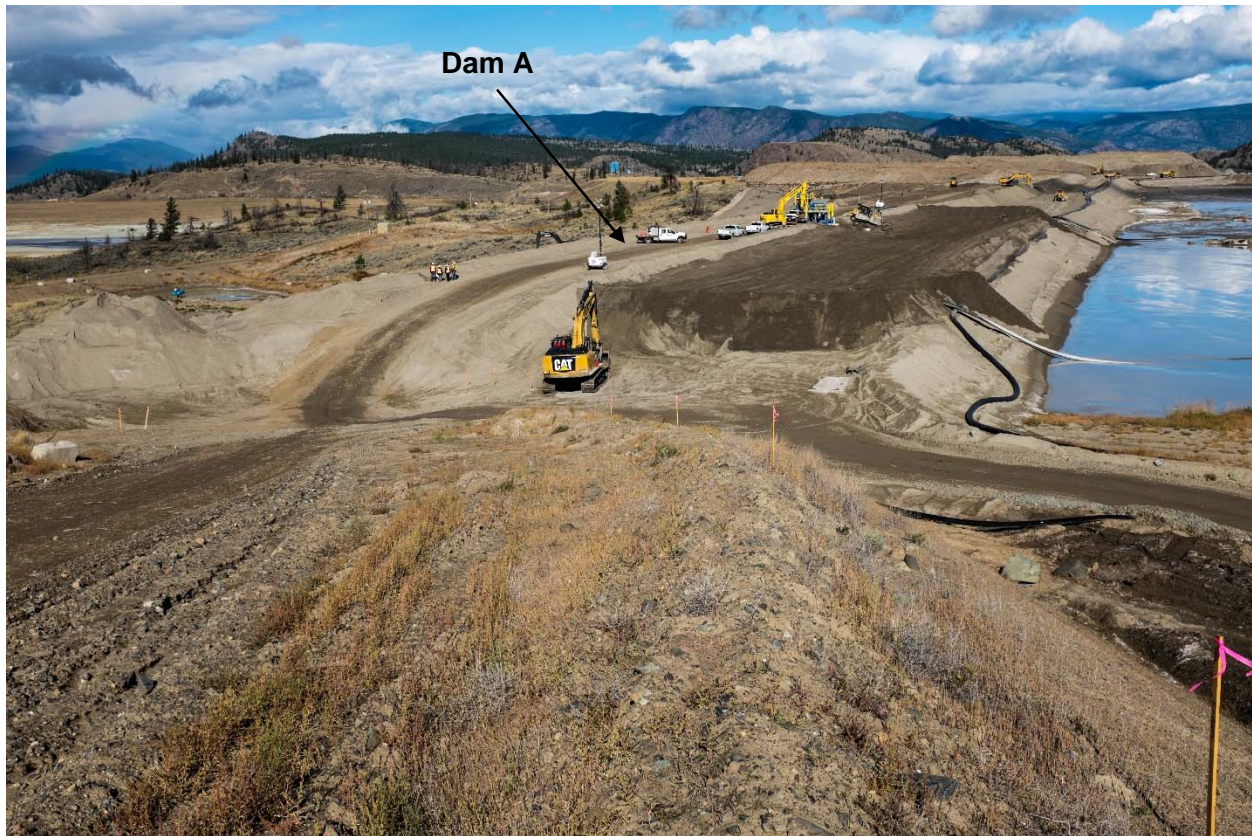
Figure 6-1. View looking north-northwest from approximately 75 m southeast of Dam A. Arrow pointing to mid-point of dam and till core at crest. September 30, 2014.

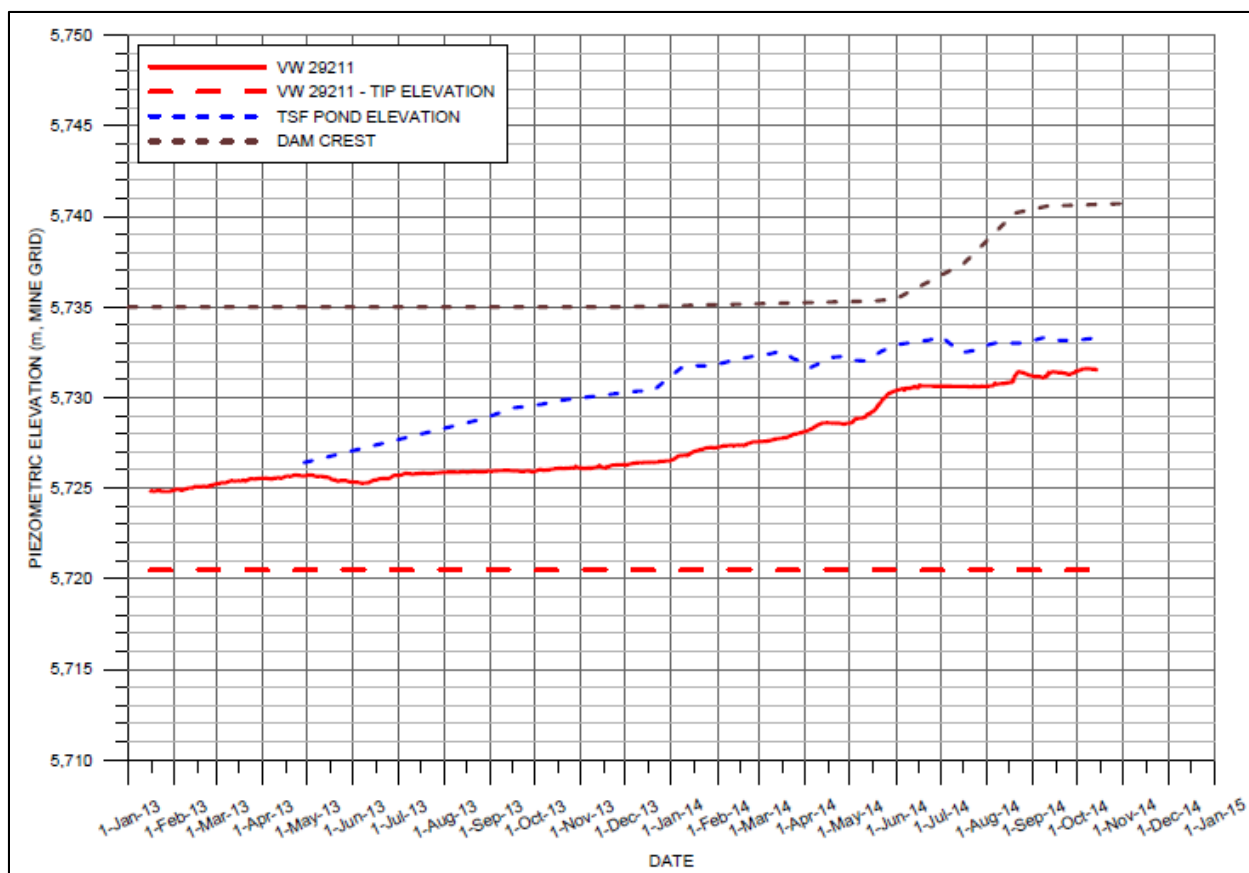
The standpipe piezometer located downstream of the dam is read manually on a monthly basis with data collected since January 16, 2013. Over this period, the standpipe piezometer has recorded fluctuations of up to 1.0 m in the piezometric level (Appendix C). Both the vibrating wire piezometer and the standpipe piezometer readings are within the acceptable operational limits outlined in the OMS manual.

Figure 6-2. Vibrating Wire Piezometer installed at Dam A.

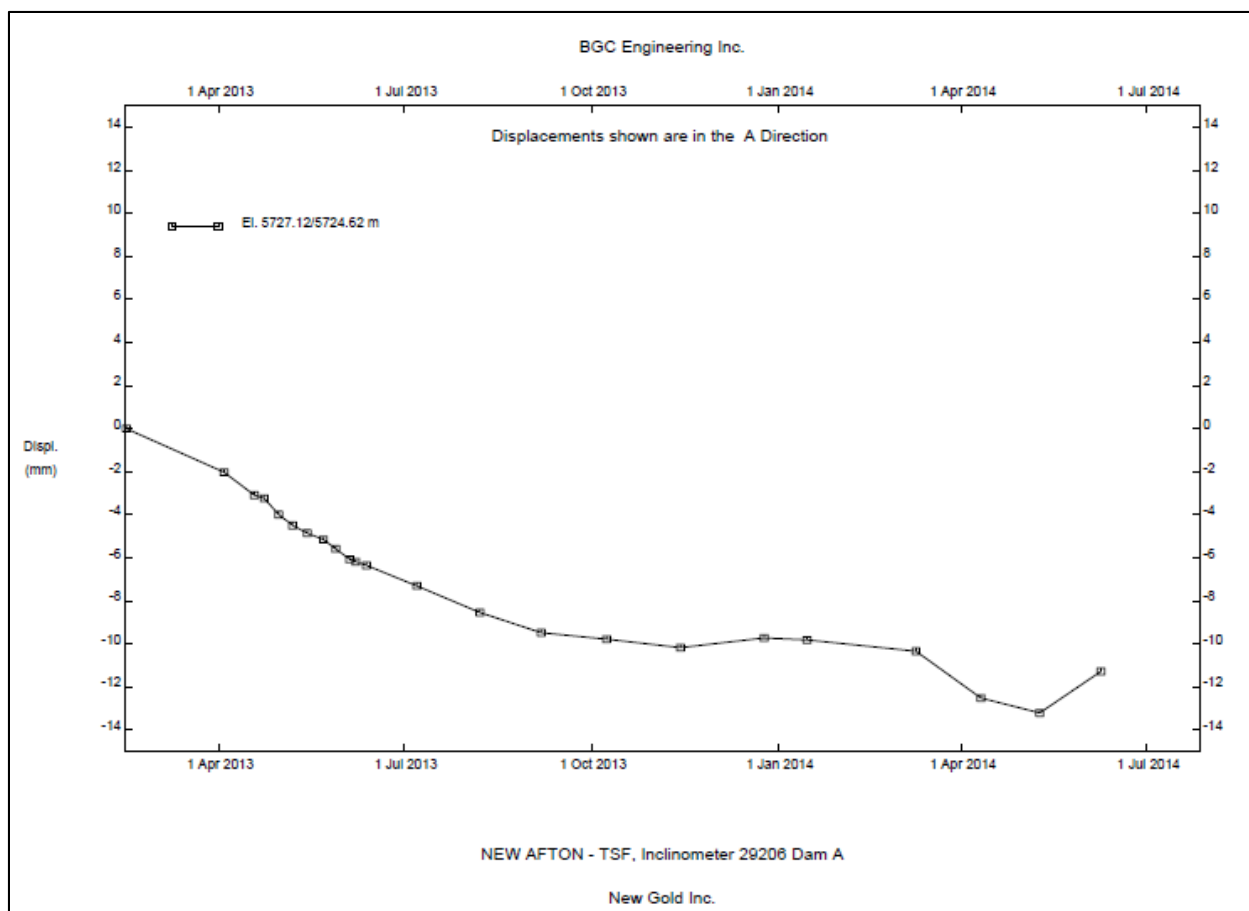
The slope inclinometer installed on the crest of Dam A, in the till core, has been manually read on a monthly basis since January 16, 2013. The inclinometer recorded approximately 13 mm of lateral displacement in the downstream direction near the base of the dam at an elevation of approximately 5,725 m between February 14 and June 8, 2014. The corresponding time-displacement plot, shown in Figure 6-3, indicates the rate of displacement increased again on March 9, 2014. BGC has interpreted the initial displacement in 2013 as settlement of Dam A over its native till foundation. The increased lateral displacement beginning in March 2014 coincides with the beginning of construction activities in the vicinity of the inclinometer and is interpreted to be as a result of compaction of dam fill upstream and adjacent to the inclinometer casing. A new baseline will be determined for future monitoring when 2014 construction activities conclude.

Figure 6-3. Slope Inclinator 29206 Time-Displacement data at Dam A. The positive A-direction is in the upstream direction and the negative A-direction is in the downstream direction.

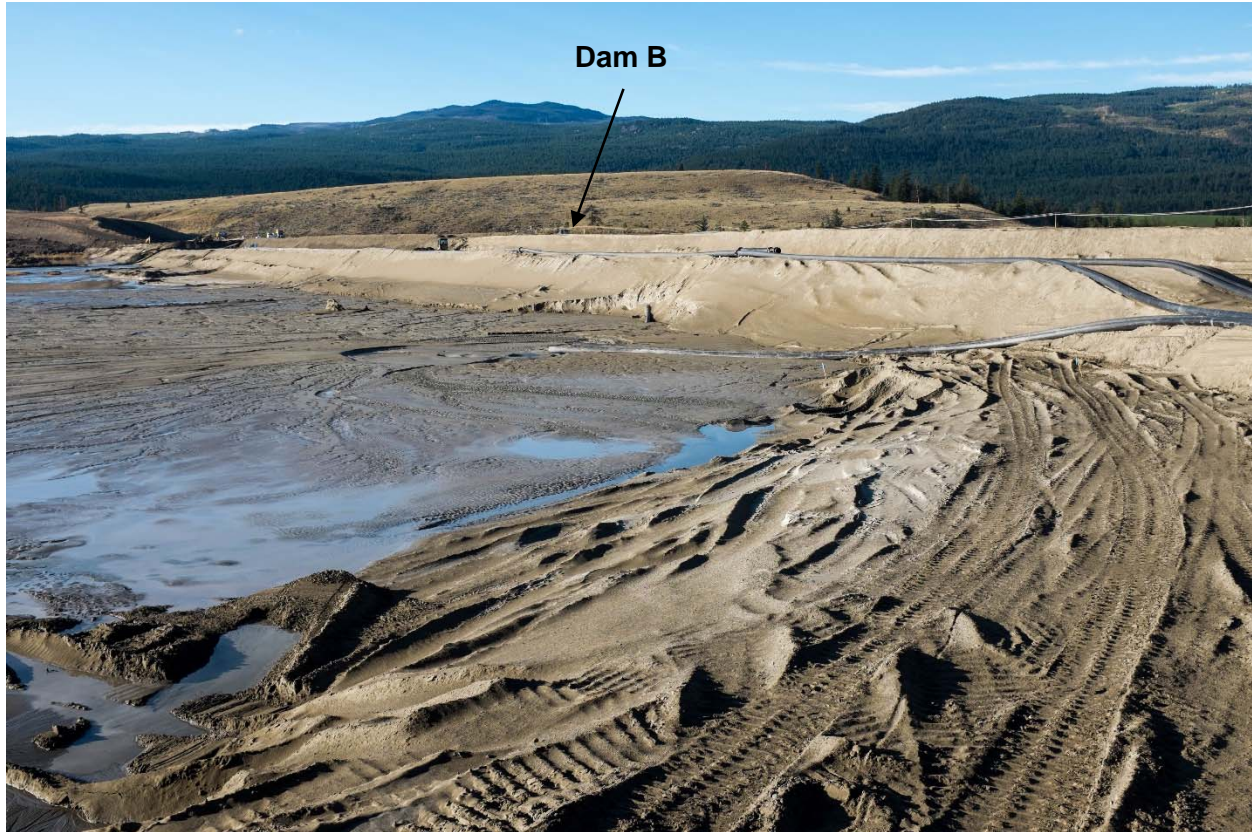
Figure 6-4. View looking north at Dam B from the upstream side of the left abutment of Dam C. Arrow pointing to mid-point of dam at upstream cyclone sand shell. October 1, 2014.

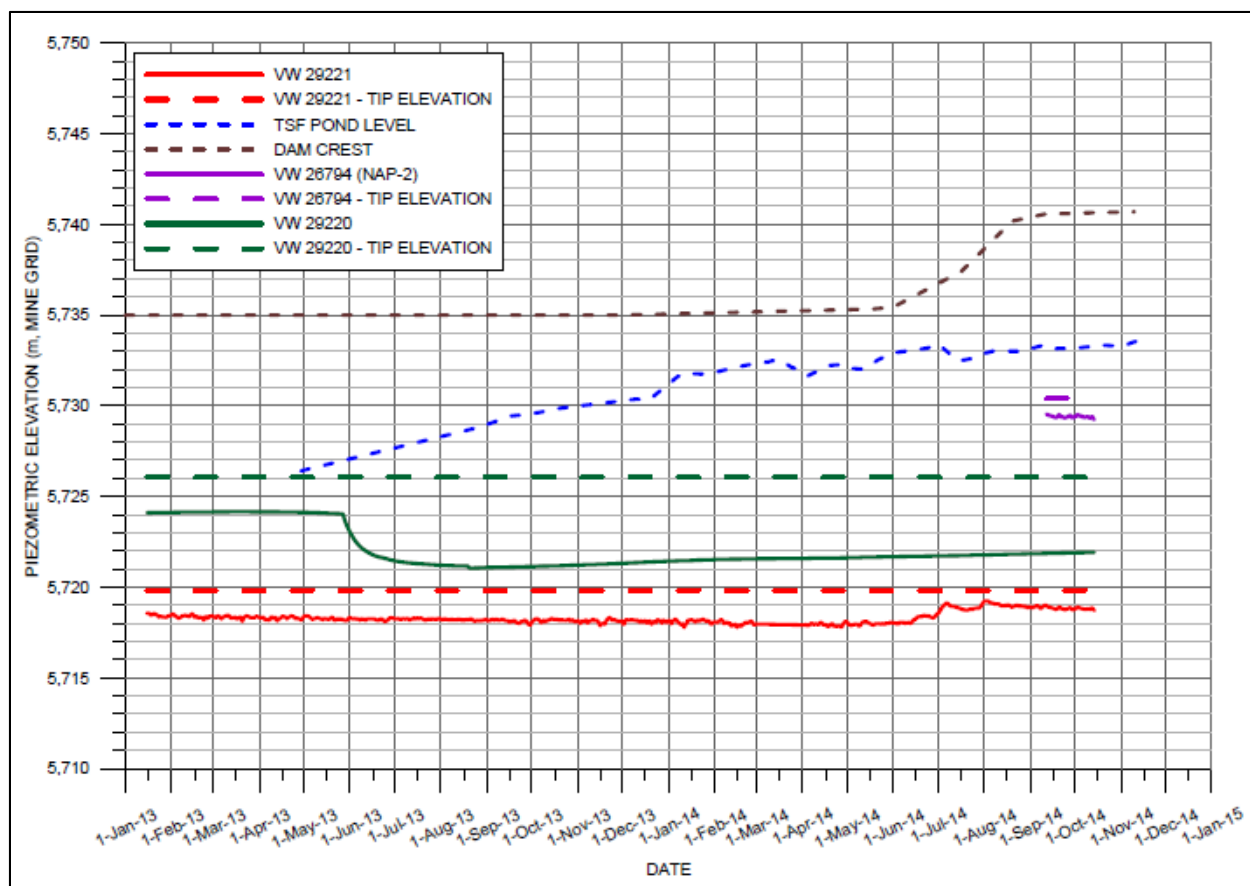
The standpipe piezometer located downstream of the dam is read manually on a monthly basis with data collected since January 16, 2013. Over this time period, the standpipe piezometer has been dry. Both the vibrating wire piezometers and the standpipe piezometer appear to be reading within acceptable operational limits.

Figure 6-5. Vibrating Wire Piezometers installed at Dam B.

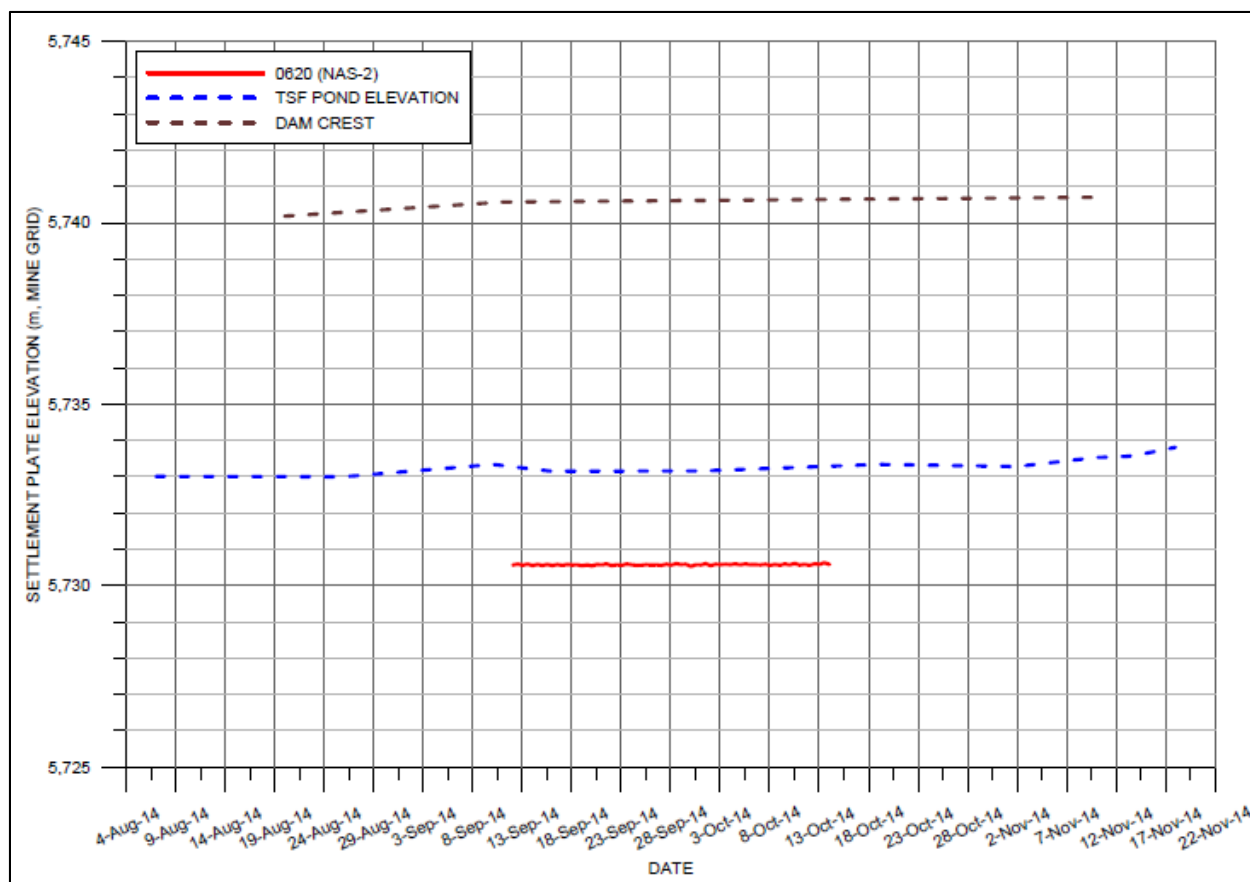
The vibrating wire settlement plate in the downstream fine filter blanket drain at Dam B is manually read on a monthly basis and data have been collected consistently since September 12, 2014 as seen in Figure 6-6. The readings from the instrument indicate no measureable settlement.

Figure 6-6. Vibrating Wire Settlement Plate installed at Dam B.

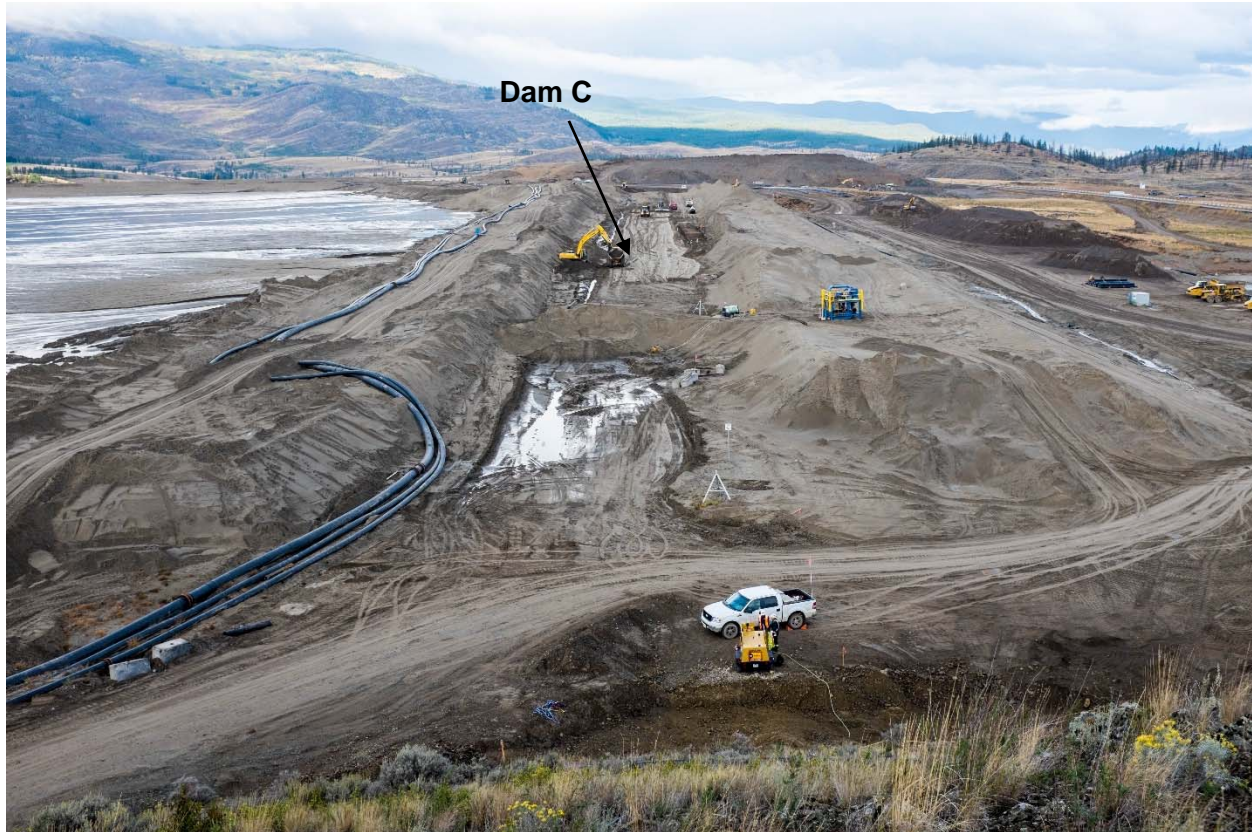
Figure 6-7. View looking west from approximately 75 m east of Dam C. Arrow pointing to mid-point of dam and till core at crest. September 30, 2014.

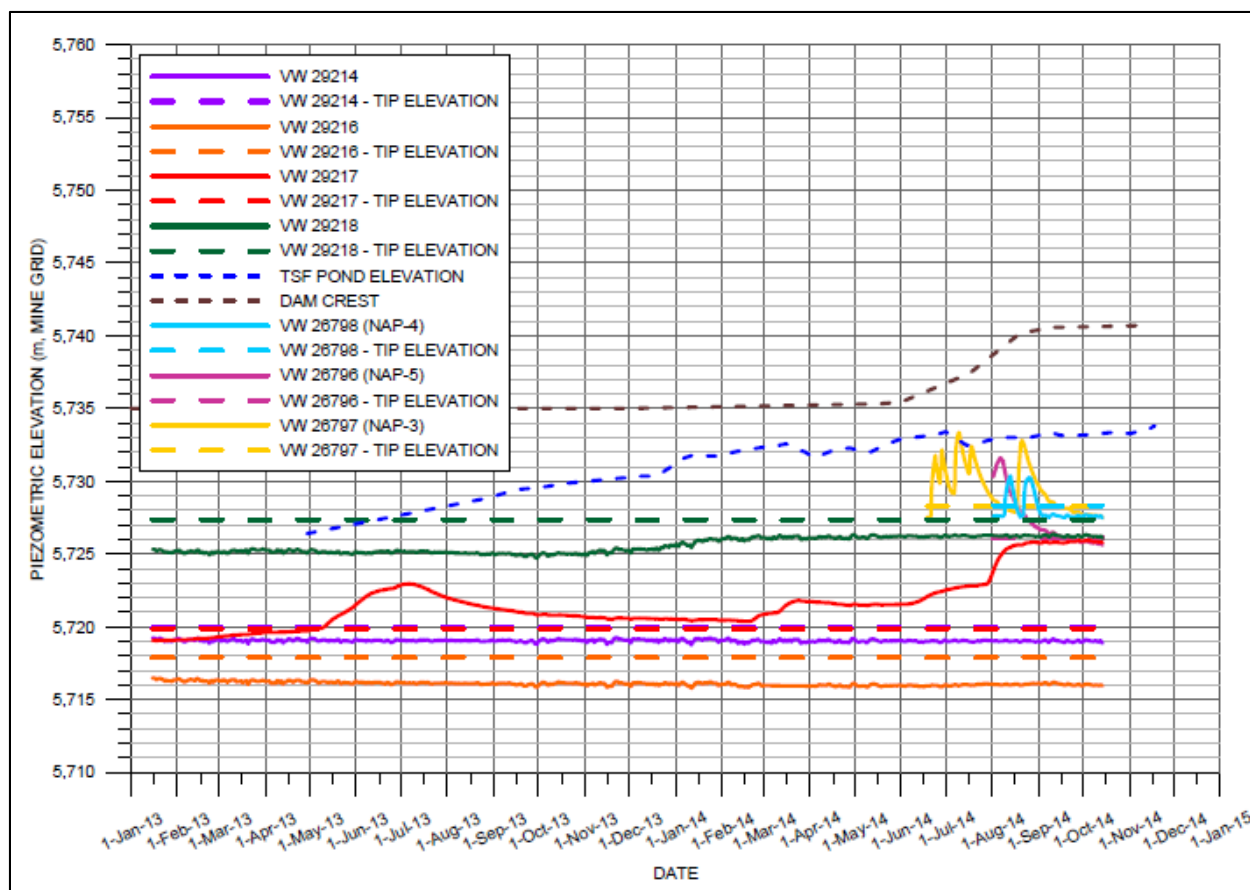
The two standpipe piezometers located downstream of Dam C have been read manually on a monthly basis since January 16, 2013. Over this period, the two standpipe piezometers have recorded fluctuations of up to 5.0 m in the piezometric level (Appendix C). Piezometer SP 34560, located downstream of the western extent of Dam C, recorded fluctuations in piezometric level between July and August 2014. The piezometric level increased by approximately 5.0 m. This response coincided with downstream sand cell construction on Dam C.

Figure 6-8. Vibrating Wire Piezometers installed at Dam C.

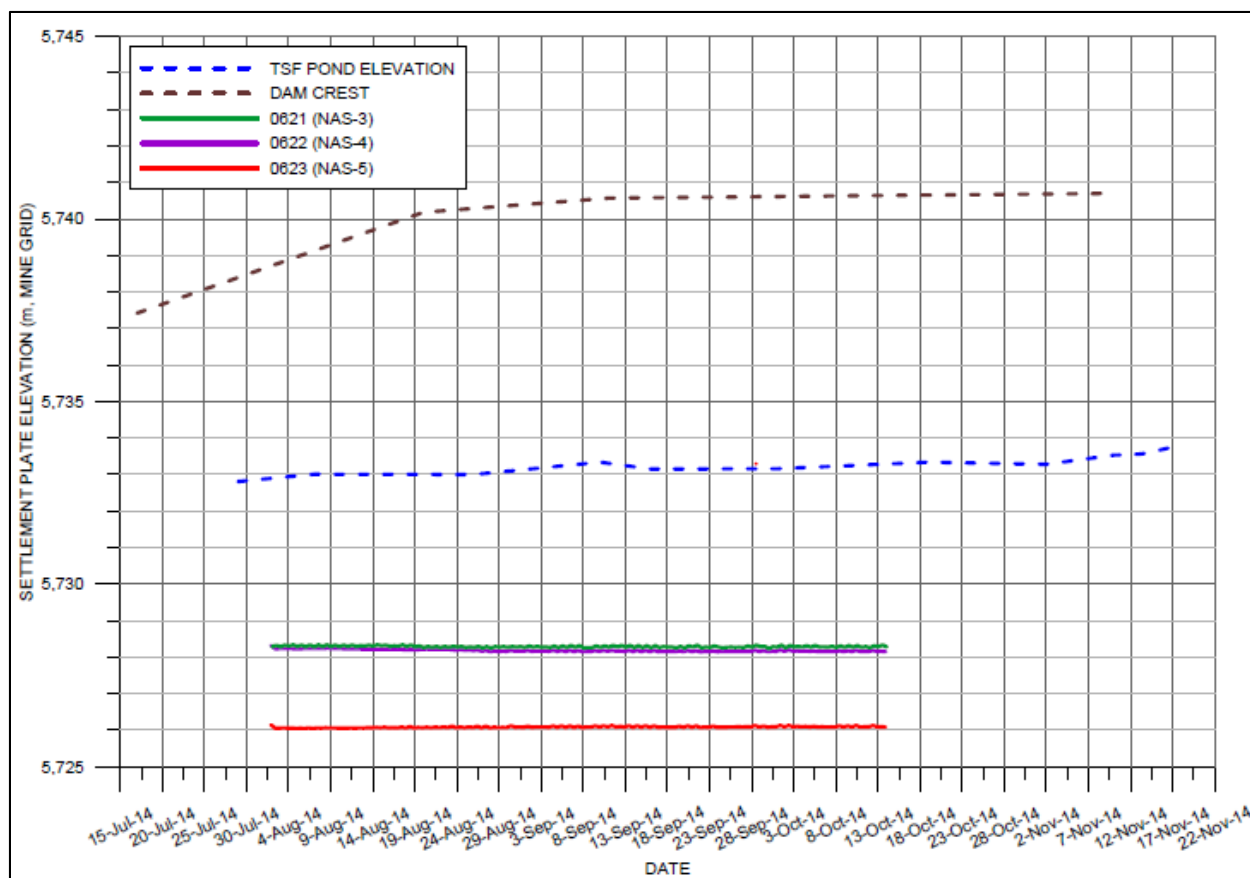
The three vibrating wire settlement plates installed in 2014 in the downstream fine filter blanket drain at Dam C are manually read on a monthly basis and data have been collected since August 1, 2014 as shown in Figure 6-9. Vibrating wire settlement plate 0622 (NAS-4) installed near 0+600 showed 80 mm of settlement over this time period, which is within the predicted range of settlement at this location. The readings from 0621 (NAS-3) and 0623 (NAS-5) indicated no measureable settlement.

Figure 6-9. Vibrating Wire Settlement Plates installed at Dam C.

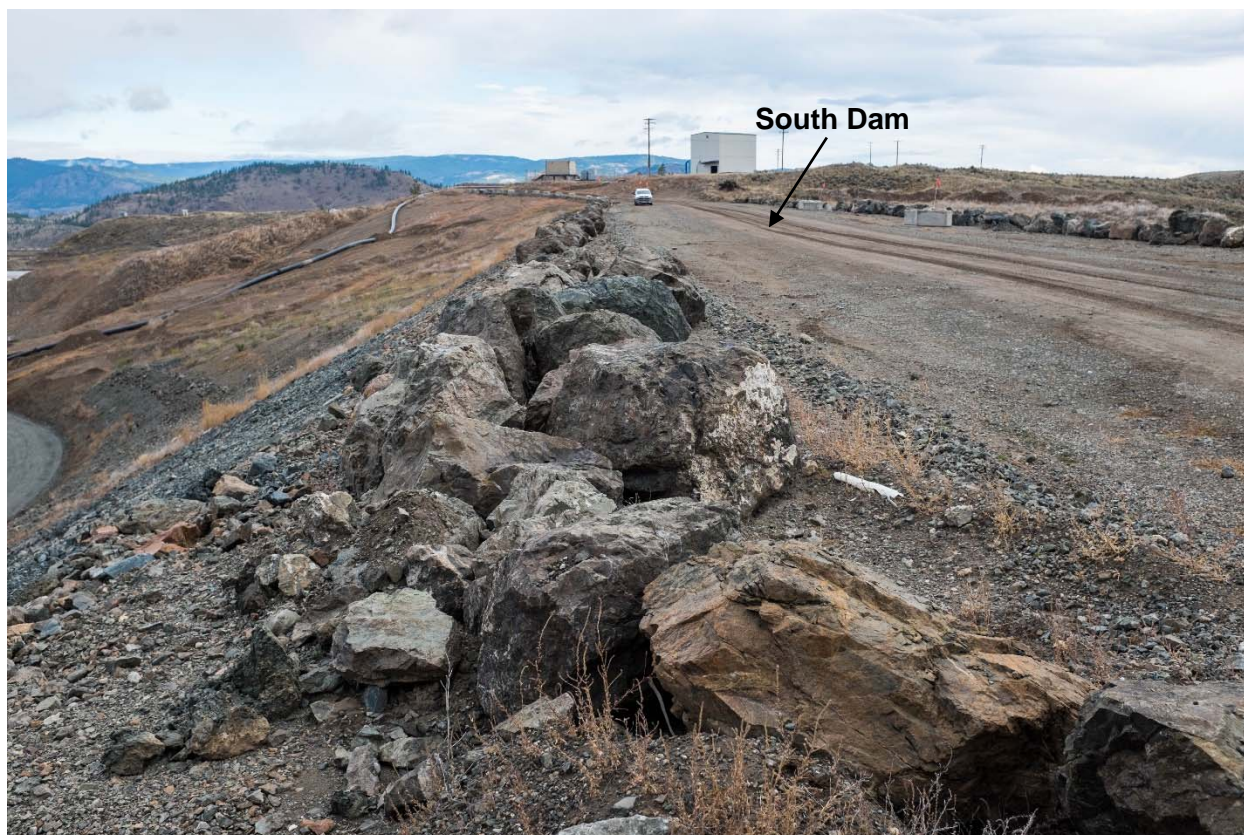
Figure 6-10. View looking north at upstream face of South Dam from right abutment. Arrow pointing to mid-point of dam. Primary cyclone house visible in the background of photo. September 30, 2014.

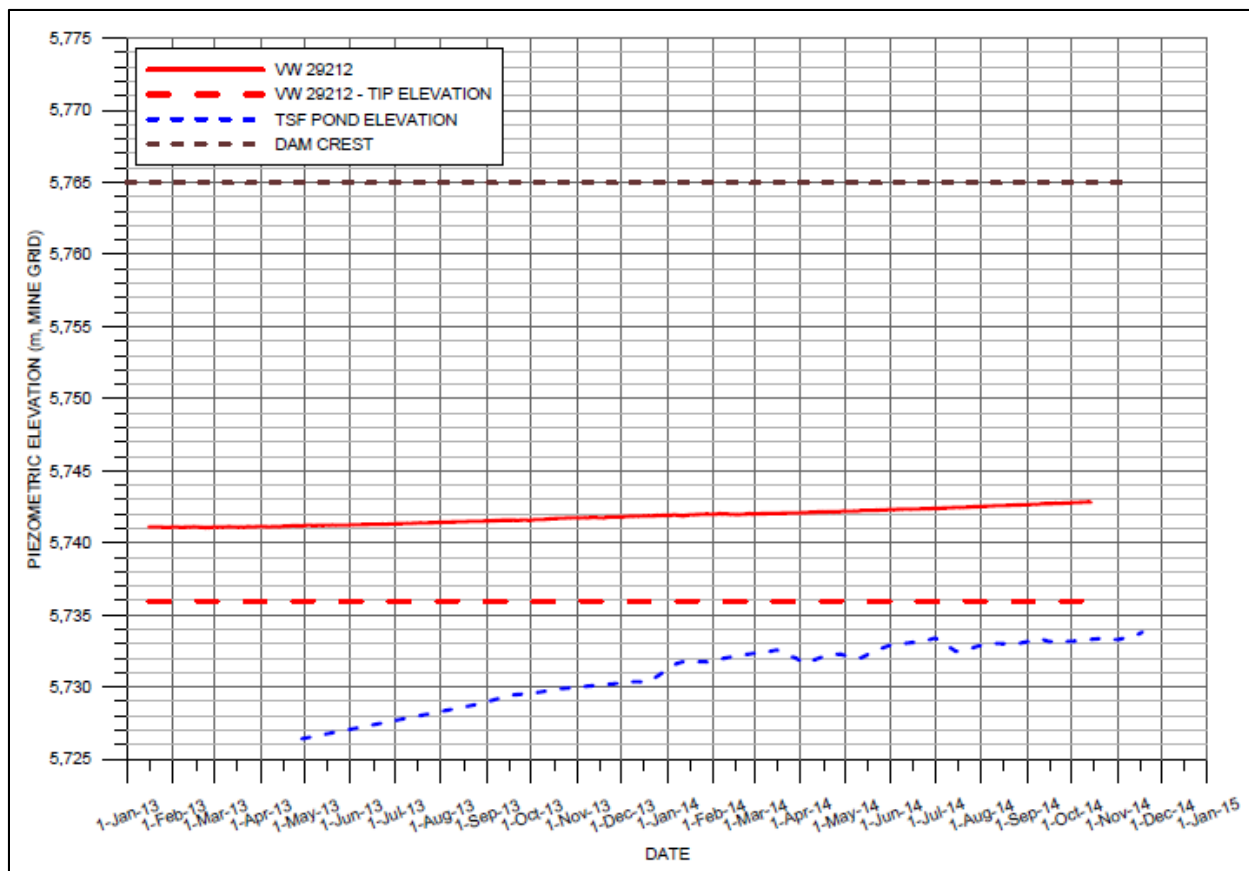
The vibrating wire piezometer and standpipe piezometer appear to be reading within acceptable operational limits.

Figure 6-11. Vibrating Wire Piezometer installed at South Dam.

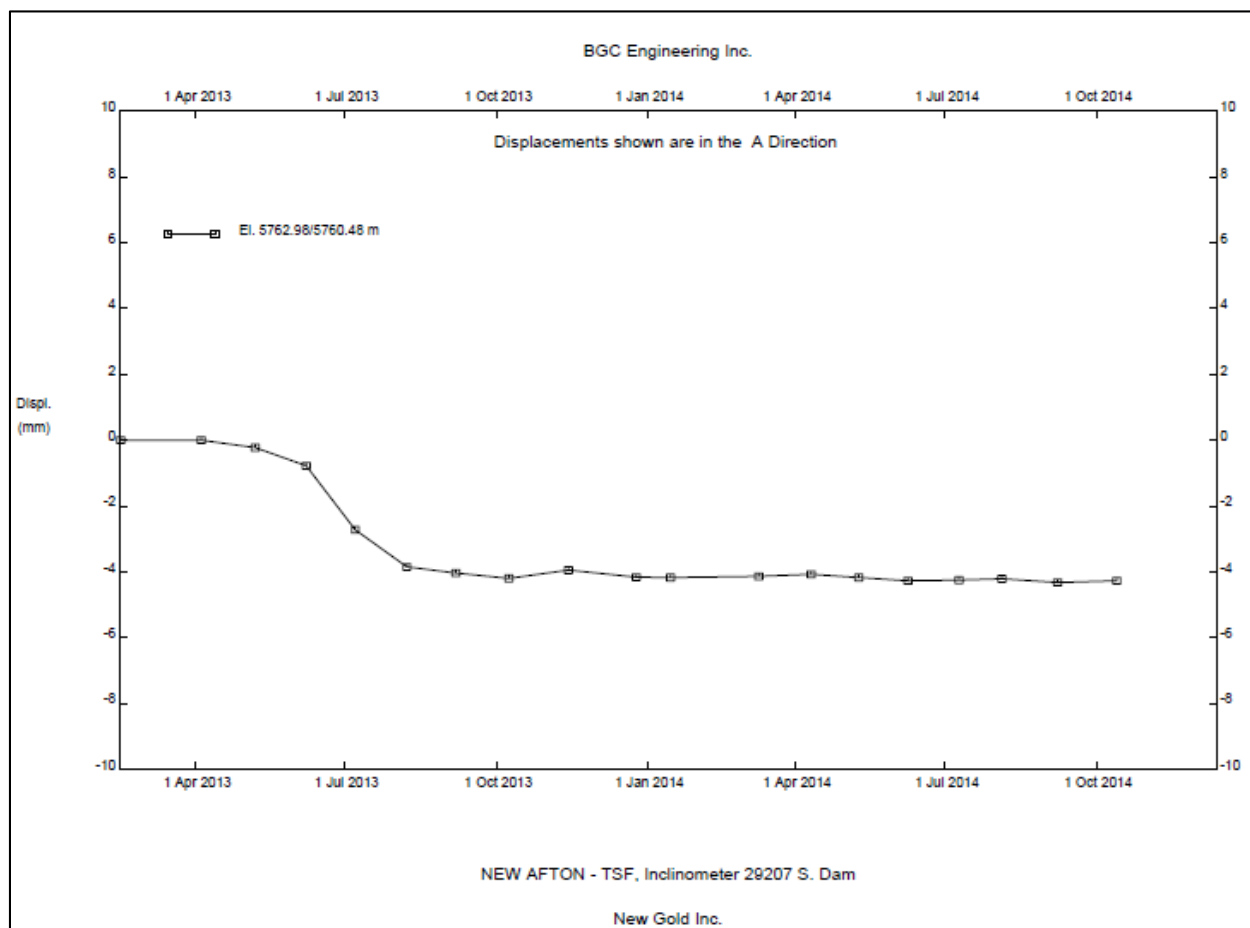
The slope inclinometer installed at the South Dam is manually read on a monthly basis and data have been collected consistently since January 16, 2013. The inclinometer has recorded approximately 4 mm of lateral displacement in the downstream direction near the crest of the dam at an elevation of approximately 5,761 m between June and August 2013. Since then, no lateral displacement has been recorded, as shown in Figure 6-12.

Figure 6-12. Slope Inclinator 29207 time-displacement data at South Dam. The positive A-direction is in the upstream direction and the negative A-direction is in the downstream direction.

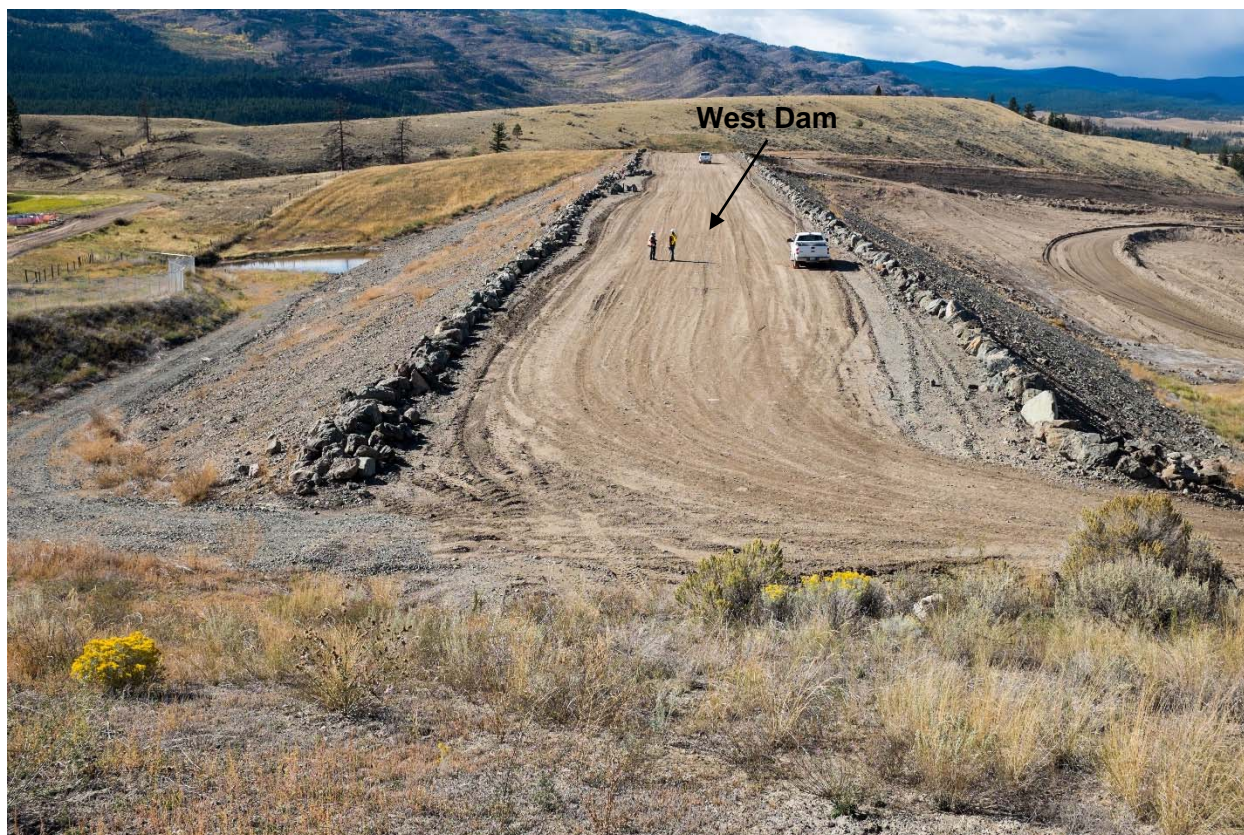
Figure 6-13. View looking west along the crest of West Dam from left abutment. Arrow pointing to mid-point of dam. September 30, 2014.

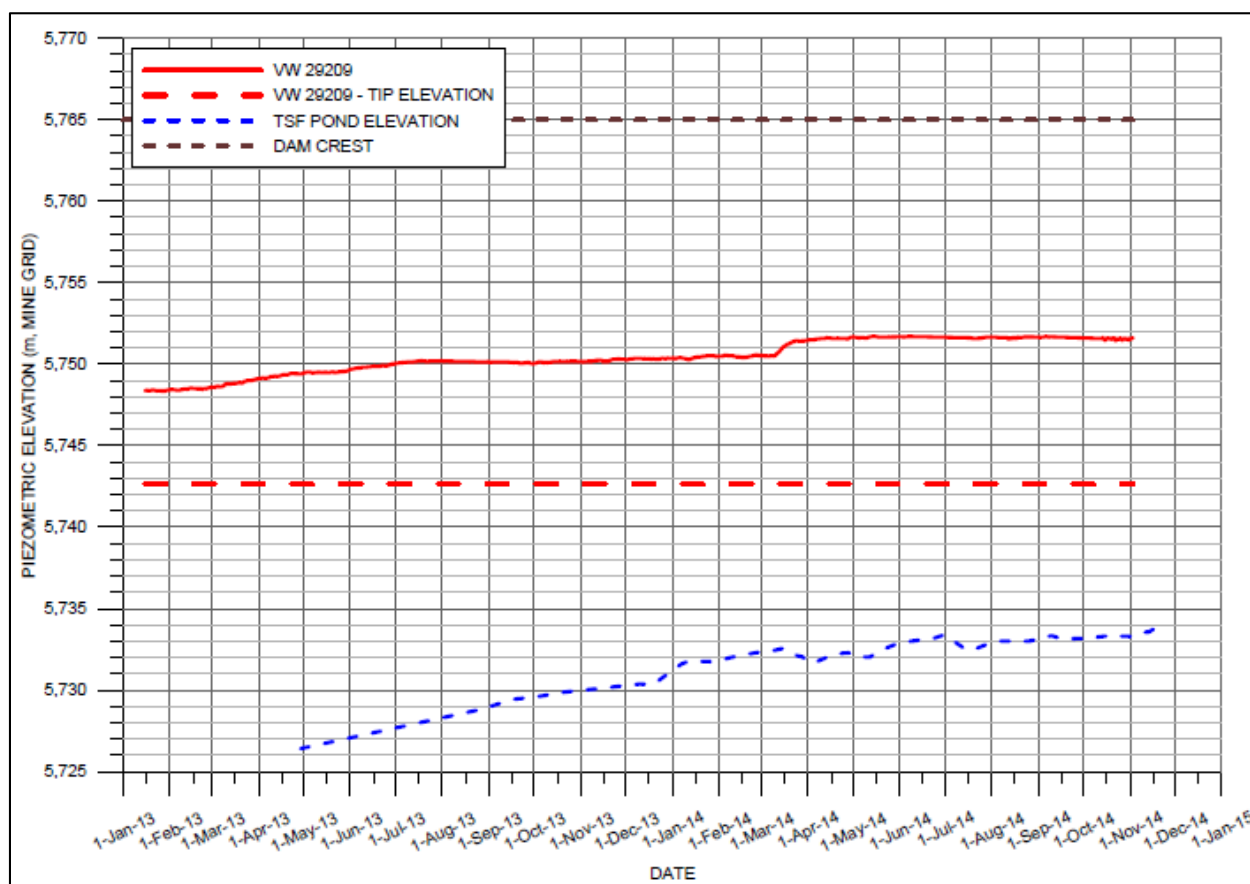
The two standpipe piezometers located downstream of the West Dam are generally read manually on a monthly basis with data being collected since January 16, 2013. Over this time period, standpipe piezometer 29203 has recorded seasonal fluctuations of approximately 2.5 m in the piezometric level (Appendix C). Standpipe piezometer 29204 has been dry over the recording period. Both the vibrating wire piezometer and the standpipe piezometers appear to be reading within acceptable operational limits.

Figure 6-14. Vibrating Wire Piezometer installed at West Dam.

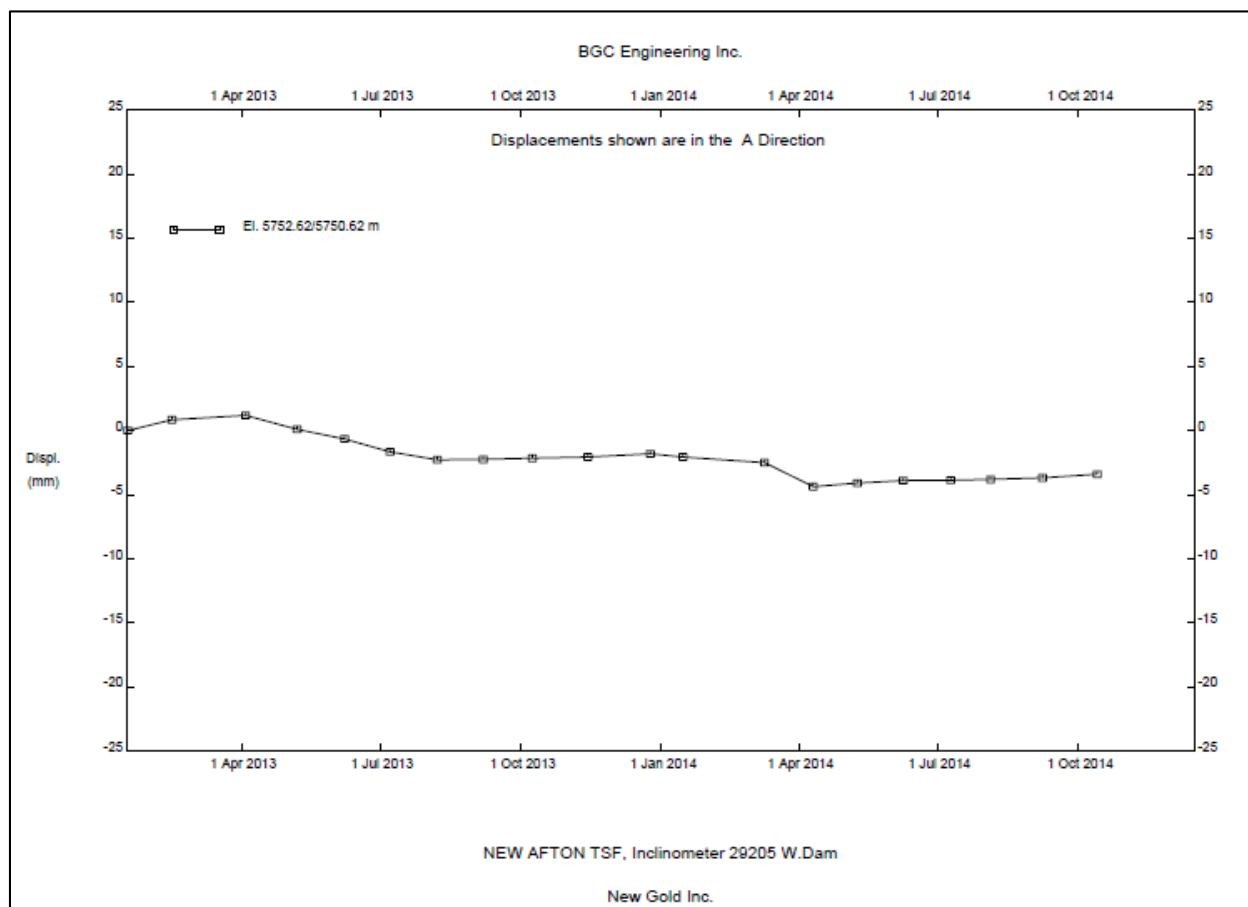
The slope inclinometer installed at the dam is manually read on a monthly basis and data have been collected consistently since January 16, 2013. The inclinometer has recorded approximately 5 mm of lateral displacement in the downstream direction near the crest of the dam at an elevation of approximately 5,762 m since January 2013, as shown in Figure 6-15. BGC has interpreted this apparent movement as settlement of the dam, and it continues to be monitored.

Figure 6-15. Slope Inclinometer 29205 time-displacement data at West Dam. The positive A-direction is in the upstream direction and the negative A-direction is in the downstream direction.

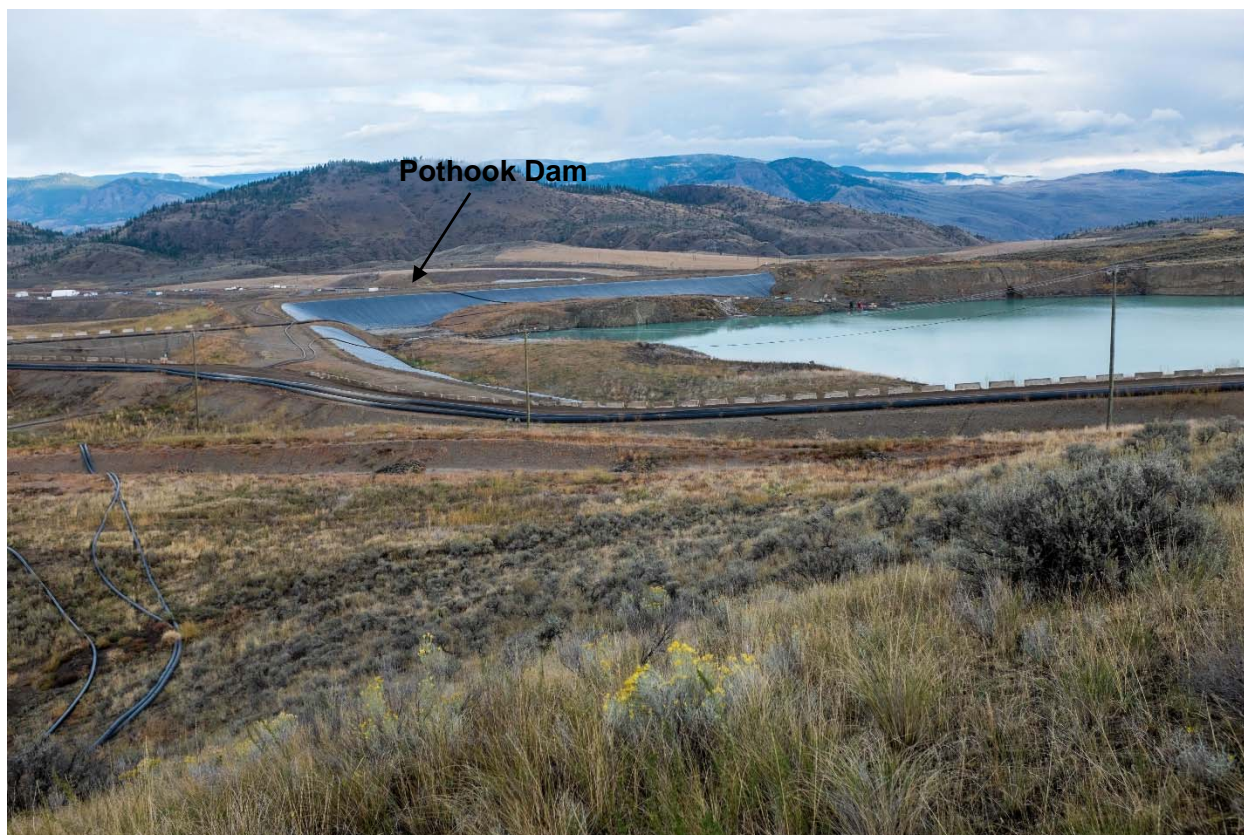
Figure 6-16. View looking north to Pothook Dam from 75 m west of Dam C. September 30, 2014.

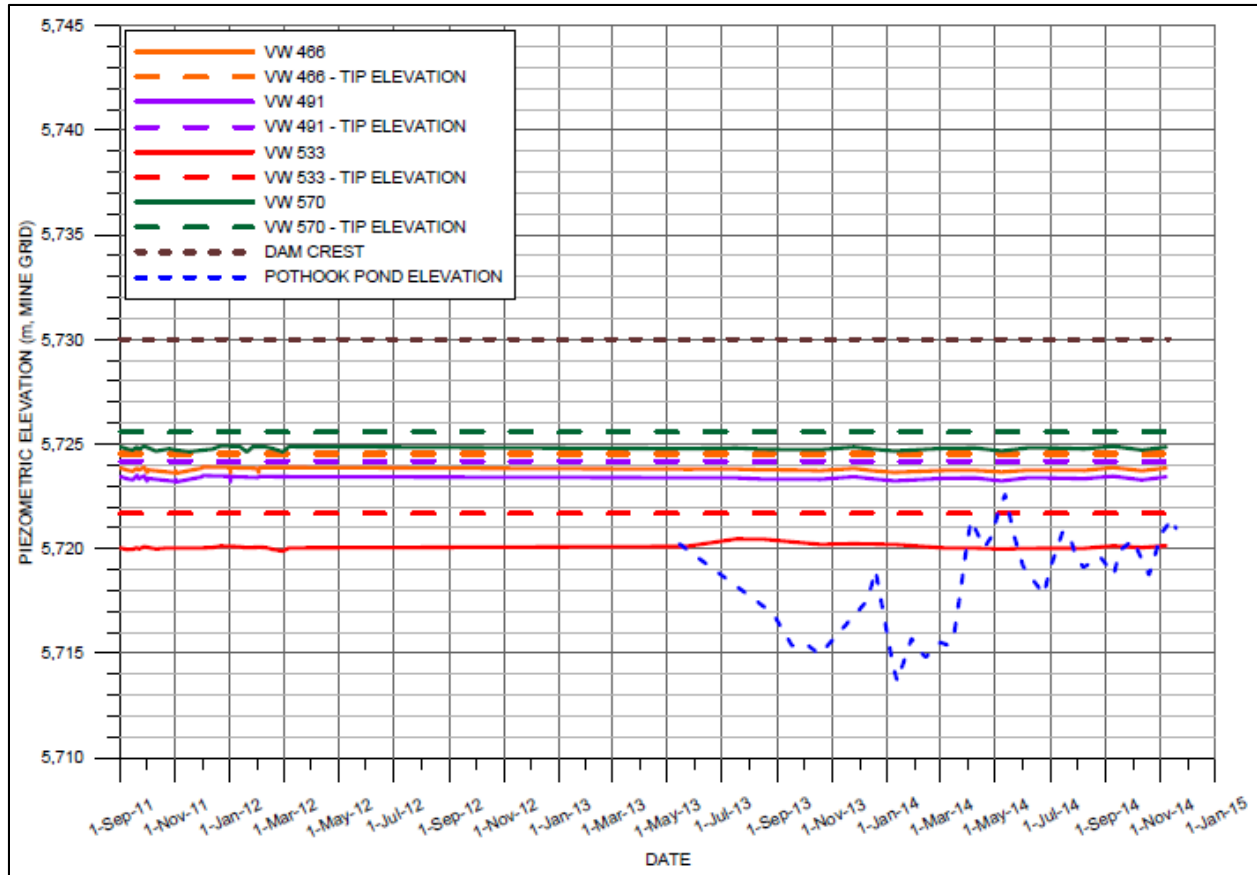
Piezometric data have been collected since 2011, and trends generally follow the expected behaviour. Since July of 2013, data has been collected from the vibrating wire piezometers and standpipe piezometers on a monthly basis. Prior to this, the data collection was sporadic. The vibrating wire piezometers installed in Pothook Dam have not recorded any pore pressure responses, as shown in Figure 6-17. The standpipe piezometers, located downstream of the dam, have all either been dry or recorded minor fluctuations in piezometric levels. Both the vibrating wire piezometer and the standpipe piezometers appear to be reading within acceptable operational limits.

Figure 6-17. Vibrating Wire Piezometers installed at Pothook Dam.

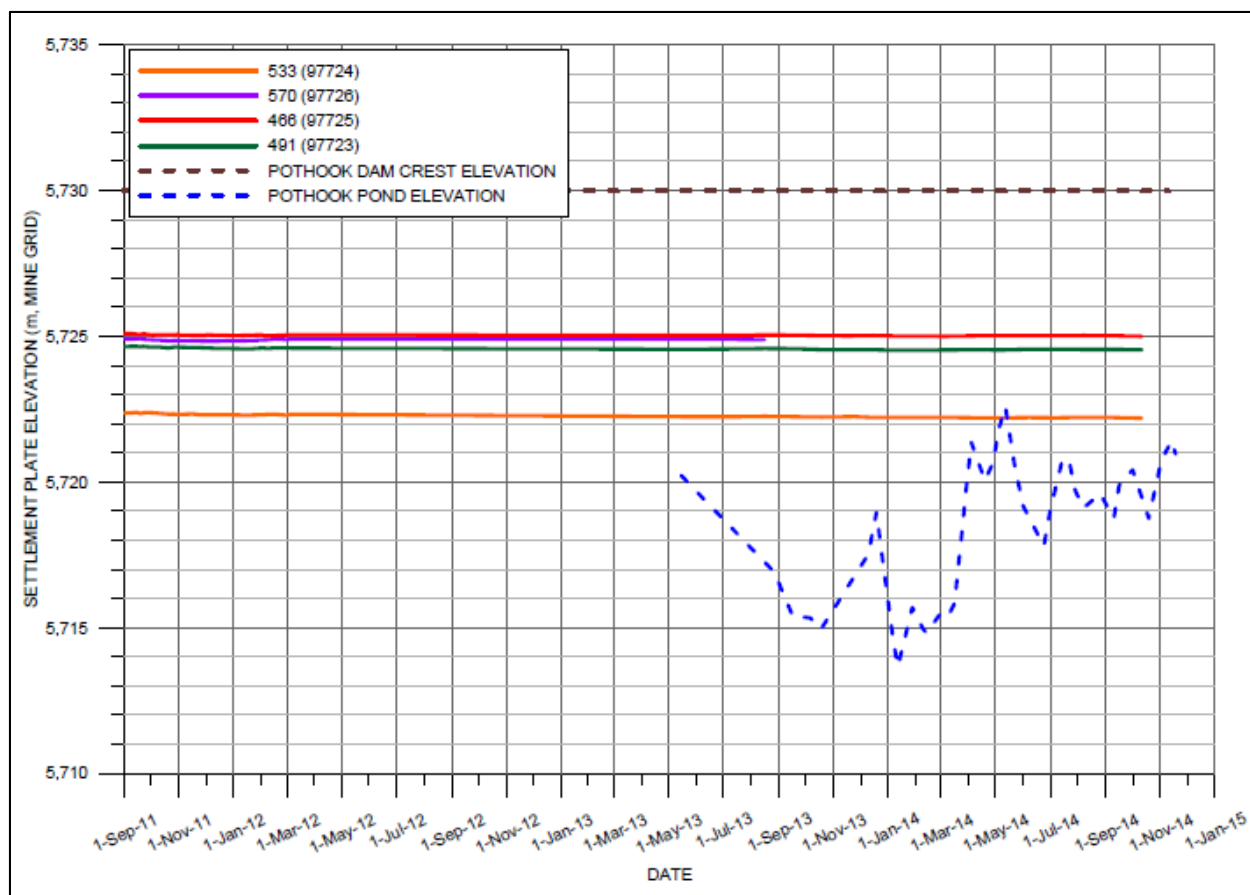
Data have been collected for the four vibrating wire settlement cells installed near the base of the dam since September 2011. However, prior to May 2013, the data collection was sporadic. Since May 2013, the settlement cells have been read manually on a monthly basis. From September 2011 to October 2014, the vibrating wire settlement plates recorded settlement ranging from 90 to 180 mm as seen in Figure 6-18, which is within the predicted range of settlement for this area. In late 2013, vibrating wire settlement plate 570 (97726) was not functioning and will be repaired.

Figure 6-18. Vibrating Wire Settlement Plates installed at Pothook Dam.

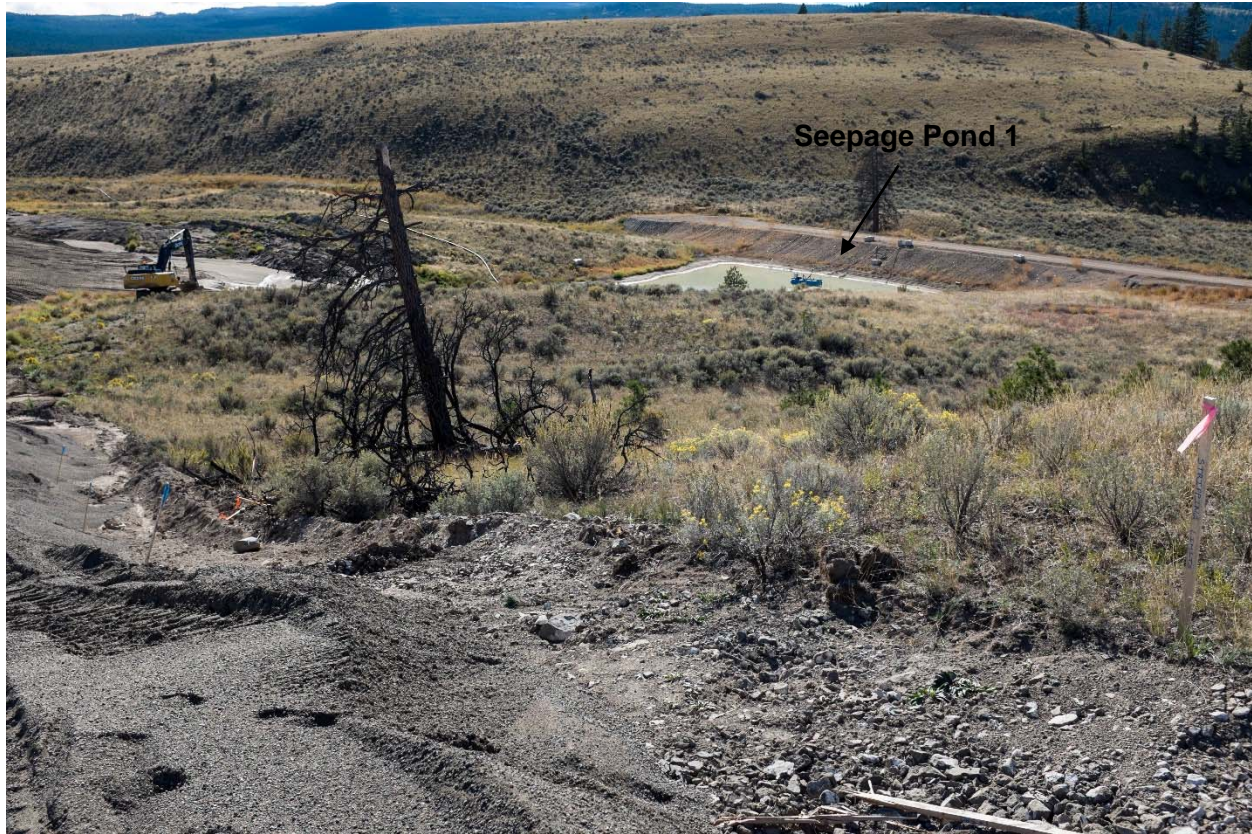
Figure 6-19. View looking southwest at Seepage Pond 1 from the downstream toe of Dam A at the boundary with Dam B. September 30, 2014.
