NEW AFTON PROJECT

2014 Annual Inspection Tailings Storage Facility

FINAL
November 28, 2014

BGC Document No.:
RP-0921011.0124

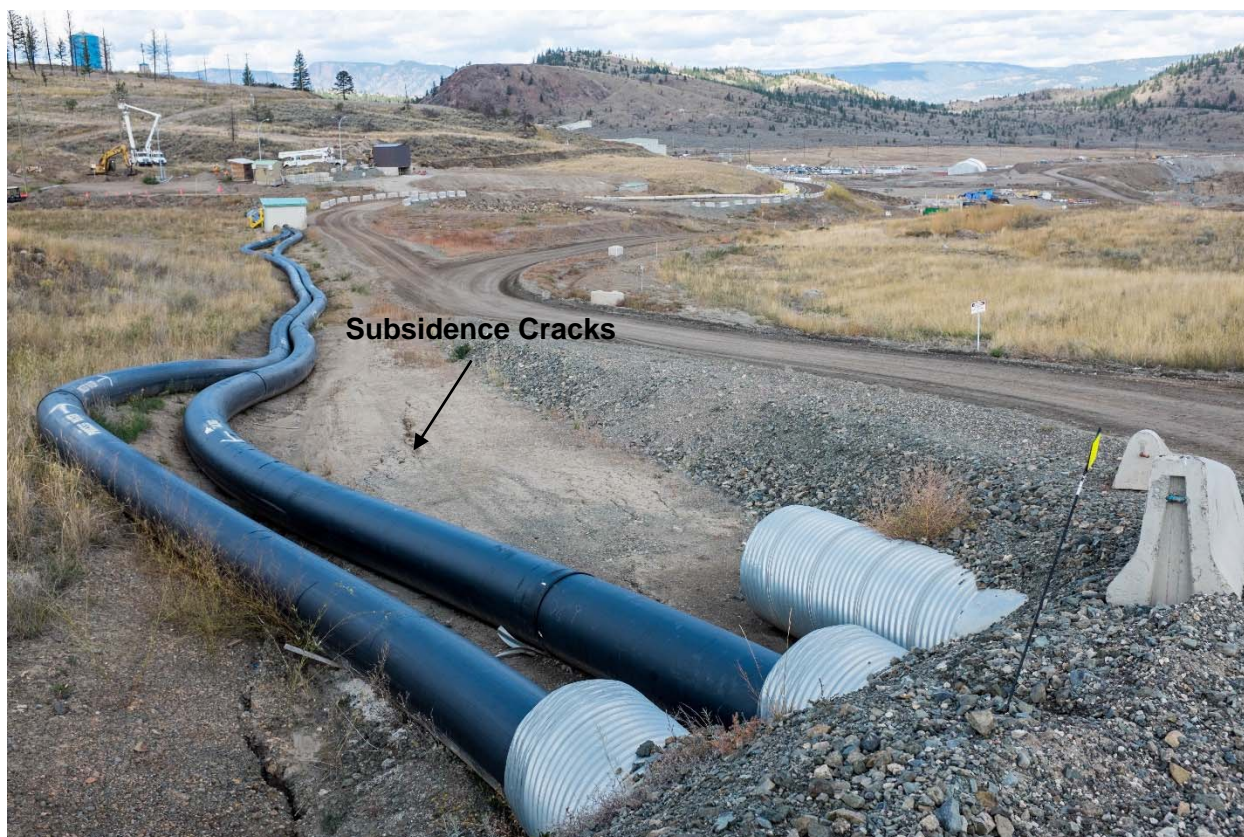
Figure 6-20. View looking north northwest at tailings line and water reclaim line. Tailings line is on the left and water reclaim line is on the right. Note subsidence cracks along pipeline corridor. October 1, 2014.

Cracking, due to the underground block cave mining, was observed adjacent to the tailings and water reclaim lines at one location, as seen in Photo TL03 in Appendix B. *It is recommended that the cracking be routinely monitored and that the tailings and water reclaim lines be moved if it appears they will be impacted by the cracking or any associated settlement.*

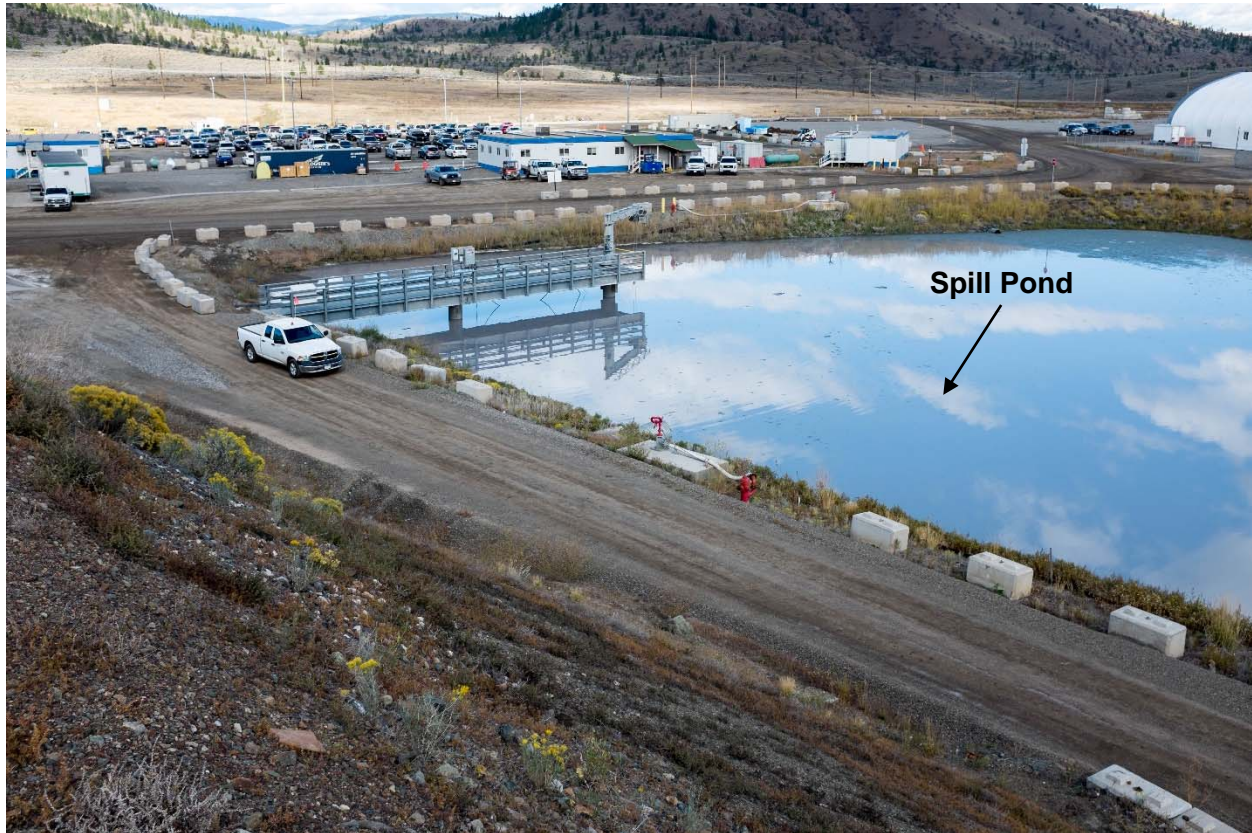
Figure 6-21. View looking North at the Tailings Spill Pond. Note the spill pond is relatively full. October 1, 2014.

The Tailings Spill Pond, located adjacent to the mill building, was also reviewed and was observed to be functional and in good condition, as seen in Photo TL13. The Tailings Spill Pond was observed to be relatively full at the time of the inspection. *It is recommended that the Tailings Spill Pond be emptied to provide capacity to drain the tailings line, if needed.*
