APPENDIX B SELECT PHOTOGRAPHS

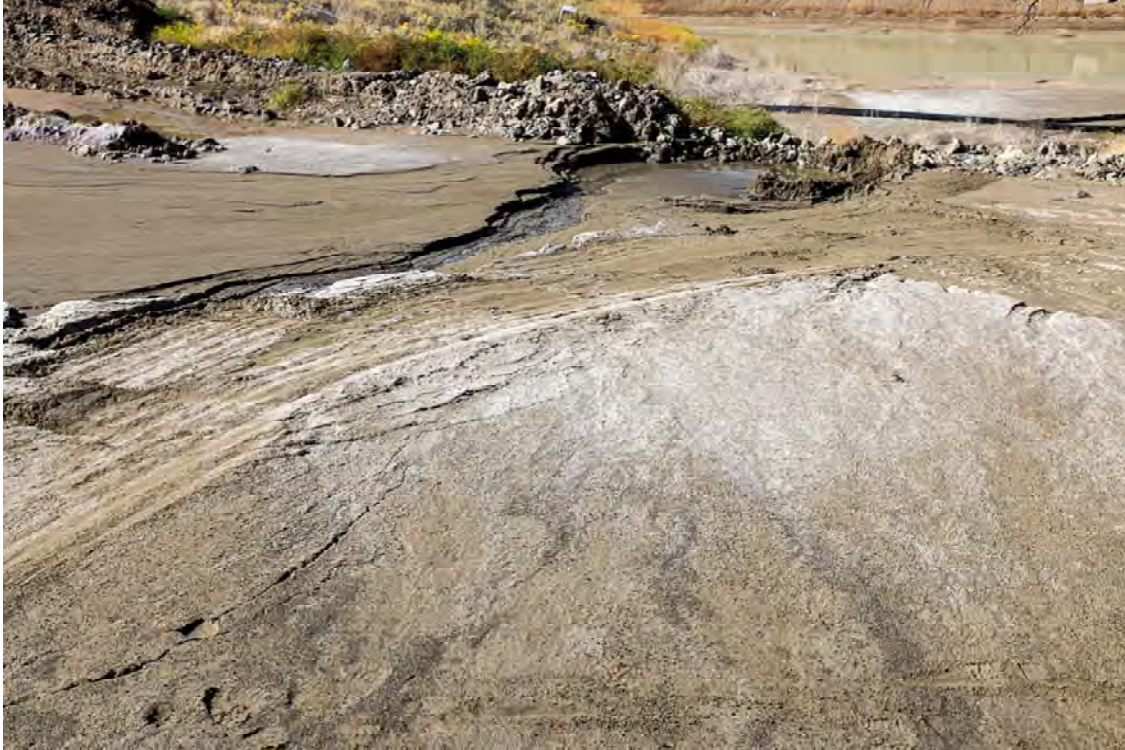
Photo DA16: View looking south at downstream toe and face, and left abutment of Dam A from downstream toe near mid point of dam. Note dressed downstream face.

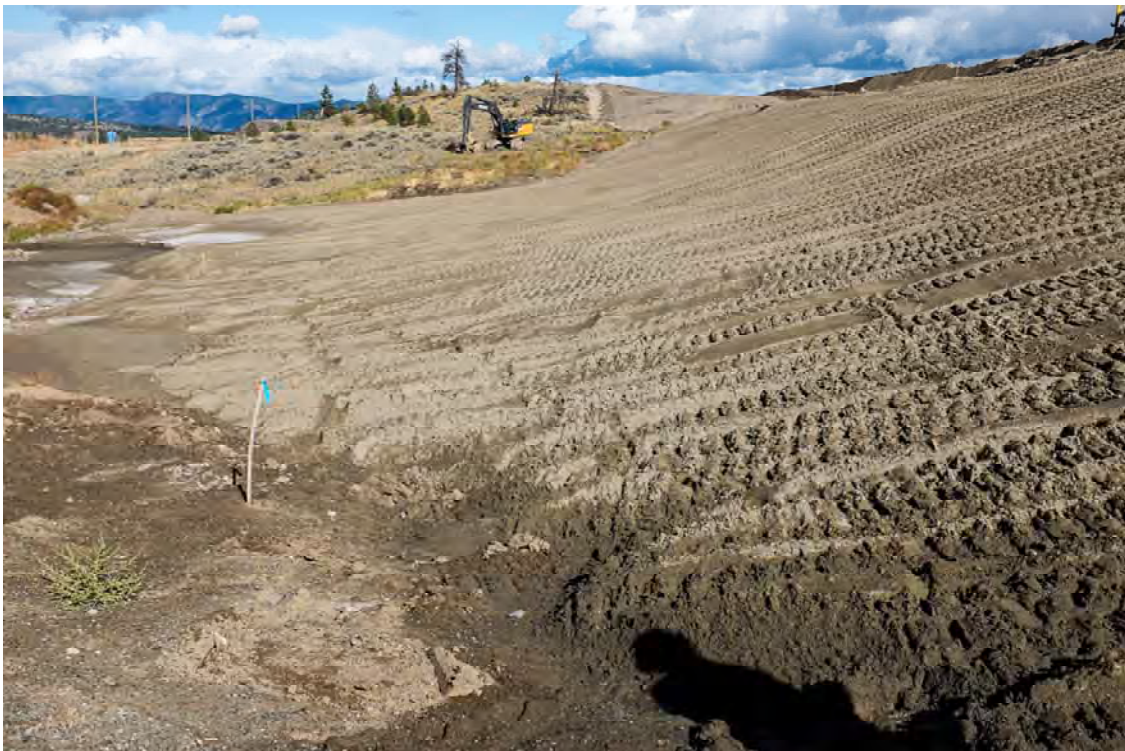
Photo DA17: View looking west at downstream toe of Dam A. Note loose saturated sand deposited at the toe of the dam immediately upstream of Seepage Pond 1 visible at top right of photo.

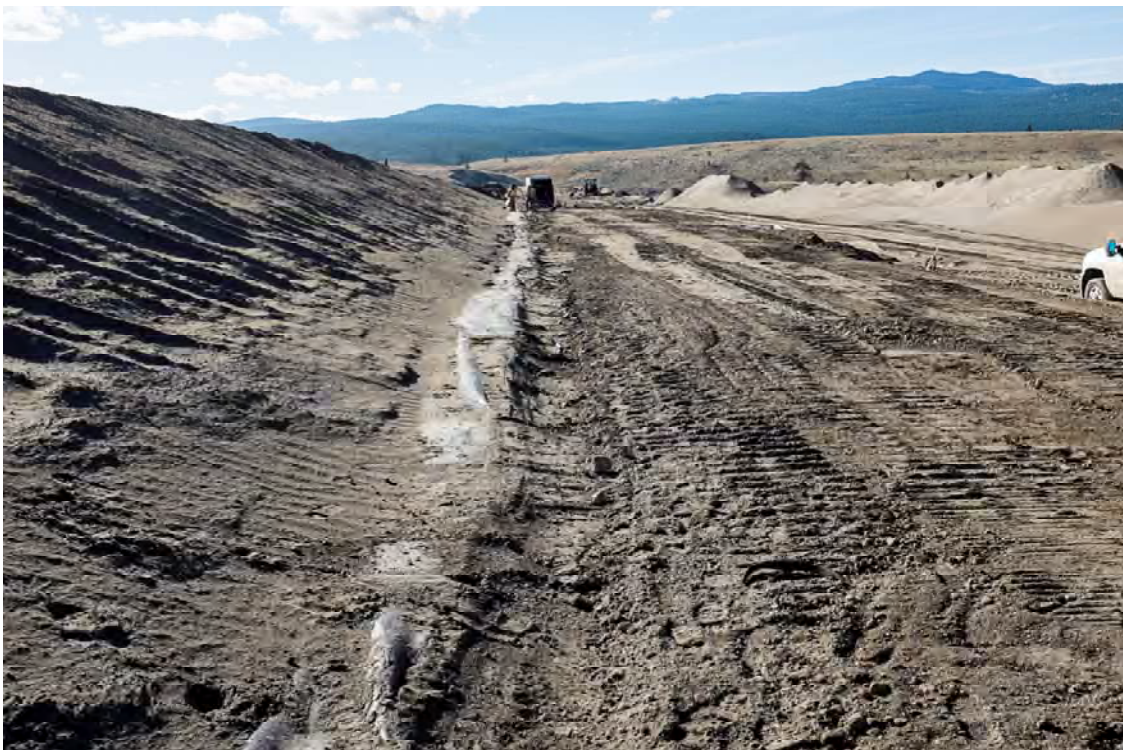
Photo DB19: View looking north at upstream sand cells and crest of Dam B from approximately sta. 1+475 m. Transition between lined and unlined section of Dam B visible in crest offset with lined portion in background.

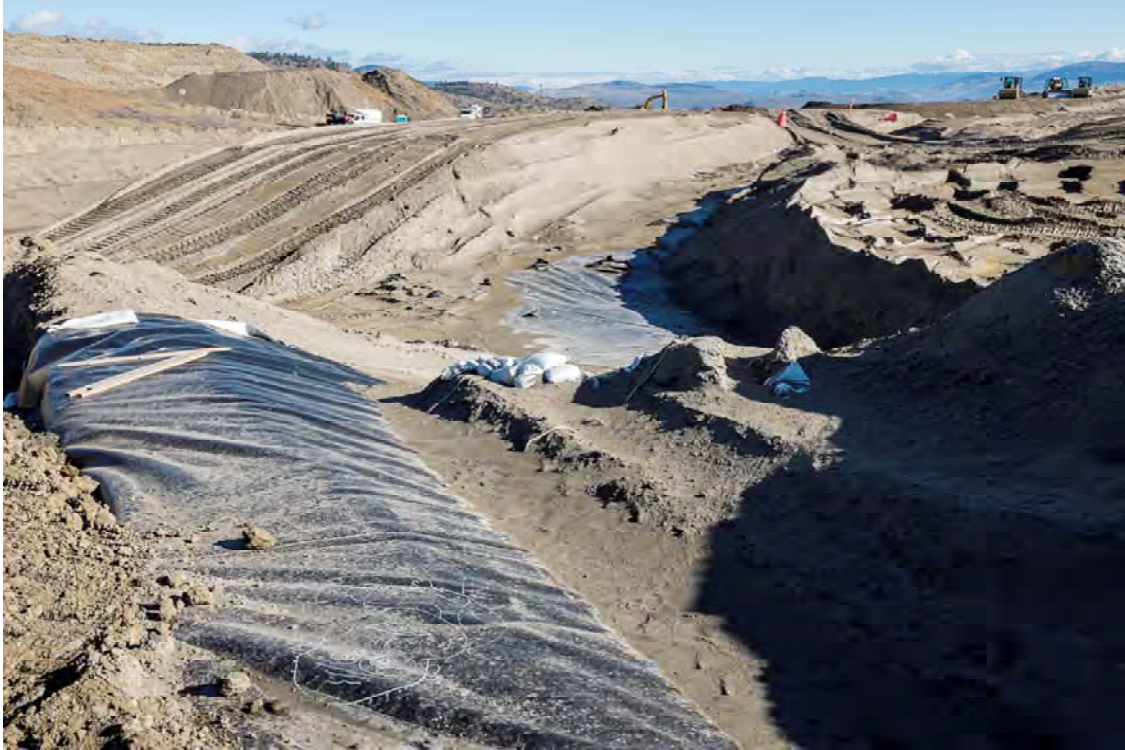
Photo DB20: View looking south at exposed liner on Dam B crest near right abutment. Note damage to liner caused by excavation to expose liner in the process of being repaired in anticipation of liner raise.

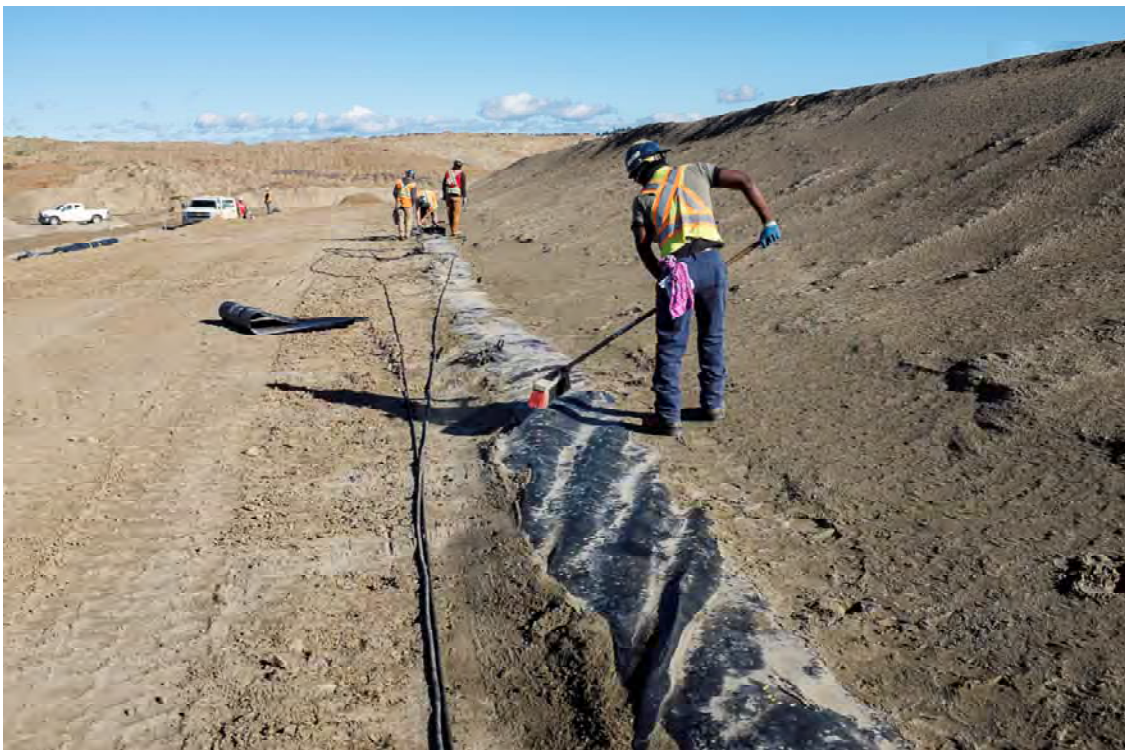
Photo DB21: View looking northeast at exposed liner at right abutment of Dam B and left abutment of Dam C. Note damage to liner caused during excavation to expose liner to be repaired.

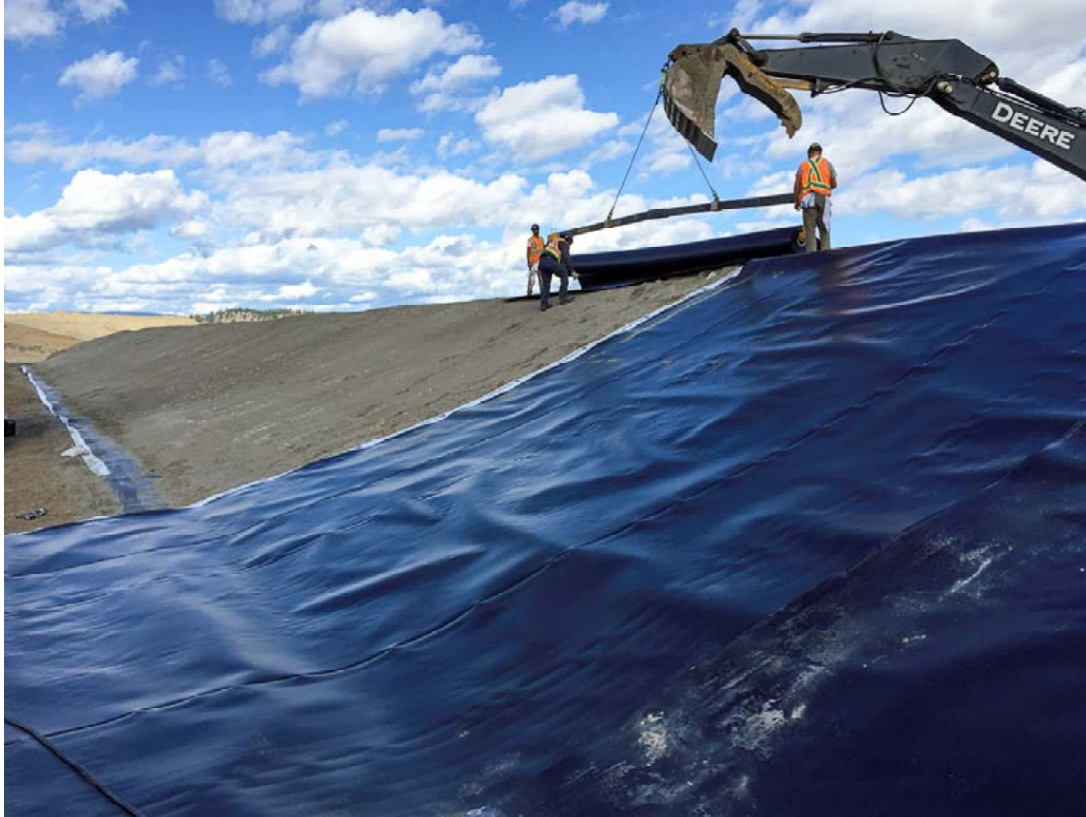
Photo DB22: View looking north at exposed liner being cleaned and repaired in anticipation of liner raise. At approximately sta. 1+375 m on Dam B crest.

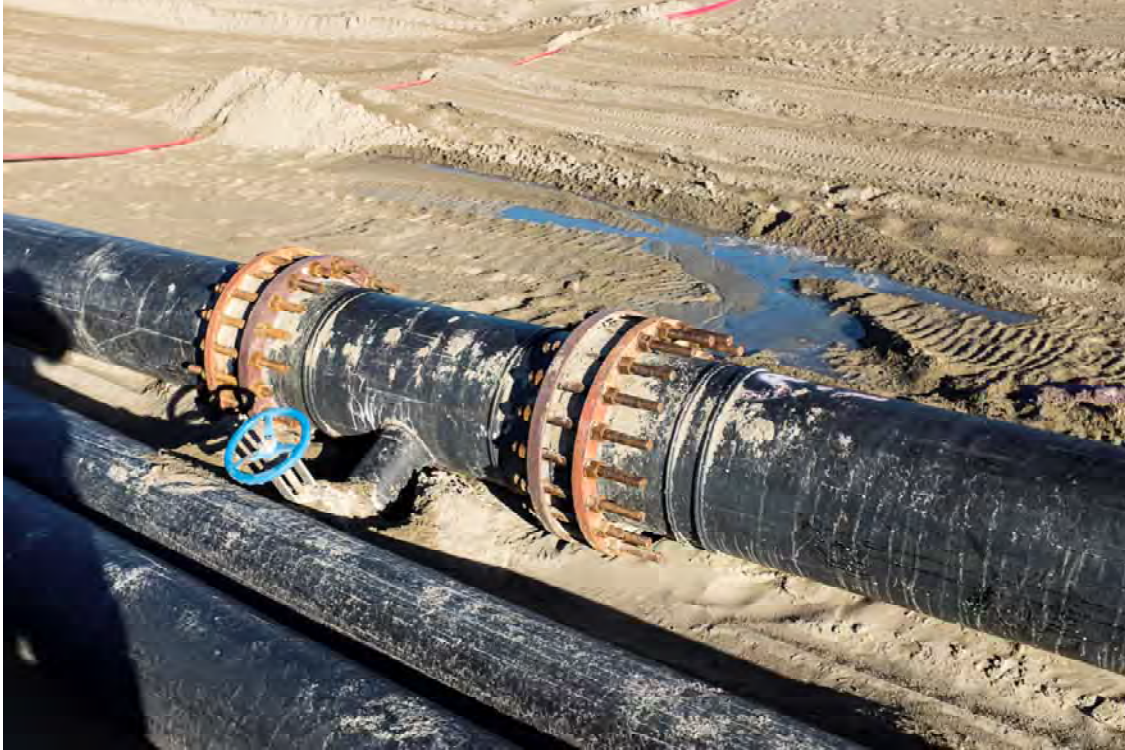
Photo DC08: View of spigot 4 on Dam C looking northwest. Note leaking connection at valve.

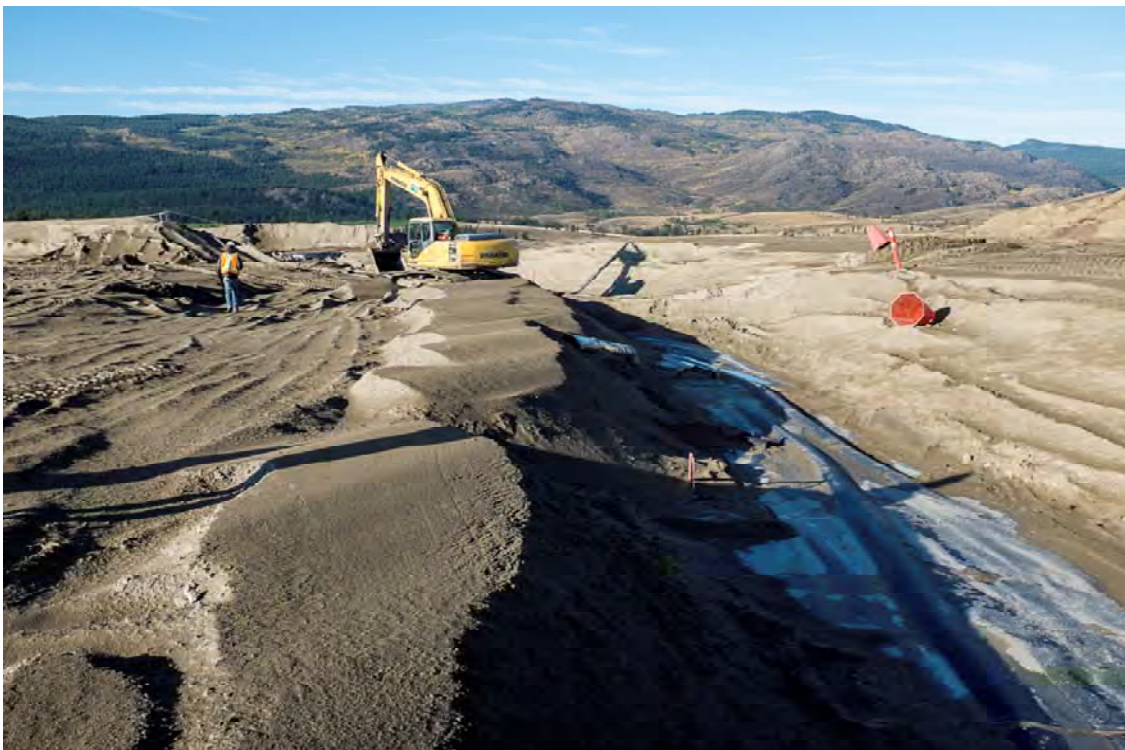
Photo DC13: View of excavation of hydraulically placed sand for use in Dam C construction looking east. Note sand cell decant pipe visible on middle right of photo.

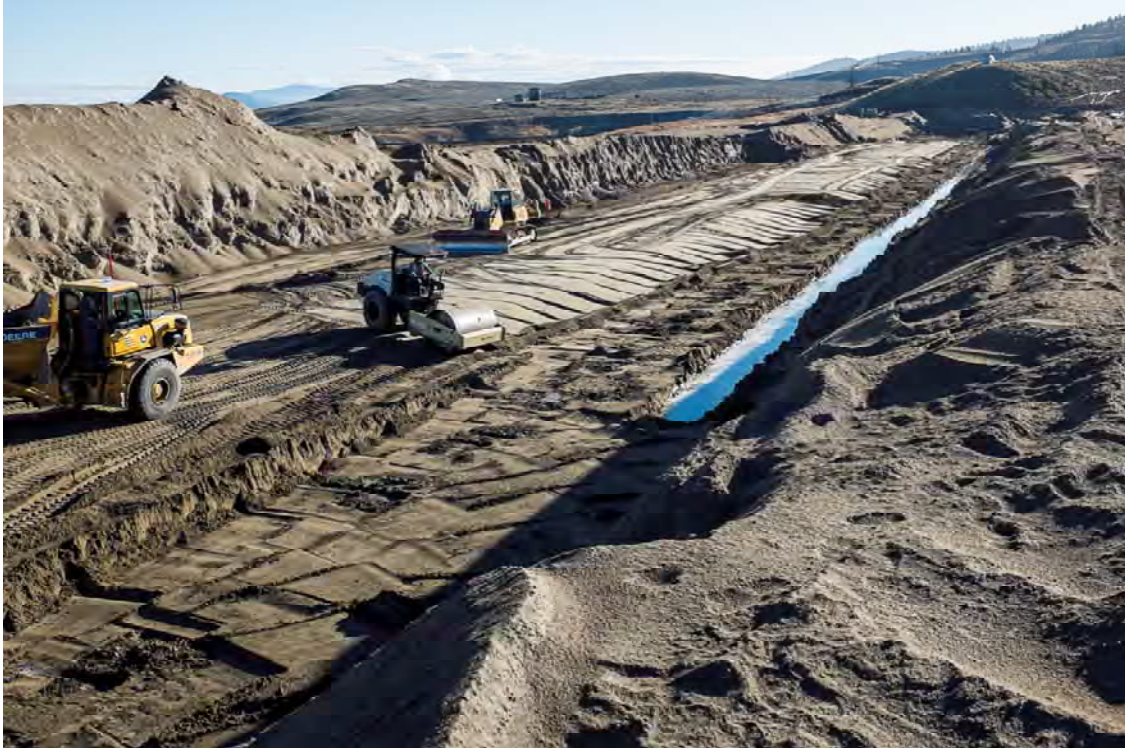
Photo DC14: View of LLDPE liner exposed near left abutment of Dam C looking west. Note tears in liner from excavation and exposure of liner. All damage to liner upstream of seamed liner raise to be repaired.

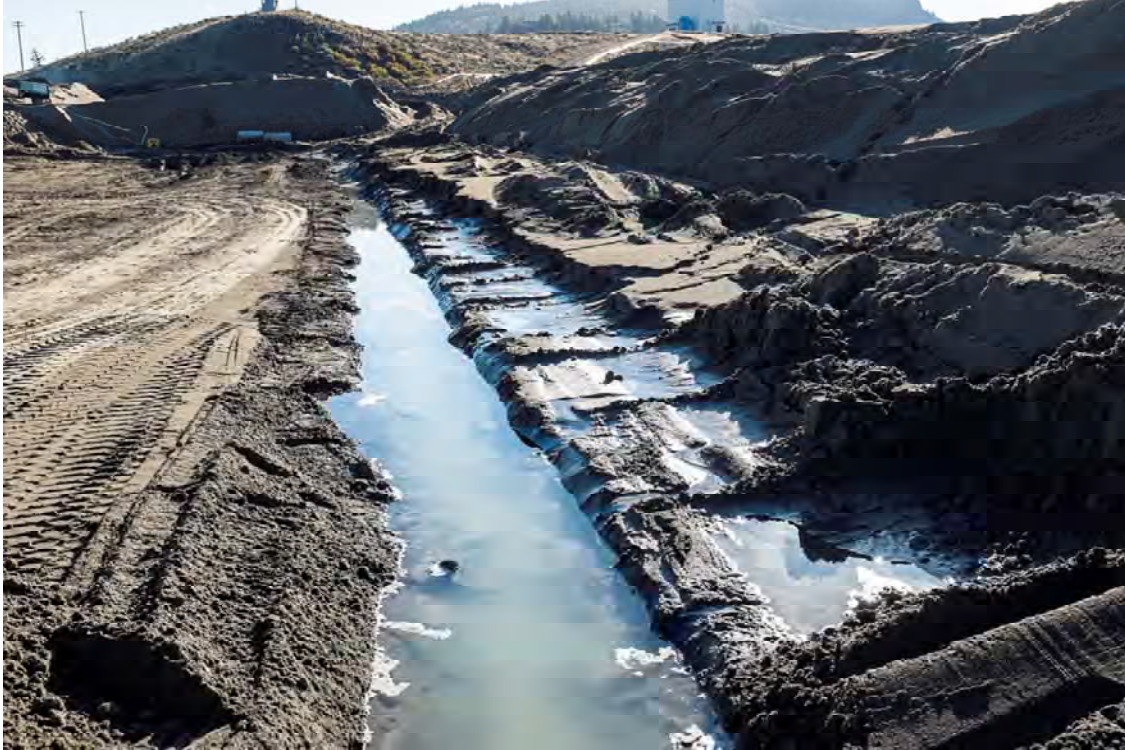
Photo DC18: View looking south at tear in liner adjacent to anchor trench at approximately sta. 0+500 m. Damage done during liner exposure to be repaired if upstream of seaming to liner raise.

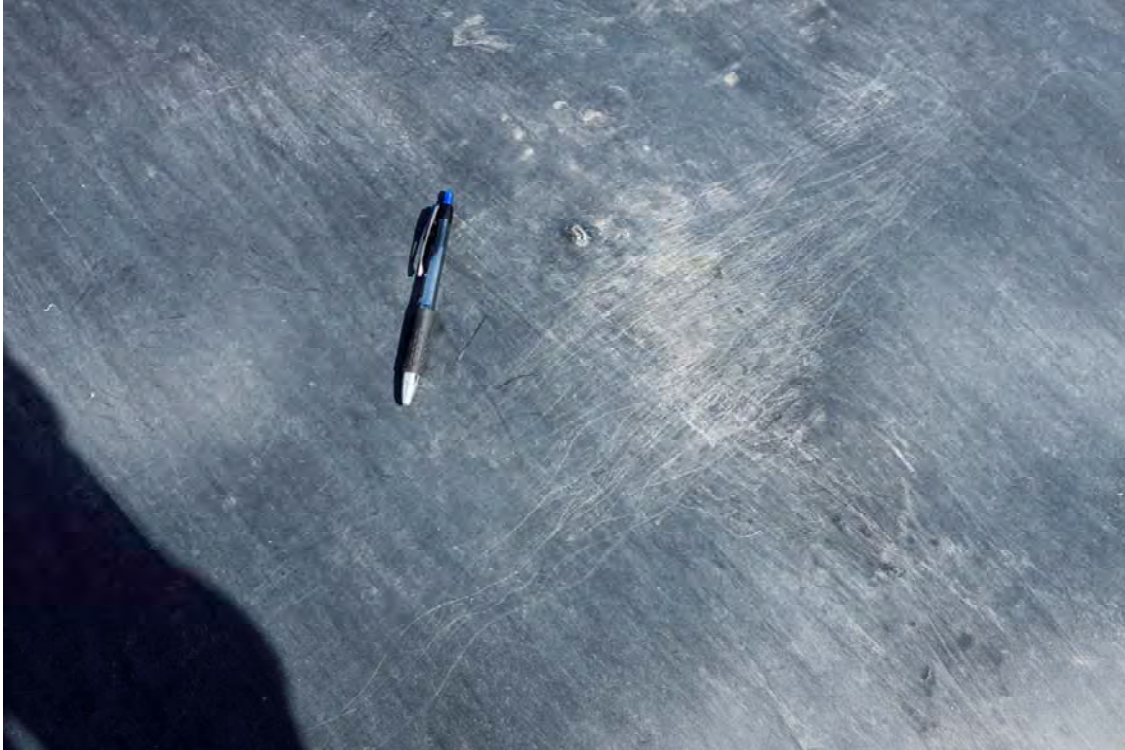
Photo PD05: View of abraision and liner bedding protrusion damage on the liner on Pothook Dam at the downstream toe one third of the way between the right abutment and the first dogleg of the dam.

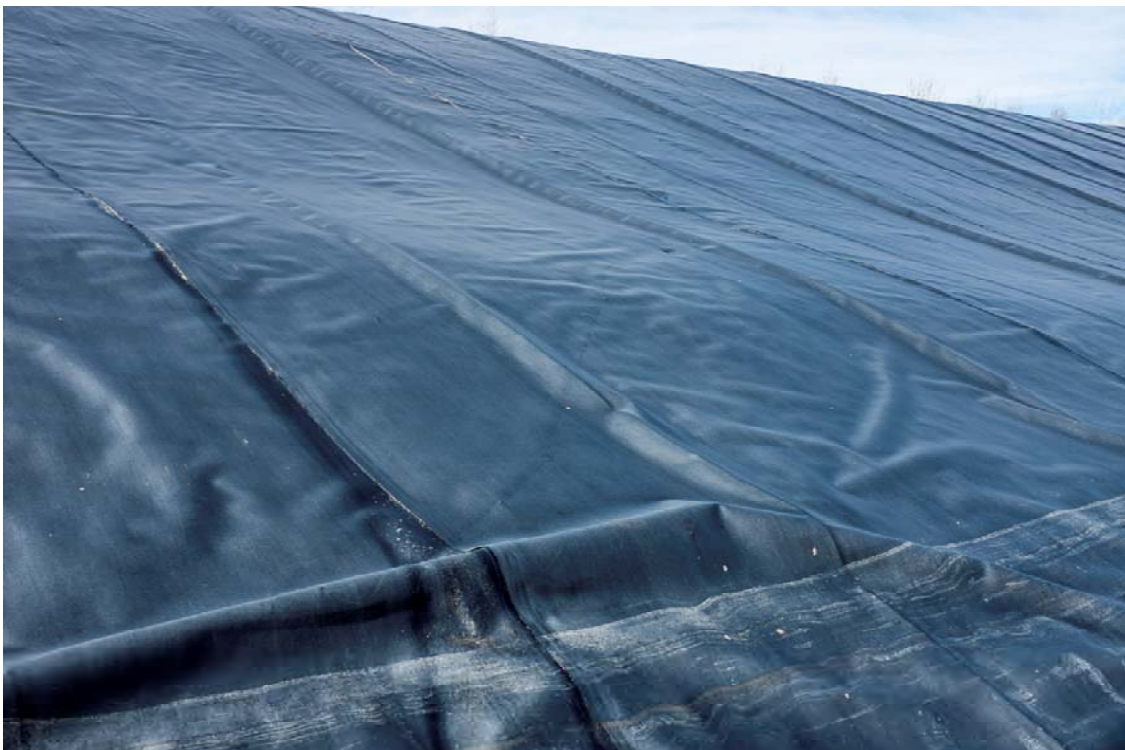
Photo PD08: View of punctures and abrasion damage on the upstream face of the Pothook Dam mid-way between the first dogleg and the tailings pipeline ramp.

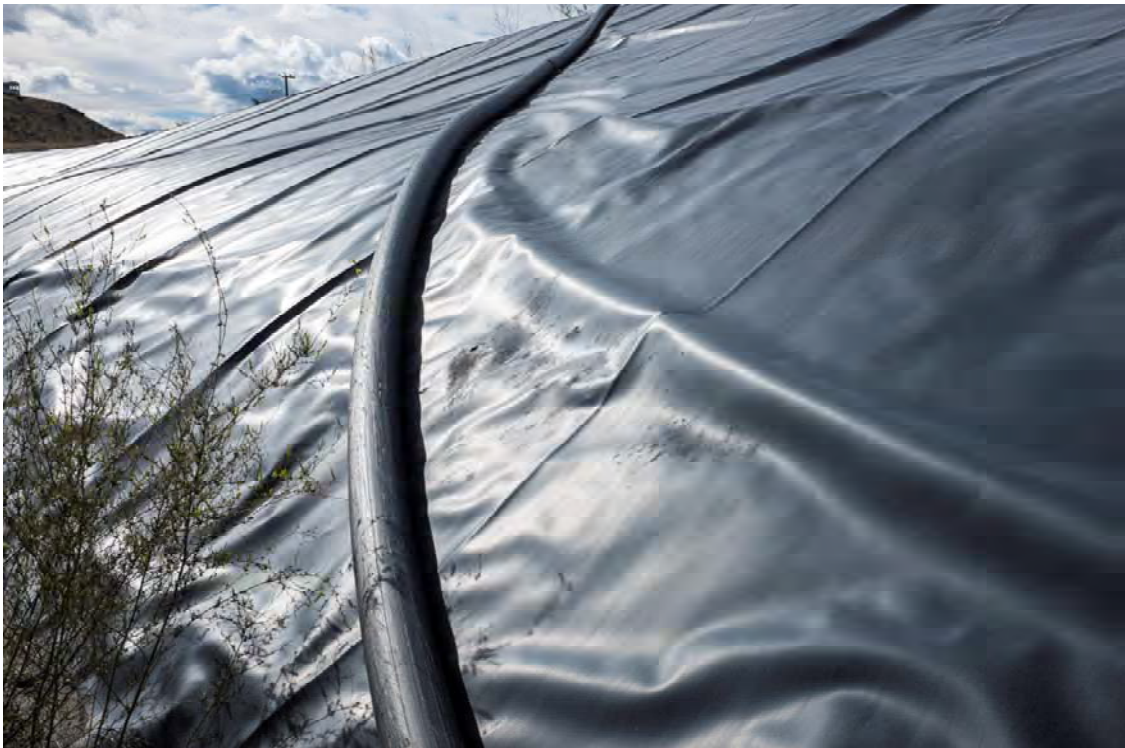
Photo PD10: View of abrasion damage and punctures in liner on upstream face of the Pothook Dam due to a waterline draped over liner south of the tailings pipeline ramp.

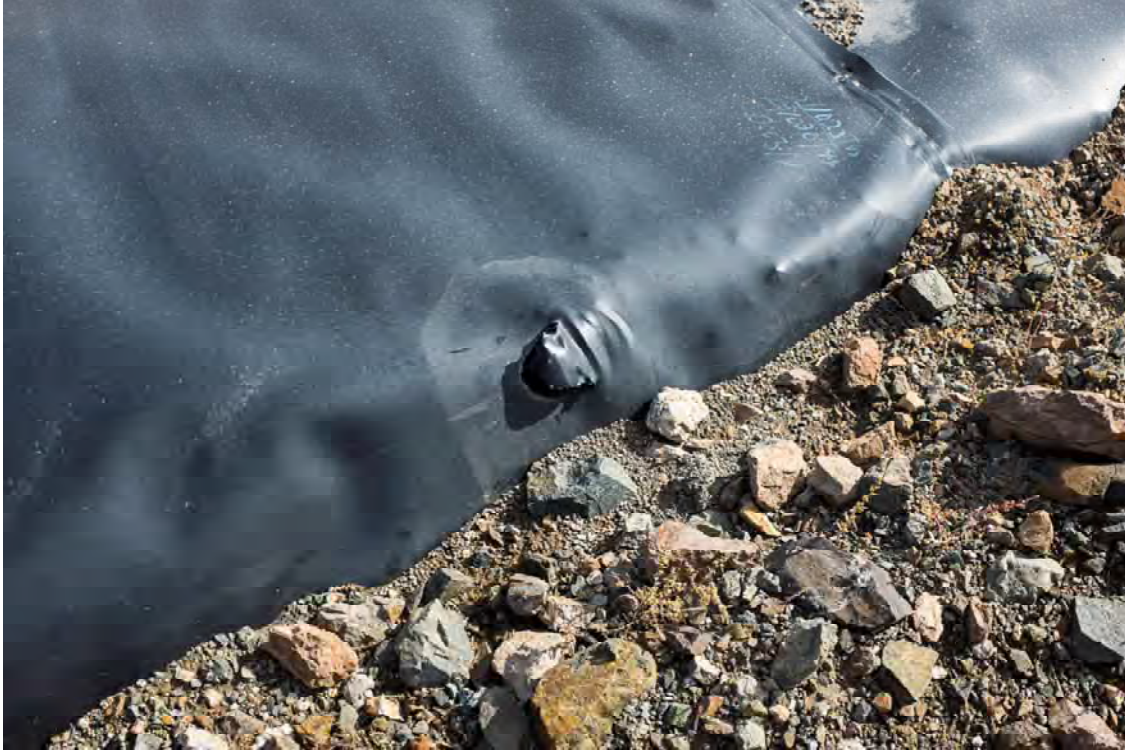
Photo PD23: Note tear in liner at anchor trench just north of the tailings pipeline ramp. Defect identified for repair in 2013 annual inspection report.

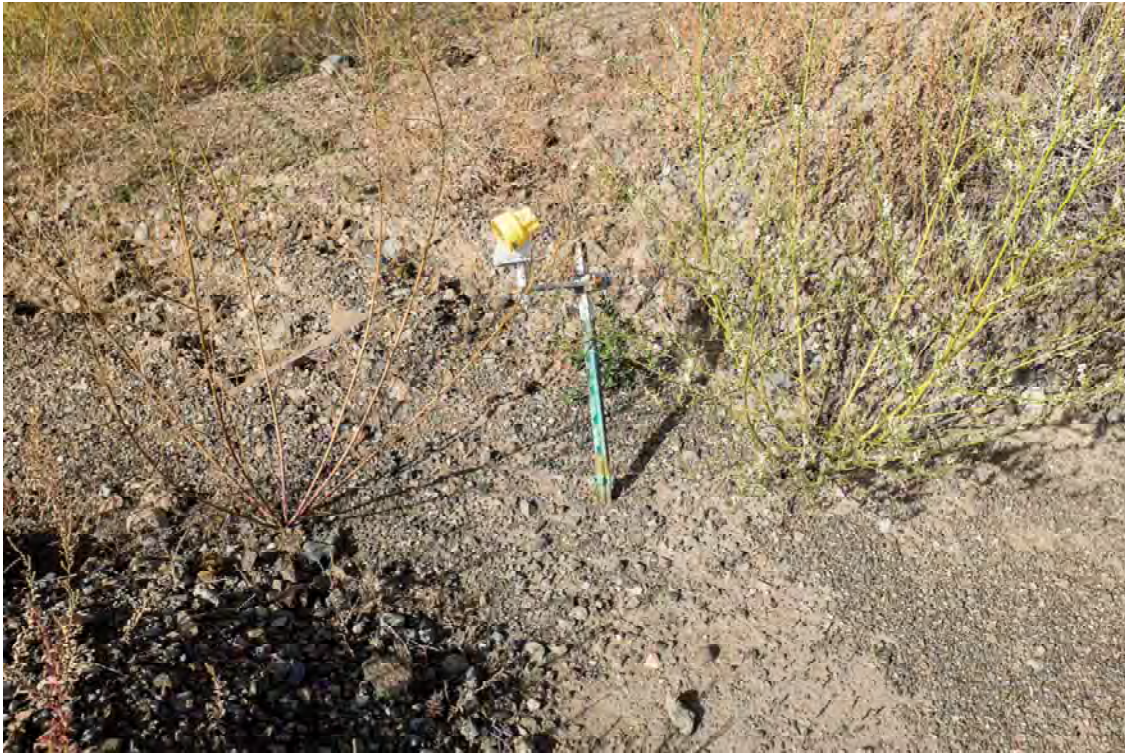
Photo PD25: View of damaged survey prism at the downstream crest of Pothook Dam at the first dogleg.

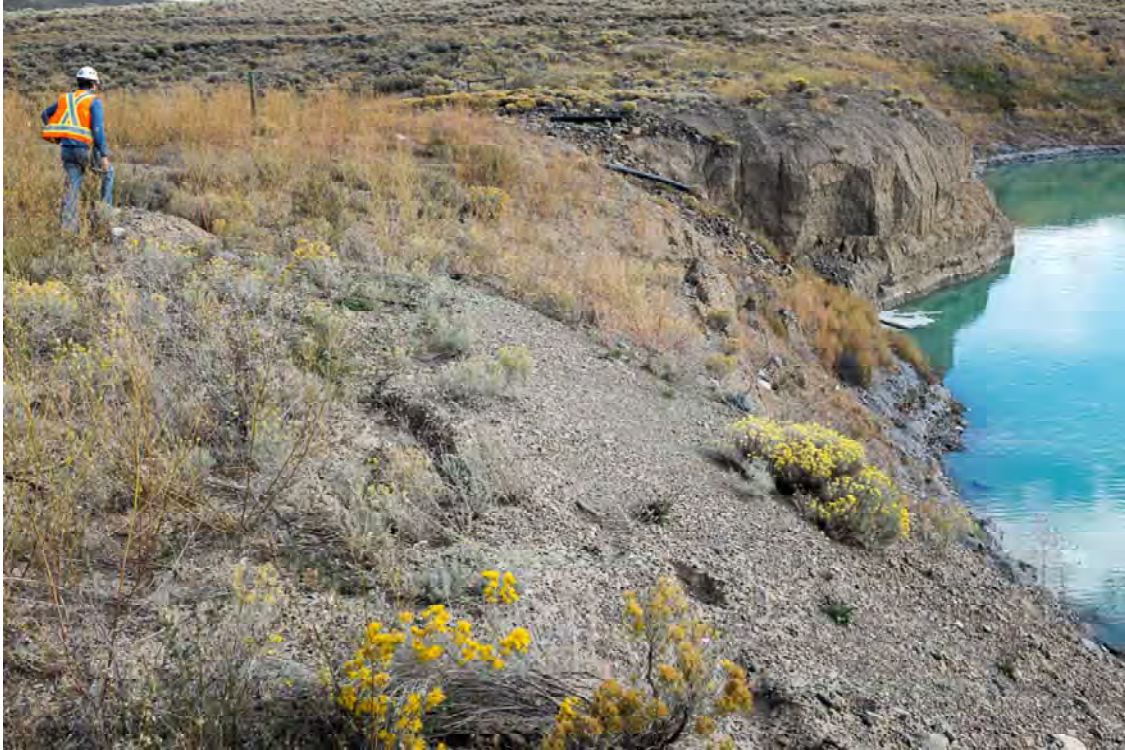
Photo PD35: View of scarps and tension cracks in till along the north rim of Pothook Pit adjacent to the Emergency Spillway looking east

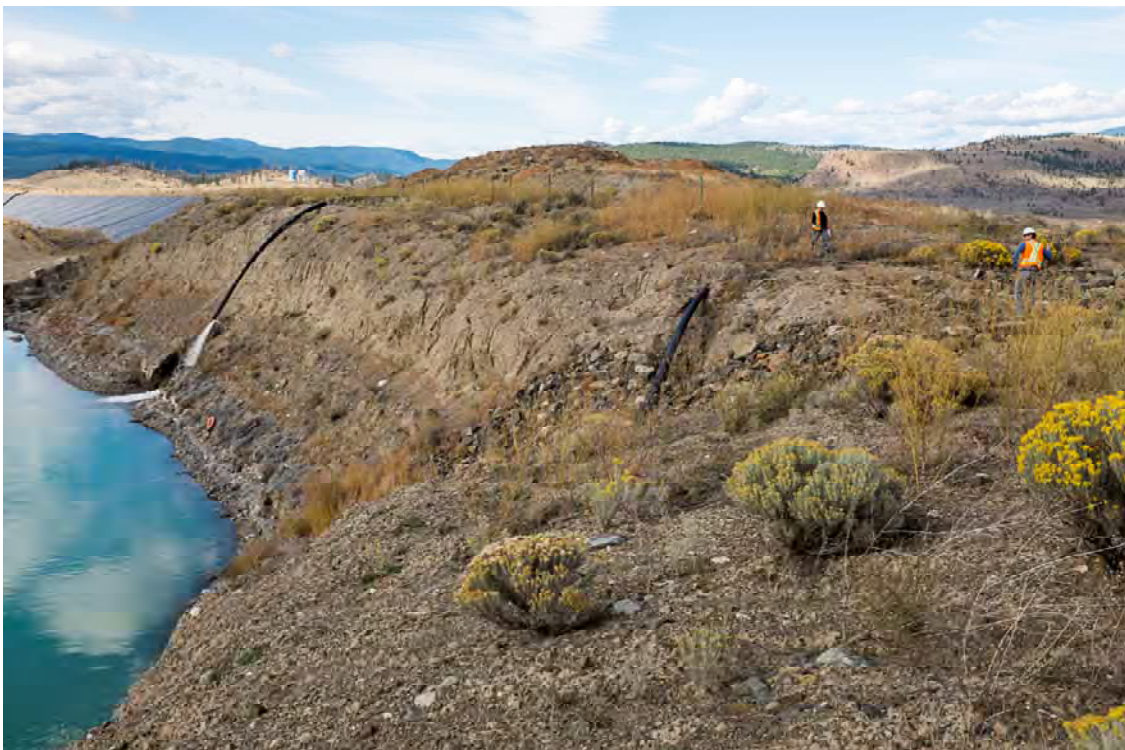
Photo PD36: View of tension cracks in the upper till unit along the north rim of Pothook Pit adjacent to the Emergency Spillway looking west

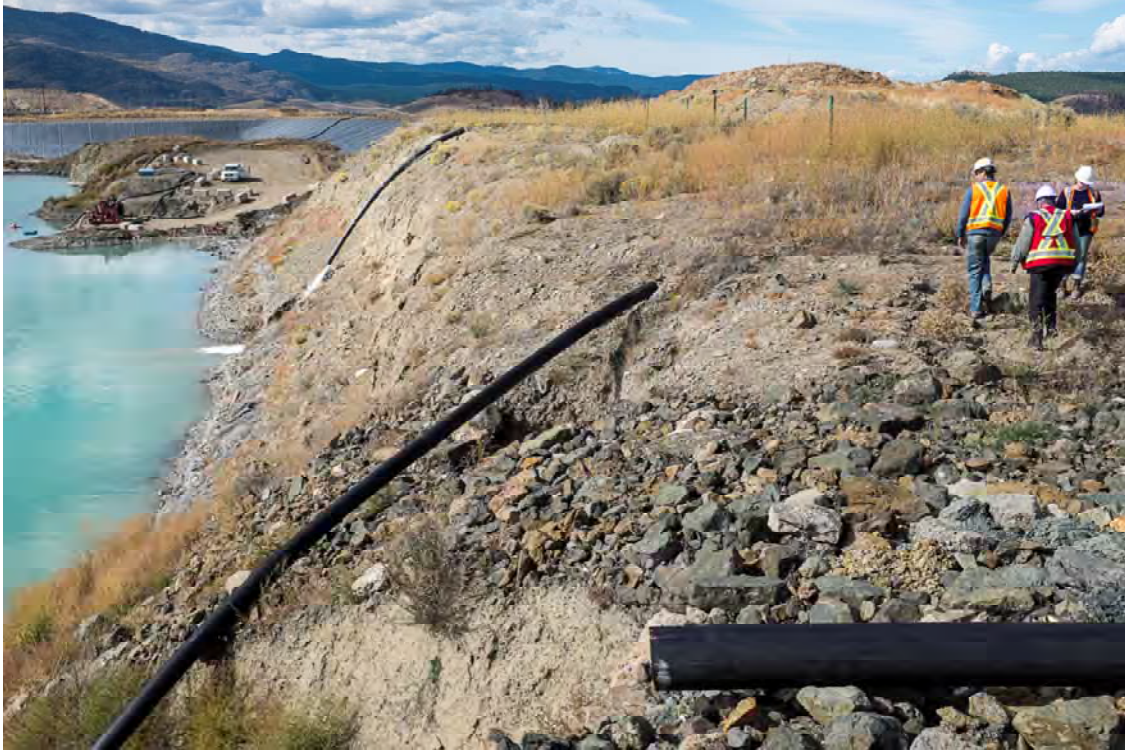
Photo PD37: View of tension cracks in the upper till unit along the north rim of Pothook Pit from the inlet to the Emergency Spillway looking west

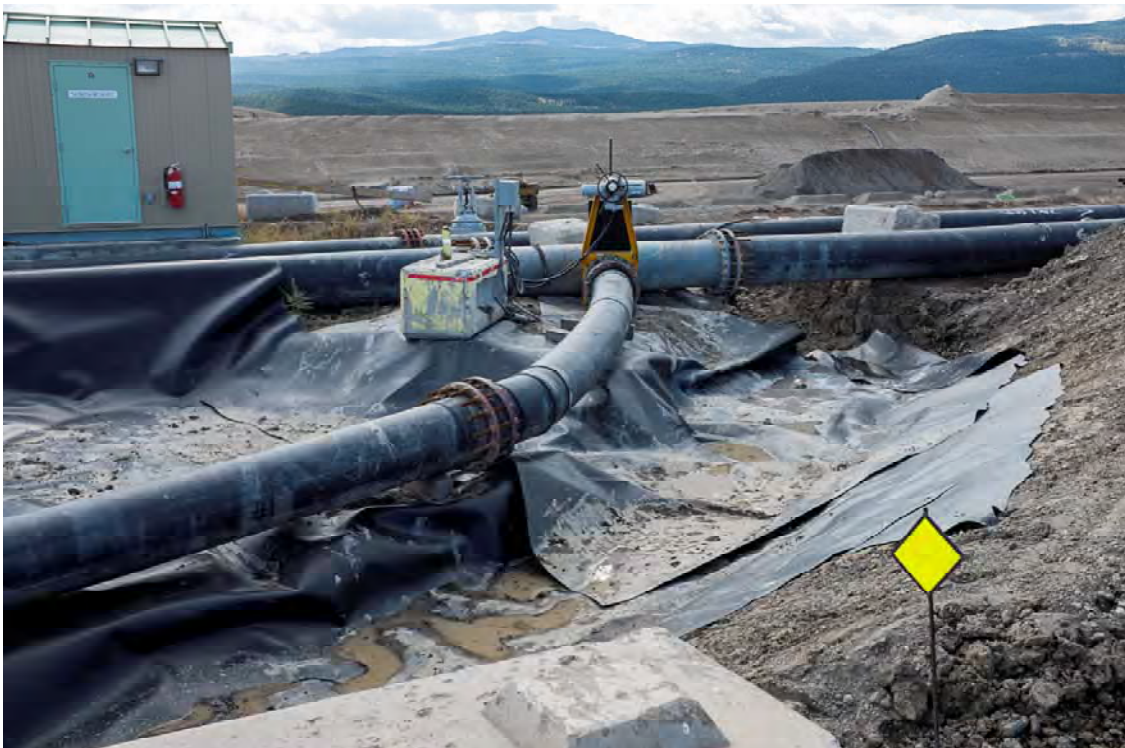
Photo TL02: View looking south at valve and liner placed and yet to be seamed to contain and direct potential spills to Seepage Pond 3. Location of previous valve leak.

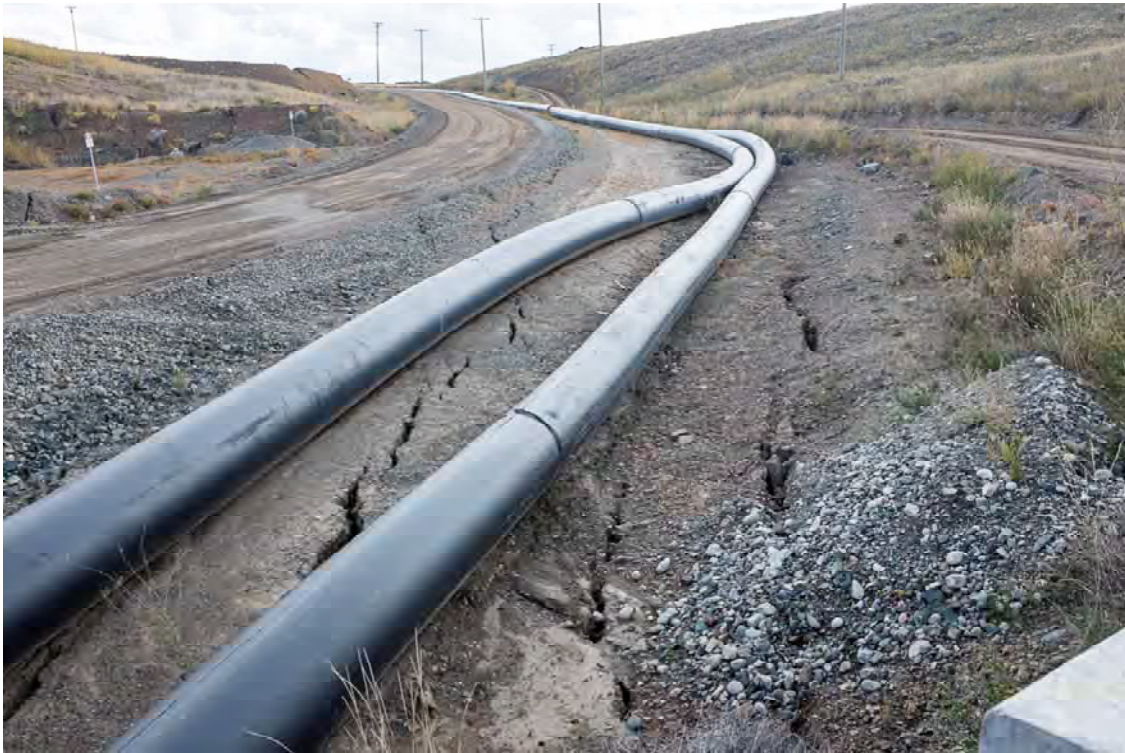
Photo TL03: View looking east at cracking from block cave subsidence along road to tailings facility just upstream of turn-off to Teck TSF. Cracking more pronounced than previous year.

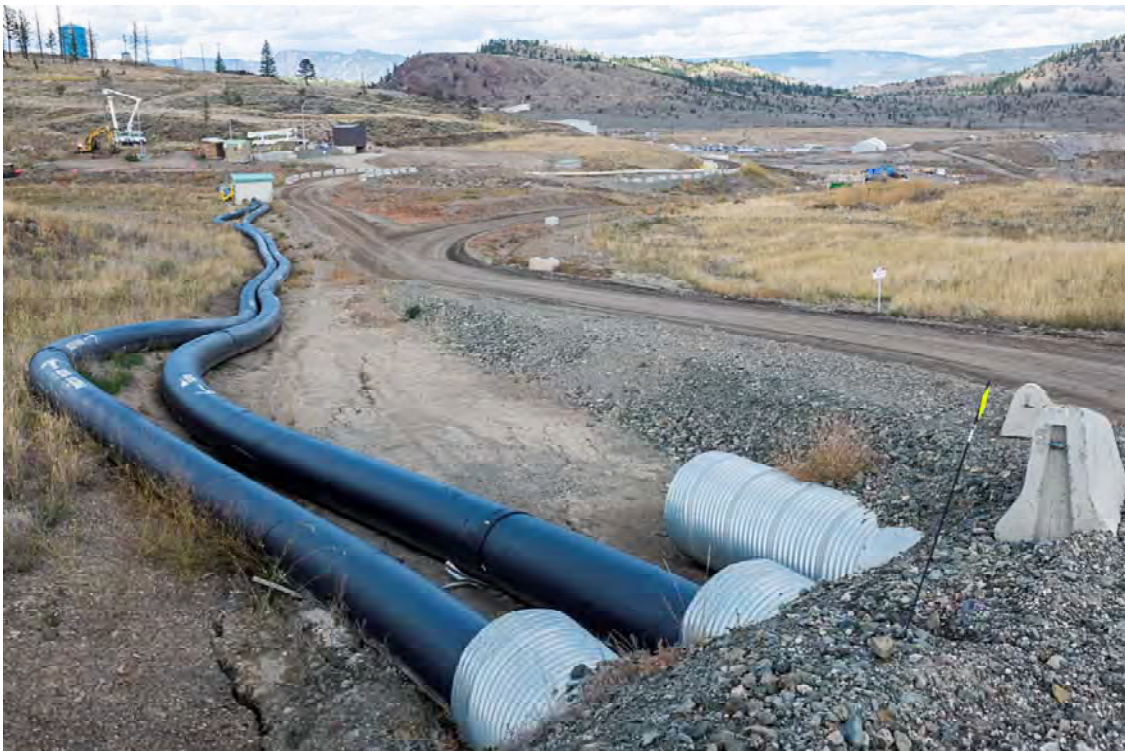
Photo TL04: View of cracking on tailings line right of way on road to TSF just upstream of turn-off to Teck TSF. Note transition from HDPE to steel pipeline in background. Note crew straightening power poles in background left of photo.

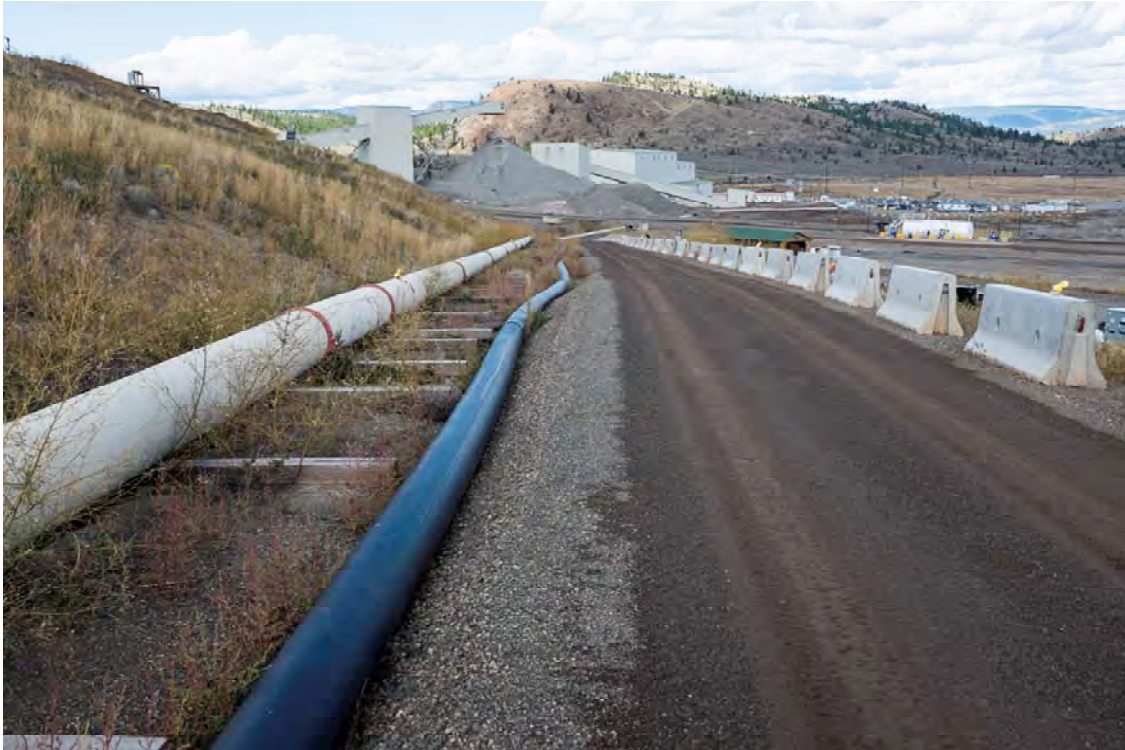
Photo TL05: View of steel tailings line just upslope of mill. Note survey prisms strapped to tailings line. In some locations along line, cribbing used to elevate line where subsidence has occurred along right of way.

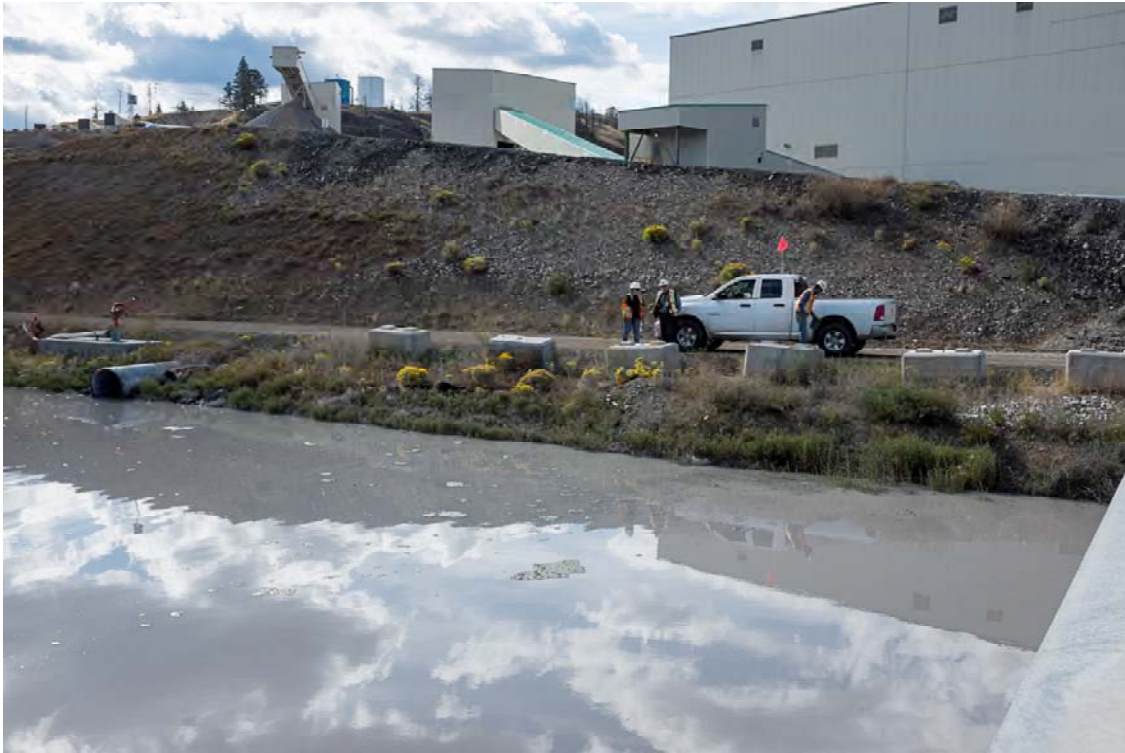
Photo TL09: View of Spill Pond adjacent to mill. Note water level relative to inlet culverts and algae rafts.
