November 26, 2014

INDEPENDENT REVIEW OF 2014 DAM SAFETY INSPECTION REPORT

Nickel Plate Tailings Dams

Reference Number: 1412161-005-Rev0-3000

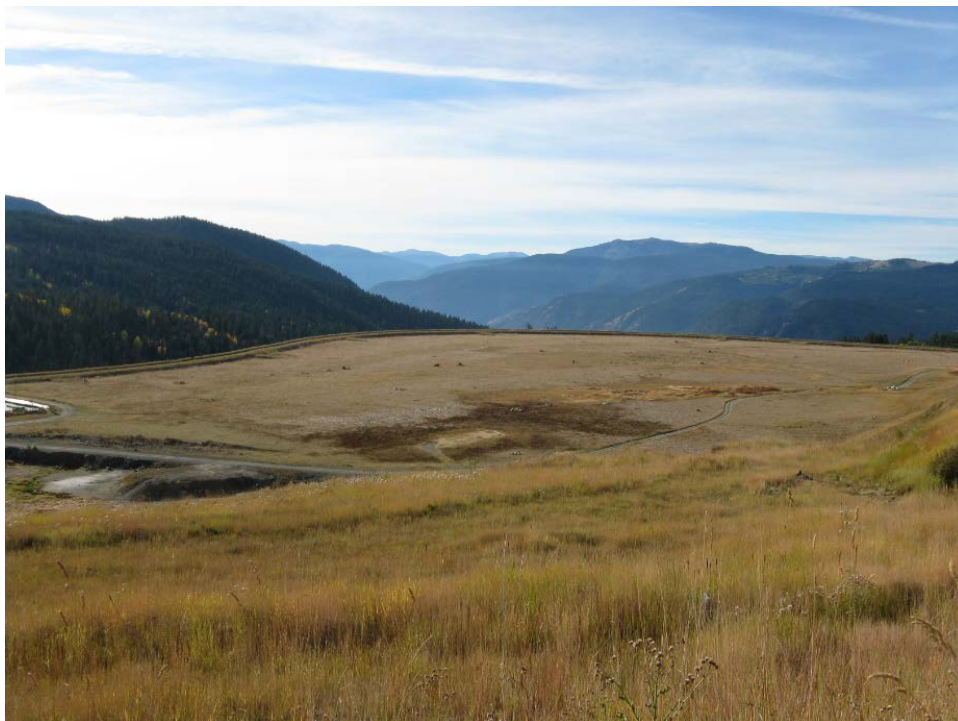
The Nickel Plate mine was an open pit and underground operation located 3 km northeast of Hedley in southern British Columbia. The mine was located at the south end of the Thompson Plateau. The main tailings pond and dam and the contingency ponds are shown in Photographs 1 and 2 in Appendix A.

Photograph 1: Overview of Tailings Facility, October 9, 2014

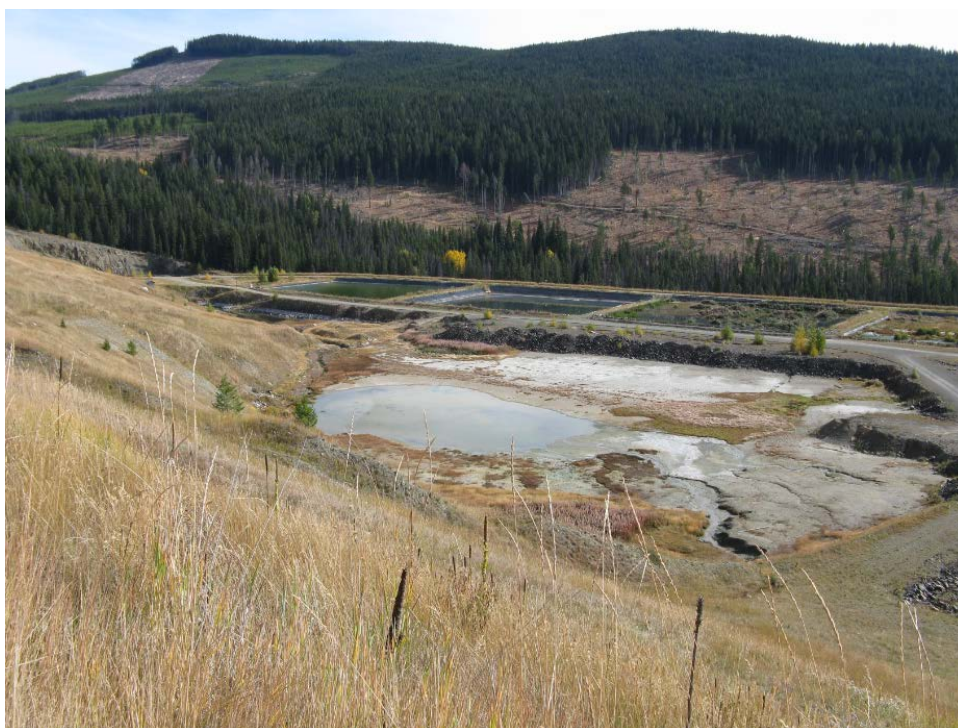
- The downstream slope of the Tailings Embankment appears to be dry and there was no indication of any 'wet' areas noted from the previous DSI.
- The lined ponds on the north end of the tailings facility appear to be in good condition, and functioning as designed.

Photograph 2: Lined Pond and Contingency Pond at North End of Tailings Facility, October 9, 2014

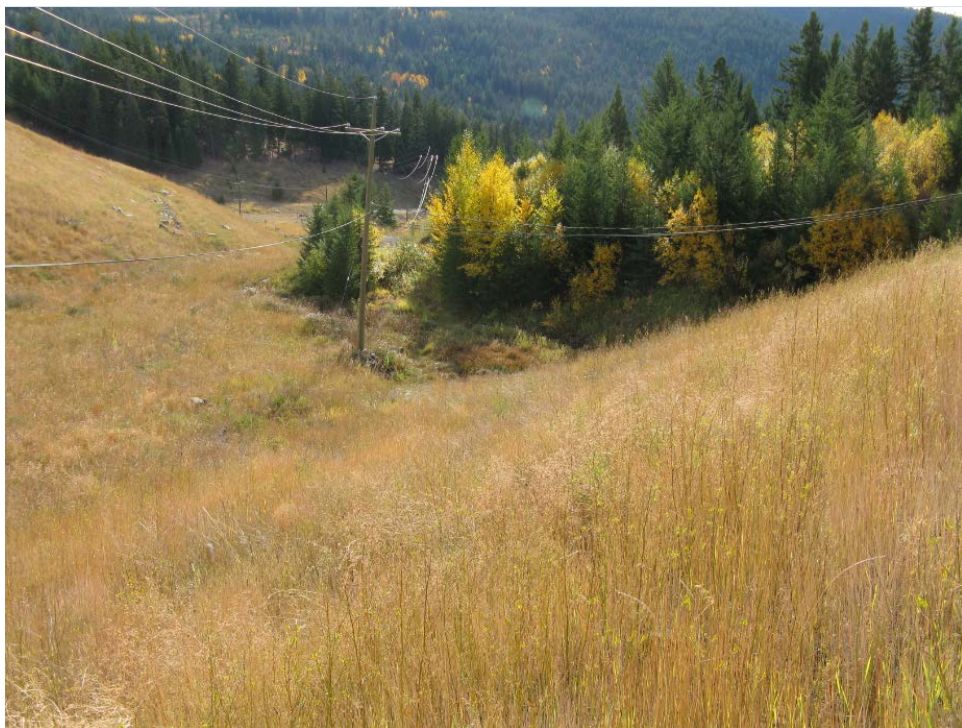
A possible dam break for the Freshwater Dam was also reviewed by EBA, as a failure of the Freshwater Dam would result in a failure of the west portion of the Tailings Embankment (Photograph 3 in Appendix A). The review indicated that the Freshwater Dam should be classified as a Very High consequence dam. The 2014 DSI references the dam break evaluation (EBA 2013) and the dam classification proposed by KP agrees with the dam break report (KP 2014).

Photograph 3: Toe of Freshwater Dam Adjacent to Tailings Facility, October 9, 2014

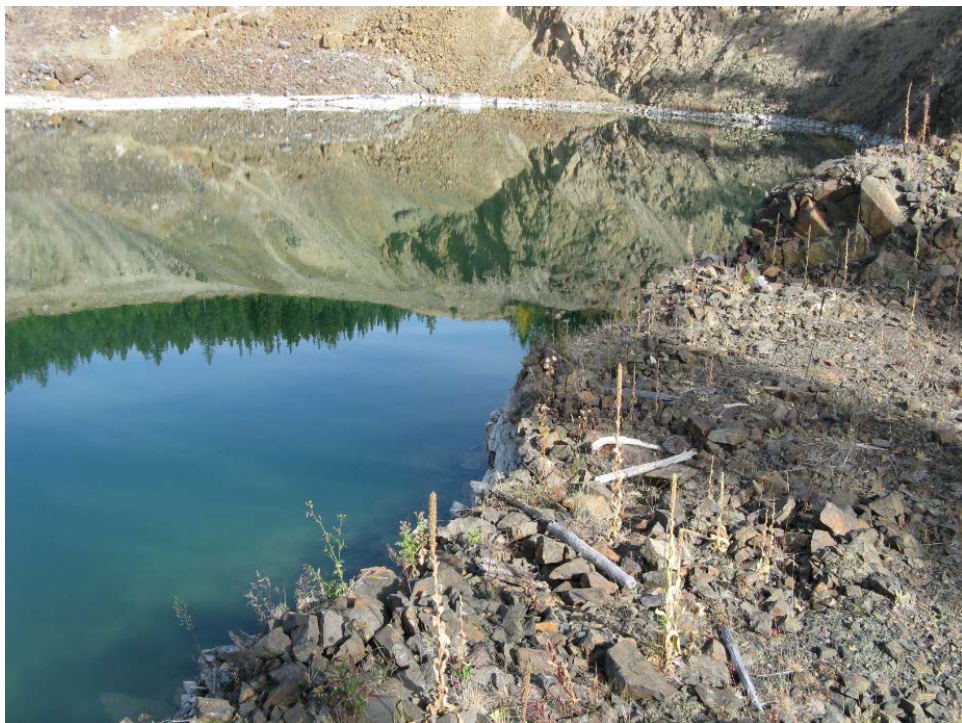
- The spillway channel to the Sediment Pond is clear and there are no concerns with managing flows from the tailings pond area (Photograph 4 in Appendix A).

Photograph 4: Contingency Pond Spillway, October 9, 2014

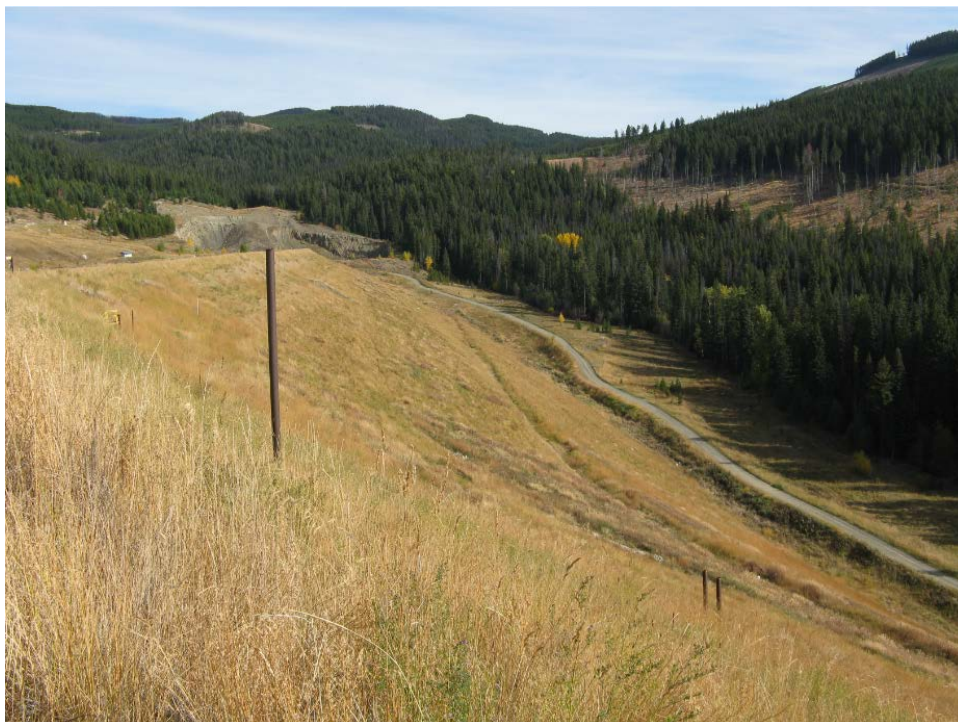
- The downstream slope of Tailings Embankment is in good shape and no cracking, settlement or movement of the downstream dam slope was noted (Photograph 5 in Appendix A). A half-round culvert on the downstream slope appears to be moving or has moved and should be re-anchored (Photograph 6 in Appendix A).

Photograph 5: Downstream Slope of Tailings Embankment, October 9, 2014

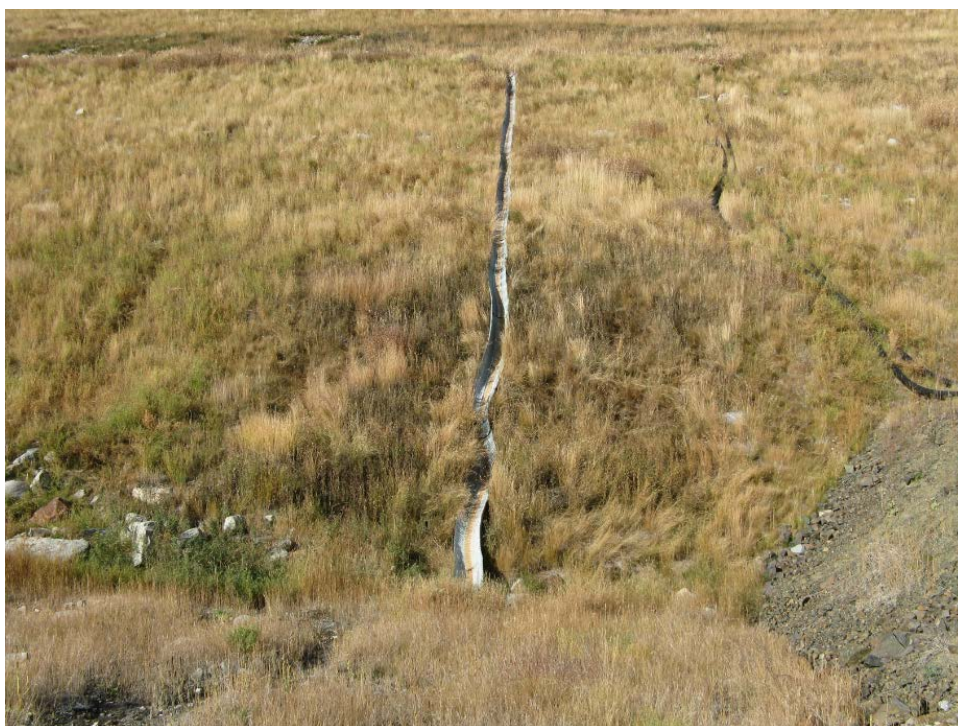
Photograph 6: Culvert On Tailings Embankment Slope, October 9, 2014
