**BARRICK GOLD INC.
NICKEL PLATE MINE**

2014 TAILINGS FACILITY ANNUAL REPORT

VA101-3/19-1
Rev 0
November 25, 2014

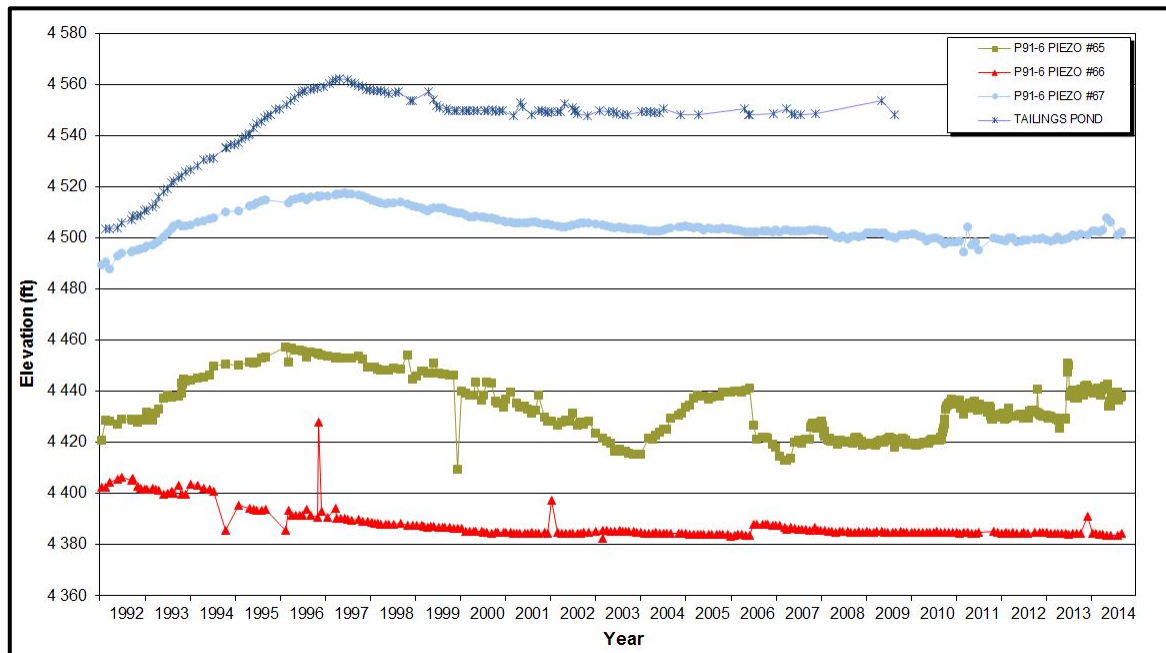
Figure 3.3 Embankment Piezometers P91-6

Similarly, piezometer P91-6-65 (located within the foundation till) has recorded relatively large increases and decreases in water level over the last decade. The piezometer level generally

remained at about El 4430 throughout 2012 and the first half of 2013, but increased to about El 4440 in late 2013, and into 2014 (see Figure 3.3). The recorded increases in piezometric level are not large enough to impact embankment stability, but this piezometer should continue to be closely monitored. The recorded variations in piezometric level are likely due to inaccurate measurements caused by standpipe blockage.

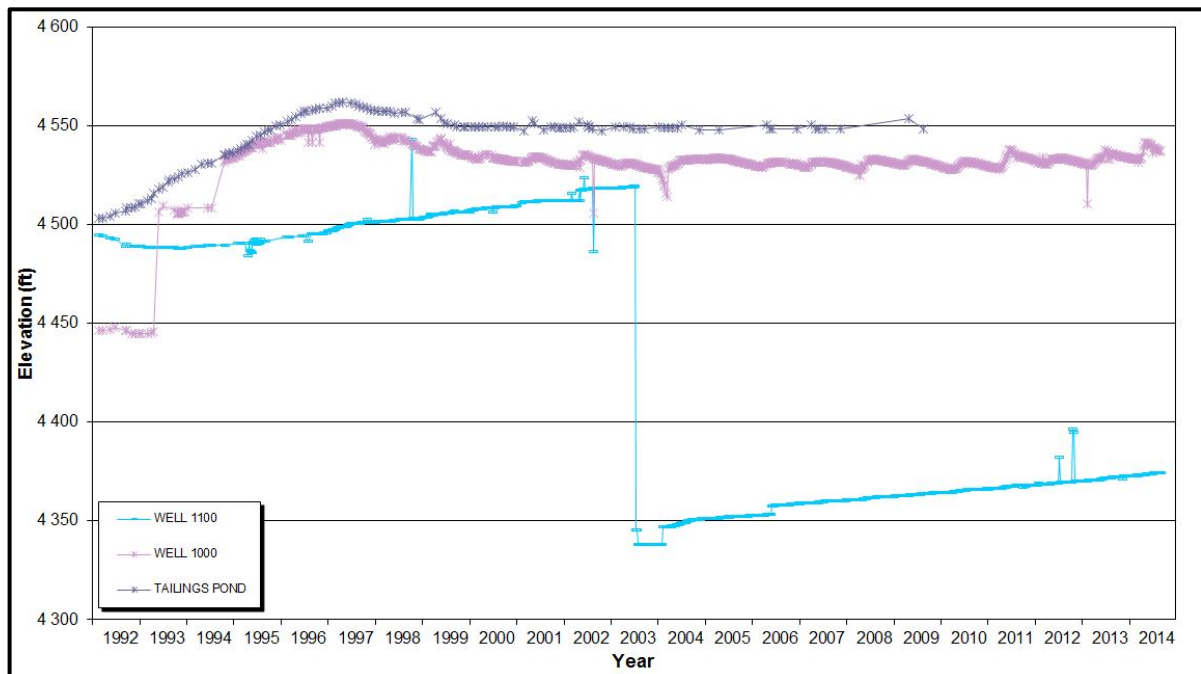
Figure 3.11 Embankment Piezometers W1000 and W1100

Data for Monitoring Well W1000 has remained reasonably stable over the last few years, with water levels typically fluctuating by less than 5 ft. Larger seasonal fluctuations were recorded in 2011 and similarly in 2013 and again in early 2014, likely for the same reason noted above for several of the embankment piezometers at Plane A and Plane B (generally higher than normal precipitation in recent years). Despite previous attempts to rehabilitate Well W1100, subsequent inspection of the well by Nickel Plate staff has indicated that it remains blocked, and that recorded water level data does not reflect actual piezometric conditions. Monitoring data for W1000 and W1100 are plotted on Figure 3.11.

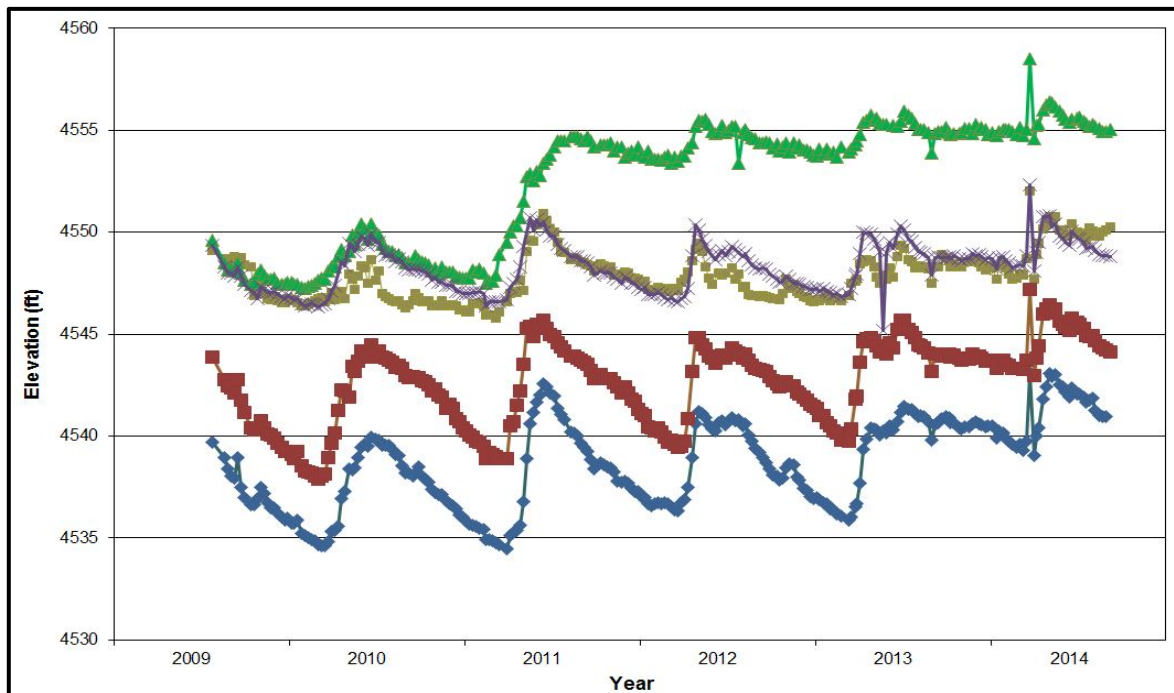
Figure 3.14 Tailings and Foundation Piezometer VP09

Additional vibrating wire piezometers (VP09-01A/B, VP09-02, VP09-03, VP09-04) were installed into the tailings deposit in 2009 by AMEC Earth and Environmental, as part of a hydrological assessment of the tailings facility. These piezometers are located farther from the embankment, as shown on Figure 3.1. Piezometer VP09-01A/B was completed as a nested piezometer with two vibrating wire piezometer instruments set at different depths within the same borehole. VP09-01A was set close to the base of the tailings deposit, and VP09-01B was set within the underlying sand-gravel foundation

soil. Recorded pore pressure measurements since 2009 suggest relatively stable water levels, with seasonal fluctuations of about 5 to 8 feet (see Figure 3.14). The seasonal fluctuations in water level are consistent with those observed at other piezometers within the tailings deposit and embankment over the same time period. However, it is noted that the recorded piezometric levels in 2013 did not exhibit the typical seasonal decline over the last half of the year. A seasonal increase and ongoing decline in levels has since occurred to date in 2014. The piezometric data is likely indicating that the seasonal increase in water levels within the tailings facility is taking longer to dissipate, due to higher than normal precipitation in 2013 accumulating within the facility. These piezometers need to be monitored closely during and following freshet in 2015.

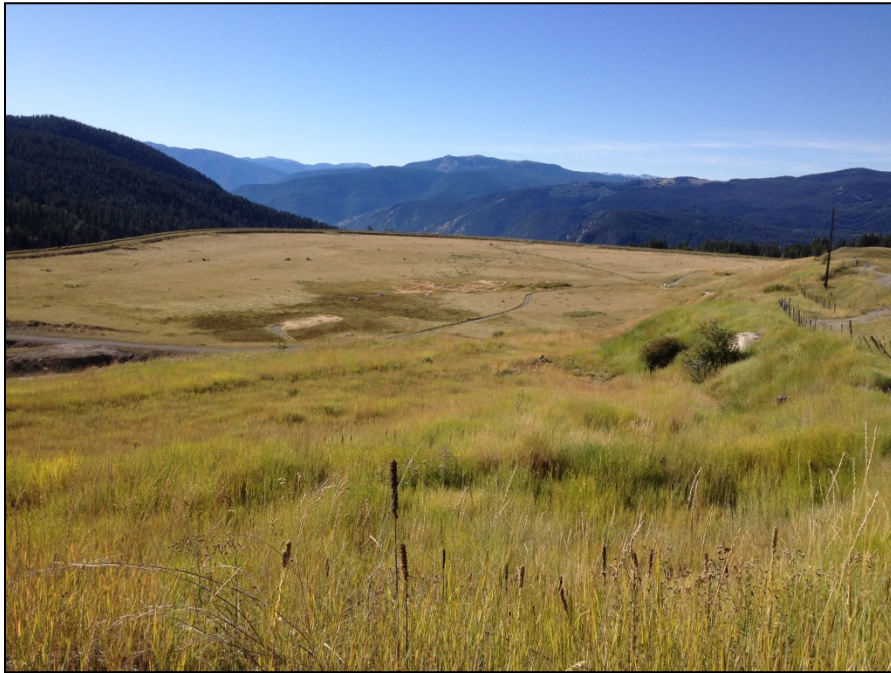
PHOTO 1 – Revegetated tailings cover, looking south.

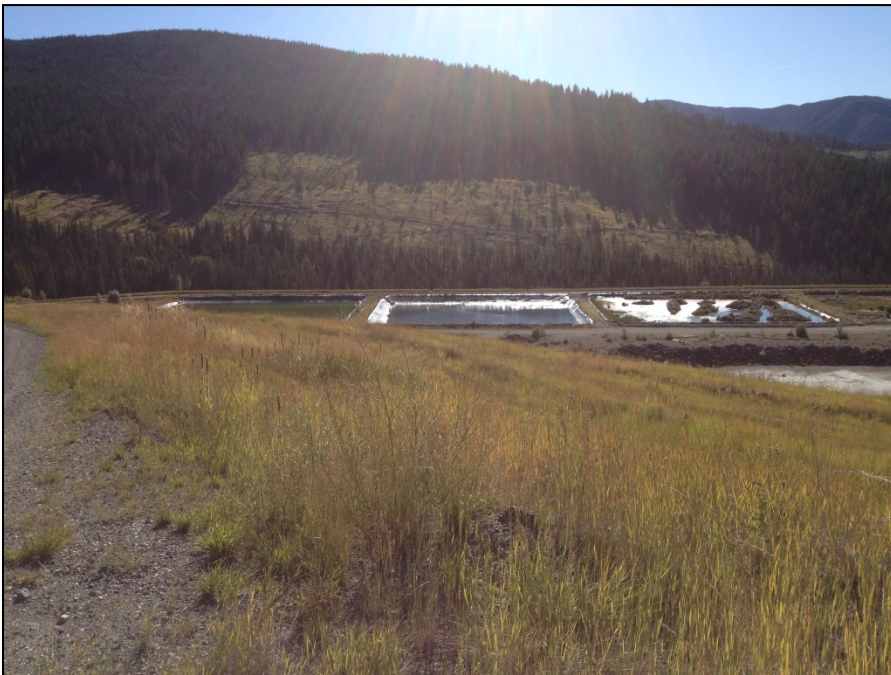
PHOTO 2 – Lined ponds on tailings surface (northeast end of facility).

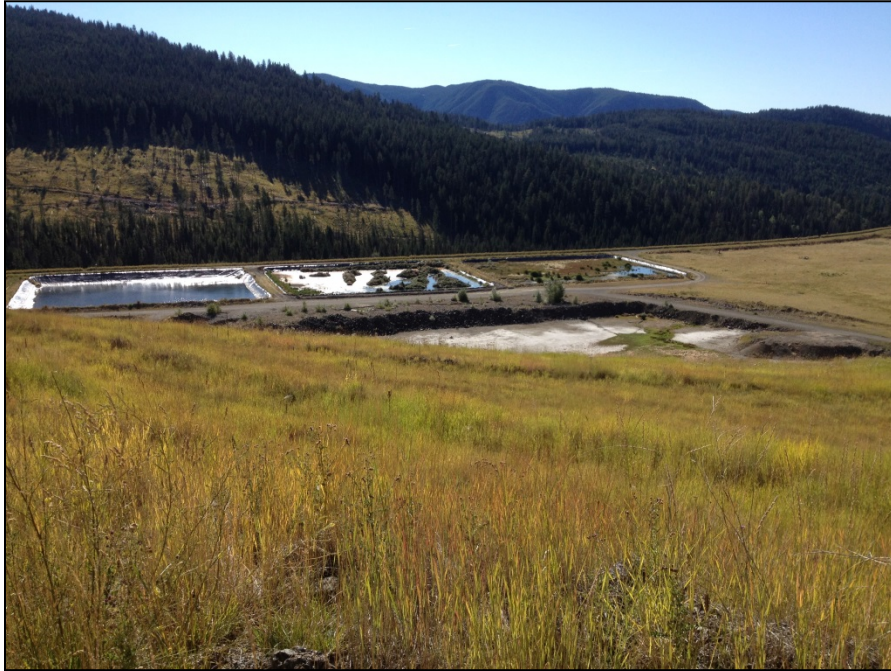
PHOTO 3 – Lined ponds (2 to 4) on tailings surface and small pond area.

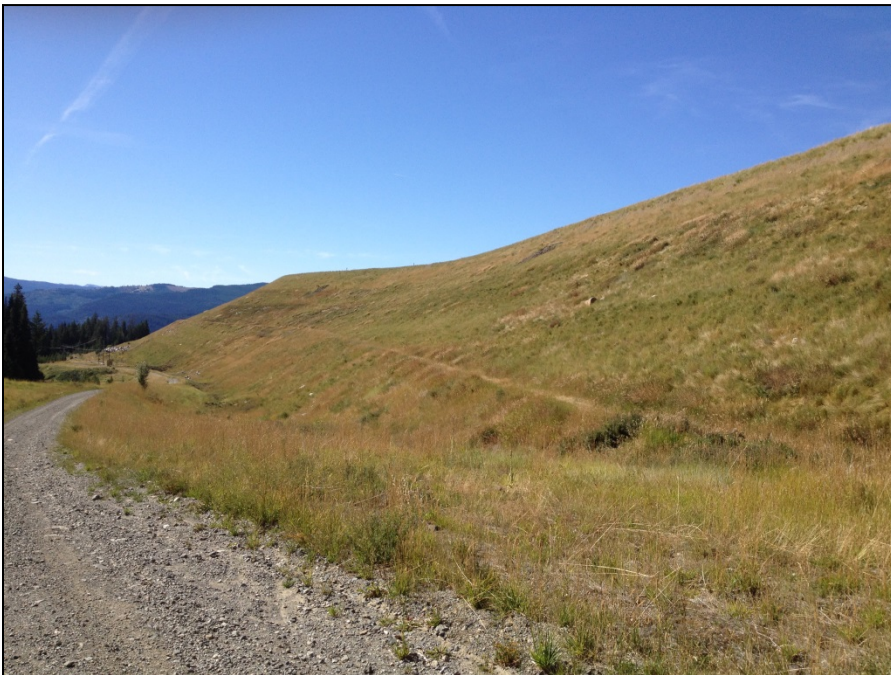
PHOTO 4 – Downstream embankment slope – East side of facility.

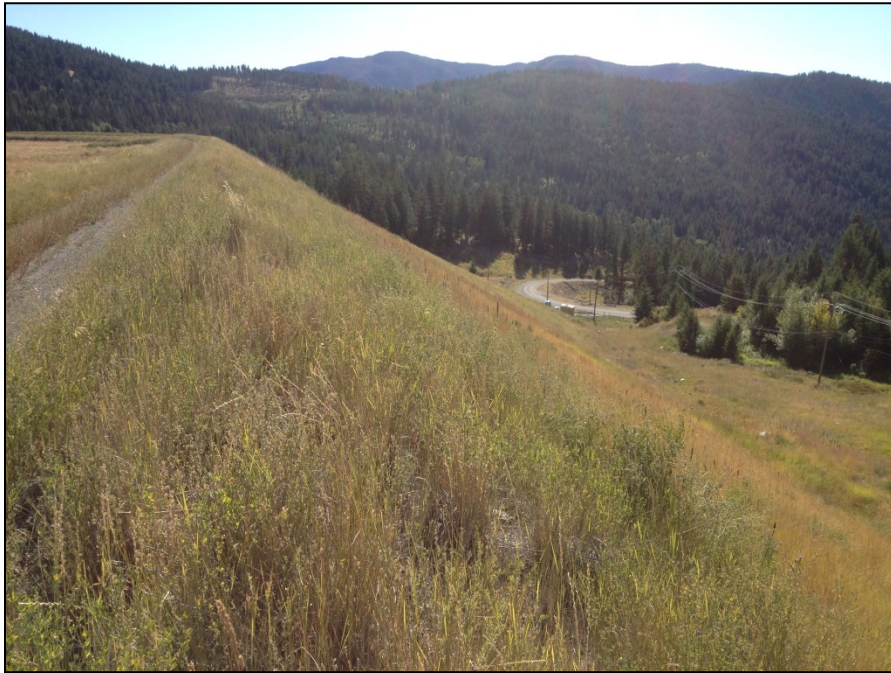
PHOTO 5 – Downstream embankment slope – South side of facility (looking east).

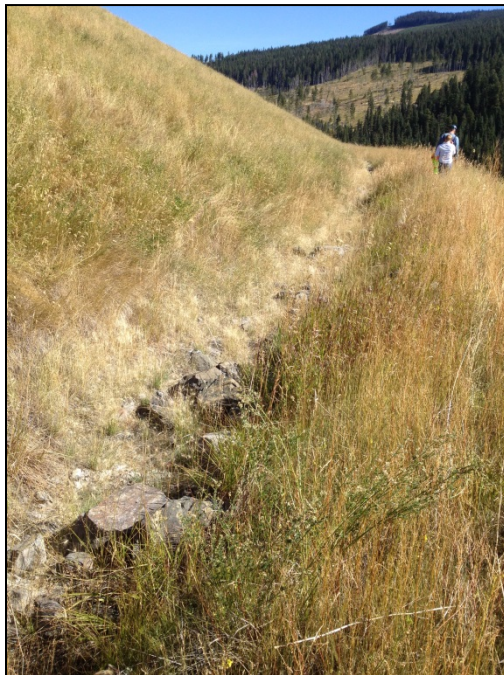
PHOTO 6 – Embankment bench area on downstream slope (eastern side).

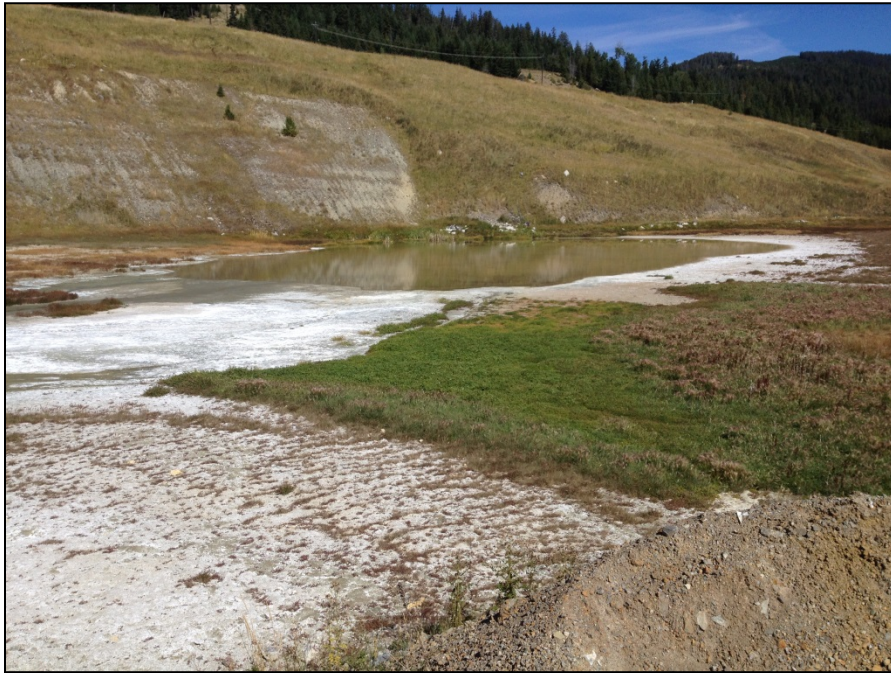
PHOTO 7 – Small pond area (uncapped) at northern corner of tailings facility.

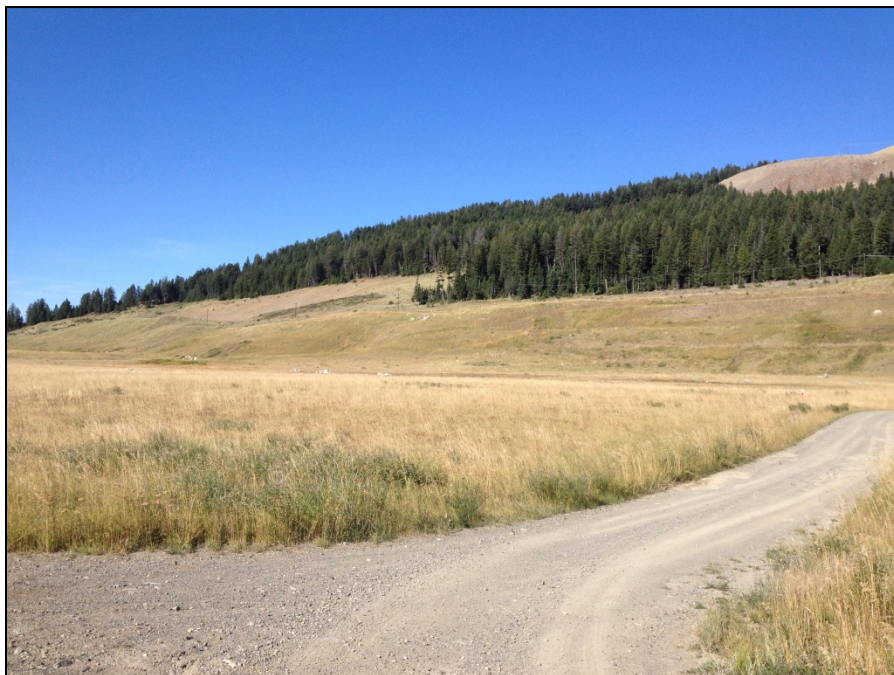
PHOTO 8 – Reclaimed slopes above tailings facility (looking west).

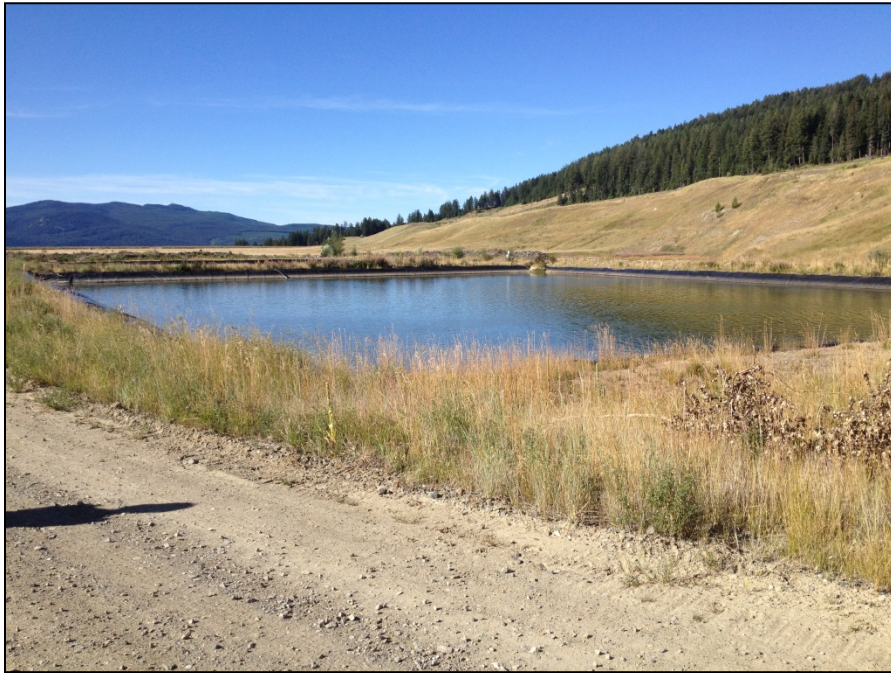
PHOTO 9 – Lined Pond 1 – Collected seepage water (looking west).

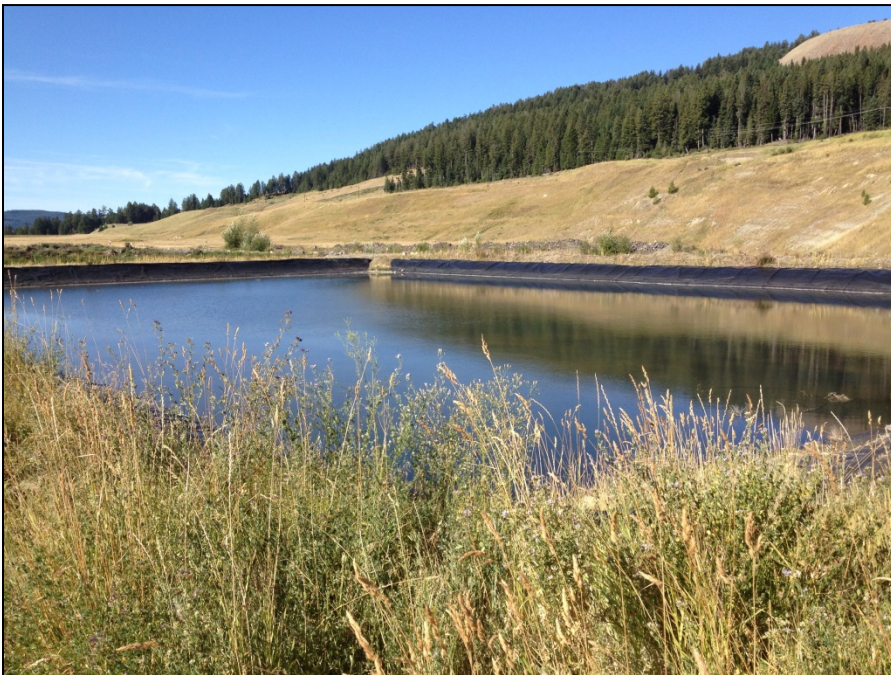
PHOTO 10 – Lined Pond 2 – Collected seepage water (looking west).

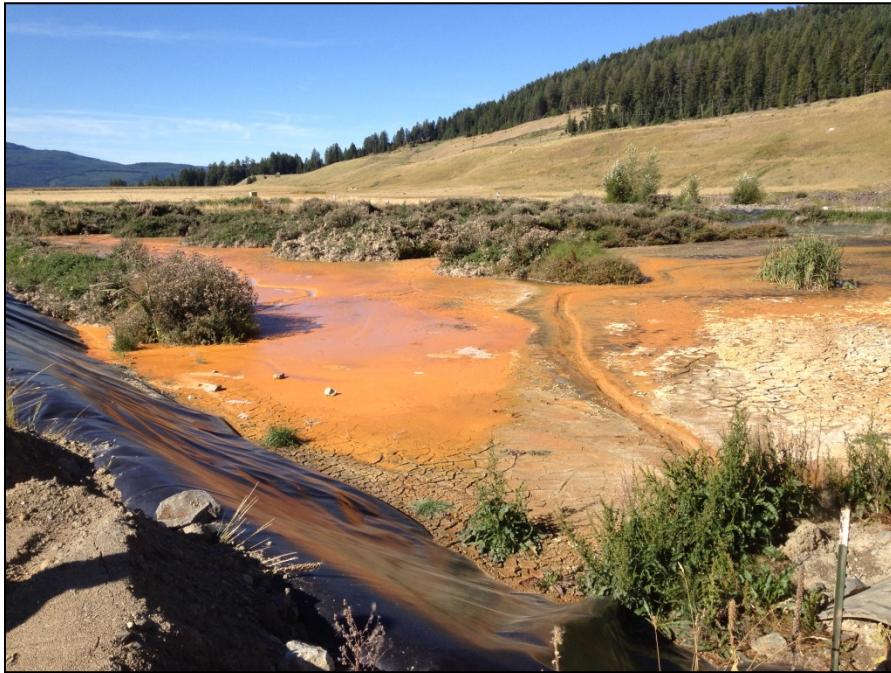
embankment toe collection systems prior to delivery to the water treatment plant. Pond 3 (Photo 11) and Pond 4 (Photo 12) are used to store sludge produced as a by-product of the water treatment process. There is significant vegetation on the surface of the stored sludge, particularly in Pond 4. The embankments forming the lined ponds appear to be in good condition.

PHOTO 11 – Lined Pond 3 – Inert sludge containment (looking west).

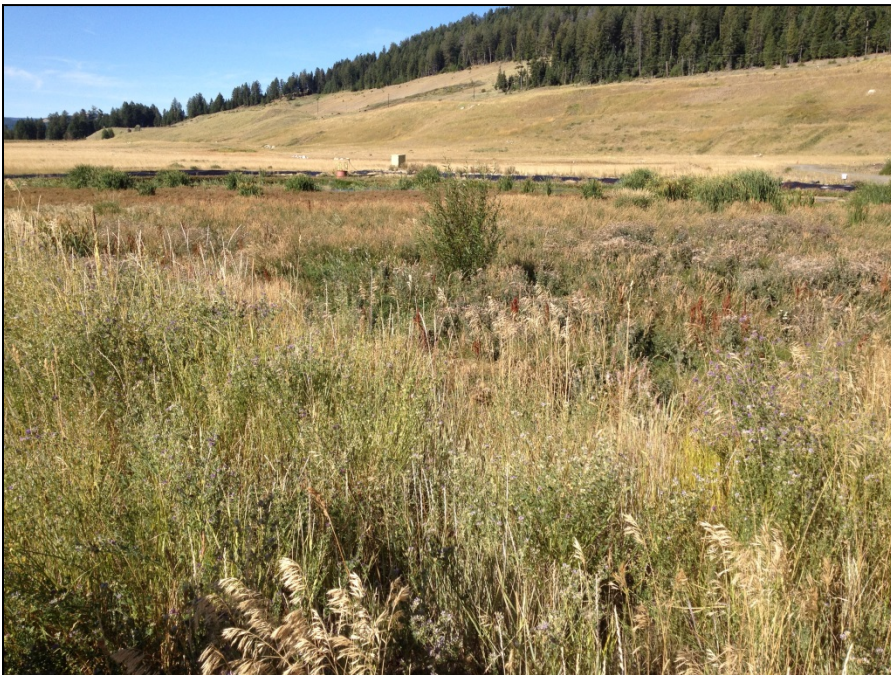
PHOTO 12 – Lined Pond 4 – Inert sludge containment (looking west).

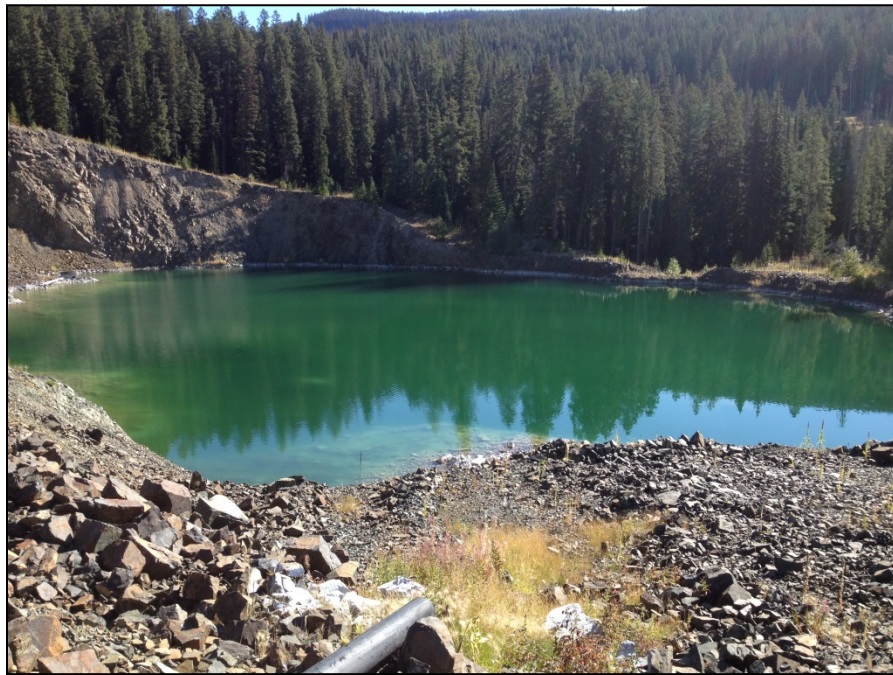
The Sediment Pond (Rock Quarry Lake) located at the northeast end of the tailings embankment is filled with water from runoff, precipitation and infiltration. At the time of the site inspection the water level in the pond was approximately 0.5 m below the spillway grade (see Photo 13).

PHOTO 13 – Sediment Pond (Rock Quarry Lake).

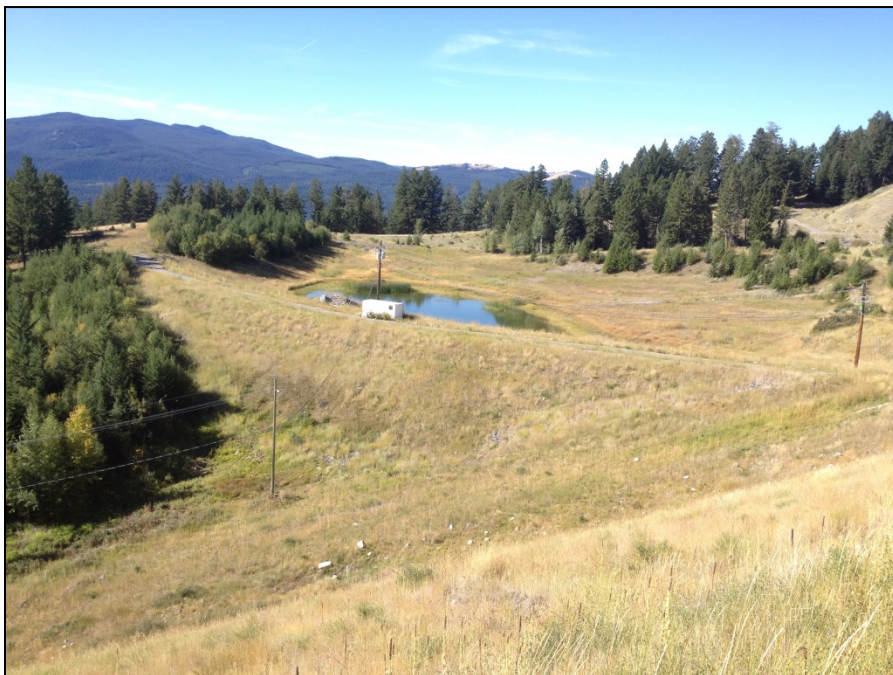
The Freshwater Dam (Mascot Pond Dam) is located downstream of the southwest corner of the tailings facility. At the time of the site inspection the dam contained a small pond from precipitation and runoff water (see Photos 14 and 15). This small dam is not currently used, but provides contingency storage for untreated water, if required. The dam is generally in good condition. Previous inspections have noted minor slope erosion and water accumulation at the toe. No seepage or water accumulation was noted at the toe of the Freshwater Dam during the dry conditions of this inspection. Overflow from the pond would discharge through a spillway located on the southwest side of the pond. The spillway channel was generally clear of vegetation and debris (see Photo 16).

PHOTO 14 – Freshwater Dam (looking from tailings embankment).

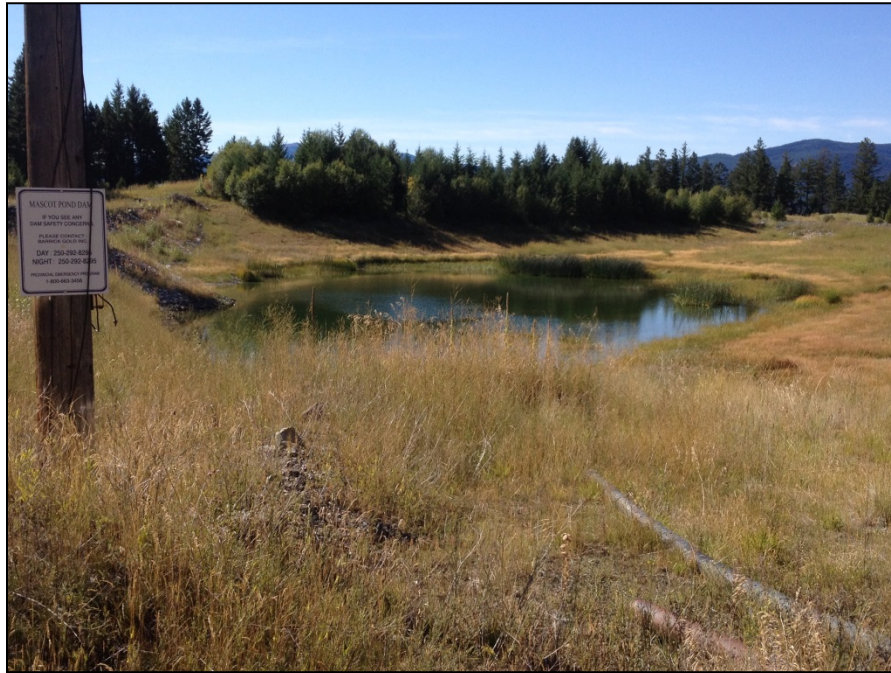
PHOTO 15 – Freshwater Dam (Mascot Pond Dam).

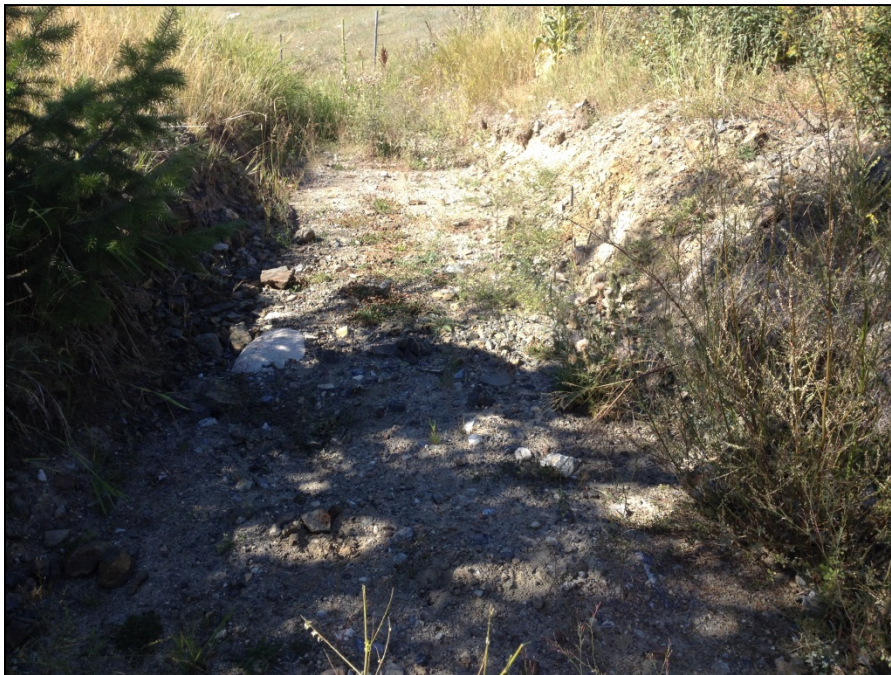
PHOTO 16 – Freshman Dam – Spillway channel.
