Barrick Gold Corporation
460 West 50 North, Suite 500
Salt Lake City, Utah
84101

27 June 2015

Re: Understanding of foundation conditions, water balance adequacy and filter adequacy
at the closed Nickel Plate tailings impoundment near Hedley, BC

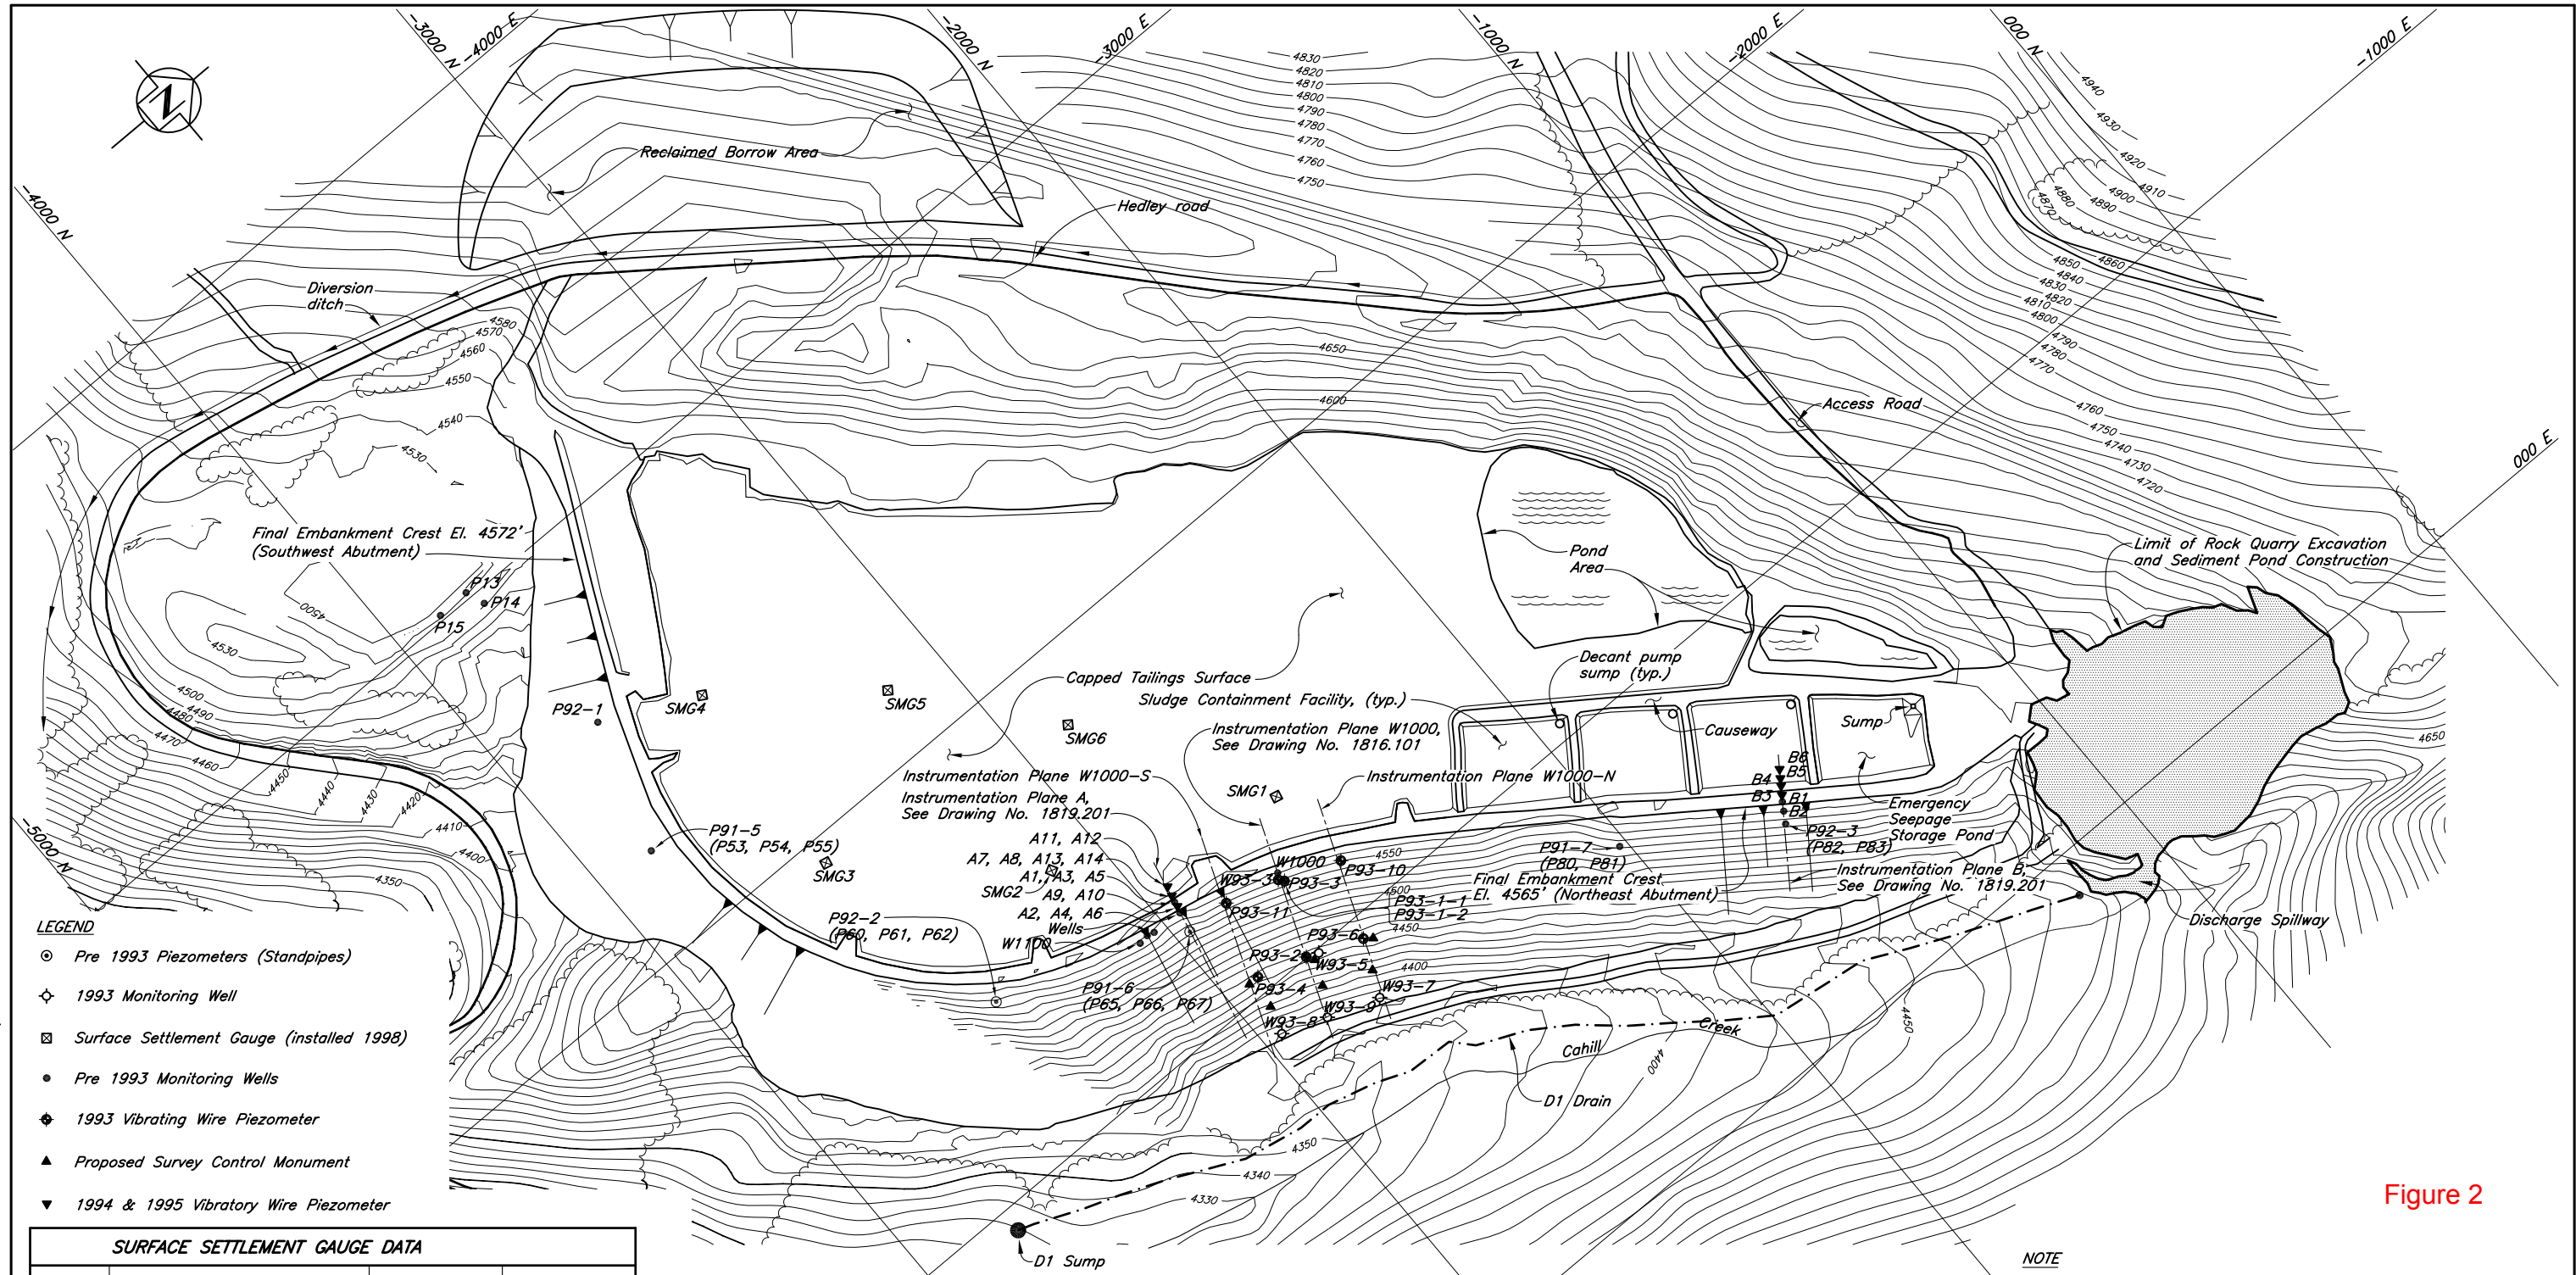
Figure 2

Figures 2 and 3 show plan view locations of geotechnical monitoring instrumentation for the Nickel Plate TSF, to March 2011 closure conditions. Figures 4 to 6 provide reference cross-sections through the TSF embankment dam corresponding to the locations as indicated in Figures 2 and 3, with some details of inferred subsurface geology provided. Figure 7, taken from the recent, independent stability and dam breach assessment (EBA, 2013) shows a typical cross-section through the main Mascot Pond Freshwater Reservoir Dam.

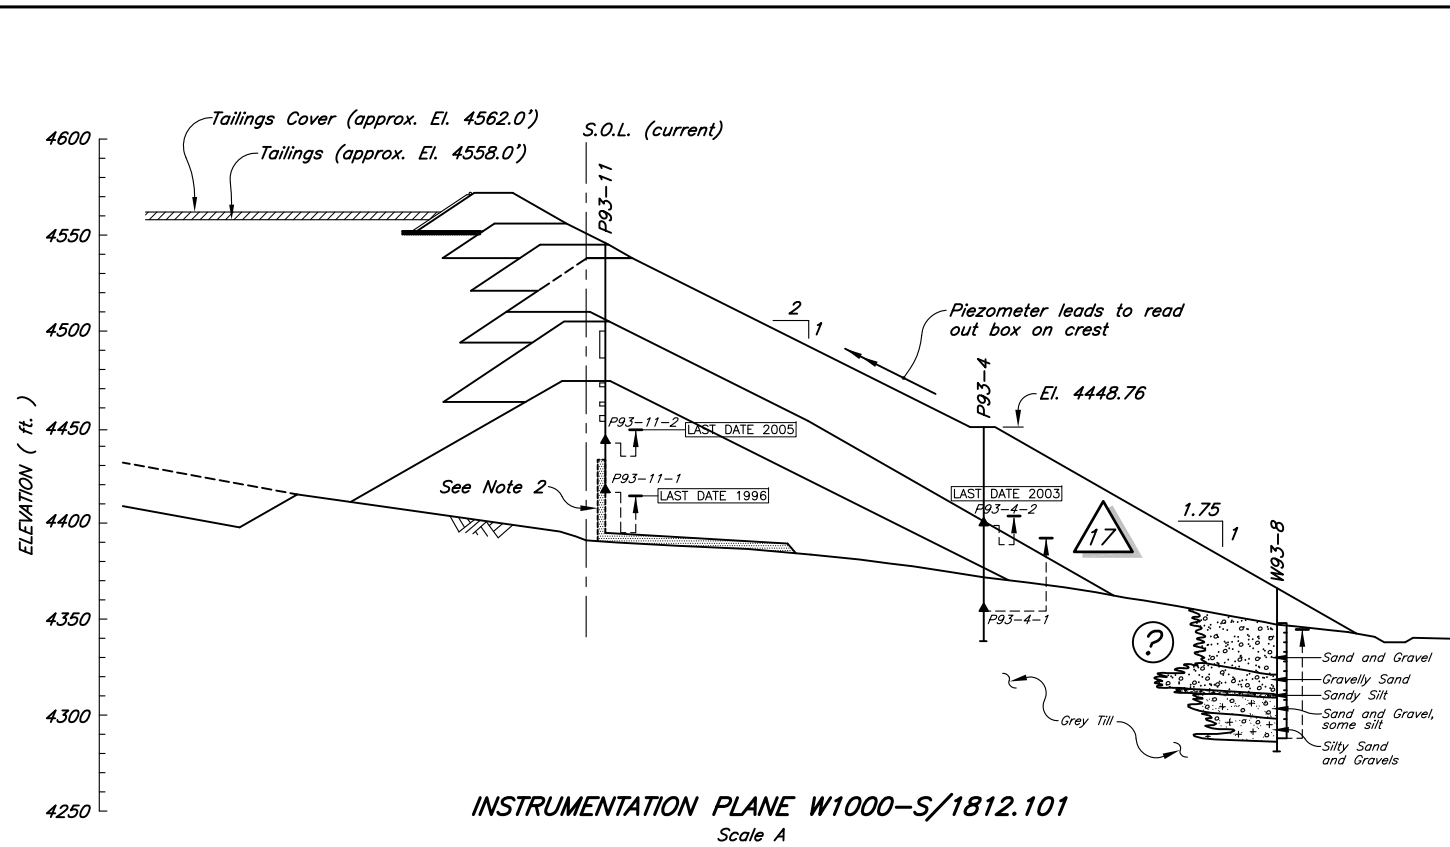
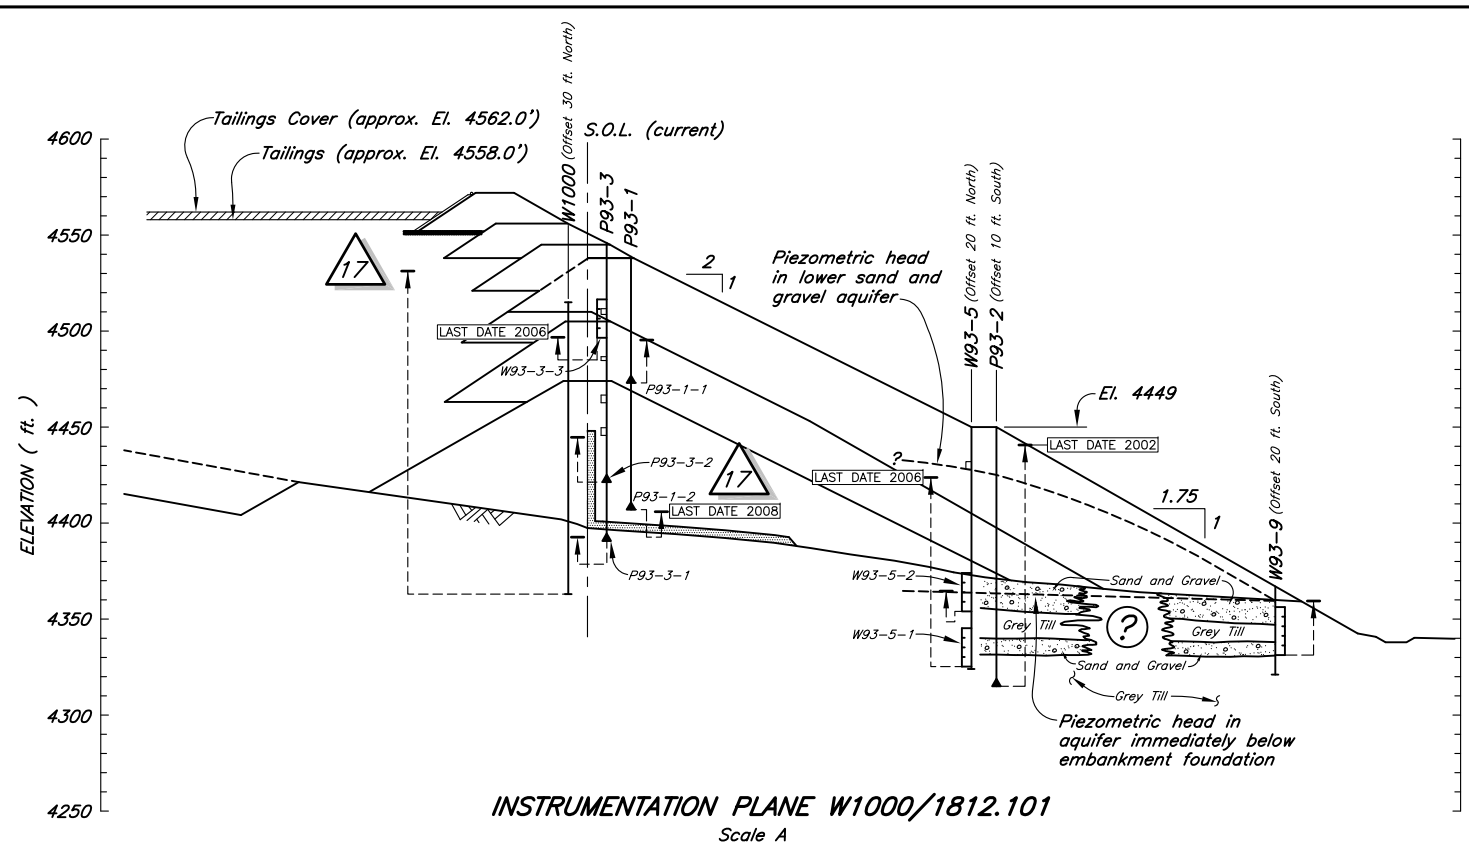
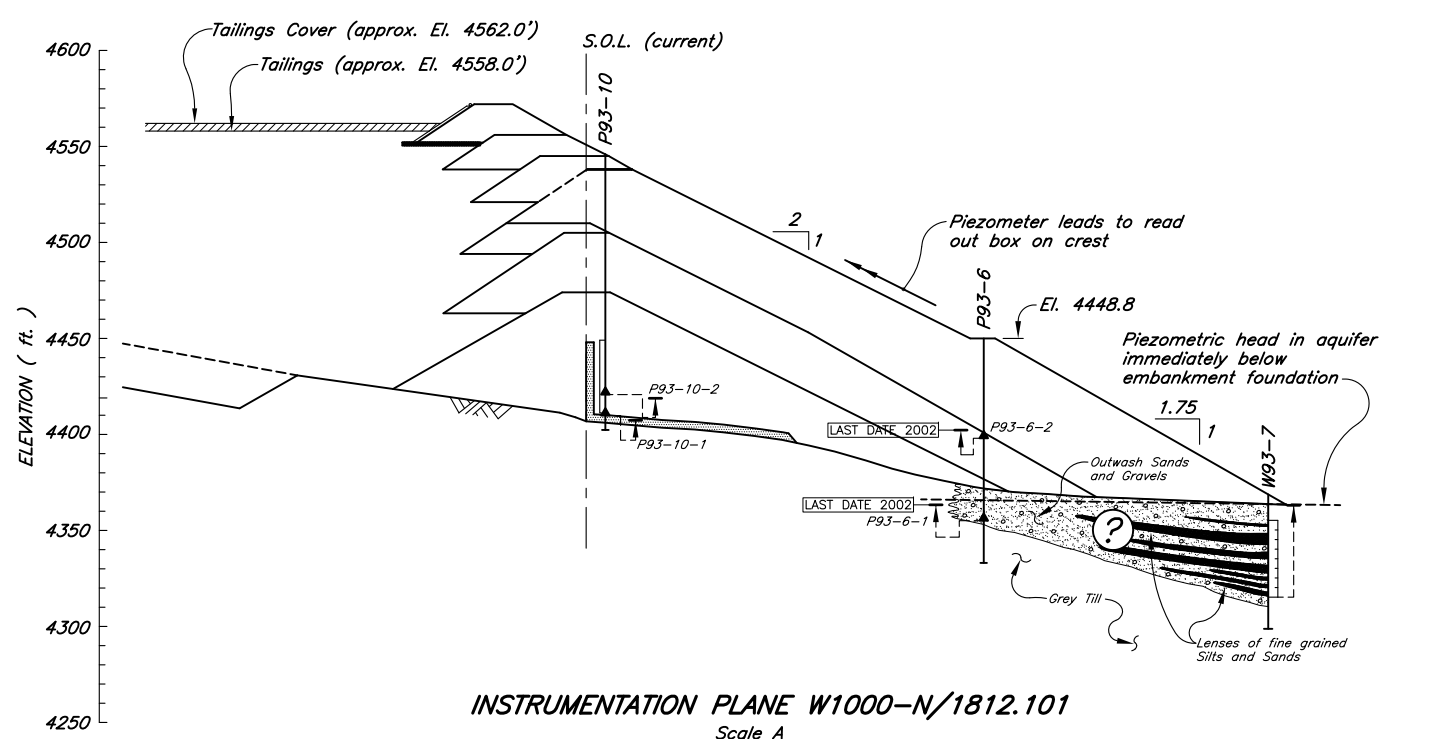
Figure 4

- NOTES**
1. Geologic interpretation is based on limited information available from drill hole logs.
 2. Chimney drain intersected down stream of location indicated in as built drawings.
 3. Piezometer levels as of January 2007.
 4. Supernatant pond El. 4549.6' as of December 30, 2000.
