Barkerville Gold Mines Ltd.

QR Mine Tailings Storage Facility

Background Report for Response to MEM Memorandum

June 2015

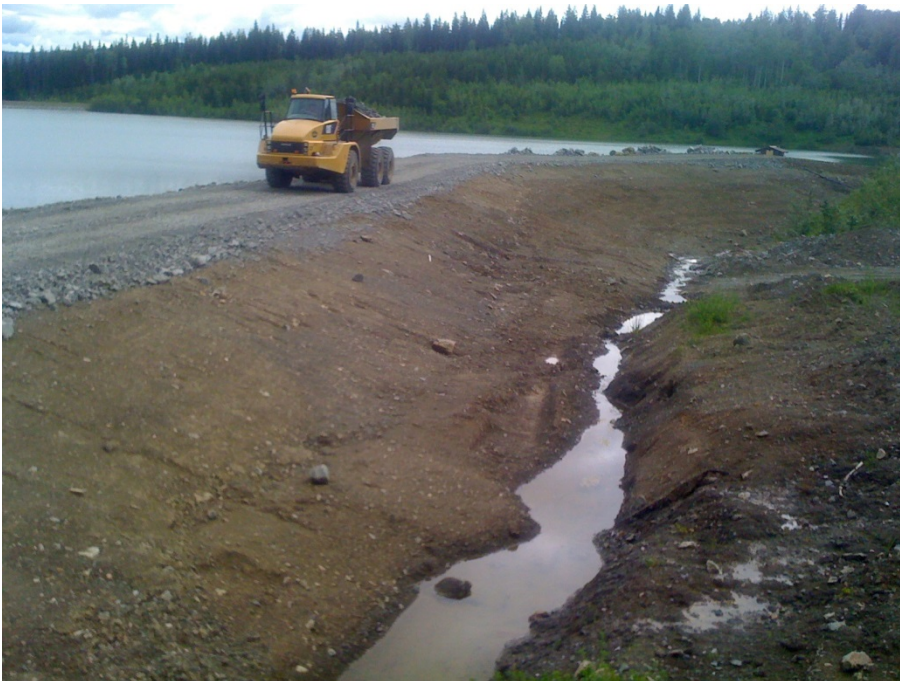
Photo I-2 **Cross Dyke: Toe Ditch from Right Abutment to French Drain.**

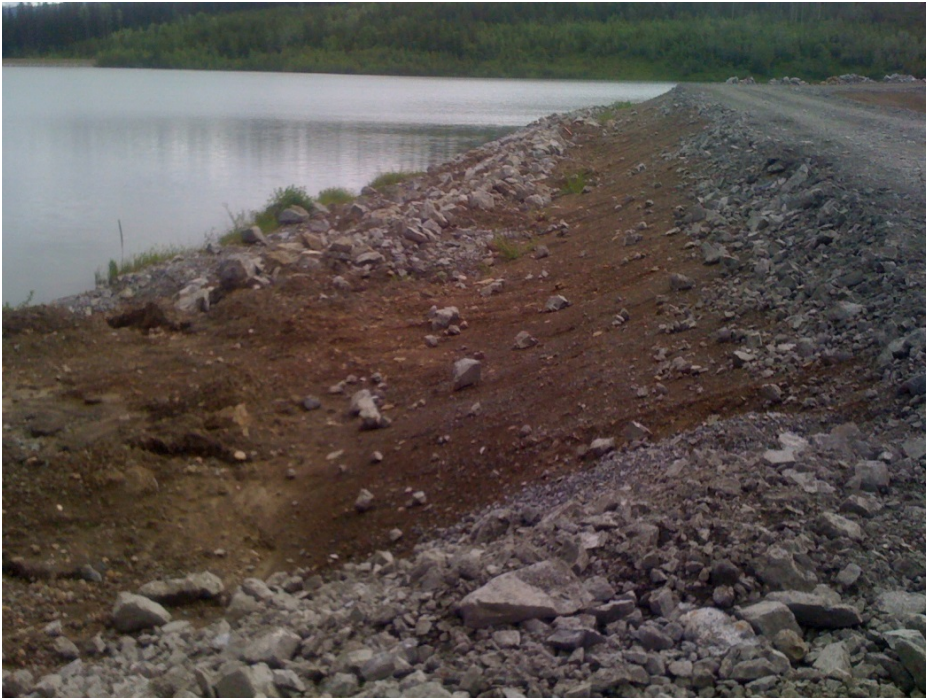
Photo I-3 **Cross Dyke: Upstream Slope, Armouring incomplete at the time of site visit.**

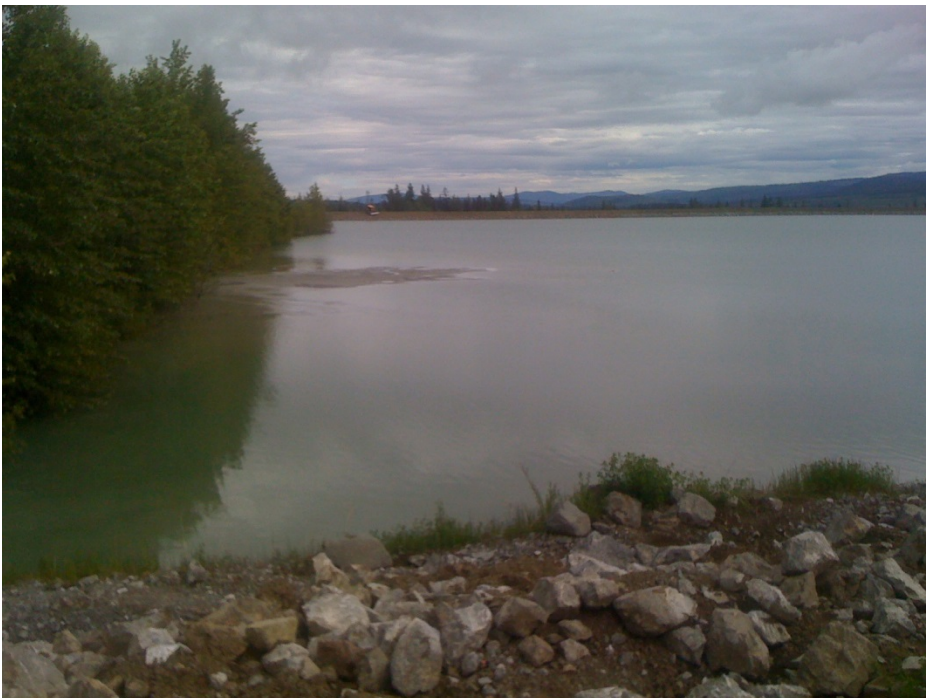
Photo I-4 **Tailings Beach on West Side of Impoundment. Heavy vegetation on slope above beach.**

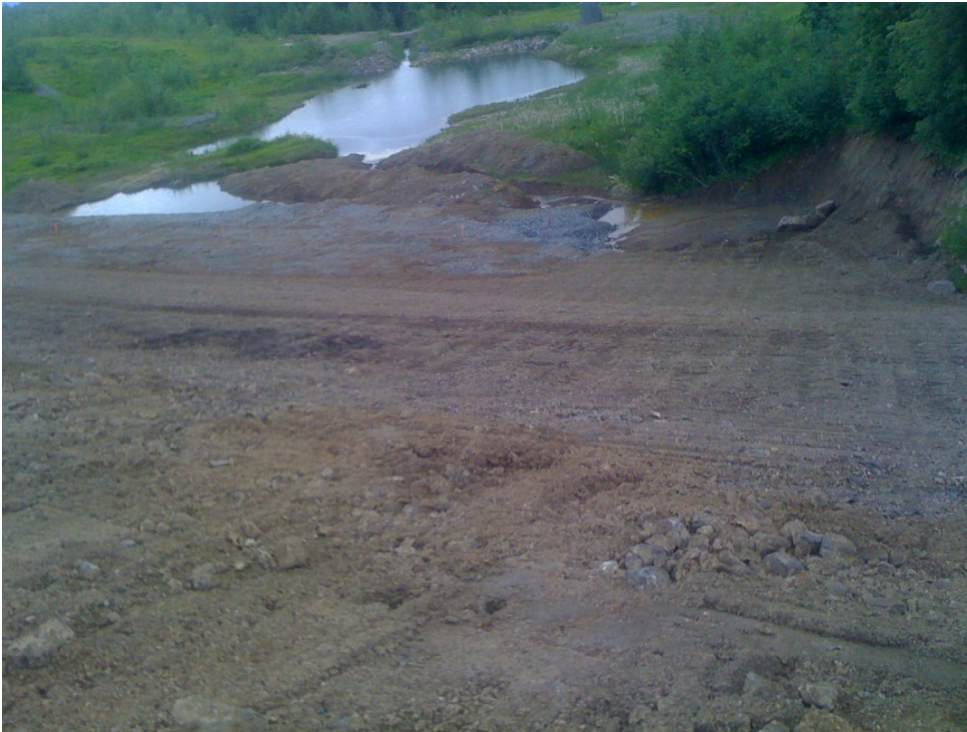
Photo I-7 **Cross Dyke Downstream Face. Seepage face observed partway down slope during DSI site visit has since dried.**

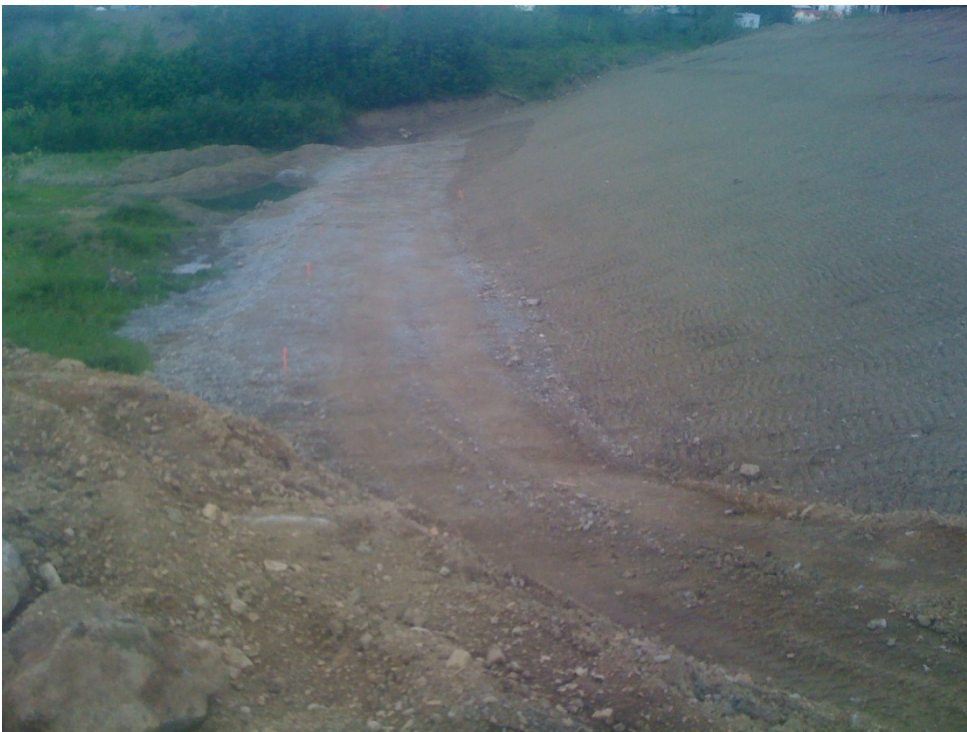
Photo I-8 **Cross Dyke: Fine Filter Blanket Drain overbuilt, but can be remediated since site visit.**

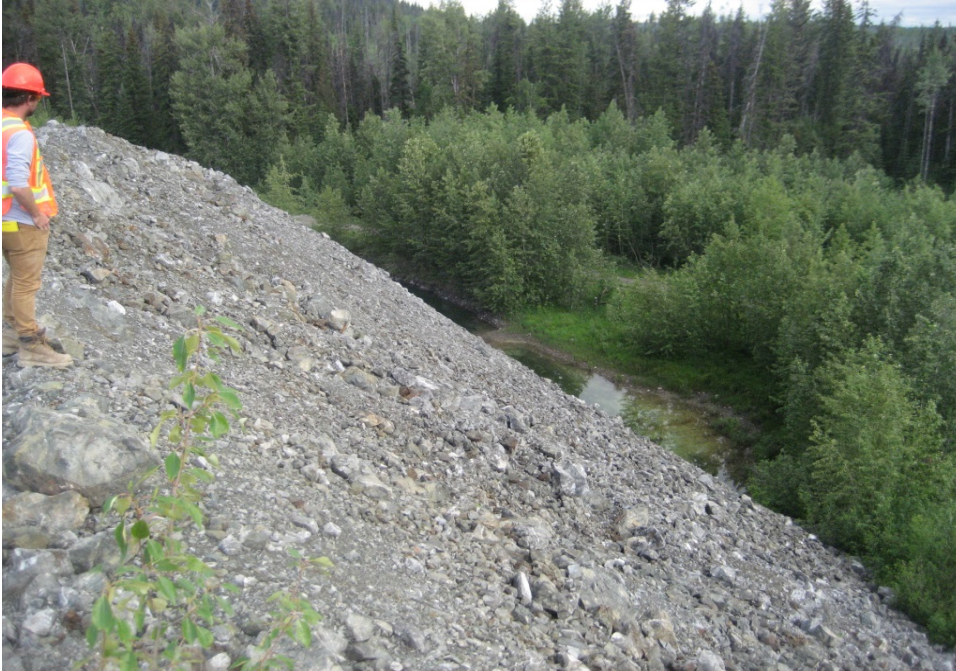
Photo I-10 North Dam Downstream Face. Appears oversteepened. Slope will be confirmed with as-constructed survey.

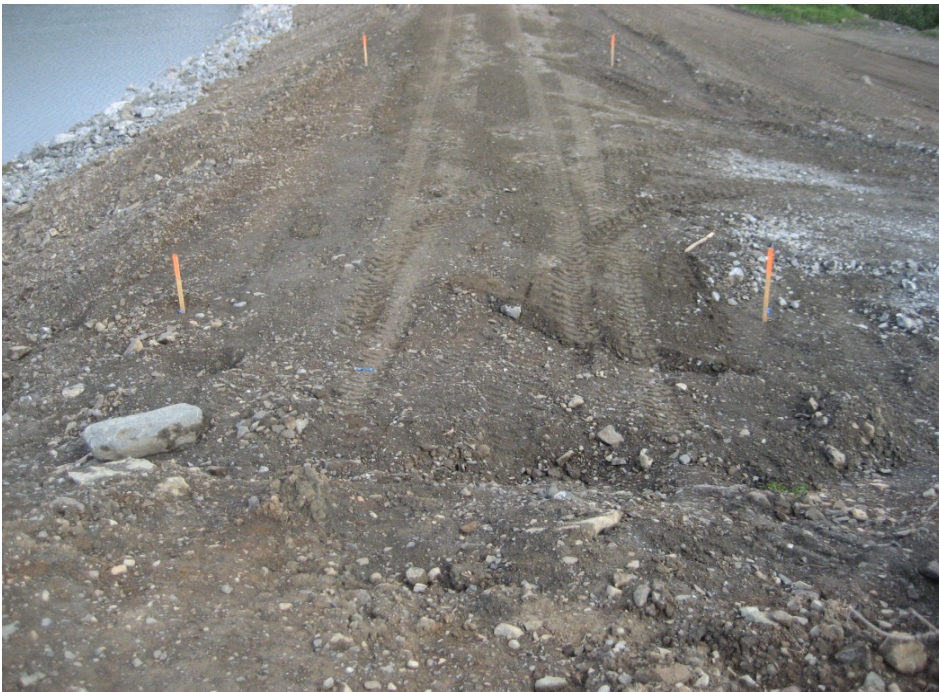
Photo I-11 North Dam Crest. Right abutment material was loose and uncompacted at time of site visit. Has since been remediated.

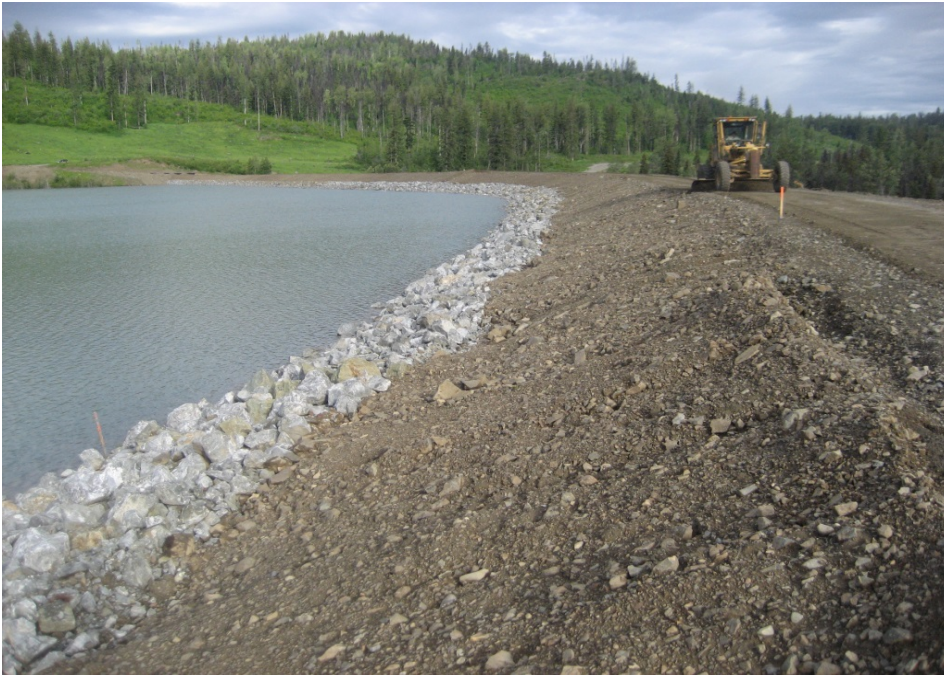
Photo I-13 **North Dam Upstream Face, Armouring incomplete at time of site visit**

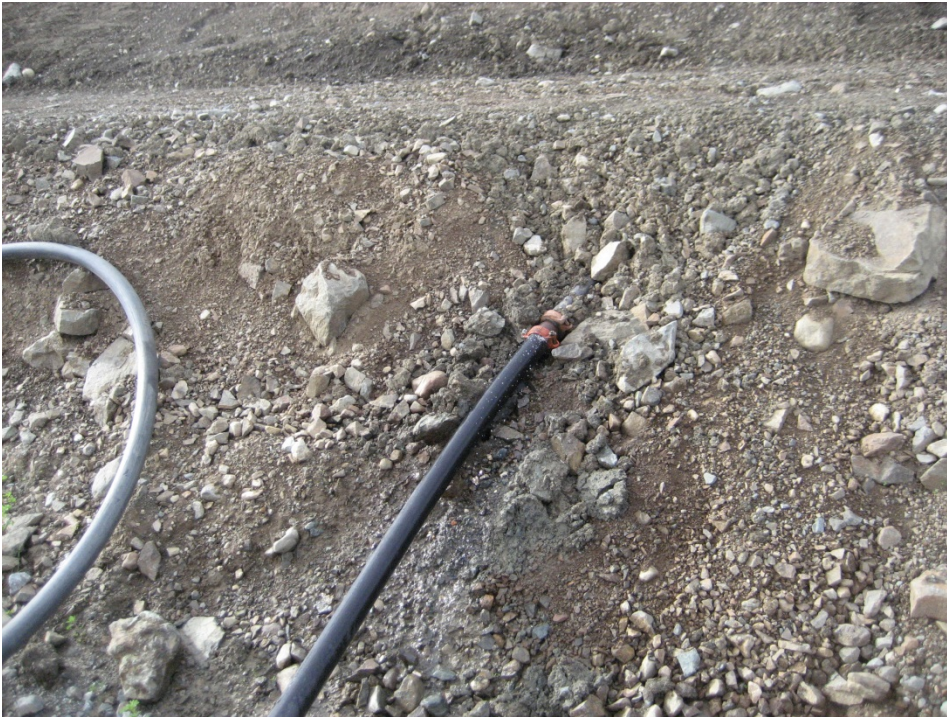
Photo I-15 North Dam Seepage Return pipe leaking at Upper Bench.

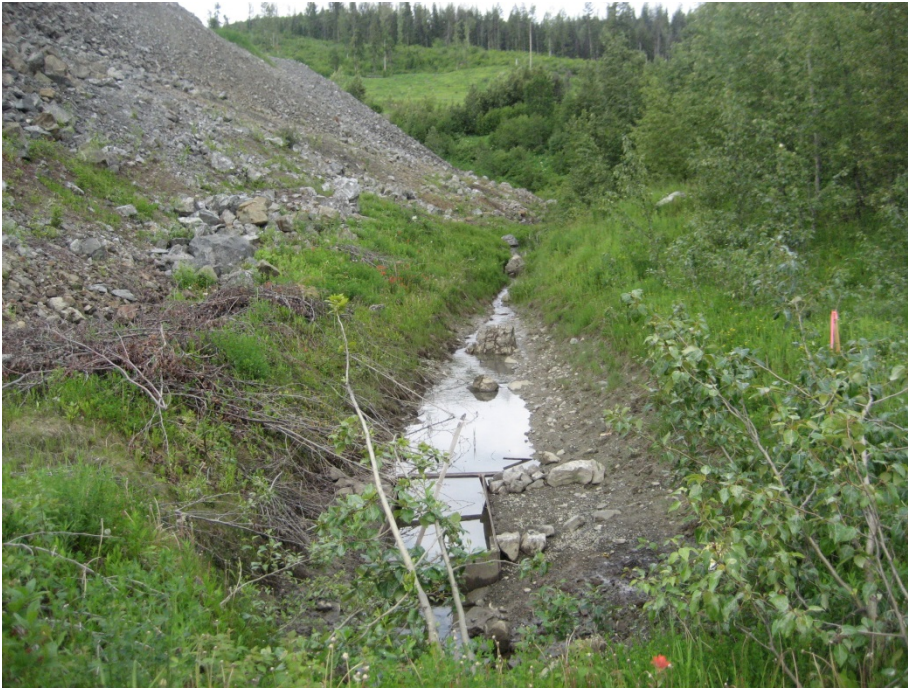
Photo I-17 North Dam Toe. Seepage weir functions but should be kept clear of debris.

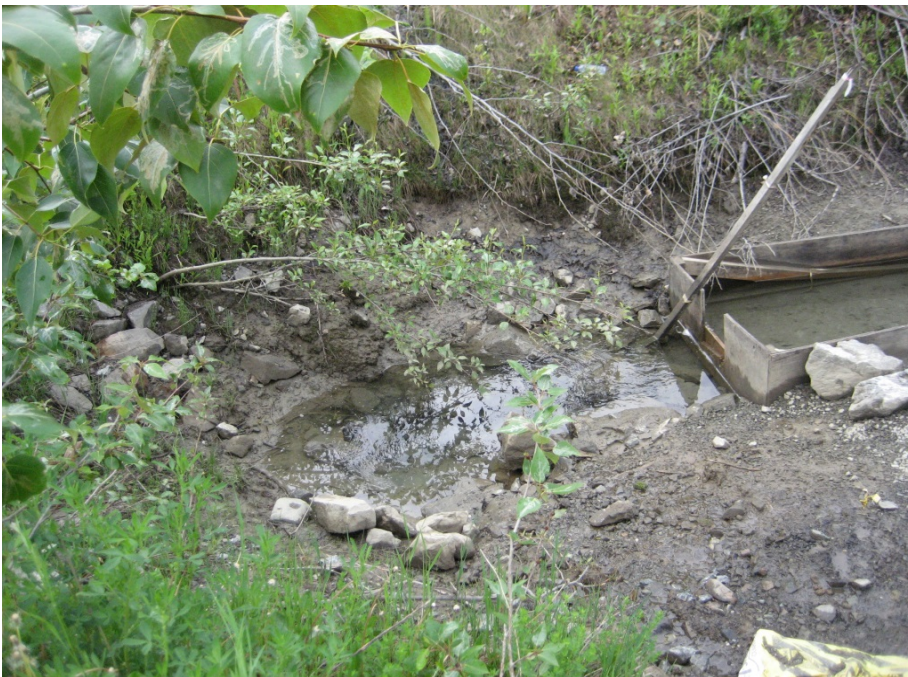
Photo I-18 North Dam Toe east weir. Flow ~ 10 L/s.

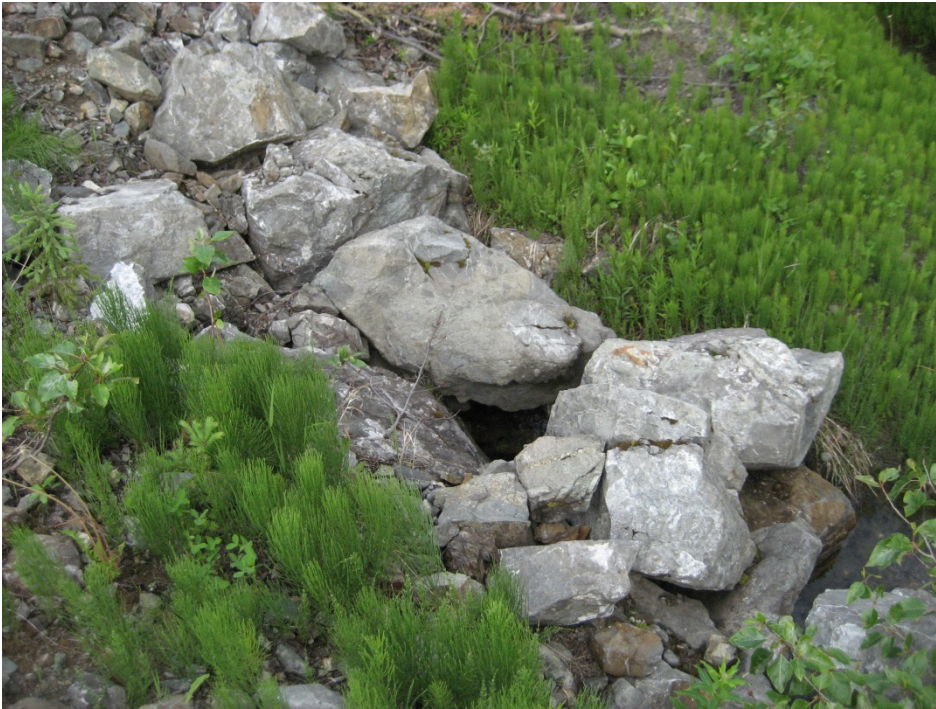
Photo I-19 North Dam Rock Drain Outlet (Flow ~ 8 L/s)

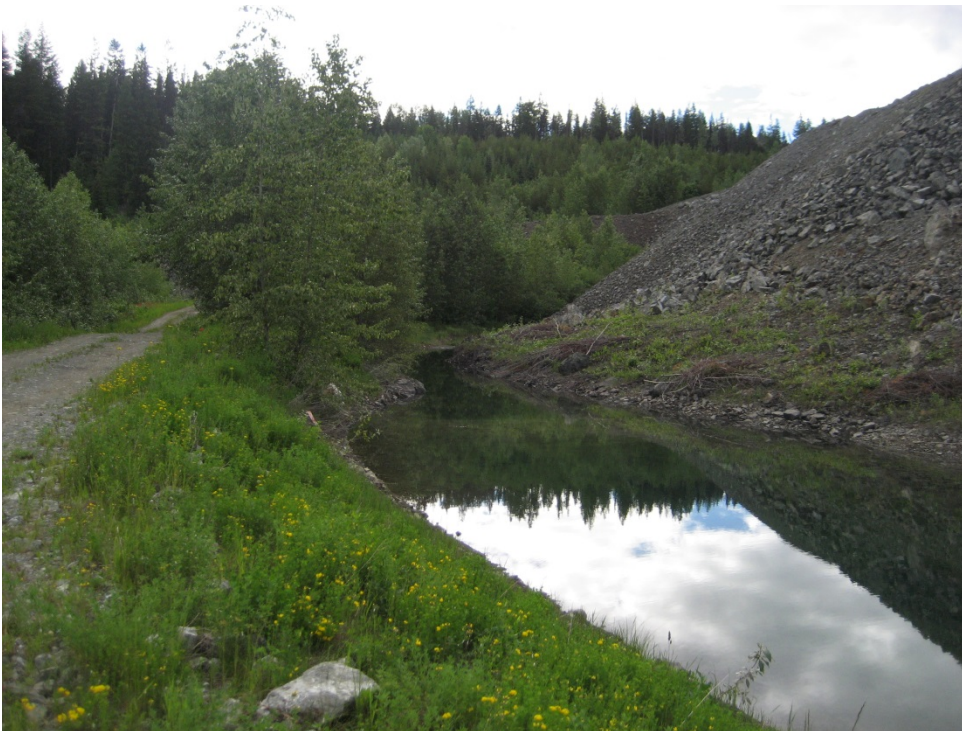
Photo I-20 Seepage Collection Pond (toe of North Dam). Note rockfill slope appears oversteepened.

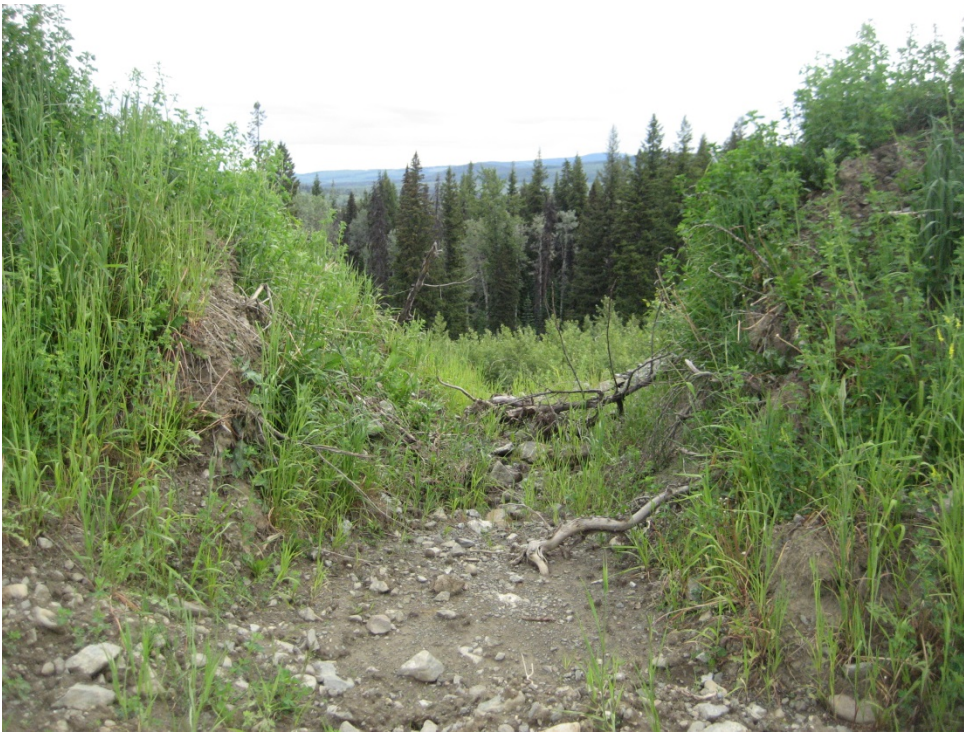
Photo I-21 **East Diversion Ditch. Overgrown but generally clear of major debris. Channel dry at the time of the site visit.**

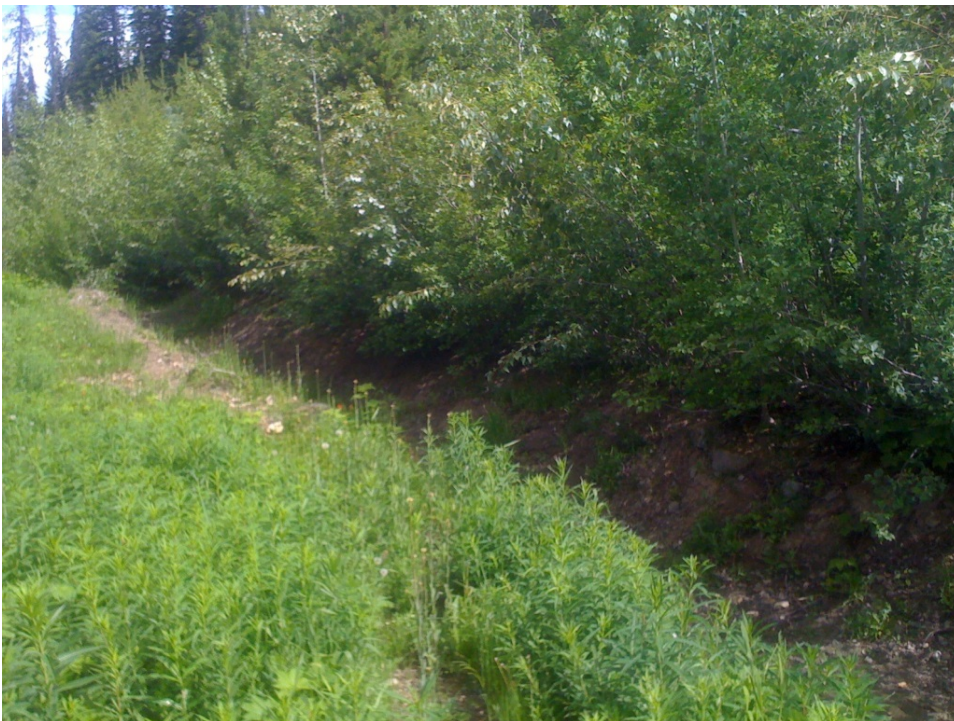
Photo I-22 **West Diversion Ditch. Clear with some indications of recent flow.**
