Teck Resources Ltd.

Quintette Coal Operations

Plantsite Tailings Dam

2014 Dam Safety Inspection

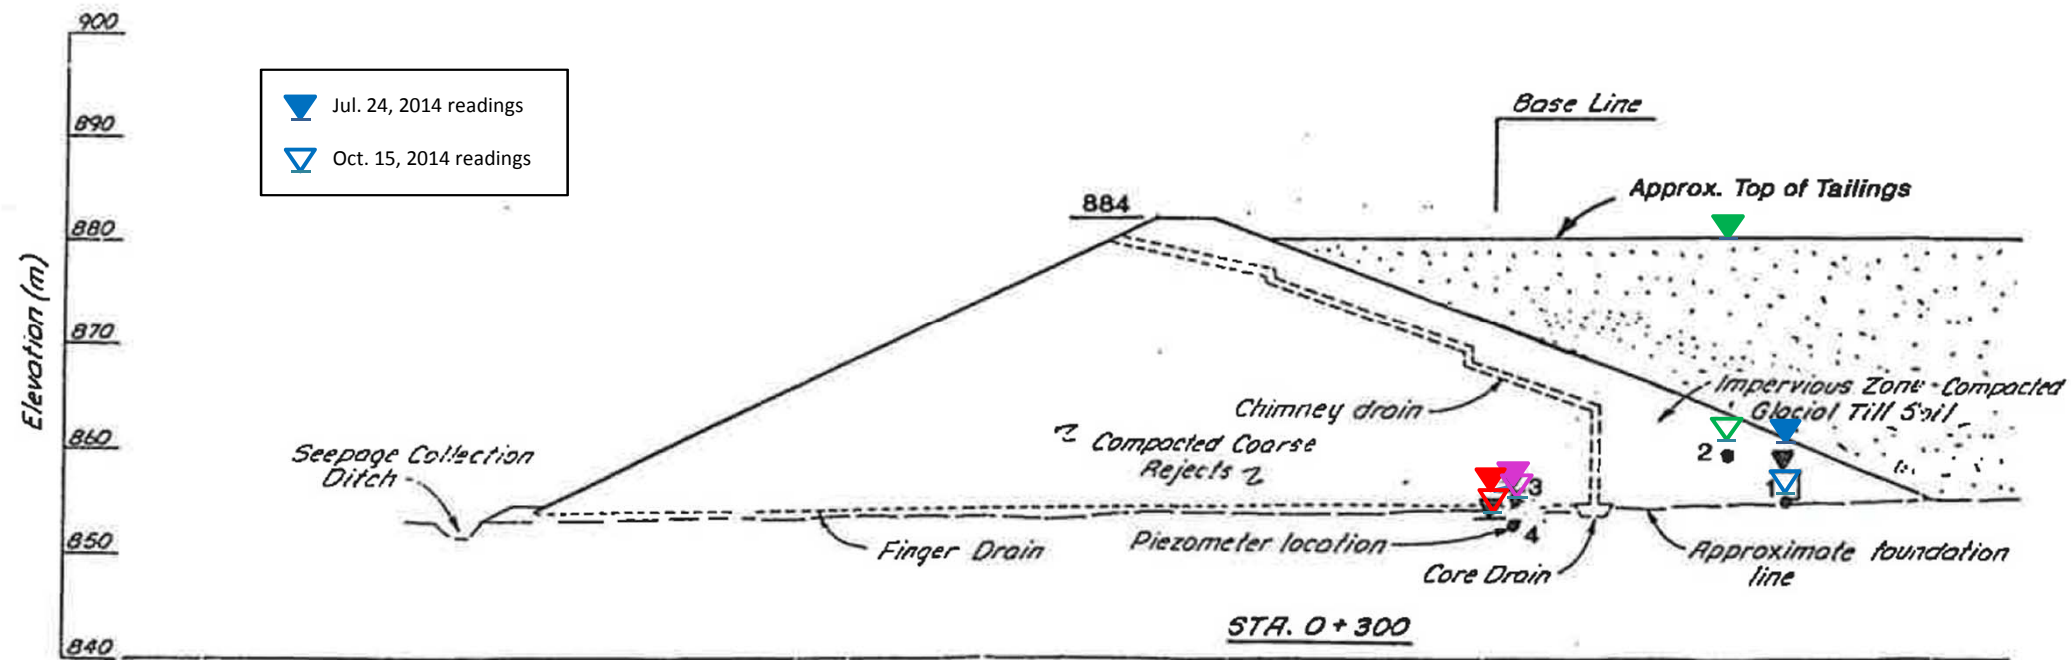
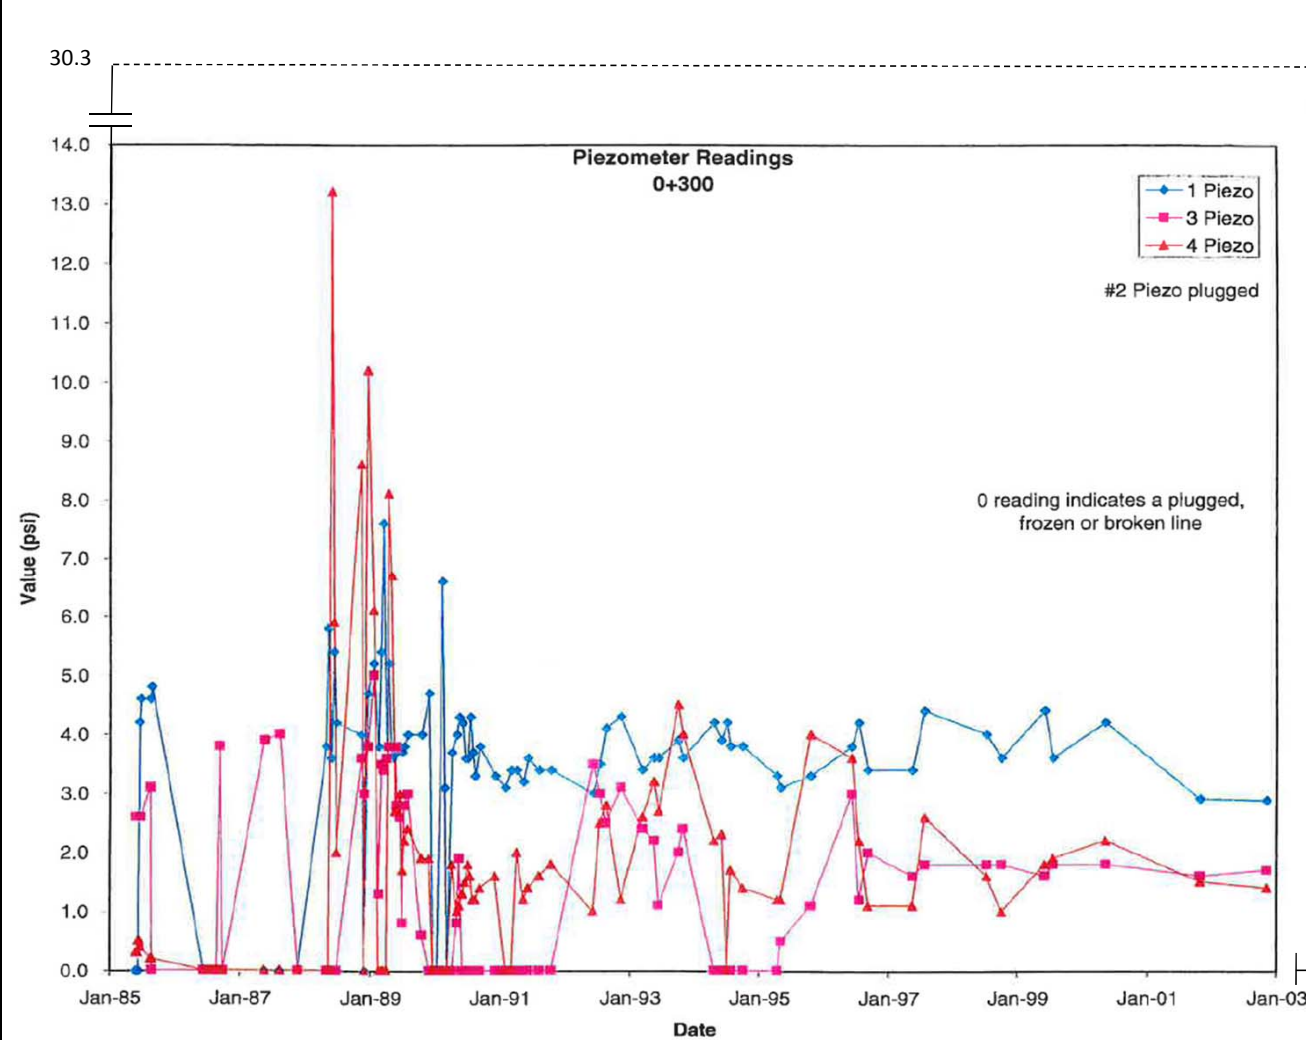
STA. 0+300

- “Piezo 2” at Sta. 0+300 was noted as “plugged” in Golder (2003). A very high pressure (21 m of pressure head) was measured from one of the piezometer leads during in July, 2014. This reading was associated to Piezo 2. When plotted on the dam cross section (Figure 2), the pore pressure projects to the tailings surface (elevation of ponded water). The October, 2014 reading from the same instrument reduced significantly to less than 2 m of pressure head. These measurements indicate that the instrument is no longer plugged.

1. Instrument section and historic readings chart from Golder(2003). Historic piezometric reading values were unavailable.
2. No labels on piezometer leads. Comparison of past readings and tip location used to infer what readings apply to what instruments. Labels should be added for ongoing comparison purposes.

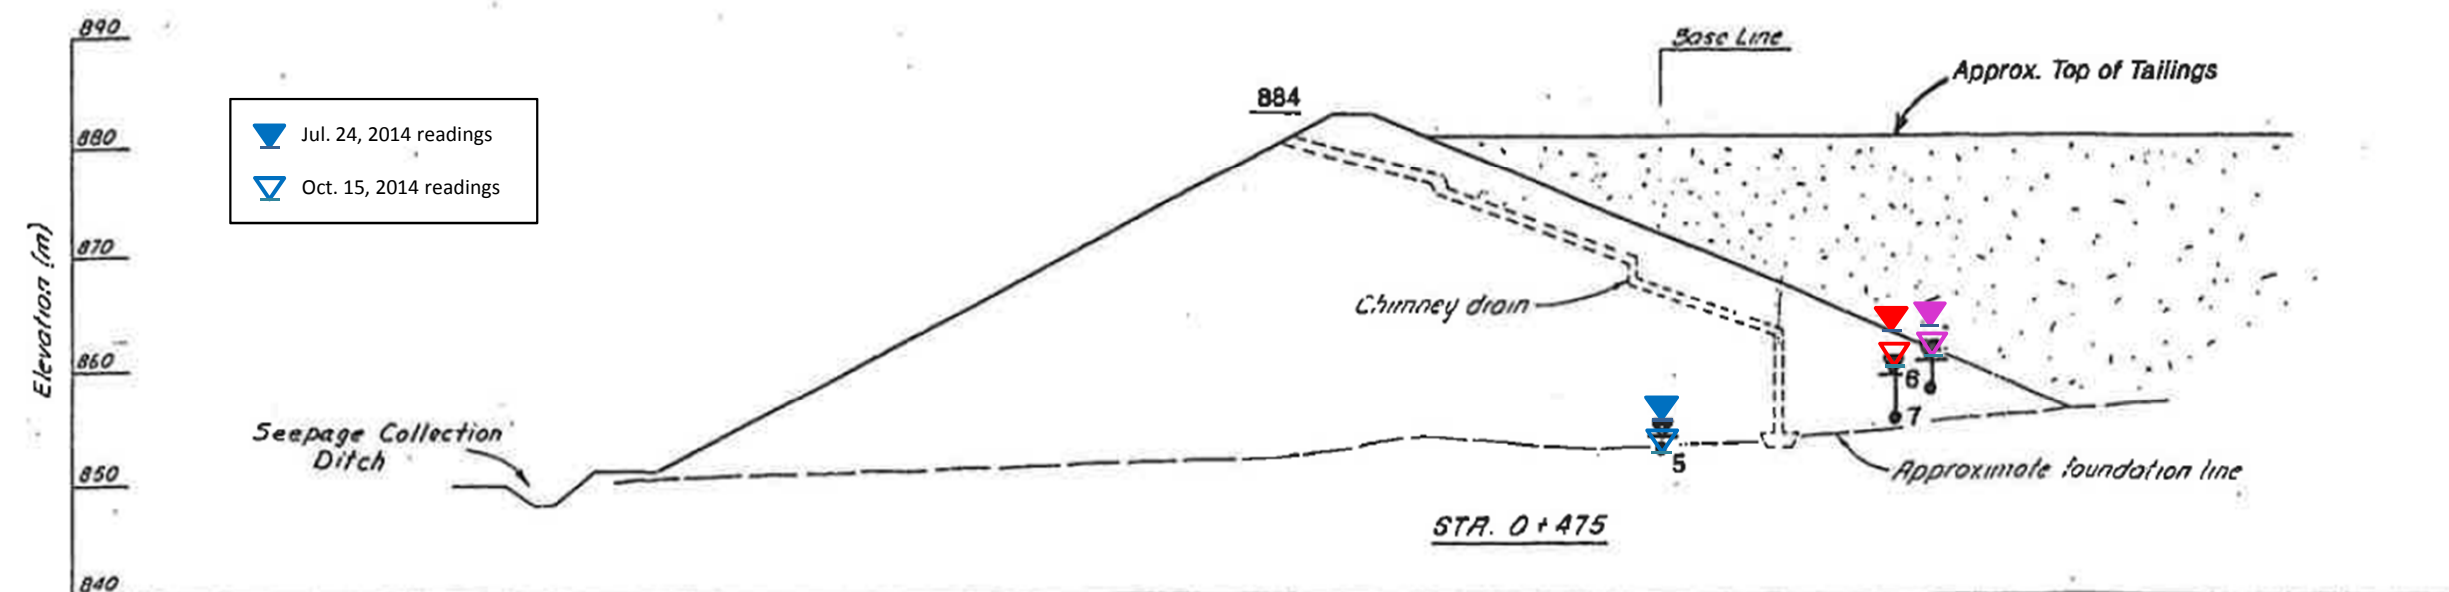
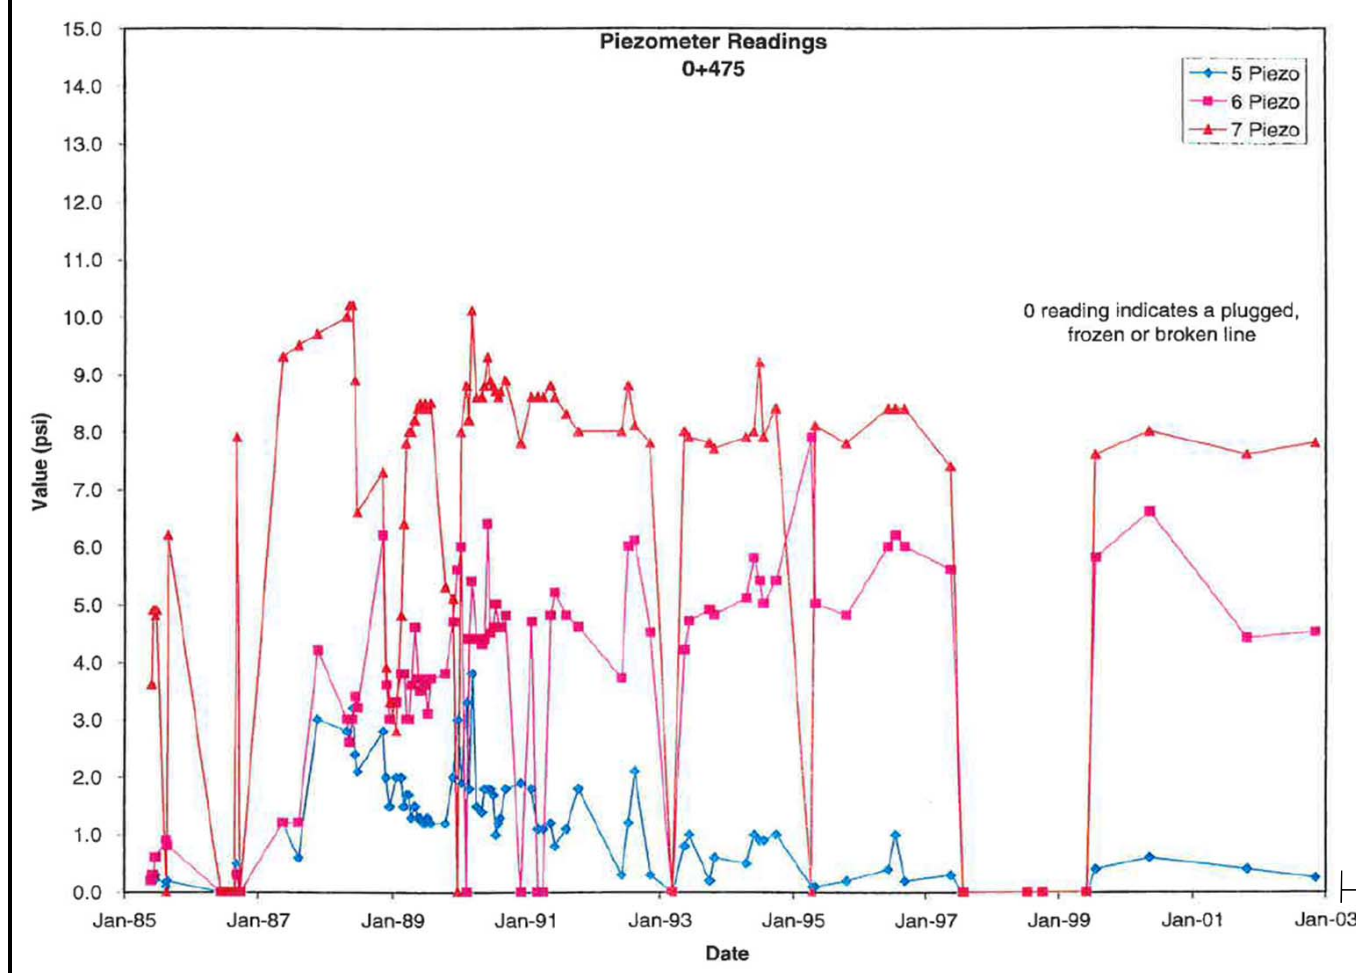
PROJECT:			
Quintette Coal Operations 2014 Dam Safety Inspections			
TITLE:			
Plantsite Tailings Dam Piezometer Readings			
Sta. 0 + 475			
PROJECT NO.	M09684A10	FIGURE	3

1. Instrument section and historic readings chart from Golder(2003). Historic piezometric reading values were unavailable.
2. No labels on piezometer leads. Comparison of past readings and tip location used to infer what readings apply to what instruments. Labels should be added for ongoing comparison purposes.

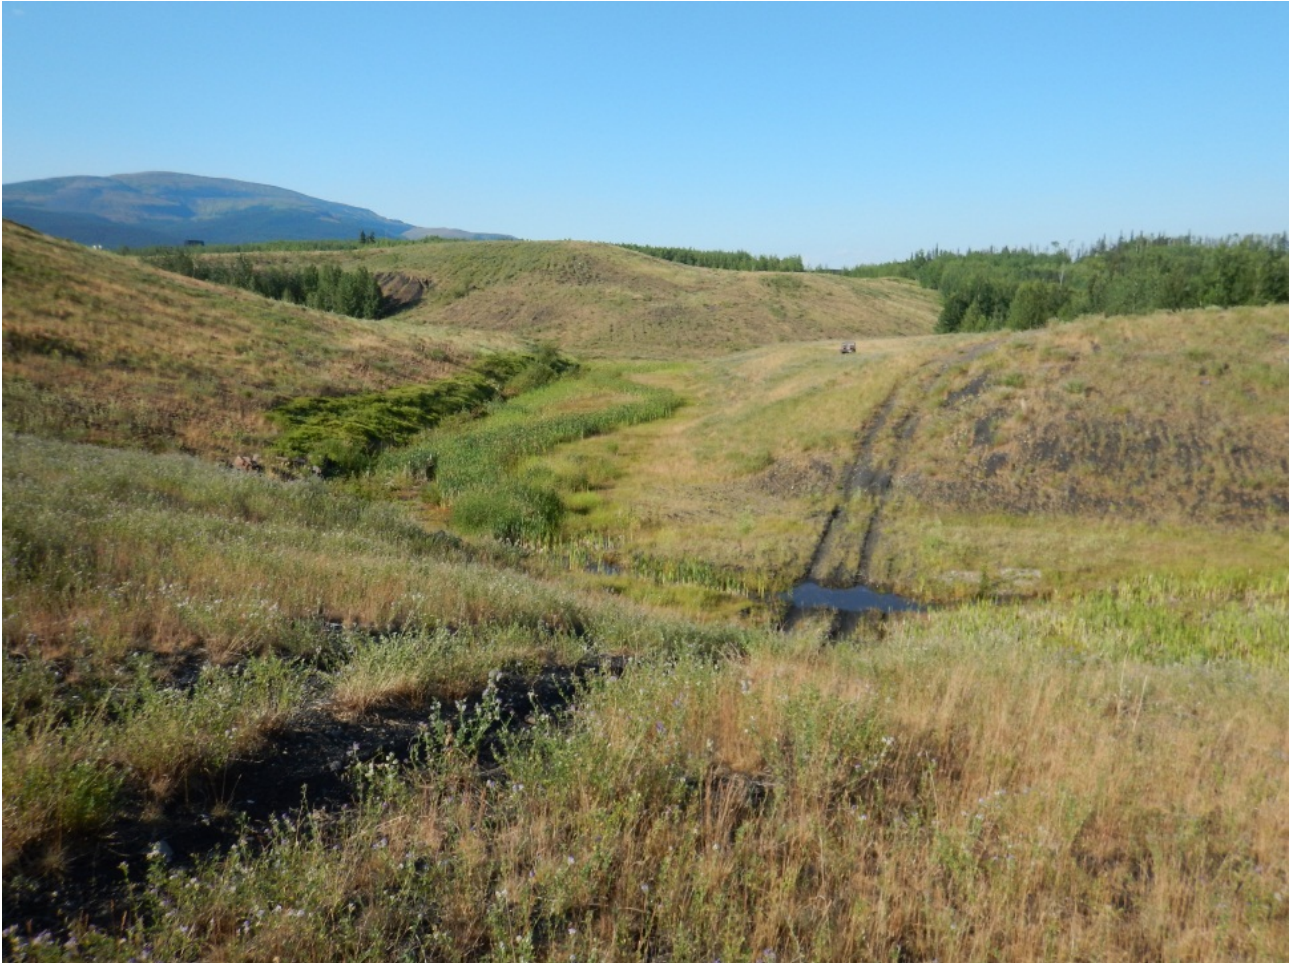
- **Closure Spillway Channel:** Good condition. The vegetation cover is well established and there are no signs of erosion damage (Photo I-1 and Photo I-2). The riprap on the natural slope bank is in good condition (Photo I-3).

Photo I-1 **Overview of spillway channel, photograph taken from inside PTD impoundment looking west towards discharge into M17 Creek. (PS-2014-01)**

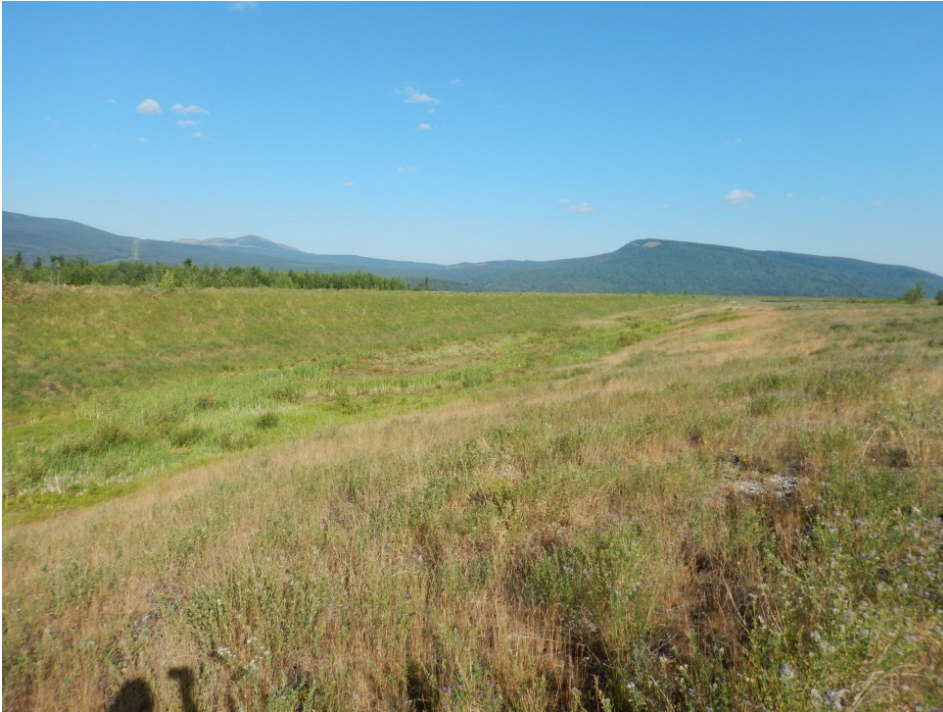
Photo I-2 Overview of spillway channel looking north towards the spillway inlet. Channel is well vegetated. (PS-2014-01)

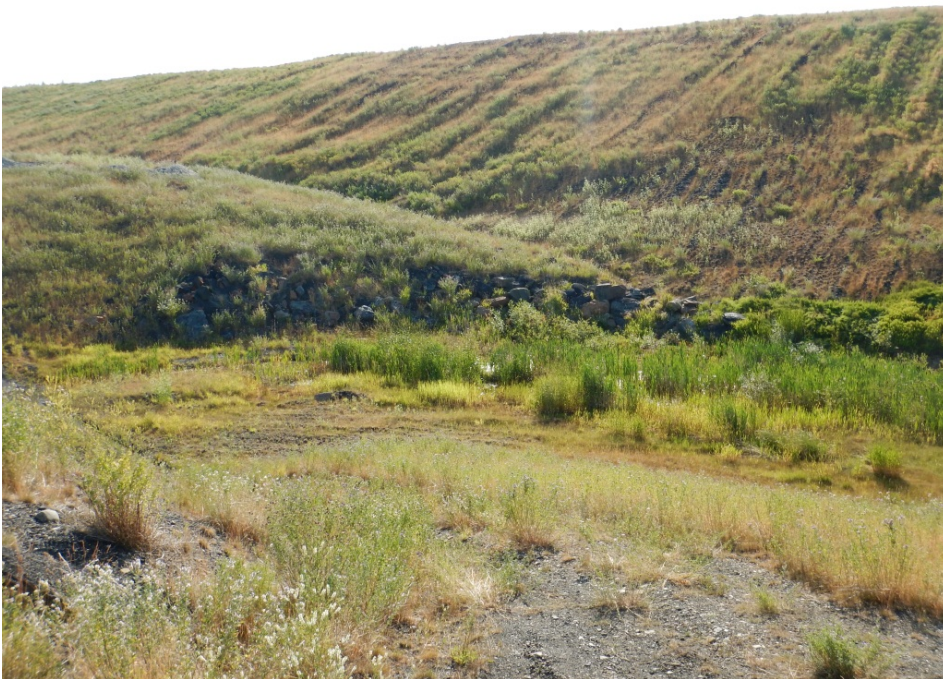
Photo I-3 Riprap (partially overgrown) along outer edge at the sharp bend in spillway channel. (PS-2014-02)

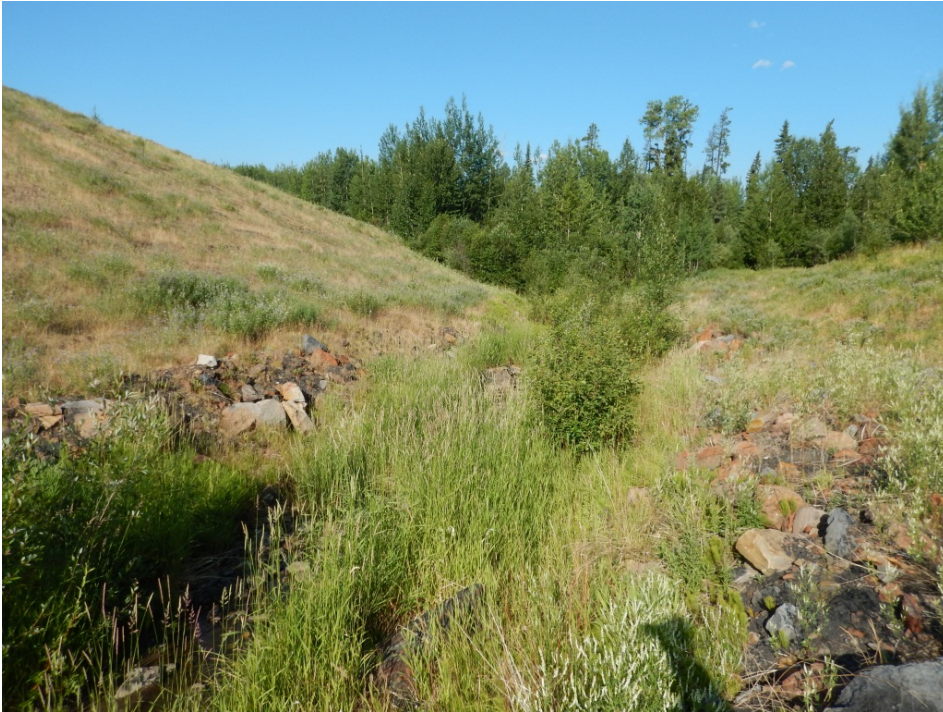
- **Closure Spillway Outlet to M17 Channel:** Good condition. Vegetation is well established and no obstructions or debris blocking outlet (Photos I-4 and I-5). Near the outlet, the M17 channel riprap also appeared to be in good condition.

Photo I-4 **Photograph taken standing at spillway discharge, looking north (downstream) at M17 creek. (PS-2014-03)**

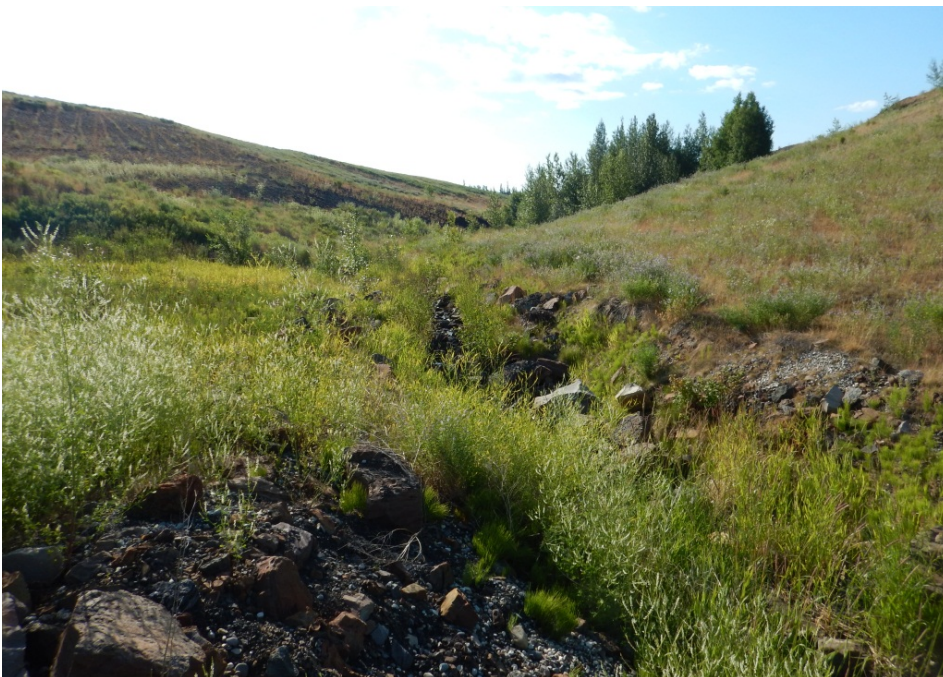
Photo I-5 **Photograph taken standing at spillway discharge, looking south (upstream) at M17 creek. (PS-2014-04)**

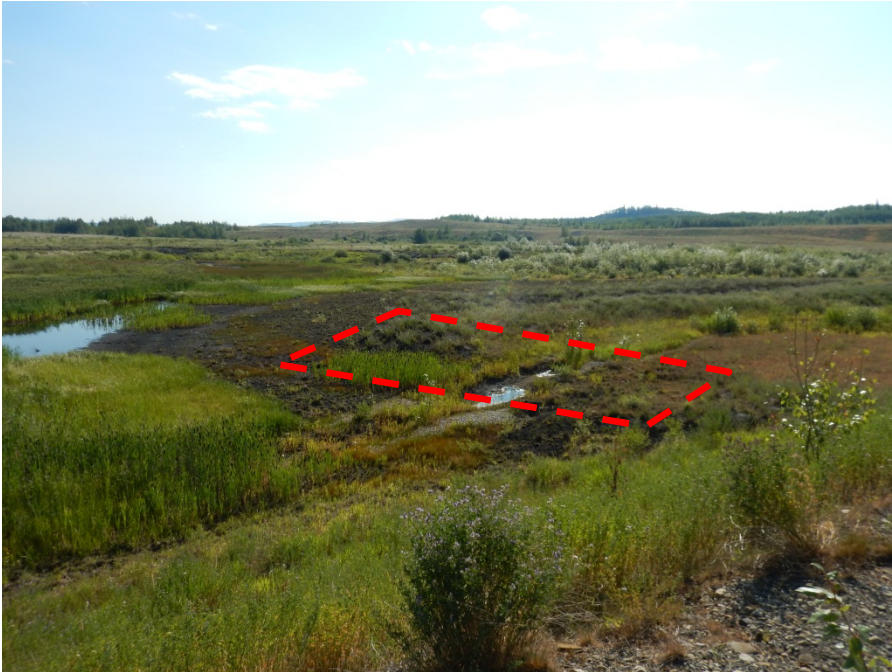
Photo I-6 Inlet to the spillway channel (red dashed area) which is clear with no obstructions.
(PS-2014-08)

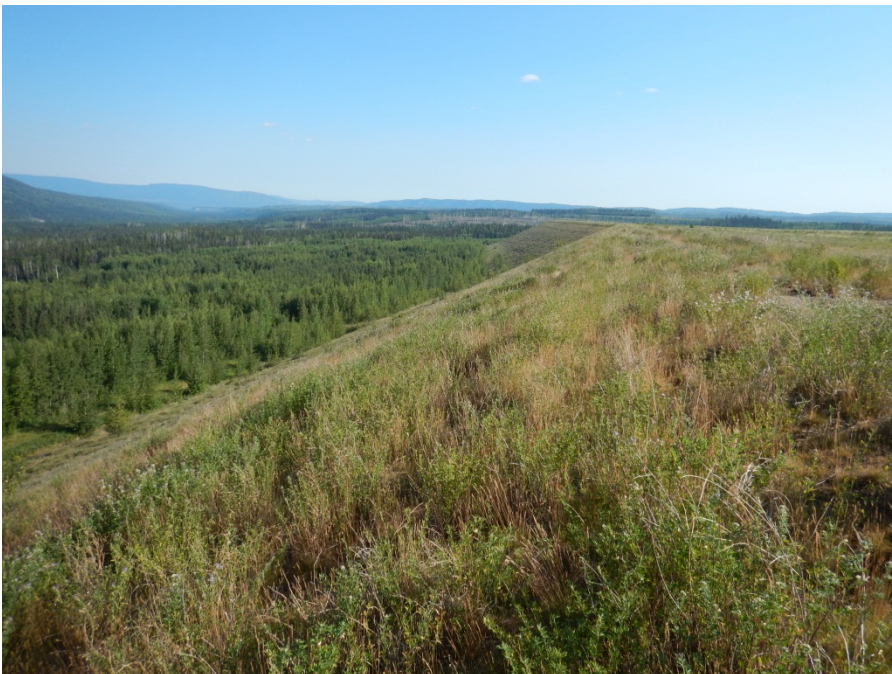
Photo I-7 Overview of downstream slope of dam, Sta. 0+475. (PS-2014-09)

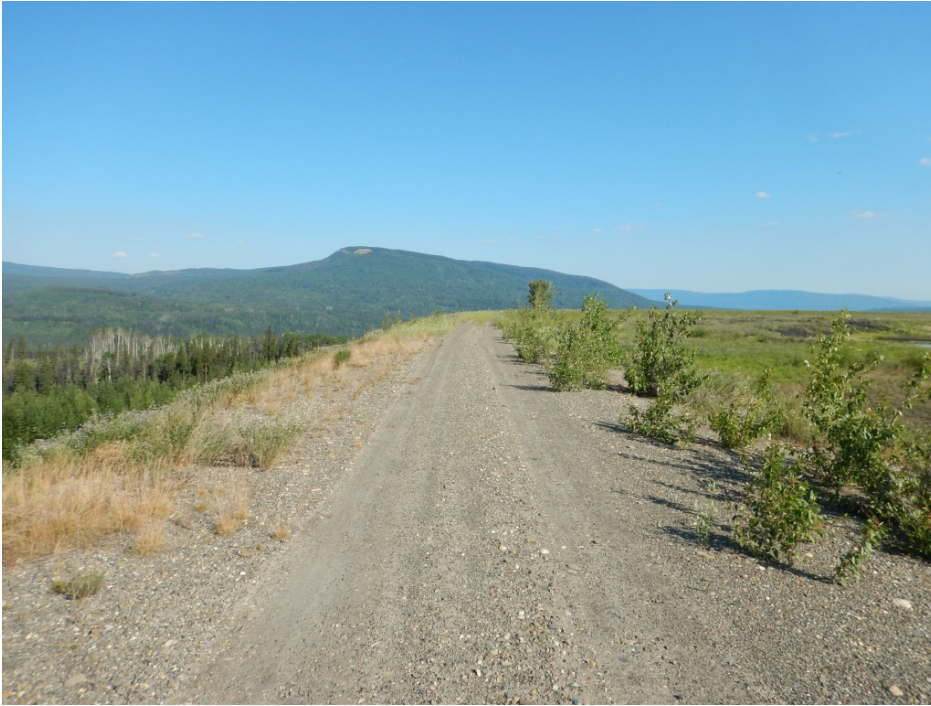
Photo I-8 Overview of dam crest, approximately Sta. 0+270. (PS-2014-07)

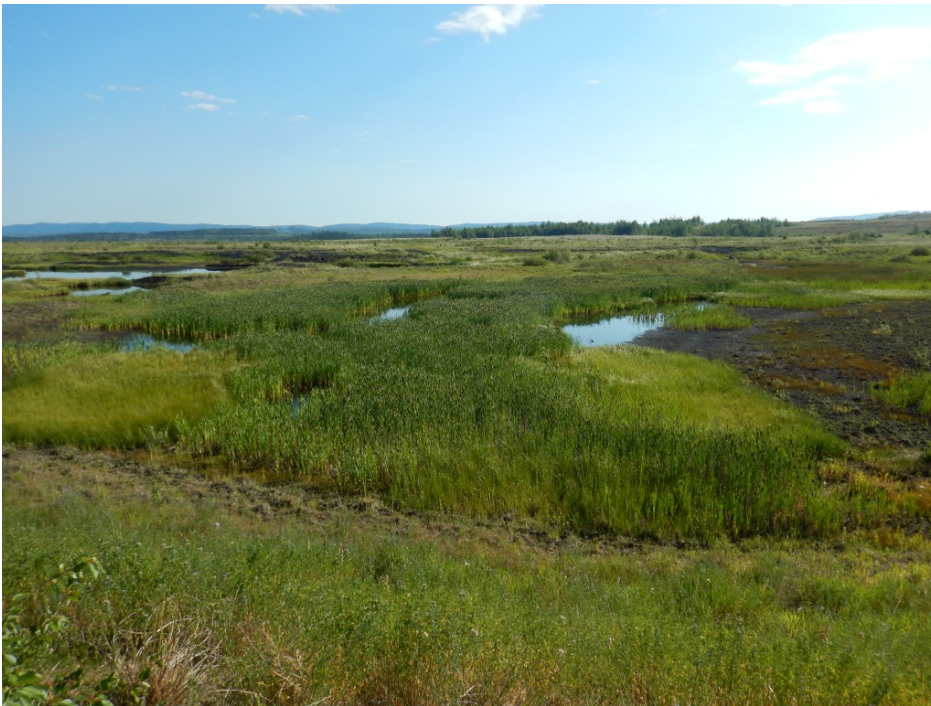
Photo I-9 Ponded water in a local depression in the tailings surface near the spillway outlet, approximately Sta. 0+400. (PS-2014-08)

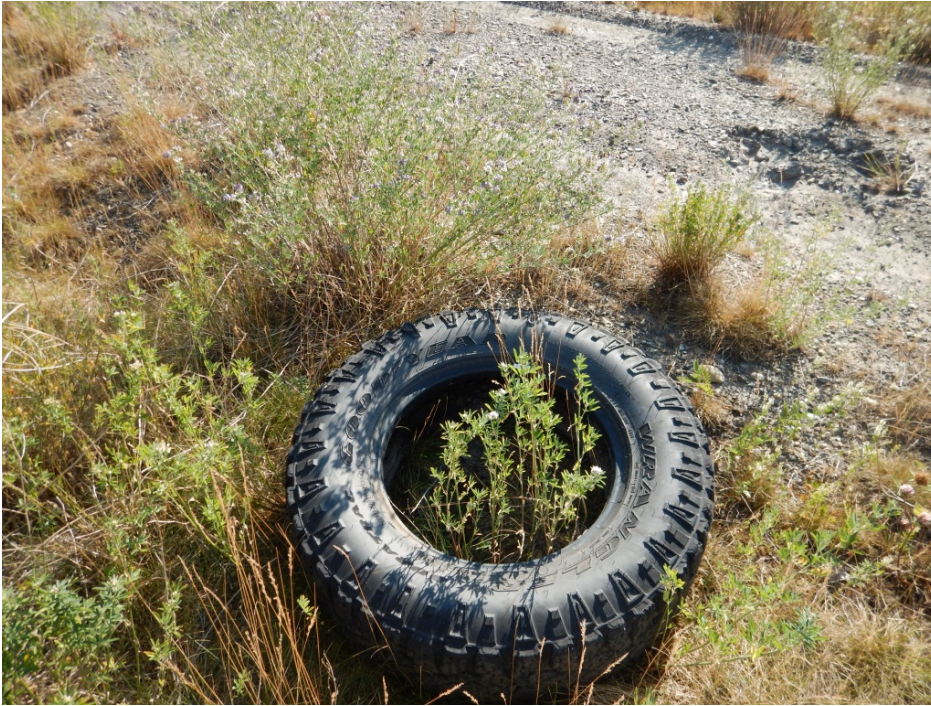
Photo I-10 Typical PTD crest survey prism (steel bar inside protective tire) installed during 2014. (PS-2014-10)

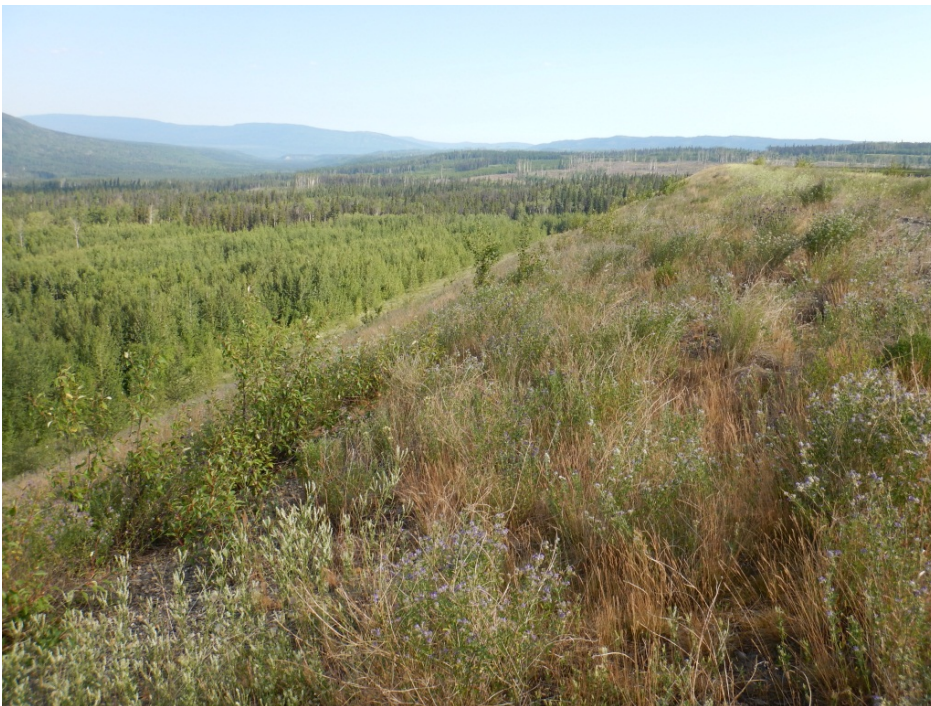
Photo I-11 Overview of downstream slope of the dam, approximately Sta. 1+150. (PS-2014-12)

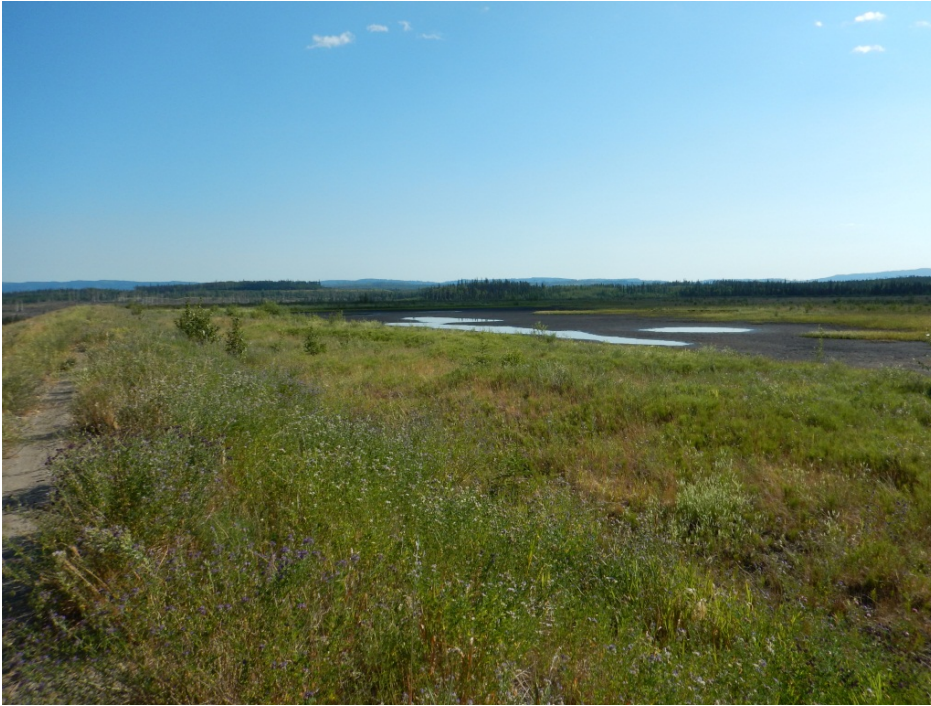
Photo I-12 **Ponded water in northwest corner of impoundment. Ponding was noted in this area noted during 2012 and 2013 DSI. (PS-2014-13)**

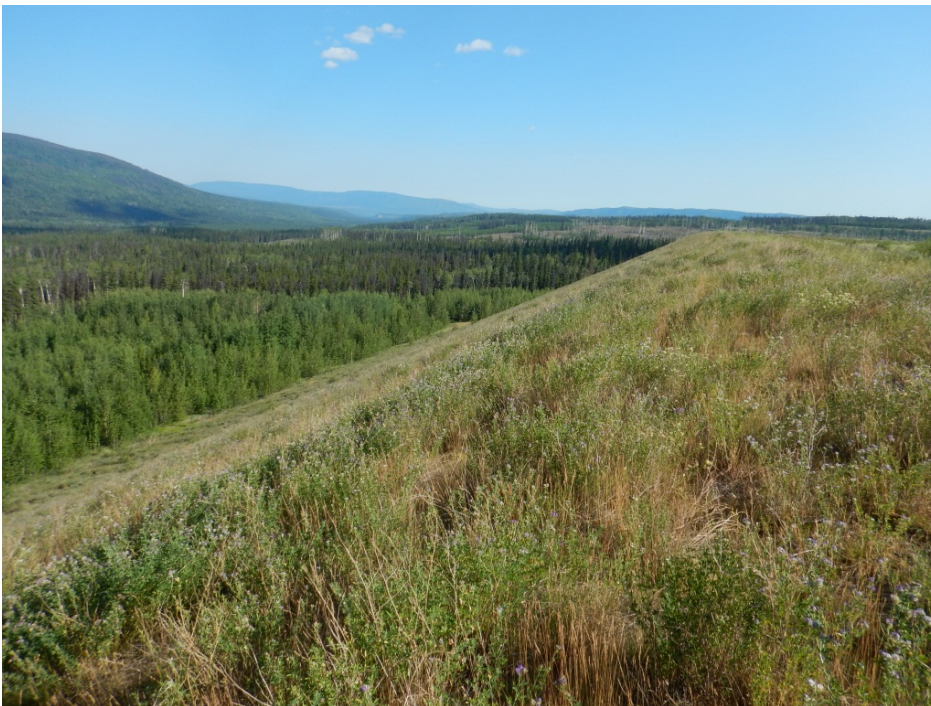
Photo I-13 **Overview of downstream slope of dam, approximately Sta. 1+550. (PS-2014-14)**

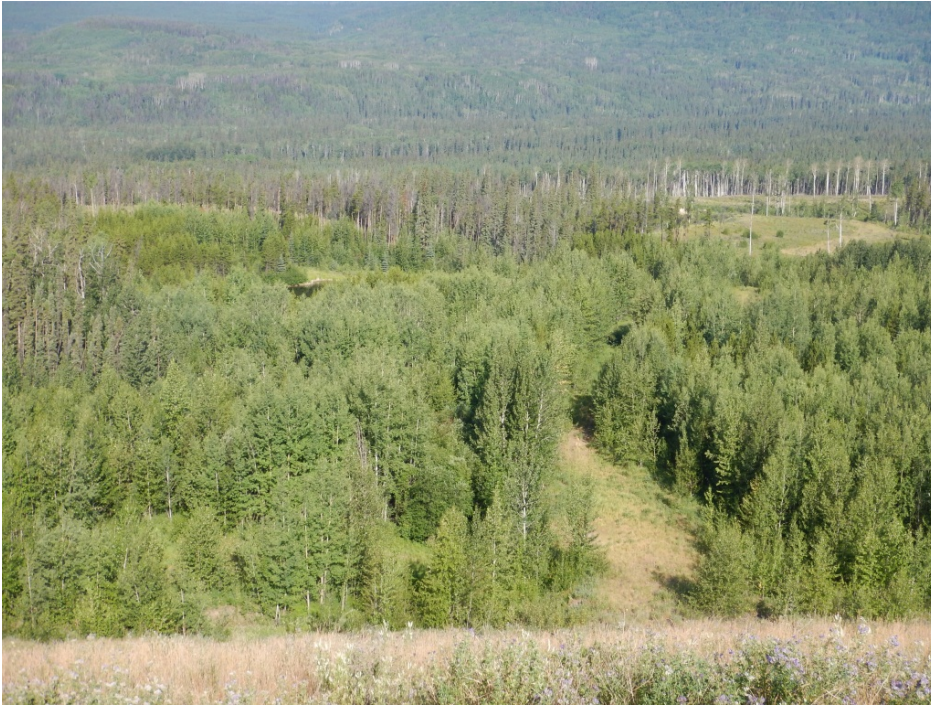
Photo I-14 Overview of access to Seepage Collection Pond, approximately Sta 0+825.
(PS-2014-11)

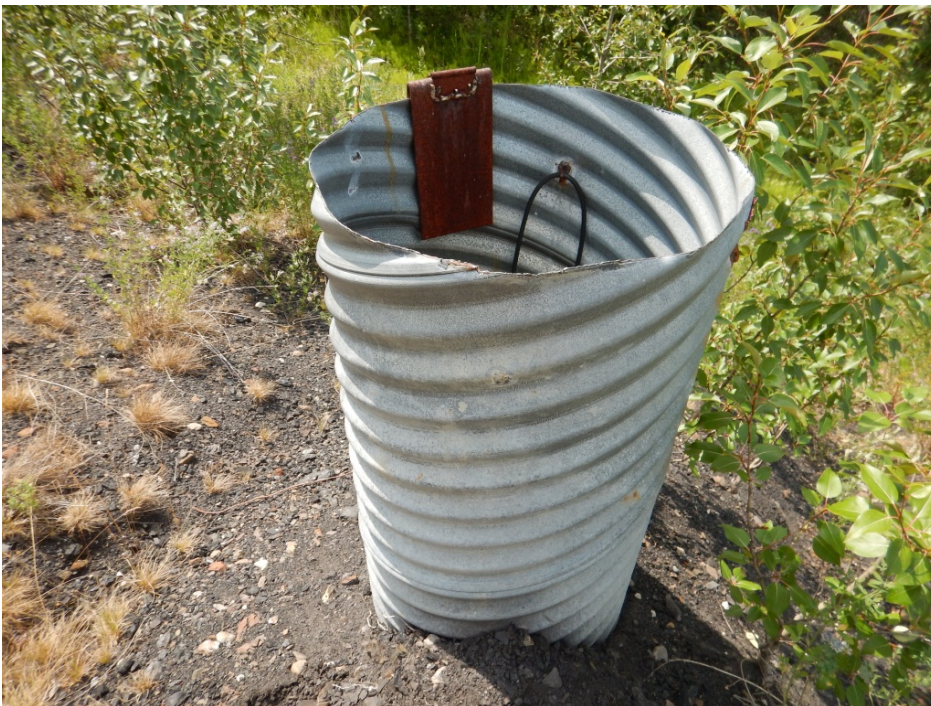
- Labels were not present on instrumentation leads, therefore measurements were inferred to piezometer ID based on comparison of measured pore pressure to historical readings. KCB recommend that new ID tags be added to instrument leads so reliable comparison of future readings can be made.

Photo I-15 Pneumatic piezometer leads (x3) at downstream toe of embankment. Sta. 0+475
readings collected during 2014 DSI. (PS-2014-26)

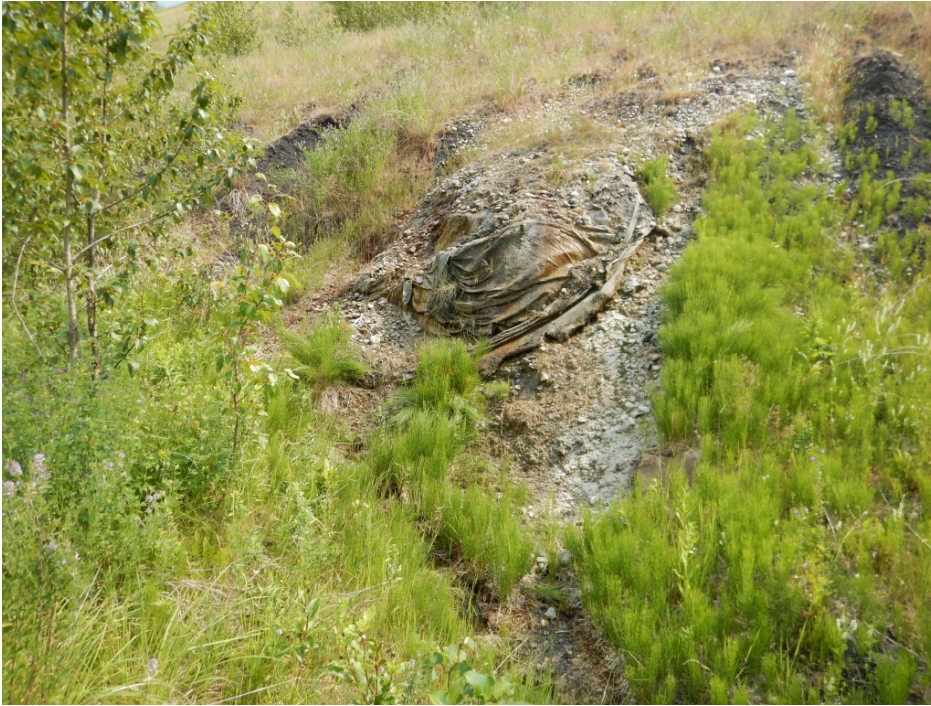
- **Seepage:** Minor seepage was observed from the underdrains constructed in the downstream shell at several locations along the downstream toe (Photos I-16). Where seepage was notably flowing from the underdrain, the water was clear. Most of the seepage areas or underdrains had no discernible flow but were identified based on wet ground or ponded water.

Photo I-16 Typical underdrain daylighting at toe of dam slope. Low rate of seepage visible from underdrain, approximately Sta. 1+150. (PS-2014-35)

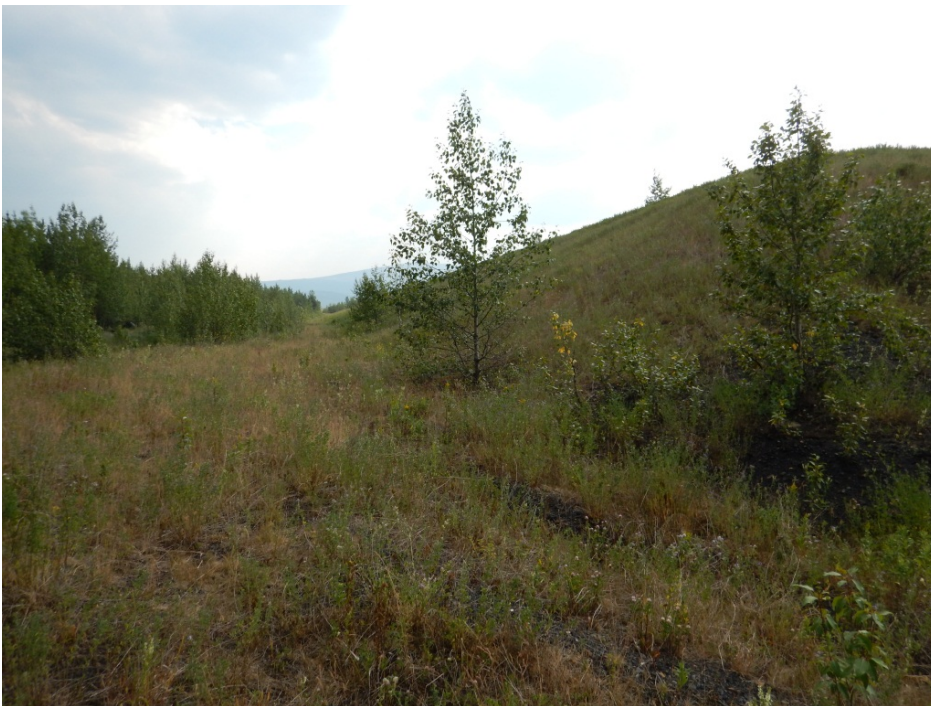
Photo I-17 Overview of downstream slope, approximately Sta. 2+040. (PS-2014-45)

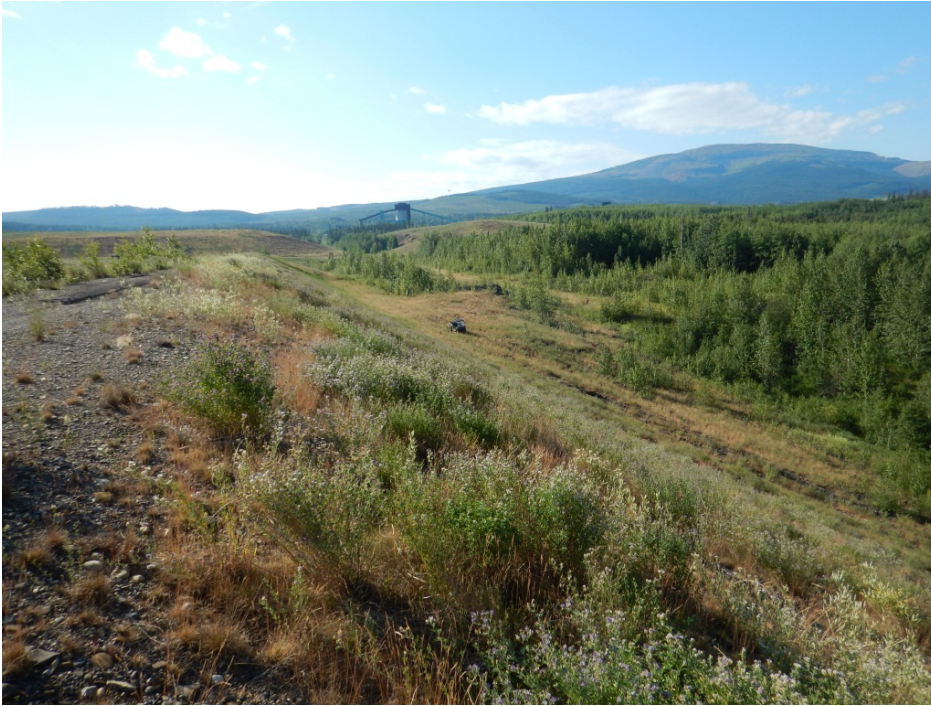
Photo I-18 Overview of downstream slope, approximately Sta. 0+270. (PS-2014-07)

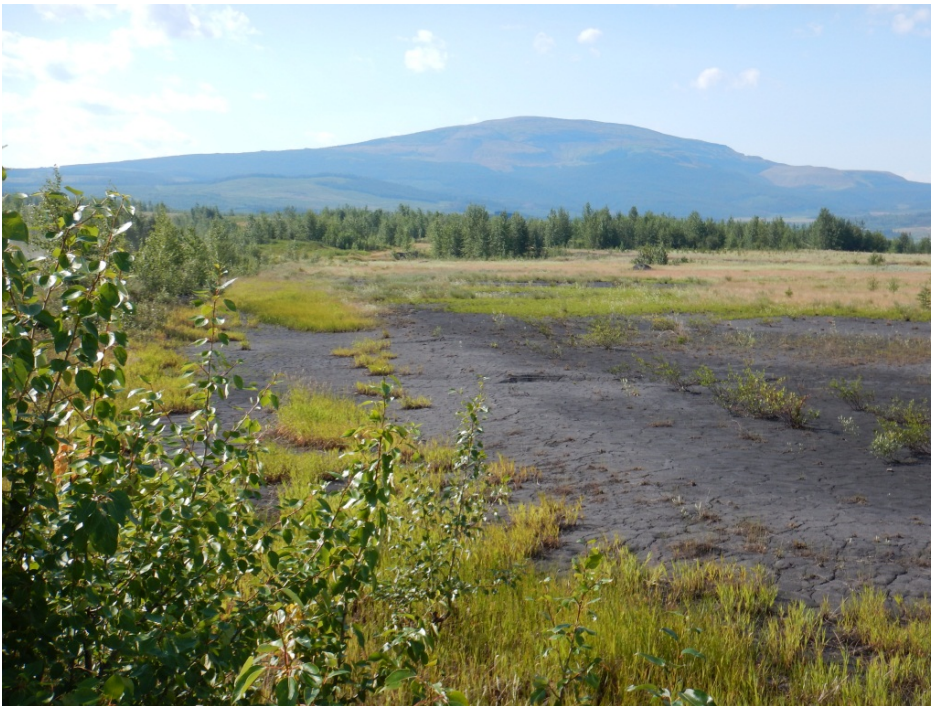
Photo I-19 Overview of tailings basin along northeast embankment. (PS-2014-16)

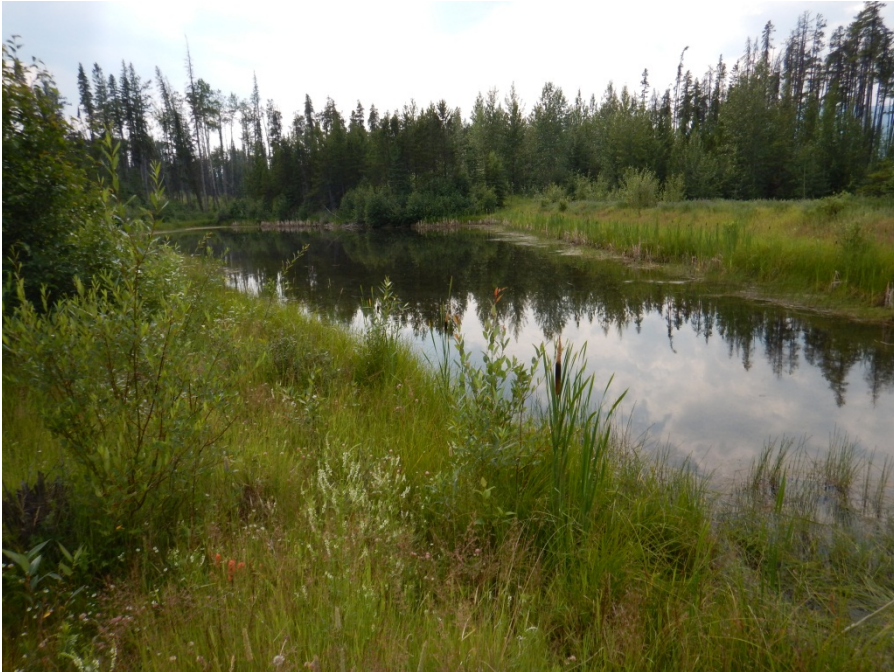
- **Seepage Collection Pond:** Good condition (Photos I-20 and I-21). There was no flow through the seepage pond outlet (Photos I-22).

Photo I-20 Seepage Collection Pond - north of the facility which discharges into M17B creek. (PS-2014-30)

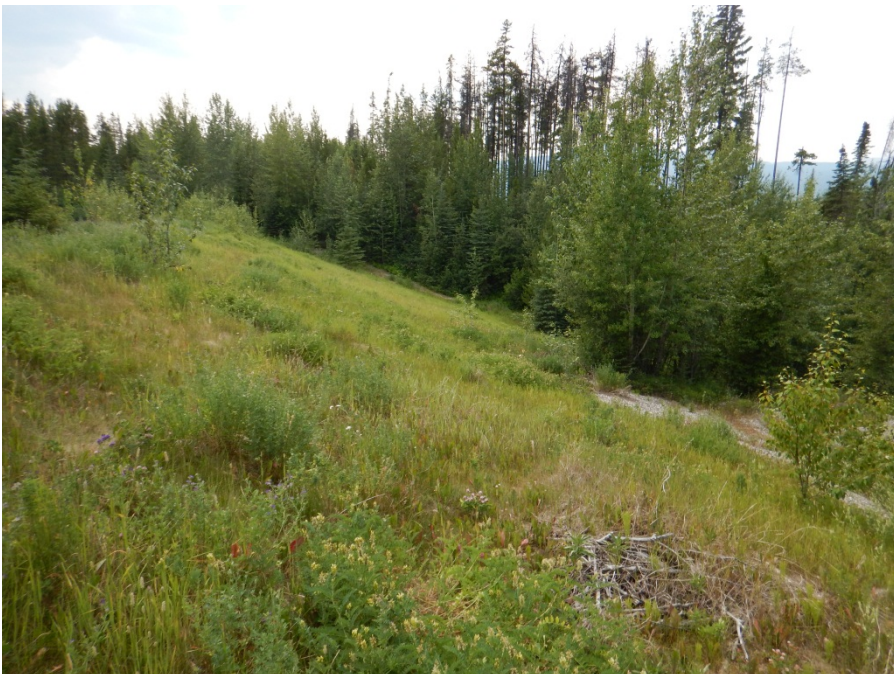
Photo I-21 Downstream slope of Seepage Collection Pond embankment. (PS-2014-31)

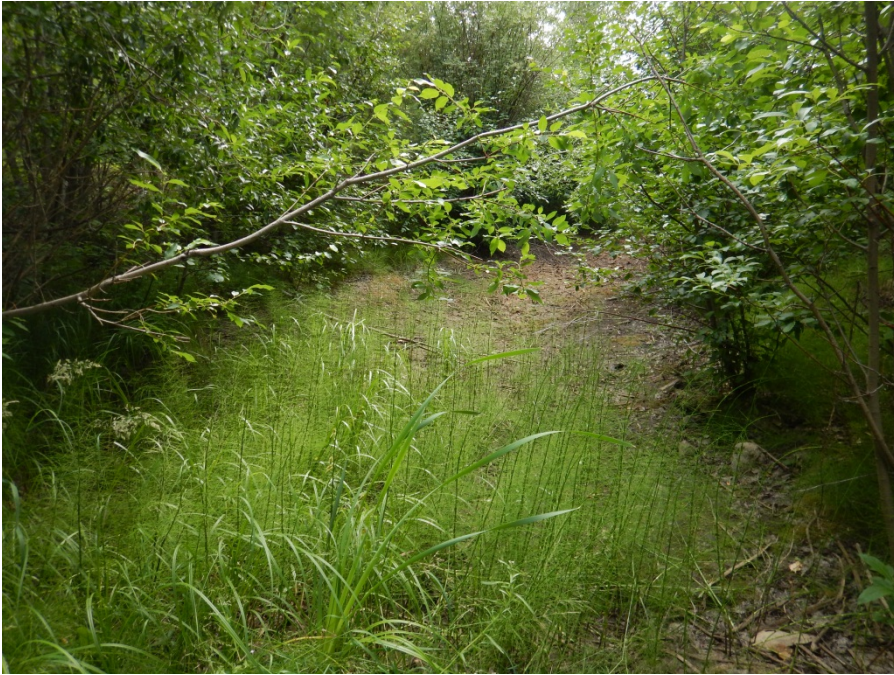
Photo I-22 **Seepage Collection Pond outfall channel, no flow observed. (PS-2014-32)**
