**Teck Coal Ltd.**

**Quintette Coal operations**

***Shikano North Tailings Dam***

***2014 Dam Safety Inspection***

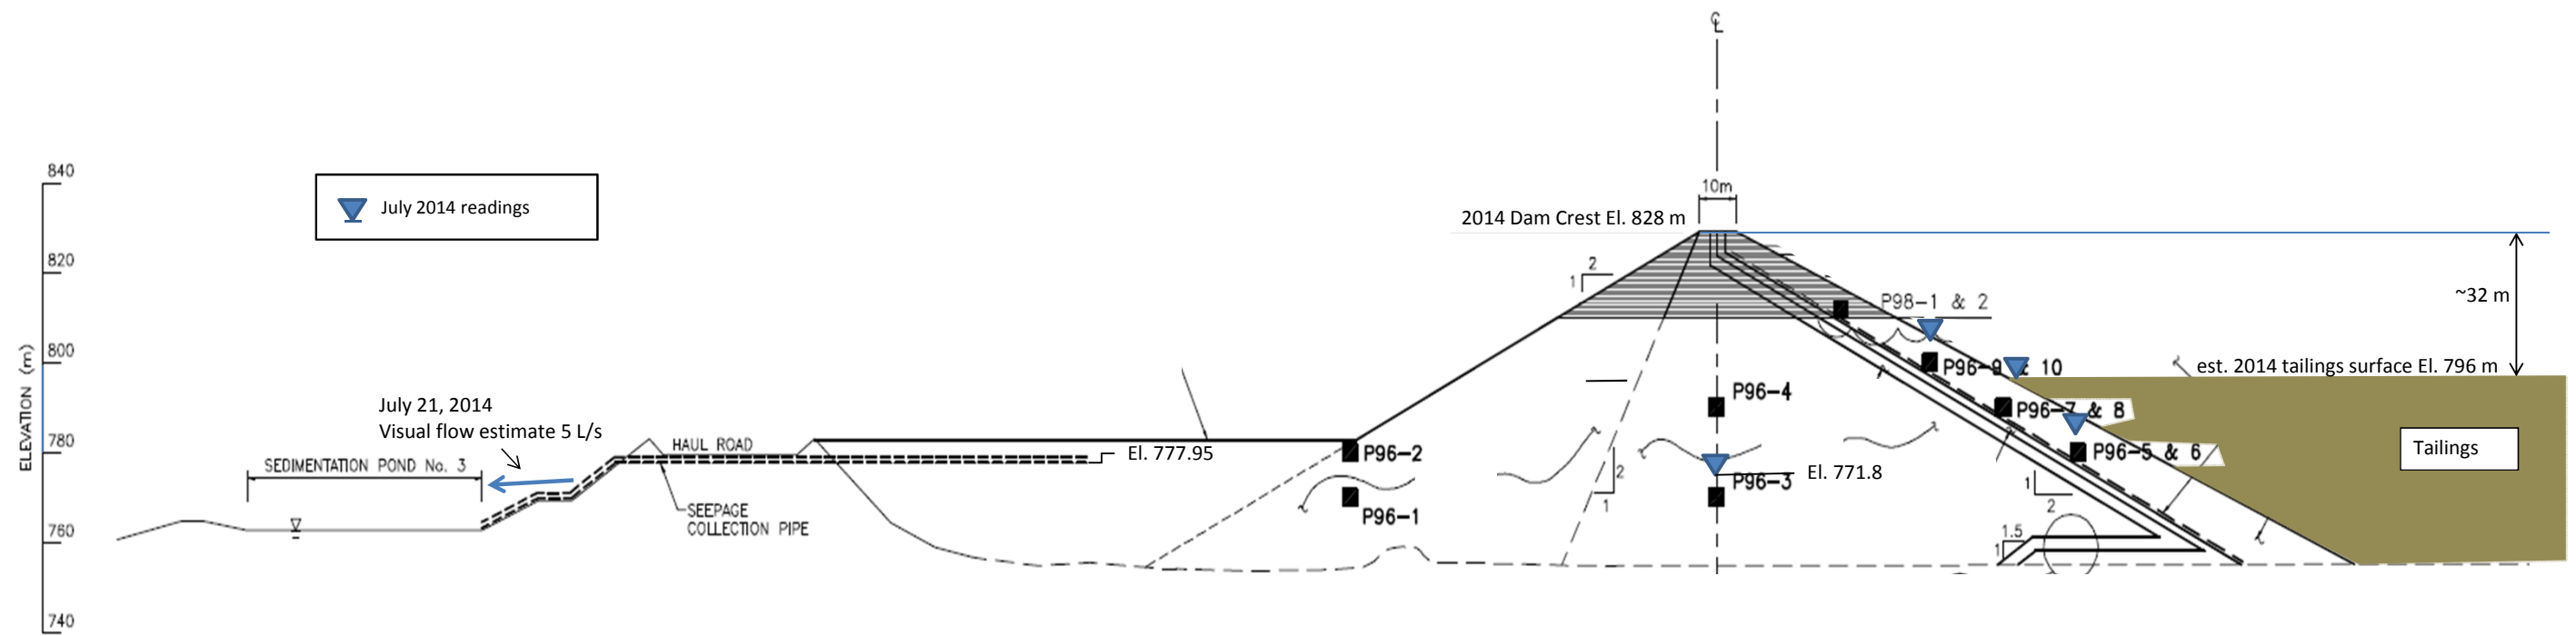
| Figure 2 | Shikano Tailings Dam Piezometer Readings |

- The pore pressure measured for piezometers at the same elevation upstream of the filter zones show a downward gradient in the upstream rockfill zone. This behaviour was observed during operations (KC, 1999a) and is likely caused by migration of fine tailings into the upstream rockfill zone lowering the permeability of the material. The pore pressures are not considered to be connected to the more recent development of sinkholes in the tailings beach.

- The reason why the measured pressure for P96-9 and P96-10 is above the current pond and tailings level is not known. The October 2014 readings were also above the tailings level but P96-10 pore pressure was 1.7 m less than the July, 2014. There is no visible seepage from the upstream face indicating a raised water level in the dam and P96-3 indicates the water level in the dam fill is below tailings level. Instrument error or locally entrained water around the instrument tip are the most likely causes for the readings. No follow up action is recommended to resolve this issue.

The piezometer readings indicate no change from historical performance and are below design threshold levels. KCB recommends annual piezometer readings during the “care and maintenance” period. Piezometer readings should be available for review during future DSIs.

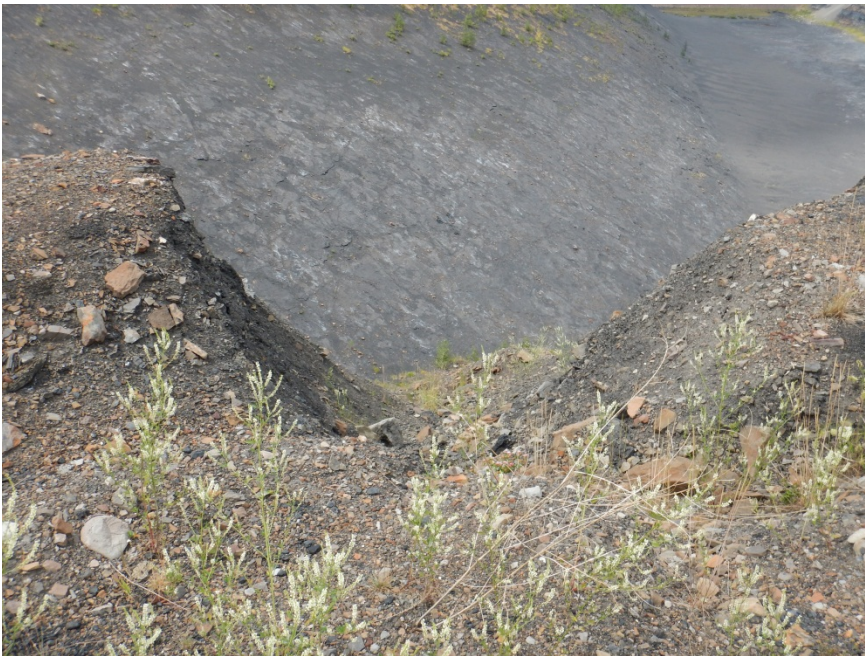
- **Erosion at southern edge of basin:** At the southeastern boundary of the impoundment, runoff flows into the impoundment through gaps in the roadside safety berms (Photo I-3). This has resulted in progressive erosion that is encroaching on the access road through this area (Photo I-4). The erosion features are approximately 4 m away from the road surface (same as noted during 2013 DSI). This does not pose a dam safety risk but additional safety berms or some other barrier between these erosion features and the roadway is recommended (Teck report this was completed in August, 2014).

**Photo I-3 Erosion of the upslope crest of the Southern Basin Wall near the access road where flow is concentrated through openings in the roadside perimeter berms. No significant observed changes since 2013 DSI. (NSTD-2014-13)**

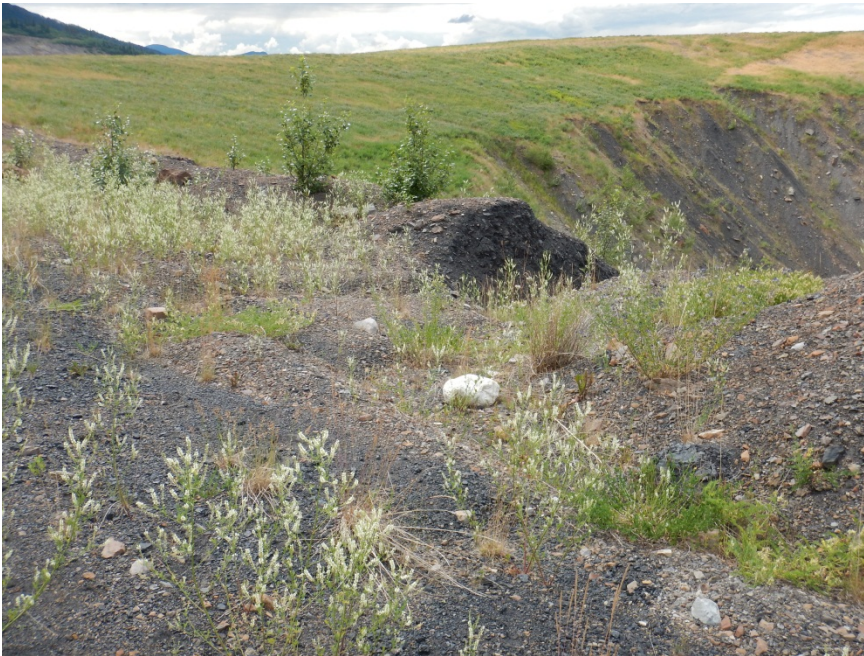
**Photo I-4** Erosion shown in Photo I-3 is encroaching on the access road (offset approximately 4 m). Safety berms constructed to the Code are recommended between the access road and erosion features. No significant observed changes since 2013 DSI. (NSTD-2014-13)

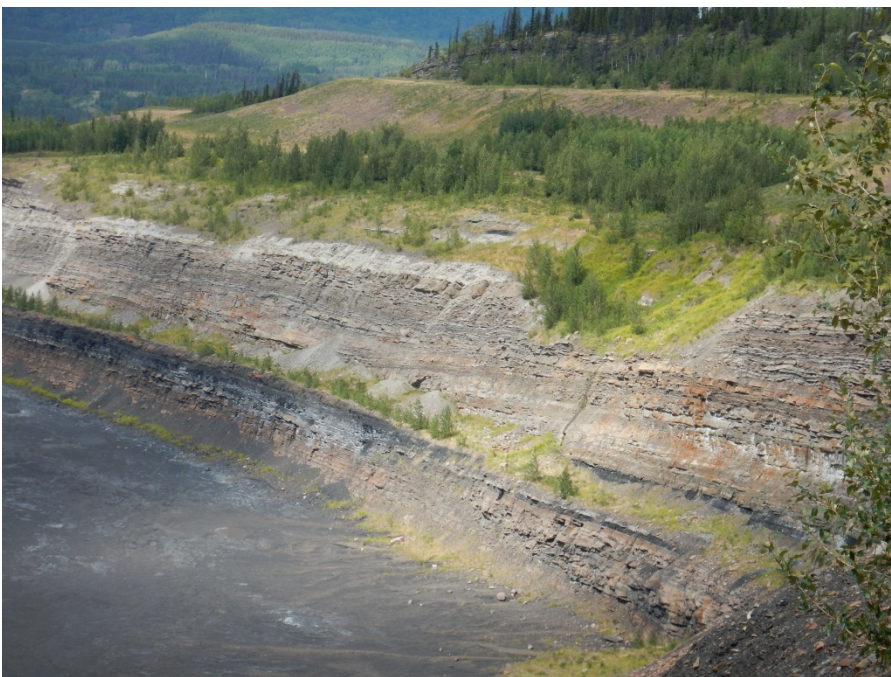
- **Historic Slumping of Pit Wall:** a historic slumping failure is present on the eastern side of the impoundment (Photo I-5) in the old pit wall. No significant change was observed in the area since the 2012 DSI.

**Photo I-5** View of historic slumping failure on the Eastern Basin Wall. No significant observed changes since 2013 DSI. (NSTD-2014-13)

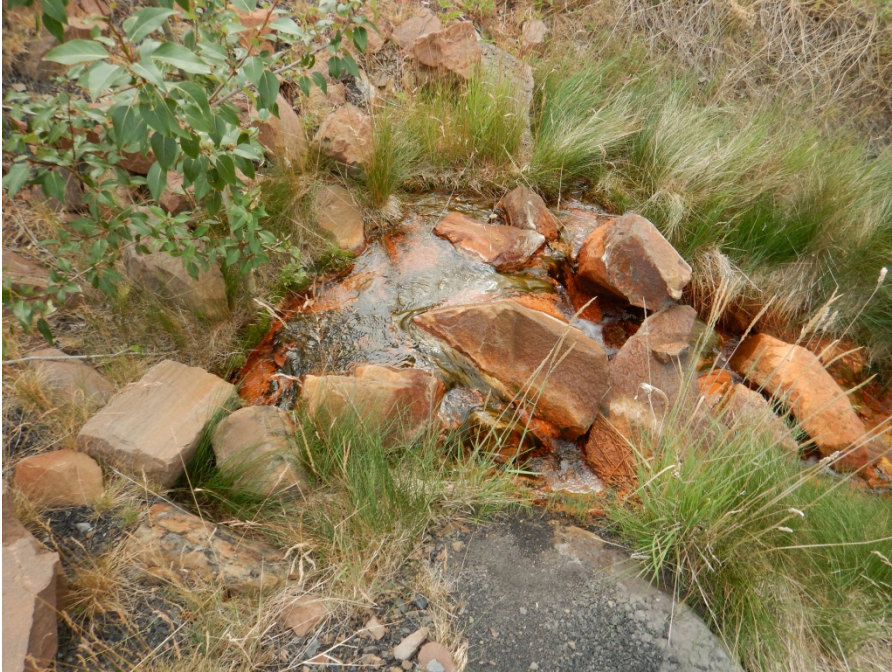
**Photo I-6** Seepage discharge from low level outlet downstream of dam. (NSTD-2014-11)

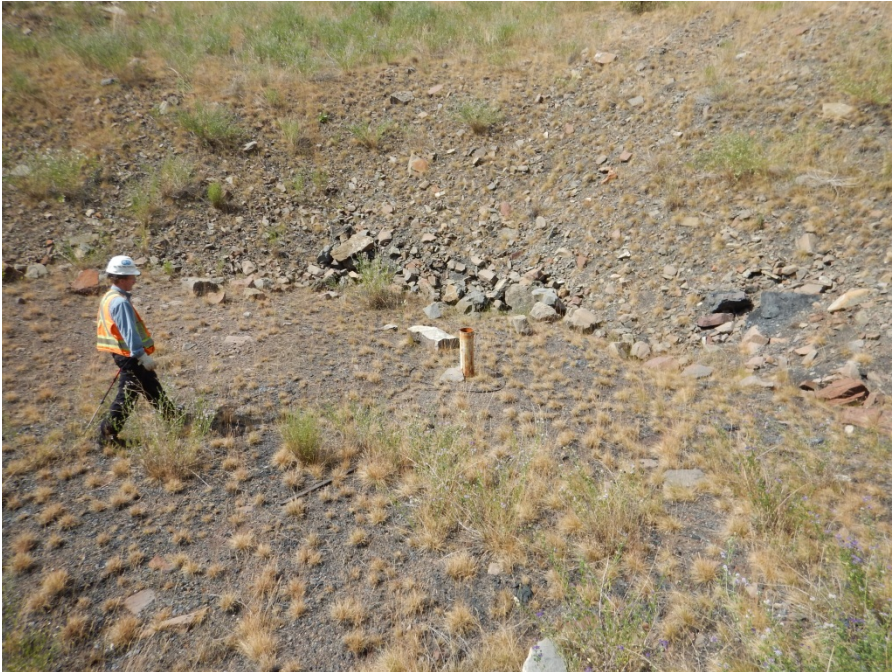
- Instruments are accessible and functioning with the exception of:
  - ◆ P96-1 and P96-2 instrument leads were not accessible or the instruments have been removed from drill casing.
  - ◆ P96-4 instrument cable was noted as plugged in KC (1999a) and the instrument did not give an appropriate reading (+450 kPa), so it has been disregarded.
  - ◆ P98-1 and P98-2 were not found.
- P95KC-2A/2B drill casing was located but instruments not tested. These readings should be included in the next DSI site visit.

**Photo I-10** P96-1 and P96-2 surface casing. No piezometer cables accessible in casing.

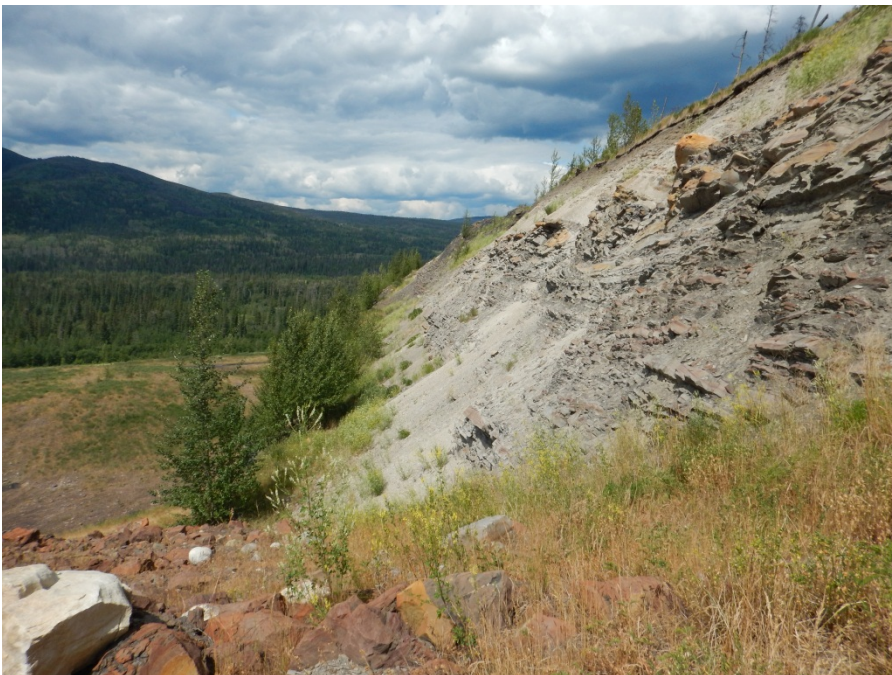
**Photo I-11** No Signs of recent movement or settling along the pit wall downstream of the NSTD or at the east abutment contact. (NSTD-2014-02)

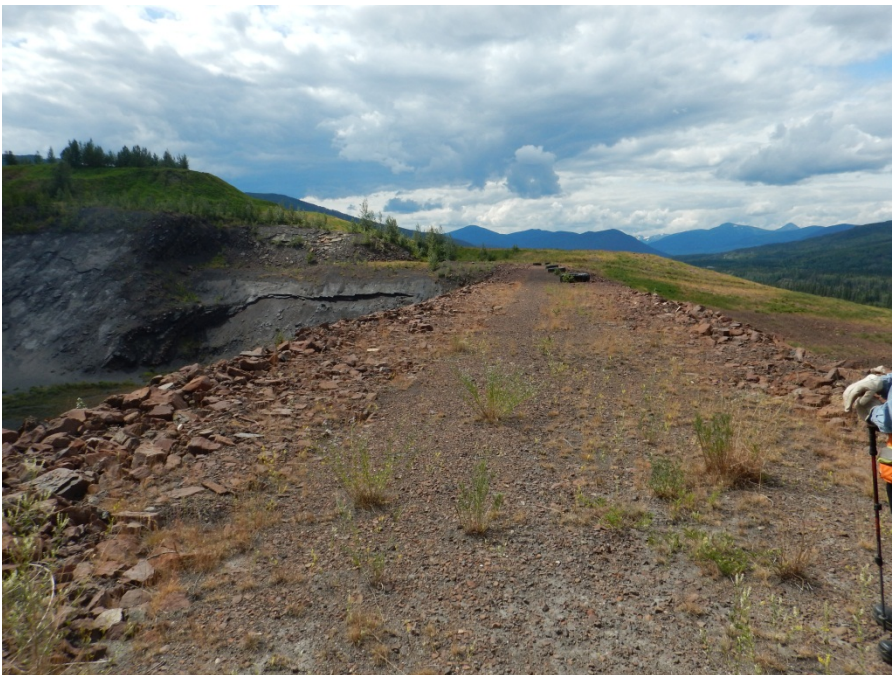
- **Dam Crest:** Good condition. No signs of lateral movement, significant differential settlement or cracking of the dam crest (Photo I-13).
- **Downstream Slope:** Good condition. No visible signs of significant erosion or displacement and no vegetation cover (Photo I-15).

**Photo I-13 Overview of NSTD dam crest. No signs of movement or settling (e.g. sinkholes, cracks, slumping) observed. (NSTD-2014-02)**

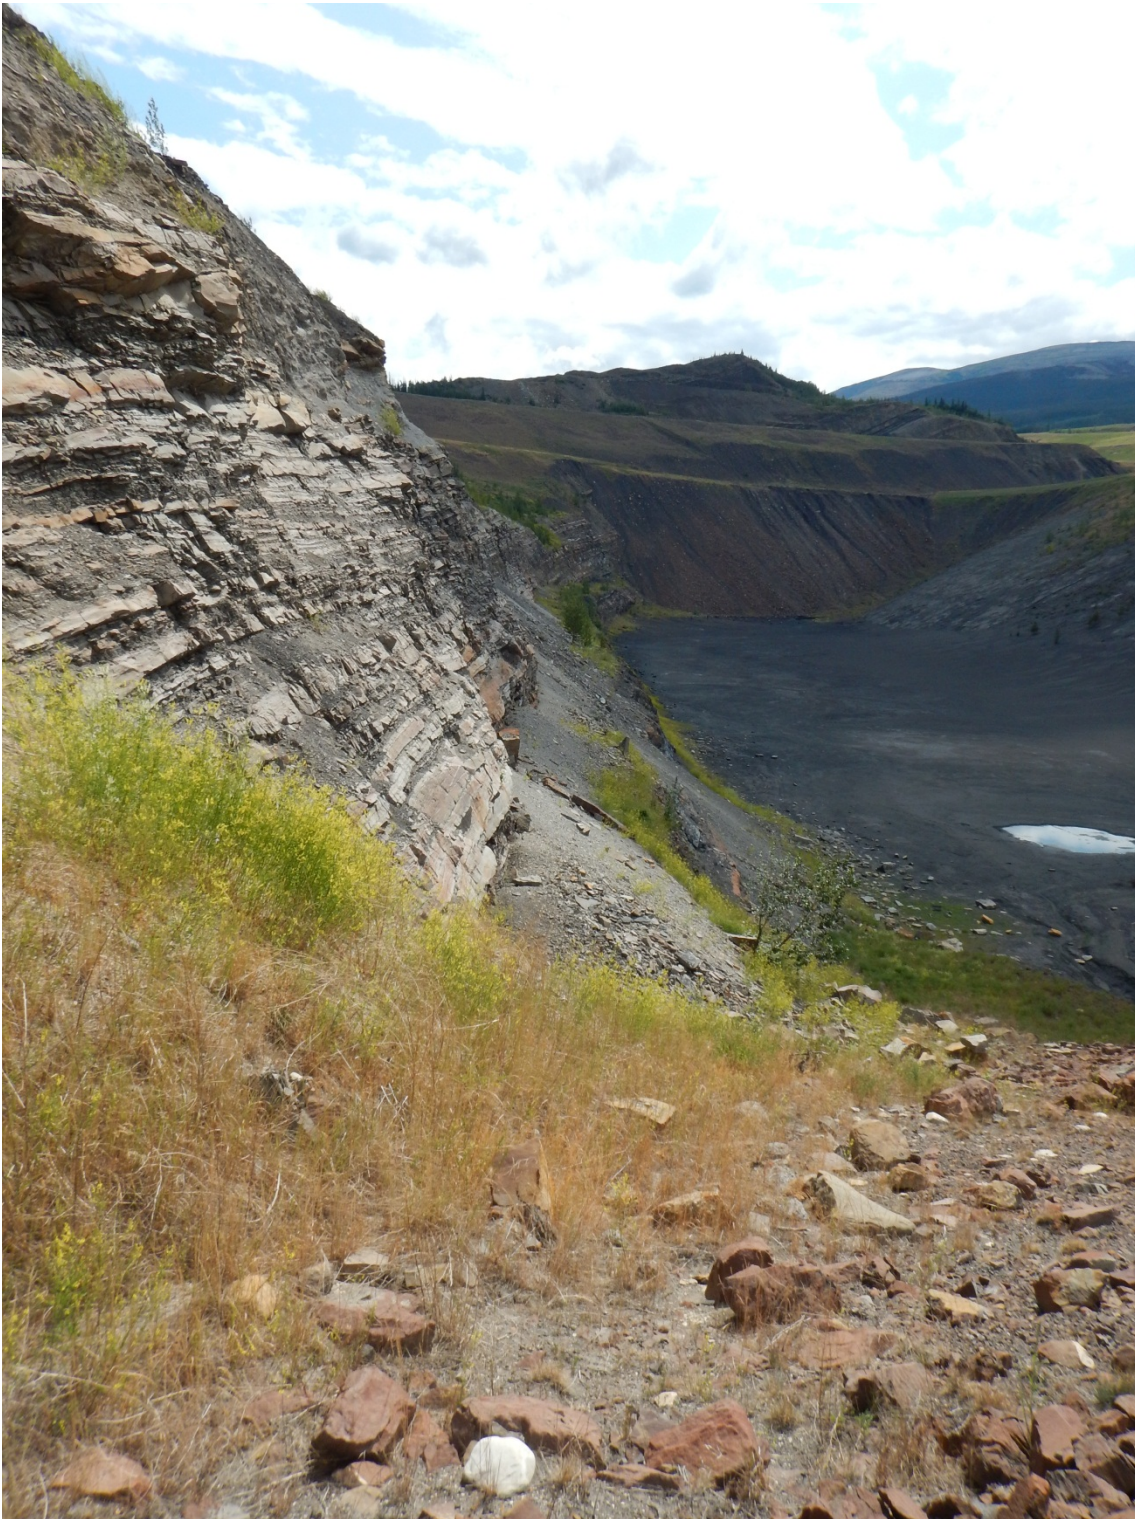
- **East Abutment:** Good condition. No visible signs of significant erosion or displacement of the pit wall (Photo I-14 and Photo I-18).
- **Tailings Impoundment:** The impoundment area was sparsely vegetated near the pond and dam. Away from the pond the tailings surface is well drained and supports human traffic (Photo I-2 and Photo I-12). The pond volume was smaller than observed during the 2012 or 2013 DSIs. The pond was set back approximately 70 m from the upstream slope of the dam.

**Photo I-14 Pit wall slope upstream of east abutment. (NSTD-2014-02)**

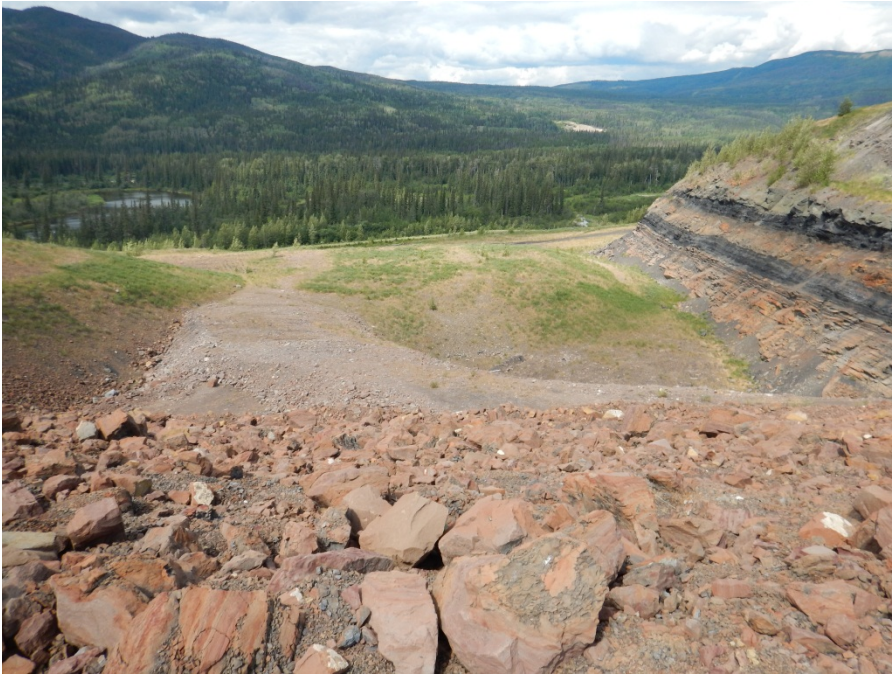
**Photo I-15** Downstream slope overview taken from mid-crest. (NSTD-2014-03)

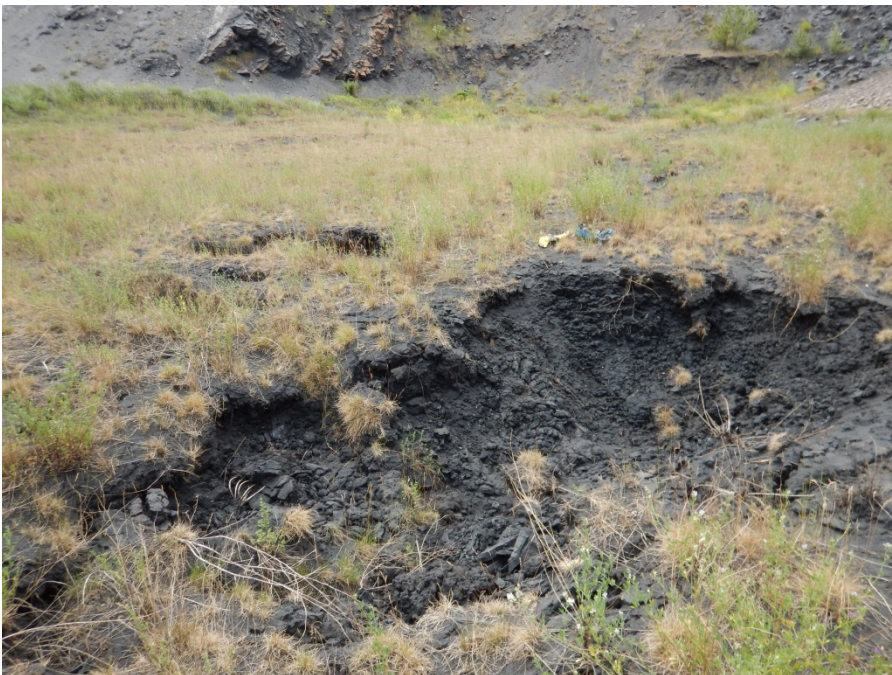
- **Sinkhole Depressions in Tailings Beach:** A cluster of three sinkholes were observed on the tailings beach (Photo I-16). These features have been noted since the 2010 DSIs but the time which they started to form is not known. There was a notable increase in size between the 2012 and 2013 DSIs but a less significant increase in size noted in 2014. The largest of the holes was approximately 7 m by 3 m and 1.5 m deep. The cause of these features is most likely migration of tailings into the upstream coarse rockfill shell which is upstream of the filters. This is a local condition and does not indicate piping through the internal filter zones in the dam. No action in addition to monitoring during ongoing DSIs is required at this time.

**Photo I-16** Sinkholes observed on tailings beach, refer to Section 5 of main text. (NSTD-2014-05)

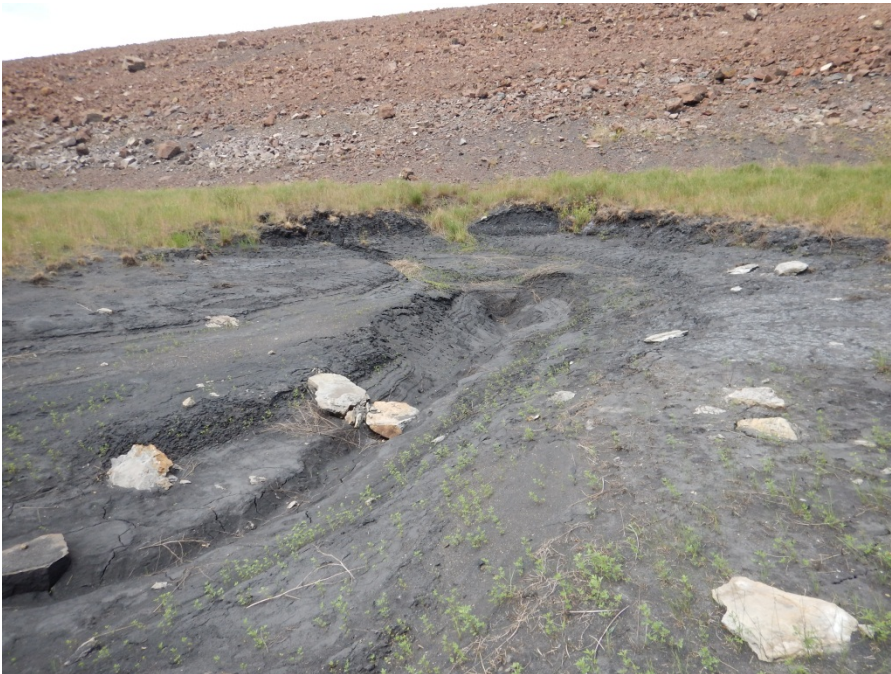
**Photo I-17**     **Drainage channel from the existing pond to the upstream face of the NSTD to promote seepage was unobstructed and dry. (NSTD-2014-07)**

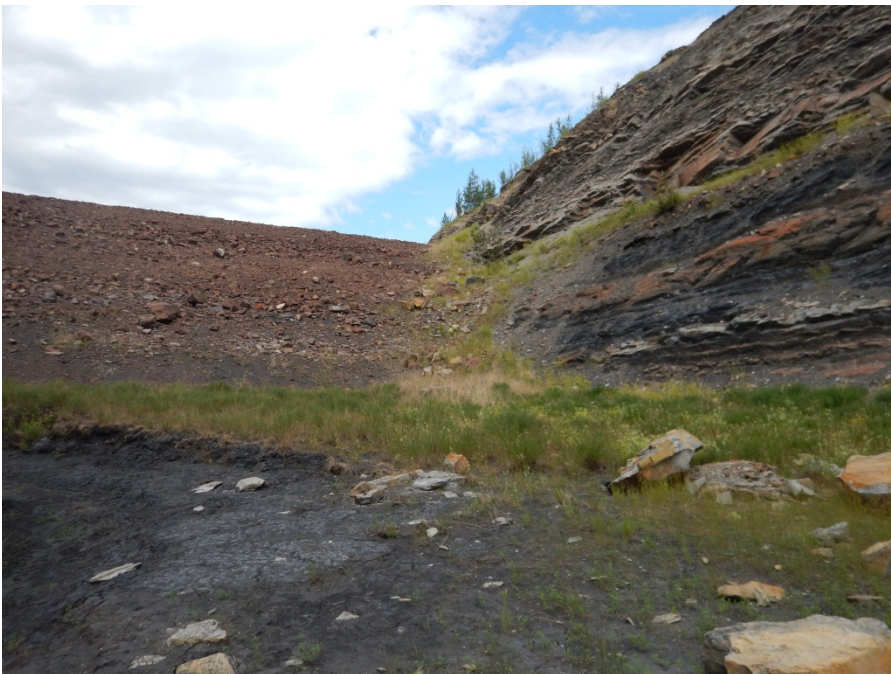
**Photo I-18**     **Upstream contact of east abutment. (NSTD-2014-07)**

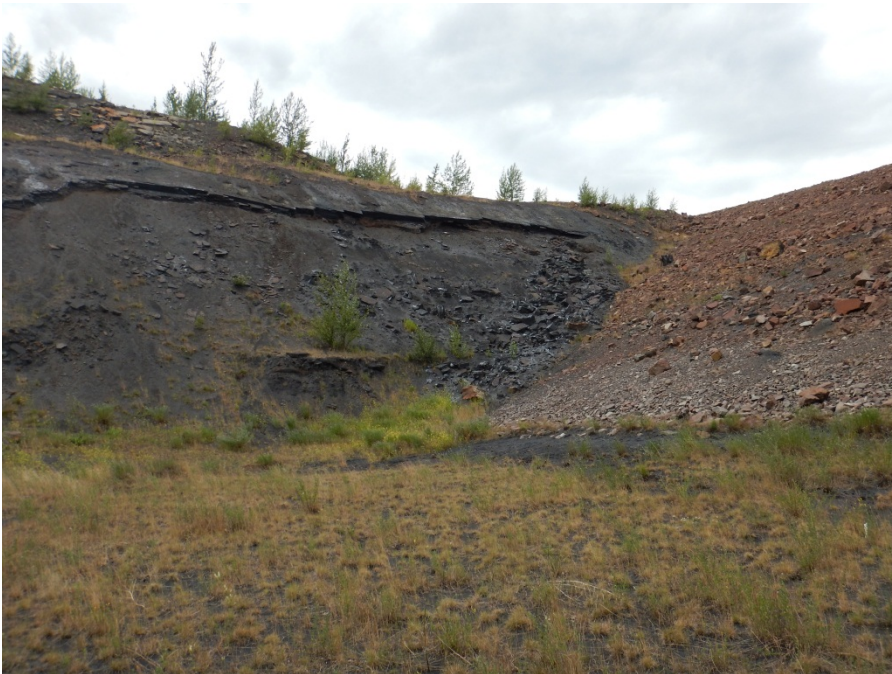
- **Upstream Slope:** Good condition. No visible signs of significant erosion or displacement and no vegetation cover (Photo I-21).
- **West Abutment:** Good condition. No visible signs of significant erosion or displacement of the pit wall (Photo I-19 and Photo I-20).

**Photo I-19** Upstream slope of dam and west abutment contact. (NSTD-2014-04)

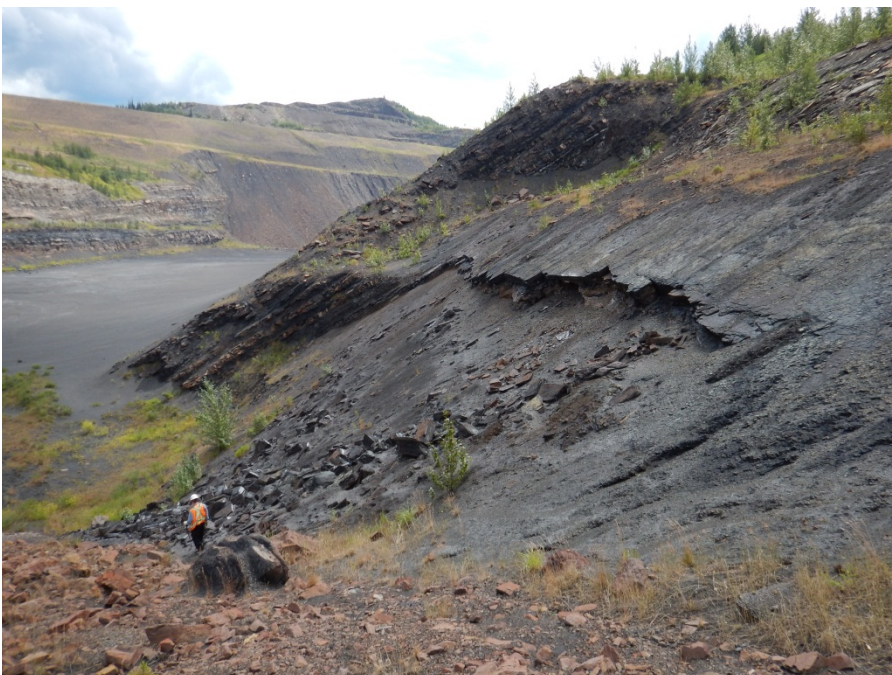
**Photo I-20** Ravelling of the exposed rock face upstream of the west abutment caused by weathering of alternating beds of sandstone and shale. No significant change from 2013 DSI.

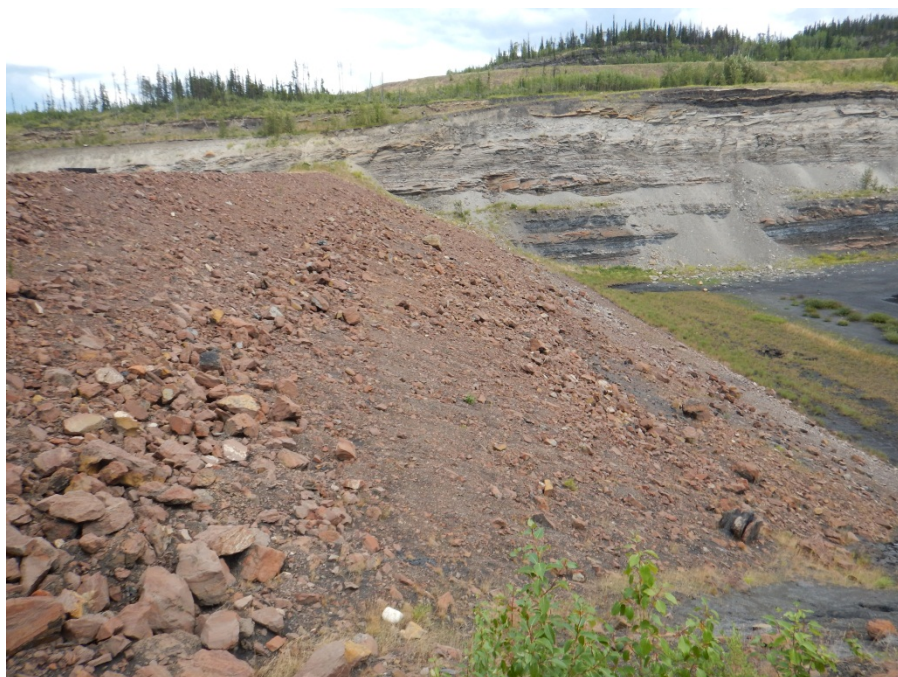
**Photo I-21**    **Overview of upstream dam slope.**
