November 25, 2014

Imperial Metals Ltd.  
580 Hornby Street  
Vancouver, British Columbia  
V6C 3B6

**DSR - North Starter Dam**  
**Independent Third Party Review**

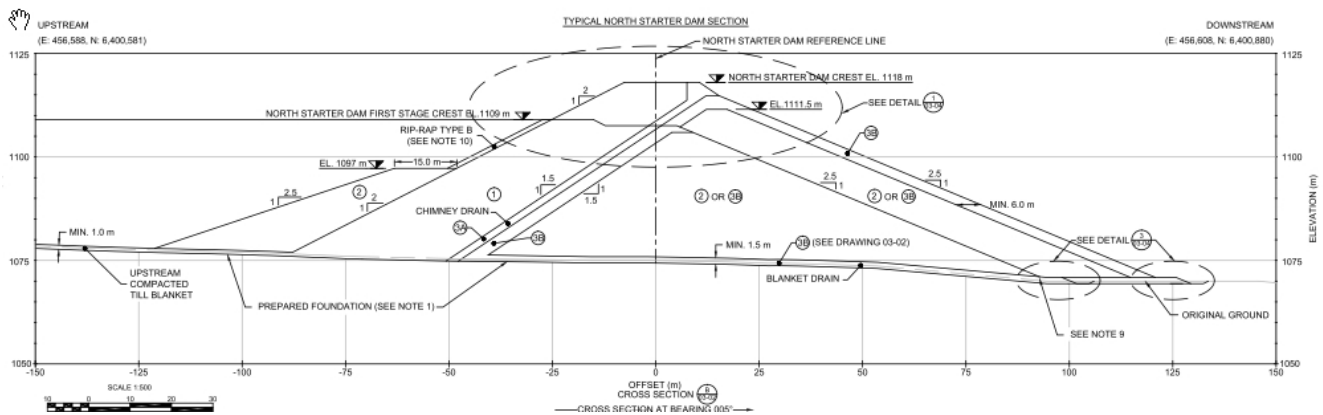
**Figure 3.1 Typical Section for NSD**

A typical design section through the dam is shown in Figure 3.1. The NSD at a final crest elevation of 1118 m will be 43 m high with a 2.5H:1V downstream slope and the same upstream slope to El. 1097 m and 2H:1V above that. The dam was constructed to El. 1097 m in 2013. At the time of our site visit in September 3 and 4, 2014, the 2014 dam construction was just starting with the intention of raising the dam to at least 1104 m in 2014 and as high as 1109 m, weather permitting. We do not know the current height of the dam.

The dam section comprises an impervious sloping core (Zone 1), a filter (Zone 3A) and a drain (Zone 3B) with a supporting downstream granular shell. The filter/drain opposite the core is connected to finger drains which convey seepage to the toe of the dam. There will also be riprap on the upstream slope down to El. 1109 m.

The dam rests on dense, granular glacio-fluvial sediments to depth of 80 m. An impervious blanket extends from the core upstream to limit seepage gradients through the pervious foundation soils. As well as data from test hole logs the writer observed dense outcrops of sands and gravels upstream of the dam in exposed borrow areas. There were no indications of lacustrine deposits in the test hole logs or in the outcrops.

For this 2.5H:1V downstream slope with a dense granular foundation and properly functioning filter and drains, the Factor of Safety will be well in excess of 1.5. The static factor of safety for the existing condition, crest at El. 1097 m, was checked by the writer using Bishop and Morgenstern (1960)<sup>3</sup>.
