## **RED CHRIS DEVELOPMENT COMPANY LTD.**

### **RED CHRIS TAILINGS FACILITY**

## **2014 DAM SAFETY INSPECTION REPORT**

PROJECT NO.: 0866001.14.7  
DATE: November 24, 2014  
DOCUMENT NO.: 0866001.14.002

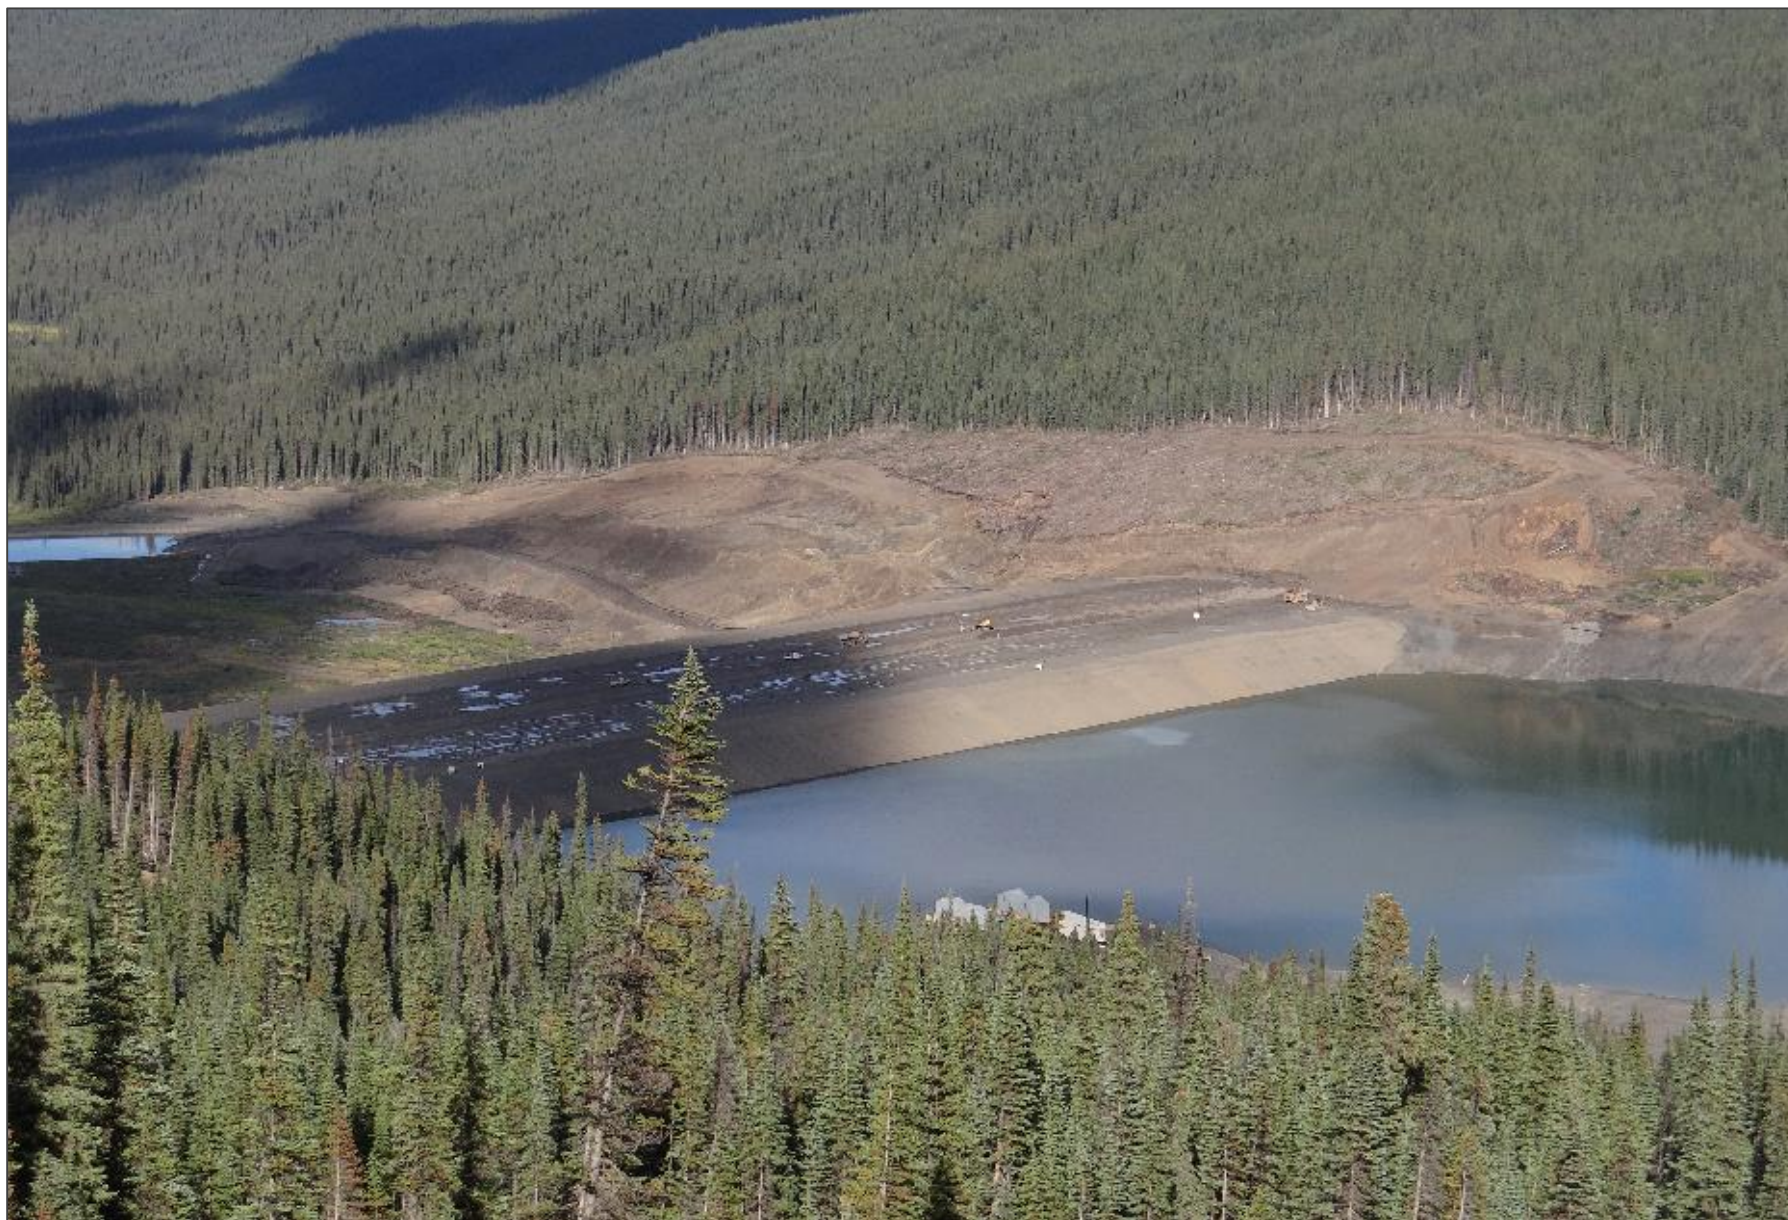
View of the crest and upstream face of the NSD, looking northwest, from vantage point on the TSF access road. Note ponds on dam surface due to recent rainfall.

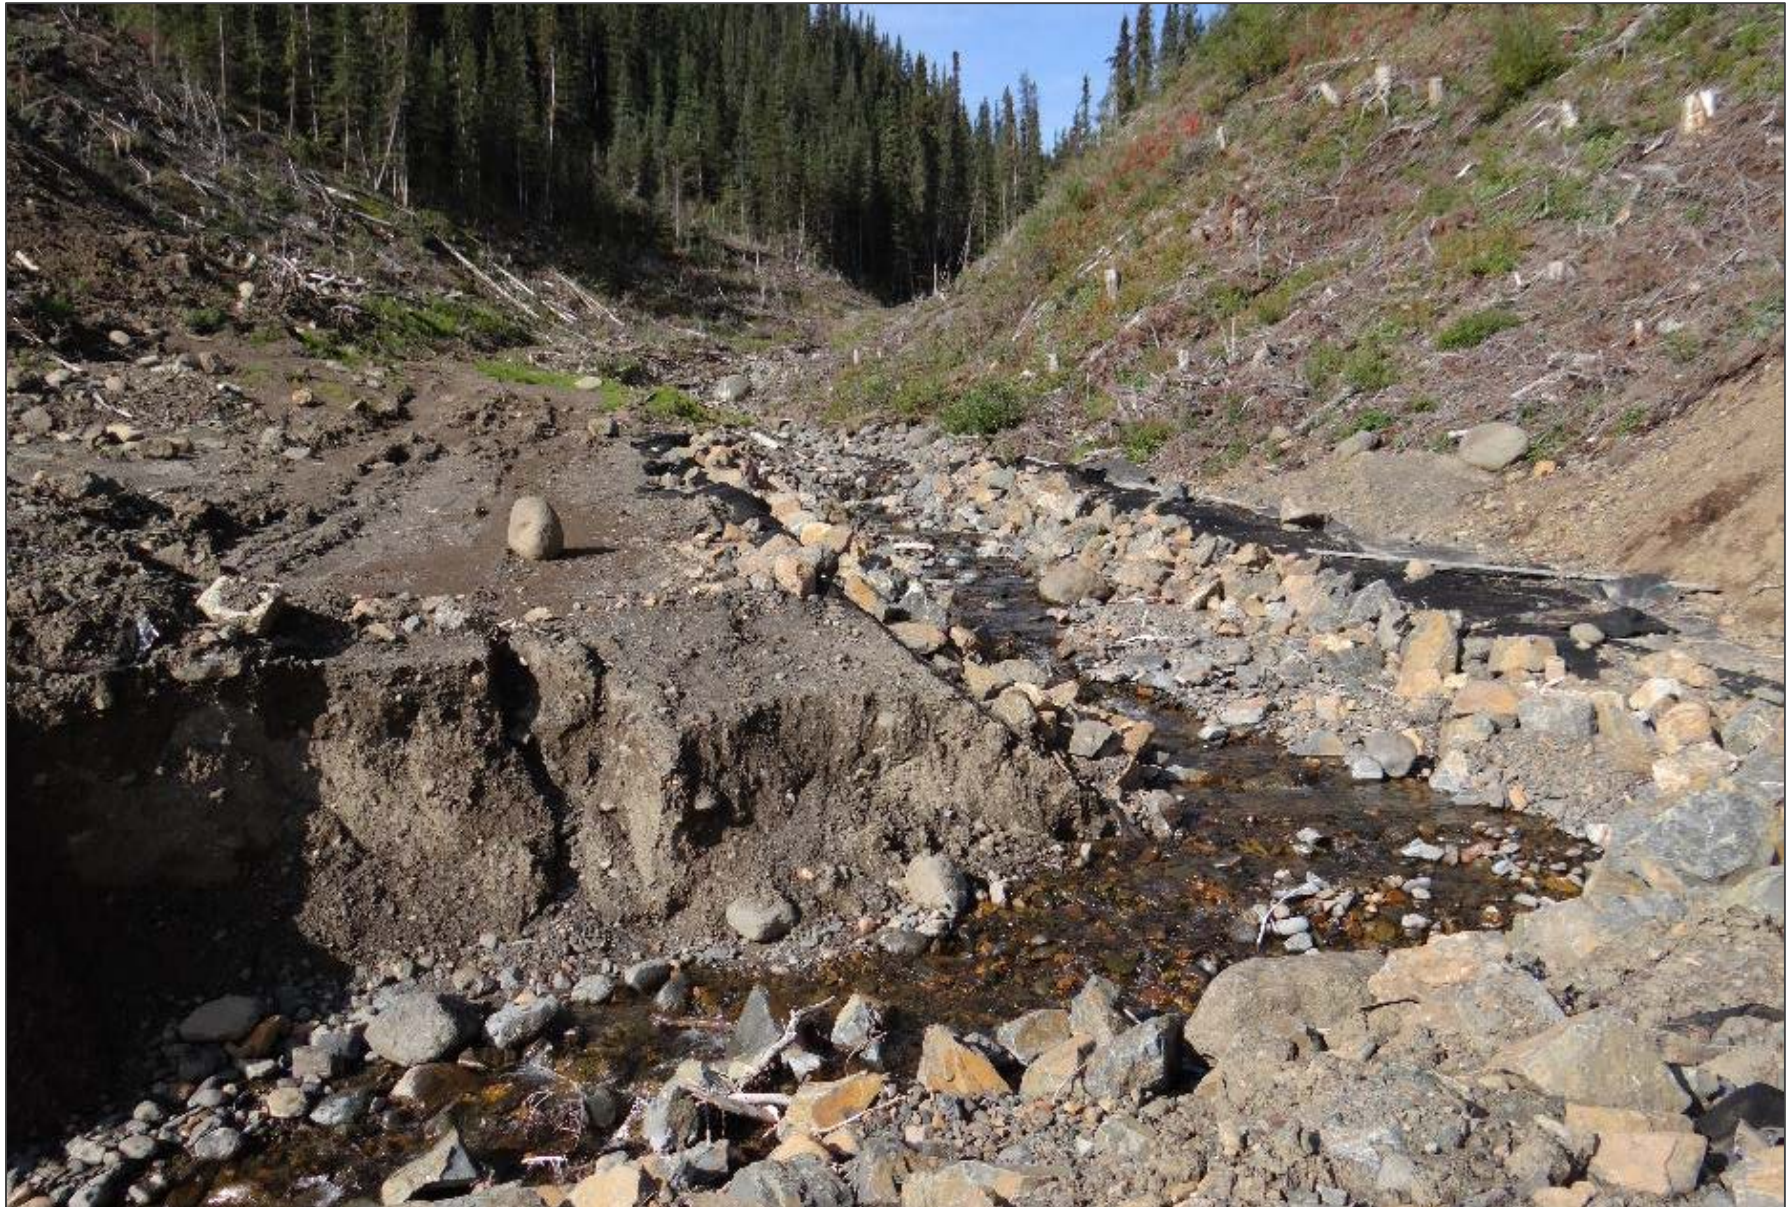
**Breached diversion embankment in Beaver Creek, to allow flows to discharge into the NSD reservoir.**

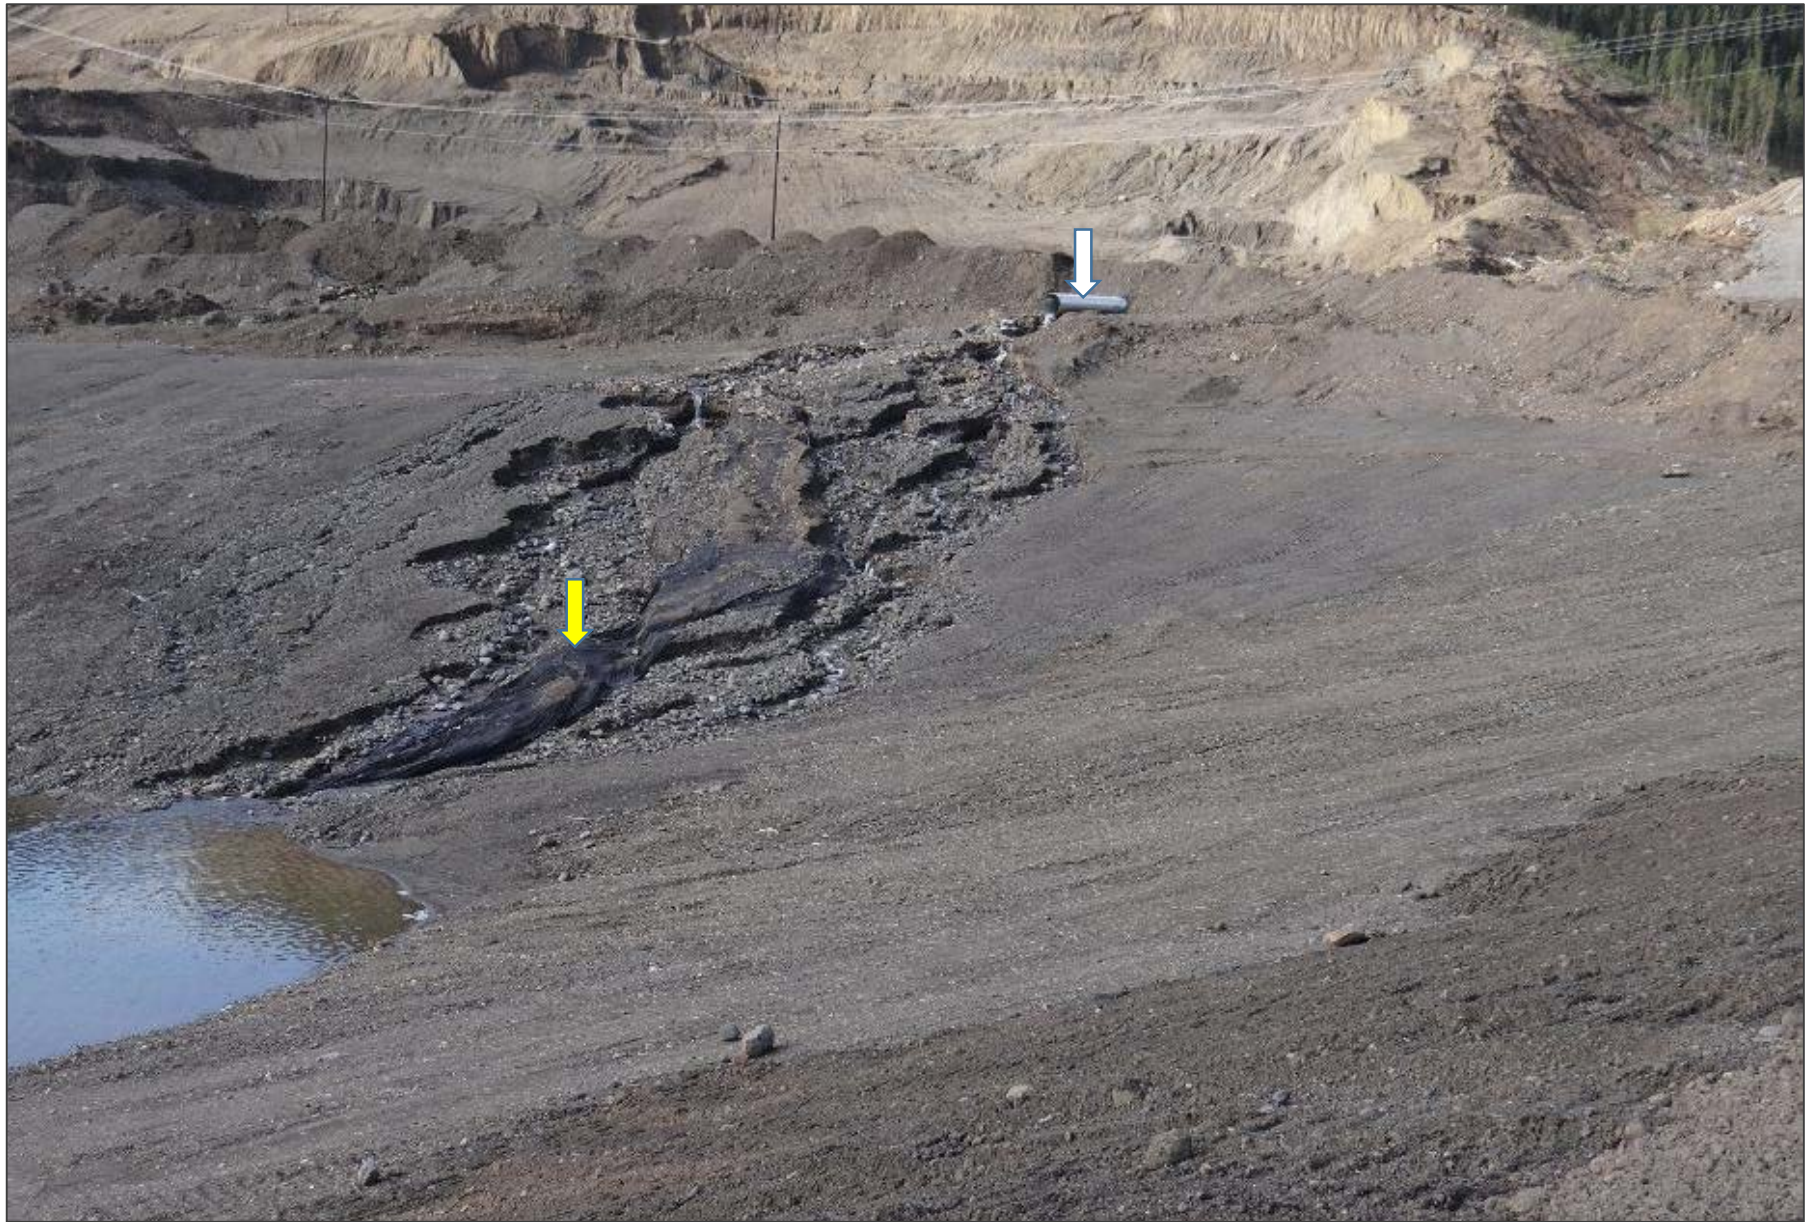
One issue noted, near the upstream left abutment of the dam, is the ongoing erosion of the compacted till seepage reduction blanket due to discharge from a culvert (see Photo 7). This discharge represents the flow from Beaver Creek (the diversion of which was deliberately breached in 2013 – see Photo 6), along with pumpback flow from the North Reclaim Dam reservoir. An unsuccessful attempt to arrest this ongoing erosion with geotextile was made. It is recommended that the till blanket erosion be repaired, and that it be protected from further concentrated erosion in this area.

Looking west from the crest of the NSD. Discharge from the culvert (white arrow) represents Beaver Creek flow and pumpback from the NRD reservoir. Note that the discharge has caused erosion damage to the upstream till seepage reduction blanket. Attempt to arrest erosion with geotextile (yellow arrow) has been of limited effectiveness..

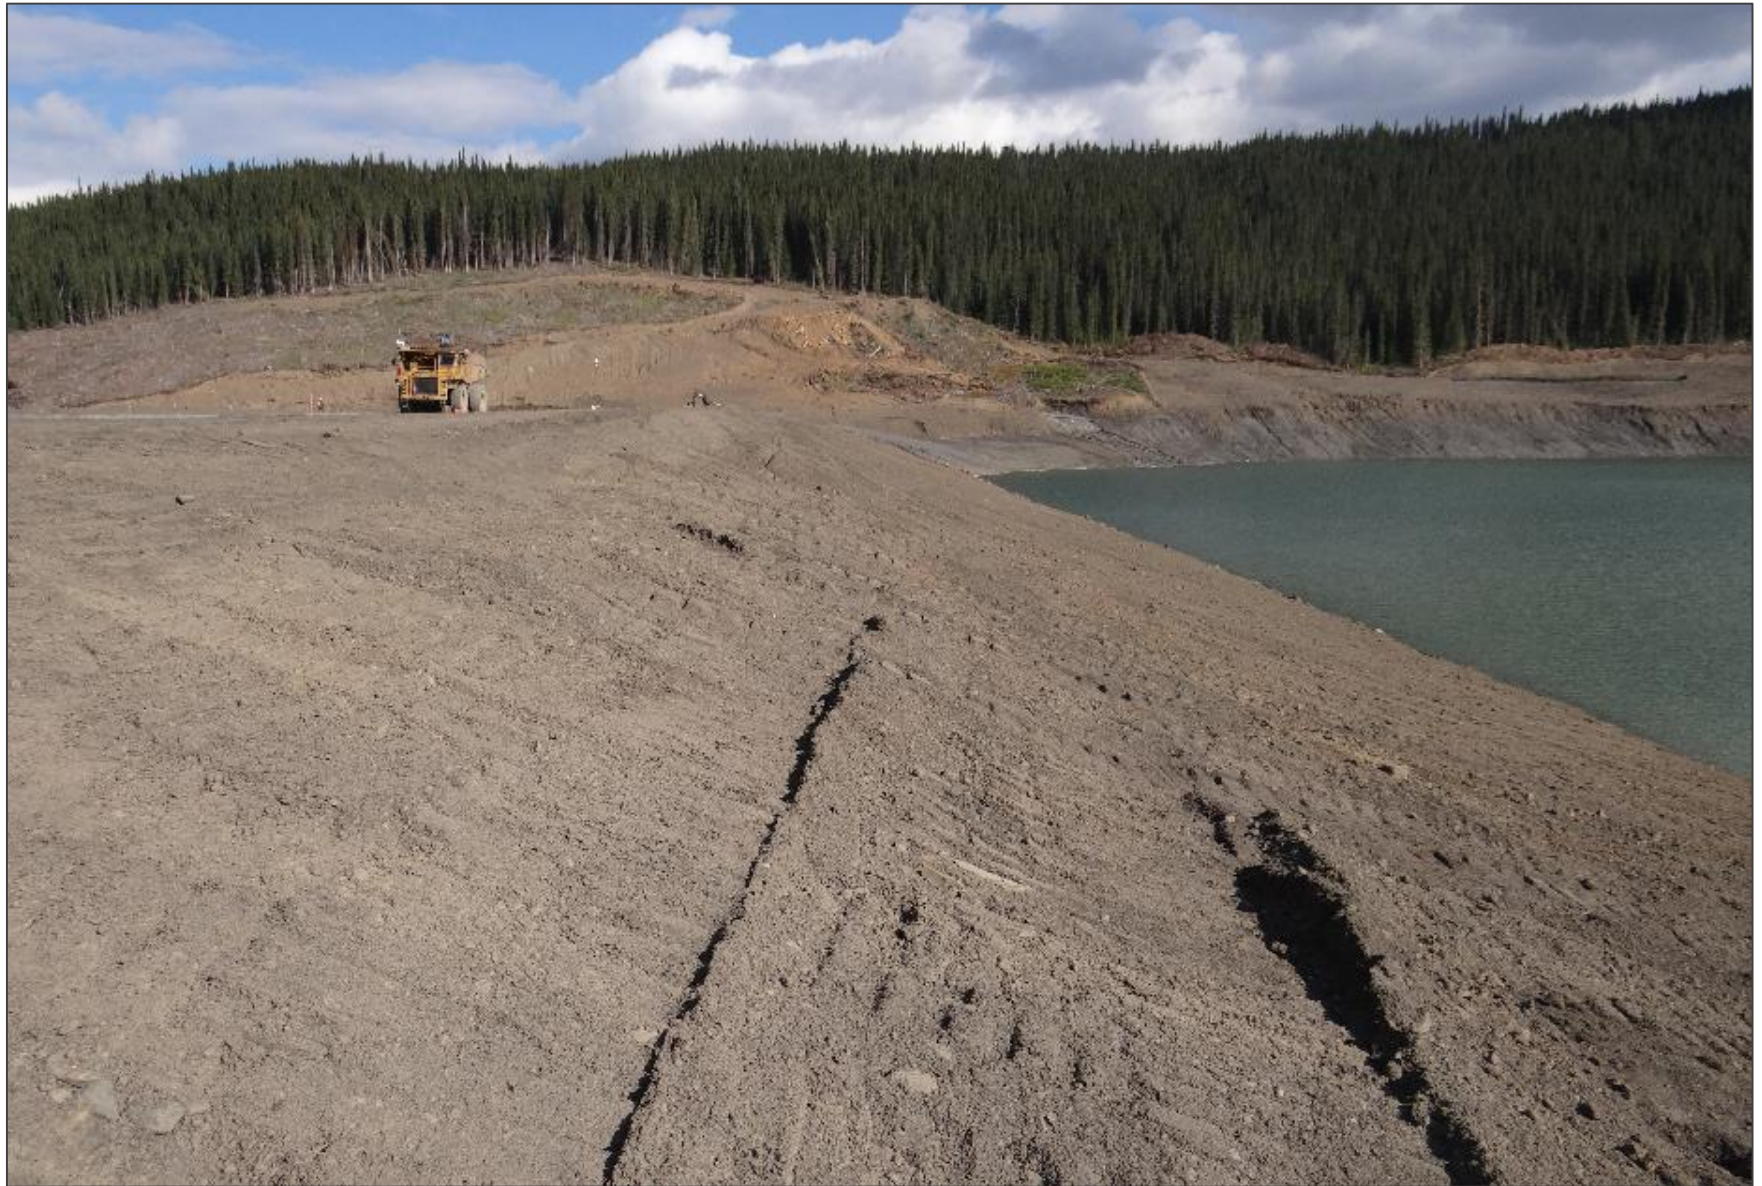
**NSD upstream facing, looking east towards the right abutment. No indications of erosion or slope instability.**

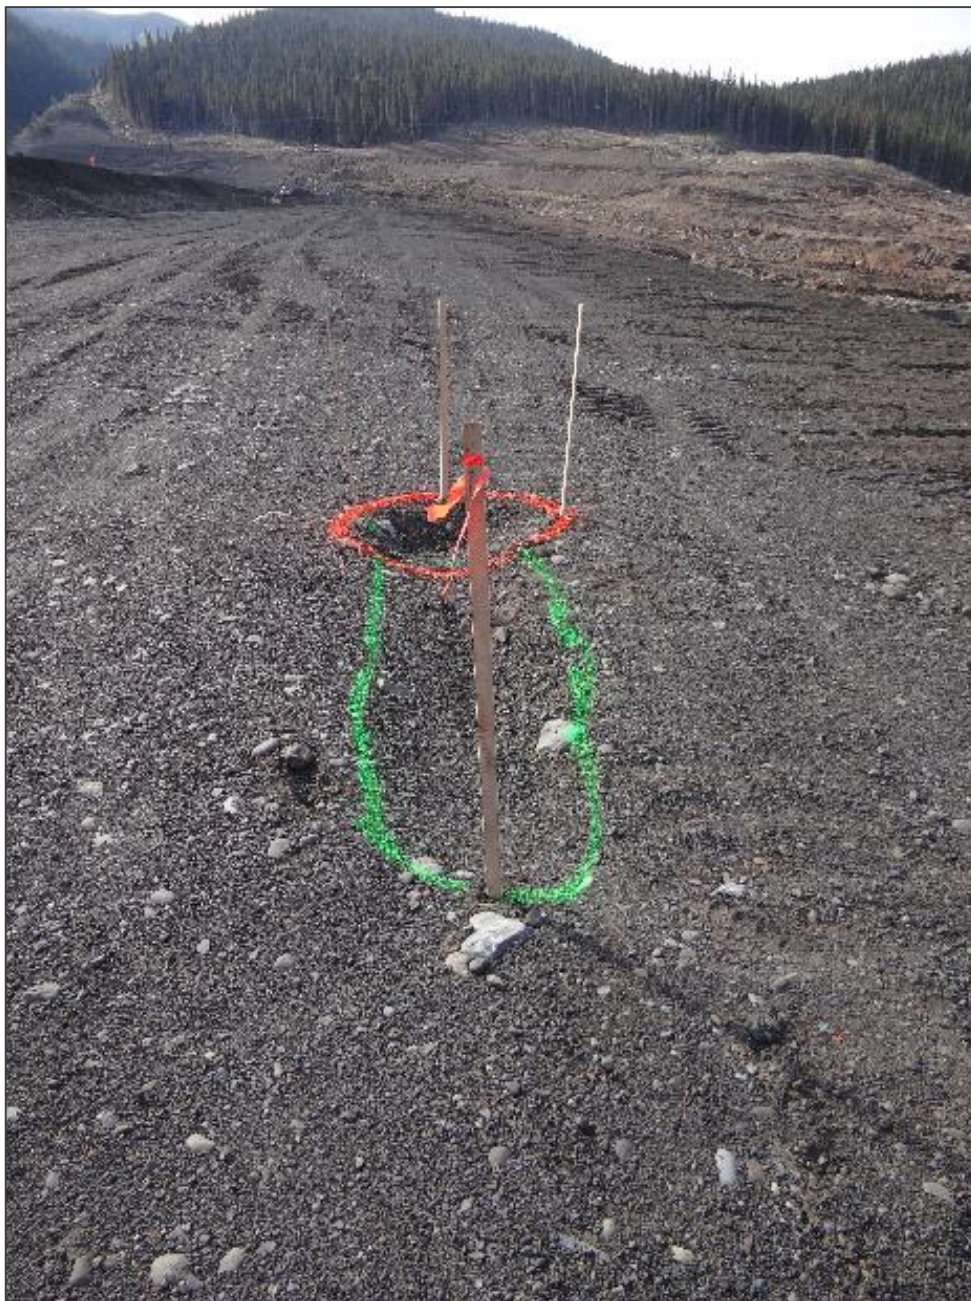
Near the downstream edge of the crest, at about Sta. 0+200 m, two small depressions were noted (see Photo 20). This area was identified by BGC construction monitoring personnel, flagged, and is being evaluated for any indications of ongoing settlement. As of issuance of this report, none has been noted.

**Crest of NSD. Flagging and paint delineates an area of a minor depression, within the downstream (Zone 2) shell of the dam, being monitored at the time of the inspection. No additional settlements have been noted. At about Sta. 0+200 m, on the El. 1,118 m bench.**

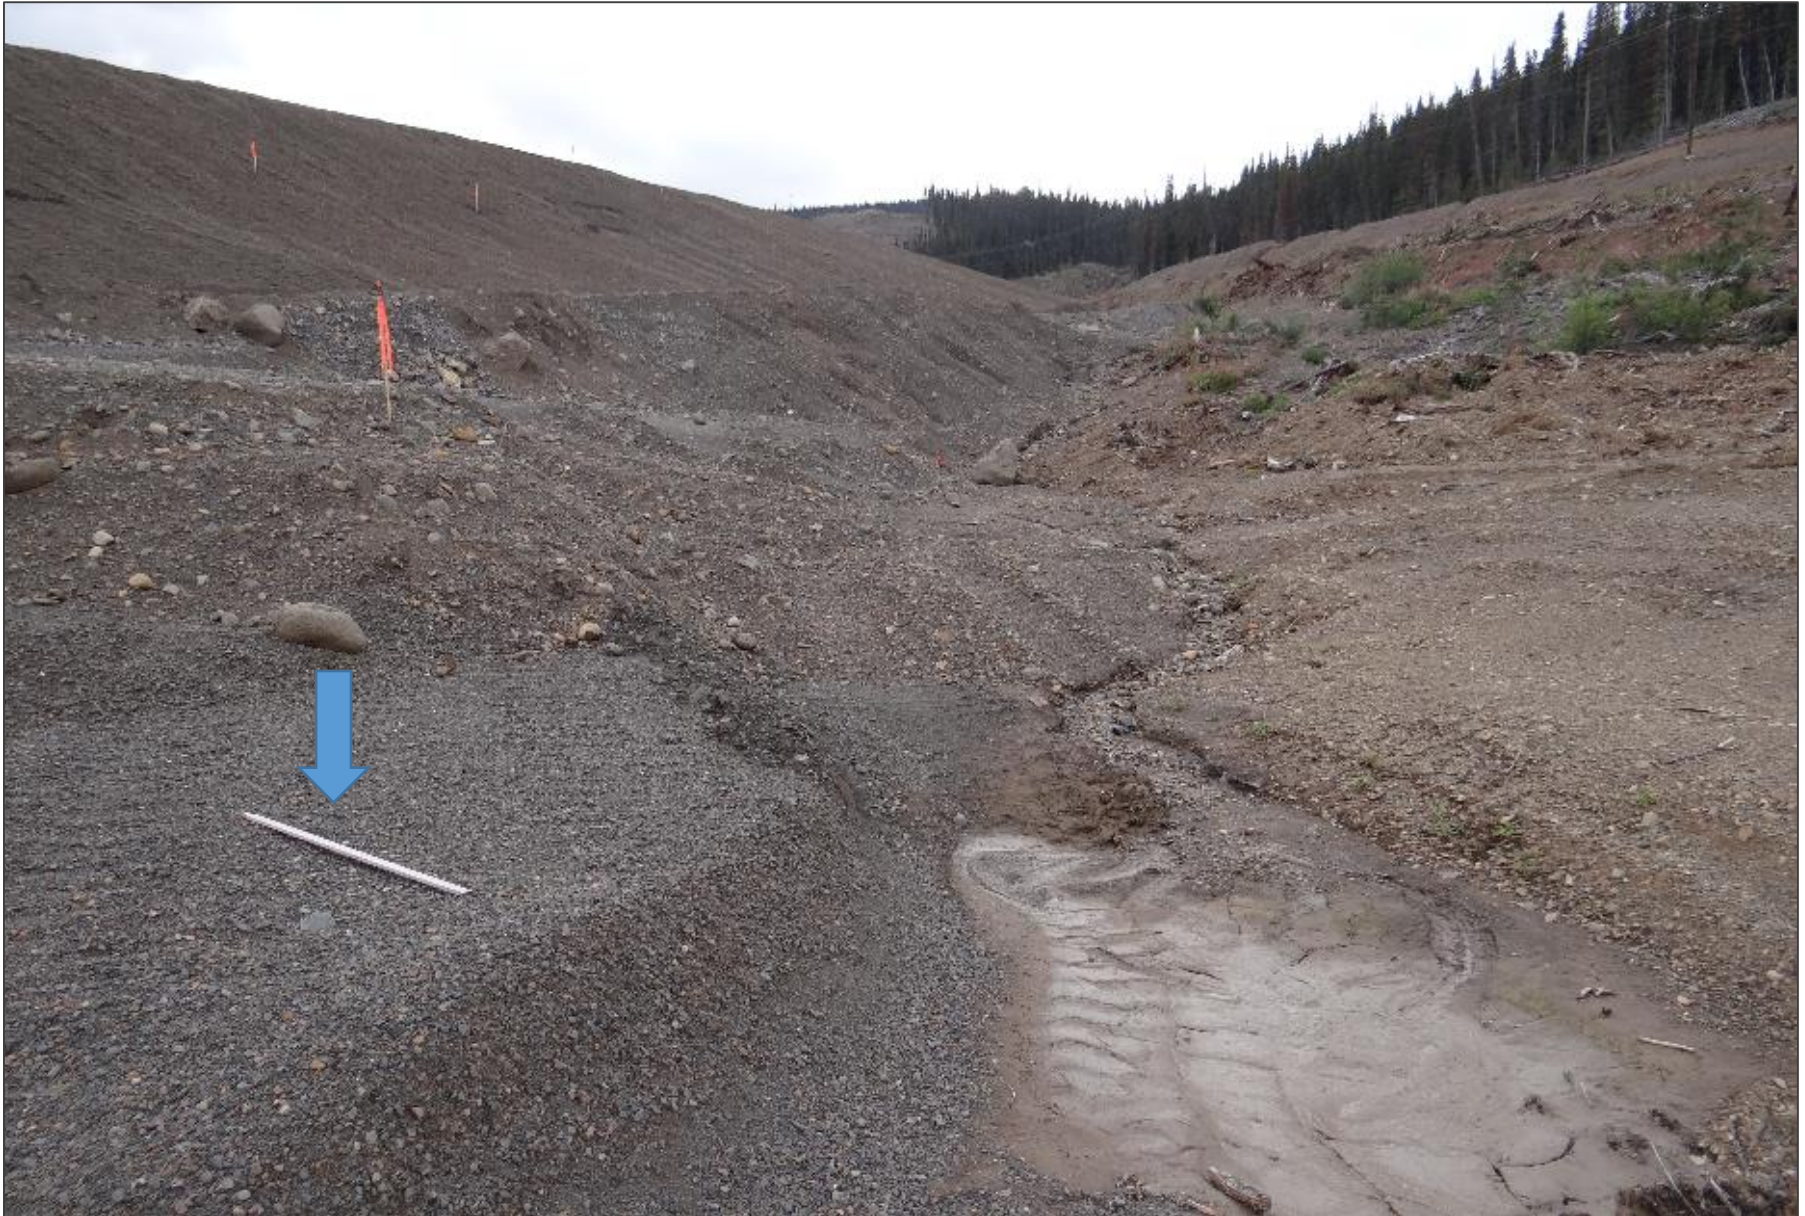
Toe of NSD looking up the left abutment. Finger drain 0+500 indicated by the arrow. Evidence of minor runoff erosion down the abutment, but no visible seepage discharge from the dam.

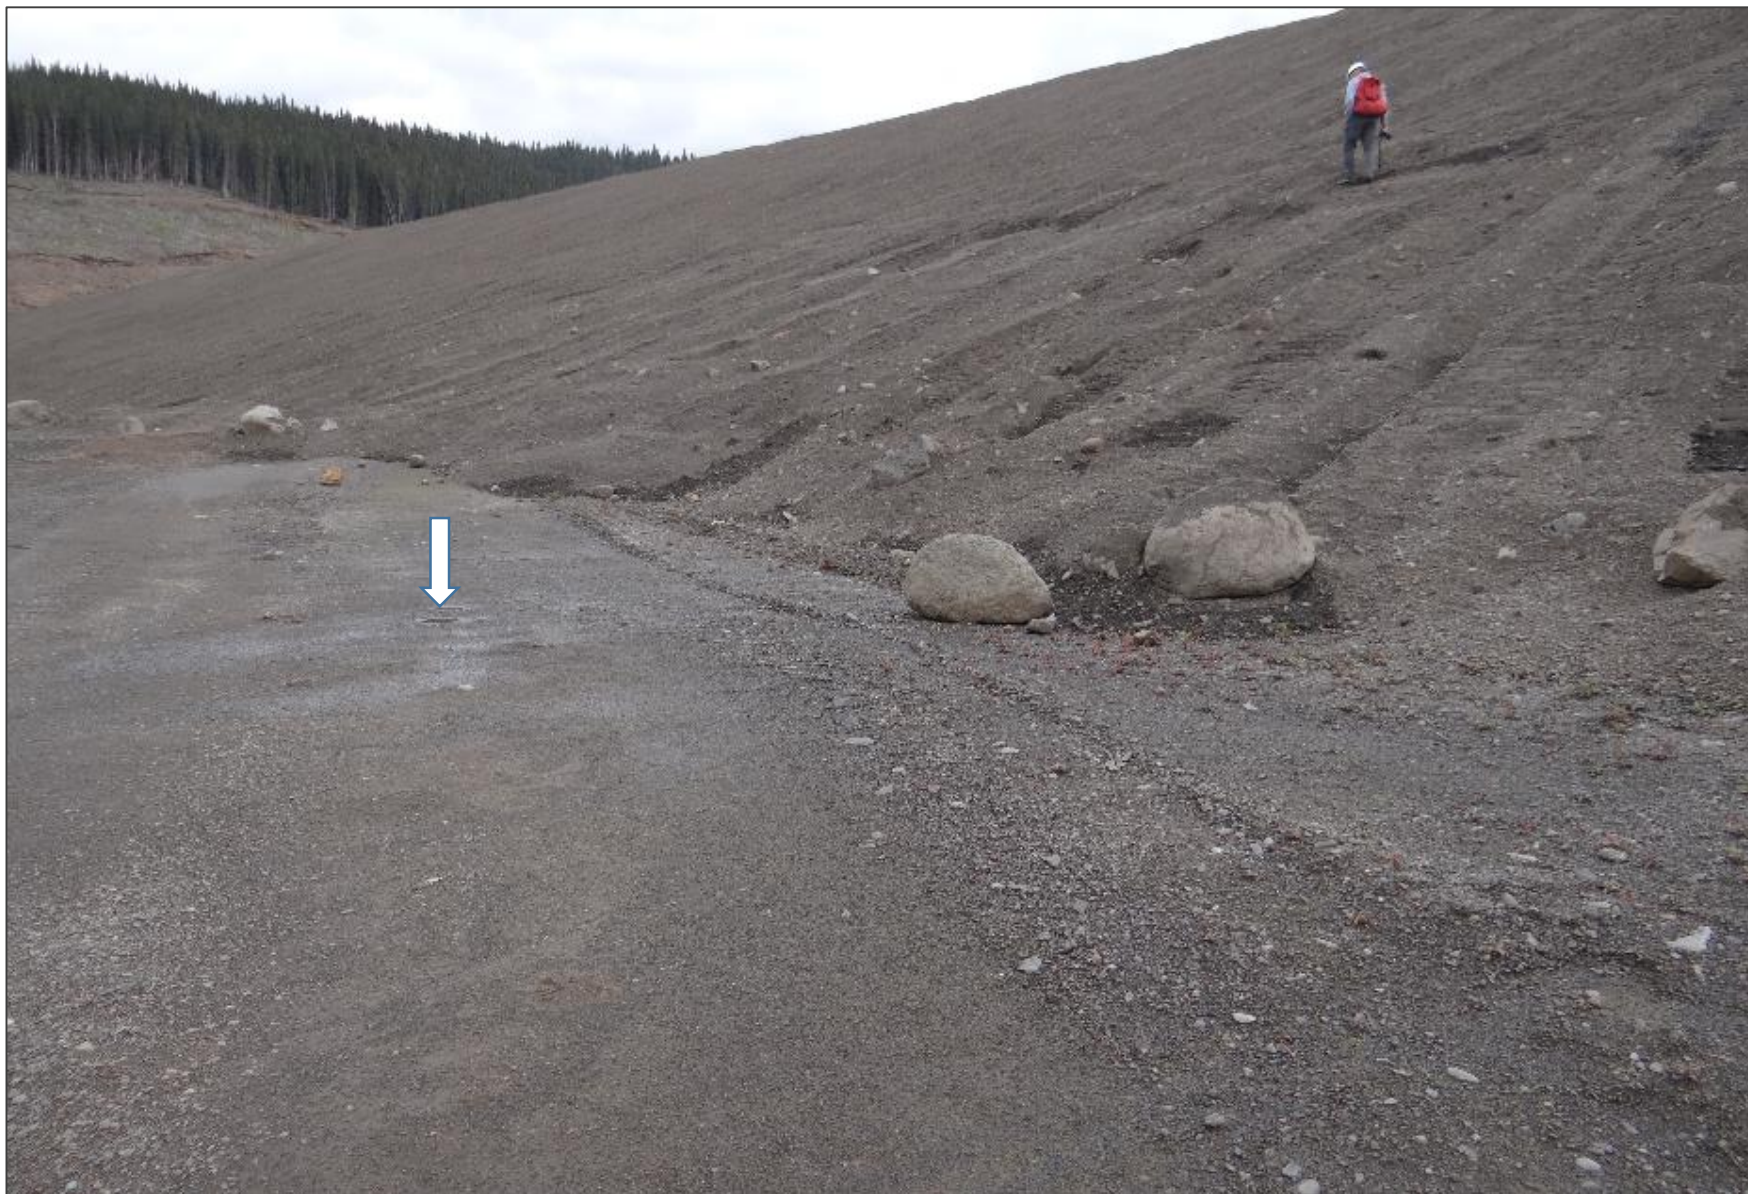
Toe of NSD looking east towards the right abutment. Wet patches on dam face judged to represent lagged discharge of infiltration from recent rains preceding the site visit. Minimal seepage indicated at the toe of the dam. Note wet spots on the surface of the drainage blanket (see arrow).

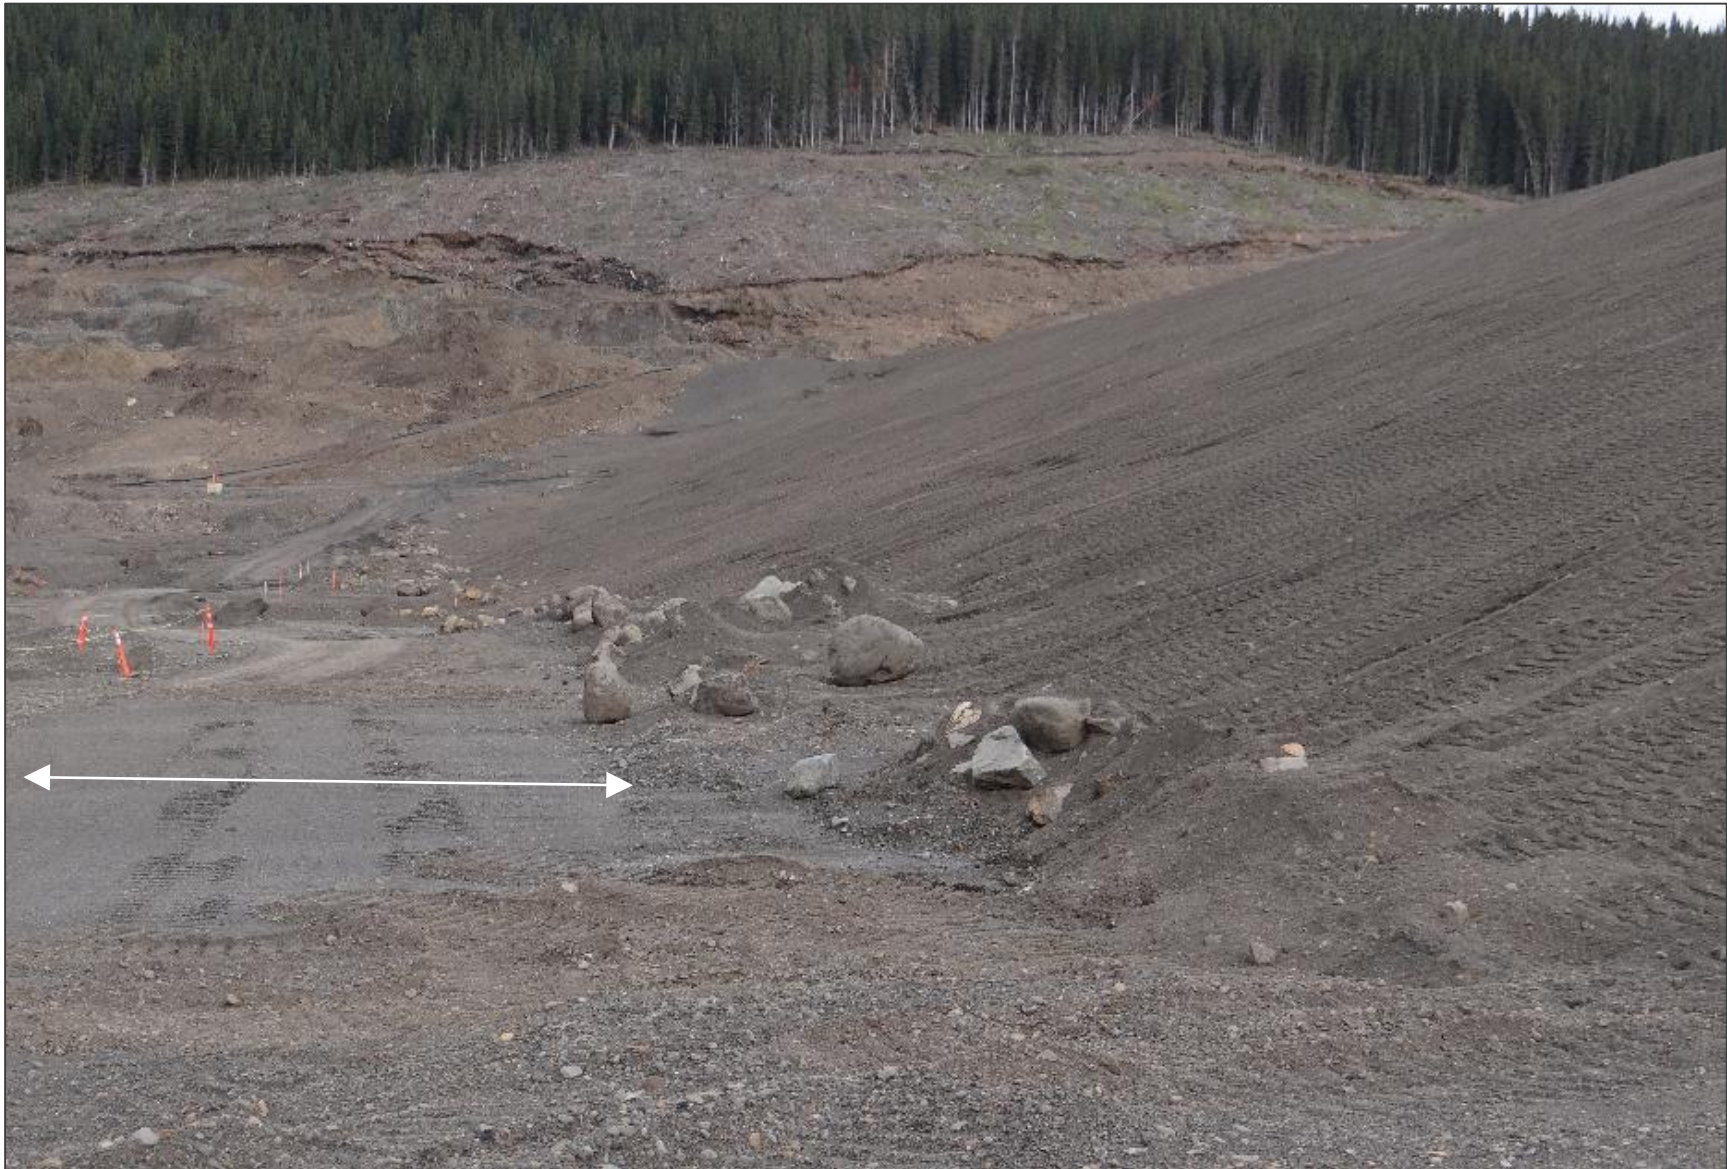
Toe of NSD looking east towards the right abutment. Minimal seepage indicated at the toe of the dam. No indications of erosion or slope instability. Drainage blanket indicated by arrow.

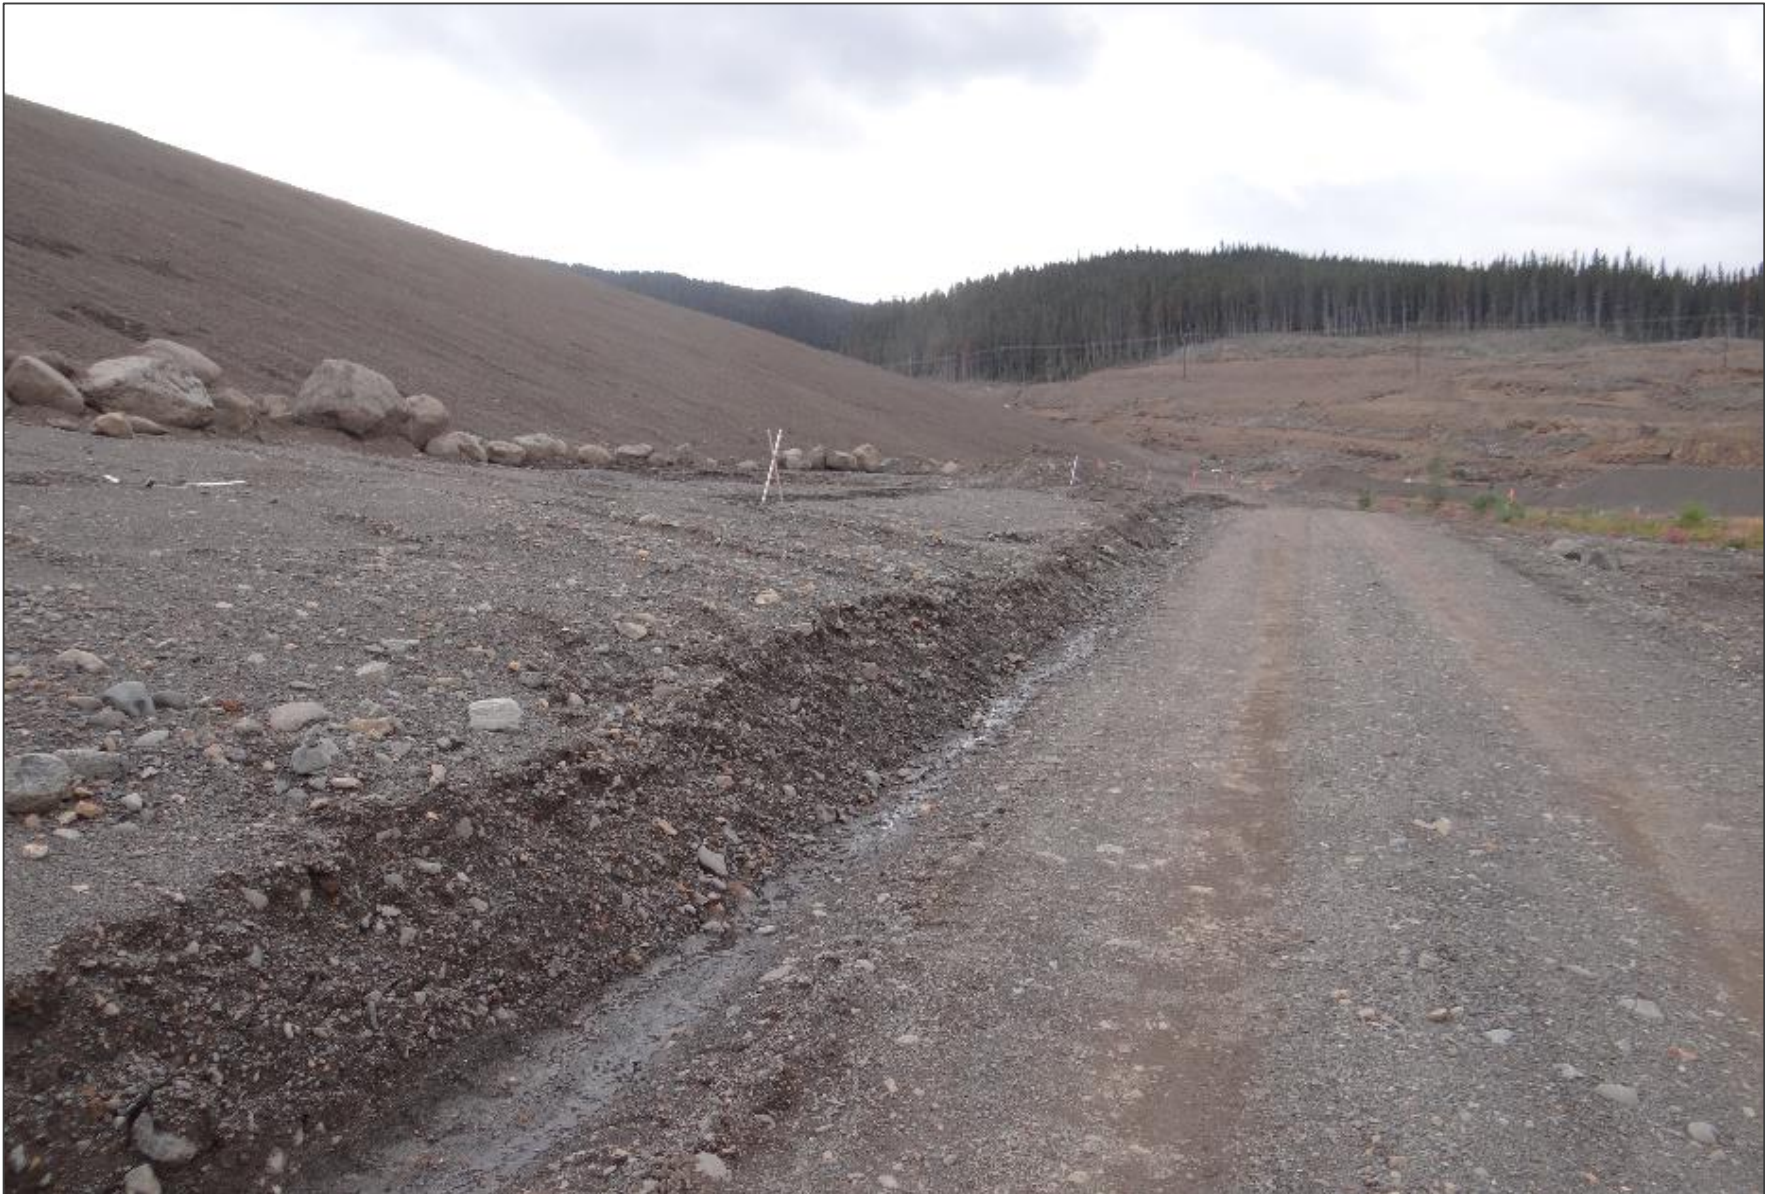
**Toe of NSD, looking west towards the left abutment. Drainage blanket adjacent to access road. Seepage in the ditch along the road visually estimated at less than 0.1 litres/sec.**

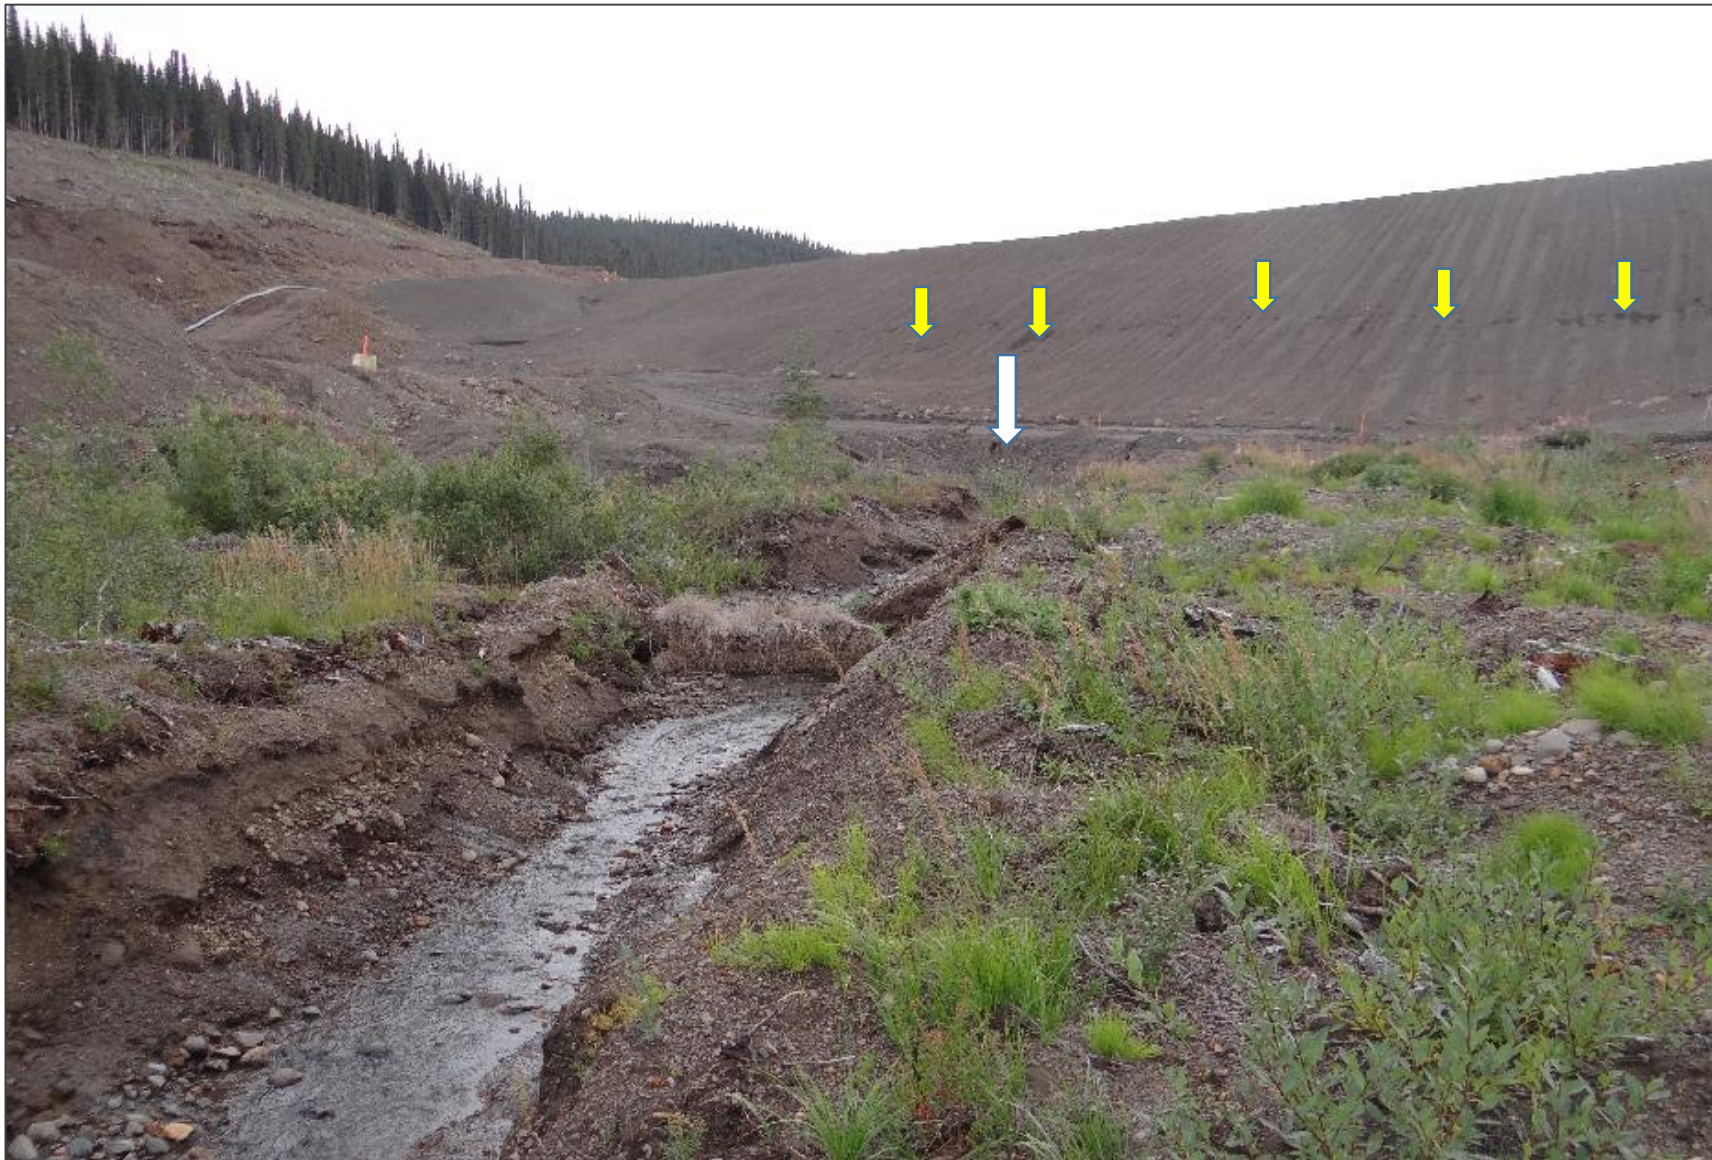
Looking towards downstream slope of the NSD. White arrow indicates the 0+200 finger drain. In creek channel, flow rate increases steadily moving downstream of the finger drain, indicating an area of groundwater discharge. Line of dark spots on the downstream face of the dam (yellow arrows, at about El. 1076 m) judged to represent lagged discharge of infiltration into the dam from recent rainfall events – concentration along a single elevation likely the result of a lift with relatively higher fines content that encourages lateral rather than downward flow.
