## **RED CHRIS DEVELOPMENT COMPANY LTD.**

### **RED CHRIS TAILINGS FACILITY**

## **2014 DAM SAFETY INSPECTION REPORT**

PROJECT NO.: 0866001.14.7  
DATE: November 24, 2014  
DOCUMENT NO.: 0866001.14.002

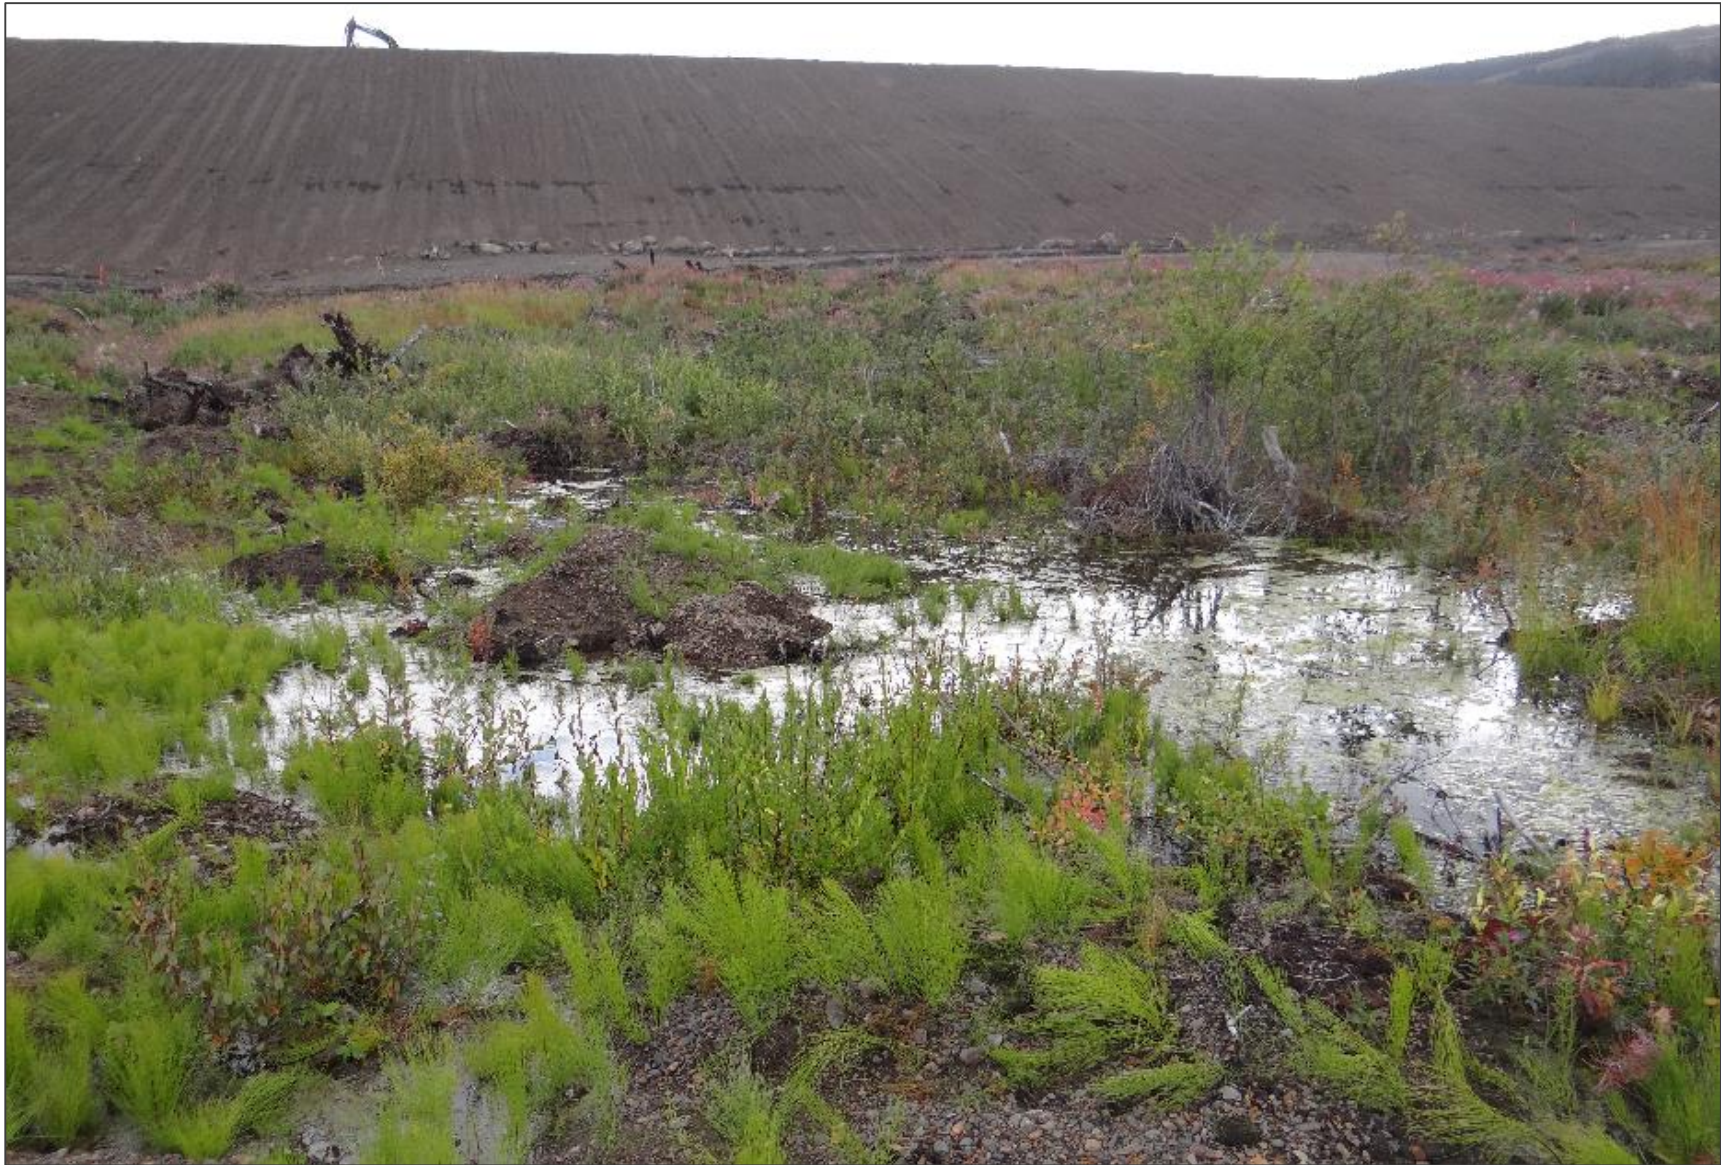
Looking south towards downstream slope of the NSD. Increased flows and springs/ponds moving progressively downstream from NSD to NRD. Note again moist spots at consistent elevations on the downstream face of the dam, representing lagged discharge of rainfall infiltration to the downstream shell of the dam, rather than seepage from the NSD reservoir. No discernible flow at any of these locations.

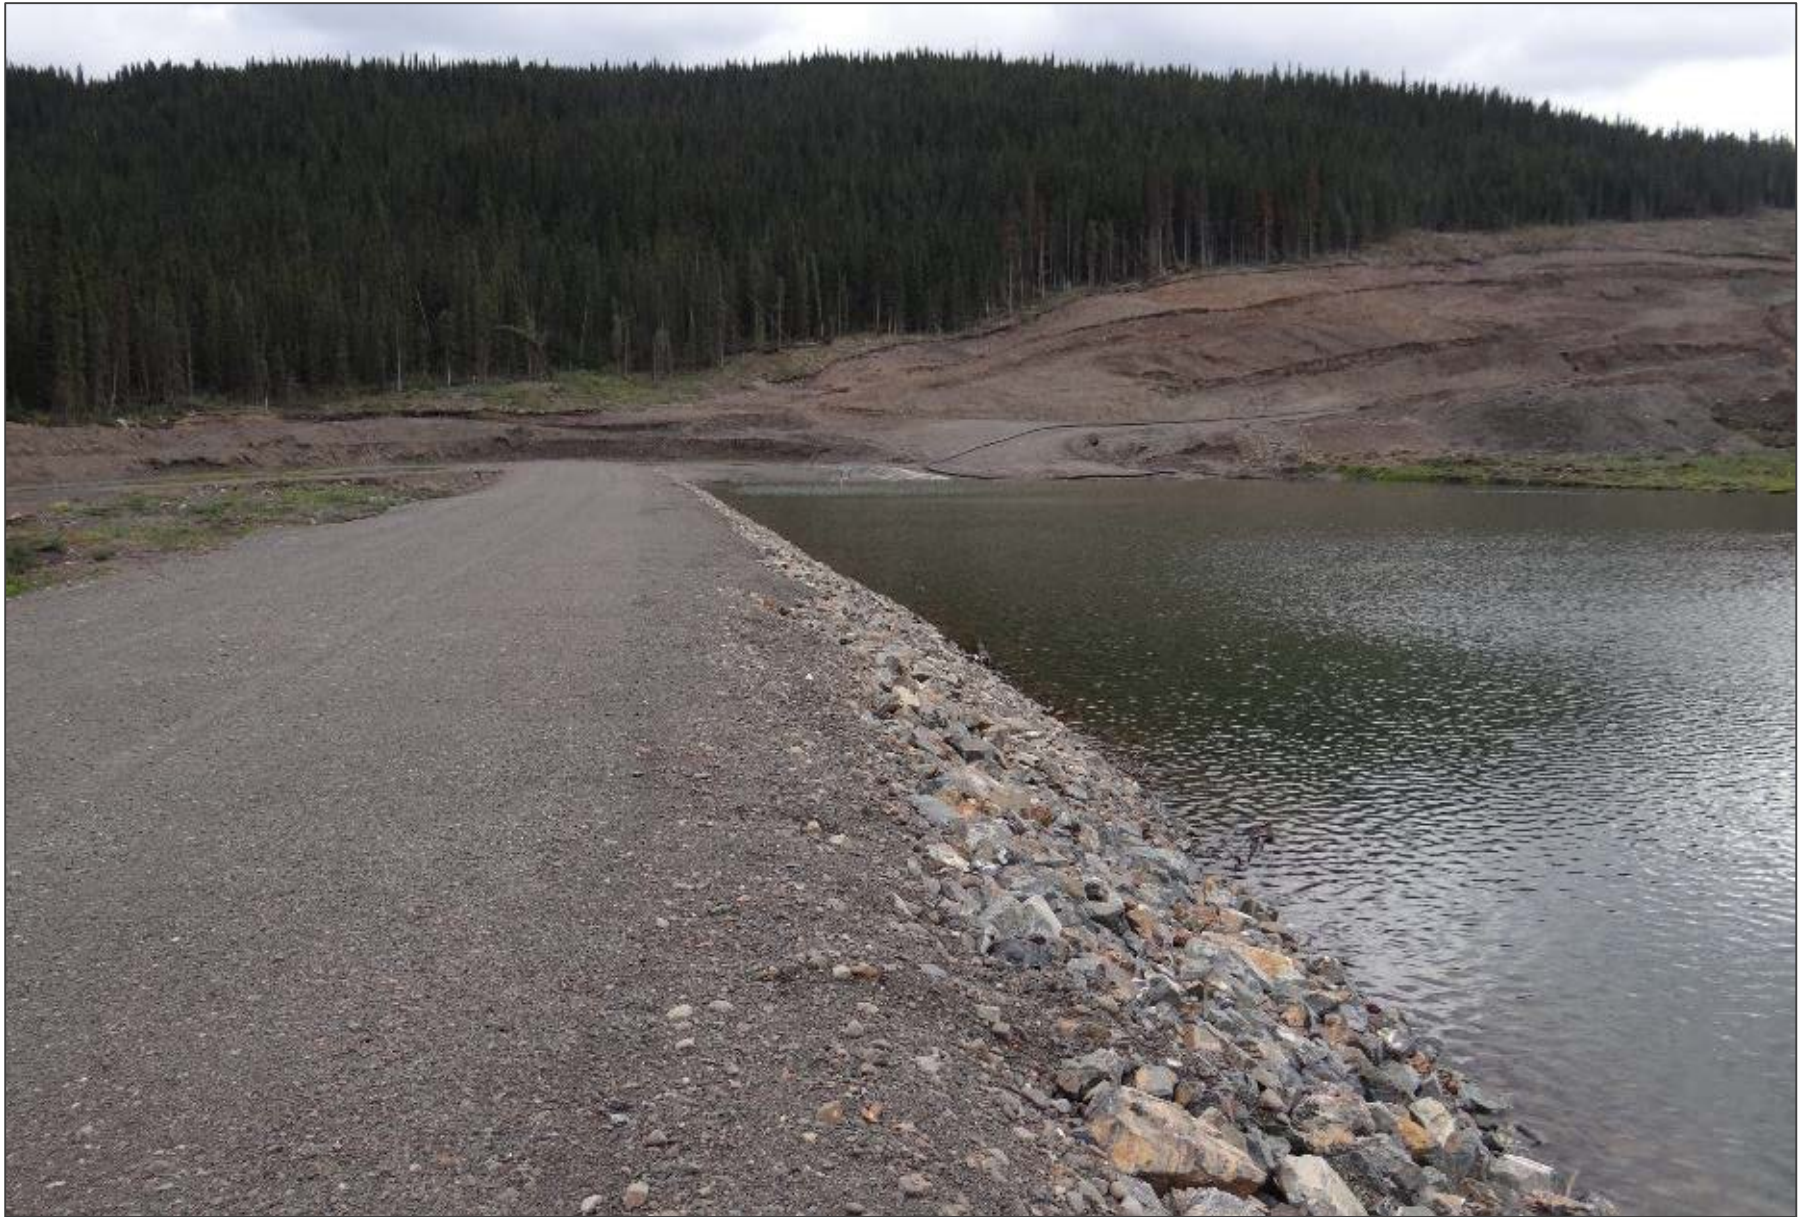
**Crest of the NRD, looking east towards the right abutment. No indications of crest settlement, and no indications of upstream slope instability. Riprap on upstream face appears stable.**

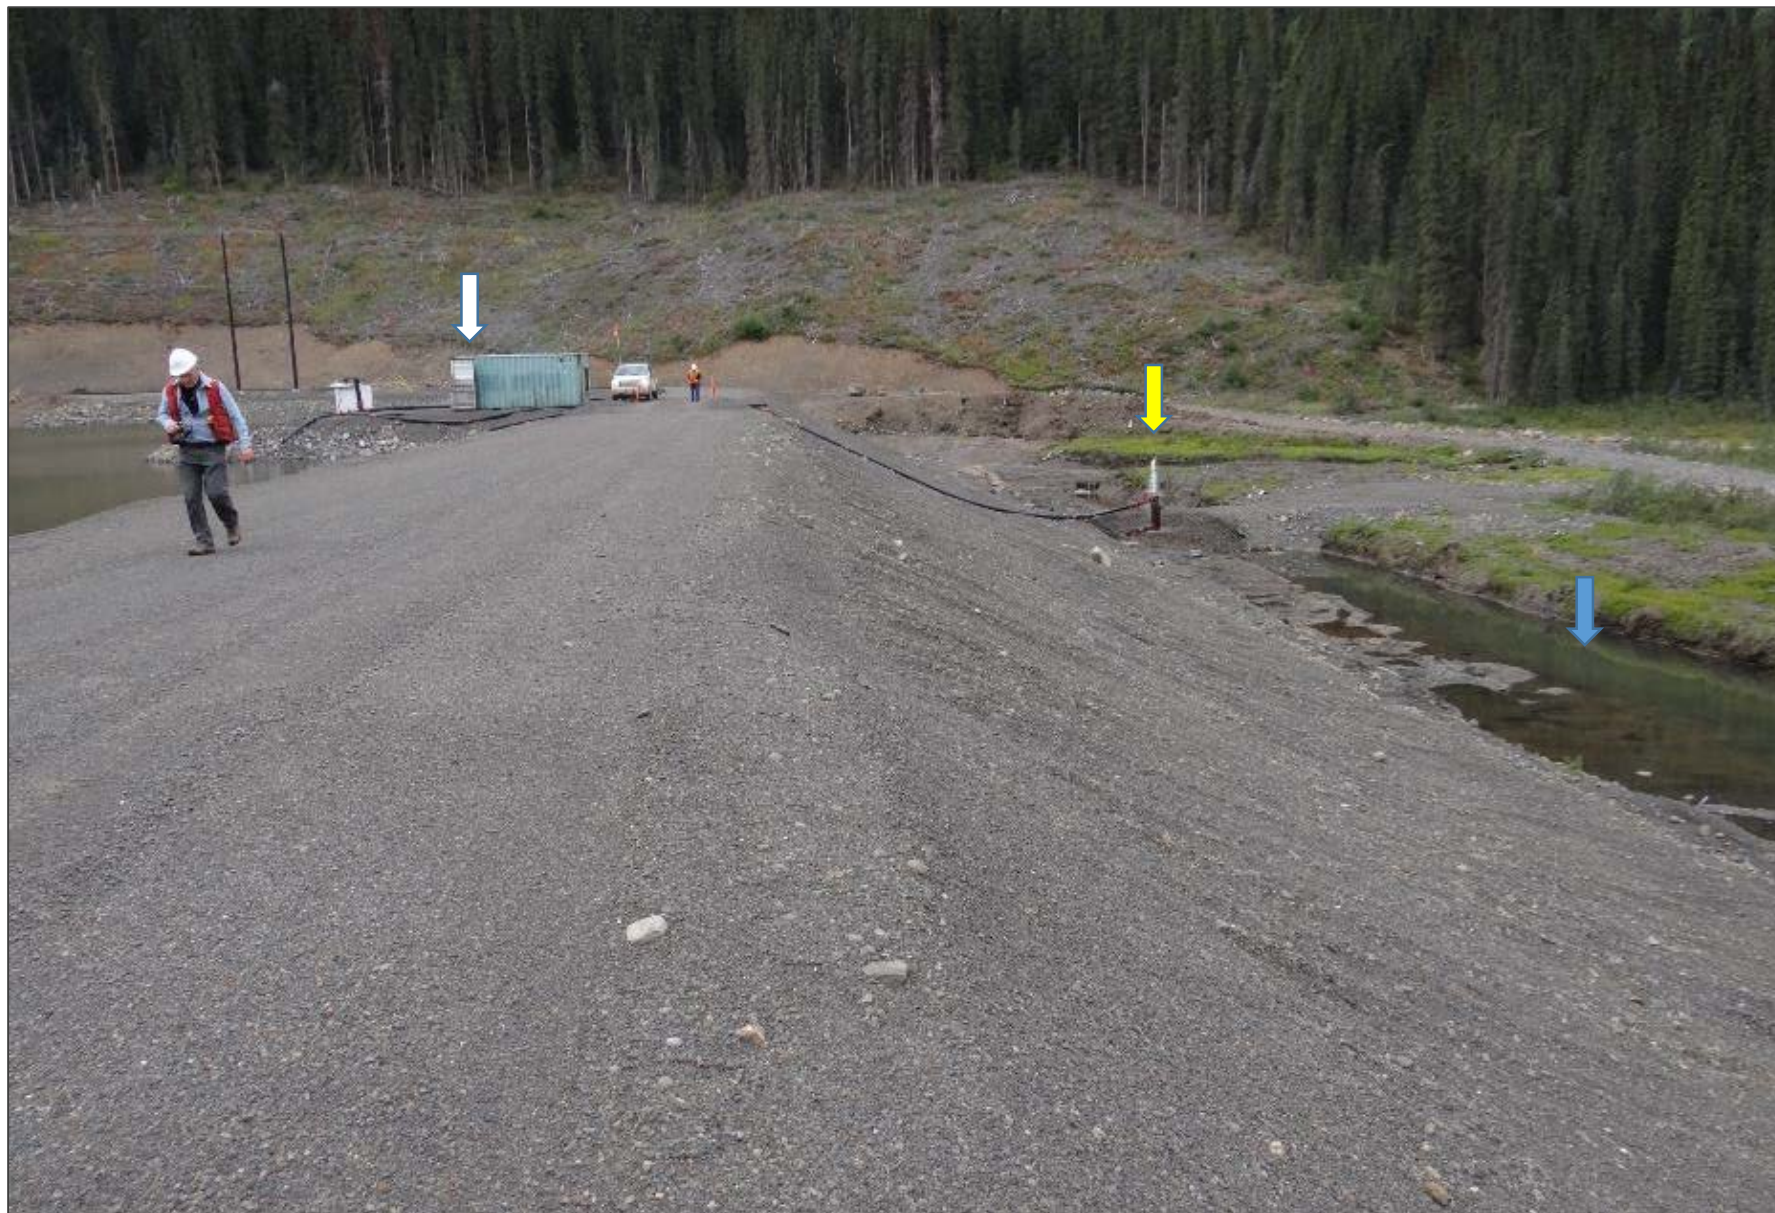
Looking west along the NRD crest, towards the left dam abutment. Pumphouse indicated by the white arrow. Artesian groundwater well 11-NPW2 indicated by the yellow arrow. Discharge from this well is ponding at the downstream toe of the NRD (blue arrow). Downstream slope shows no indications of instability or erosion.

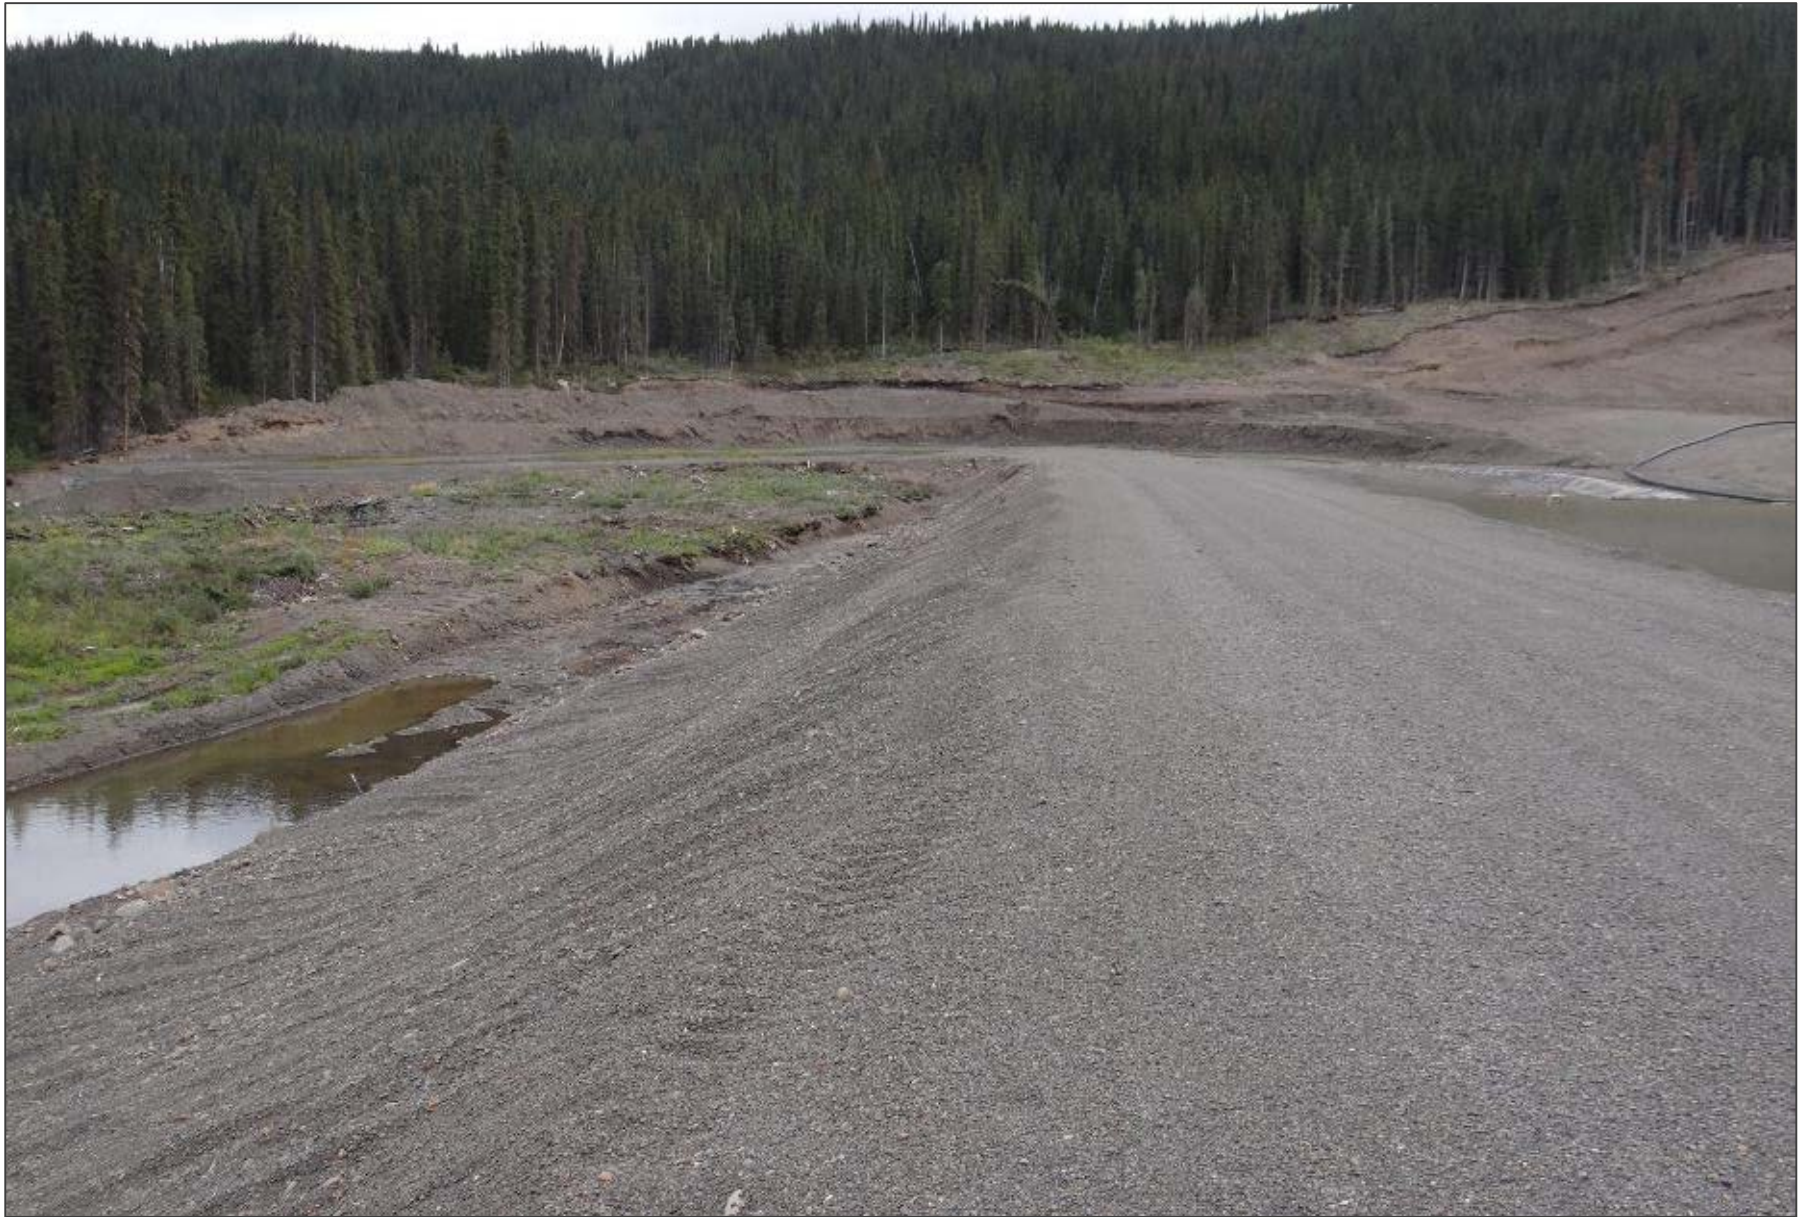
Looking east along the NRD crest and downstream slope, towards the right dam abutment and overflow spillway. Note ponding water and wet conditions along the downstream toe.

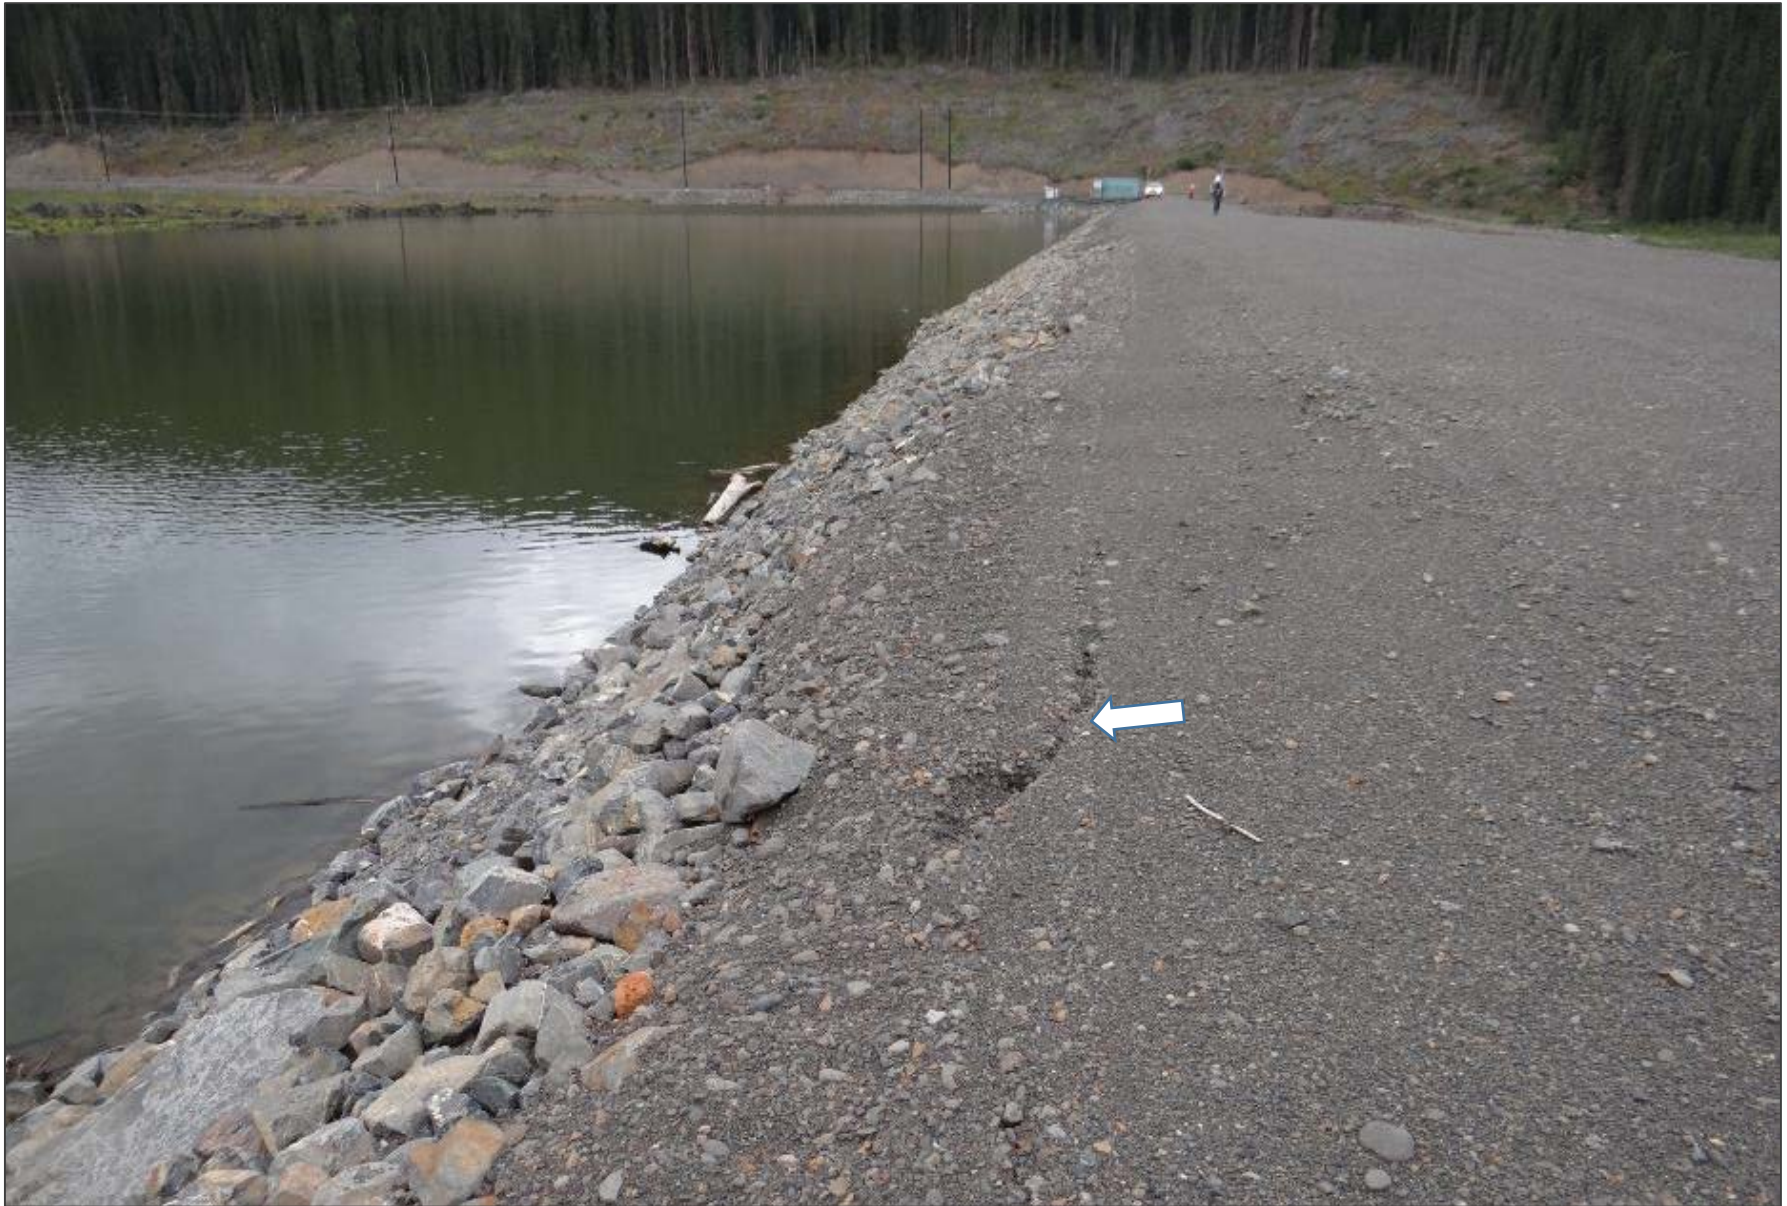
Looking west along the NRD crest and upstream slope, towards the left dam abutment. Apparent crack indicated by arrow appears to be the result of granular road surfacing eroding into the underlying riprap. No indications of upstream slope instability or crest settlement. No indications of riprap instability.

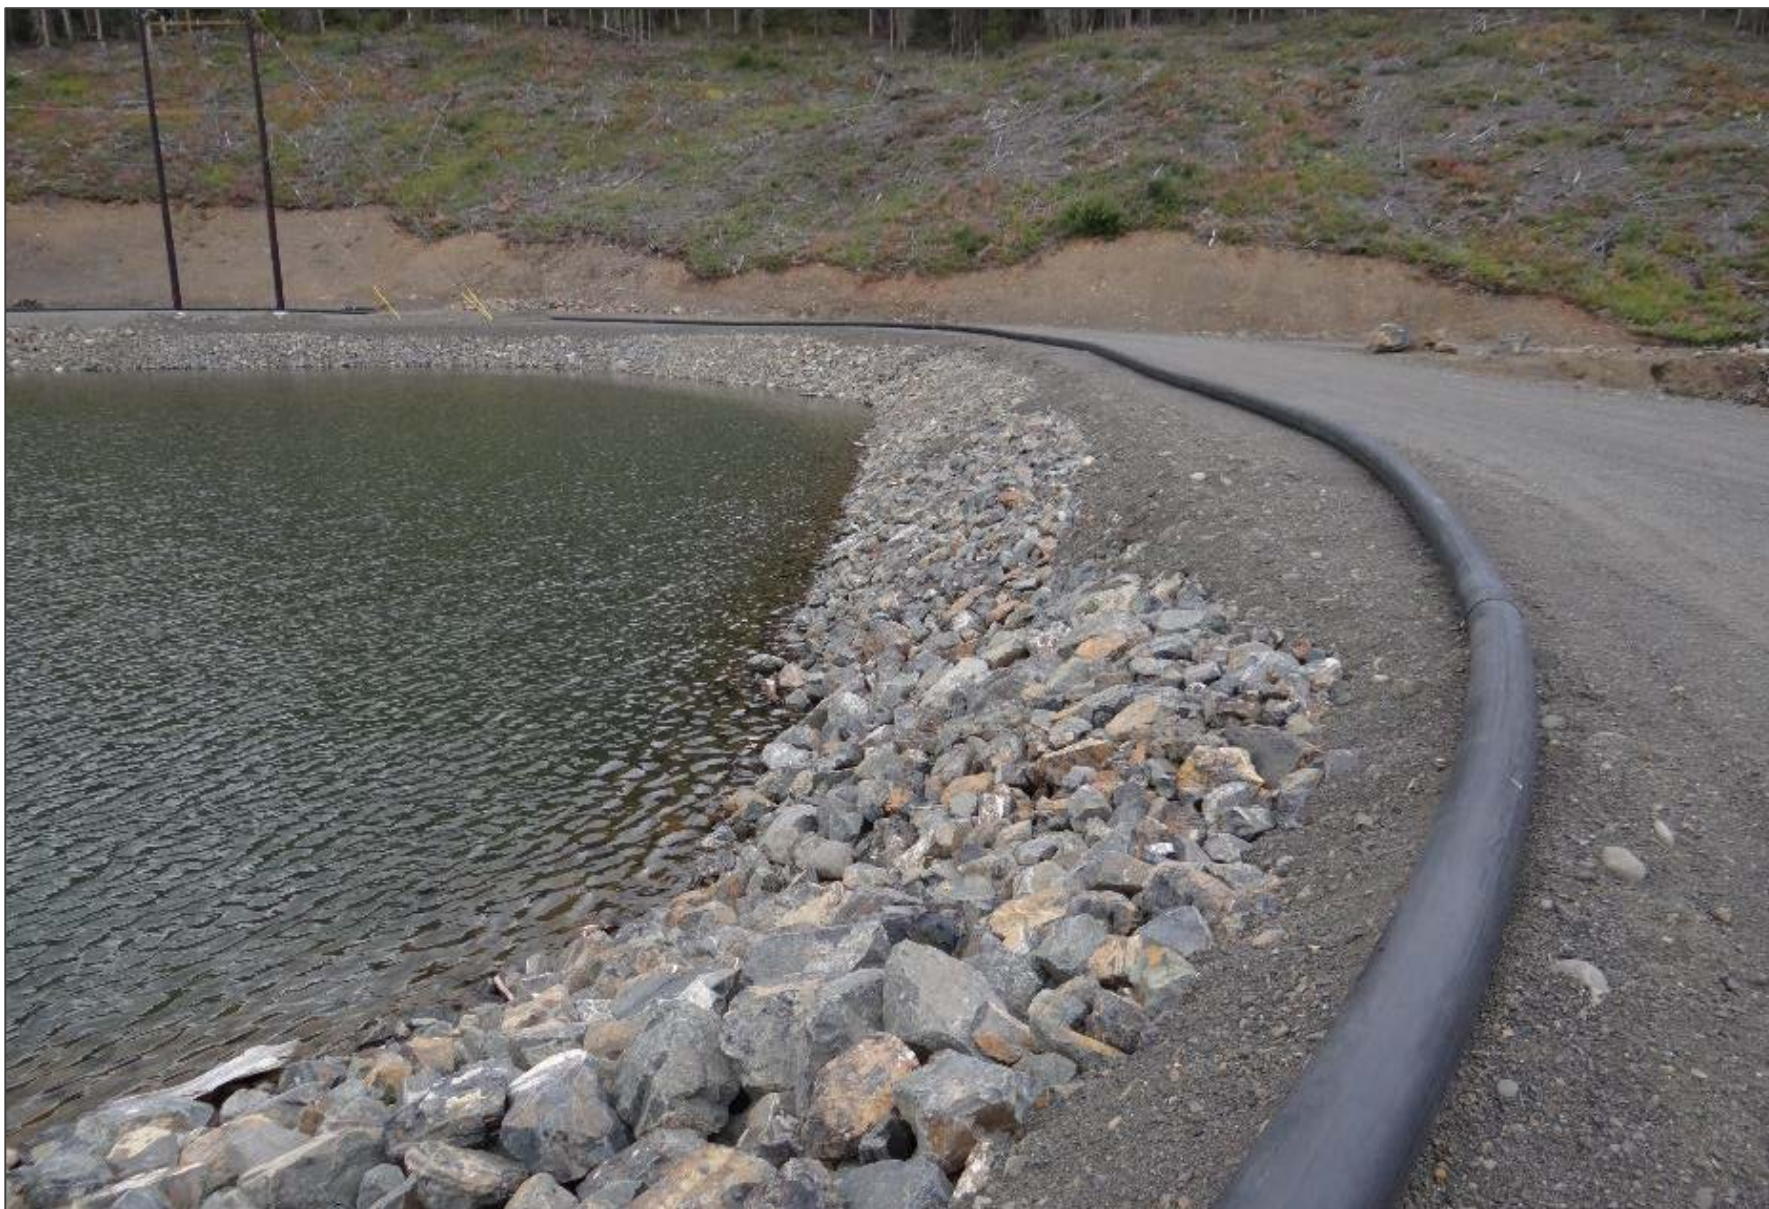
Looking west along the NRD crest and upstream slope, towards the left dam abutment. Pipeline is for pumpback from the NRD reservoir to the NSD reservoir. No indications of upstream slope instability or crest settlement. No indications of riprap instability.

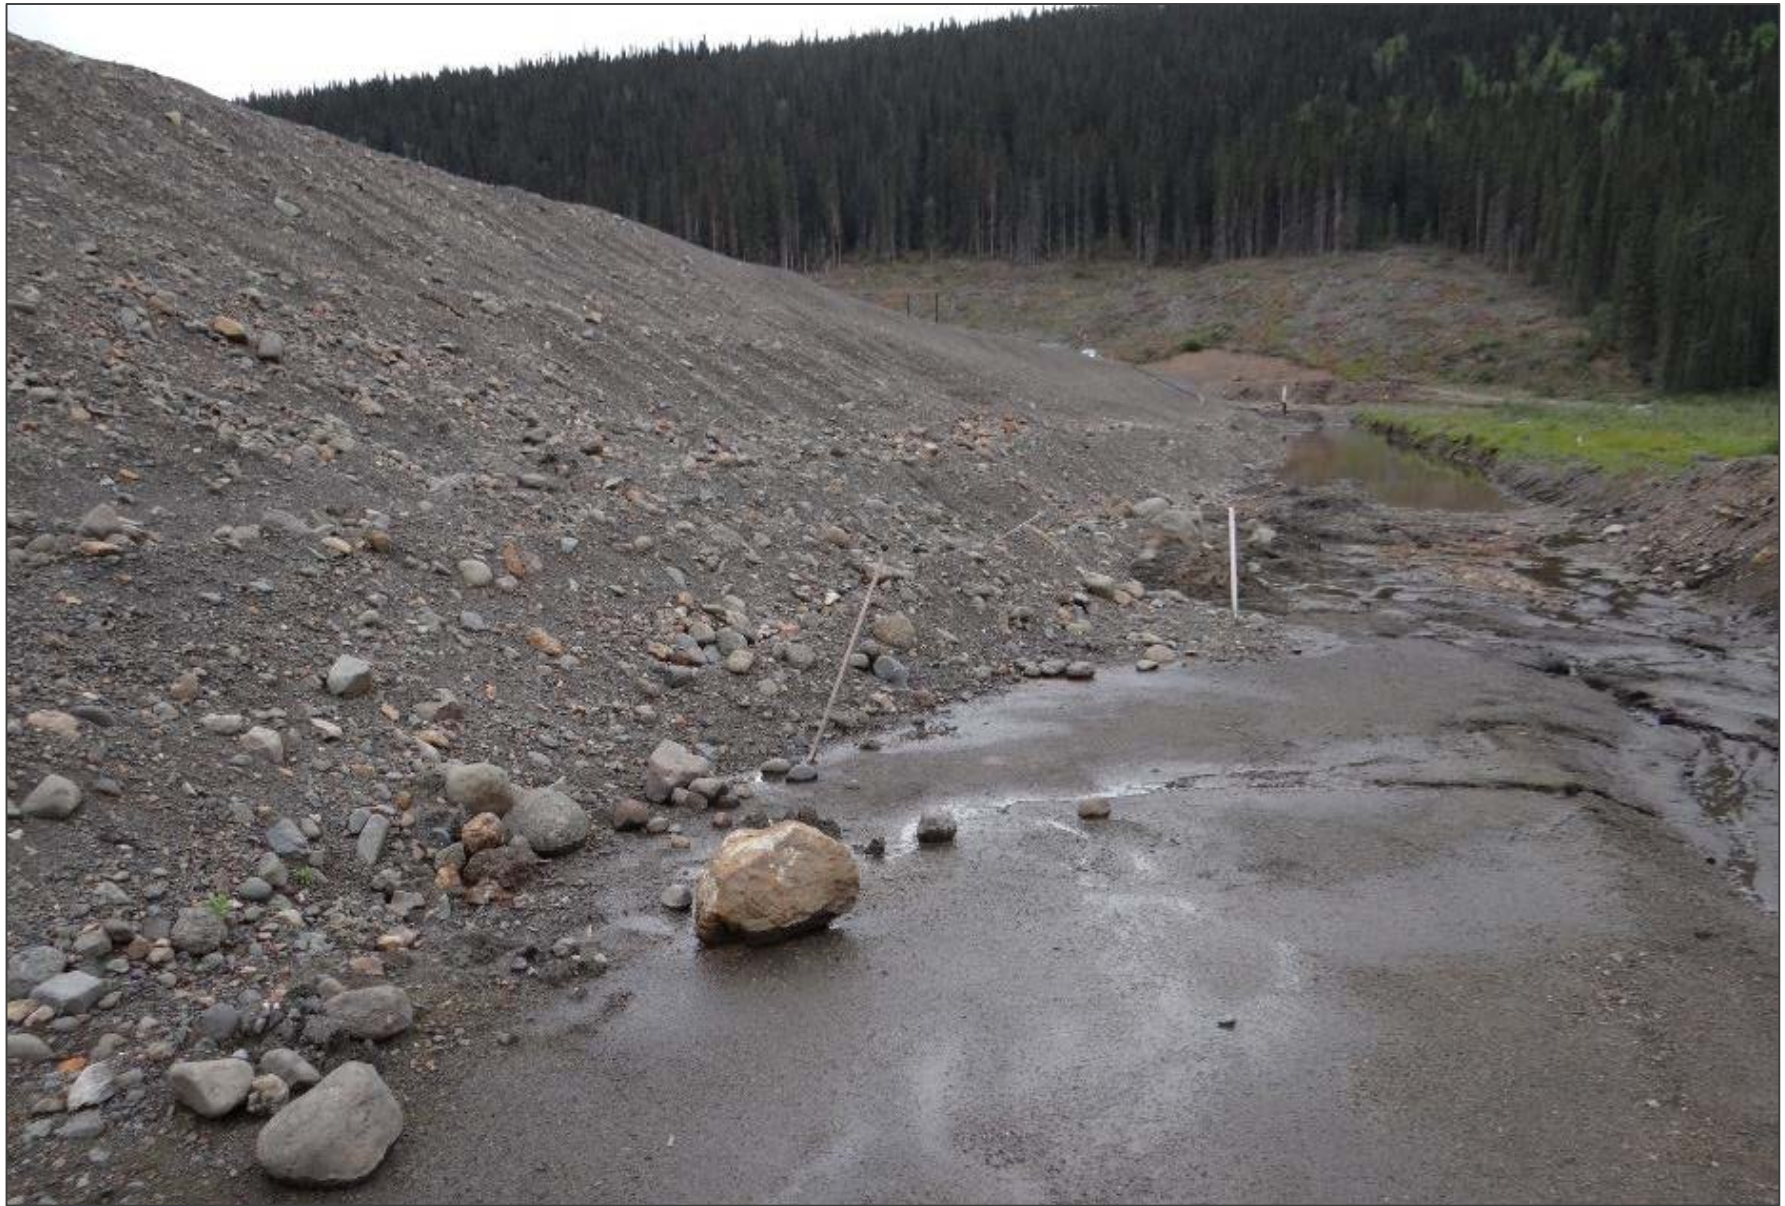
Wet conditions prevail along most of the toe of the North Reclaim Dam. In numerous areas, upwelling seepage was noted, although there were no indications of associated internal erosion. Such conditions were encountered during the 2013 construction of the North Reclaim Dam, consistent with this area being a natural groundwater discharge zone. Although there were no indications of internal erosion, and there is minimal hydraulic head across the dam, it

Looking west along the NRD toe, towards the left dam abutment. Note wet conditions owing to this being a groundwater discharge area. No indications of internal erosion, but clear indications of upwelling seepage. A sand and gravel drainage blanket is recommended for construction in the toe area, to protect against potential internal erosion.

is recommended that a weighted filter blanket be constructed, extending from Sta. 0+020 to 0+300 m.

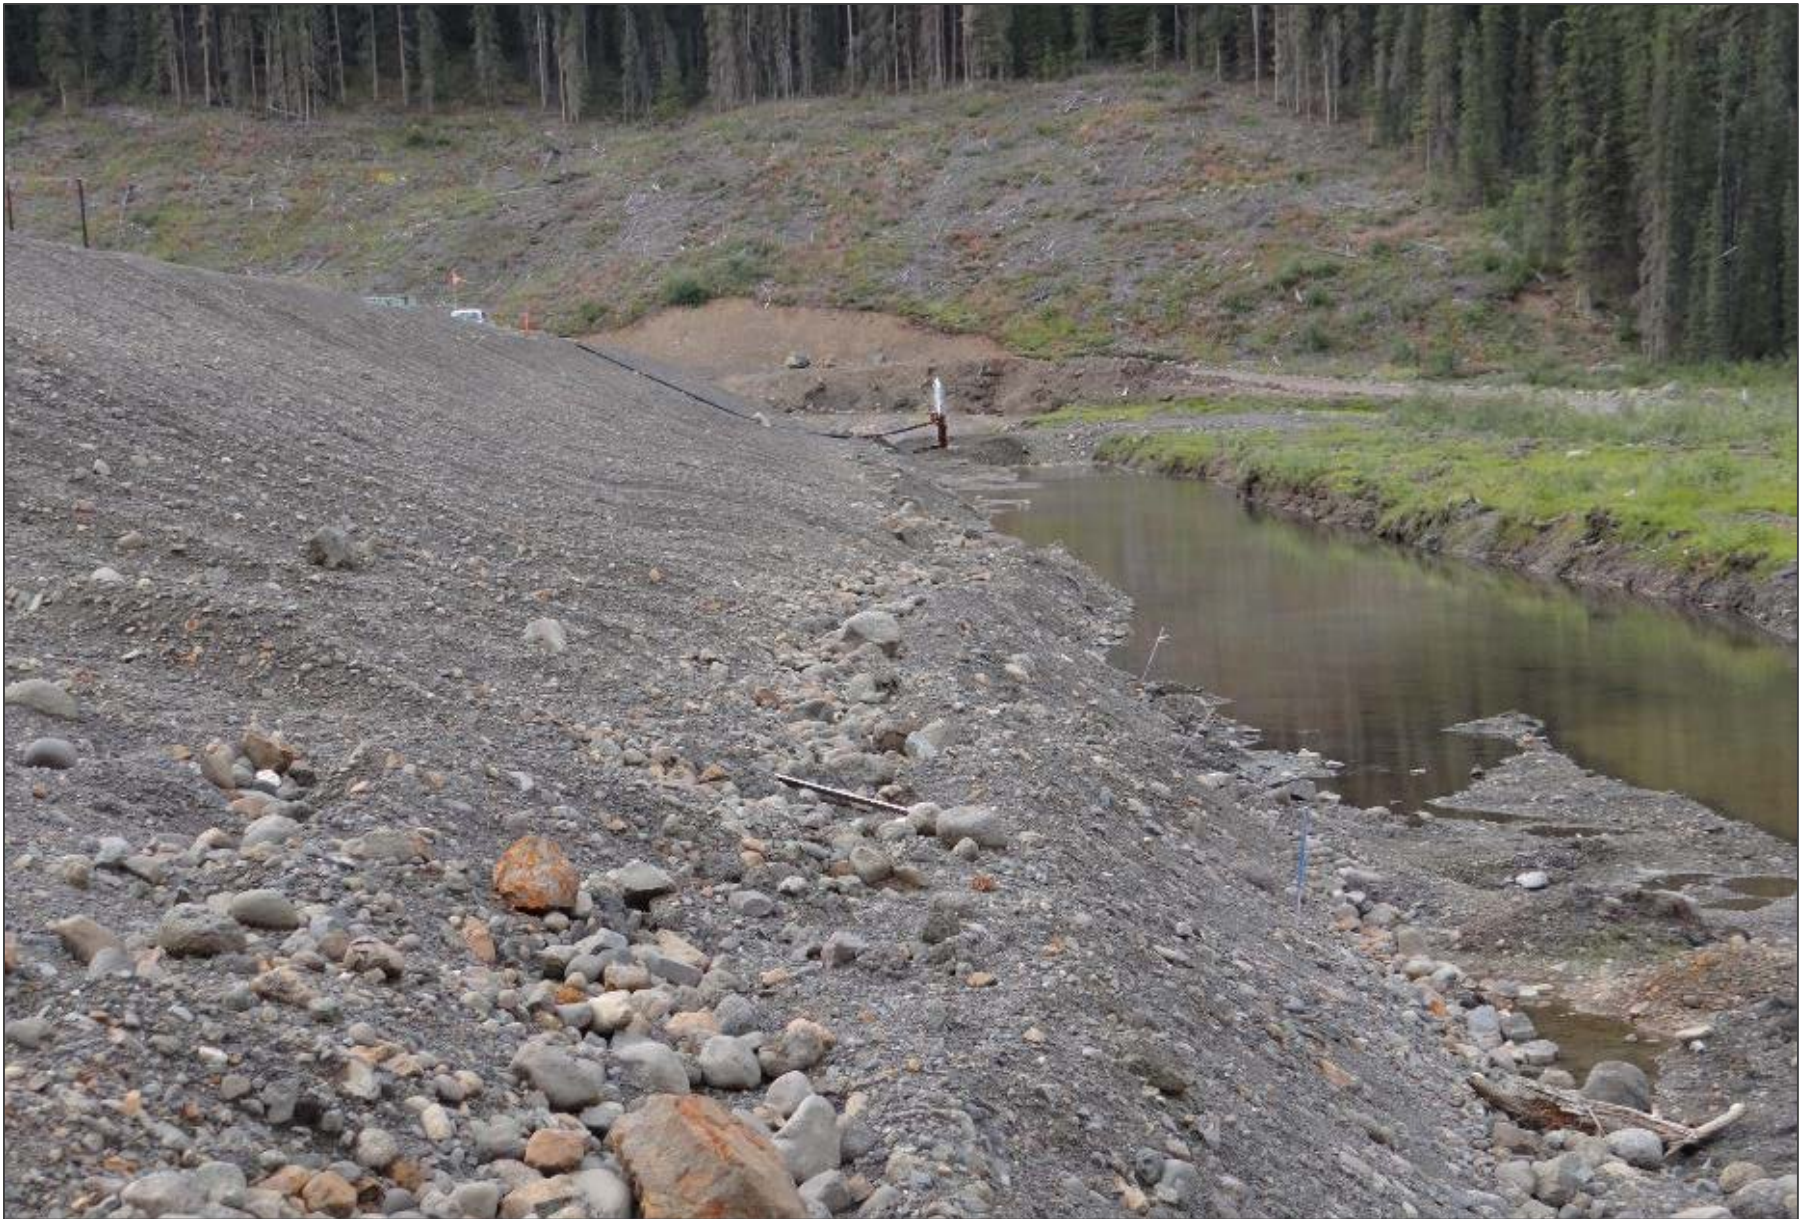
Contributing to the wet conditions at the toe of the dam is the discharge from artesian groundwater well 11-NPW2 (see Photo 55). The discharge from this well should be capped off, or directed to the downstream.

Looking west along the NRD toe, towards the left dam abutment. Discharge from artesian groundwater well 11-NPW2, and upwelling seepage, resulting in water ponding at the toe of the dam. A filter blanket is to be constructed at the toe of the dam to reduce potential for internal erosion of foundation soils.

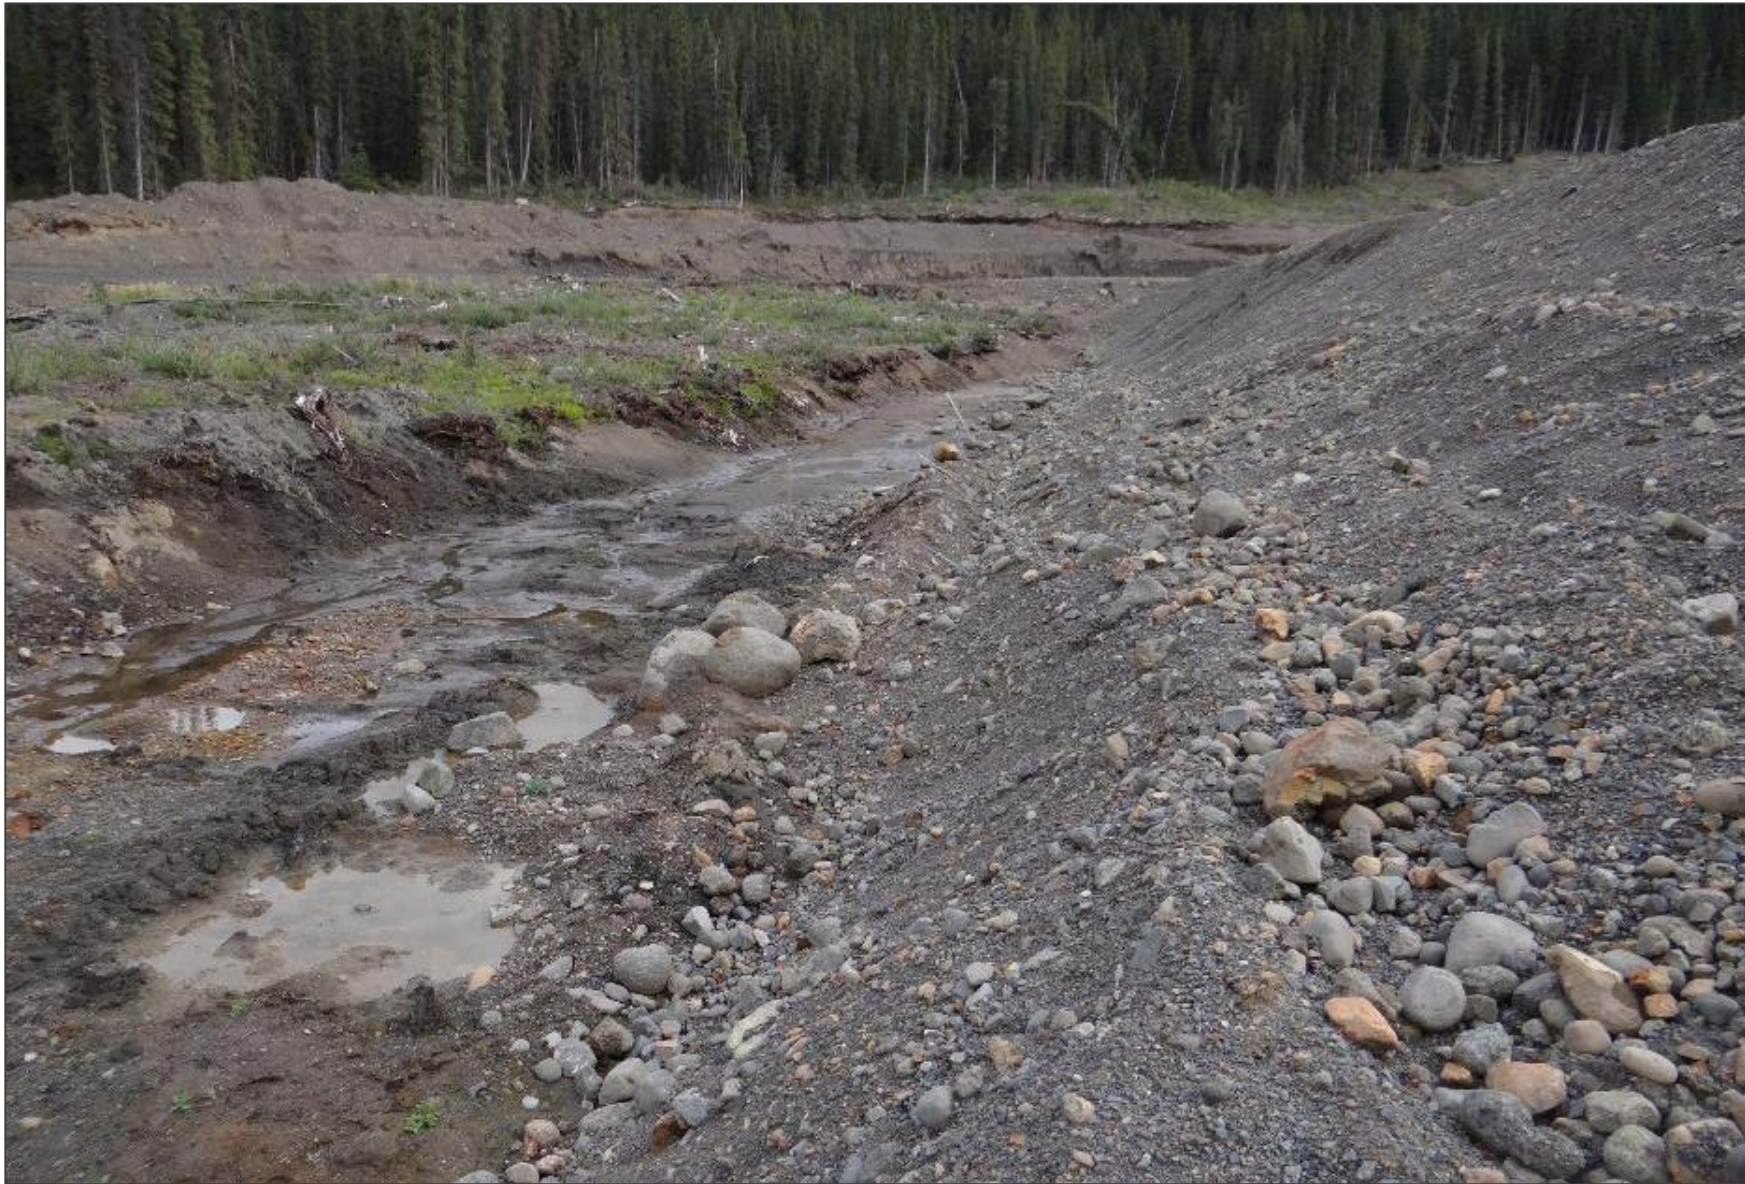
Looking east along the NRD toe and downstream face, towards the right dam abutment. Note wet toe conditions.

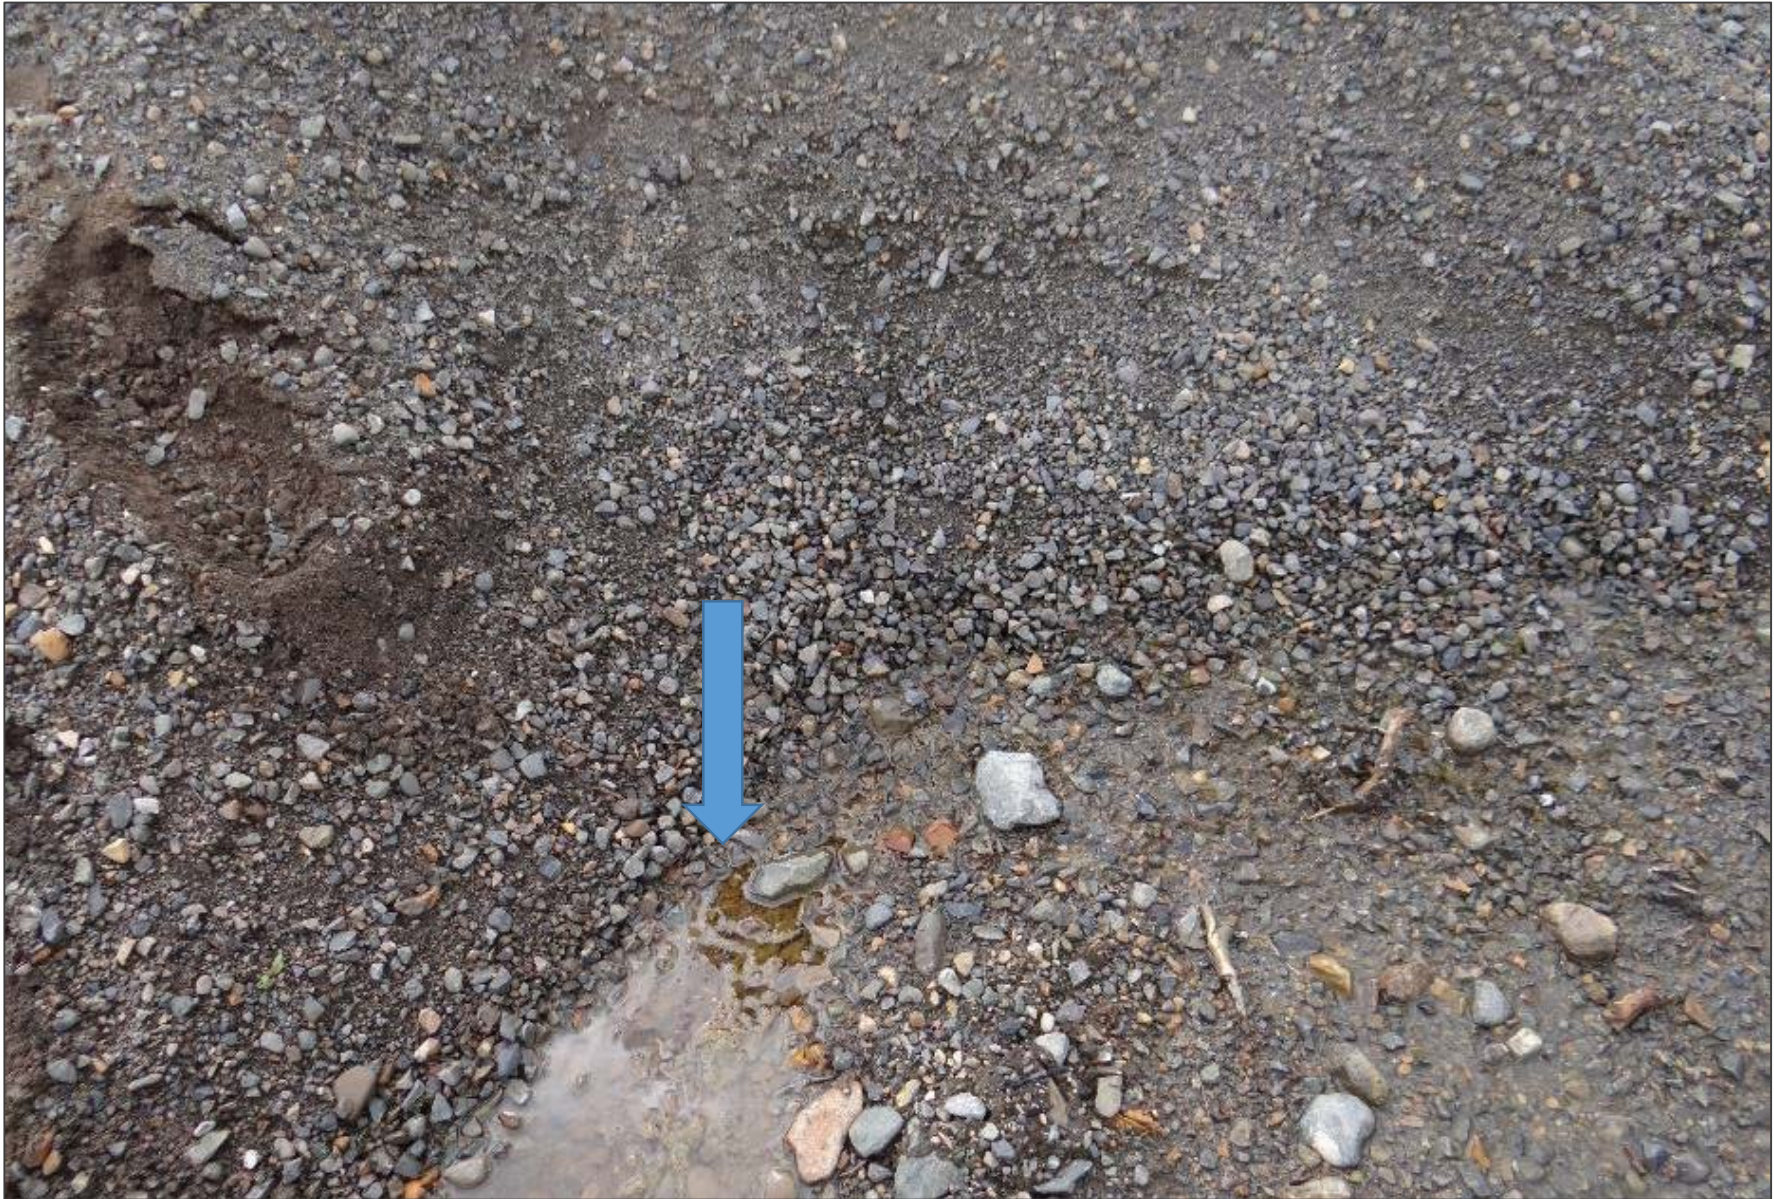
**Arrow indicates upwelling seepage at the toe of the NRD – to be remediated via a filter blanket.**
